MEMORANDUM

RE: Commodore 5 Tunnel Rehabilitation Concept; Creede, Colorado;
D&A Job No. CG-0547.002.00

This updated memorandum is in response to your request of November 29, 2017 to describe a rehabilitation concept for the Commodore 5 Tunnel near Creede, Colorado which could be implemented as a time critical removal action (TCRA). This rehabilitation would complement the Flow Control Interim Action and other options evaluated in the *Focused Feasibility Study for Flow Control; Nelson Tunnel/Commodore Waste Rock Pile NPL Site* by HDR and Deere & Ault Consultants Inc. dated March 27, 2017. The goal of this rehabilitation would be to maintain access from the portal to the Del Monte Shaft, secure the ground to keep material from impounding water in the Commodore 5, and maintain access to the Nelson Tunnel until the longer-term remediation is implemented (assumed to be within 15 years). This memo is intended to be the first step in developing plans for the rehabilitation of the Commodore 5 Tunnel as a TCRA.

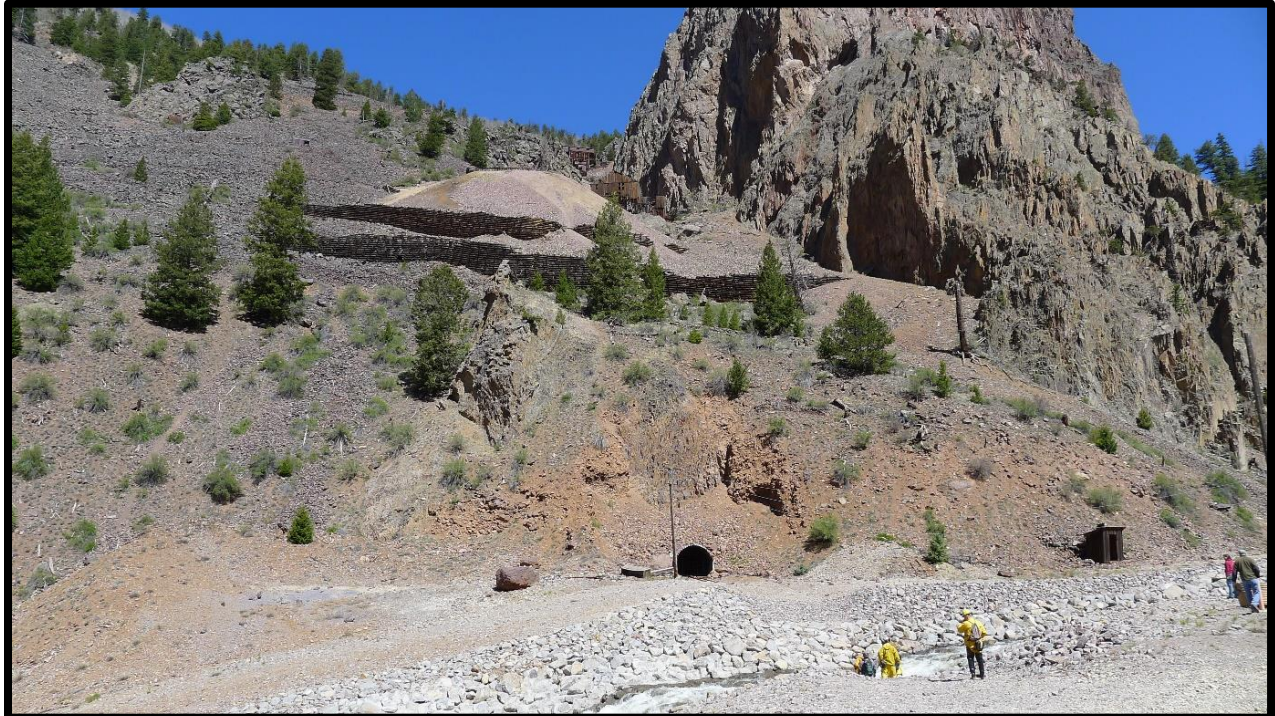
Photo 1: Commodore Levels 3, 4, and 5 Portal Area with Willow Creek in front

aging wooden planks. Access to the bridge is a narrow trail, inadequate for equipment larger than a small skid steer loader. The contractor should install a temporary bridge of appropriate size and capacity for their equipment and to accommodate seasonal creek flow changes. Other portal area work such as installing generators, lights, storage, offices, etc., would be included in a mobilization cost. See **Photos 1-4**.

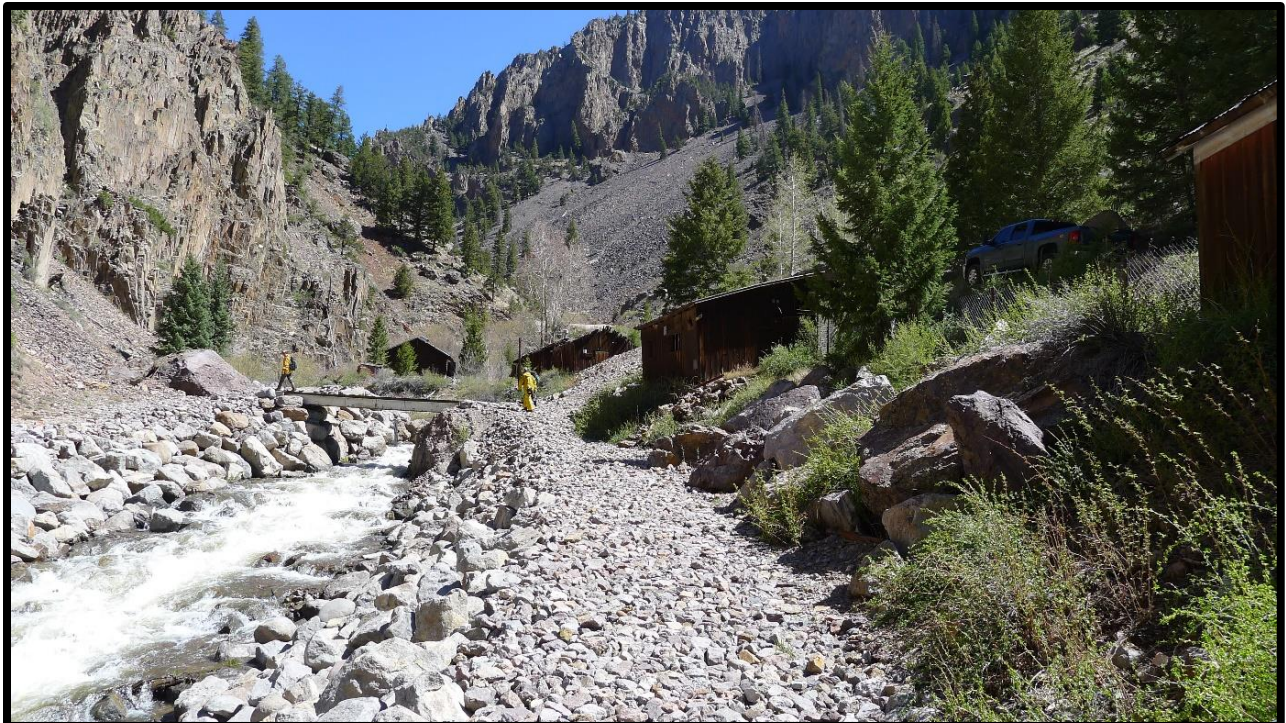
At this time, work in the portal area will be limited to activities the contractor will need for access and staging during construction. The key issue is that the existing bridge is narrow with

Photo 2: Willow Creek at portal looking upstream; Note small bridge and path for access

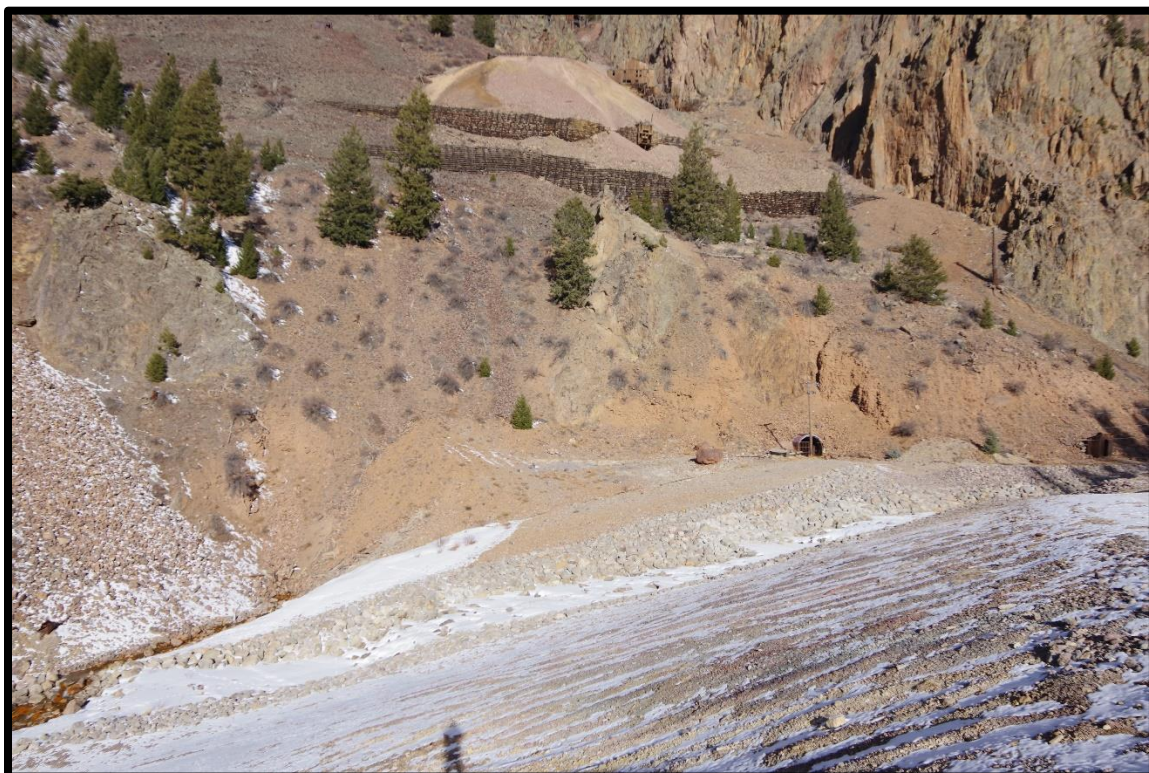
Photo 3: Nelson Tunnel and Commodore Level 5 Portal; Note steep grading left of portal

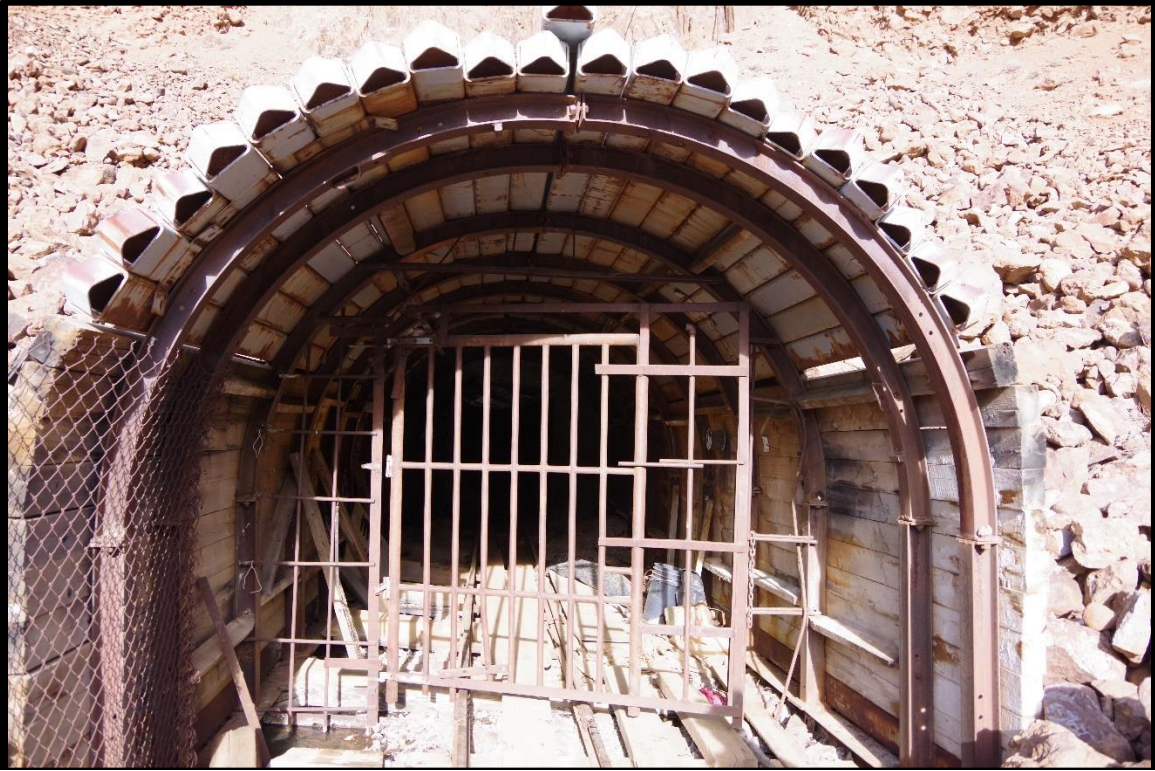
Photo 5: Portal Gate to be replaced

Rehabilitation in this segment will consist of scaling, mucking, debris removal, ditch cleaning, track repair, replacement of the portal gate, and the installation of two air doors. The Manhattan Drift and another smaller room, near station 12+00, can serve as storage during construction.

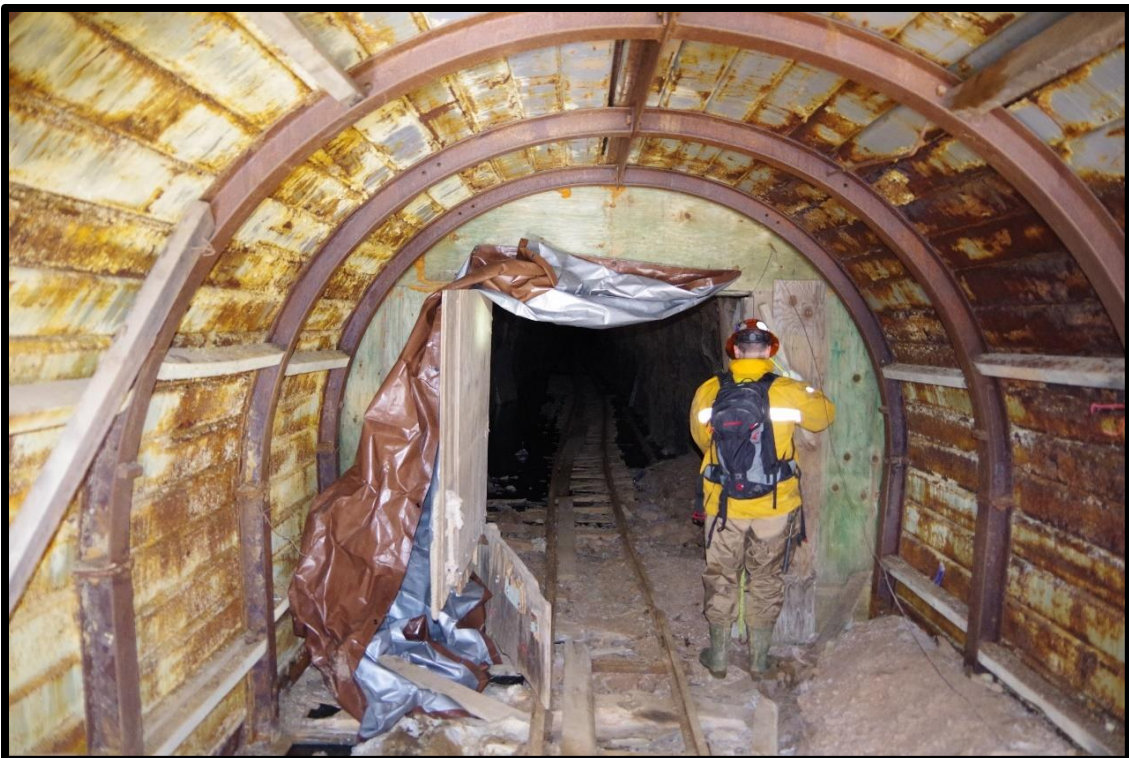
Photo 6: First Air Door to be replaced

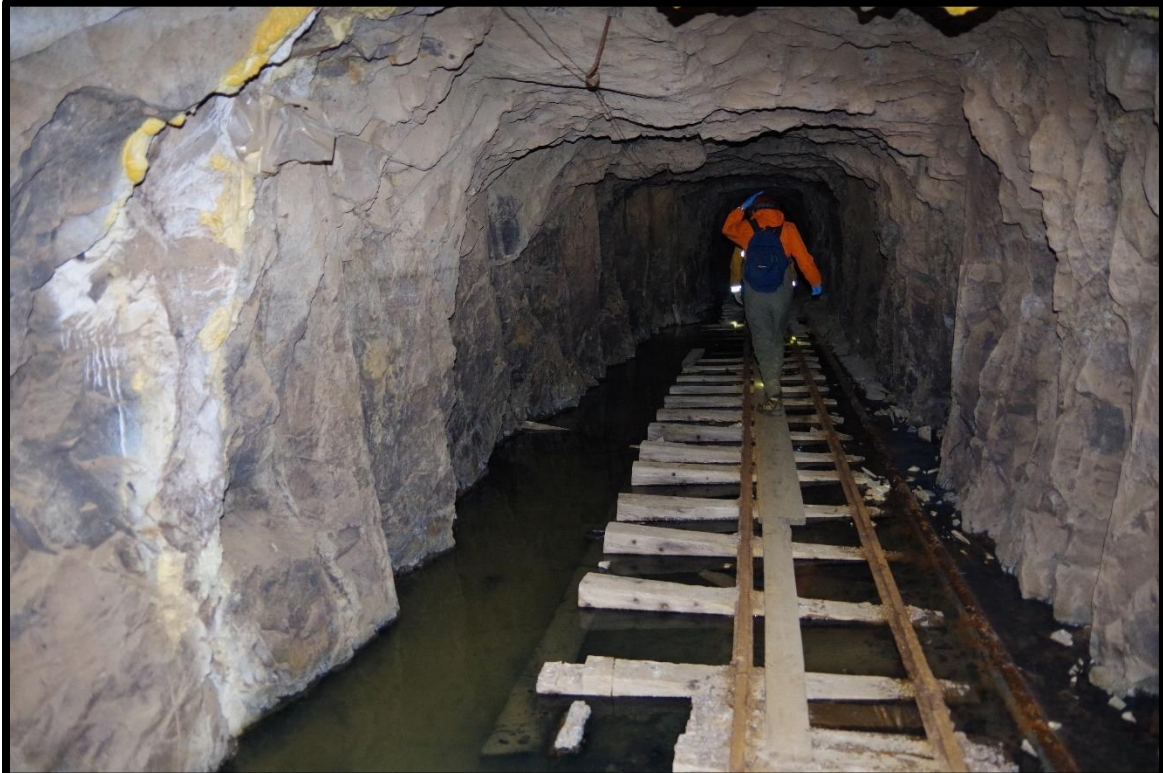
Photo 7: Floating rail ties and poor drainage near 1+00

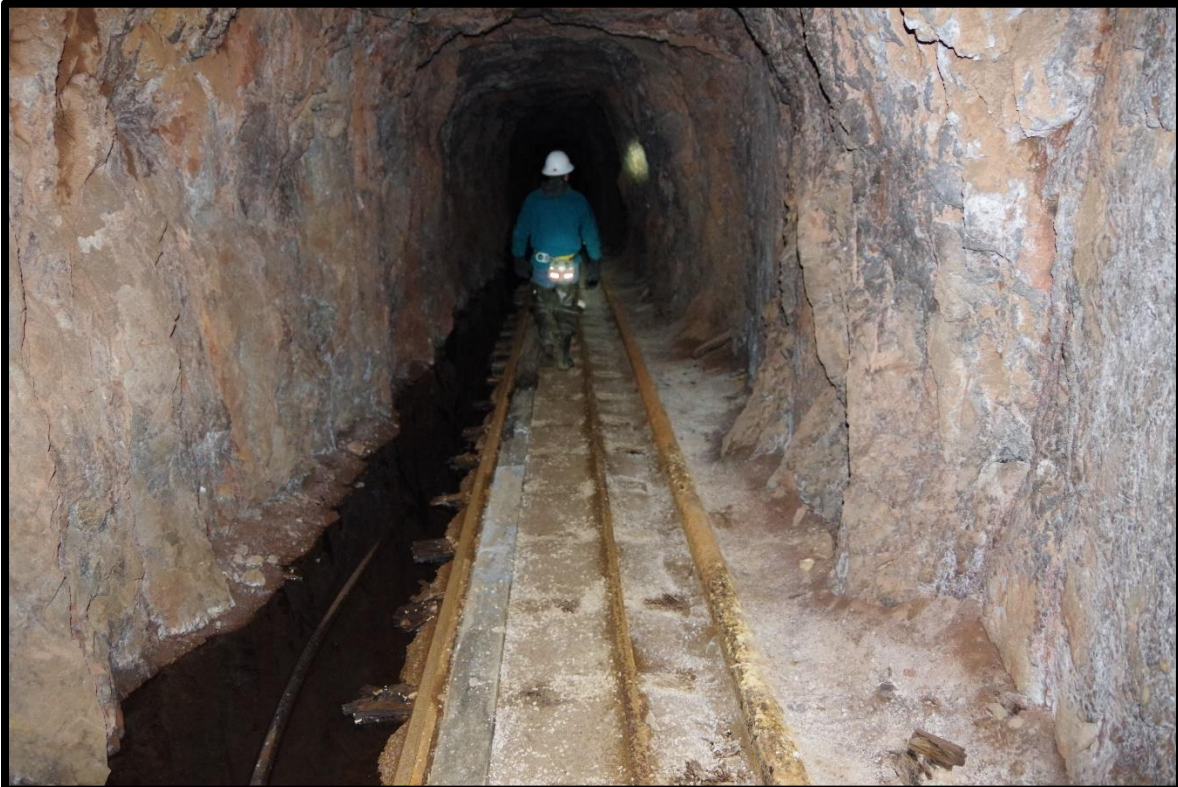
Segment 2 consists of the cross cut adit from the portal to the Daylight Corner where the adit intersects the Amethyst Vein. The first half of the segment was driven through slabby, closely spaced vertically jointed rhyolitic tuff. The second half is in a much more densely welded and massive rhyolitic tuff that eventually becomes the footwall of the Amethyst Vein (specifically the Willow Creek Member of the Bachelor Mountain Tuff). See the Geologic Map in **Figure 6**. Both areas were dry during our site visit. No ground support is currently installed. The track was generally in good shape after the first 200 feet. Several gallons per minute of water flowed through a ditch at the side of the track. See **Photos 5-11**.

Photo 11: Typical conditions in Commodore 5 Cross Cut

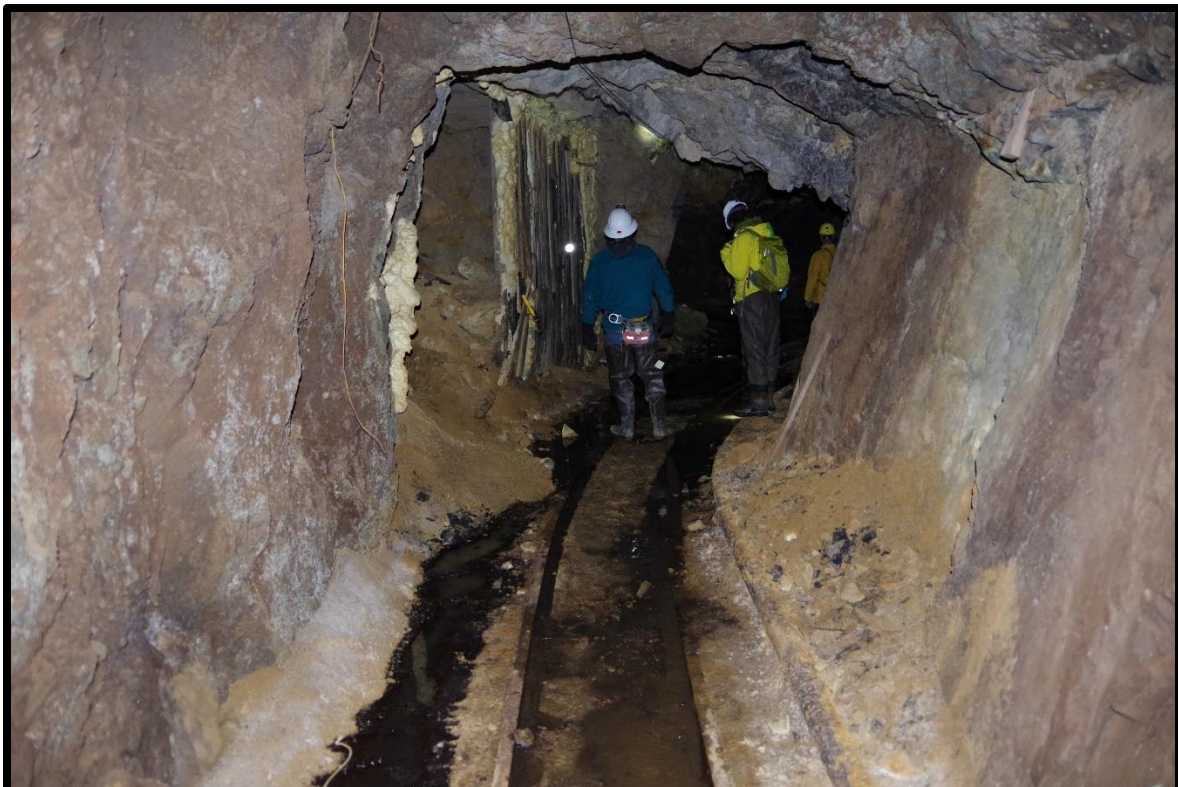
Photo 12: Daylight Corner with collapsed raise from Nelson Tunnel in left rib

While the rock is generally good, the large span of the intersection and importance of keeping this area accessible leads us to recommend scaling, pattern bolting (6' long), and installing wire mesh. The same applies at the wide section where the collapsed raise from the Nelson intersects the floor (22+10). Two small but high stopes in the middle of this segment should have steel sets, lagging, and foam installed underneath them to limit raveling.

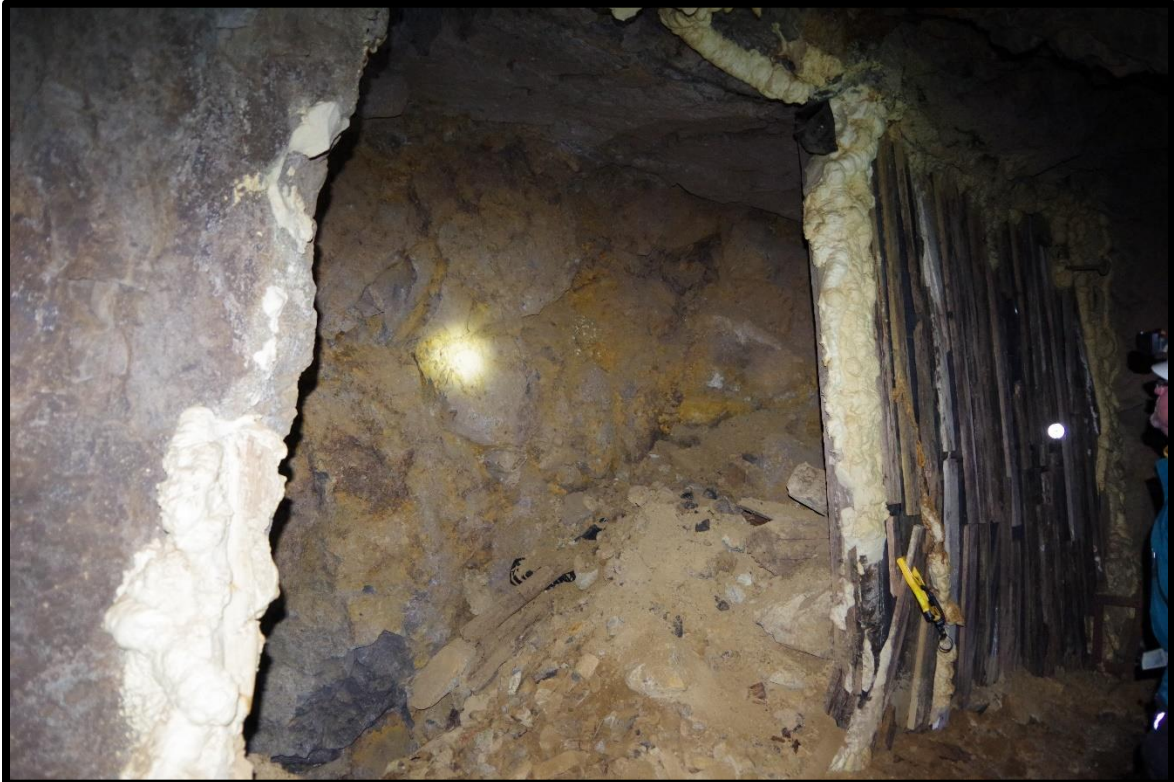
Photo 13: Close up of collapsed raise from Nelson Tunnel

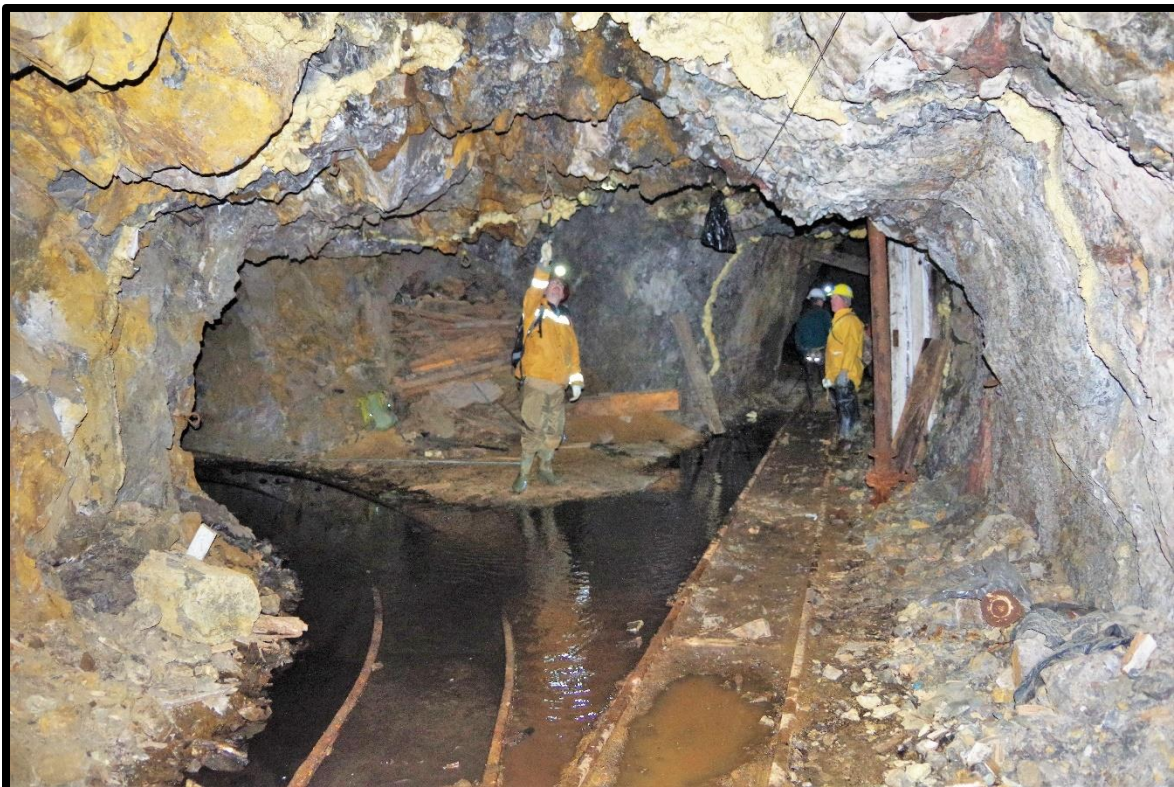
Photo 14: Intersection with McClure Cross Cut to left; Daylight Winze to right

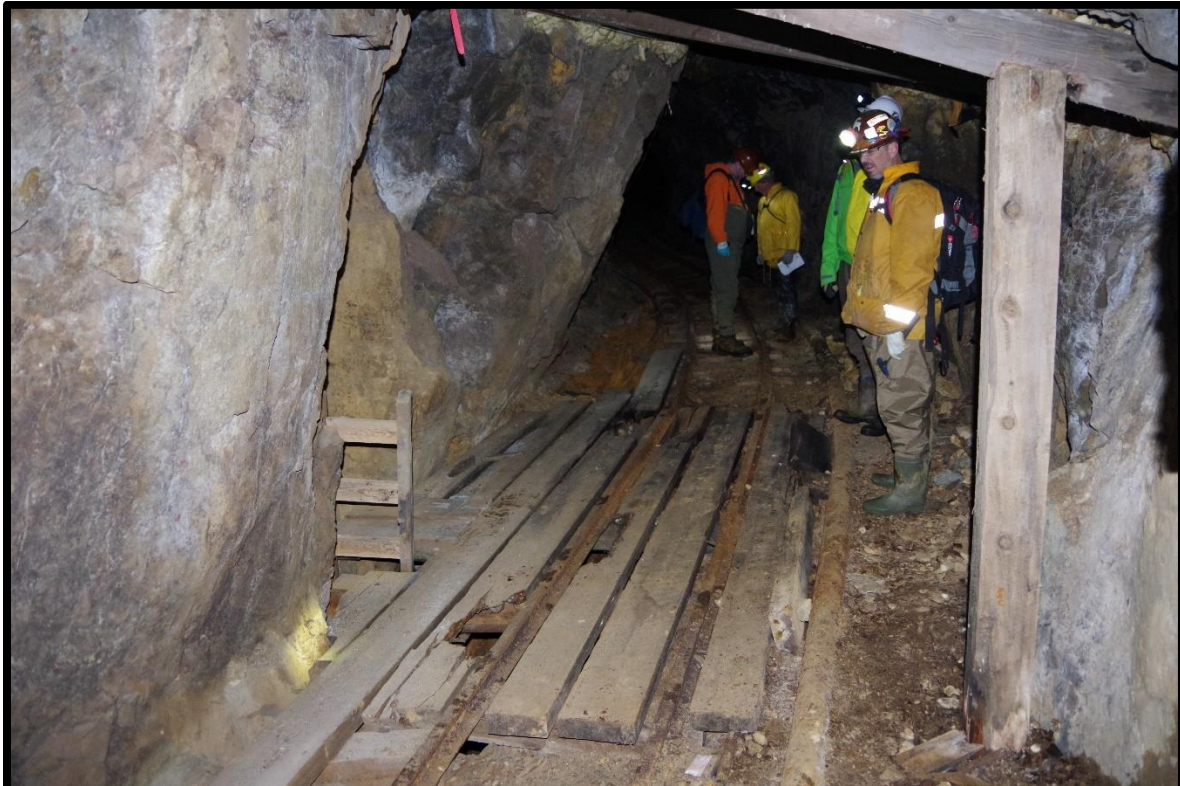
Photo 16: Overview of Daylight Winze; Note decayed wood cover

Significant work is also needed at the Daylight Winze and the raise above it. Due to its importance of acting as the last drain into the Nelson Tunnel, the Daylight Winze should be fully rehabilitated by scaling, bolting, and installing new ladders and landings made of non-decaying or corroding material such as fiber reinforced plastic (FRP). This work would take place above the Nelson Tunnel without impacting the impounded mine pool areas. A cover capable of supporting vehicle traffic and allowing water inflow should also be installed. We anticipate the cover consisting of a concrete collar with coated steel beam supports and grated FRP cover.

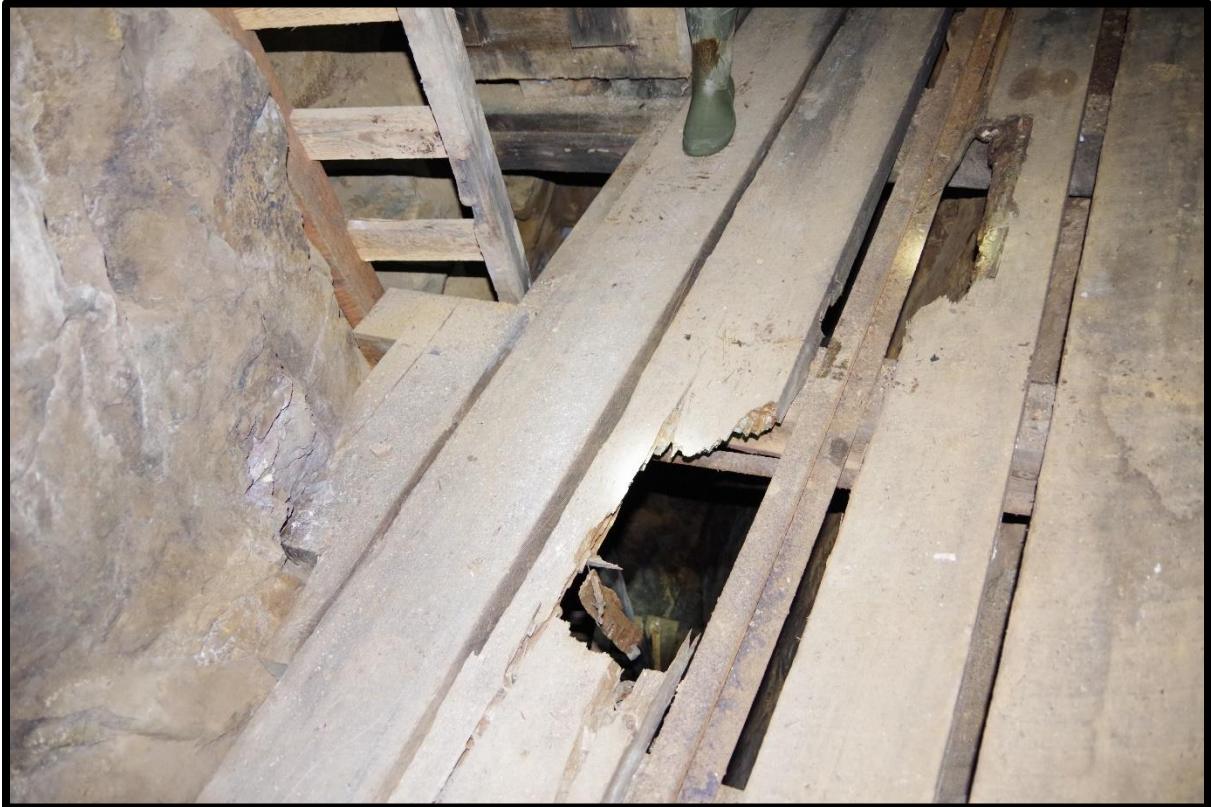
Photo 17: Daylight Winze with rotten wood cover

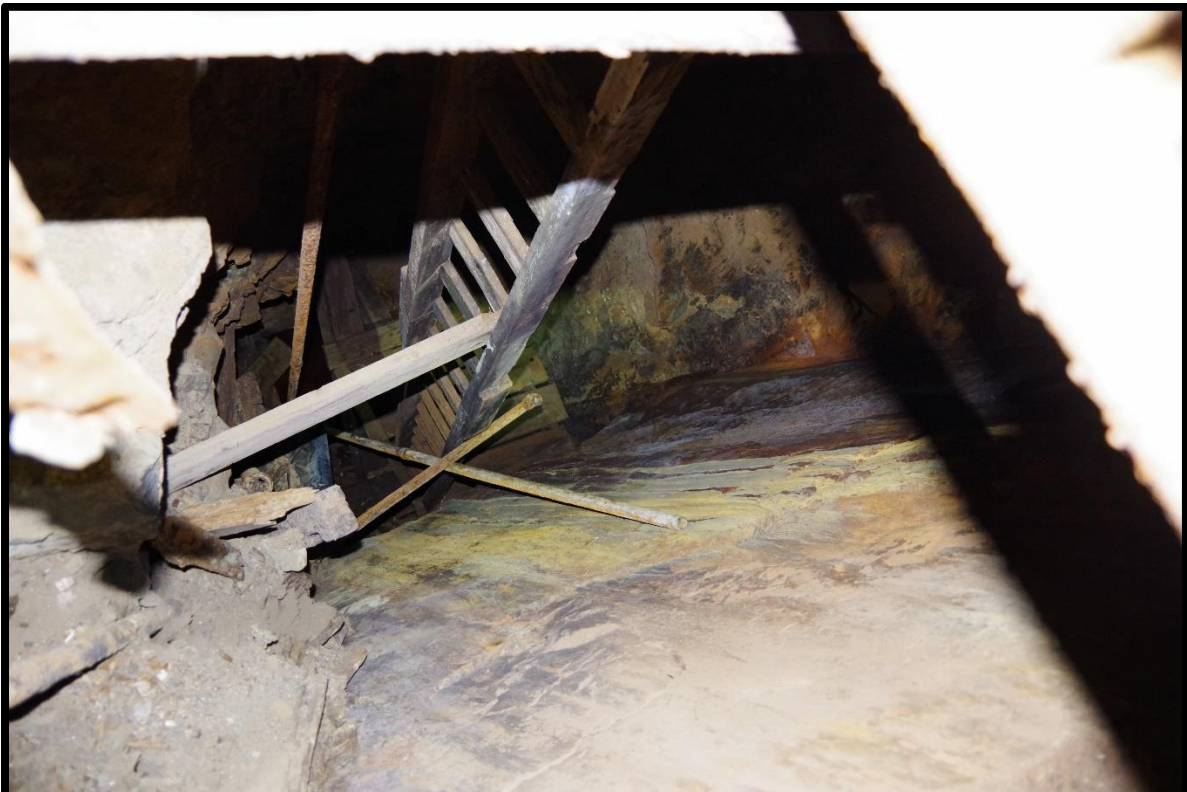
Photo 18: Looking down Daylight Winze: Note smooth footwall, ladder, and landing

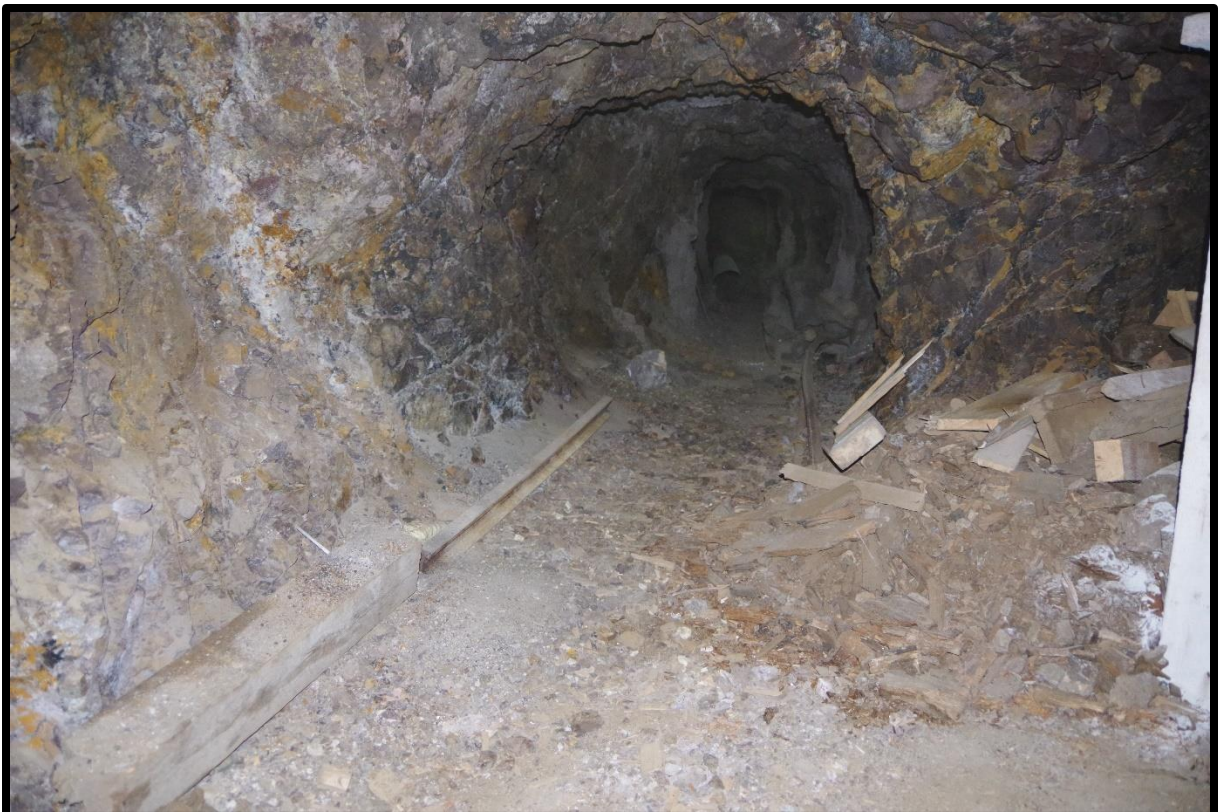
Photo 20: McClure Cross Cut with debris

Based on our observations, only minimal cleanup work will be required in the McClure Cross Cut area. The moldy canopy may have to be removed and replaced with bolts and wire mesh, depending on the ground conditions behind it. The bulk of the work will be in the Bachelor Shaft where the untreated wood ladders and landings should be replaced with fiber glass reinforced plastic ladders and landings, anchored into the rock wall. **Figure 5** shows the Bachelor Shaft in cross section. Note that the work would be limited to the Bachelor Shaft and landing, without impacting or accessing the Nelson Tunnel.

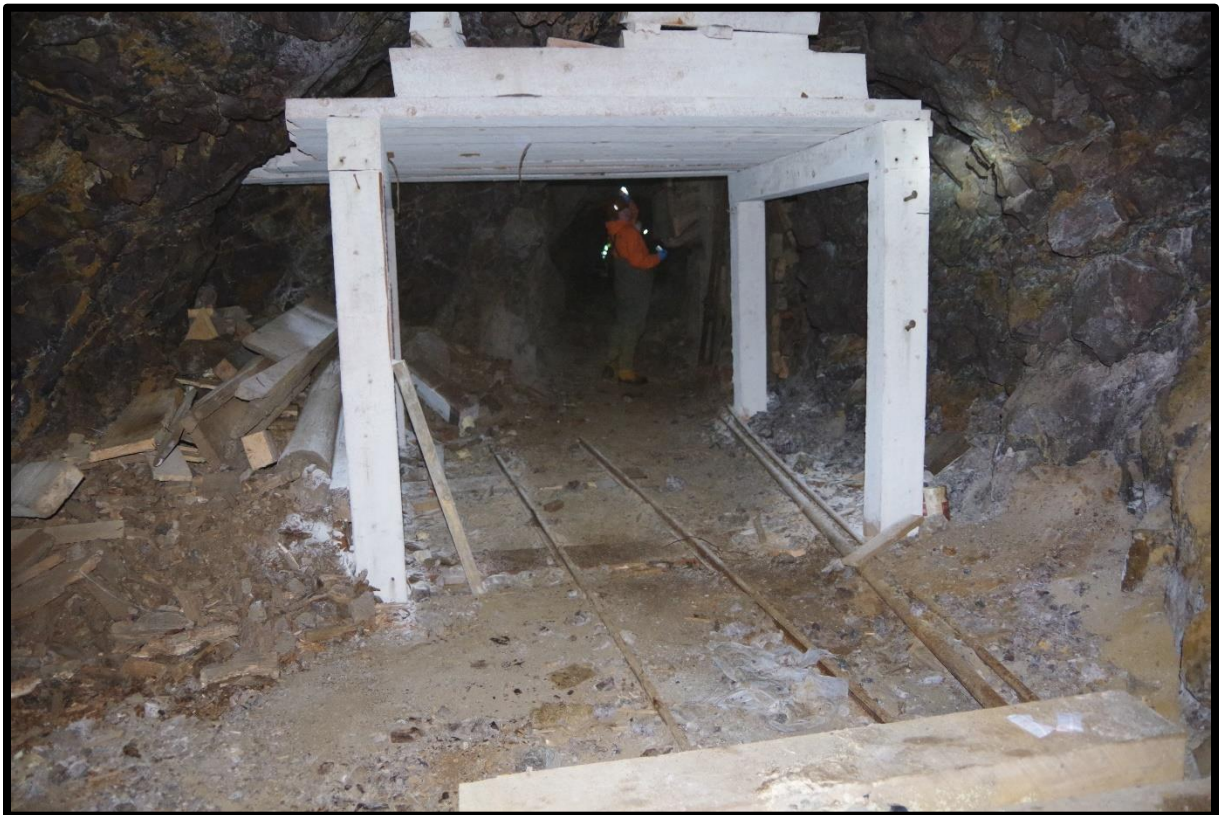
The rock in the McClure Crosscut, in the hanging wall, consists of massive rhyolitic tuff, specifically the Campbell Mountain Member of the Bachelor Mountain Tuff. It was dry during our site visit and contained some ore chutes from upper levels. No ground support was noted but there was a moldy wood canopy possibly providing protection from small debris. See **Photos 20-31**.

Photo 21: Moldy canopy in McClure Cross Cut

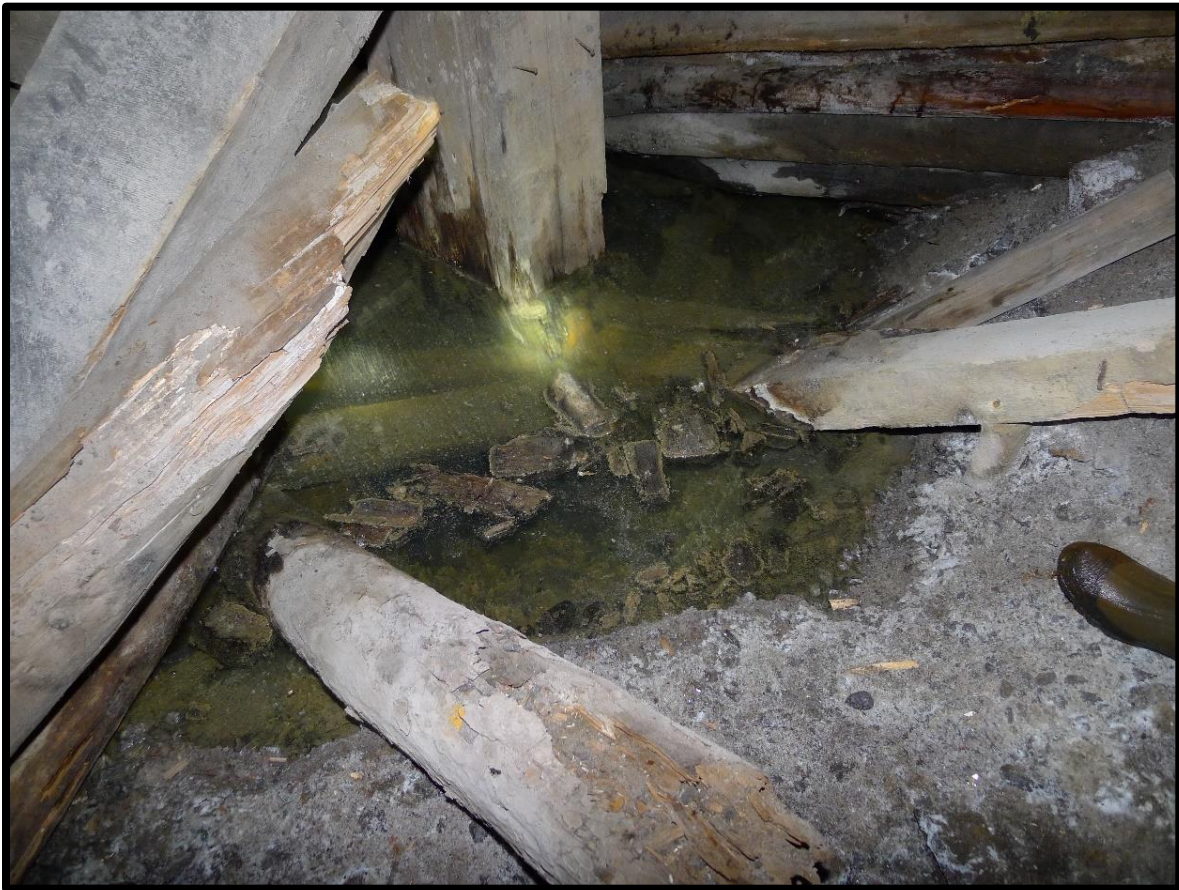
Photo 31: Collapsed Timbers at Bachelor Shaft Nelson Tunnel landing

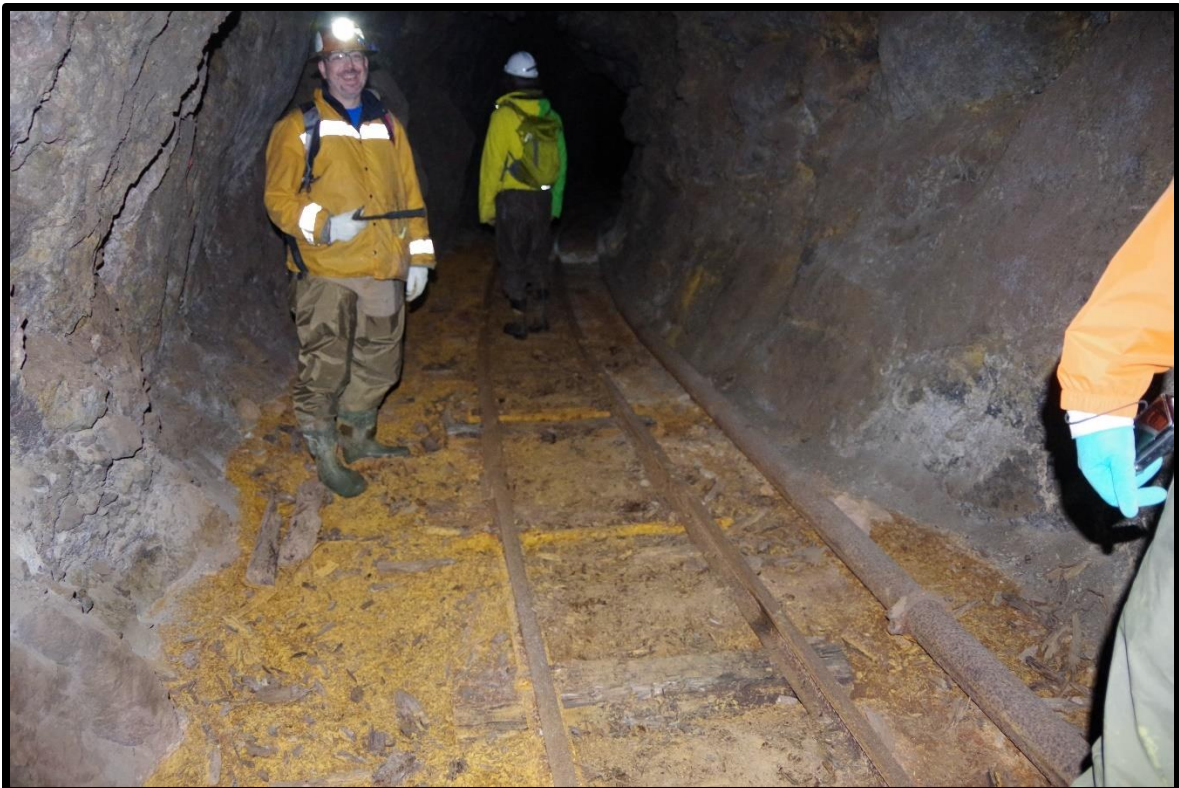
Photo 32: Decayed rail ties near 25+00; Note staining from water

Rehabilitation work in this segment will require considerable time, cost, and effort. While the removal of the wood and rock debris from the floor is a significant undertaking, the main cost will be in the installation of steel stulls and steel sets. At numerous locations, the back has been stoped up and supported with timber posts. Most of these are rotting and need to be replaced. Removing and disposing of the timber will also be a major cost factor, particularly if they must be removed from site. There are also several raises that ravel down material. For safety and to keep the Commodore 5 open, these areas will need lagged steel sets with foam backfill across the openings. For safety, this work will have to be carried out sequentially from the Daylight Winze to the Del Monte Raise.

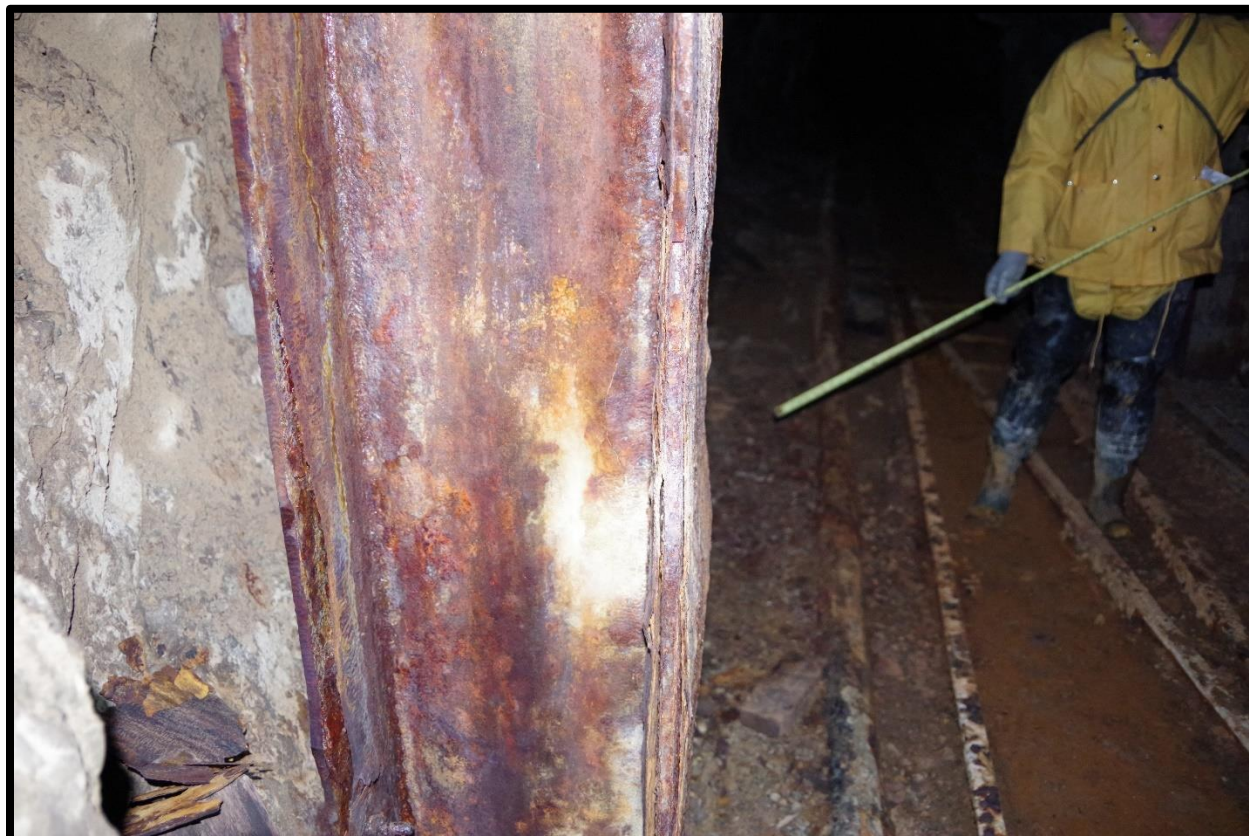
Photo 34: Close up of Archimedes Raise steel posts; Note corrosion and delamination

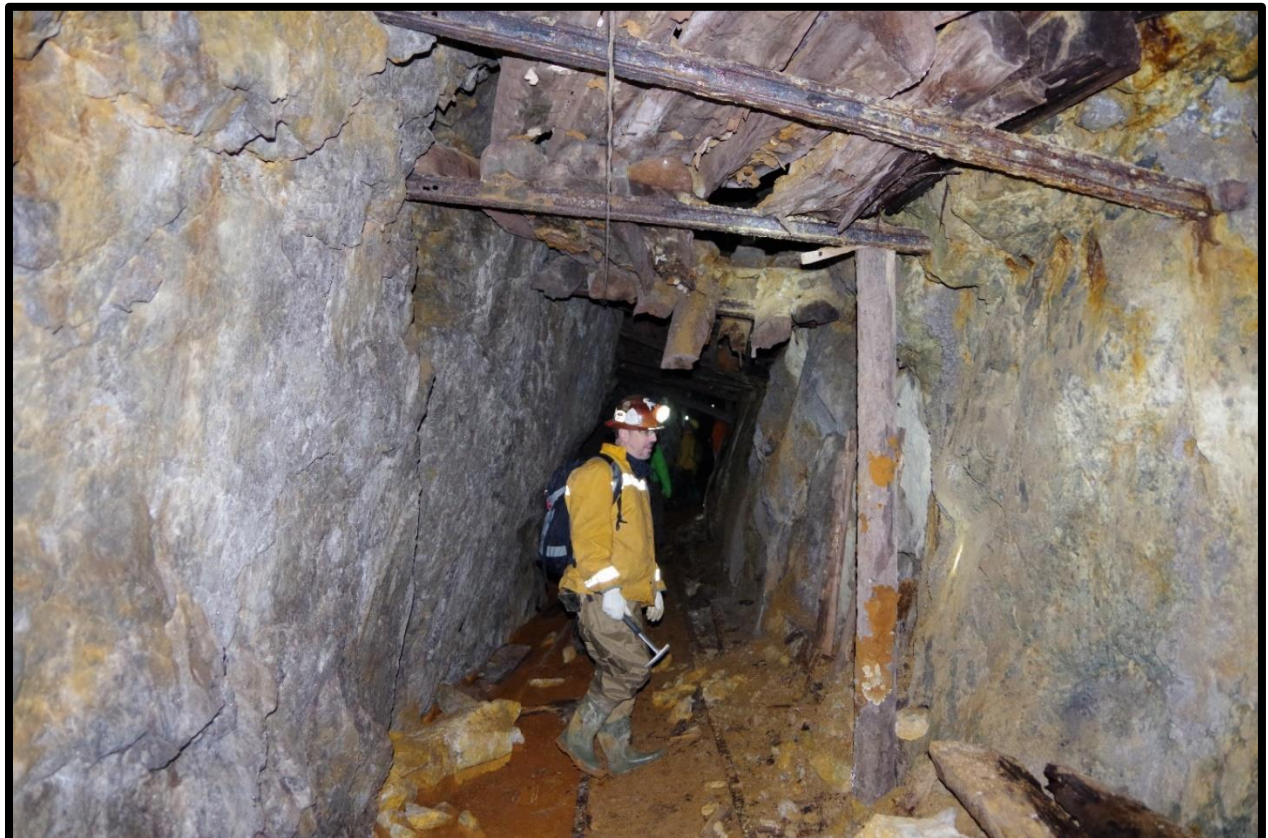
Photo 36: Steel rail stulls with rotten timber lagging 30+50

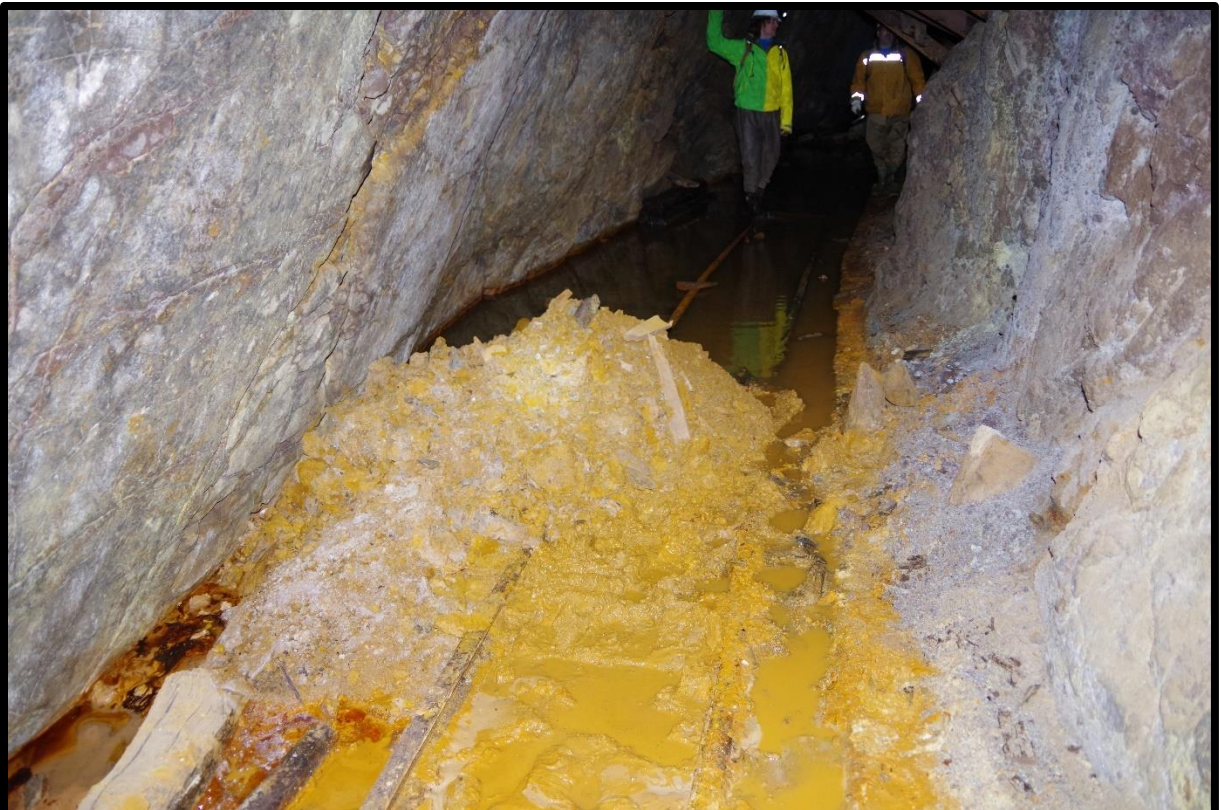
Photo 38: Debris from actively raveling raise near 32+00; Note water backed up behind

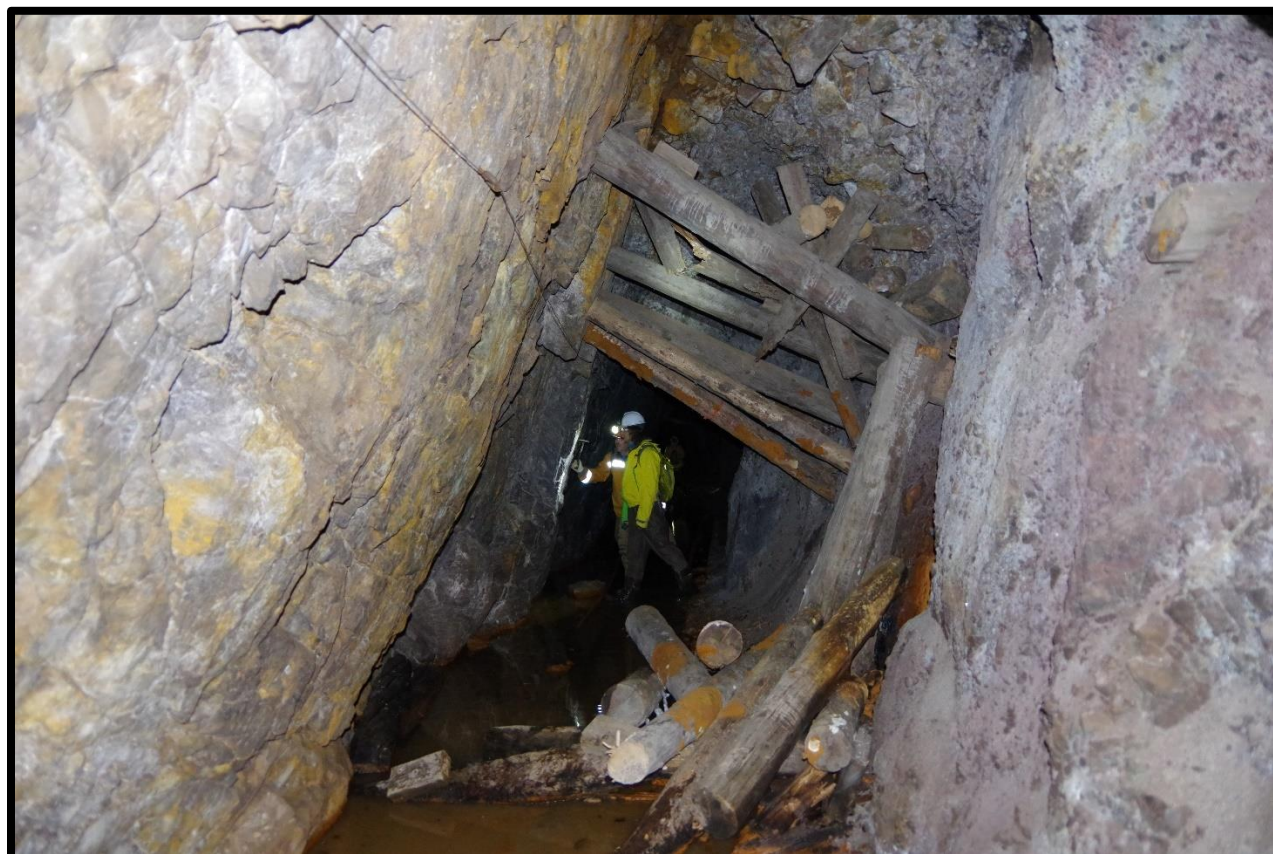
Photo 40: Failed timber stulls near 32+80
