MEMORANDUM

RE: Commodore 5 Tunnel Rehabilitation Concept; Creede, Colorado;
D&A Job No. CG-0547.002.00

This updated memorandum is in response to your request of November 29, 2017 to describe a rehabilitation concept for the Commodore 5 Tunnel near Creede, Colorado which could be implemented as a time critical removal action (TCRA). This rehabilitation would complement the Flow Control Interim Action and other options evaluated in the *Focused Feasibility Study for Flow Control; Nelson Tunnel/Commodore Waste Rock Pile NPL Site* by HDR and Deere & Ault Consultants Inc. dated March 27, 2017. The goal of this rehabilitation would be to maintain access from the portal to the Del Monte Shaft, secure the ground to keep material from impounding water in the Commodore 5, and maintain access to the Nelson Tunnel until the longer-term remediation is implemented (assumed to be within 15 years). This memo is intended to be the first step in developing plans for the rehabilitation of the Commodore 5 Tunnel as a TCRA.

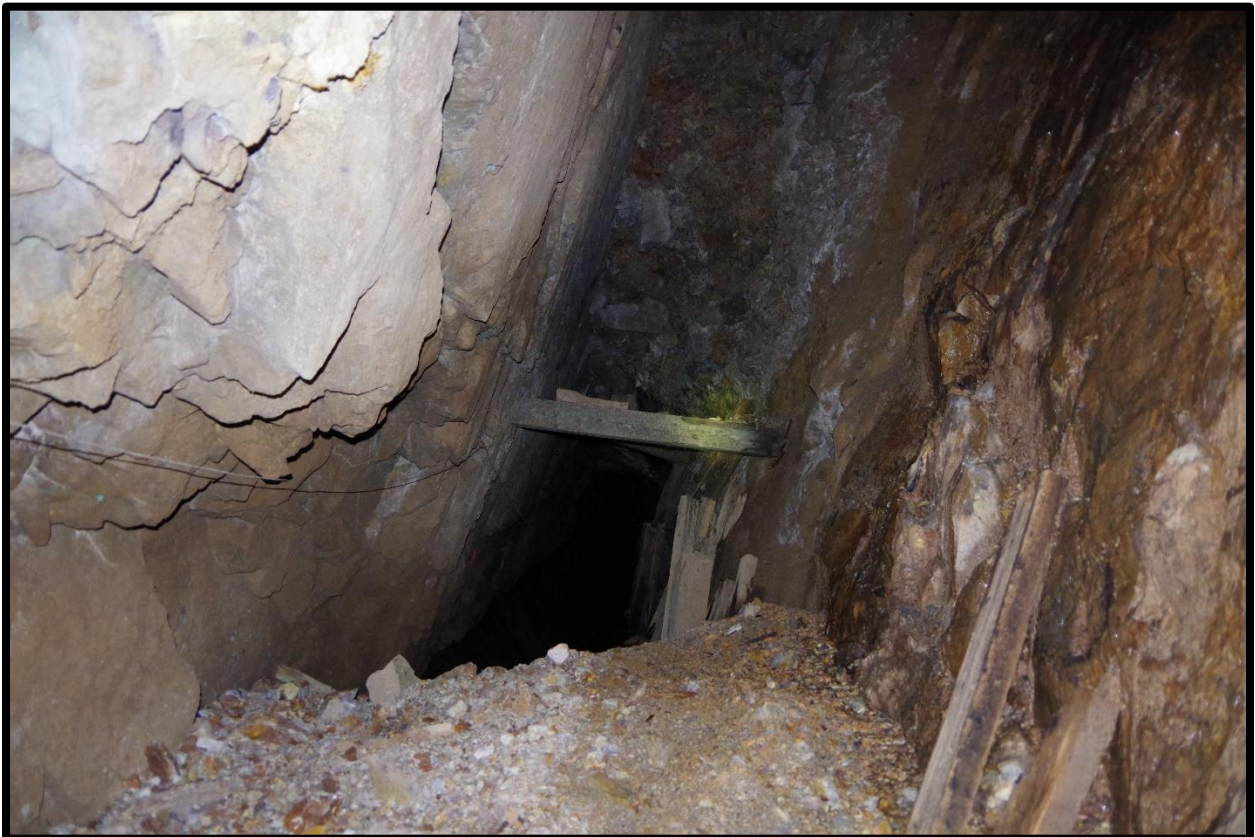
The Commodore Shaft area consists of two large underground chambers, neither of which had any ground support. This demonstrates the generally good rock quality in the foot wall in this area. North of the Commodore Shaft, the ground becomes blockier and weaker. A large roof fall by the 44 Raise caused mine pool two to three feet deep to build up behind it. At various locations, the tunnel curves around sections of bad ground where the main drive had been abandoned. North of the No Name (Y02) Winze, iron staining is visible on the floor. When the Upper Mine Pool elevation exceeds that of the Del Monte Raise collar, the mine water flows from the Del Monte Raise to the No Name Winze where it drops back into the Nelson Tunnel. See **Photos 32-62**.

Photo 41: Debris pile at very active 44 Raise 36+82

An item of note is the pool behind the 44 Raise debris pile. To avoid interfering with the work, prior to removing the debris this pool should be pumped out into the nearby Commodore Shaft, allowing it to flow into the mower mine pool. Given the quantity and buffering effect of the Nelson mine pools, this is unlikely to have a significant impact on the flow out of the Nelson Tunnel. If needed, caustic could be added to the 44 Raise pool prior to pumping.

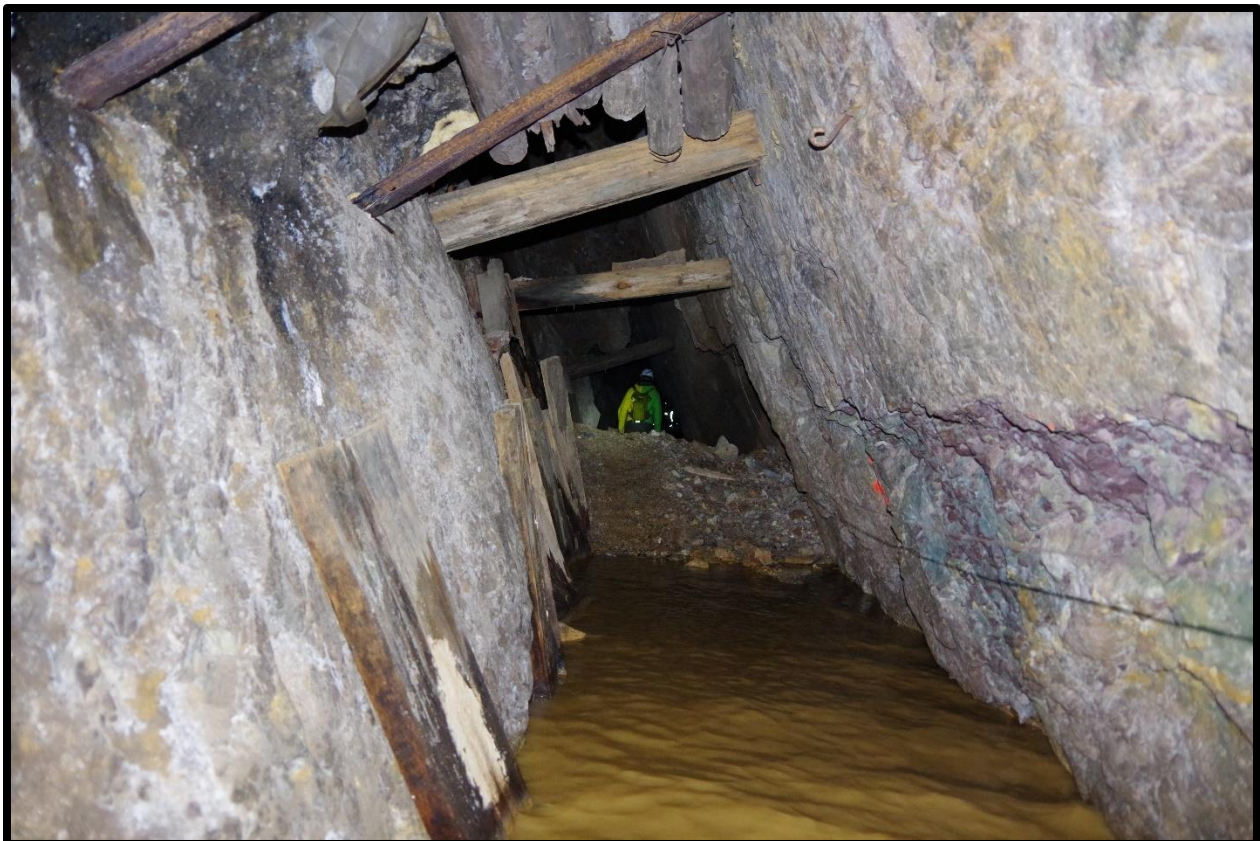
Photo 42: Debris pile at 44 Raise 36+82 looking outby; Note water ponded behind pile

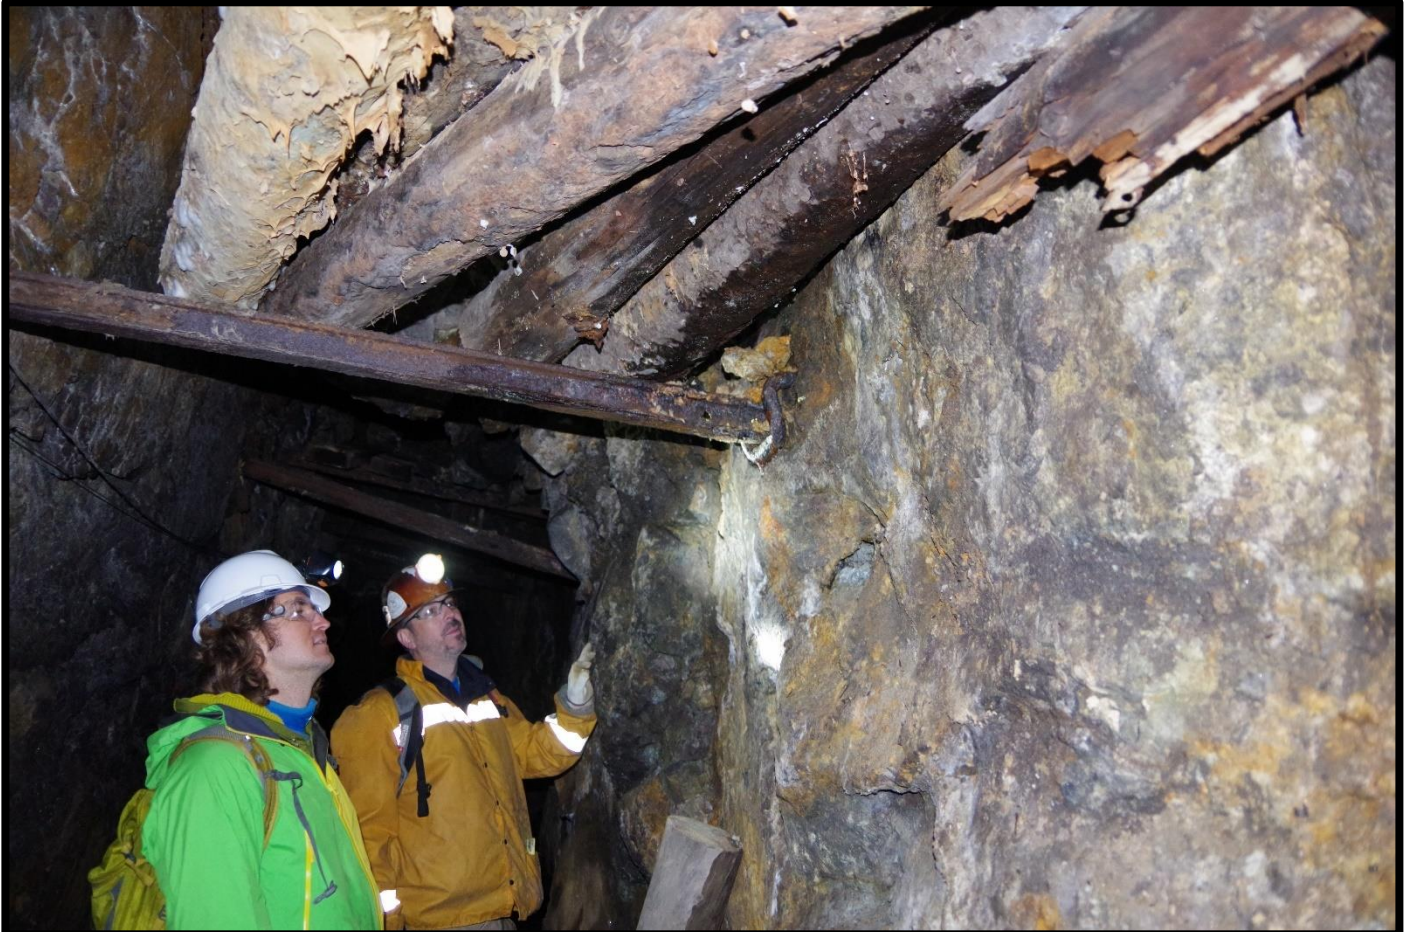
Photo 43: Steel rail stulls and rotten wood lagging near 37+50

Rehabilitation work in this segment will require considerable time, cost, and effort. While the removal of the wood and rock debris from the floor is a significant undertaking, the main cost will be in the installation of steel stulls and steel sets. At numerous locations, the back has been stoped up and supported with timber posts. Most of these are rotting and need to be replaced. Removing and disposing of the timber will also be a major cost factor, particularly if they must be removed from site. There are also several raises that ravel down material. For safety and to keep the Commodore 5 open, these areas will need lagged steel sets with foam backfill across the openings. For safety, this work will have to be carried out sequentially from the Daylight Winze to the Del Monte Raise.

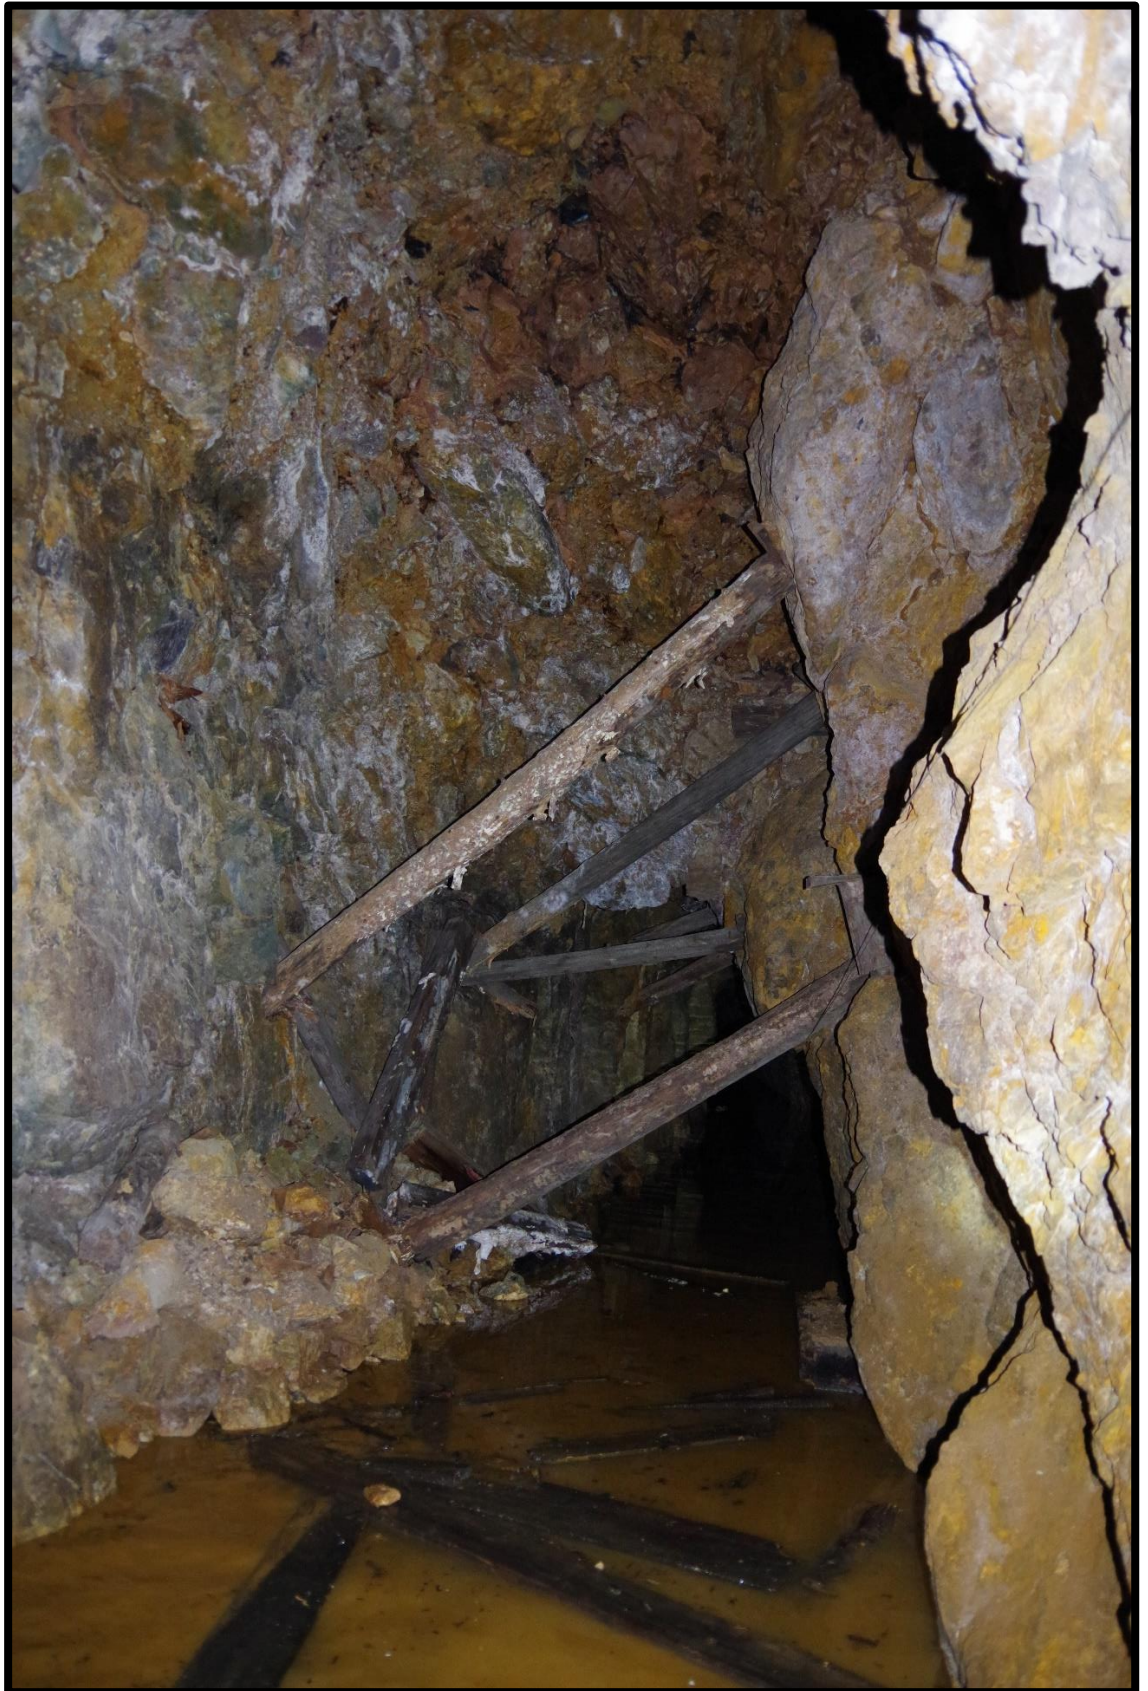
Photo 44: Large loose slabs in hanging wall near 38+10; View is outby

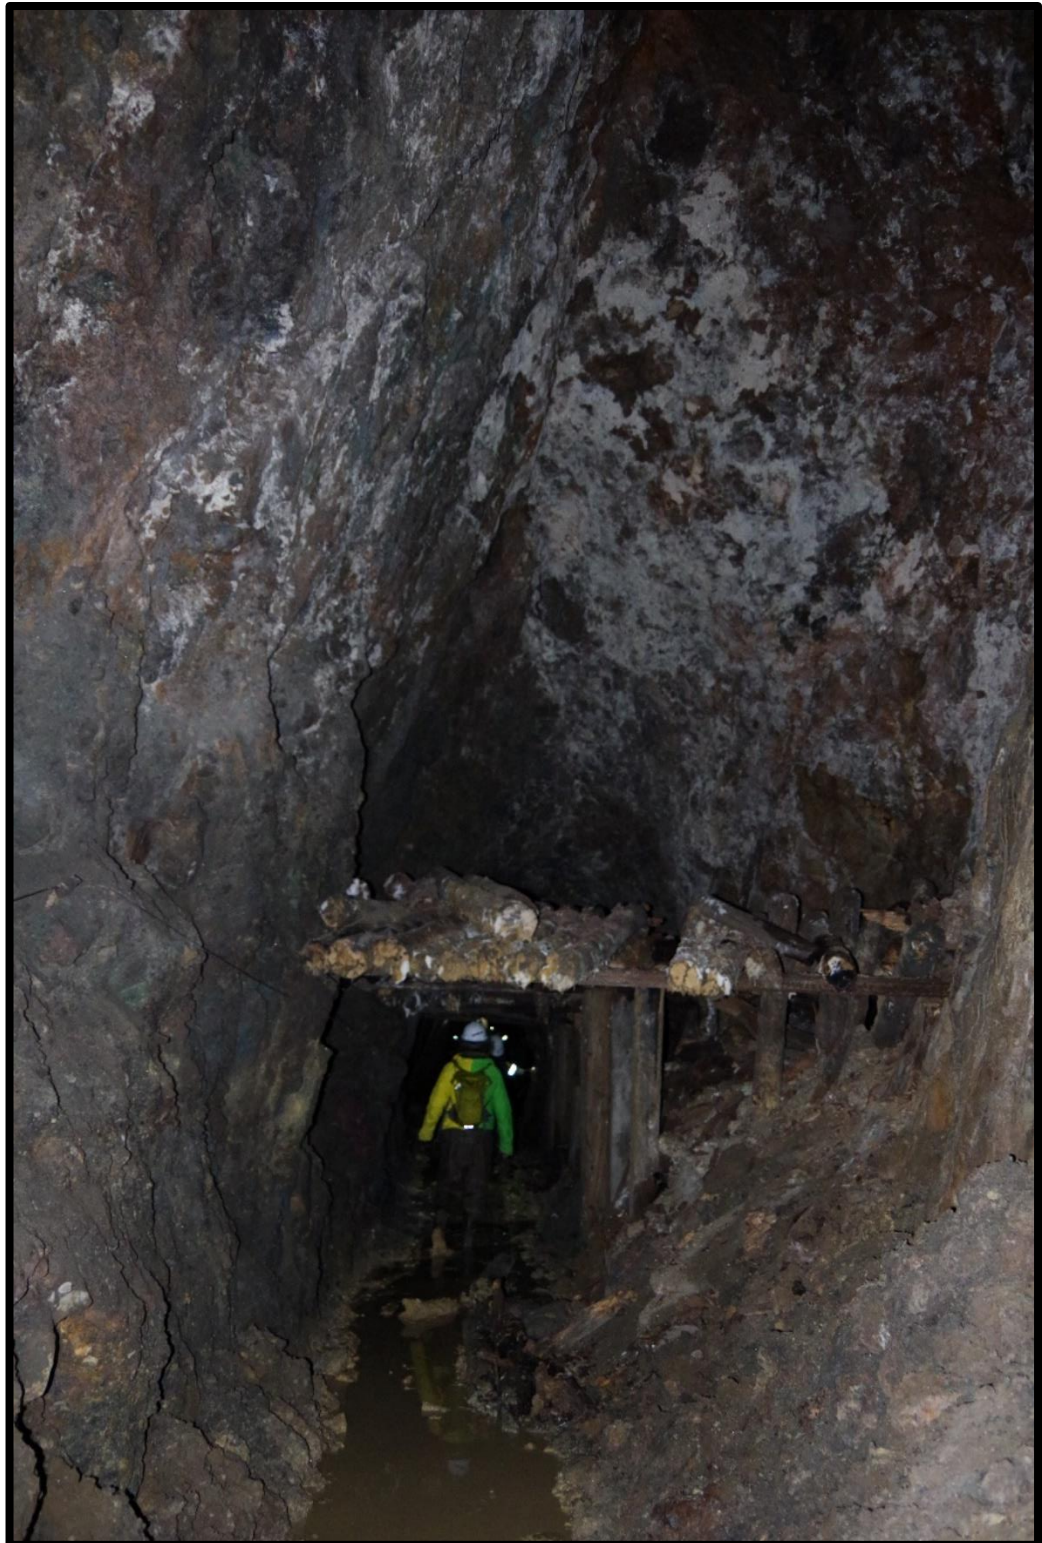
Photo 50: Cathedral near 43+50; Note loose muck in right rib and rotten timber lagging

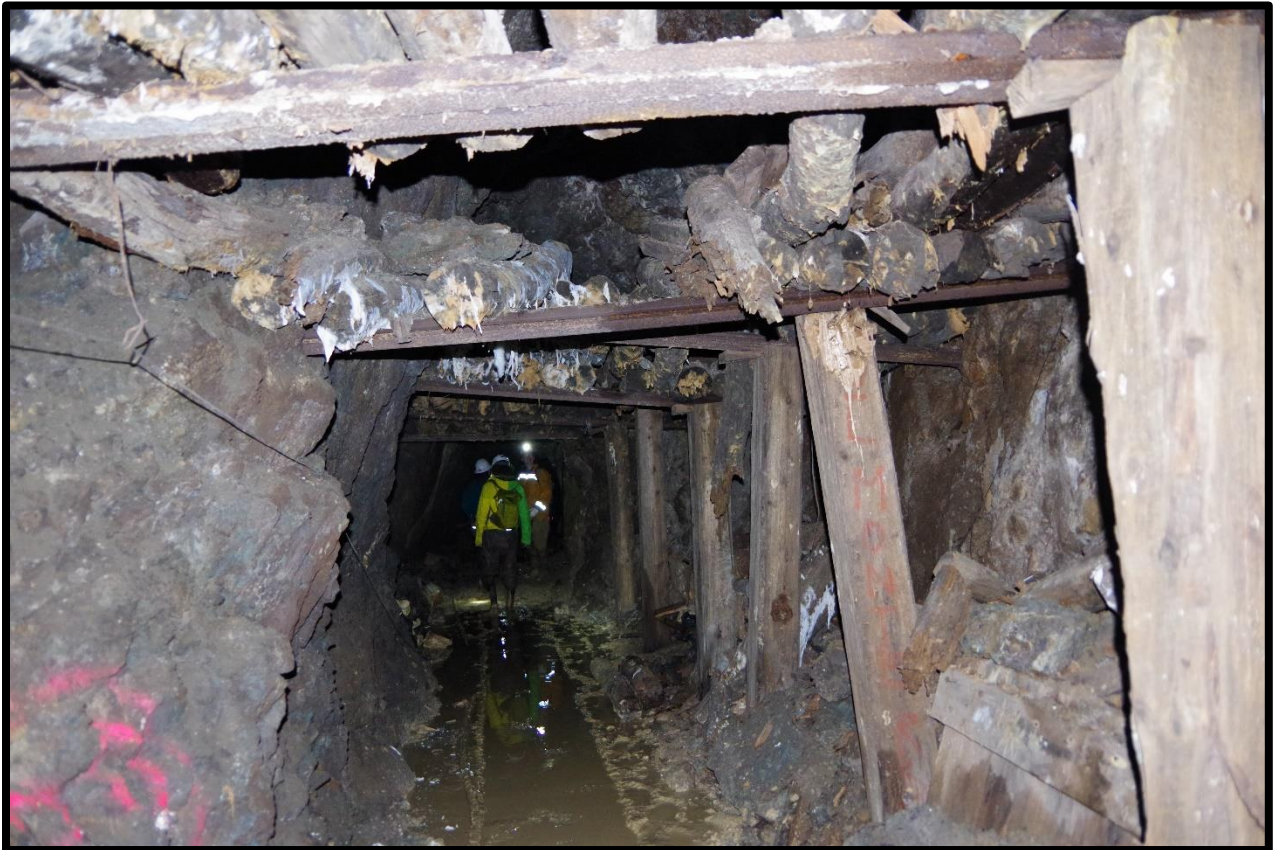
Photo 51: Raise with steel rail, wood posts, and rotten cribbing near 44+00

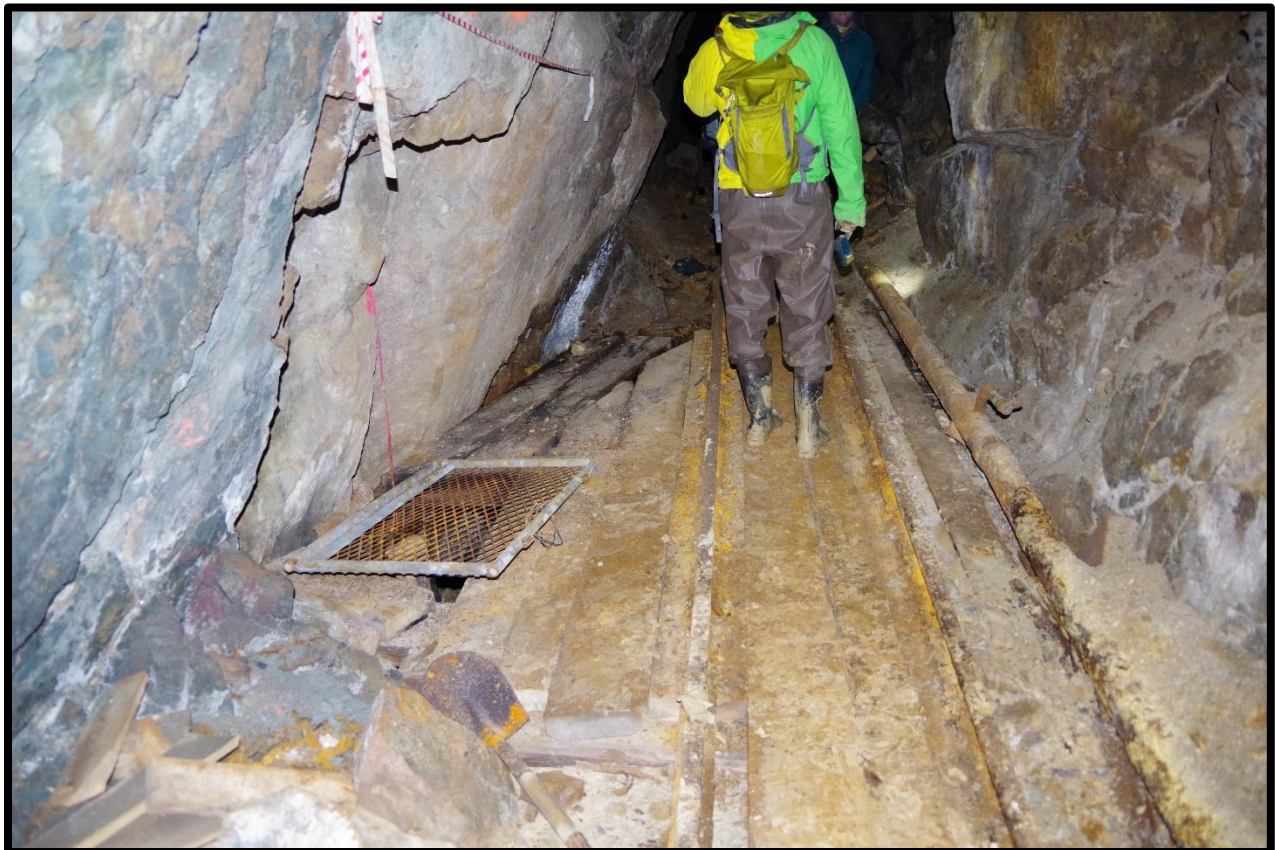
Photo 53: No Name/Y02 Winze 44+60

Due to its importance of acting as the overflow for the upper mine pool, the No Name/Y02 Winze should be fully rehabilitated by scaling, bolting, and installing new ladders and landings, much like the Daylight Winze. This work would take place above the Nelson Tunnel without impacting the impounded mine pool areas. A cover capable of supporting vehicle traffic and allowing water inflow should also be installed. We anticipate the cover consisting of a concrete collar with coated steel beam supports and grated FRP cover.

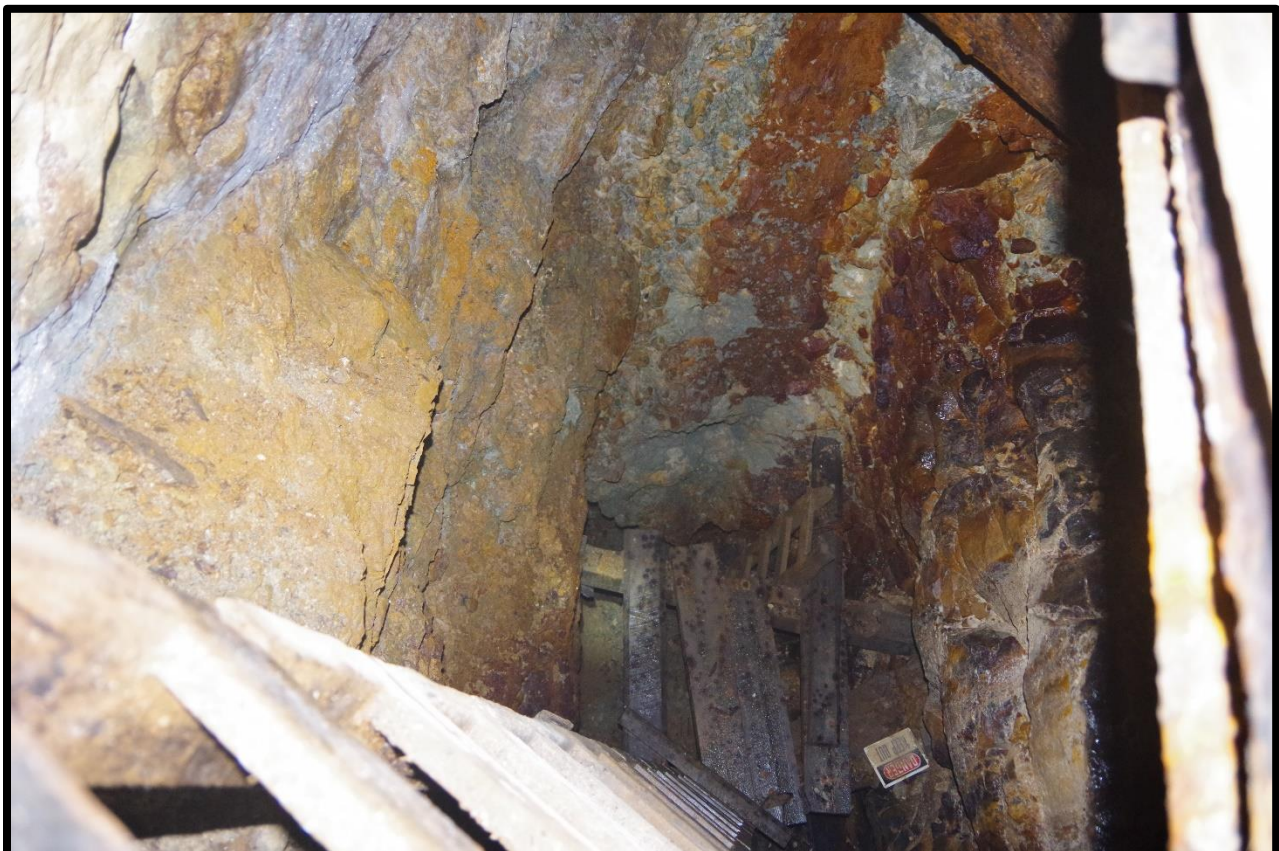
Photo 54: Looking down No Name/y02 Winze

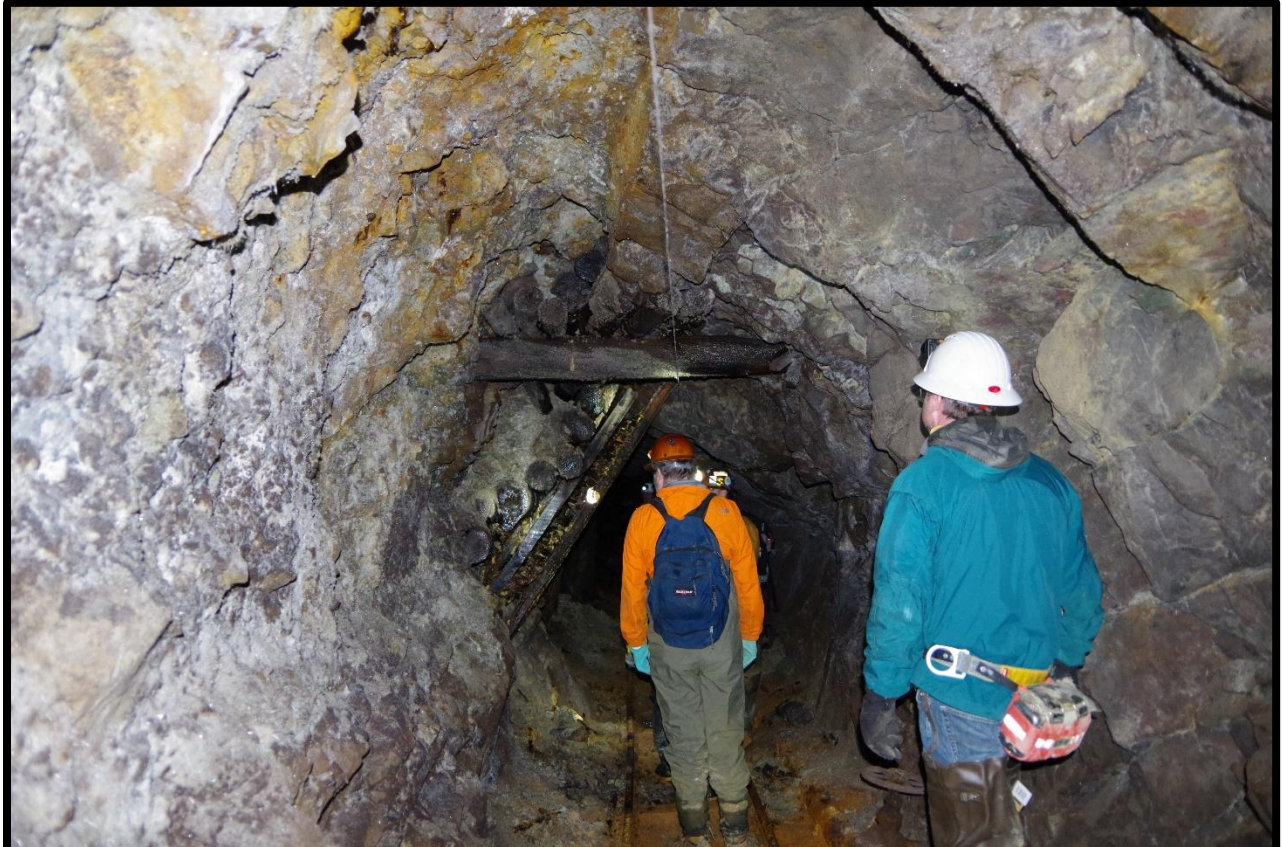
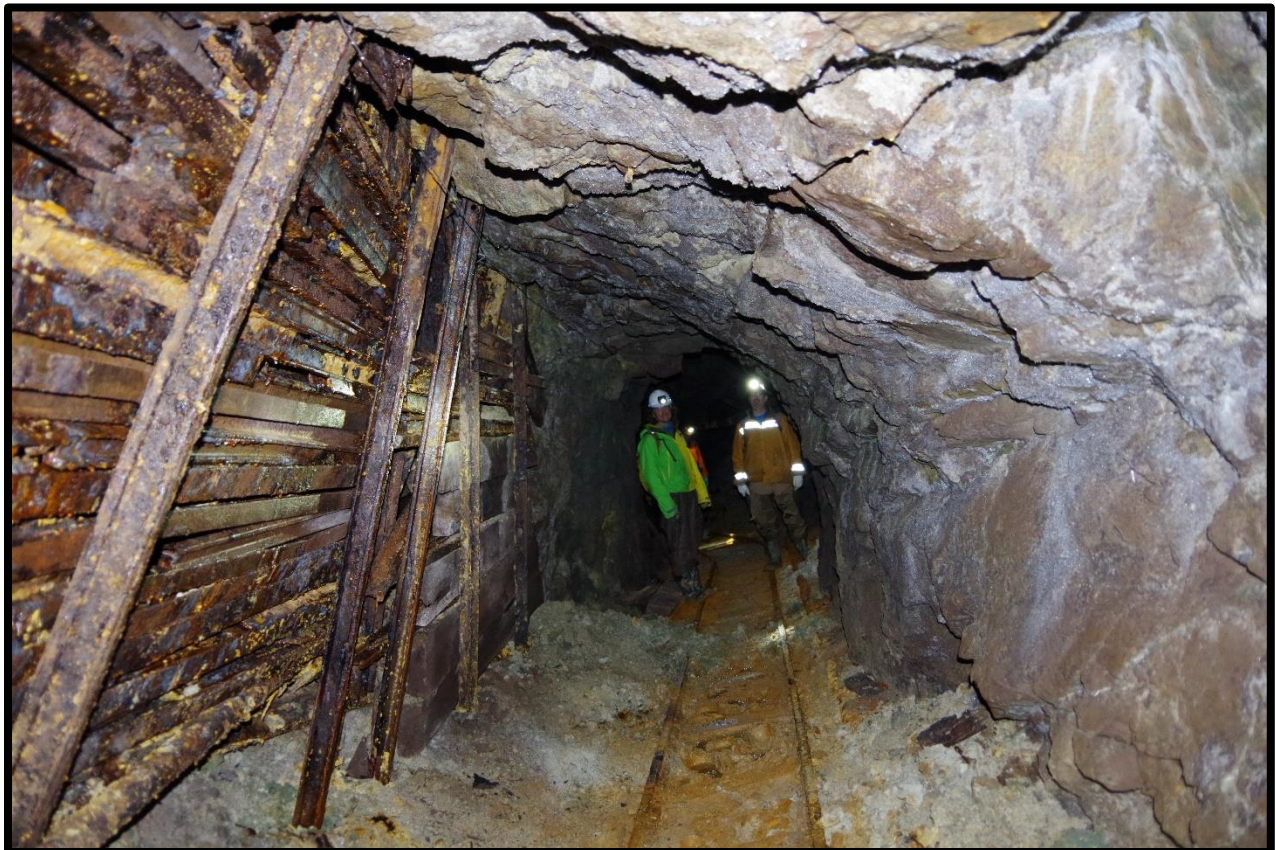
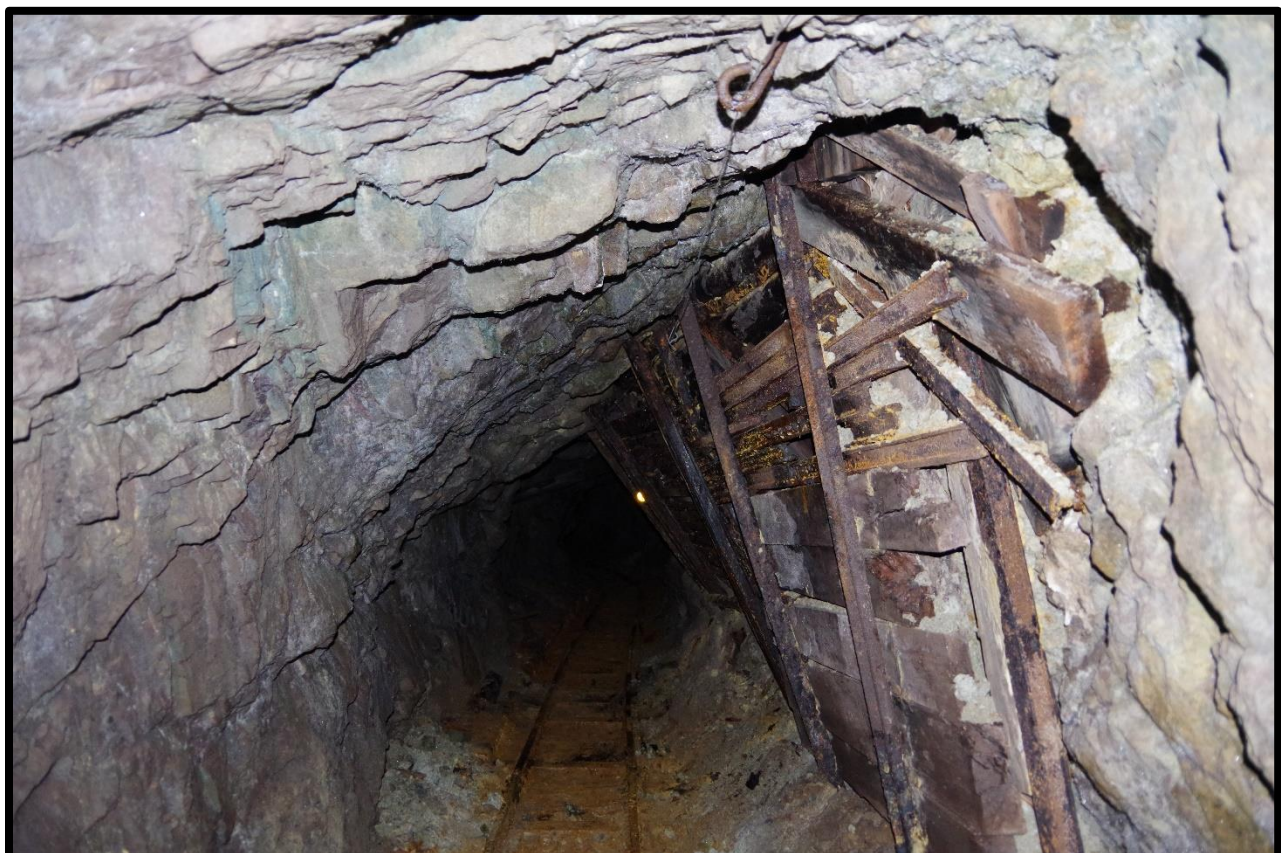
The area of greatest concern for keeping the “overflow” from the Del Monte Raise to the No Name/Y02 Winze open is a section of clay gouge between stations 47+10 and 47+40. It is supported by rail posts, rail lagging, and wood lagging. If the lagging fails in this area, the drift would likely be blocked, leading to higher water pressures and water volume in the upper mine pool.

Photo 56: Area of clay gouge in left rib near 47+10

Photo 57: Area of clay gouge in left rib near 47+10; Note heavy steel rail lagging

Photo 58: Area of clay gouge in left rib near 47+10 looking outby; Note timber lagging

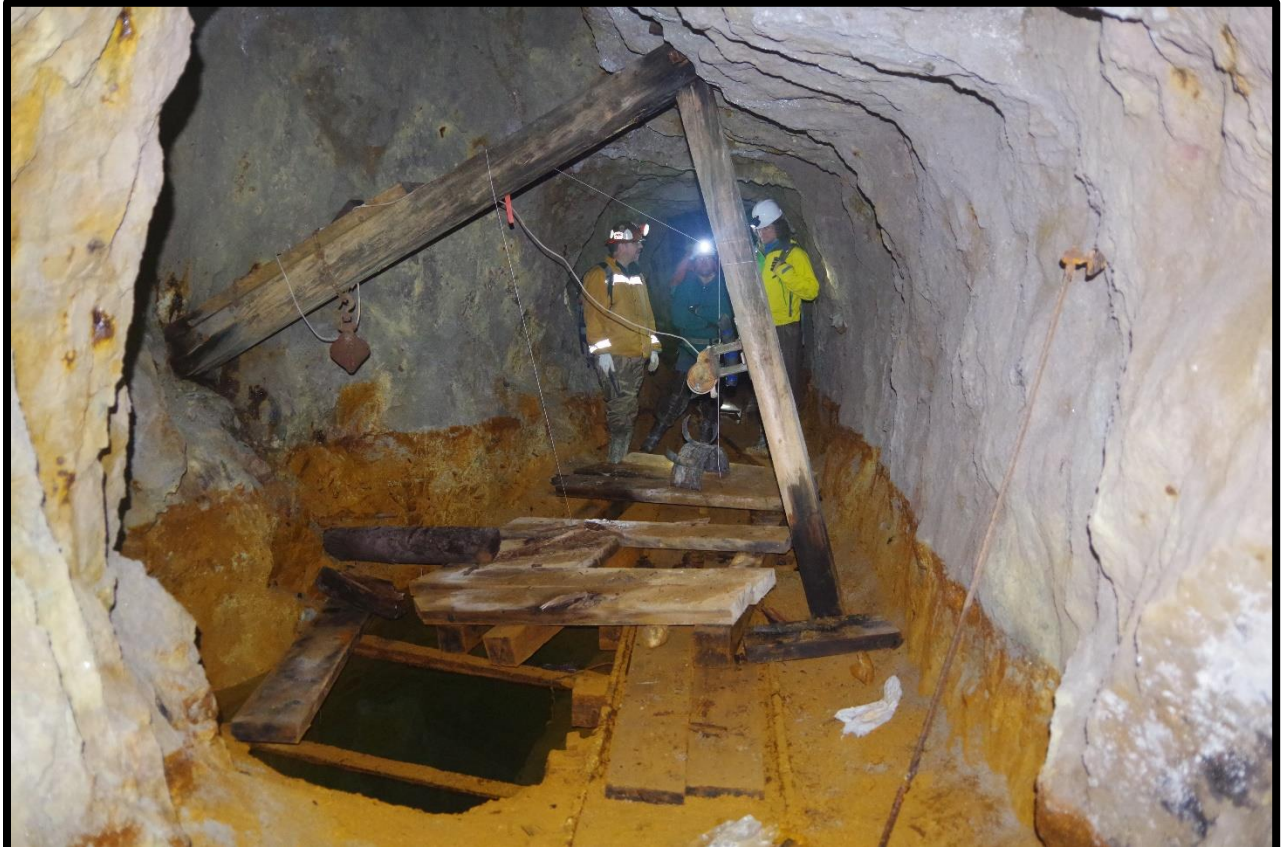
Photo 60: Del Monte Raise 53+15; Note sampling platform

The collar at the Del Monte Raise should have an elevated platform installed above the high water line to allow safe and efficient sampling without hindering the flow of the mine pool. This platform would also be made of FRP or similar material.
