**Subject: Targeted Brownfields Assessment Survey Report for Asbestos, Lead-Based Paint, and Polychlorinated Biphenyls at Mead Hansen Building, 408 S. 8th Street, St. Joseph, Buchanan County, Missouri**  
**U.S. EPA Region 7, START 4, Contract No. EP S7 13 06, Task Order No. 0002.043**  
**Task Monitor: Todd Davis, EPA On-Scene Coordinator**

**TARGETED BROWNFIELDS ASSESSMENT  
SURVEY REPORT FOR ASBESTOS, LEAD-BASED PAINT, AND POLYCHLORINATED  
BIPHENYLS**

**MEAD HANSEN BUILDING  
408 S. 8<sup>th</sup> STREET  
ST. JOSEPH, MISSOURI**

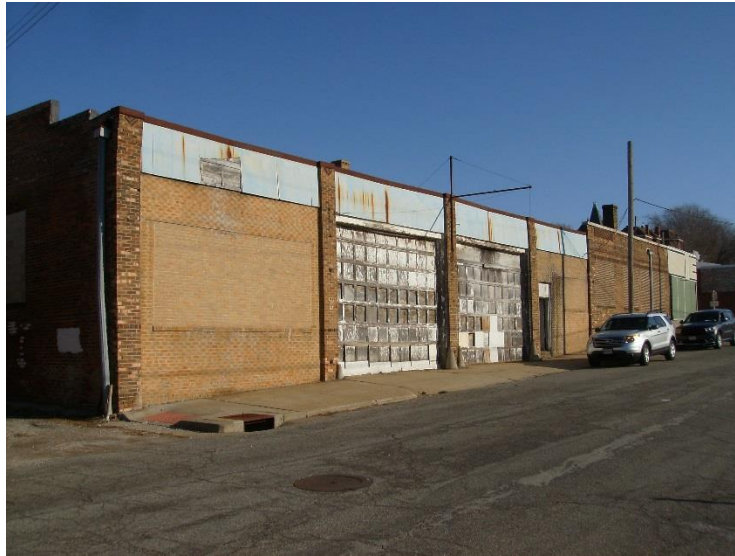
TETRA TECH PROJECT NO. 103X9025140002.043  Direction: South	DESCRIPTION	This photograph shows the exterior of the building.	1
	CLIENT	U.S. Environmental Protection Agency Region 7	Date
	PHOTOGRAPHER	M. Sawyer	12/19/2017

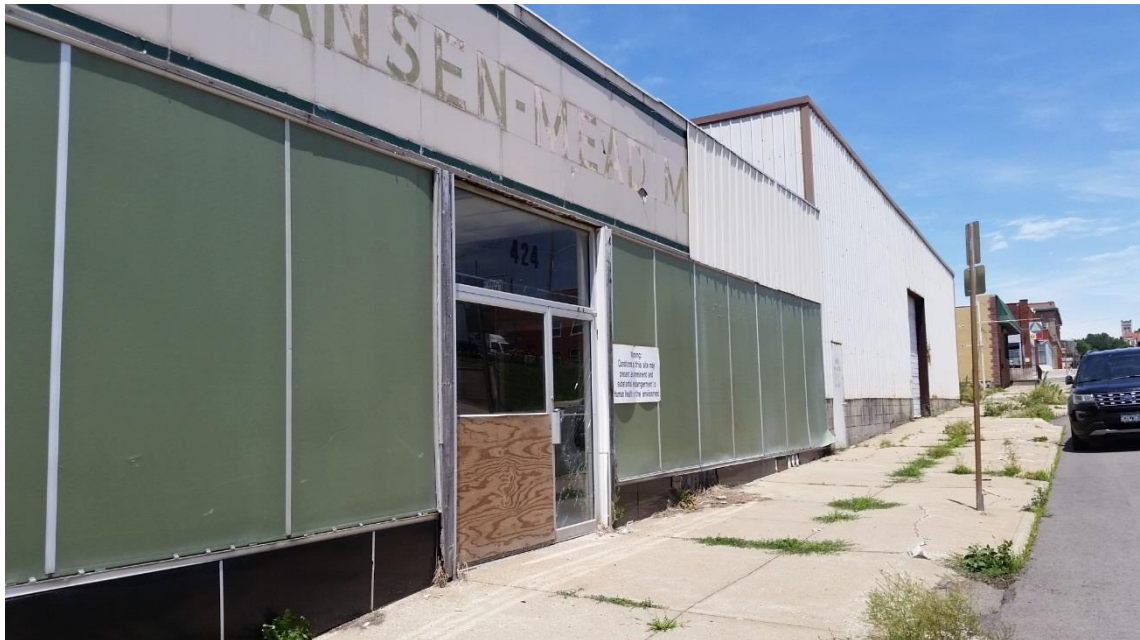
TETRA TECH PROJECT NO. 103X9025140002.043  Direction: West	DESCRIPTION	This photograph shows the exterior of building and transite underneath the black paneling.	2
	CLIENT	U.S. Environmental Protection Agency Region 7	Date
	PHOTOGRAPHER	M. Sawyer	12/19/2017

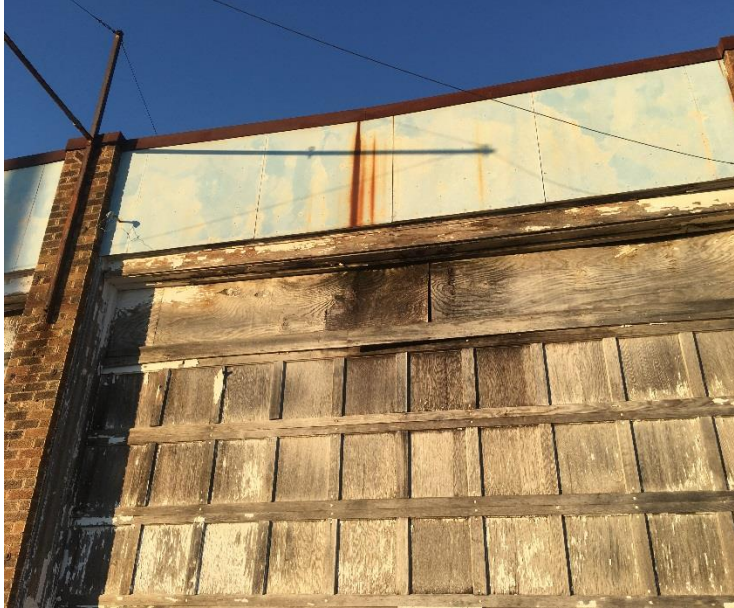
TETRA TECH PROJECT NO. 103X9025140002.043  Direction: East	DESCRIPTION	This photograph shows blue transite paneling and the garage door on the exterior of the building.	3
	CLIENT	U.S. Environmental Protection Agency Region 7	Date
	PHOTOGRAPHER	M. Sawyer	12/19/2017

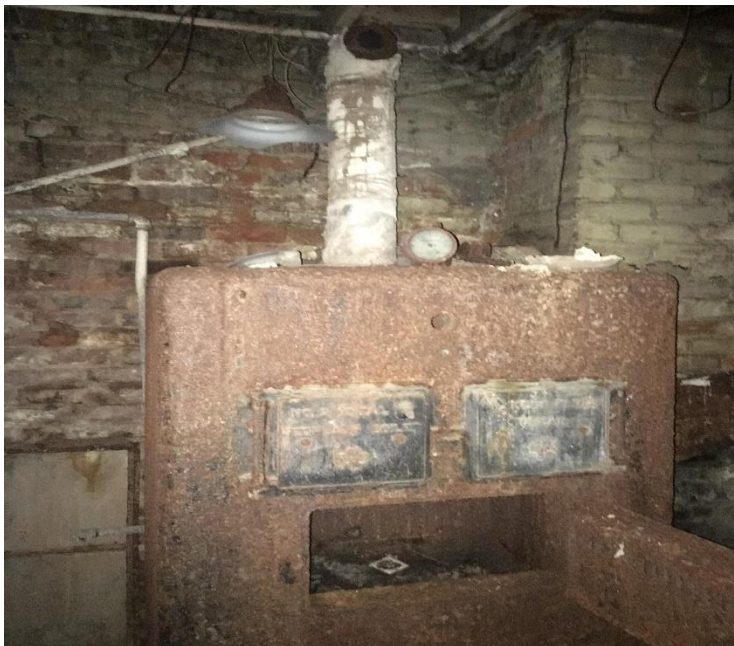
TETRA TECH PROJECT NO. 103X9025140002.043  Direction: South	DESCRIPTION	This photograph shows 12" joint insulation on the south boiler in the basement.	4
	CLIENT	U.S. Environmental Protection Agency Region 7	Date
	PHOTOGRAPHER	M. Sawyer	12/19/2017

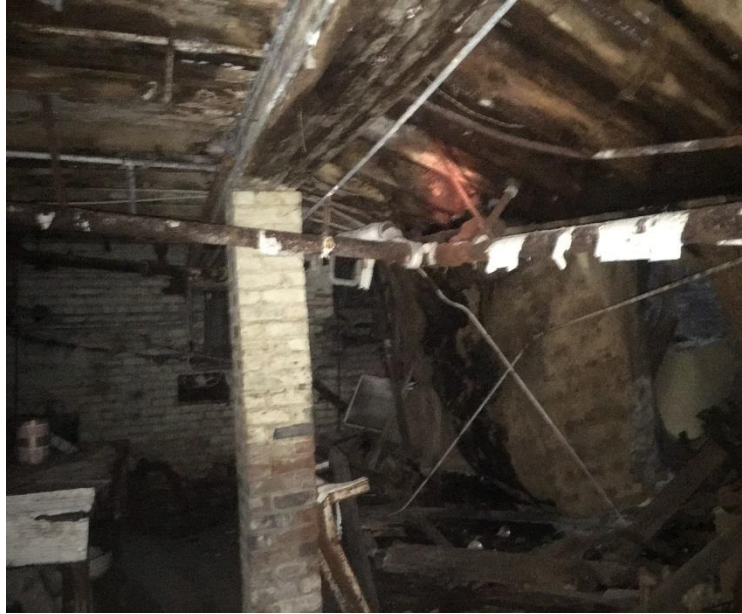
<b>TETRA TECH PROJECT NO.</b> 103X9025140002.043  Direction: Southwest	<b>DESCRIPTION</b>	This photograph shows 3" airocell pipe insulation in the basement.	5
	<b>CLIENT</b>	U.S. Environmental Protection Agency Region 7	Date
	<b>PHOTOGRAPHER</b>	M. Sawyer	12/19/2017

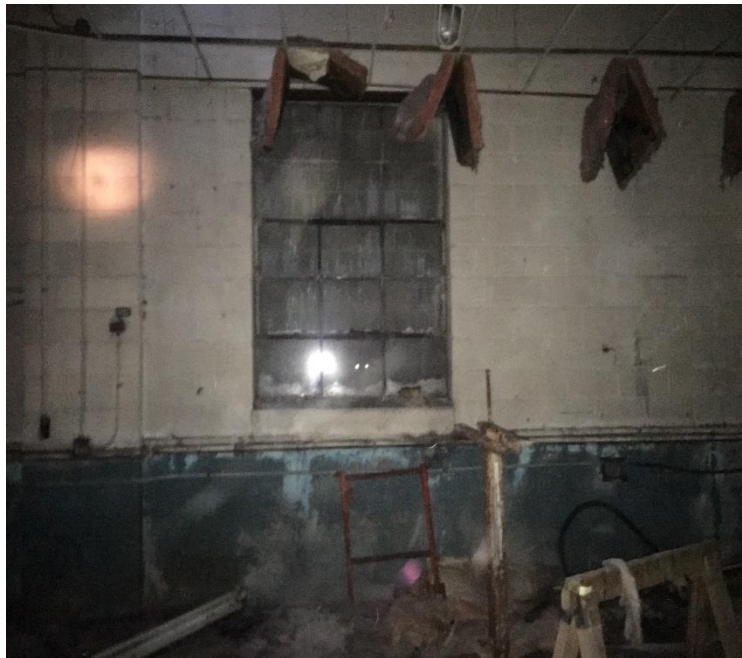
<b>TETRA TECH PROJECT NO.</b> 103X9025140002.043  Direction: North	<b>DESCRIPTION</b>	This photograph shows window glaze in the manufacturing area.	6
	<b>CLIENT</b>	U.S. Environmental Protection Agency Region 7	Date
	<b>PHOTOGRAPHER</b>	M. Sawyer	12/19/2017

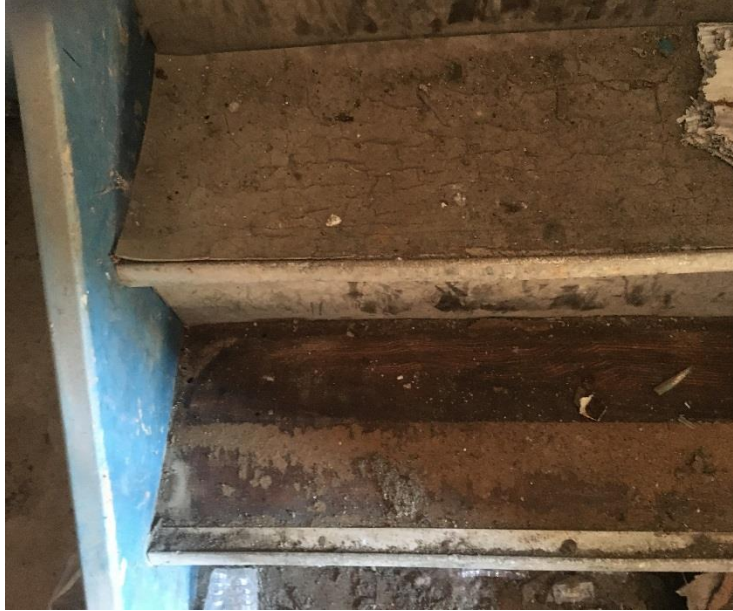
TETRA TECH PROJECT NO. 103X9025140002.043  Direction: East	DESCRIPTION	This photograph shows brown floor tile near the south entrance.	7
	CLIENT	U.S. Environmental Protection Agency Region 7	Date
	PHOTOGRAPHER	M. Sawyer	12/19/2017

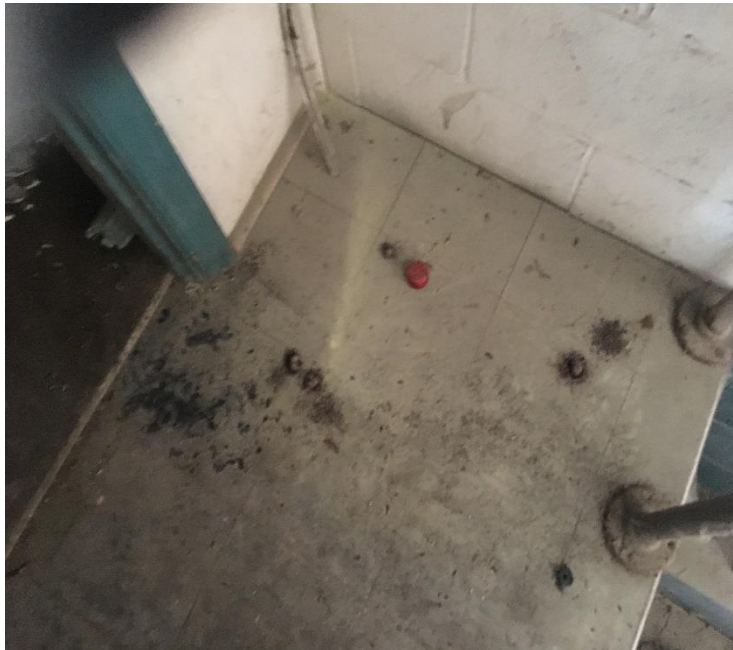
TETRA TECH PROJECT NO. 103X9025140002.043  Direction: West	DESCRIPTION	This photograph shows 9" X 9" floor tile with associated mastic on the south entrance stairs.	8
	CLIENT	U.S. Environmental Protection Agency Region 7	Date
	PHOTOGRAPHER	M. Sawyer	12/19/2017

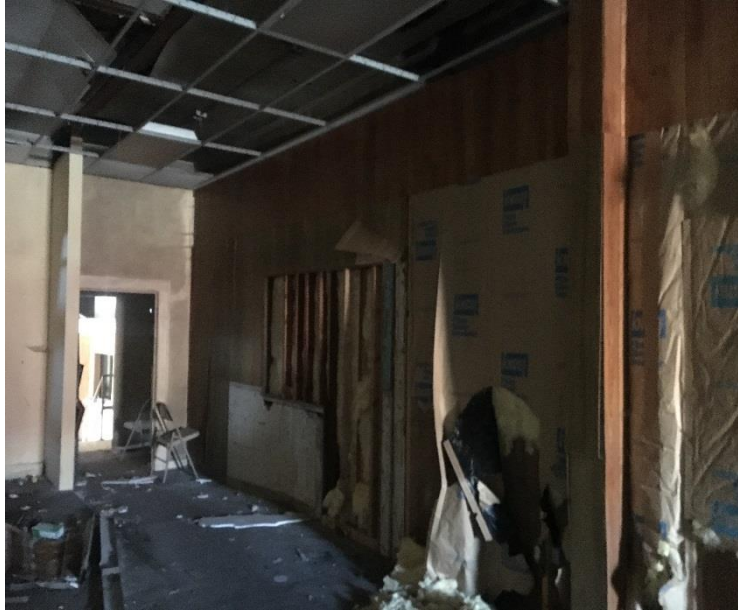
<b>TETRA TECH PROJECT NO.</b> 103X9025140002.043  Direction: West	<b>DESCRIPTION</b>	This photograph shows the plaster system and 2" X 4" fissure and pinhole ceiling tile in the office.	9
	<b>CLIENT</b>	U.S. Environmental Protection Agency Region 7	Date
	<b>PHOTOGRAPHER</b>	M. Sawyer	12/19/2017

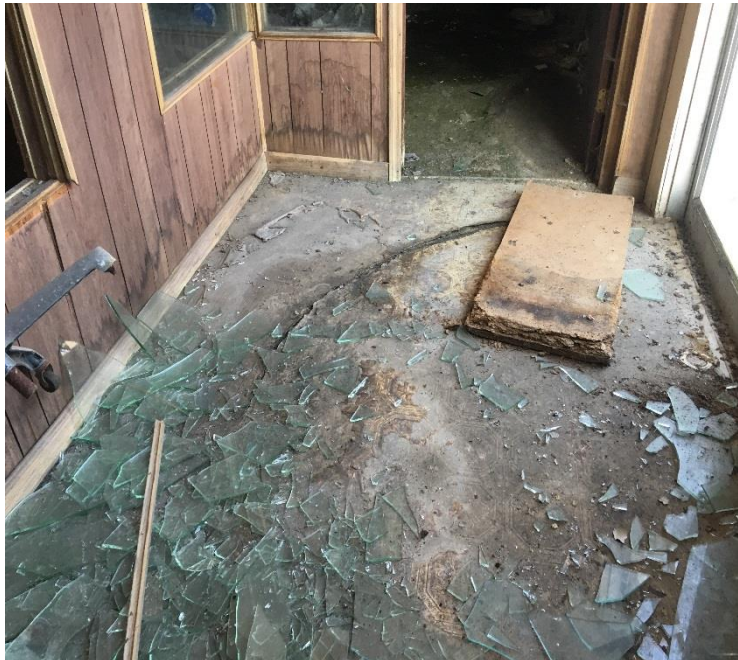
<b>TETRA TECH PROJECT NO.</b> 103X9025140002.043  Direction: Northeast	<b>DESCRIPTION</b>	This photograph shows square pattern linoleum with associated mastic at the south entrance.	10
	<b>CLIENT</b>	U.S. Environmental Protection Agency Region 7	Date
	<b>PHOTOGRAPHER</b>	M. Sawyer	12/19/2017

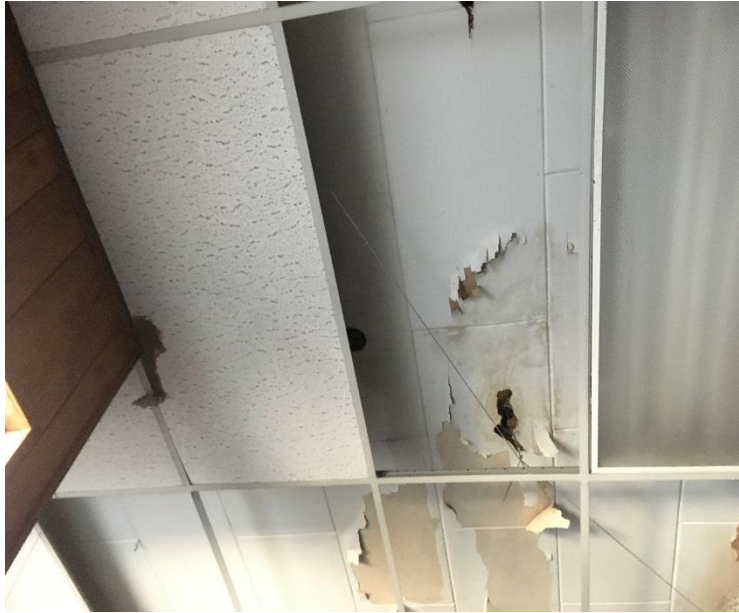
<b>TETRA TECH PROJECT NO.</b> 103X9025140002.043  Direction: Northwest	<b>DESCRIPTION</b>	This photograph shows 2' X 4" white fissure and pinhole ceiling tile, and 1' X 4' smooth ceiling tile in the office.	11
	<b>CLIENT</b>	U.S. Environmental Protection Agency Region 7	Date
	<b>PHOTOGRAPHER</b>	M. Sawyer	12/19/2017

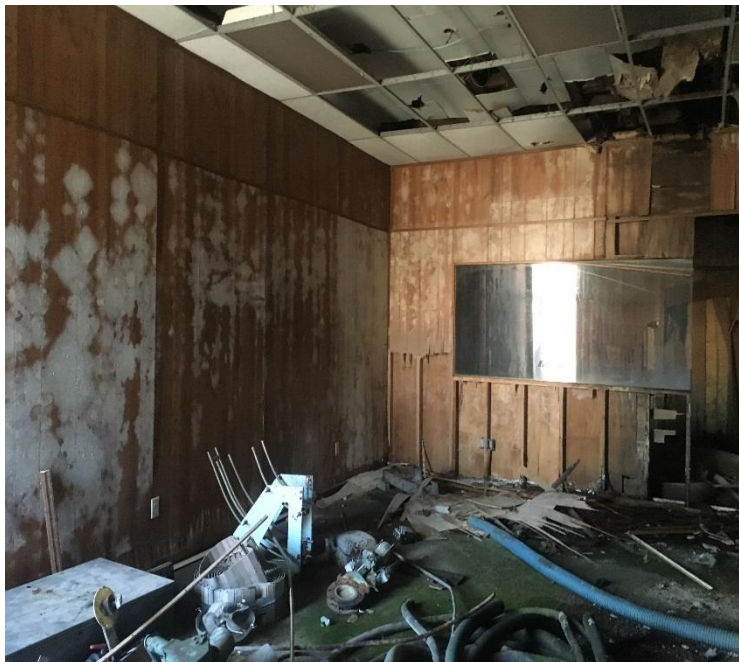
<b>TETRA TECH PROJECT NO.</b> 103X9025140002.043  Direction: Southwest	<b>DESCRIPTION</b>	This photograph shows the north side office area.	12
	<b>CLIENT</b>	U.S. Environmental Protection Agency Region 7	Date
	<b>PHOTOGRAPHER</b>	M. Sawyer	12/19/2017

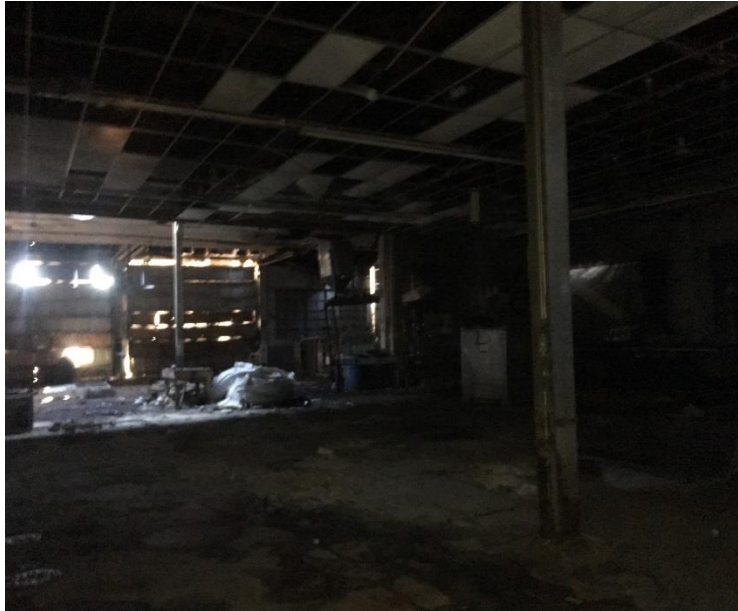
<b>TETRA TECH PROJECT NO.</b> 103X9025140002.043  Direction: Northwest	<b>DESCRIPTION</b>	This photograph shows an overview of the manufacturing area.	13
	<b>CLIENT</b>	U.S. Environmental Protection Agency Region 7	Date
	<b>PHOTOGRAPHER</b>	M. Sawyer	12/19/2017

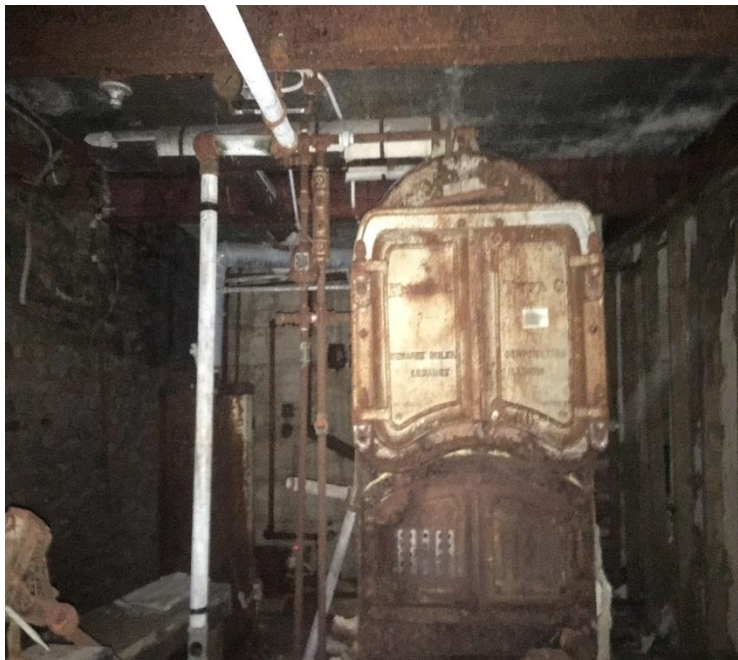
<b>TETRA TECH PROJECT NO.</b> 103X9025140002.043  Direction: Southwest	<b>DESCRIPTION</b>	This photograph shows the basement boiler.	14
	<b>CLIENT</b>	U.S. Environmental Protection Agency Region 7	Date
	<b>PHOTOGRAPHER</b>	M. Sawyer	12/19/2017

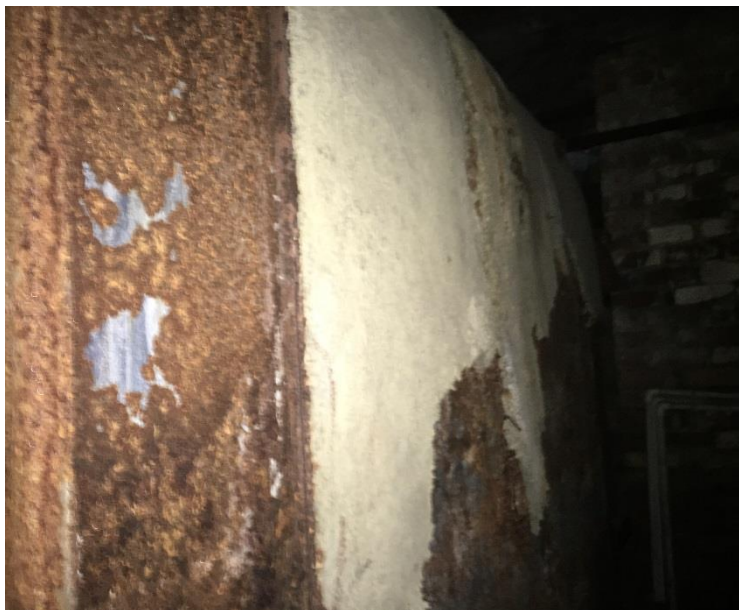
<b>TETRA TECH PROJECT NO.</b> 103X9025140002.043  Direction: Northwest	<b>DESCRIPTION</b>	This photograph shows deteriorated boiler insulation.	15
	<b>CLIENT</b>	U.S. Environmental Protection Agency Region 7	Date
	<b>PHOTOGRAPHER</b>	M. Sawyer	12/19/2017
