MEMORANDUM

RE: Commodore 5 Tunnel Rehabilitation Concept; Creede, Colorado;
D&A Job No. CG-0547.002.00

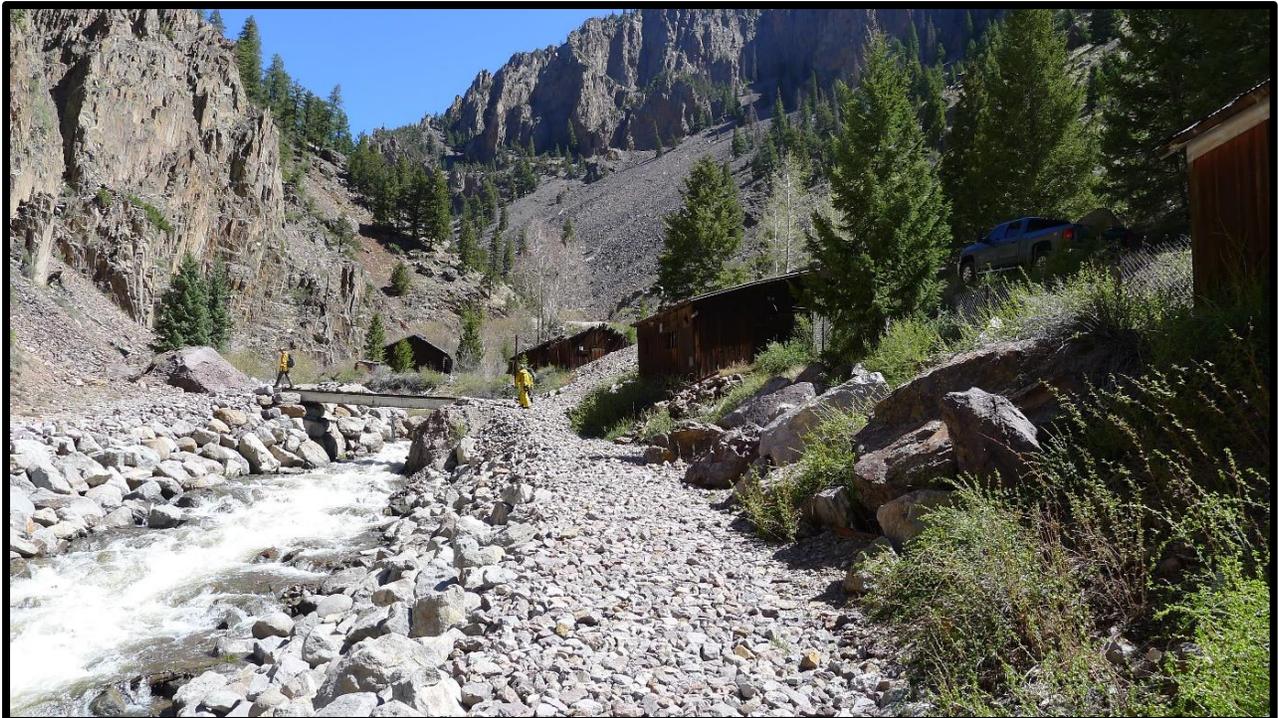
Photo 2: Willow Creek at portal looking upstream; Note small bridge and path for access

aging wooden planks. Access to the bridge is a narrow trail, inadequate for equipment larger than a small skid steer loader. The contractor should install a temporary bridge of appropriate size and capacity for their equipment and to accommodate seasonal creek flow changes. Other portal area work such as installing generators, lights, storage, offices, etc., would be included in a mobilization cost. See **Photos 1-4**.

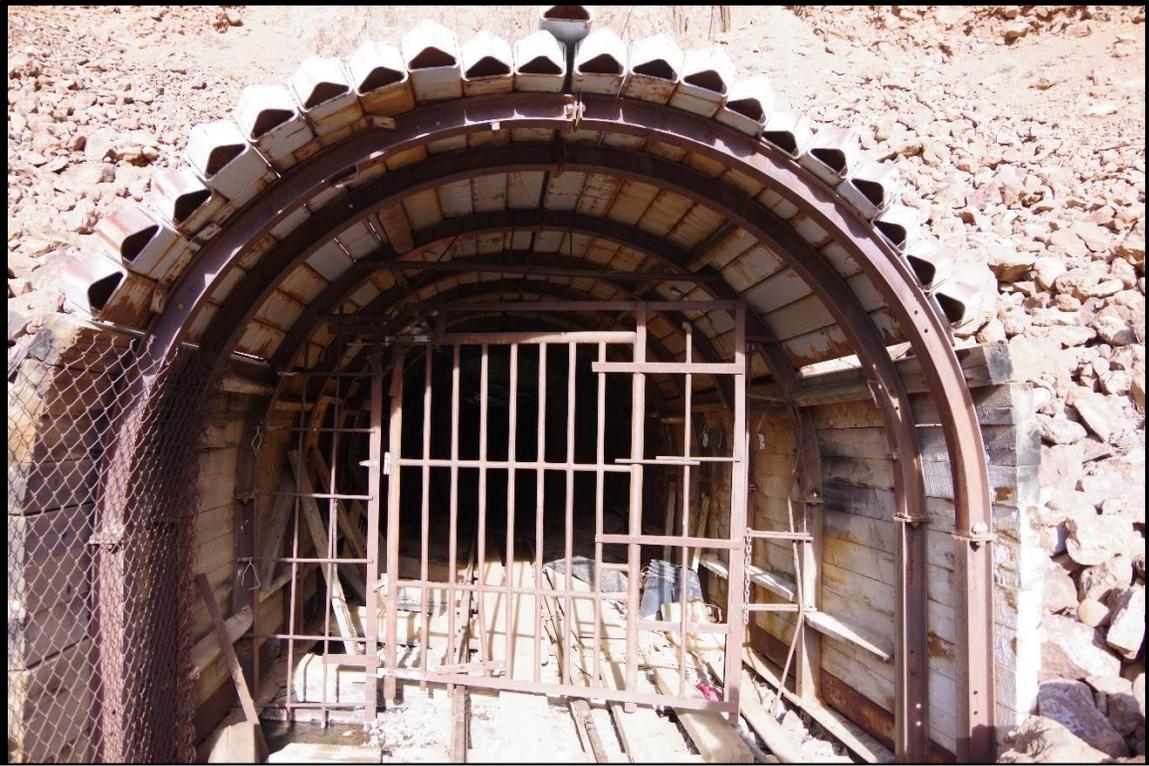
Photo 5: Portal Gate to be replaced

Rehabilitation in this segment will consist of scaling, mucking, debris removal, ditch cleaning, track repair, replacement of the portal gate, and the installation of two air doors. The Manhattan Drift and another smaller room, near station 12+00, can serve as storage during construction.

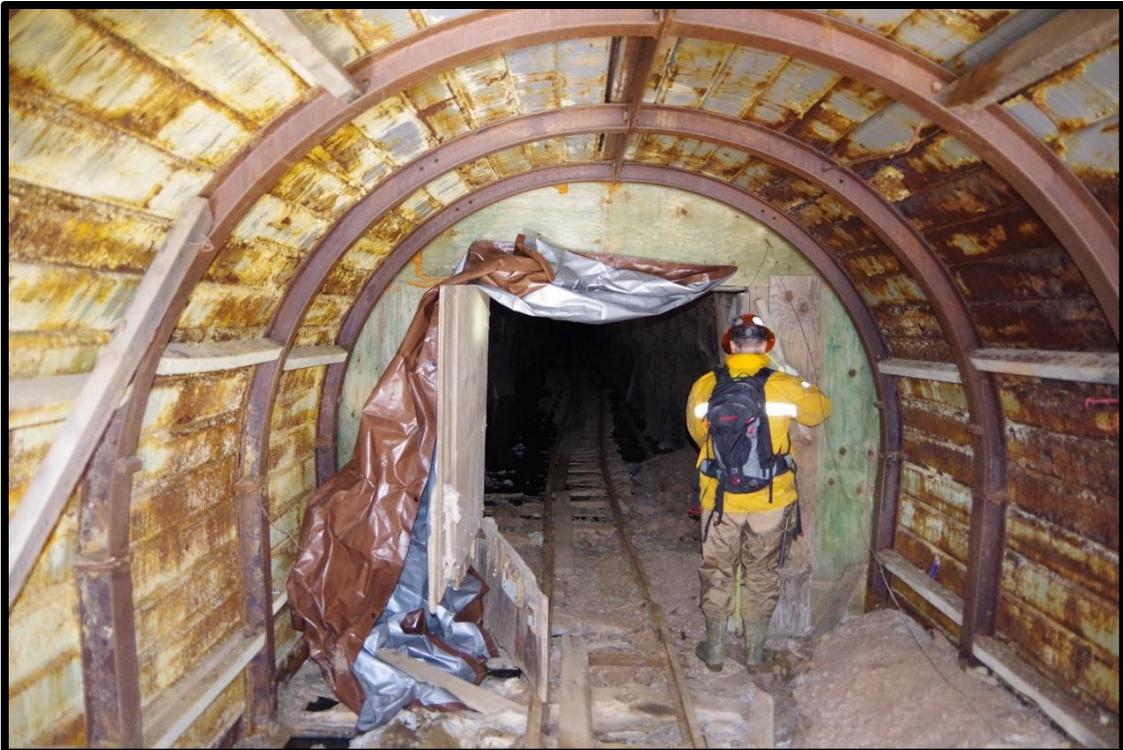
Photo 6: First Air Door to be replaced

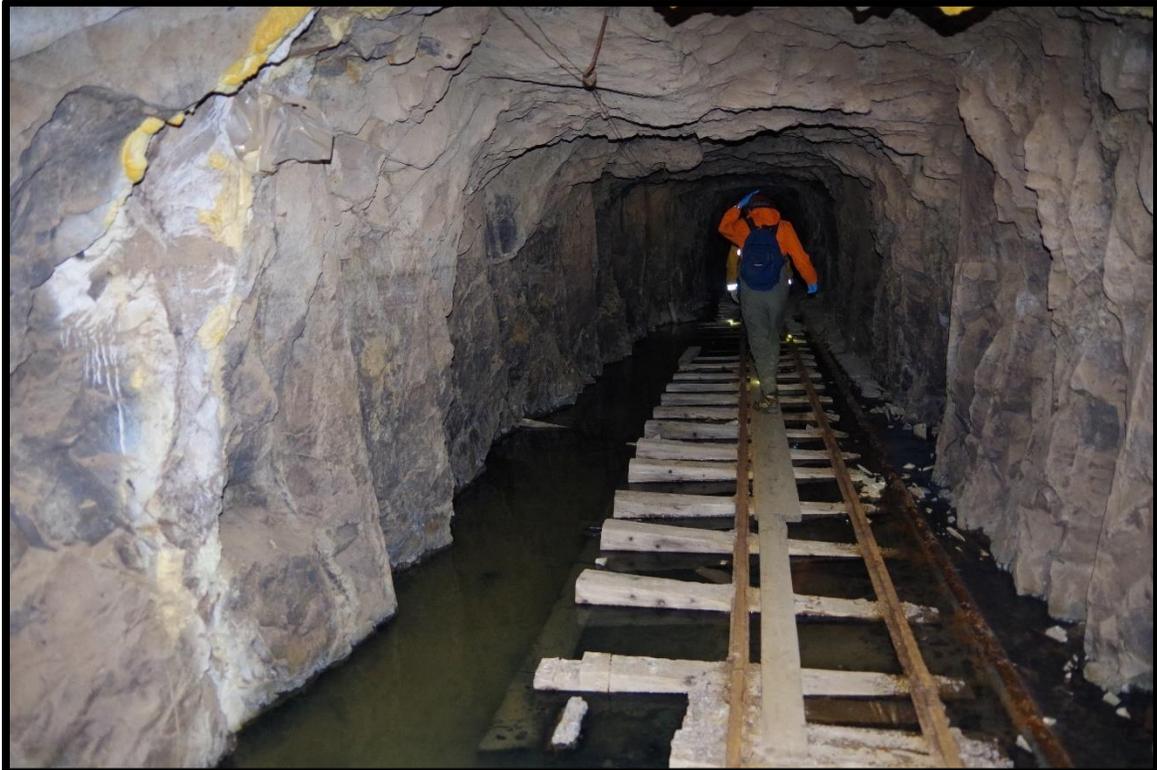
Photo 7: Floating rail ties and poor drainage near 1+00

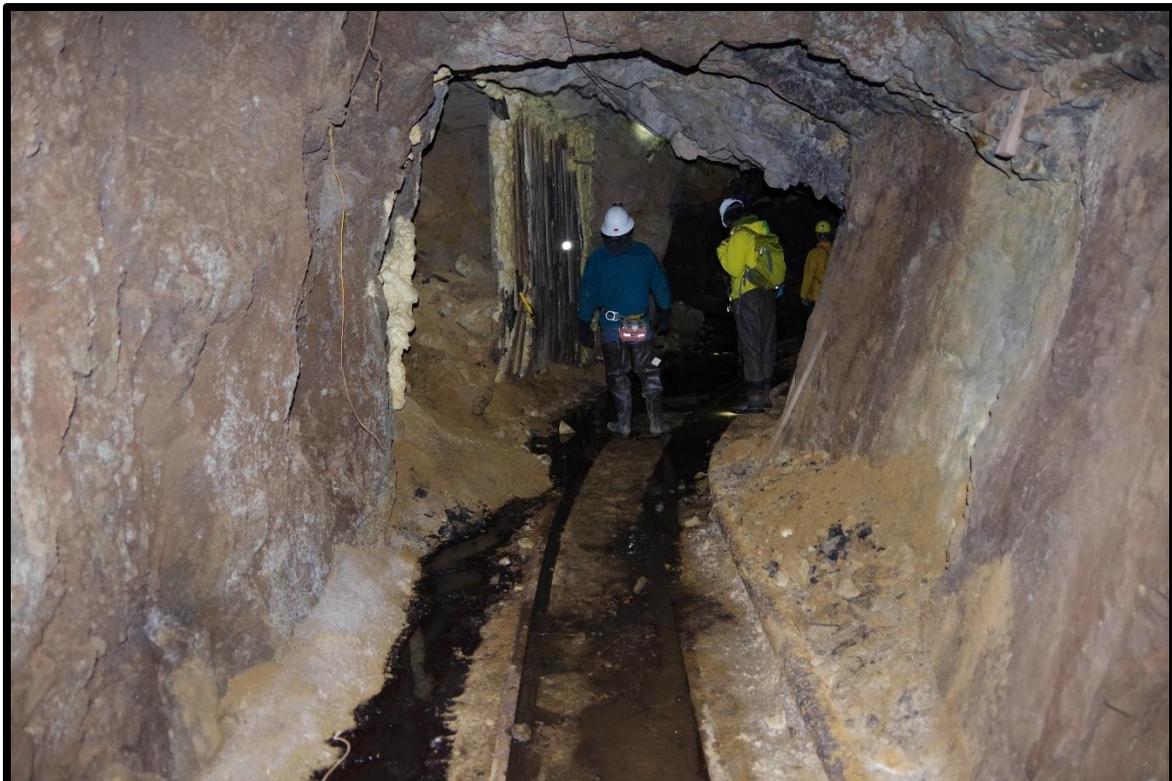
Photo 12: Daylight Corner with collapsed raise from Nelson Tunnel in left rib

While the rock is generally good, the large span of the intersection and importance of keeping this area accessible leads us to recommend scaling, pattern bolting (6' long), and installing wire mesh. The same applies at the wide section where the collapsed raise from the Nelson intersects the floor (22+10). Two small but high stopes in the middle of this segment should have steel sets, lagging, and foam installed underneath them to limit raveling.

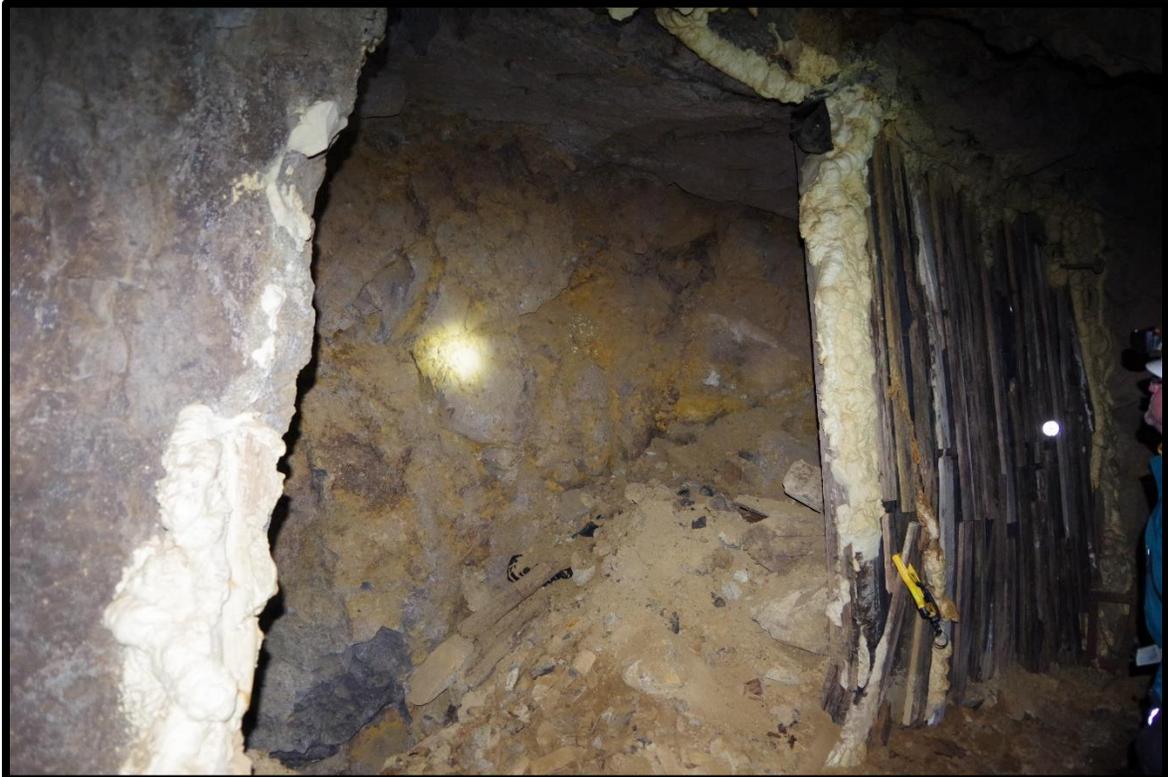
Photo 13: Close up of collapsed raise from Nelson Tunnel

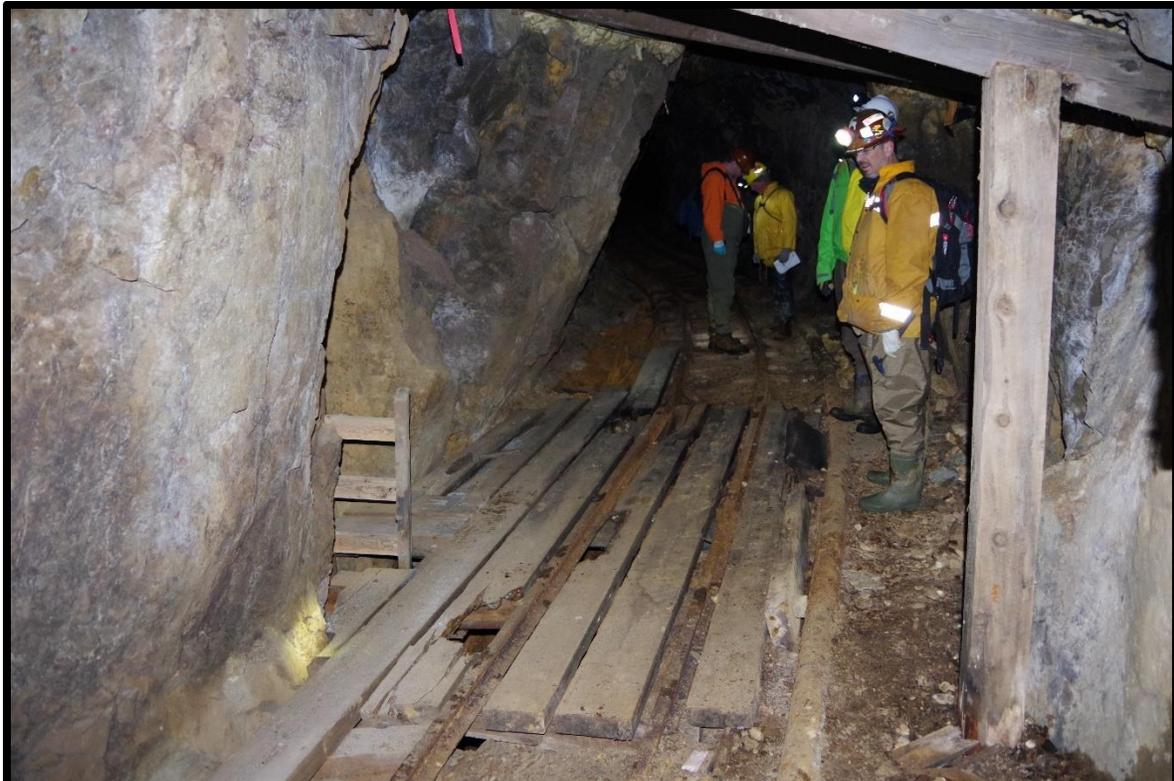
Photo 16: Overview of Daylight Winze; Note decayed wood cover

Significant work is also needed at the Daylight Winze and the raise above it. Due to its importance of acting as the last drain into the Nelson Tunnel, the Daylight Winze should be fully rehabilitated by scaling, bolting, and installing new ladders and landings made of non-decaying or corroding material such as fiber reinforced plastic (FRP). This work would take place above the Nelson Tunnel without impacting the impounded mine pool areas. A cover capable of supporting vehicle traffic and allowing water inflow should also be installed. We anticipate the cover consisting of a concrete collar with coated steel beam supports and grated FRP cover.

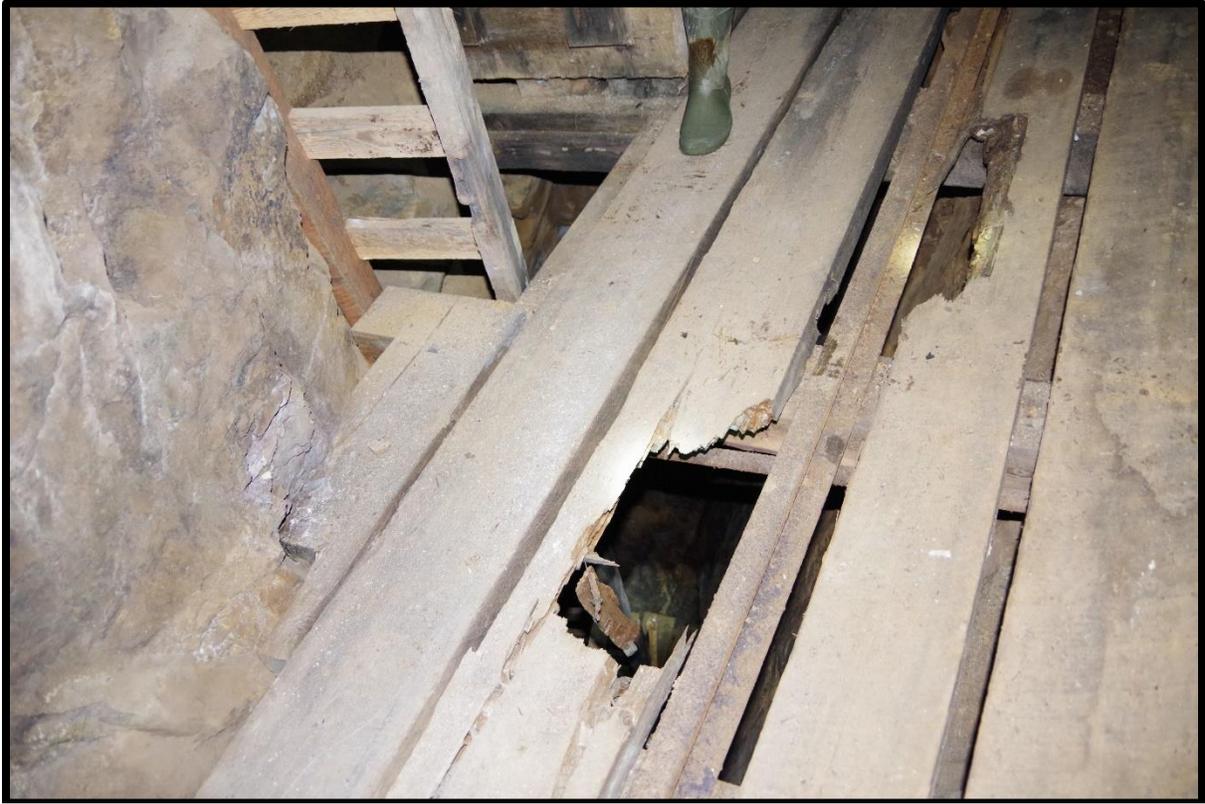
Photo 17: Daylight Winze with rotten wood cover

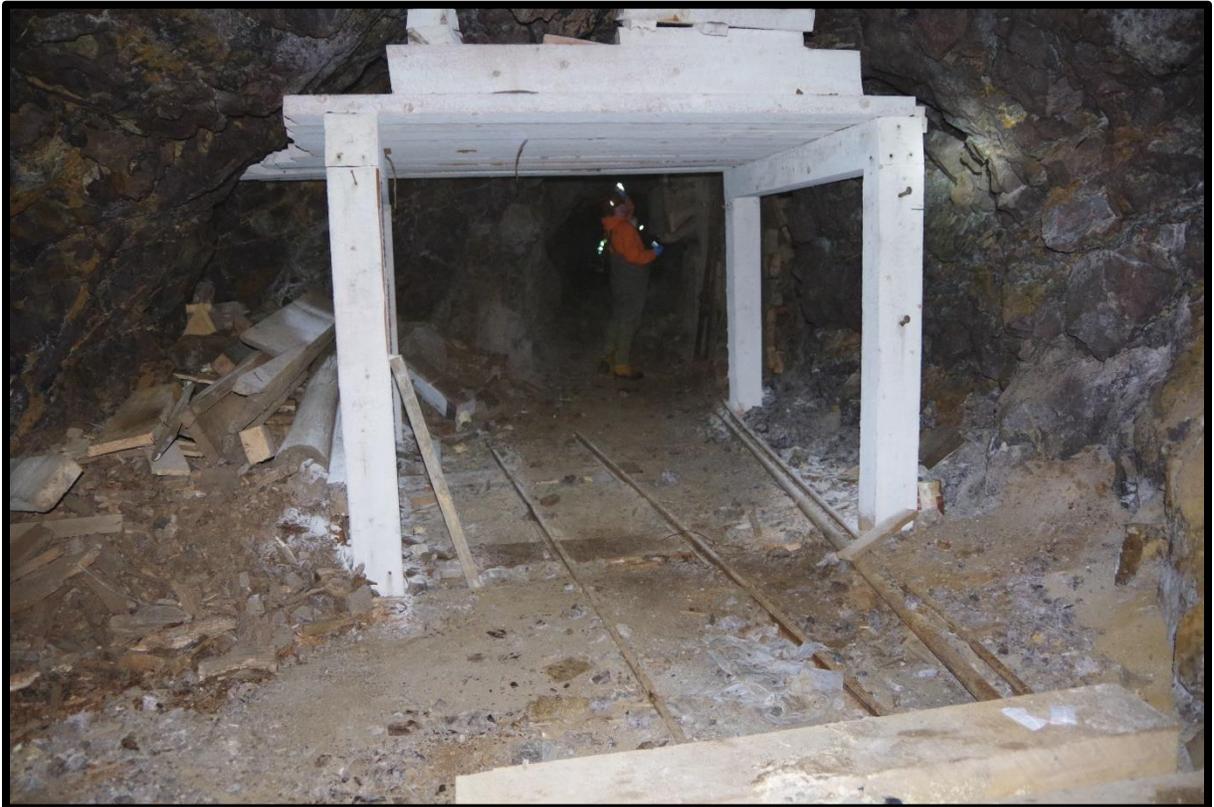
Photo 21: Moldy canopy in McClure Cross Cut

Based on our observations, only minimal cleanup work will be required in the McClure Cross Cut area. The moldy canopy may have to be removed and replaced with bolts and wire mesh, depending on the ground conditions behind it. The bulk of the work will be in the Bachelor Shaft where the untreated wood ladders and landings should be replaced with fiber glass reinforced plastic ladders and landings, anchored into the rock wall. **Figure 5** shows the Bachelor Shaft in cross section. Note that the work would be limited to the Bachelor Shaft and landing, without impacting or accessing the Nelson Tunnel.

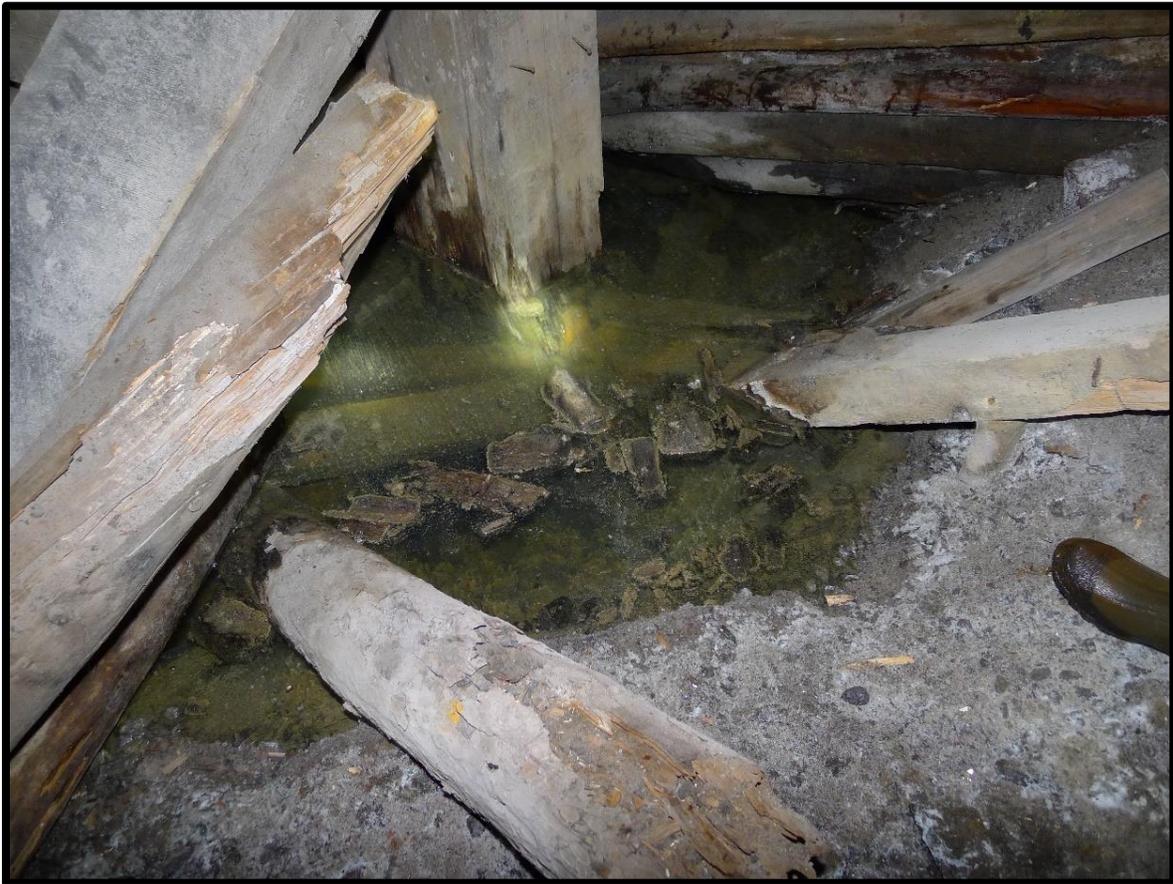
Photo 31: Collapsed Timbers at Bachelor Shaft Nelson Tunnel landing

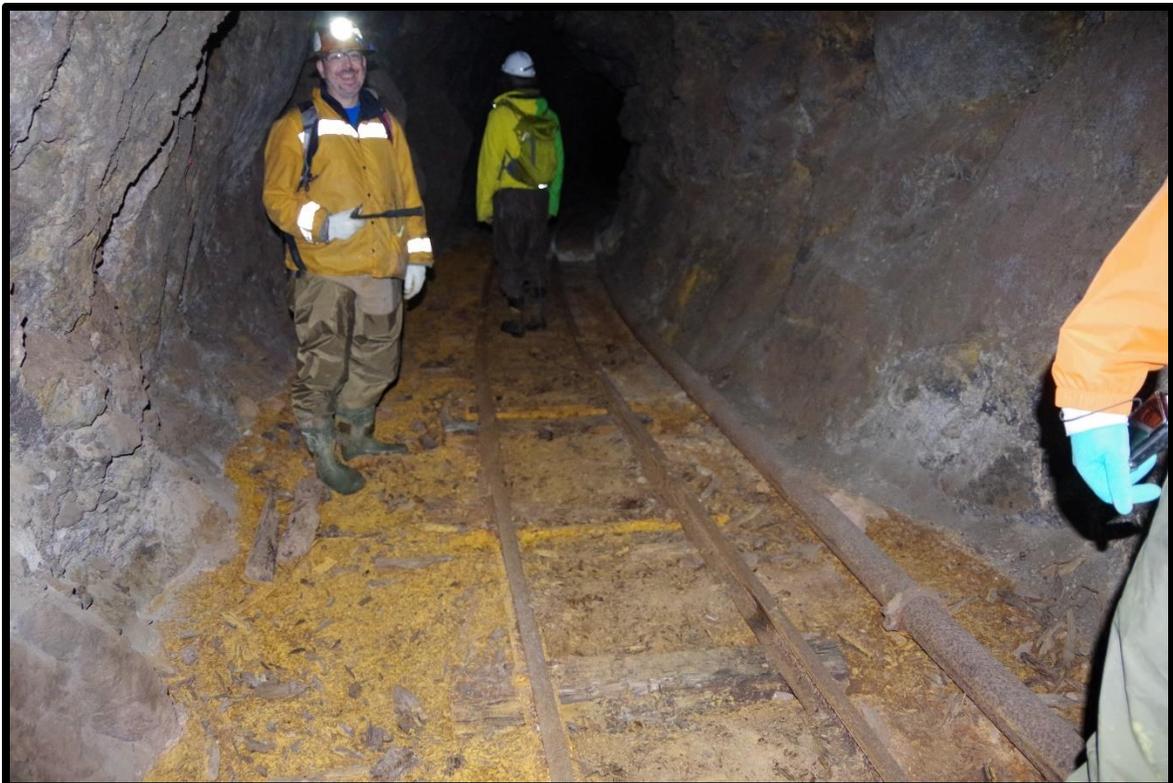
Photo 32: Decayed rail ties near 25+00; Note staining from water

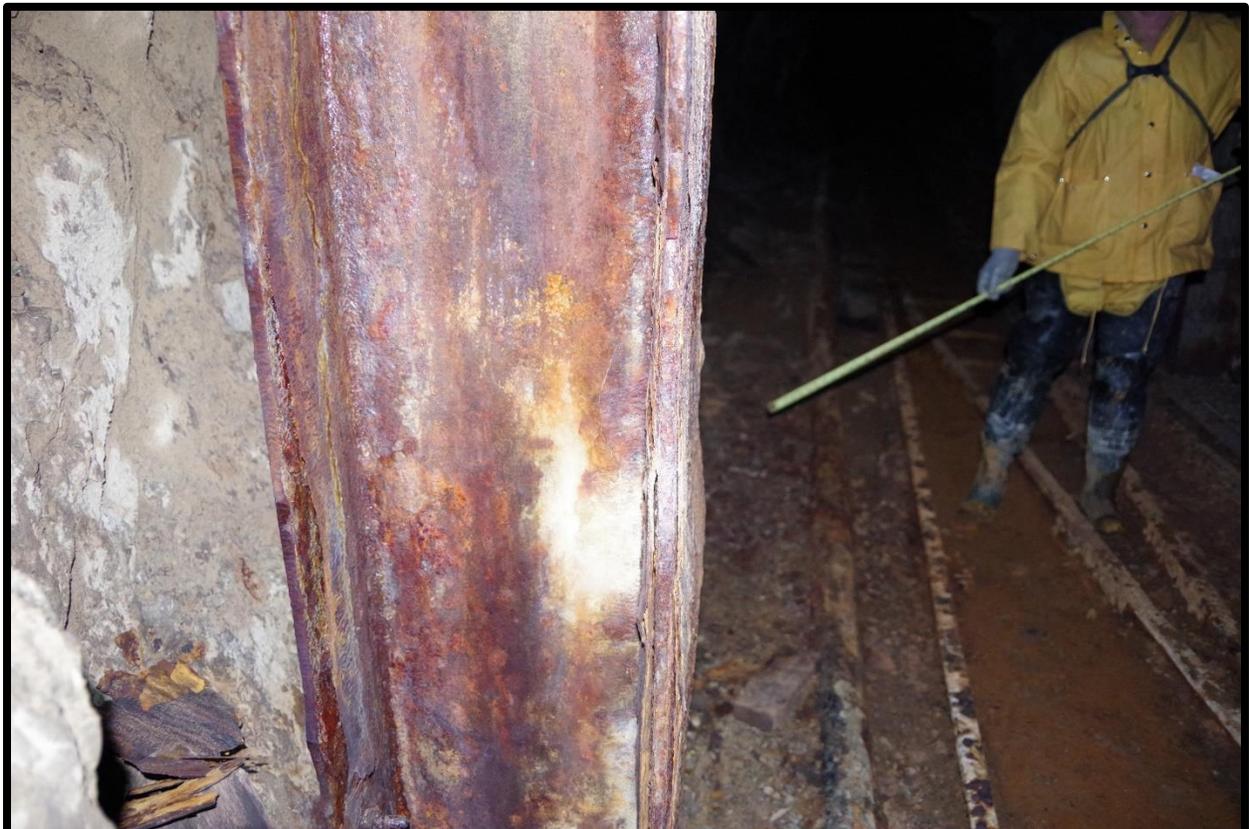
Photo 34: Close up of Archimedes Raise steel posts; Note corrosion and delamination

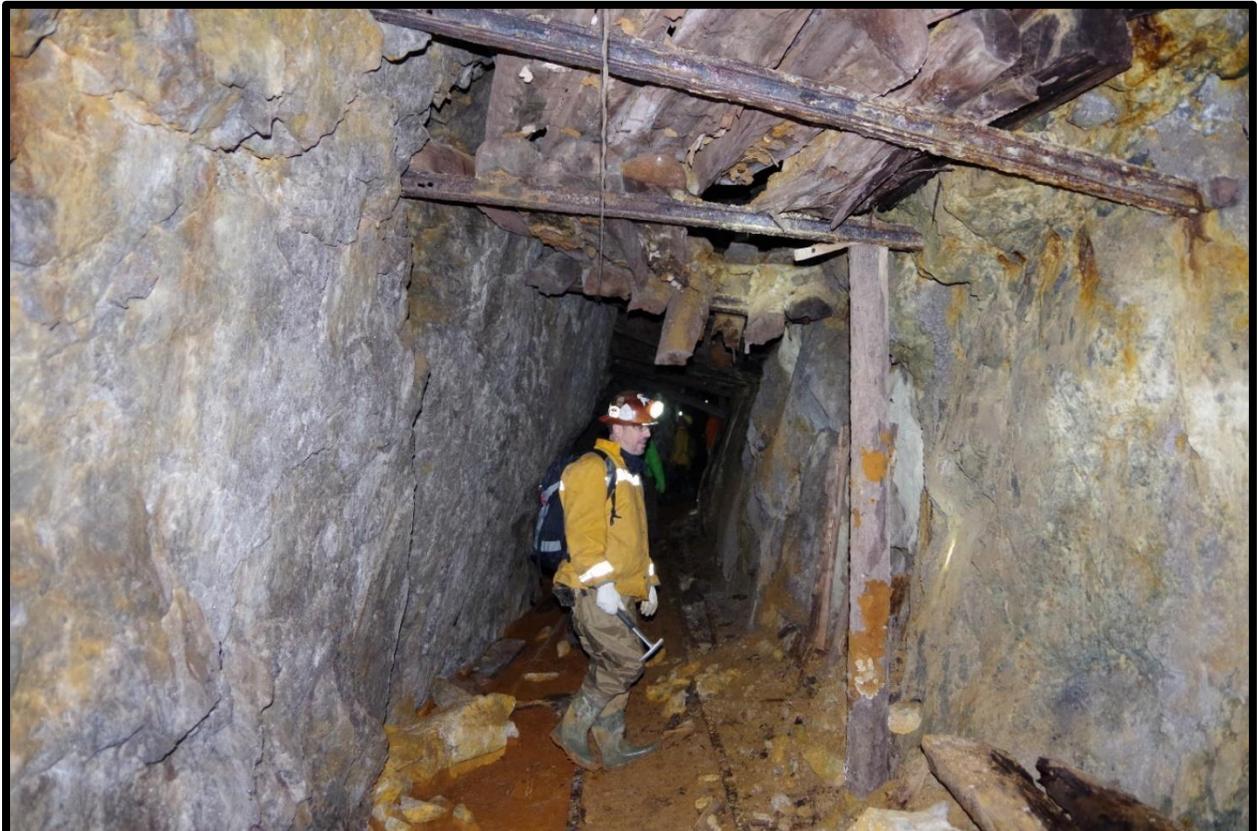
Photo 36: Steel rail stulls with rotten timber lagging 30+50

37	30+50	32+00	150	LF	Steel stulls w/ rotten timber lagging		Remove lagging, add a few stulls scale, spot bolt
38	32+00	32+15	15	LF	Raise		6.2' wide, 8.7' tall; install steel sets, lagging and foam
	31+90	32+00	10		Narrow section over 10+ ft length		5.4' wide x 9.5' high; contractor evaluate need for expansion w/o blasting
39	31+90	32+00	10	LF	Timber lagging rotten		By spad 14 (no data); remove loose timber
40	32+00	32+20	20	LF	Raise: active raveling		New 2 cy debris pile on floor, water backing up 4"; 25' past Spad 14
41	32+20	32+60	40	LF	Steel pipe stulls with debris		6.6-8.5' long; 5.5-8.7 tall; bolt in new stulls or sets 2' OC for 10', stull 4' OC with lagging for 30'
42	32+80	33+05	25	LF	Failed timber stulls		Replace with steel stulls 10' diagonal width; remove debris
	33+18	33+50	32		Blacksmith's Shop		Use as muck/debris stockpile area
	33+81	33+81			Spad 15	9241.73	
43	34+20	34+45	25	LF	Steel pipe stulls with cribbing		7.7' long; add sister stulls

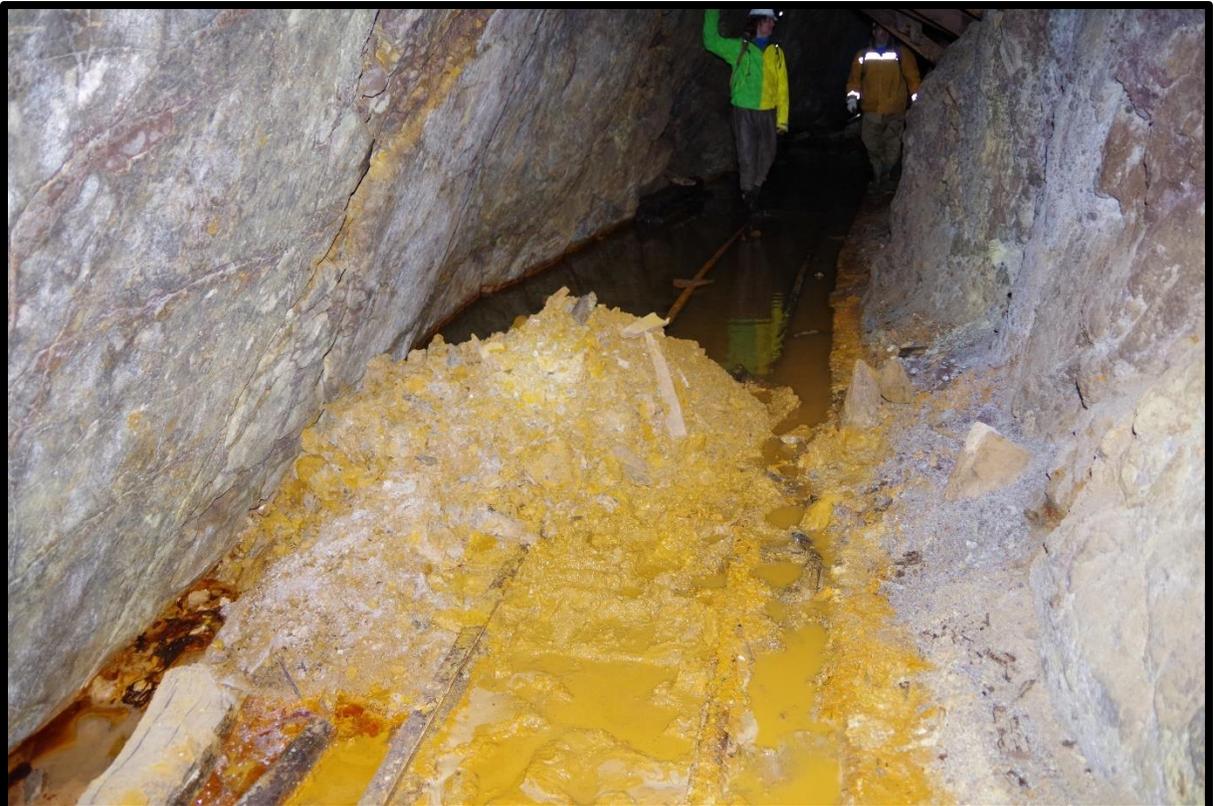
Photo 38: Debris from actively raveling raise near 32+00; Note water backed up behind

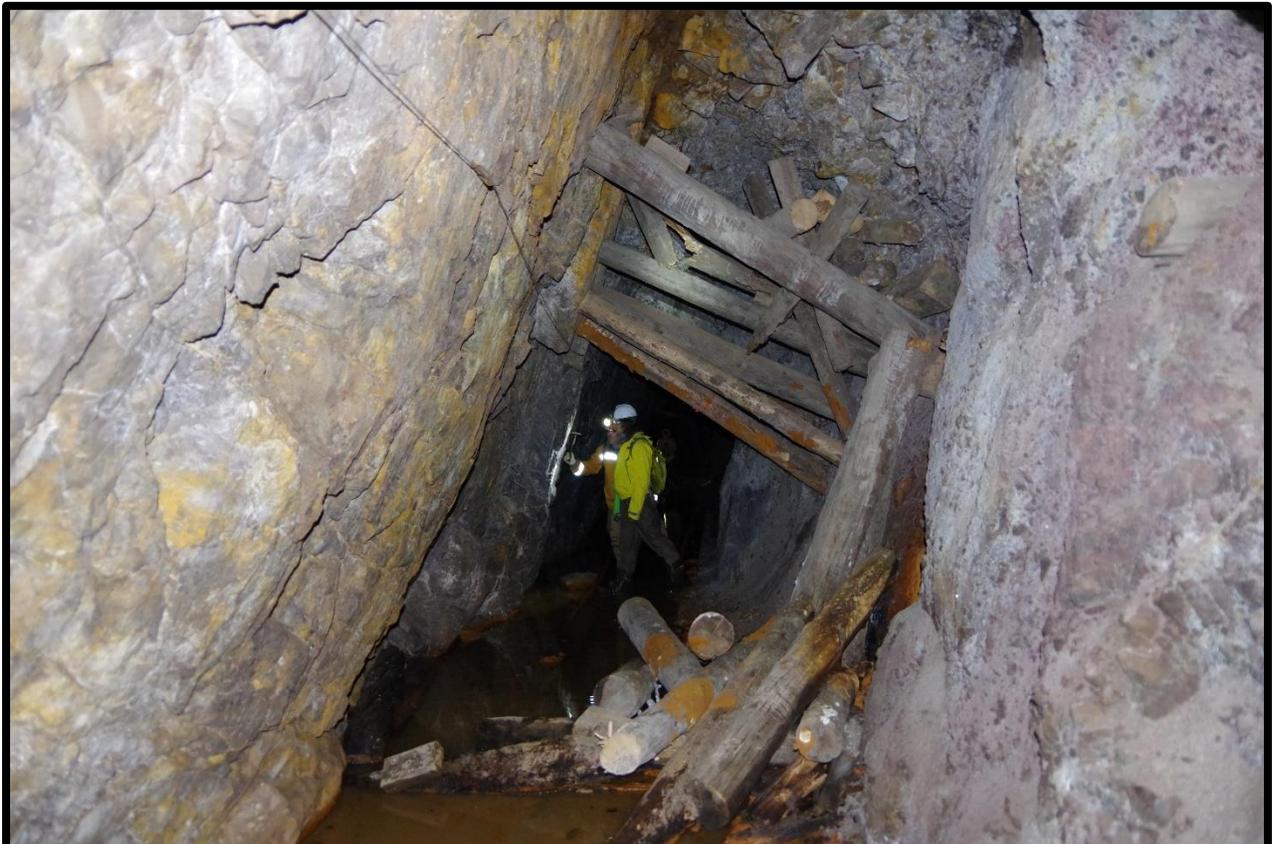
Photo 40: Failed timber stulls near 32+80

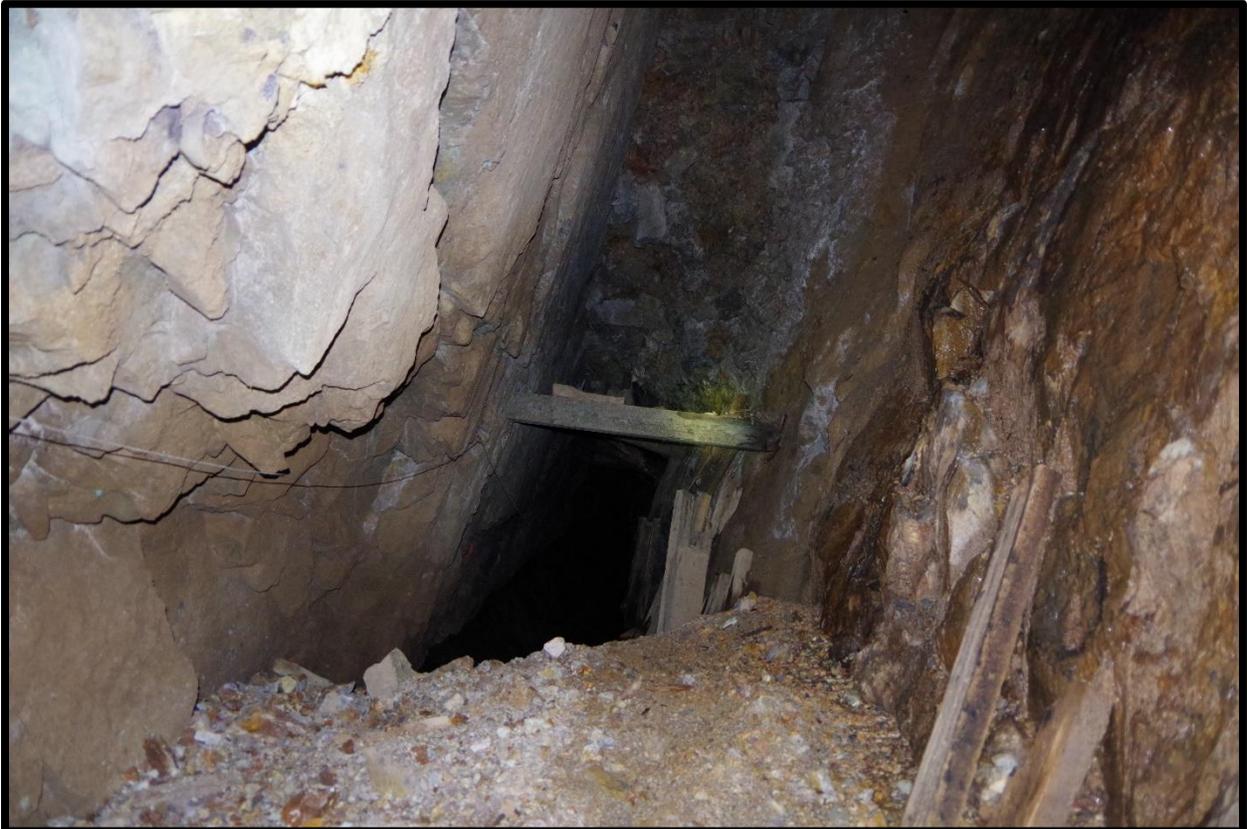
Photo 41: Debris pile at very active 44 Raise 36+82

An item of note is the pool behind the 44 Raise debris pile. To avoid interfering with the work, prior to removing the debris this pool should be pumped out into the nearby Commodore Shaft, allowing it to flow into the mower mine pool. Given the quantity and buffering effect of the Nelson mine pools, this is unlikely to have a significant impact on the flow out of the Nelson Tunnel. If needed, caustic could be added to the 44 Raise pool prior to pumping.

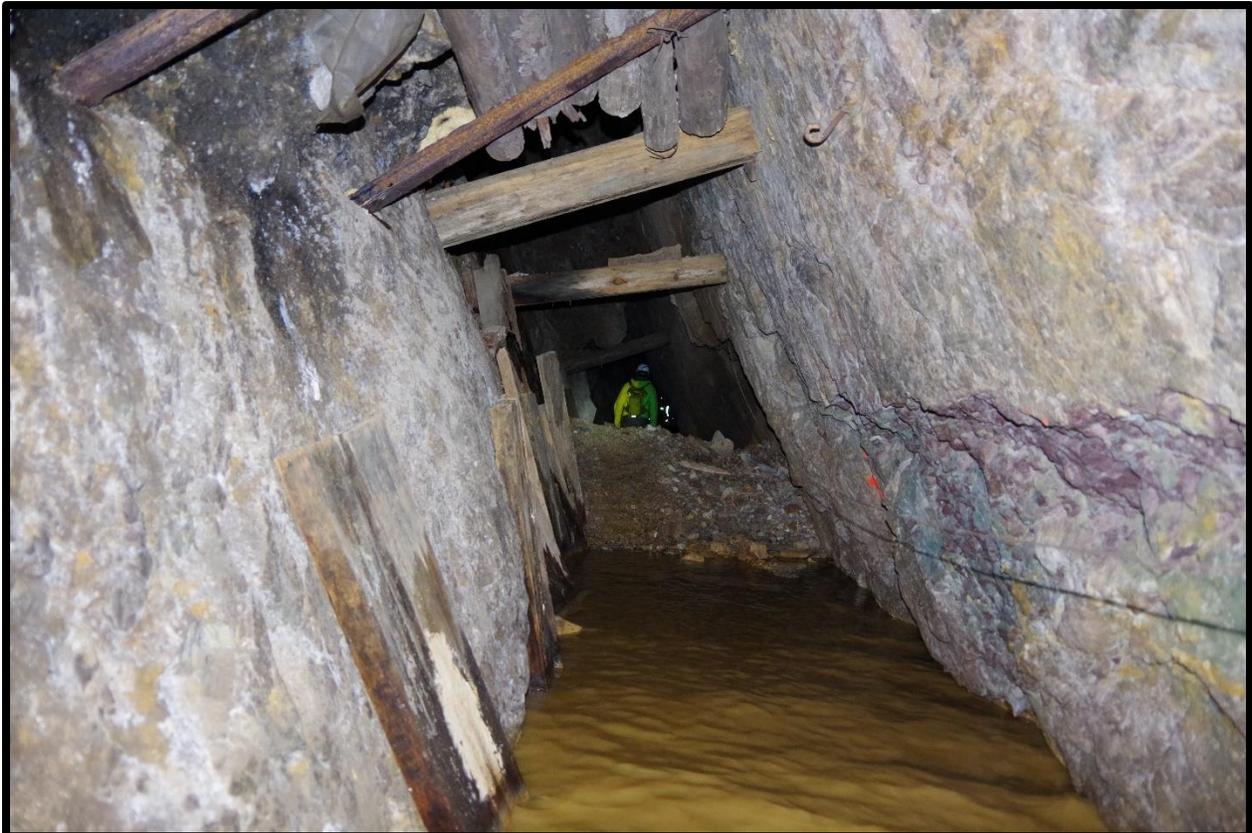
Photo 42: Debris pile at 44 Raise 36+82 looking outby; Note water ponded behind pile

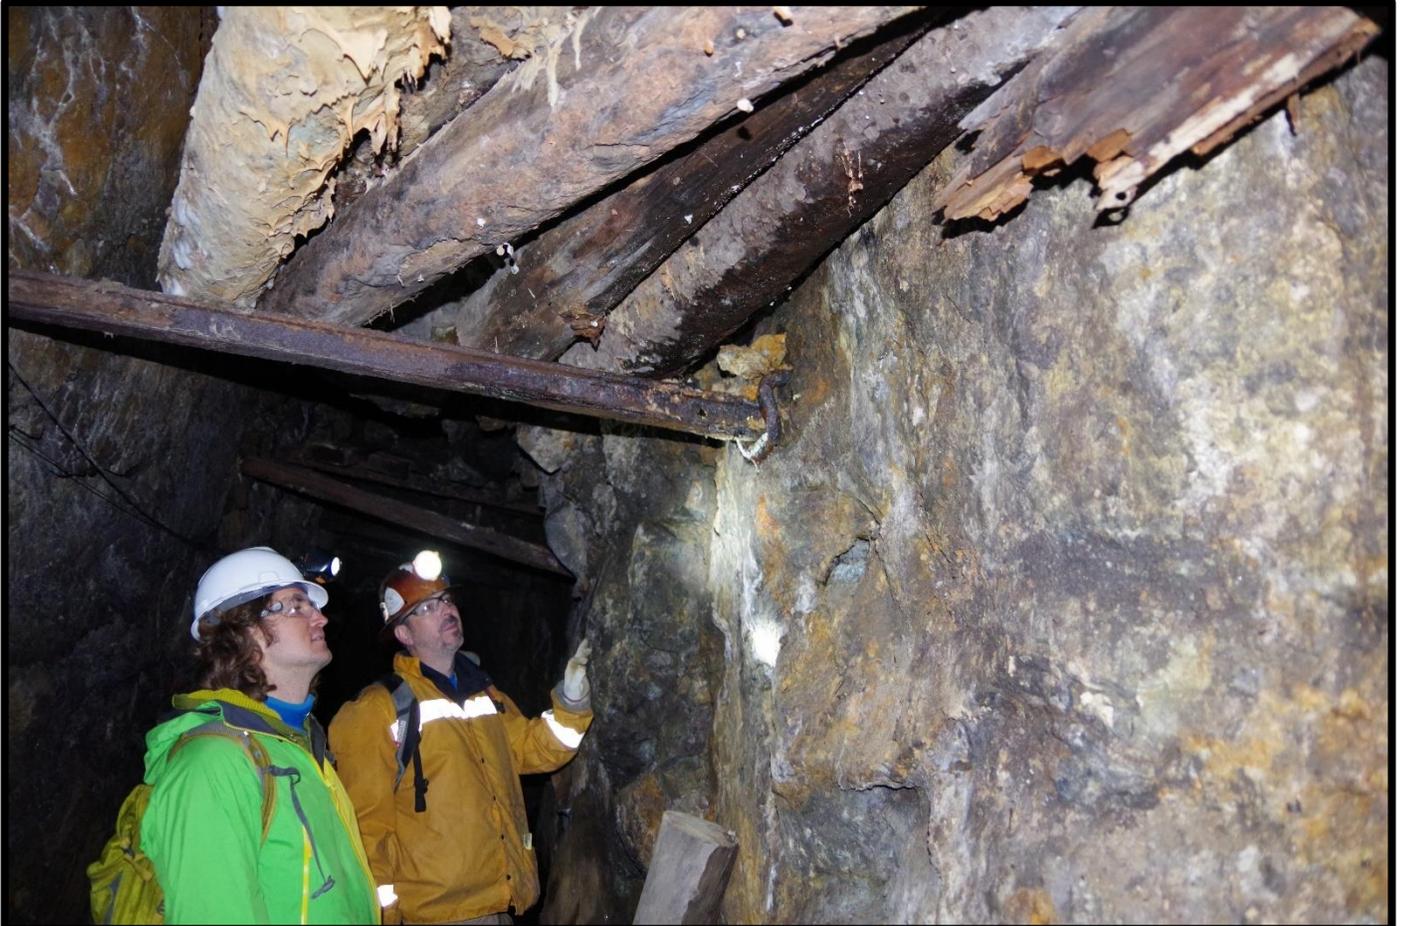
Photo 43: Steel rail stulls and rotten wood lagging near 37+50

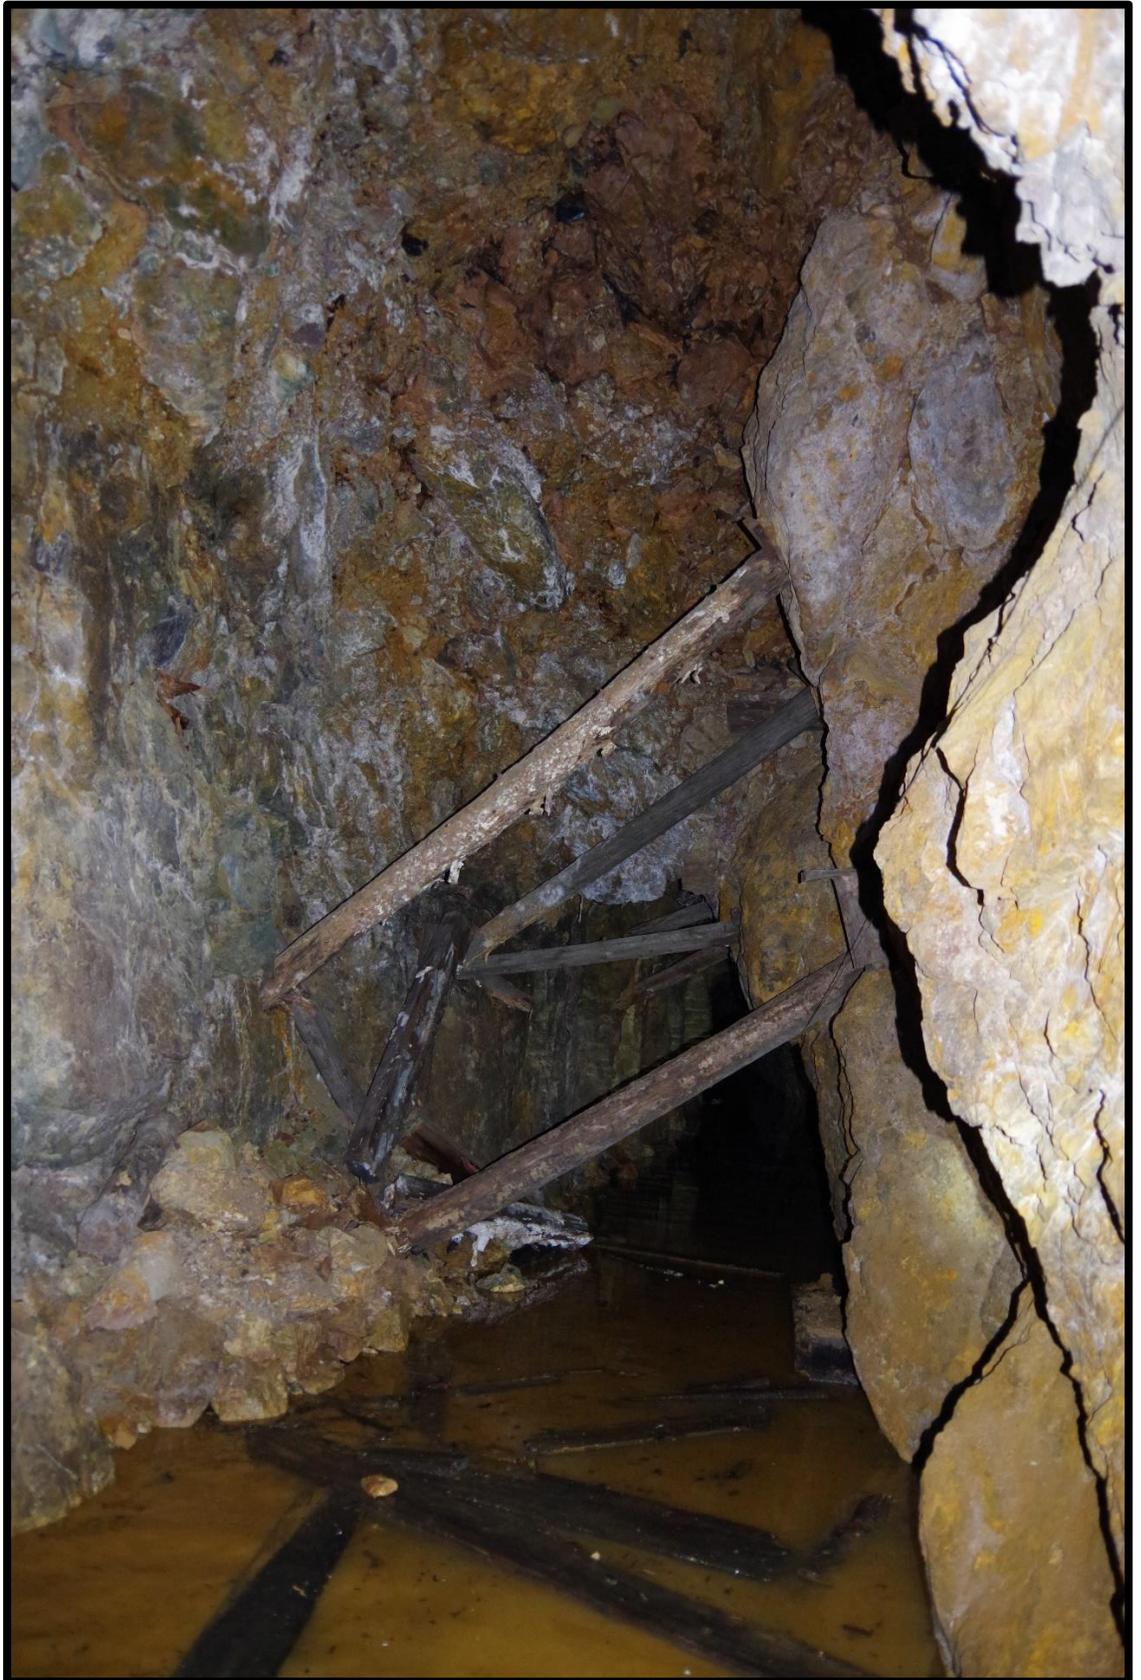
Photo 44: Large loose slabs in hanging wall near 38+10; View is outby

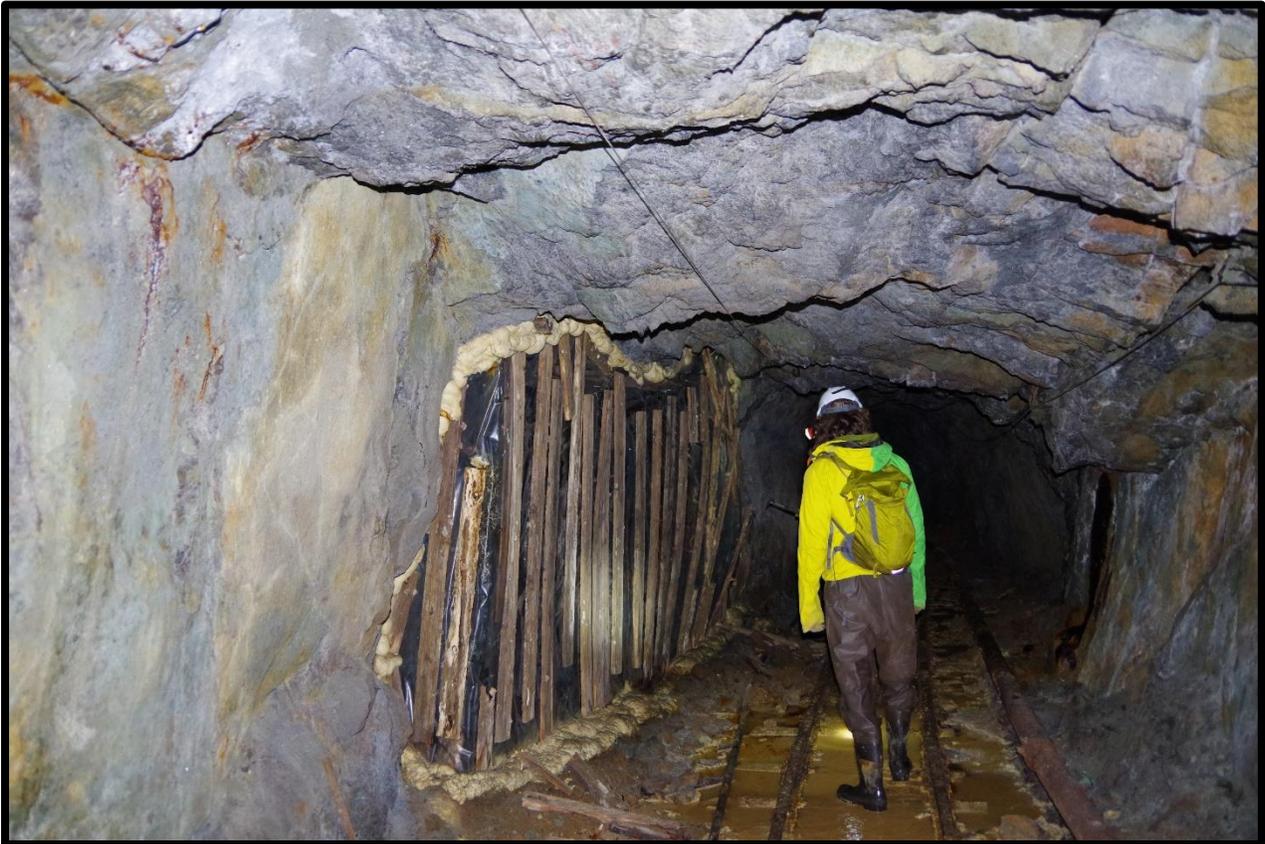
Photo 47: Sealed opening in left rib near 41+50; Loose debris is behind it

53	41+50	41+68	18	LF	Opening in left rib		7' tall, cribbing and rubble behind; install steel posts
	42+00	42+05	5		Low back and narrow spot just past Spad 19		5.8 tall 4.3 wide - contractor to evaluate if needed to enlarge w/o blasting
54	42+79	43+19	40	LF	Large chamber, drift in left rib		20' wide, remove rubble and timber, scale and pattern bolt
	43+58	43+58			Spad 20	9245.86	
55	43+50	43+90	40	LF	Cathedral		26' tall, 11' wide, remove timbers, muck, scale, bolt
56	44+00	44+17	17	LF	Raise with rail stulls; active raveling		9.1' stulls, height 7.8-9.6; install sister stulls, lagging and foam
57	44+60	44+74	1	LS	No Name Winze (Y02)		8' wide, new cover with inflow, rehab winze and ladders, scaling
58	44+60	53+27	867	LF	Debris removal Y02 to Del Monte		Avoid material blocking flow into Y02; more thorough clean up than rest
	45+43	45+43			Spad 21	9245.36	
59	45+45	46+10	65	LF	Drip pan		Remove timbers and drip pan; scale, spot bolt
