MEMORANDUM

RE: Commodore 5 Tunnel Rehabilitation Concept; Creede, Colorado;
D&A Job No. CG-0547.002.00

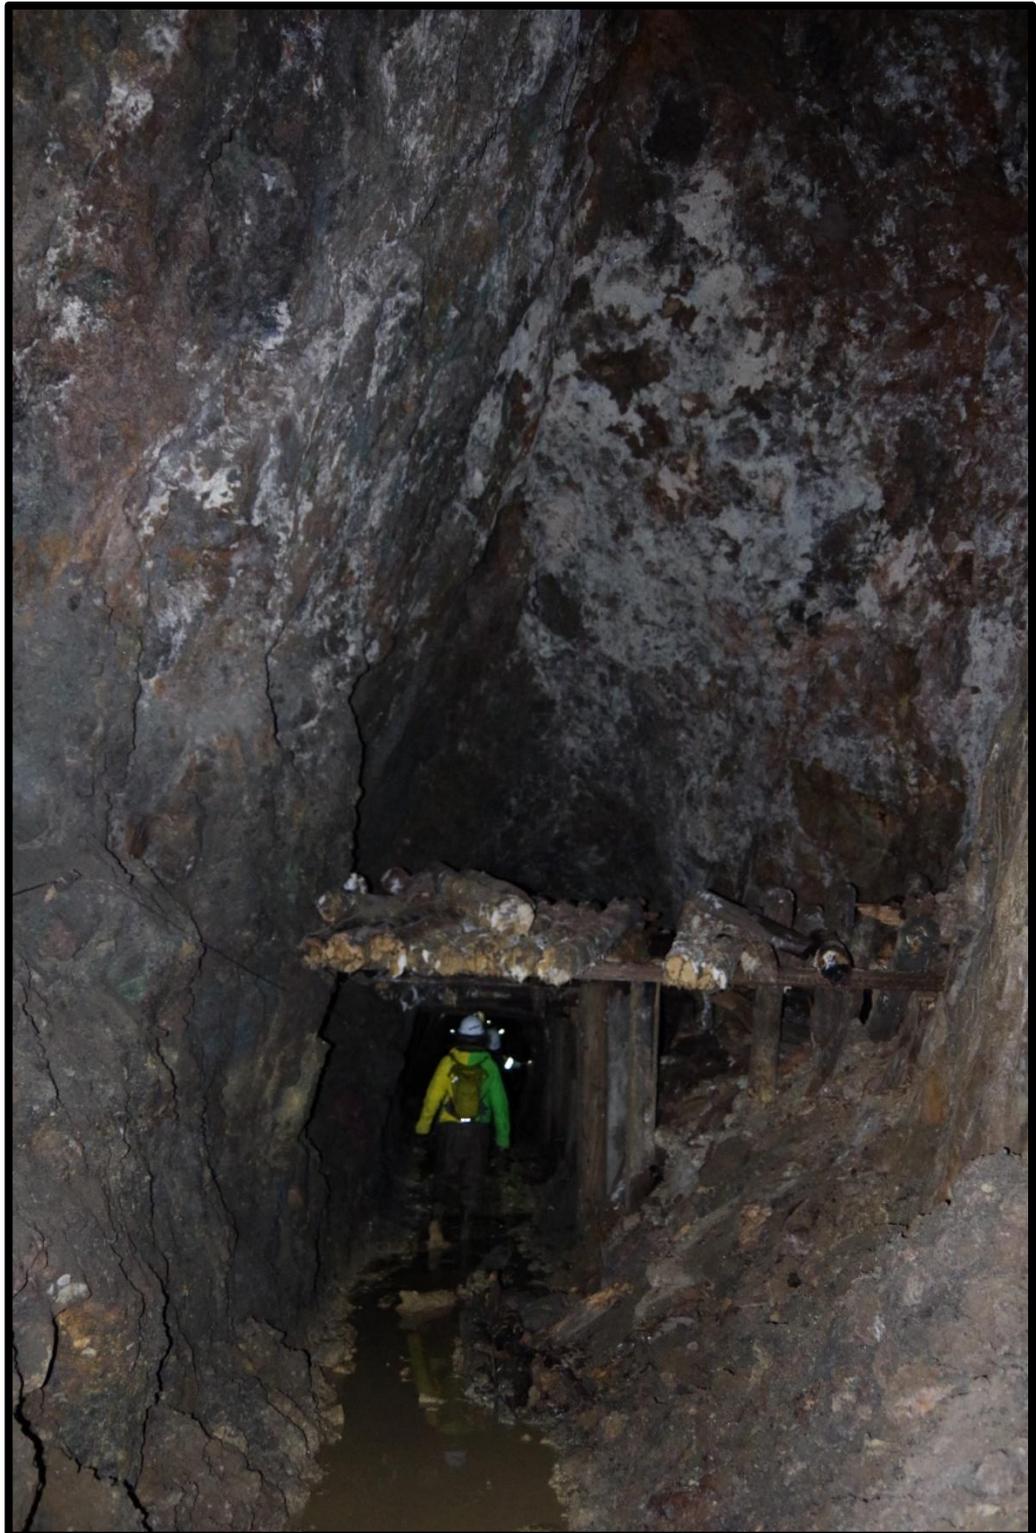
Photo 50: Cathedral near 43+50; Note loose muck in right rib and rotten timber lagging

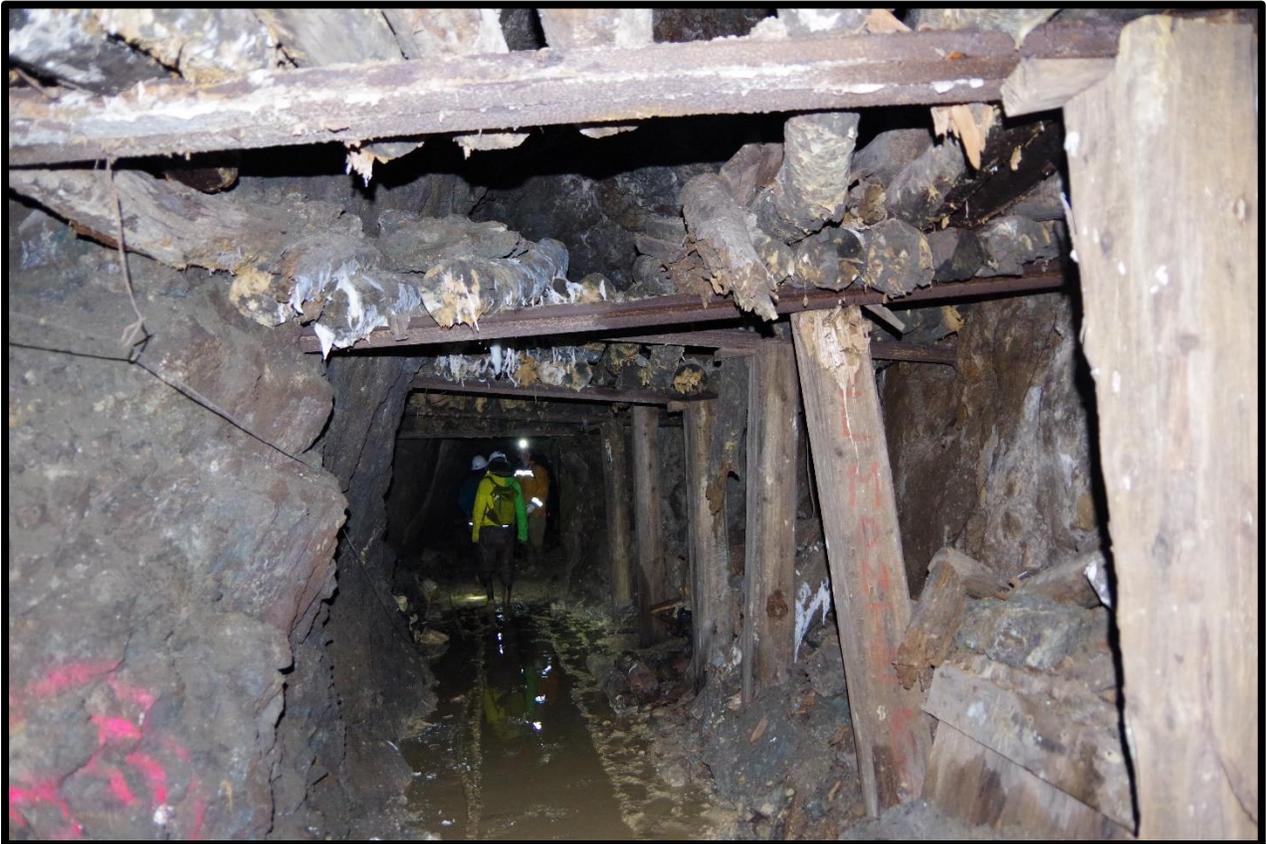
Photo 51: Raise with steel rail, wood posts, and rotten cribbing near 44+00

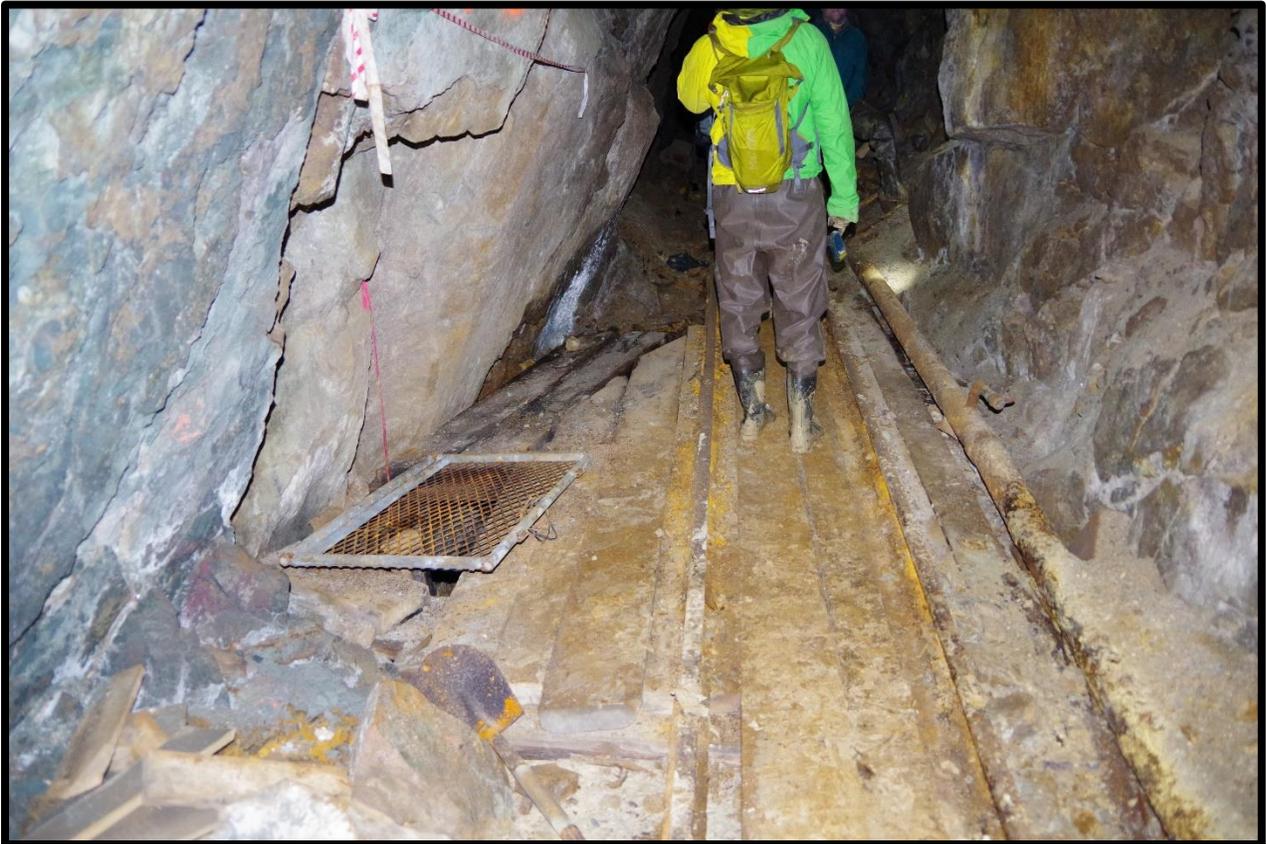
Photo 53: No Name/Y02 Winze 44+60

Due to its importance of acting as the overflow for the upper mine pool, the No Name/Y02 Winze should be fully rehabilitated by scaling, bolting, and installing new ladders and landings, much like the Daylight Winze. This work would take place above the Nelson Tunnel without impacting the impounded mine pool areas. A cover capable of supporting vehicle traffic and allowing water inflow should also be installed. We anticipate the cover consisting of a concrete collar with coated steel beam supports and grated FRP cover.

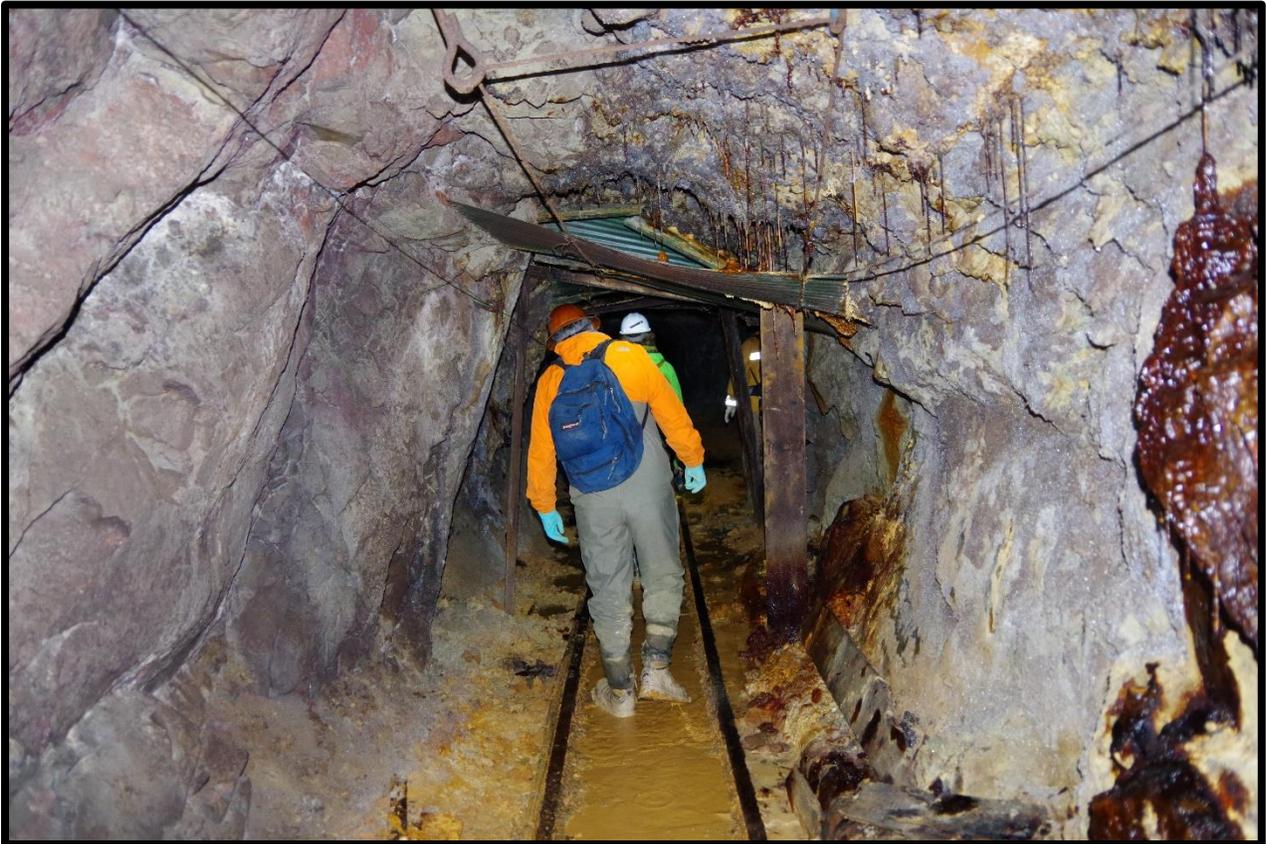
Photo 55: Drip pan in back near 45+45

53	41+50	41+68	18	LF	Opening in left rib		7' tall, cribbing and rubble behind; install steel posts
	42+00	42+05	5		Low back and narrow spot just past Spad 19		5.8 tall 4.3 wide - contractor to evaluate if needed to enlarge w/o blasting
54	42+79	43+19	40	LF	Large chamber, drift in left rib		20' wide, remove rubble and timber, scale and pattern bolt
	43+58	43+58			Spad 20	9245.86	
55	43+50	43+90	40	LF	Cathedral		26' tall, 11' wide, remove timbers, muck, scale, bolt
56	44+00	44+17	17	LF	Raise with rail stulls; active raveling		9.1' stulls, height 7.8-9.6; install sister stulls, lagging and foam
57	44+60	44+74	1	LS	No Name Winze (Y02)		8' wide, new cover with inflow, rehab winze and ladders, scaling
58	44+60	53+27	867	LF	Debris removal Y02 to Del Monte		Avoid material blocking flow into Y02; more thorough clean up than rest
	45+43	45+43			Spad 21	9245.36	
59	45+45	46+10	65	LF	Drip pan		Remove timbers and drip pan; scale, spot bolt

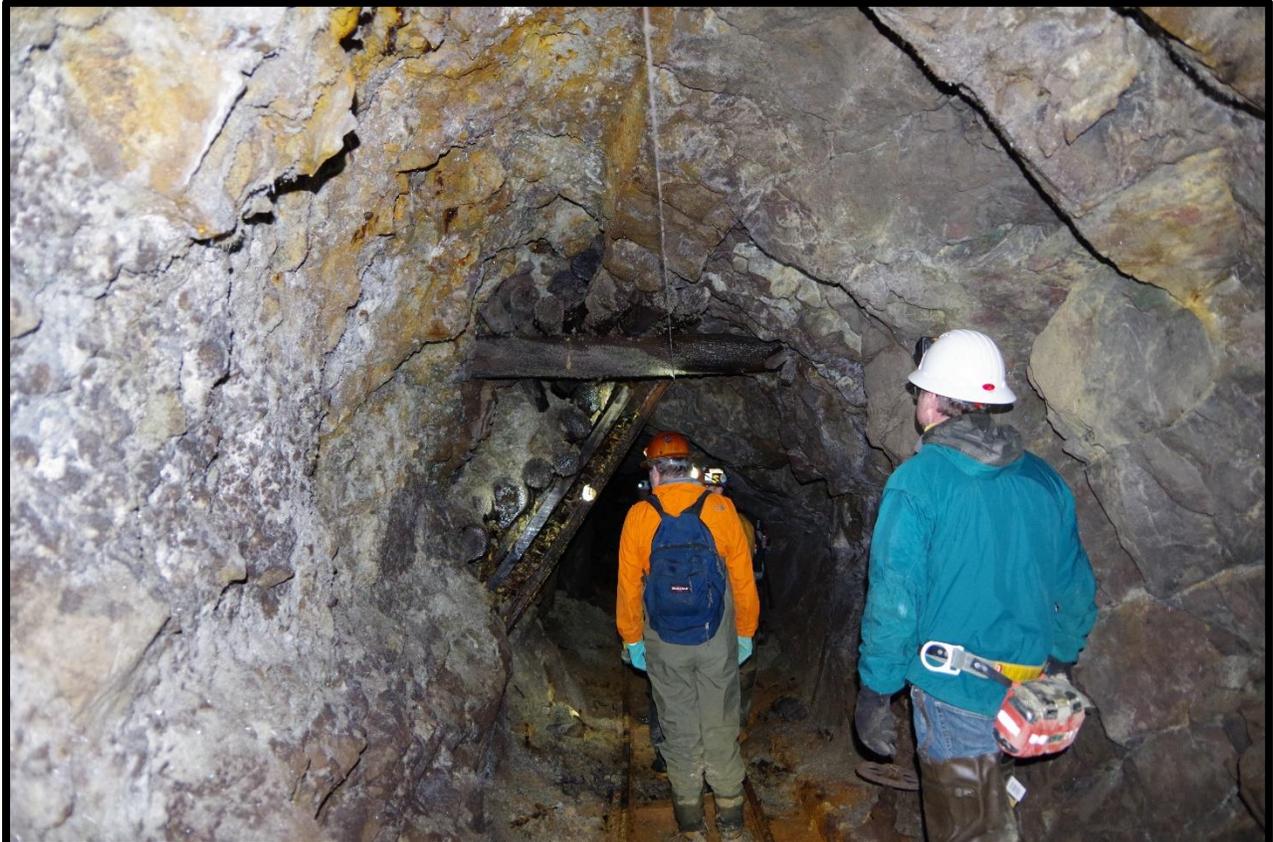
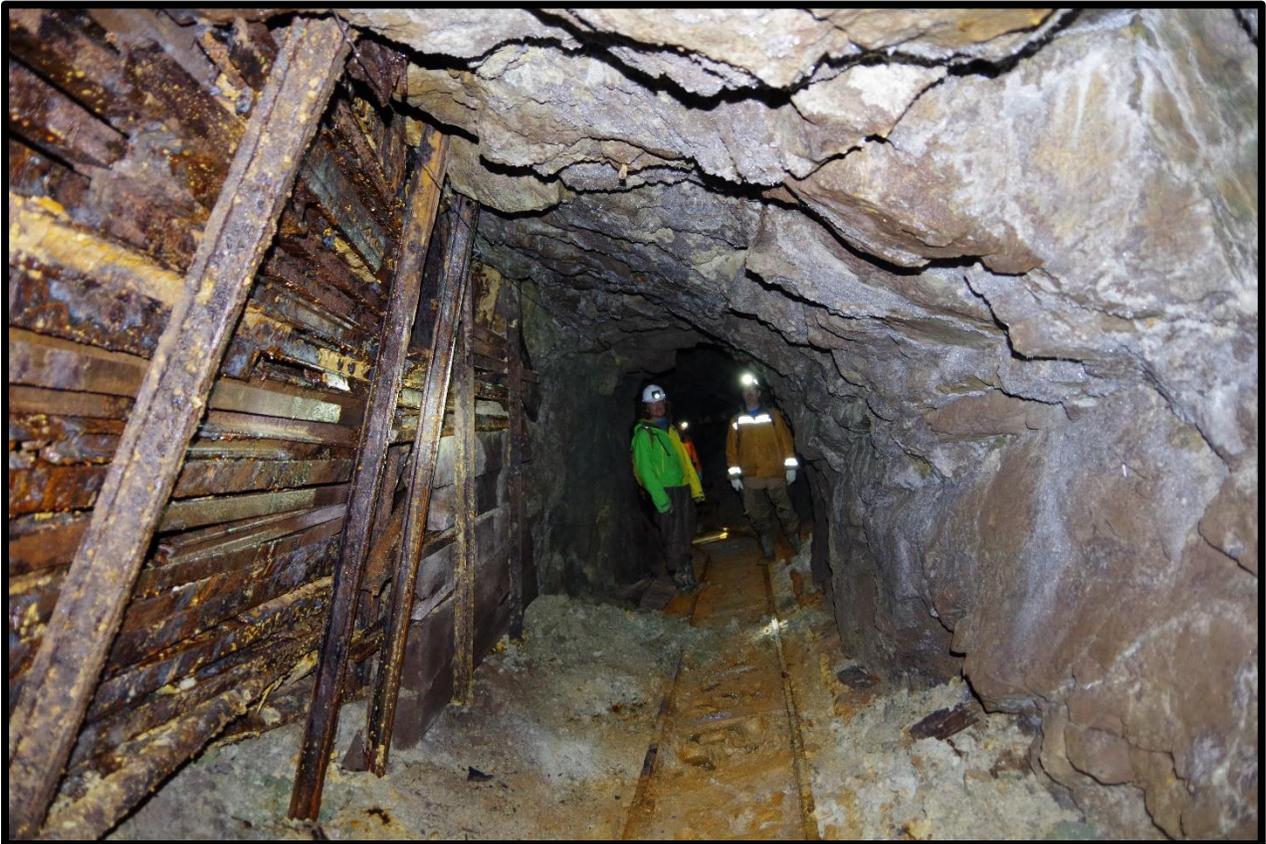
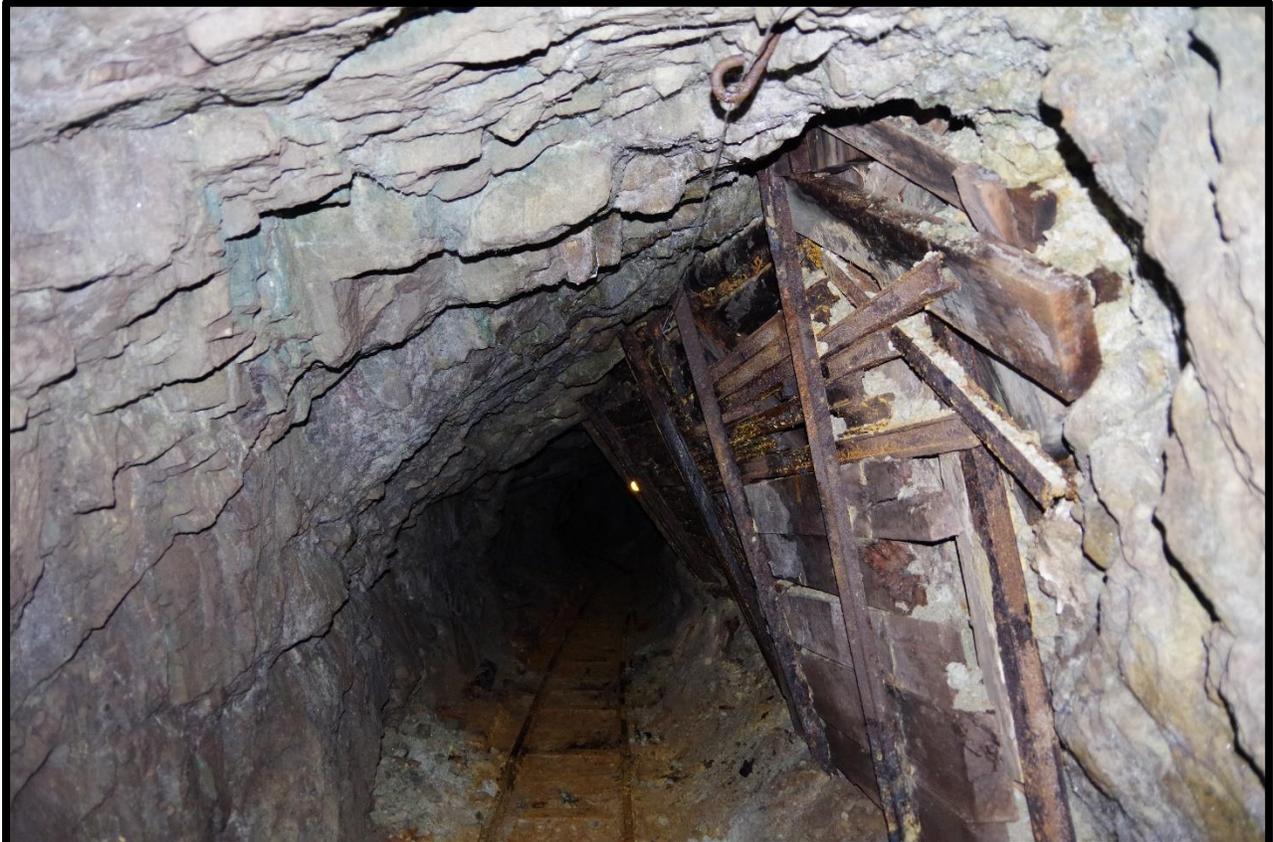
The area of greatest concern for keeping the “overflow” from the Del Monte Raise to the No Name/Y02 Winze open is a section of clay gouge between stations 47+10 and 47+40. It is supported by rail posts, rail lagging, and wood lagging. If the lagging fails in this area, the drift would likely be blocked, leading to higher water pressures and water volume in the upper mine pool.

Photo 56: Area of clay gouge in left rib near 47+10

Photo 57: Area of clay gouge in left rib near 47+10; Note heavy steel rail lagging

Photo 58: Area of clay gouge in left rib near 47+10 looking outby; Note timber lagging

60	46+20	46+21	1	EA	Small prop		Add sister prop
61	47+10	47+40	30	LF	Clay gouge left rib, rail & timbers		8.8 tall, 5.9 wide; install heavy steel sets and lagging
	47+80	47+80			Spad 22	9245.56	
	49+75	49+75			Spad 23	9244.15	Potential negative grade in this area may be due to spad height setting and will not be addressed
	51+77	51+77			Spad 24	9244.17	
62	53+15	53+27	1	LS	Del Monte Raise		High water line 2' above floor; construct elevated platform

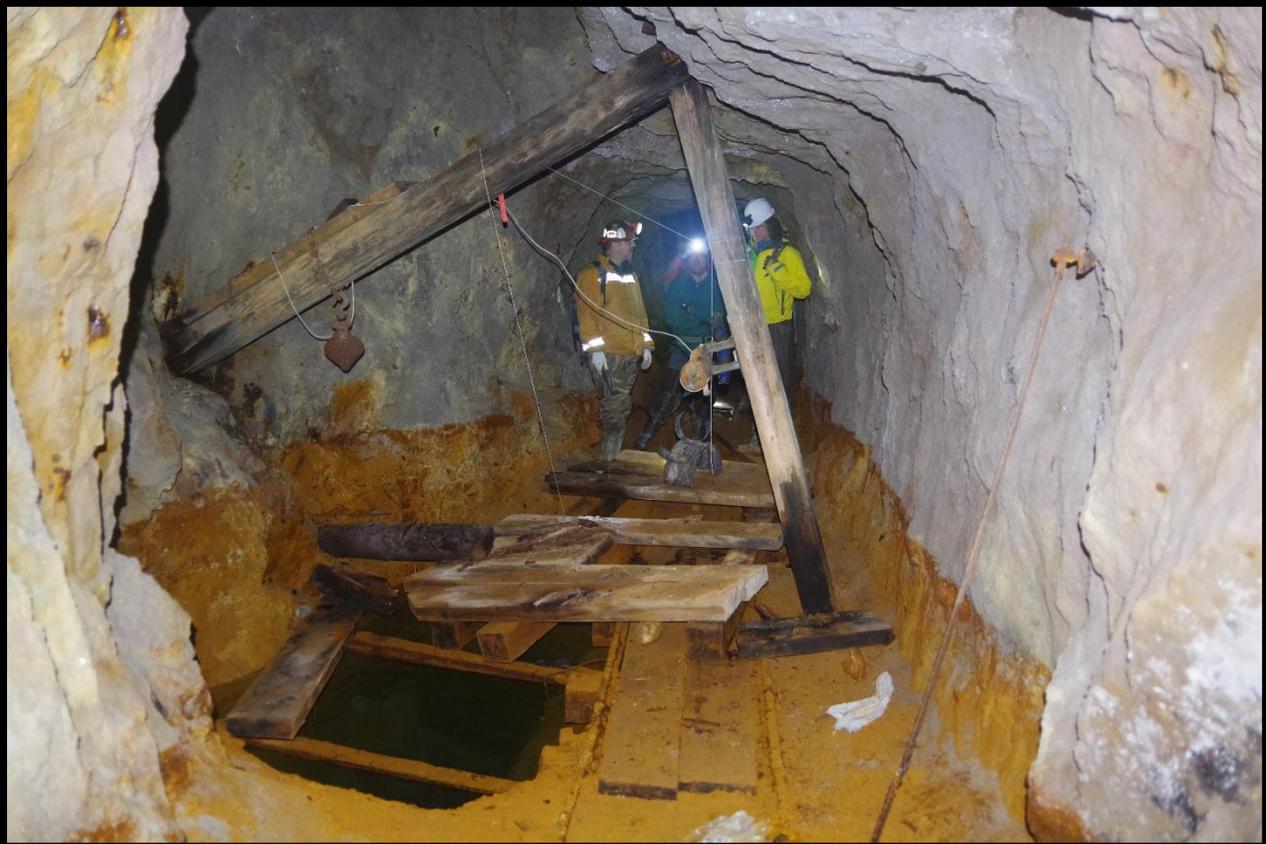
Photo 60: Del Monte Raise 53+15; Note sampling platform

The collar at the Del Monte Raise should have an elevated platform installed above the high water line to allow safe and efficient sampling without hindering the flow of the mine pool. This platform would also be made of FRP or similar material.
