**Subject: Analysis of Brownfields Cleanup Alternatives
Old St. Elizabeth Hospital, Hannibal, Missouri
EPA Region 7, START 4, Contract No. EP-S7-13-06, Task Order No. 0002.048
Task Monitor: Todd Davis, Site Assessment Manager**

ANALYSIS OF BROWNFIELDS CLEANUP ALTERNATIVES

**OLD ST. ELIZABETH HOSPITAL
HANNIBAL, MISSOURI**

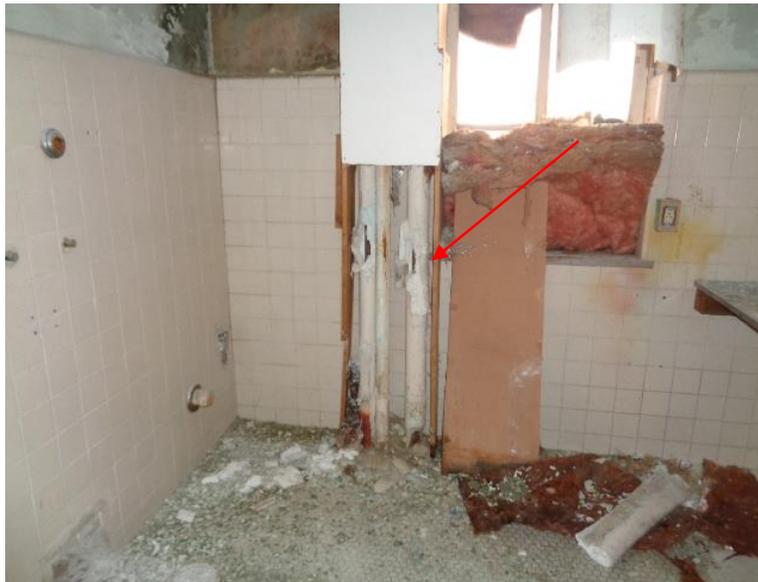
TETRA TECH PROJECT NO. 103X9025140002.048 Direction: NA	DESCRIPTION	This photograph shows asbestos-containing thermal system insulation (TSI) on pipes (red arrow), and ceramic tile with associated mastic in a 1 st floor bathroom of the main building.	6
	CLIENT	U.S. Environmental Protection Agency Region 7	Date
	PHOTOGRAPHER	Kaitlyn Mitchell	3/30/2018

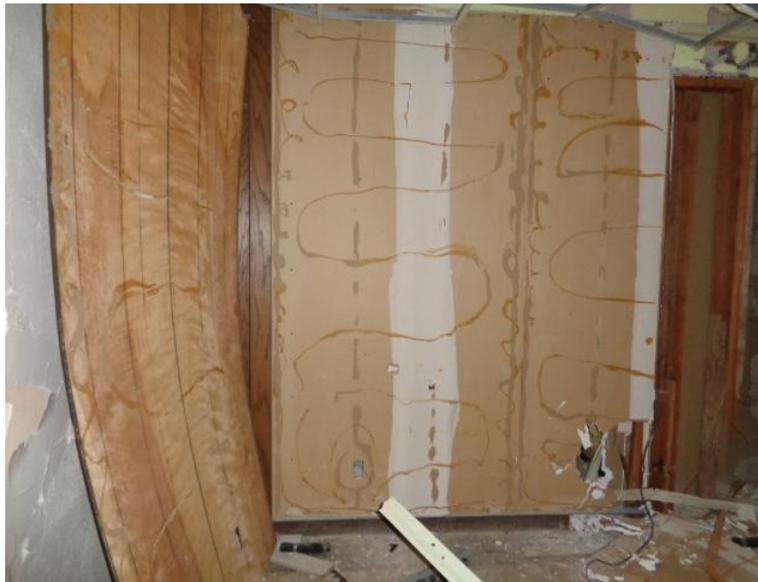
TETRA TECH PROJECT NO. 103X9025140002.048 Direction: NA	DESCRIPTION	This photograph shows asbestos-containing tan wall mastic behind wood paneling in a 2 nd floor patient room and throughout the main building.	10
	CLIENT	U.S. Environmental Protection Agency Region 7	Date
	PHOTOGRAPHER	Kaitlyn Mitchell	3/30/2018

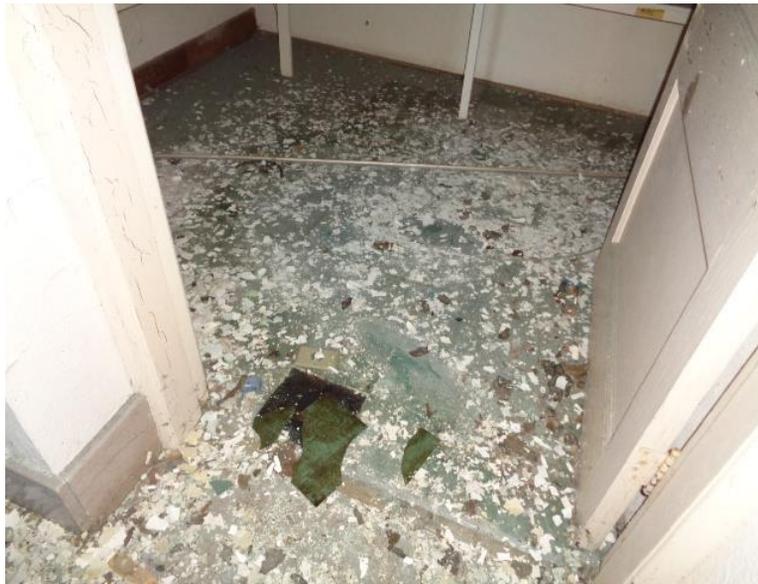
TETRA TECH PROJECT NO. 103X9025140002.048 Direction: NA	DESCRIPTION	This photograph shows asbestos-containing 9" x 9" green floor tile in room 2 on the 3 rd floor of the main building.	14
	CLIENT	U.S. Environmental Protection Agency Region 7	Date
	PHOTOGRAPHER	Kaitlyn Mitchell	3/30/2018

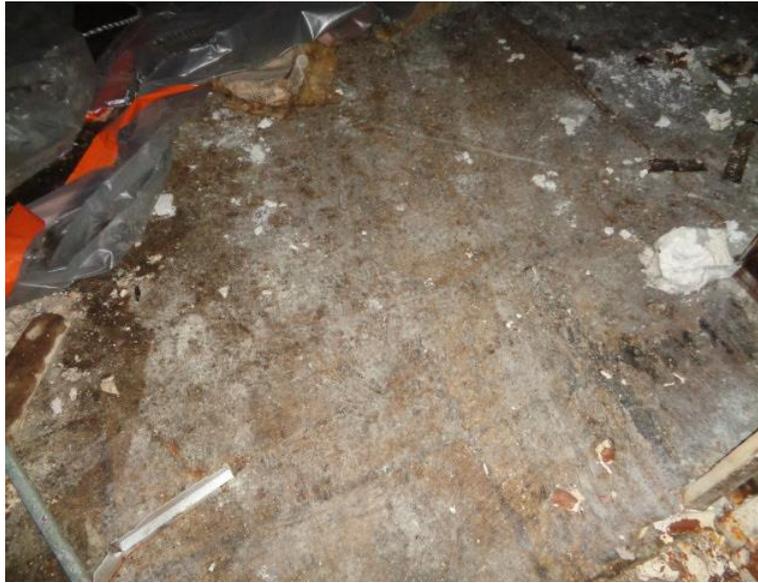
TETRA TECH PROJECT NO. 103X9025140002.048 Direction: NA	DESCRIPTION	This photograph shows asbestos-containing brown linoleum in the basement of the main building.	15
	CLIENT	U.S. Environmental Protection Agency Region 7	Date
	PHOTOGRAPHER	Kaitlyn Mitchell	3/30/2018

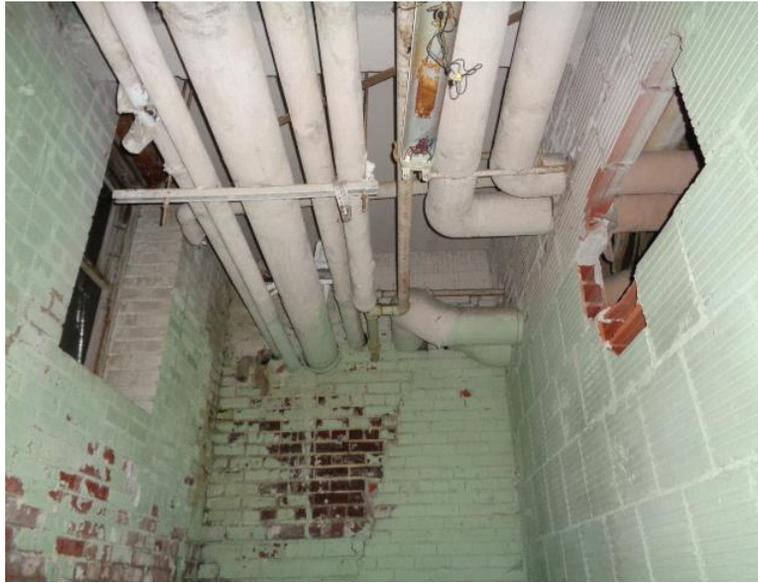
TETRA TECH PROJECT NO. 103X9025140002.048 Direction: NA	DESCRIPTION	This photograph shows asbestos-containing TSI pipe runs and joints in the basement boiler room of the main building.	19
	CLIENT	U.S. Environmental Protection Agency Region 7	Date
	PHOTOGRAPHER	Kaitlyn Mitchell	3/30/2018

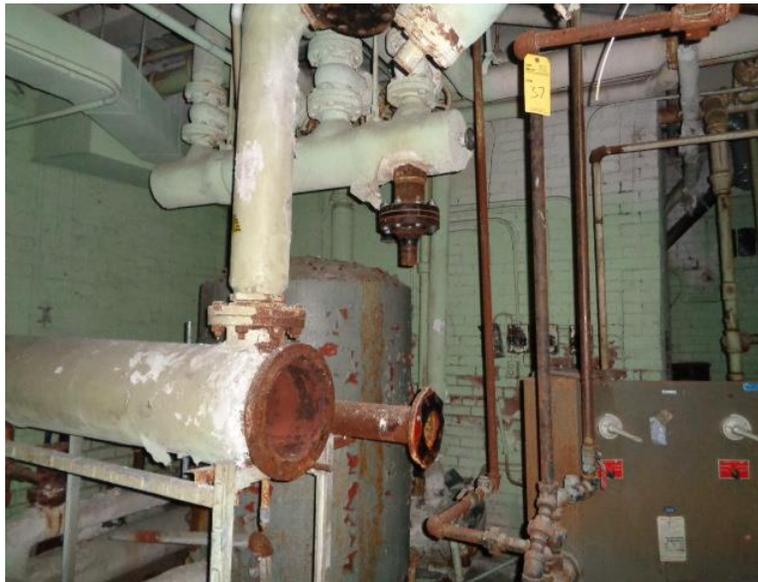
TETRA TECH PROJECT NO. 103X9025140002.048 Direction: NA	DESCRIPTION	This photograph shows asbestos-containing TSI pipe runs and joints in the basement boiler room of the main building.	20
	CLIENT	U.S. Environmental Protection Agency Region 7	Date
	PHOTOGRAPHER	Kaitlyn Mitchell	3/30/2018

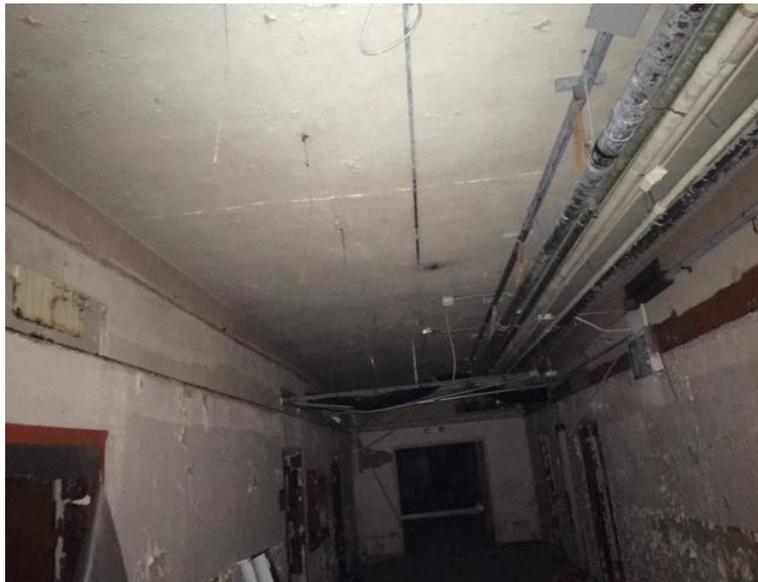
TETRA TECH PROJECT NO. 103X9025140002.048 Direction: NA	DESCRIPTION	This photograph shows beige lead-based paint (LBP) on walls in the basement hallway of the main building.	28
	CLIENT	U.S. Environmental Protection Agency Region 7	Date
	PHOTOGRAPHER	Jeffrey Mitchell	2/27/2018

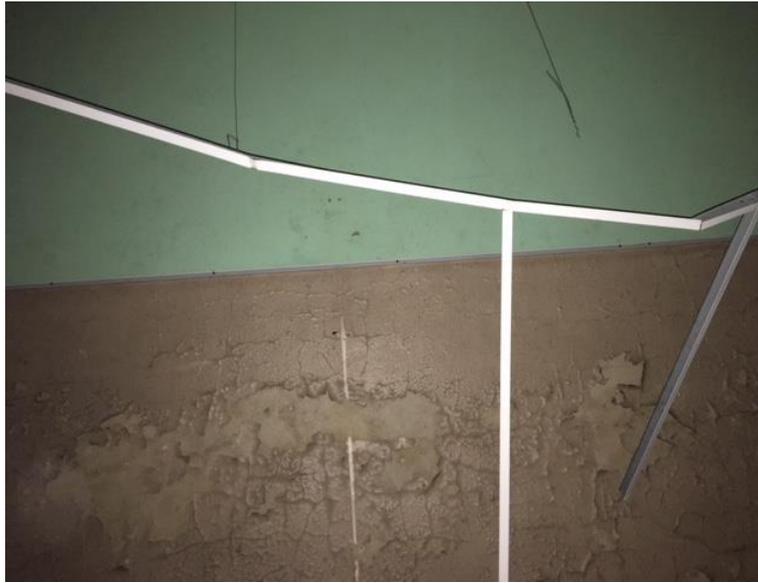
TETRA TECH PROJECT NO. 103X9025140002.048 Direction: NA	DESCRIPTION	This photograph shows brown LBP on walls in the 1 st -floor north hallway and west room of the main building.	29
	CLIENT	U.S. Environmental Protection Agency Region 7	Date
	PHOTOGRAPHER	Jeffrey Mitchell	2/27/2018

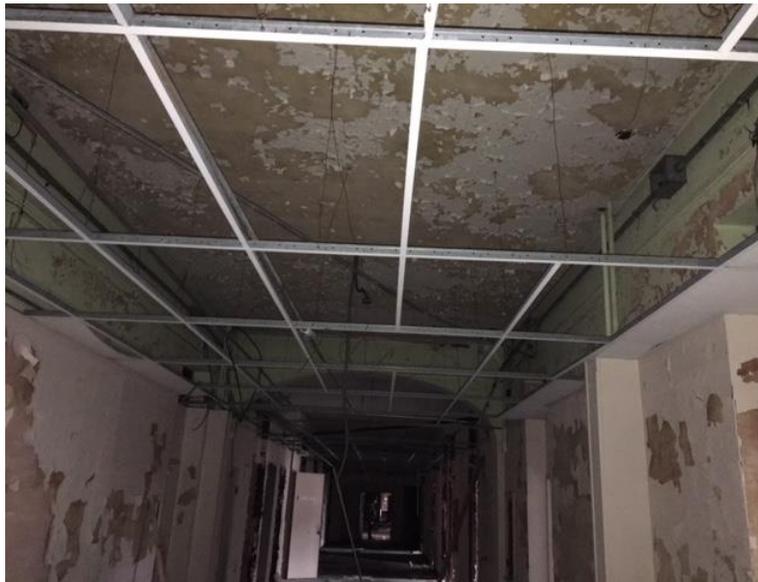
TETRA TECH PROJECT NO. 103X9025140002.048 Direction: NA	DESCRIPTION	This photograph shows white LBP on the ceiling in the 1 st -floor north hallway and rooms of the main building.	30
	CLIENT	U.S. Environmental Protection Agency Region 7	Date
	PHOTOGRAPHER	Jeffrey Mitchell	2/27/2018

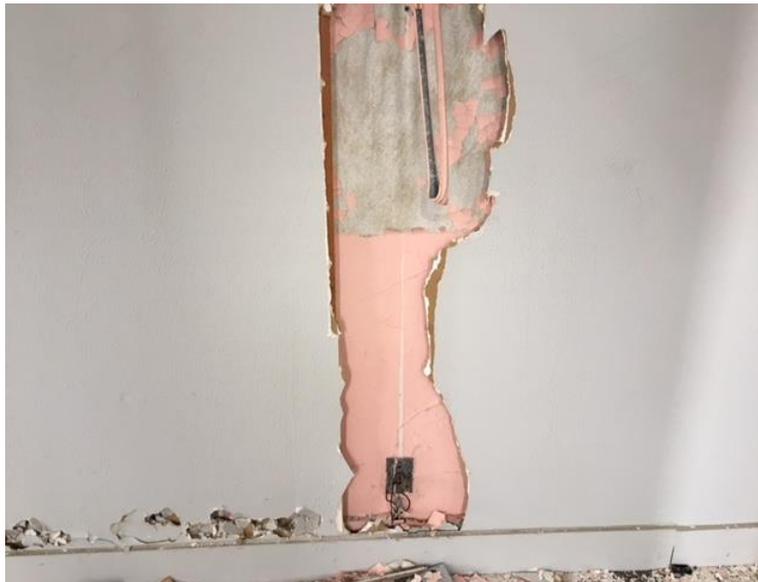
TETRA TECH PROJECT NO. 103X9025140002.048 Direction: NA	DESCRIPTION	This photograph shows pink LBP on walls in the 1 st -floor south rooms of the main building.	32
	CLIENT	U.S. Environmental Protection Agency Region 7	Date
	PHOTOGRAPHER	Jeffrey Mitchell	2/27/2018

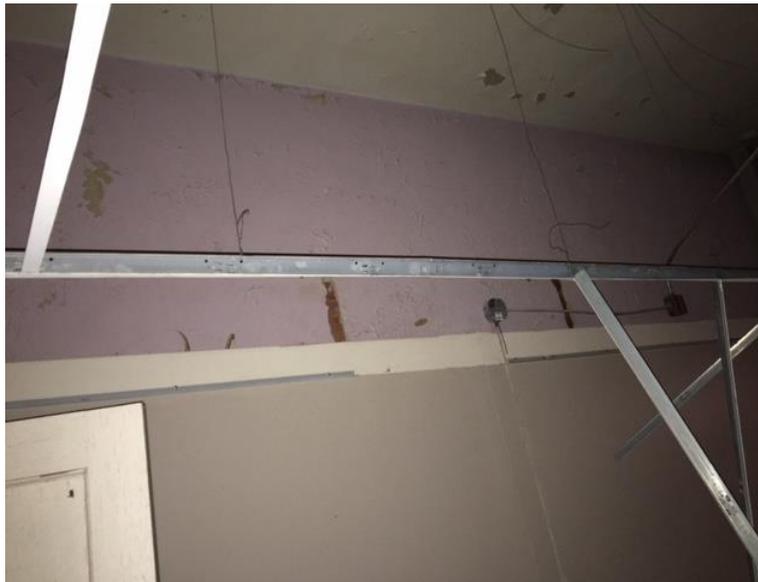
TETRA TECH PROJECT NO. 103X9025140002.048 Direction: NA	DESCRIPTION	This photograph shows purple LBP on walls in the 1 st -floor west rooms of the main building.	34
	CLIENT	U.S. Environmental Protection Agency Region 7	Date
	PHOTOGRAPHER	Jeffrey Mitchell	2/27/2018

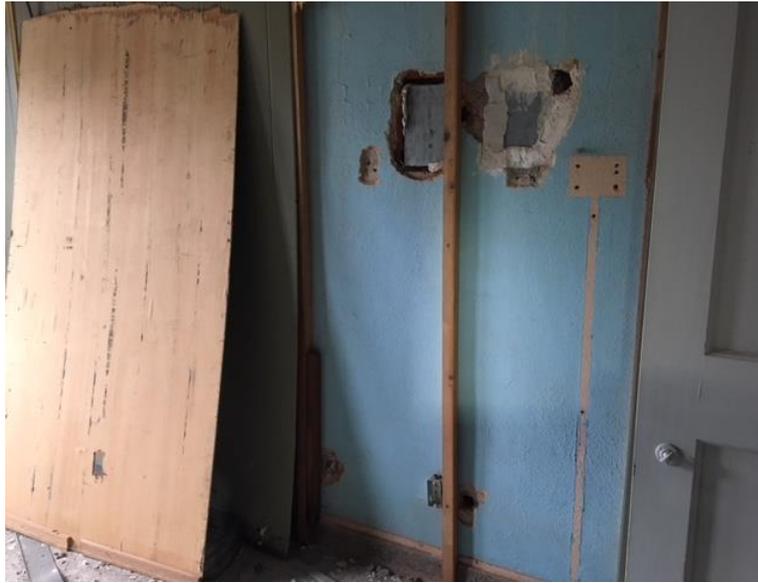
TETRA TECH PROJECT NO. 103X9025140002.048 Direction: NA	DESCRIPTION	This photograph shows blue LBP on walls in the 2 nd -floor east side north room of the main building.	37
	CLIENT	U.S. Environmental Protection Agency Region 7	Date
	PHOTOGRAPHER	Jeffrey Mitchell	2/27/2018

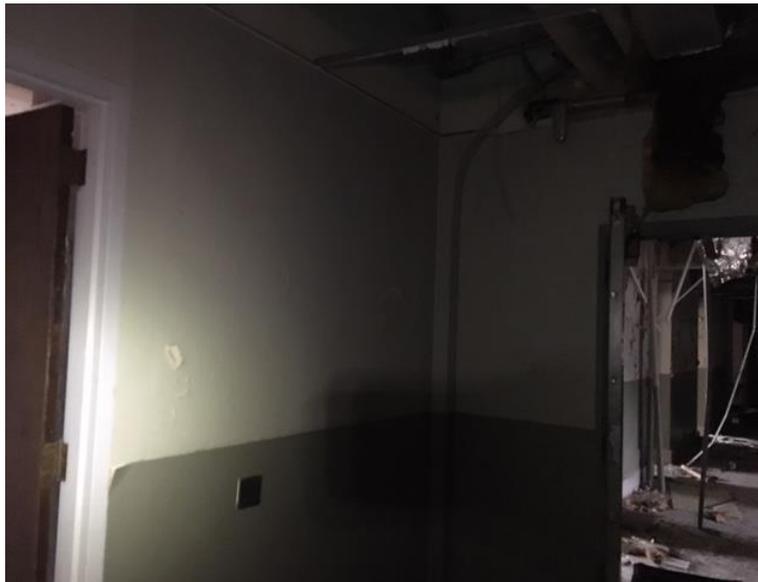
TETRA TECH PROJECT NO. 103X9025140002.048 Direction: NA	DESCRIPTION	This photograph shows off-white LBP on walls in the 2 nd -floor hallway of the main building.	38
	CLIENT	U.S. Environmental Protection Agency Region 7	Date
	PHOTOGRAPHER	Jeffrey Mitchell	2/27/2018

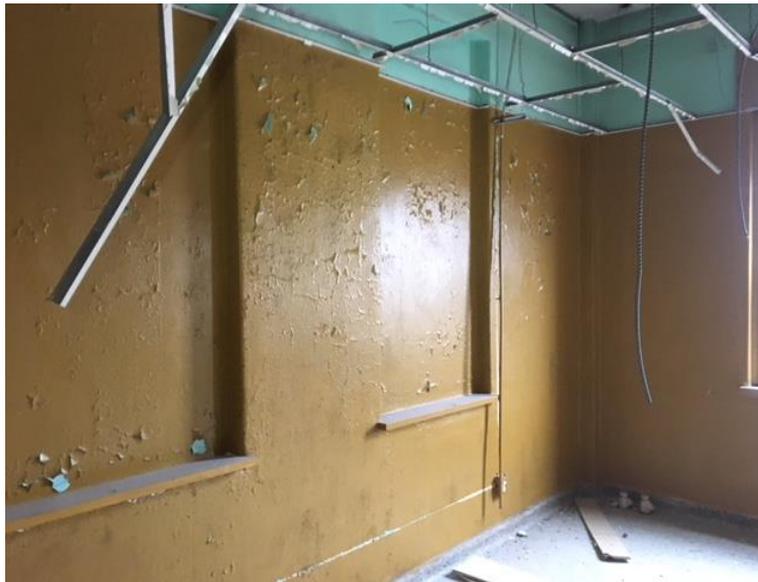
TETRA TECH PROJECT NO. 103X9025140002.048 Direction: NA	DESCRIPTION	This photograph shows dark yellow LBP on walls in the 2 nd -floor north rooms of the main building.	40
	CLIENT	U.S. Environmental Protection Agency Region 7	Date
	PHOTOGRAPHER	Jeffrey Mitchell	2/27/2018

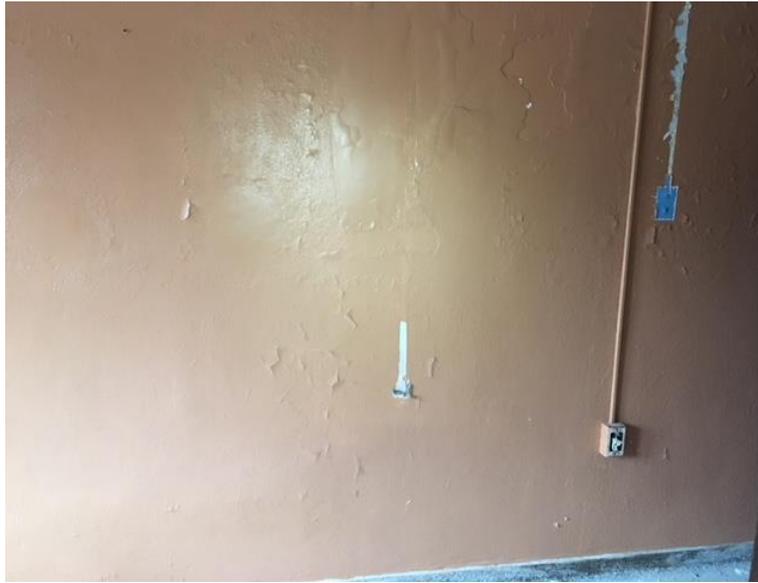
TETRA TECH PROJECT NO. 103X9025140002.048 Direction: NA	DESCRIPTION	This photograph shows peach LBP on walls in the 2 nd -floor east side north room of the main building.	41
	CLIENT	U.S. Environmental Protection Agency Region 7	Date
	PHOTOGRAPHER	Jeffrey Mitchell	2/27/2018

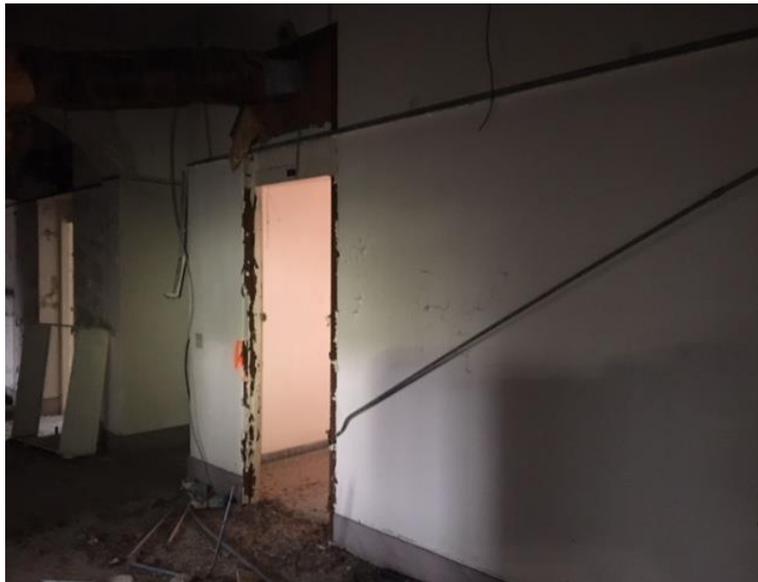
TETRA TECH PROJECT NO. 103X9025140002.048 Direction: NA	DESCRIPTION	This photograph shows beige LBP on walls and ceiling in the 3 rd -floor hallway between rooms 322 and 326 of the main building.	42
	CLIENT	U.S. Environmental Protection Agency Region 7	Date
	PHOTOGRAPHER	Jeffrey Mitchell	2/27/2018

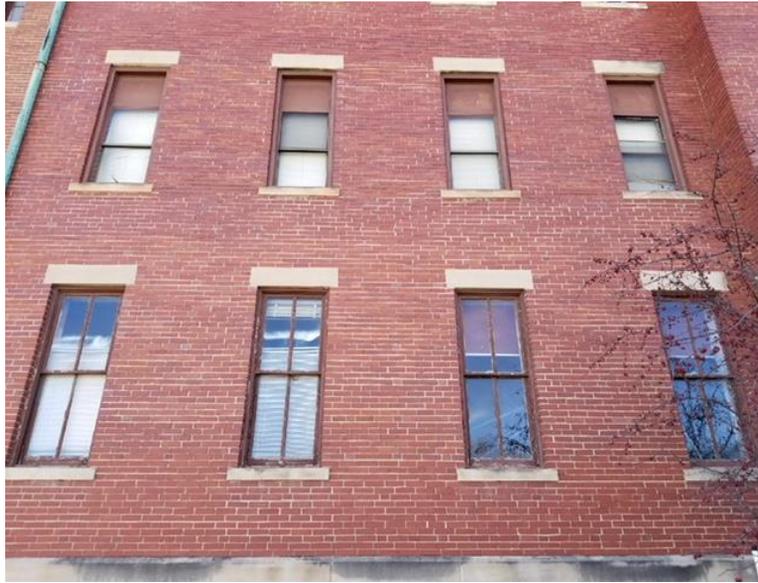
TETRA TECH PROJECT NO. 103X9025140002.048 Direction: NA	DESCRIPTION	This photograph shows brown LBP on window frames on the exterior of the main building.	43
	CLIENT	U.S. Environmental Protection Agency Region 7	Date
	PHOTOGRAPHER	Jeffrey Mitchell	2/27/2018

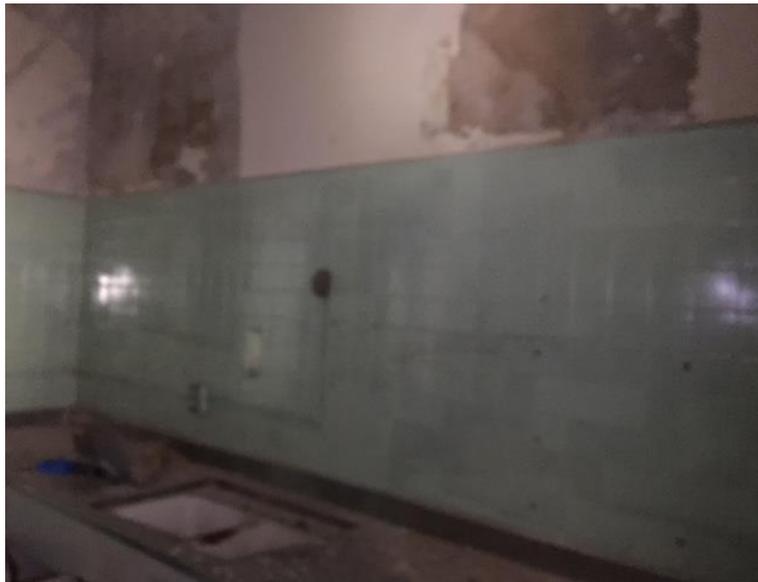
TETRA TECH PROJECT NO. 103X9025140002.048 Direction: NA	DESCRIPTION	This photograph shows green LBP on ceramic tile in the 3 rd -floor rooms of the main building.	44
	CLIENT	U.S. Environmental Protection Agency Region 7	Date
	PHOTOGRAPHER	Jeffrey Mitchell	2/27/2018

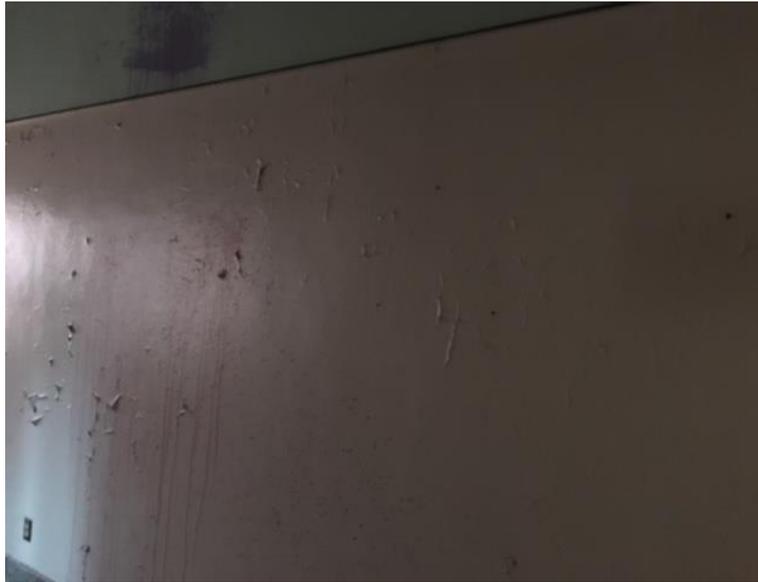
TETRA TECH PROJECT NO. 103X9025140002.048 Direction: NA	DESCRIPTION	This photograph shows beige LBP on walls in the 3 rd -floor room 326 of the main building.	46
	CLIENT	U.S. Environmental Protection Agency Region 7	Date
	PHOTOGRAPHER	Jeffrey Mitchell	2/27/2018

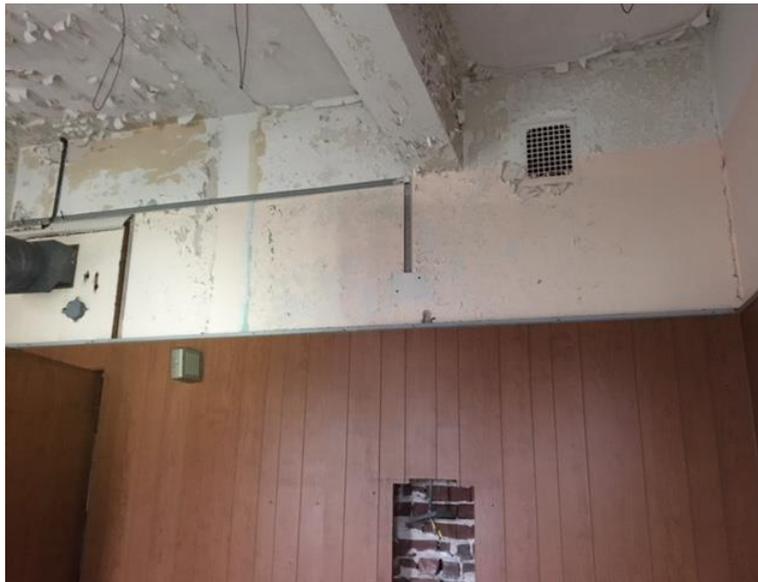
TETRA TECH PROJECT NO. 103X9025140002.048 Direction: NA	DESCRIPTION	This photograph shows peach LBP on walls in 3 rd -floor room 311 of the main building.	48
	CLIENT	U.S. Environmental Protection Agency Region 7	Date
	PHOTOGRAPHER	Jeffrey Mitchell	2/27/2018

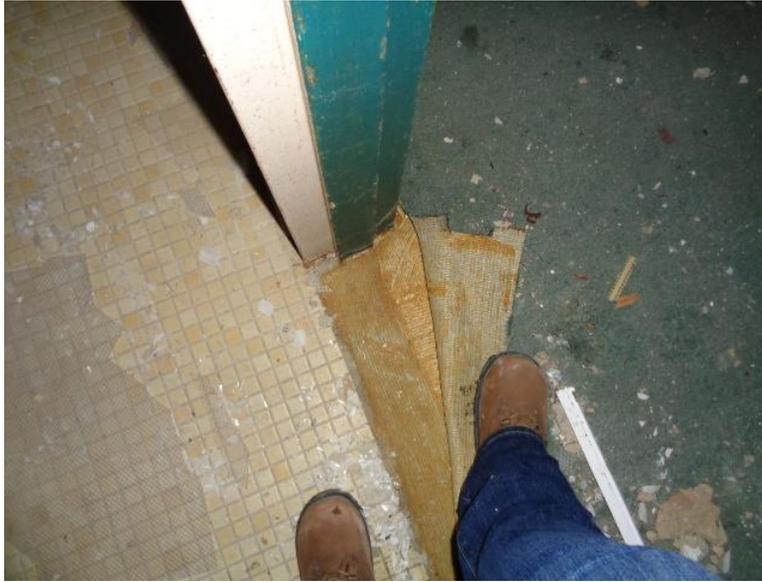
TETRA TECH PROJECT NO. 103X9025140002.048 Direction: NA	DESCRIPTION	This photograph shows asbestos-containing, off-white linoleum under carpet on the 2 nd floor of the 5-story building.	51
	CLIENT	U.S. Environmental Protection Agency Region 7	Date
	PHOTOGRAPHER	Kaitlyn Mitchell	3/30/2018

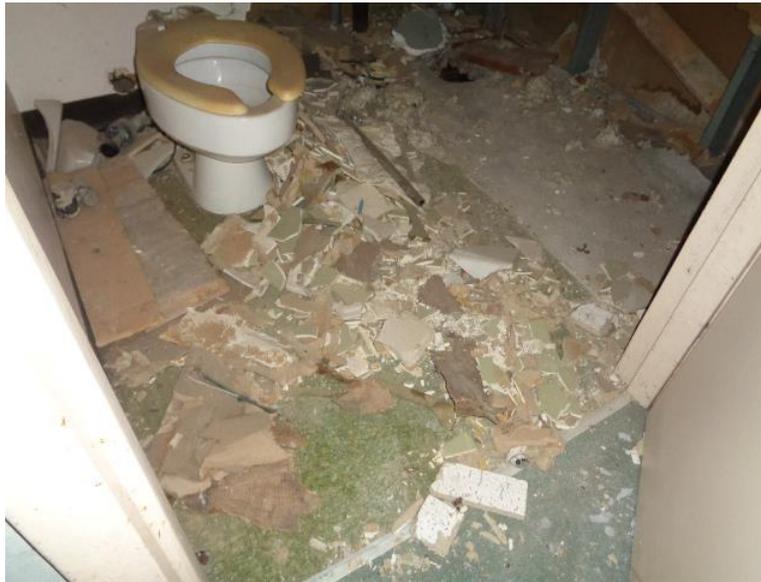
TETRA TECH PROJECT NO. 103X9025140002.048 Direction: NA	DESCRIPTION	This photograph shows asbestos-containing green linoleum in a 2 nd -floor bathroom of the 5-story building.	52
	CLIENT	U.S. Environmental Protection Agency Region 7	Date
	PHOTOGRAPHER	Kaitlyn Mitchell	3/30/2018

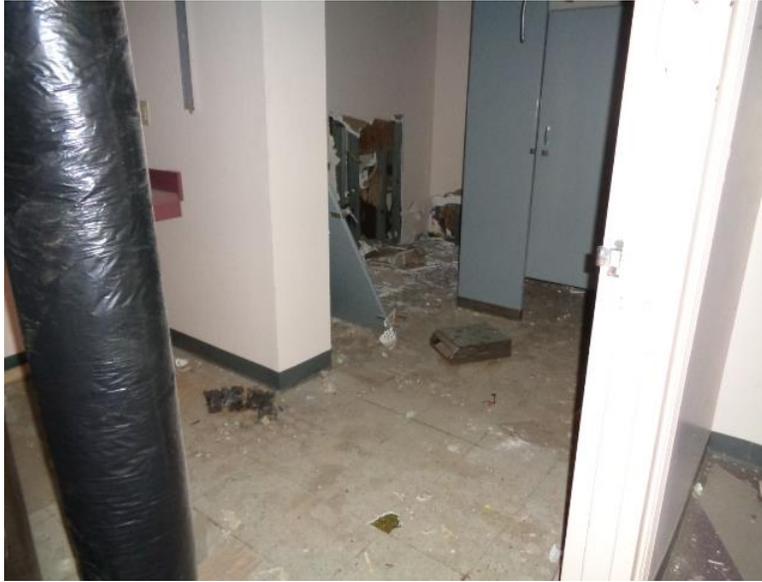
TETRA TECH PROJECT NO. 103X9025140002.048 Direction: NA	DESCRIPTION	This photograph shows 12" x 12" tan with grey streaks floor tile and associated asbestos-containing black mastic in the 2 nd -floor staff bathroom of the 5-story building.	53
	CLIENT	U.S. Environmental Protection Agency Region 7	Date
	PHOTOGRAPHER	Kaitlyn Mitchell	3/30/2018

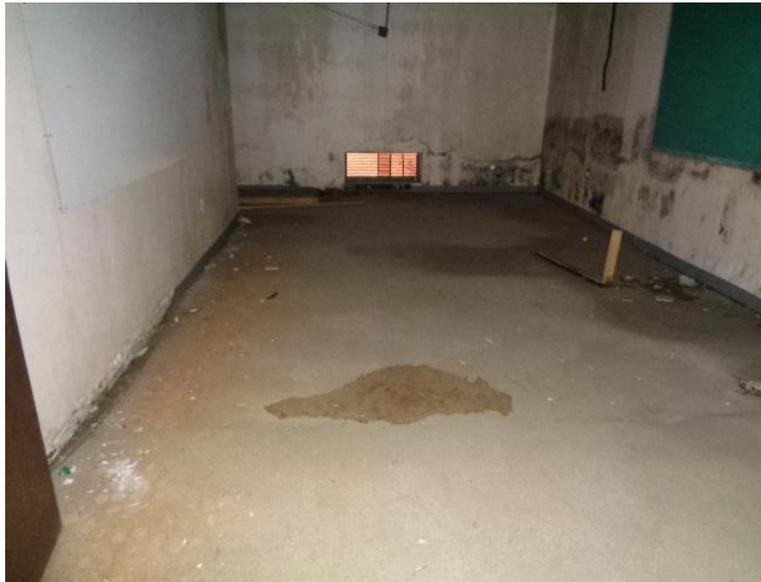
TETRA TECH PROJECT NO. 103X9025140002.048 Direction: NA	DESCRIPTION	This photograph shows asbestos-containing, off-white linoleum in the 3 rd -floor southeast room of the 5-story building.	54
	CLIENT	U.S. Environmental Protection Agency Region 7	Date
	PHOTOGRAPHER	Kaitlyn Mitchell	3/30/2018

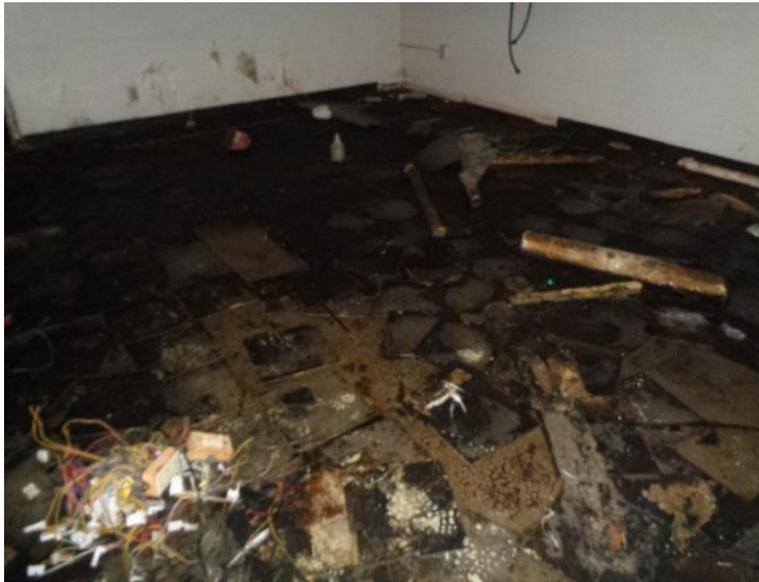
TETRA TECH PROJECT NO. 103X9025140002.048 Direction: NA	DESCRIPTION	This photograph shows asbestos-containing 12" x 12" brown floor tile in the basement of the 5-story building.	57
	CLIENT	U.S. Environmental Protection Agency Region 7	Date
	PHOTOGRAPHER	Kaitlyn Mitchell	3/30/2018

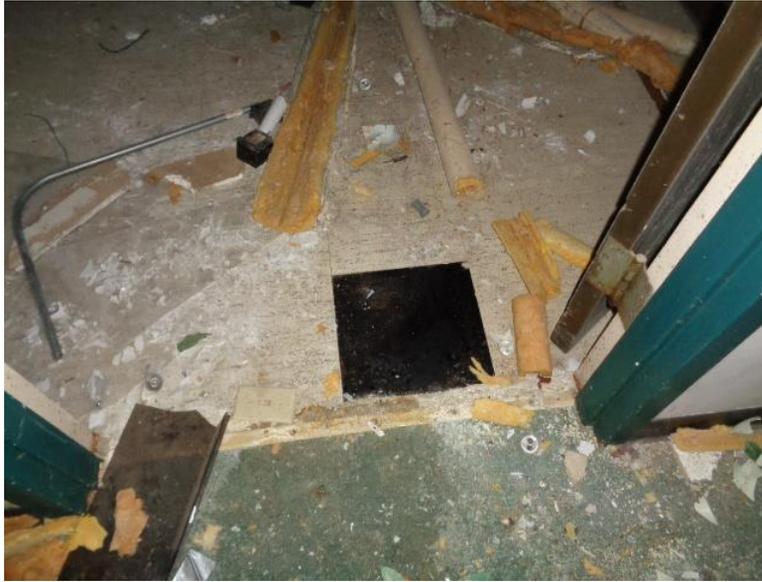
TETRA TECH PROJECT NO. 103X9025140002.048 Direction: NA	DESCRIPTION	This photograph shows asbestos-containing 12" x 12" tan with brown streaks floor tile in a 1 st -floor office of the 5-story building.	59
	CLIENT	U.S. Environmental Protection Agency Region 7	Date
	PHOTOGRAPHER	Kaitlyn Mitchell	3/30/2018

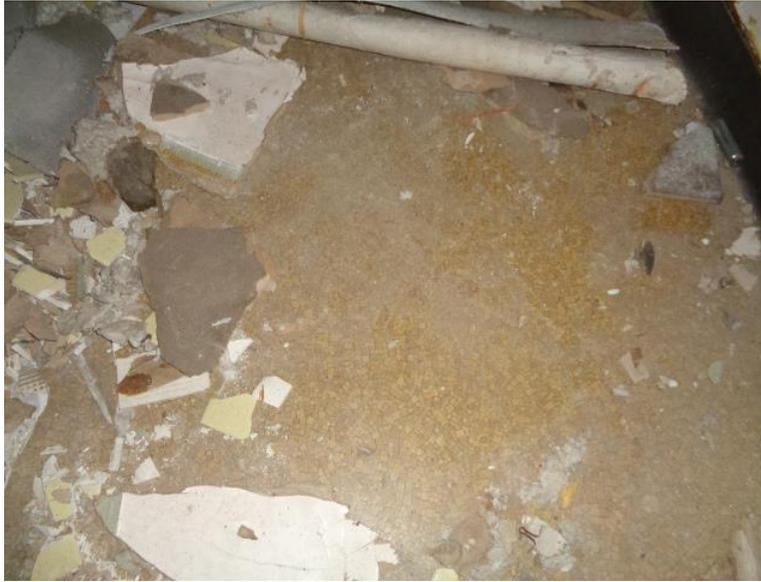
TETRA TECH PROJECT NO. 103X9025140002.048 Direction: NA	DESCRIPTION	This photograph shows asbestos-containing tan/yellow linoleum in a 1 st -floor bathroom of the 5-story building.	63
	CLIENT	U.S. Environmental Protection Agency Region 7	Date
	PHOTOGRAPHER	Kaitlyn Mitchell	3/30/2018

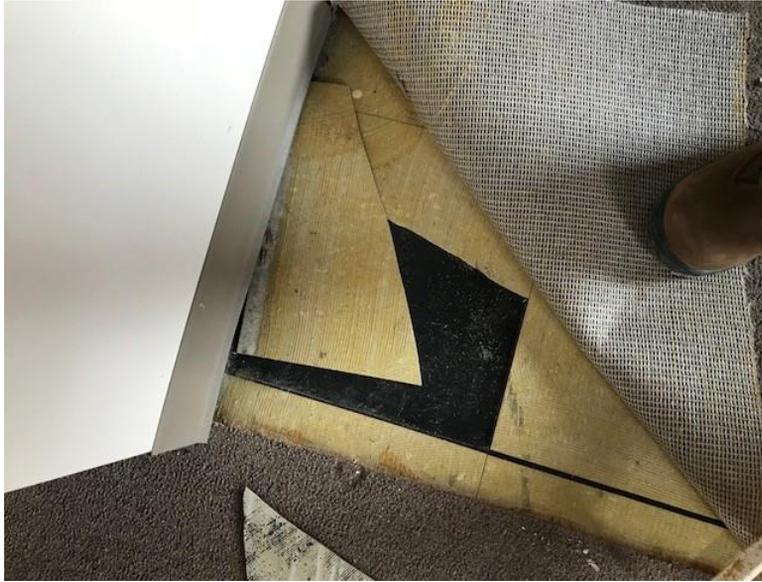
TETRA TECH PROJECT NO. 103X9025140002.048 Direction: NA	DESCRIPTION	This photograph shows 12" x 12" tan with grey streaks floor tile and associated asbestos-containing black mastic in the 5 th -floor northwest rooms of the 5-story building.	65
	CLIENT	U.S. Environmental Protection Agency Region 7	Date
	PHOTOGRAPHER	Kaitlyn Mitchell	3/30/2018

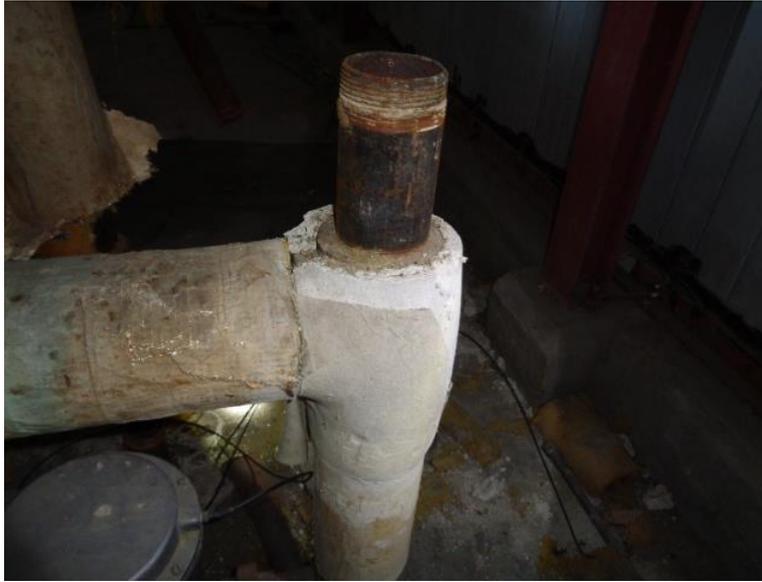
TETRA TECH PROJECT NO. 103X9025140002.048 Direction: NA	DESCRIPTION	This photograph shows TSI in the penthouse of the 5-story building.	67
	CLIENT	U.S. Environmental Protection Agency Region 7	Date
	PHOTOGRAPHER	Kaitlyn Mitchell	3/30/2018
