Re: Contract Number EP-S7-06-02, Technical Direction Document Number 10-08-0001
Removal Site Evaluation Report, Orofino Asbestos Site, Orofino, Clearwater County,
Idaho

REMOVAL SITE EVALUATION REPORT

Orofino Asbestos Site
Orofino, Clearwater County, Idaho
TDD: 10-08-0001

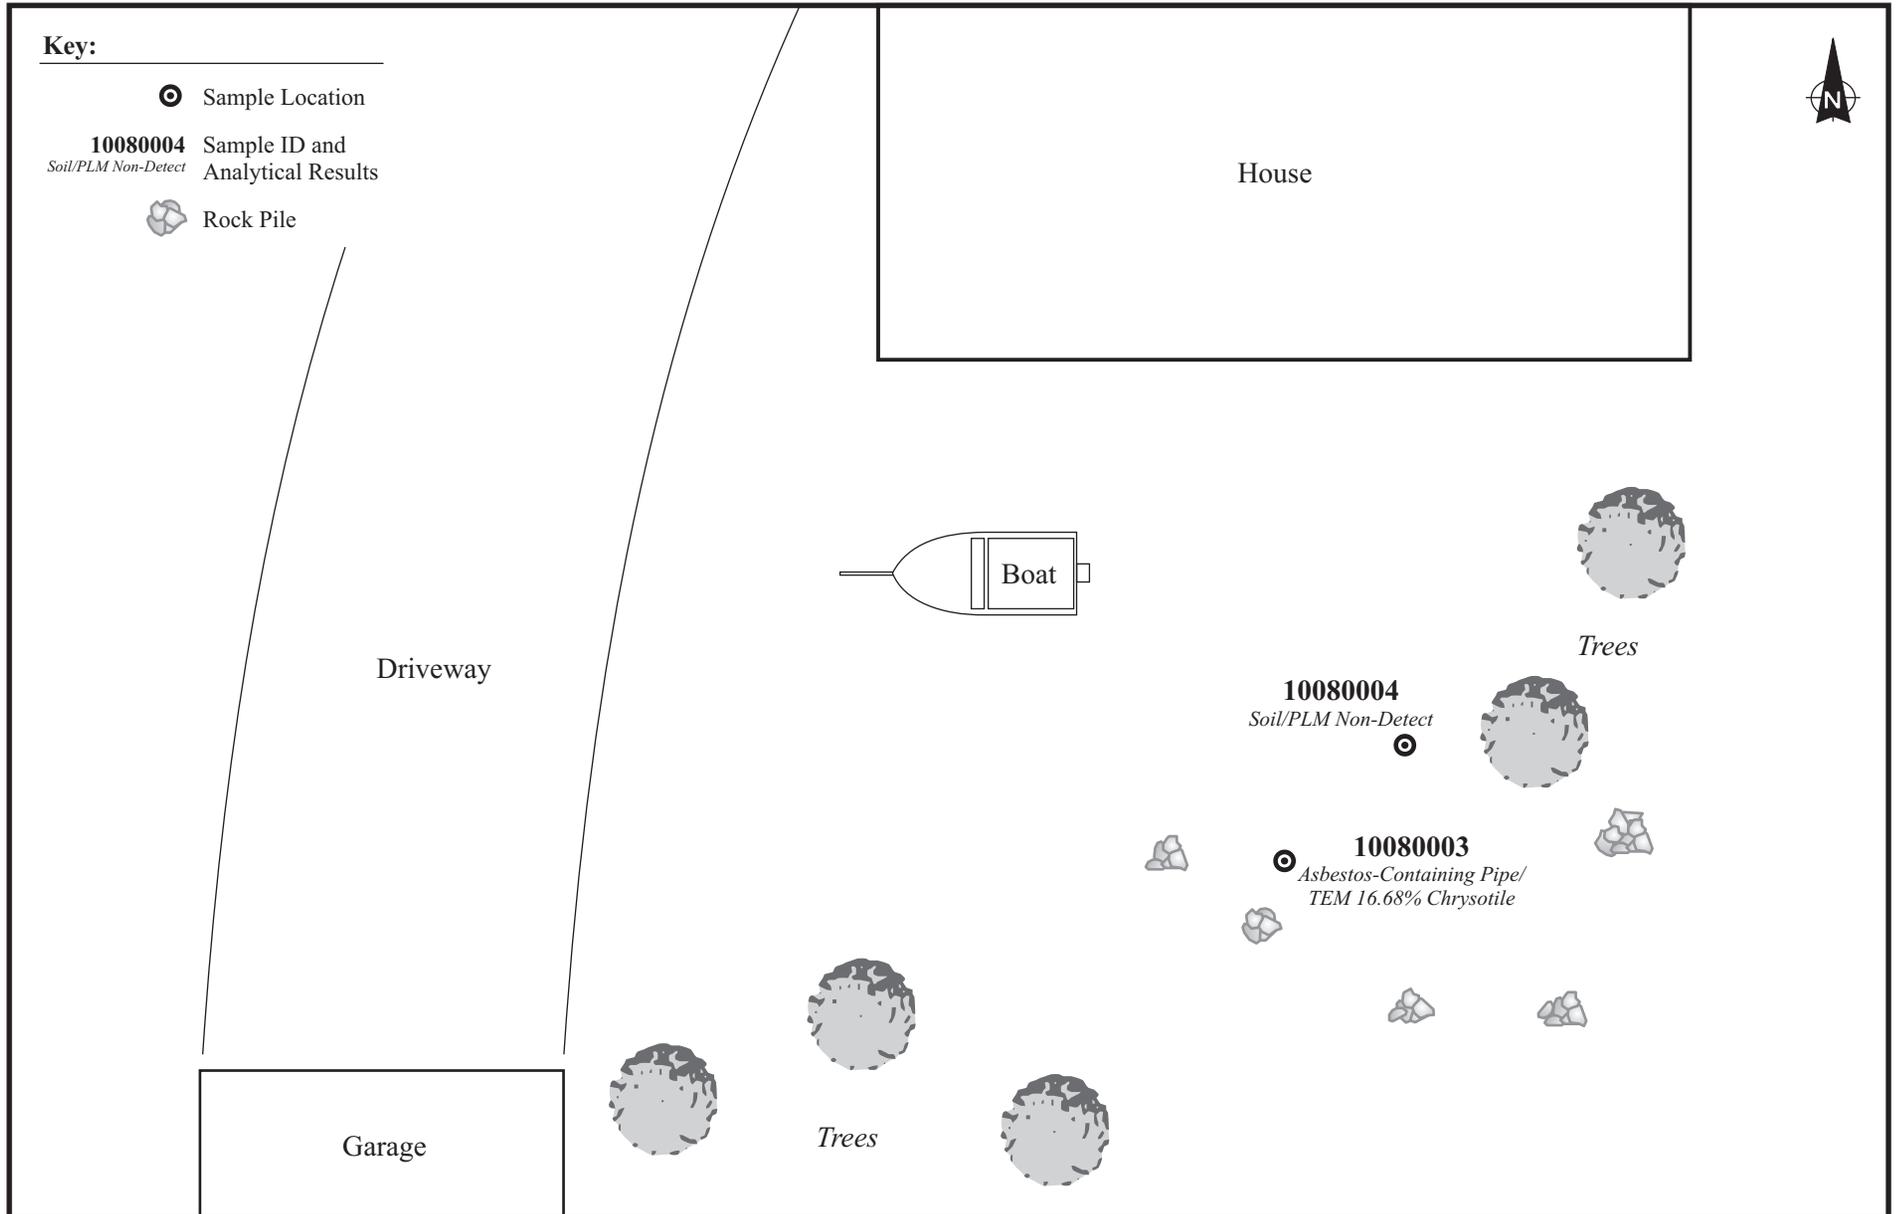
<p>ecology and environment, inc. Global Specialists in the Environment Seattle, Washington</p>	<p>OROFINO ASBESTOS SITE Orofino, Idaho</p>		<p>Figure 3-2 12586 HARTFORD AVENUE SAMPLE LOCATION MAP</p>	
	<p>Not to Scale</p>	<p>Date: 2/22/11</p>	<p>Drawn by: AES</p>	<p>10:START-3\10080001\fig 3-2</p>

12586 Hartford Avenue (Figure 3-2): START collected two samples, one ACP sample (10080003) and one soil sample (10080004).

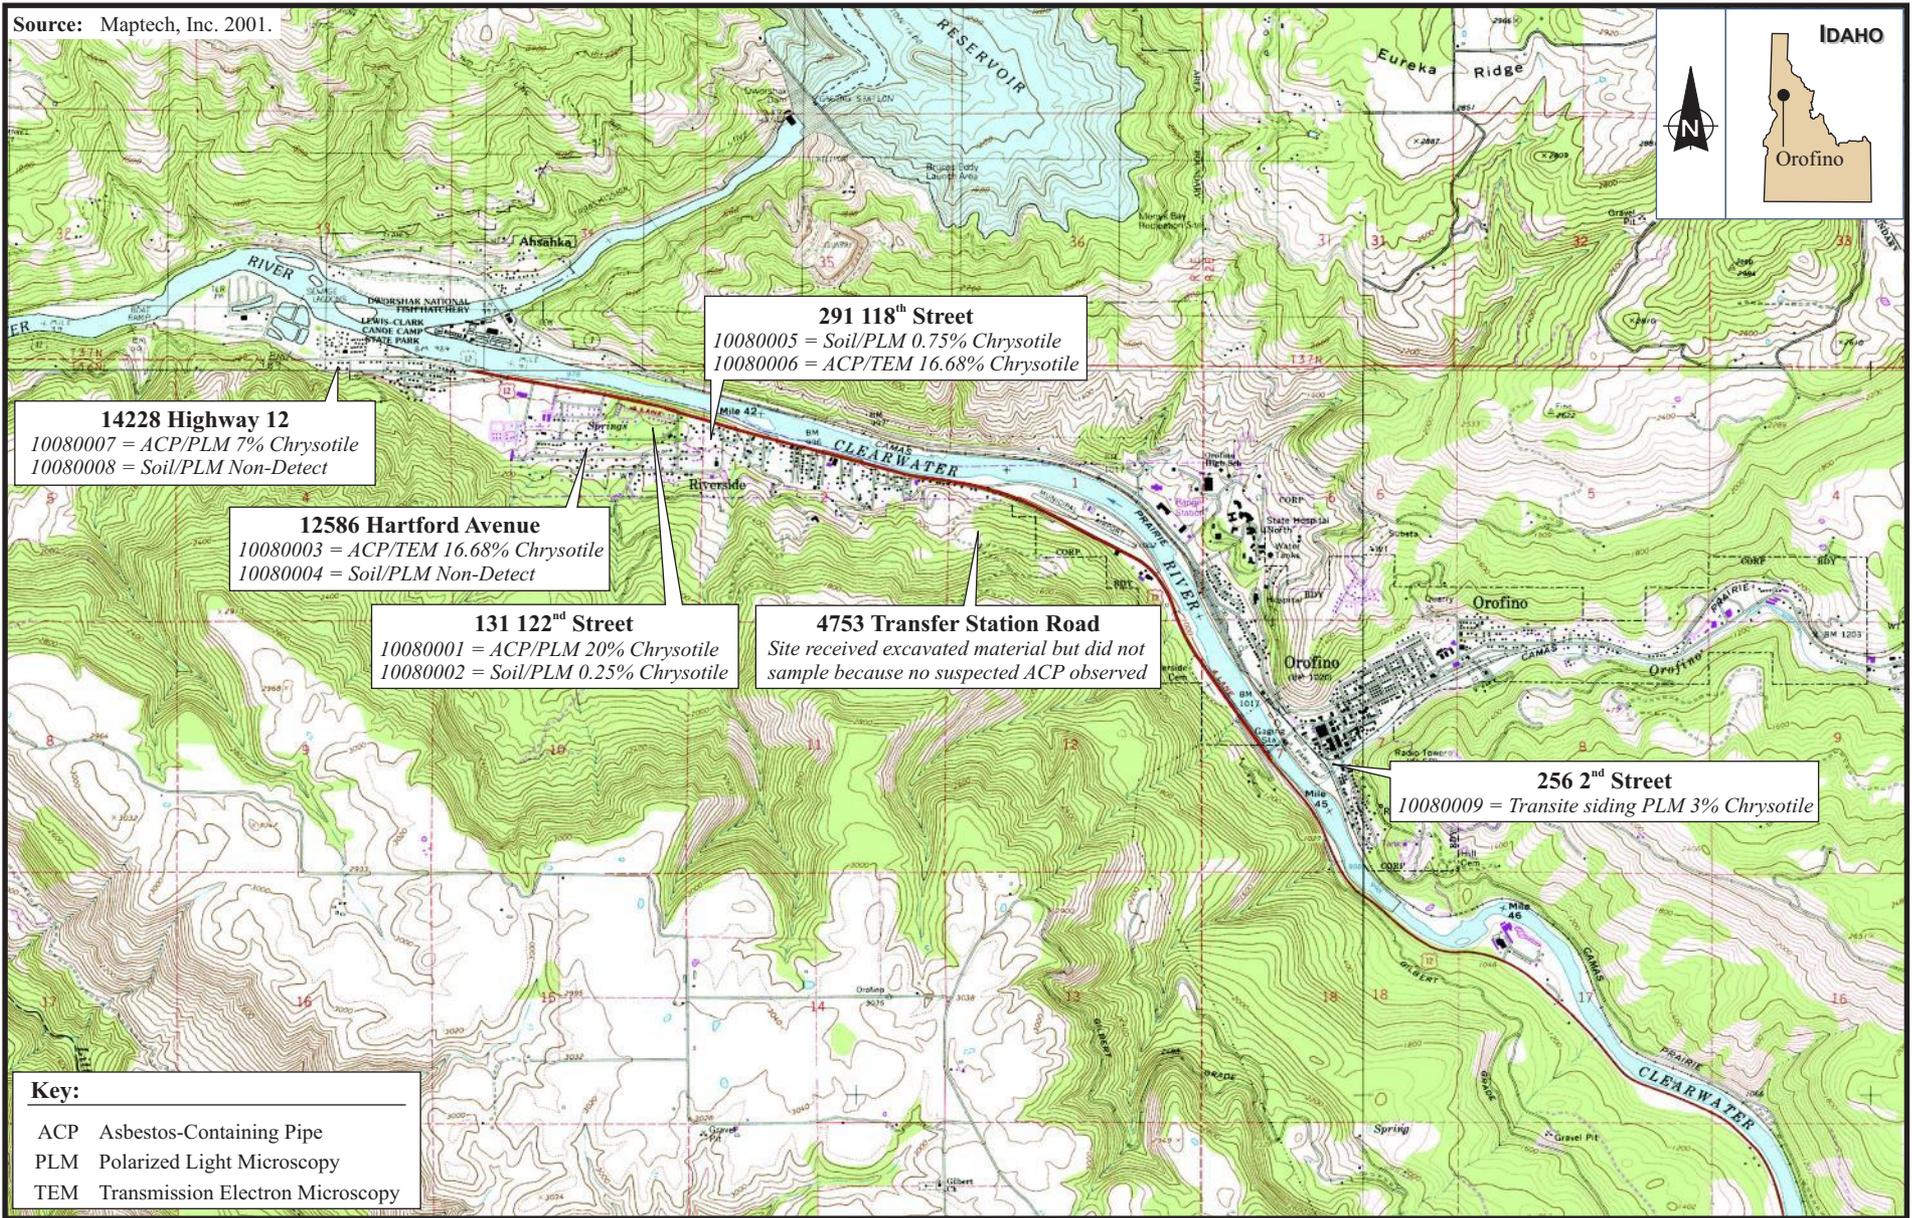
<p>ecology and environment, inc. Global Specialists in the Environment Seattle, Washington</p>	OROFINO ASBESTOS SITE Orofino, Idaho		Figure 3-6 SUMMARY SITE LOCATIONS AND SAMPLE RESULTS

The results of the asbestos analyses are presented in Table 3-1. The sample results for each property are included in the individual property figures (Figures 3-1 through 3-5). The results for all samples are also included in the area-wide summary figure (Figure 3-6).

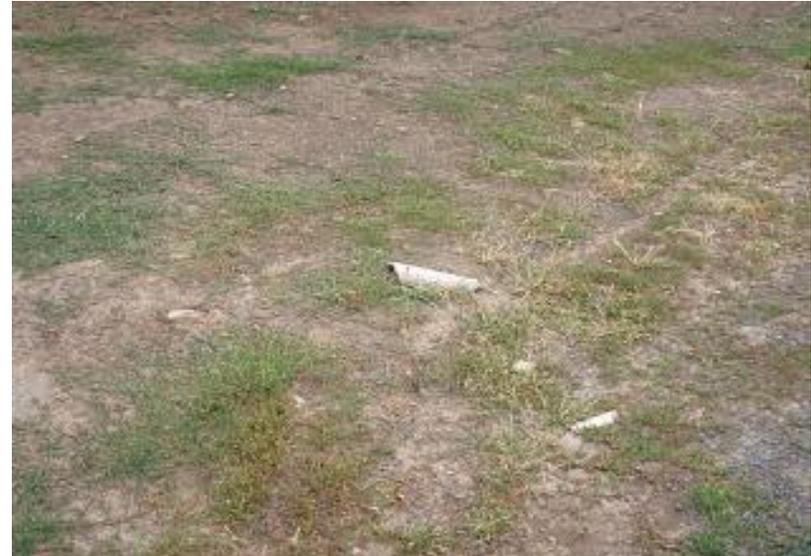
Description: Section of asbestos-cement pipe (ACP) partially buried.

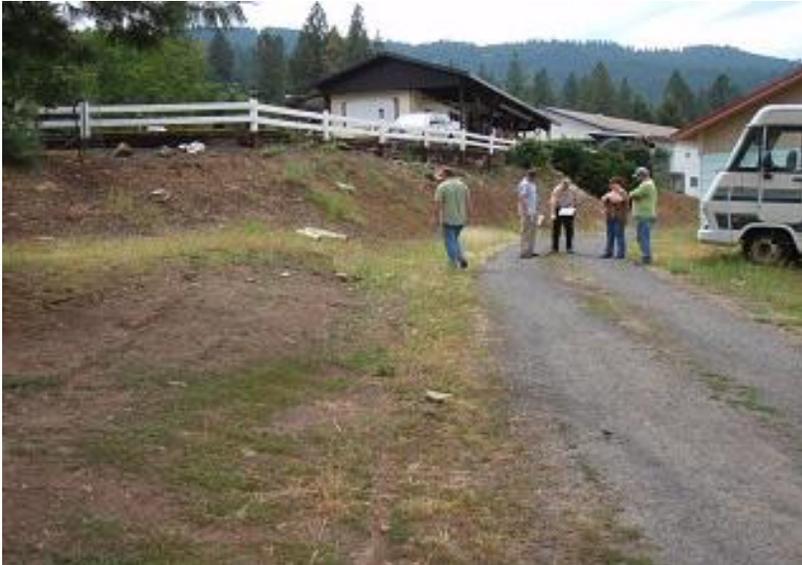
Photo No: P8090003

Description: EPA and Riverside Water and Sewer District investigating partially buried ACP at the 131 122nd Street property.

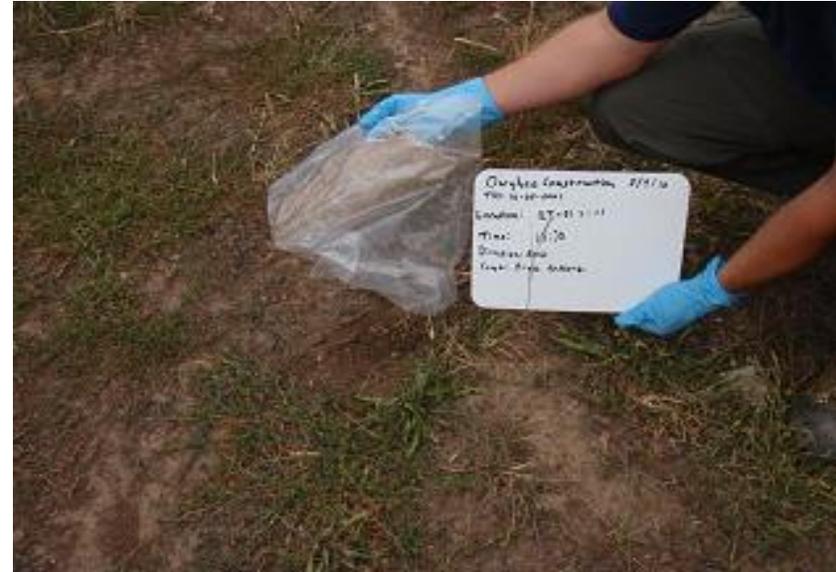
Description: ACP sample number 10080001 collected at the 131 122nd property.

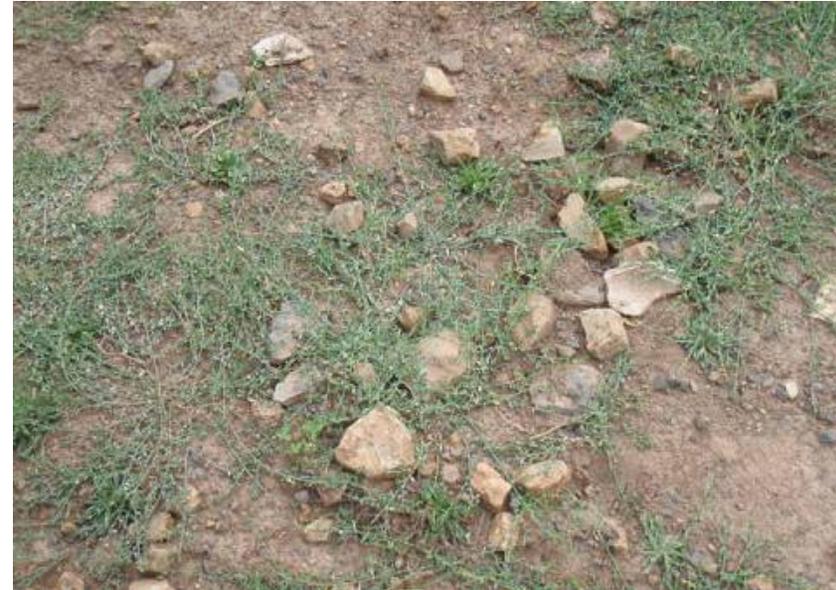
Description: Shards of ACP mixed with surface soil at the 131 122nd property.

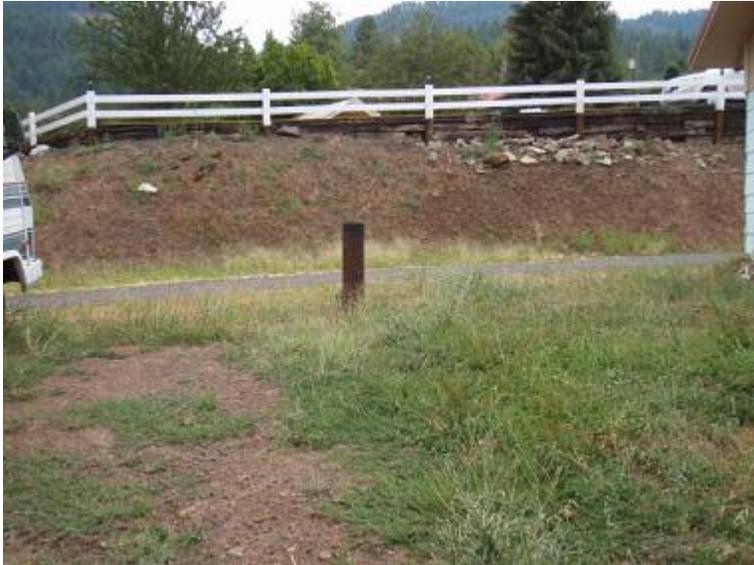
Photo No: P8090009

Description: ACP visible in the hillside at the 131 122nd property.

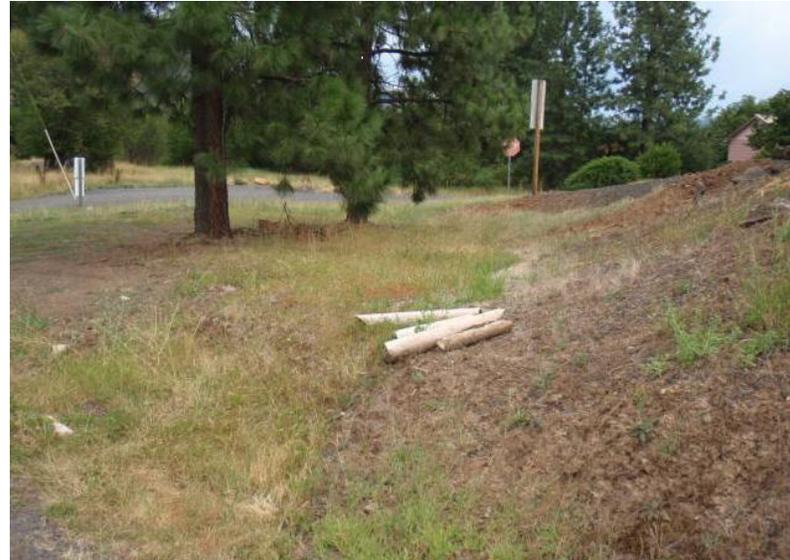
131 122nd Street (Figure 3-1): Large sections of ACP are visible in photograph P8090010 (Appendix A). START collected two samples, one ACP sample (10080001) and one soil sample (10080002).

Description: Section of ACP collected and stacked in the front yard at the 131 122nd property.

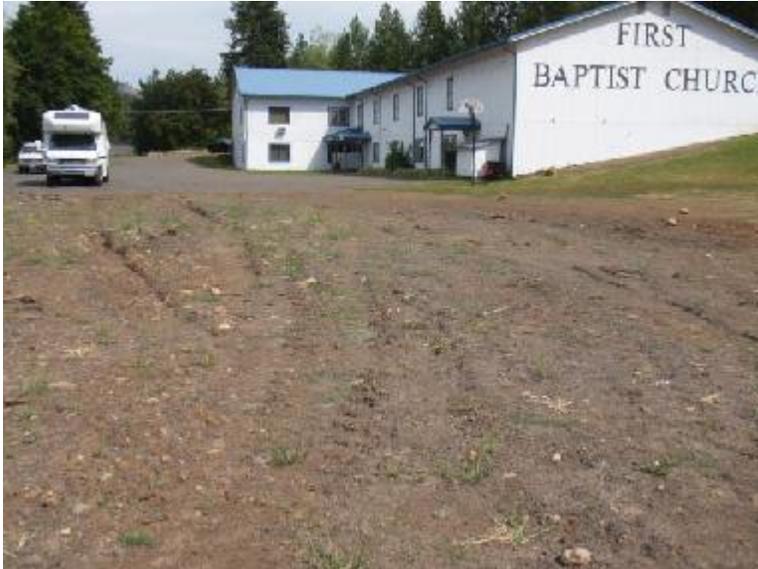
Photo No: P8090015

291 118th Street (Figure 3-3): The parking lot constructed from the contaminated fill was covered with a layer of pea gravel and is visible in photograph P809015 (Appendix A). Several chunks of ACP were visible on the ground in the gravel lot. START collected two samples, one soil sample (10080005) and one ACP sample (10080006).

Description: ACP-contaminated fill material deposited in the parking lot at the 291 118th Street property.

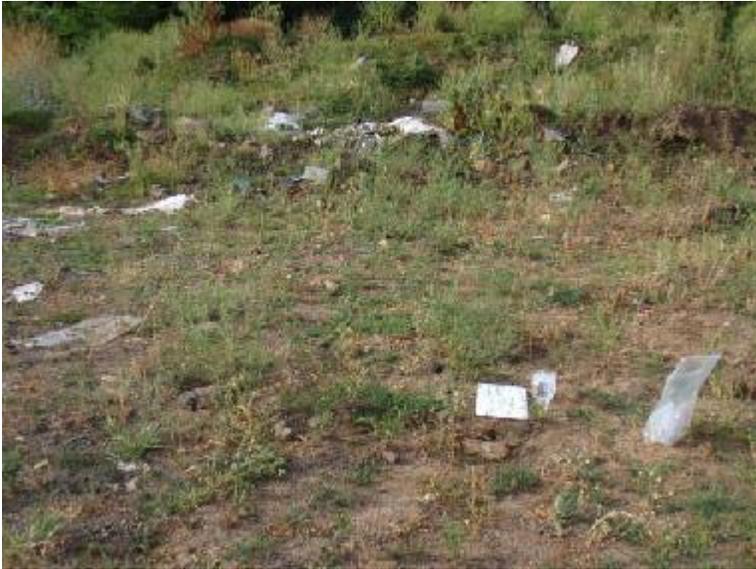
Photo No: P8090019

14228 Highway 12 (Figure 3-4): Several pieces of ACP were visible in the vacant lot near Highway 12. START collected two samples, one ACP sample (10080007) and one soil sample (10080008).

Description: ACP shards and debris at 14228 Highway 12 property.

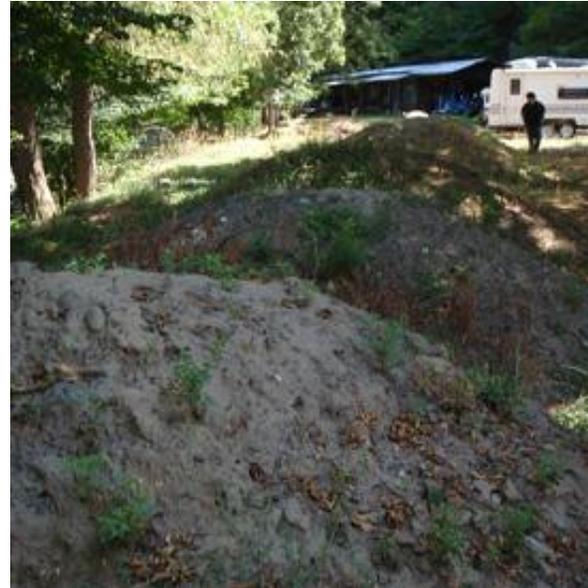
256 2nd Street (Figure 3-5): This property received three truck loads of soil; each truckload was segregated into a distinct pile, as visible in photograph P8090020 (Appendix A). The third pile, nearest to 2nd Street, had one piece of transite siding on the surface. START collected a sample (10080009) of the transite siding.

Description: Piles of fill dirt with transite (cement-asbestos board) on the surface at the 256 2nd Street property.

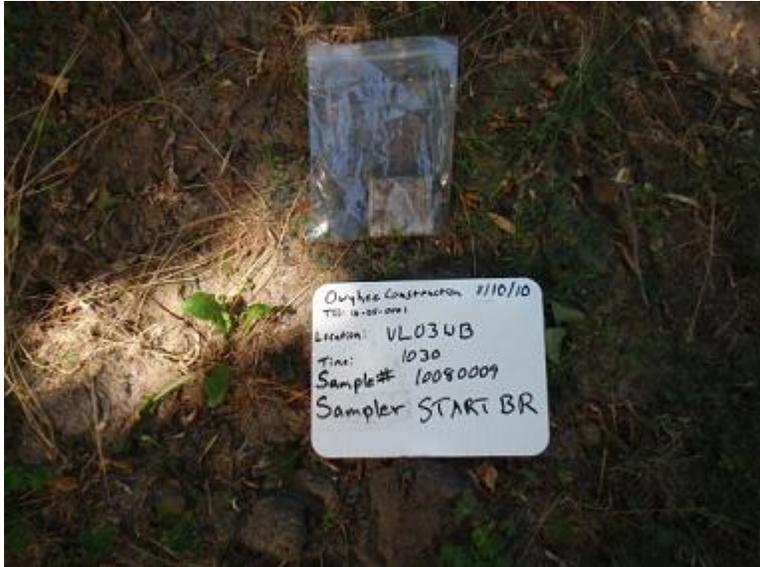
Photo No: P8090021

Description: Transite (cement-asbestos board) sample number 10080009 collected by START at the 256 2nd Street property.

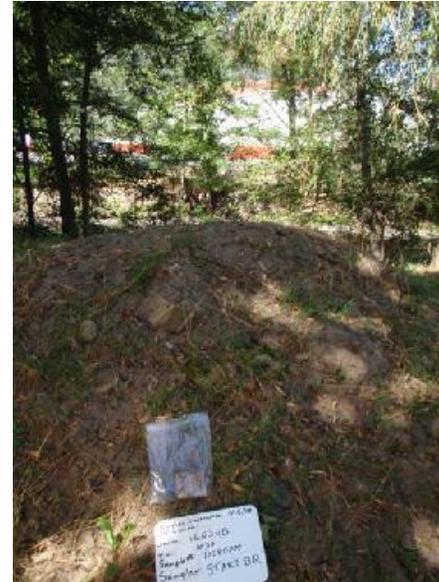
Description: Transite (cement-asbestos board) sample number 10080009 from the 256 2nd Street property.
