ASBESTOS INSPECTION REPORT

For
Demolition
At

**122 Carson Ave.
La Junta, CO 81050**

Project# 17-2984

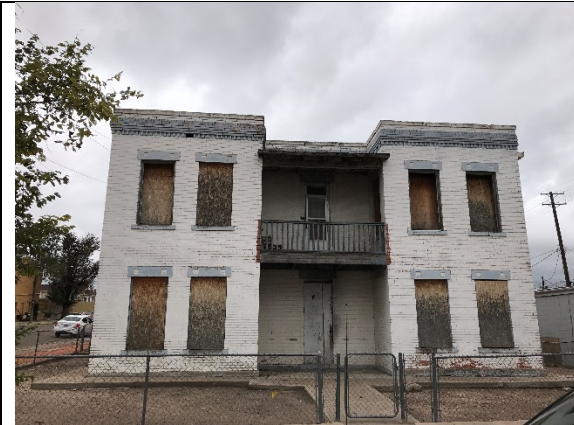
Subject Property

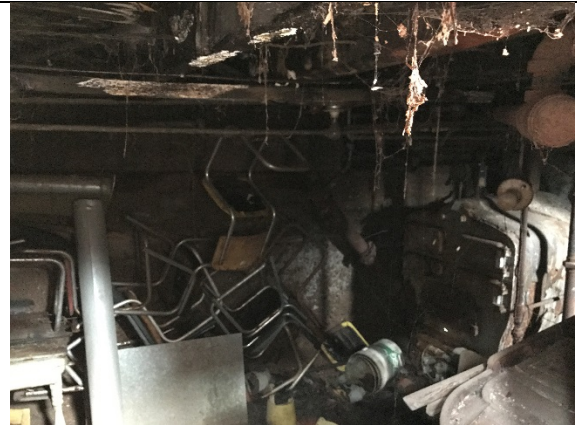
1. Built in 1906
2. **The top floor of the property has been gutted at one time**
3. **Plaster is observed throughout the main floor-walls/ceilings**
4. Brick construction with wood walls and floors
5. **Textured drywall was observed in some small areas**
6. **Linoleum was observed**
7. Roofing appeared to be homogenous
8. Basement was inaccessible due to flooring and wall damage
9. **Boiler system was observed through small coal chute-assumed ACM**

Boiler in Basement - Assumed

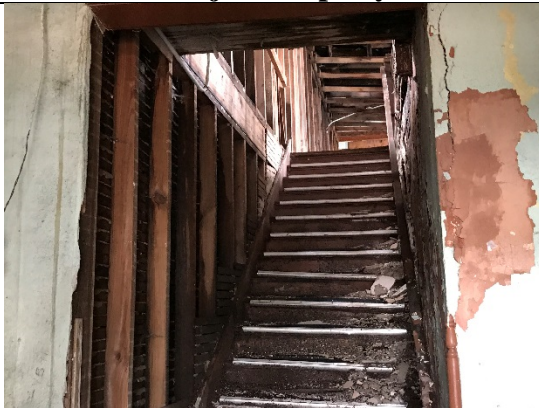
Plaster Walls

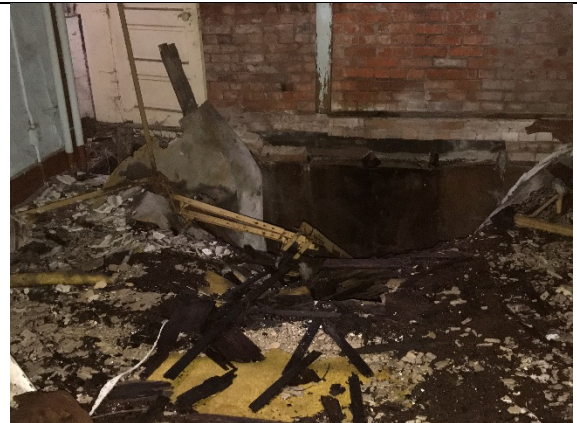
Yellow Linoleum
