# ASBESTOS INSPECTION REPORT

For  
Demolition  
At

**218 Dalton Ave  
La Junta, CO 81050**

**Date(s) of Inspection:** May 2, 2018

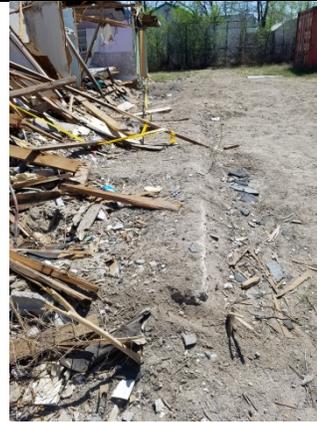
West Foundation (addition)

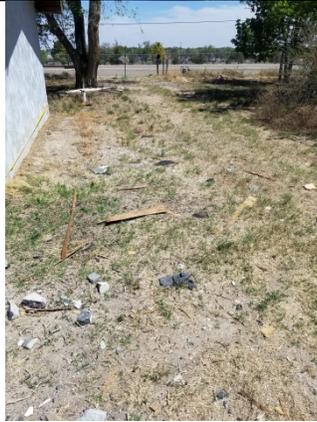
East side Debris

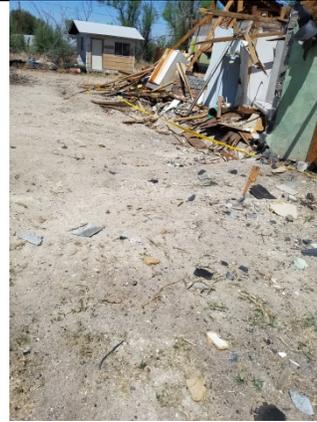
West side Debris

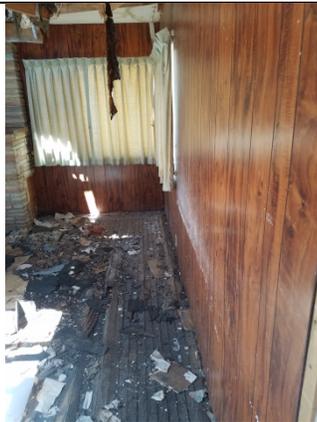
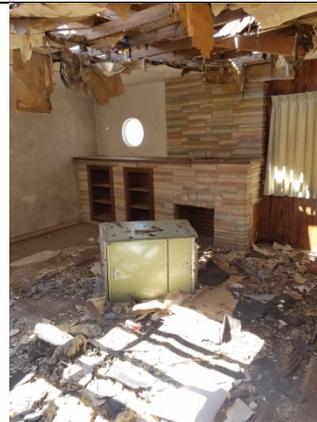
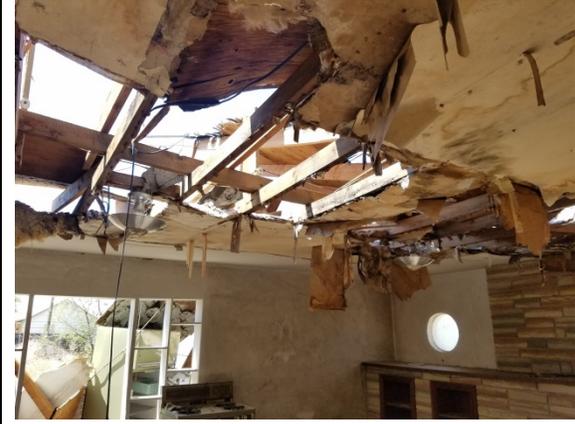
Front Room

- Drywall Heavy Texture (2B) located in the front room on Subject Property was confirmed to be OSHA regulated material by Point Count method:
  - *218-FR-2B-Texture is 2% Chrysotile*

The materials assessed were in damaged condition at the time of the inspection and non-friable.

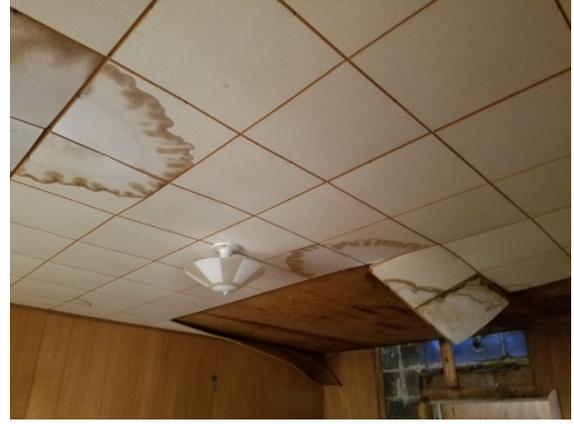
Ceiling Tile
