LIMITED ASBESTOS INSPECTION REPORT

For
DEMOLITION
At

**1501 Edison Ave.
La Junta, CO 81050**

Project# 17-2824

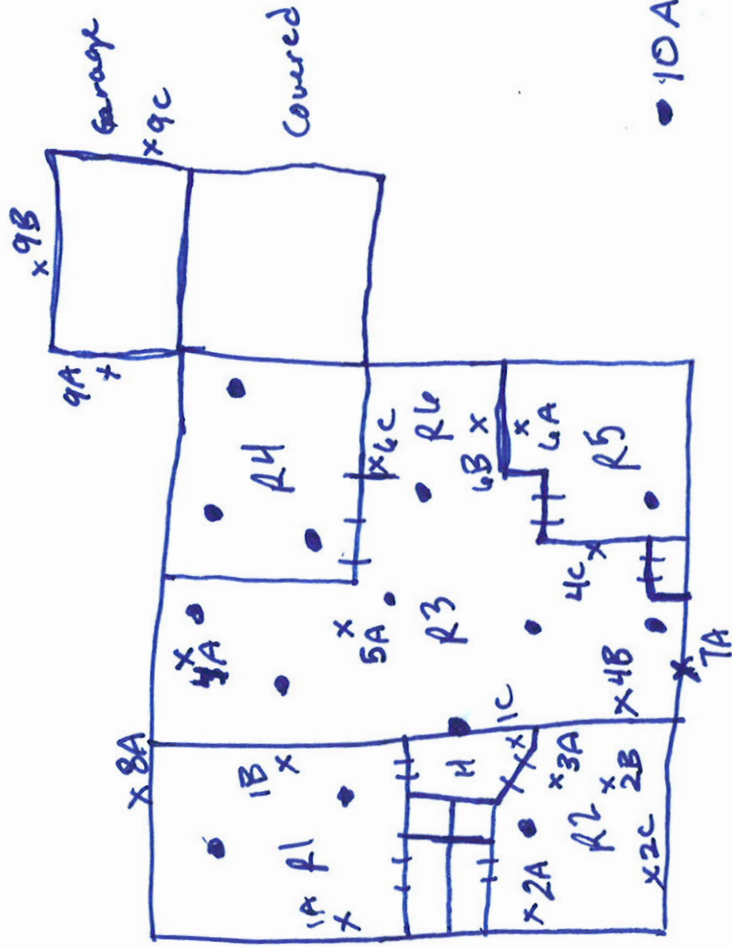
POSITIVE SAMPLE LOCATION DIAGRAM

• 10A Composite
