Construction Specific Limited Asbestos Inspection Report

Address: 1119 Smithland Ave La Junta CO 81050

Date of Inspection: September 15, 2016

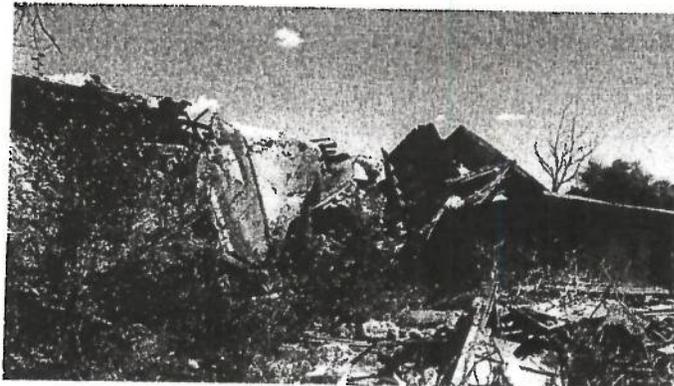
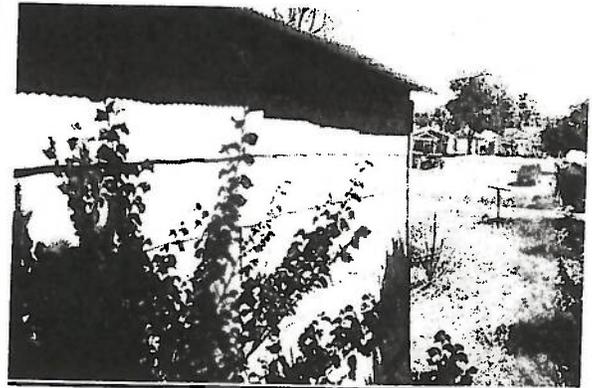
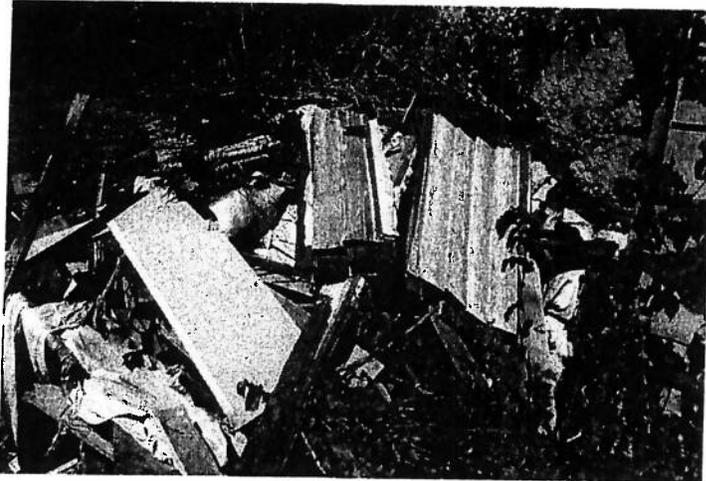
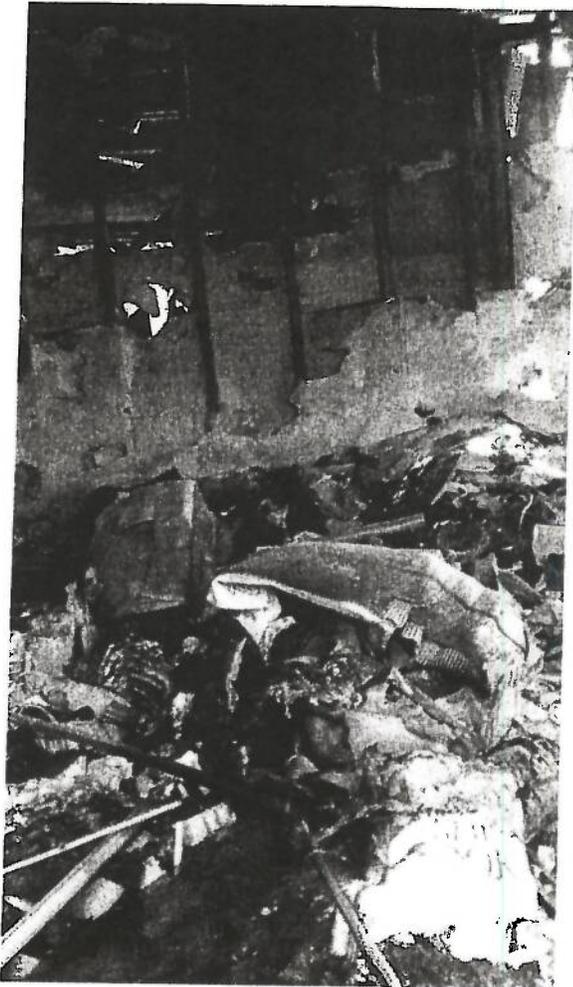
Pictures

Conclusion: ACM –asbestos containing material was identified during this limited survey. The cement siding found throughout the debris both interior and exterior, and also on the exterior shed, was found to contain asbestos at 20% Chrysotile. The siding was present in both big and small broken fragments throughout the debris. *Because the fire and the two yrs. the structure has sat, caused so much damage in and around the structure, it is the opinion of LTS Resource that the property is a major asbestos spill and a licensed abatement contractor must be used for proper removal, disposal and spill response.
