Subject: **Removal Assessment Report, Final
Rock-Tenn Site - RS
Otsego, Allegan County, Michigan
TDD No.: 0001/S05-0001-17-11-001
SRS Contract No.: EP-S5-16-01**

**REMOVAL ASSESSMENT REPORT
ROCK-TENN SITE
OTSEGO, ALLEGAN COUNTY, MICHIGAN**

Final Report

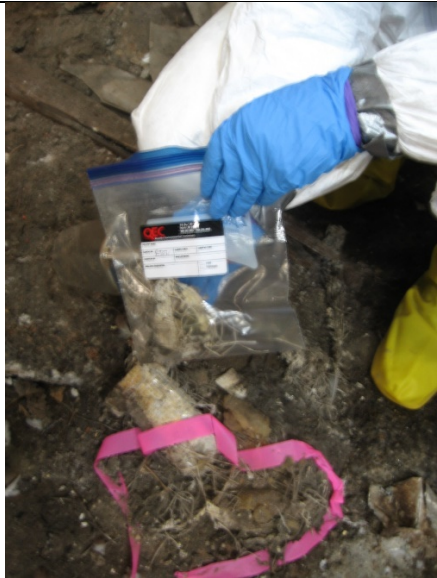
Sample ID	RT01	RT02
Sample Location	First level on along the eastern wall	First level along the southern wall
Material Description	Gray homogenous crumbly material - Friable	Gray layers of crumbly material -Friable
	No photo

Lab Results		
Amosite	10-20%	1-3%
Sample ID	RT03	RT04
Material Description	Basement level	Basement level
Sample Location	Gray/white/black homogeneous crumbly material	Gray/white homogeneous crumbly material - Friable

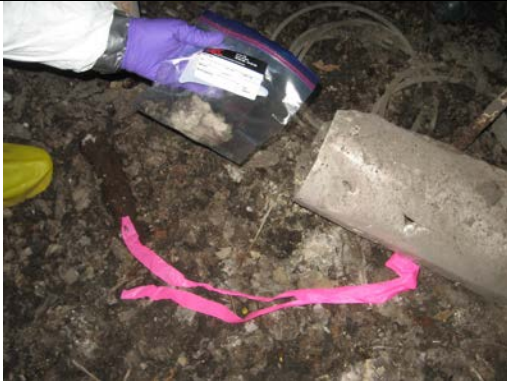
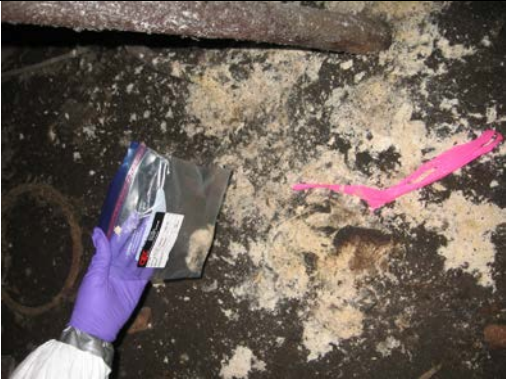
Lab Results		
Amosite	Trace (<1%)	20-30%

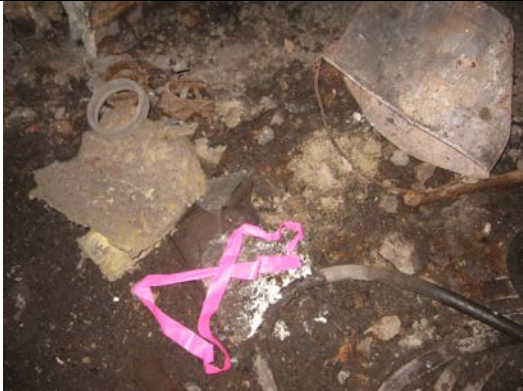
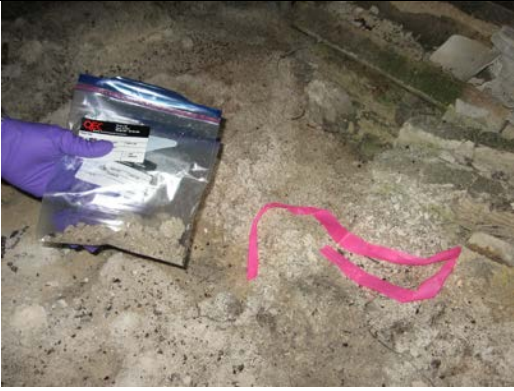
ranged from 1% to 40% amosite. The highest amosite result was found in a sample collected from the basement level, RT05. All five ACM samples collected were friable based on the definition in 40 CFR Part 61.141.

Sample ID	RT05	RT06 & RT07 (Duplicate)
Sample Location	Basement level	Basement level
Material Description	Black homogeneous crumbly material - Friable	Gray homogeneous crumbly material - Friable

Lab Results		
Amosite	30-40%	3-5%

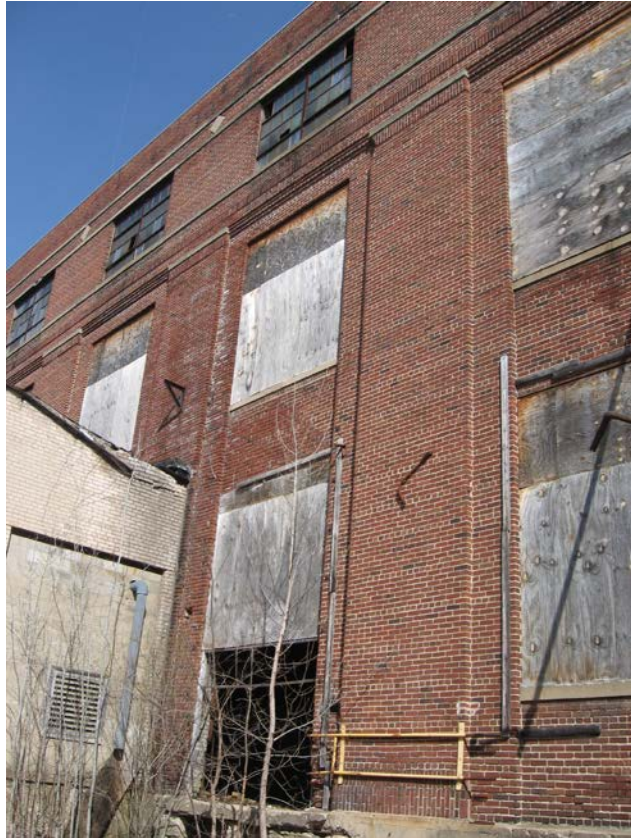
Official Photograph No.1:
Southern portion of the Power
House building. Facing northwest.

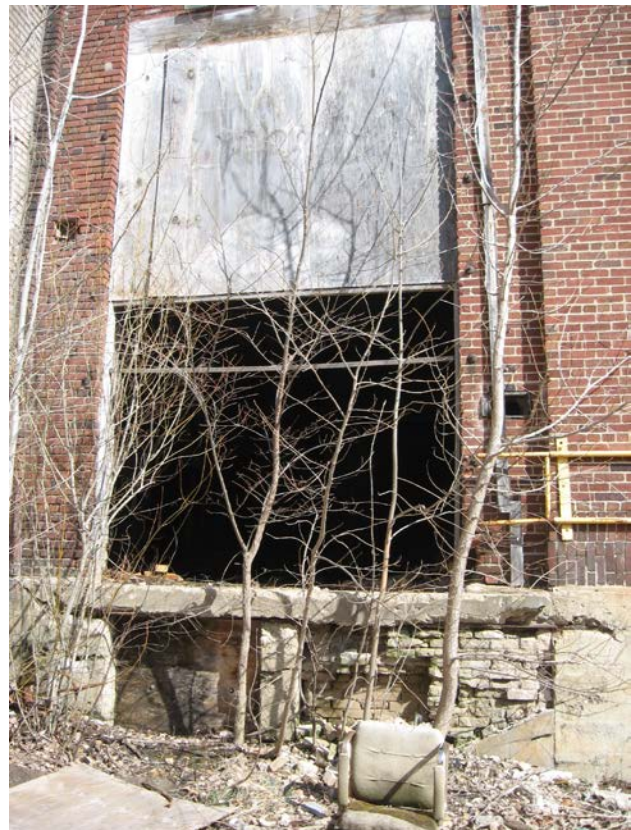
Official Photograph No. 2:
Southern unsecured bay opening to
Power House building. Facing north.

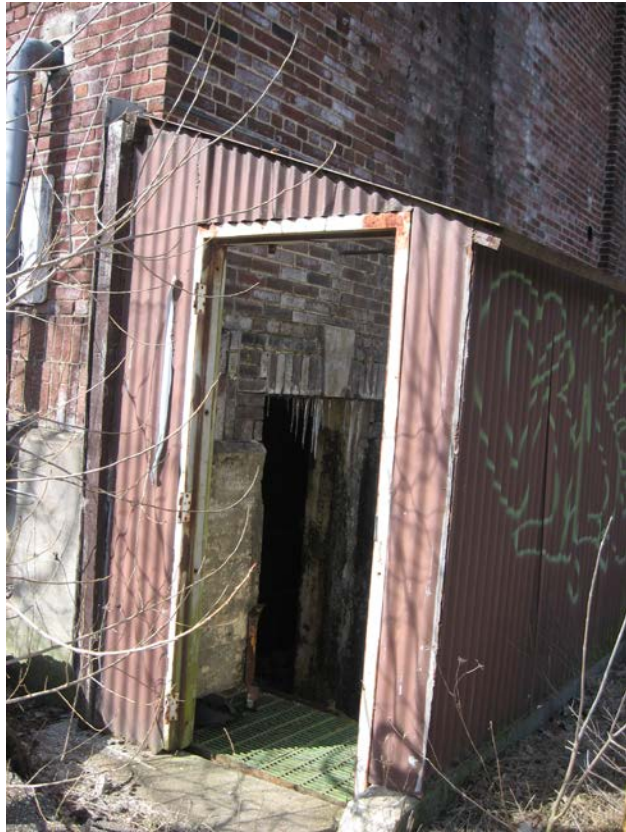
Official Photograph No.3:
Northeast corner of Power House
building. Unsecured entrance, facing
southwest.

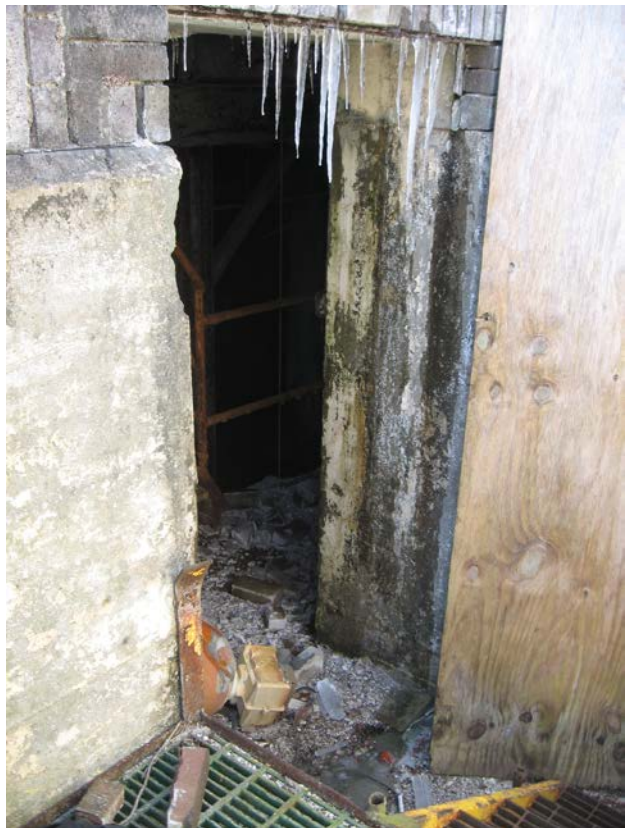
Official Photograph No.4:
Northeast corner of Power House
building. Unsecured entrance,
facing southwest.

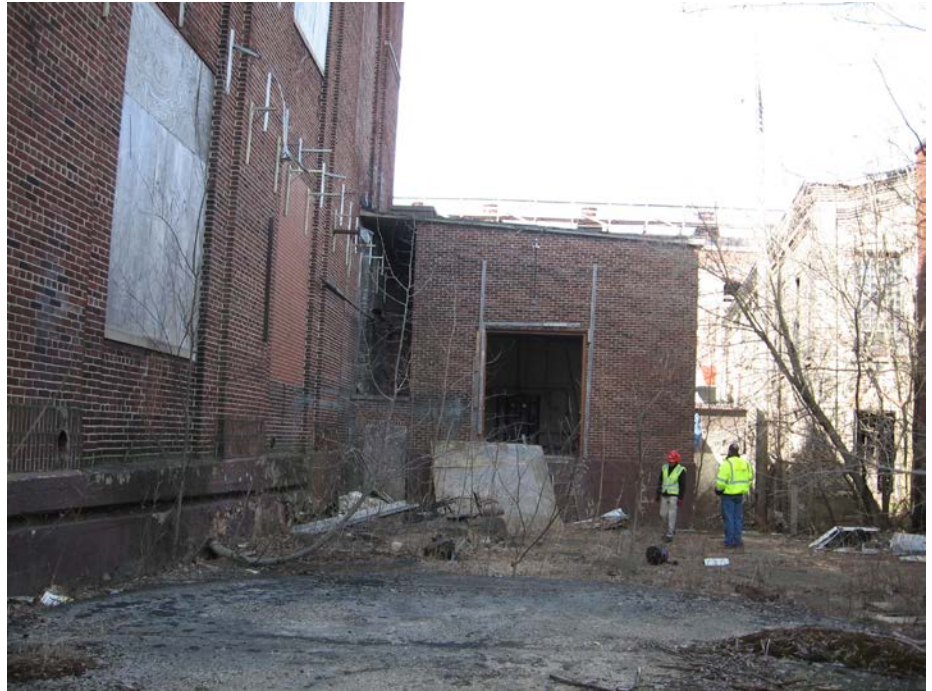
Official Photograph No.5:
Northern wall of the Power House
building, western unsecured
entrance, facing southwest.

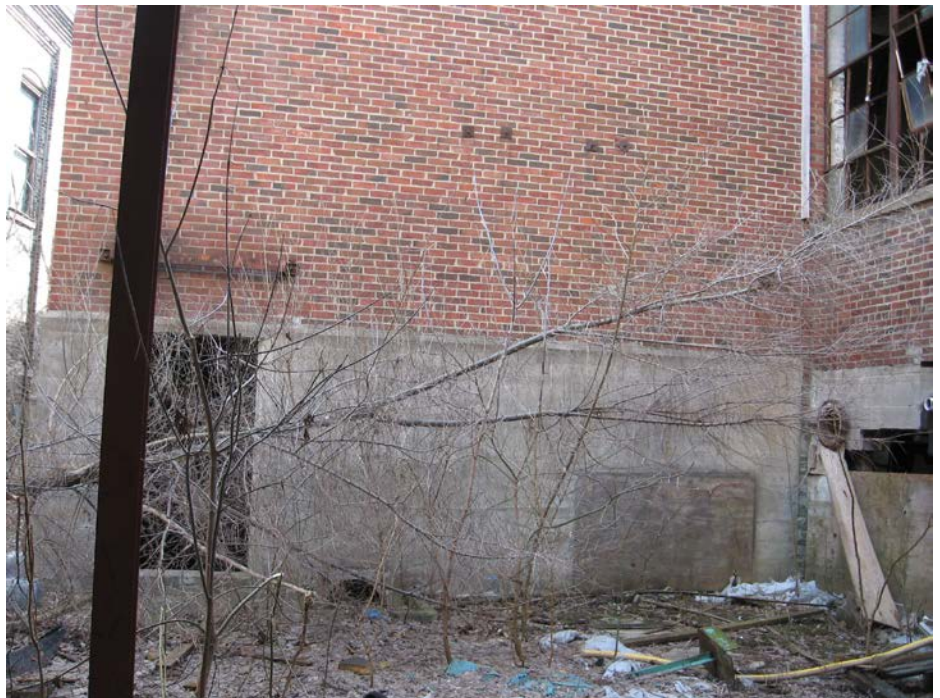
Official Photograph No.6:
Northwest corner of the Power House
building. Unsecured opening in the
adjacent building, facing west.

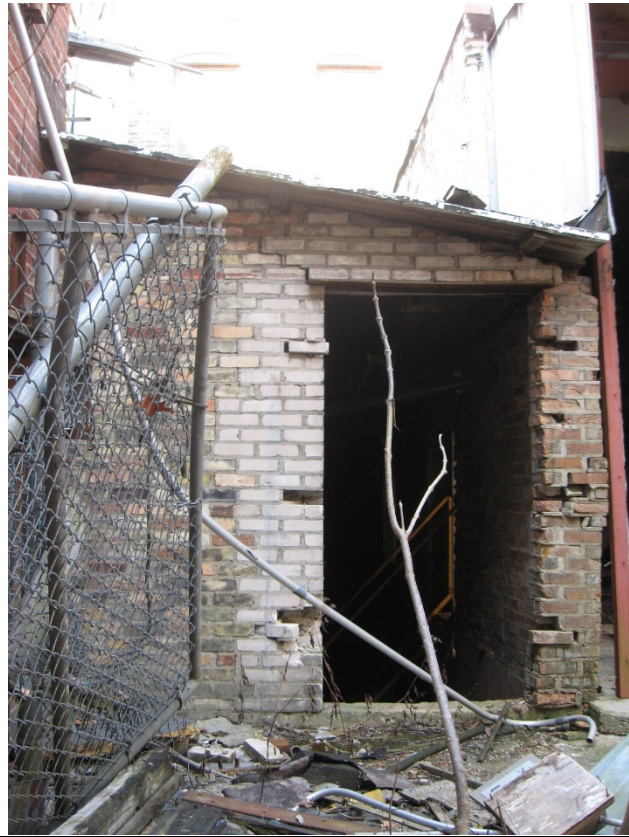
Official Photograph No.7:
Northwest of the Power House building.
Unsecured opening in the adjacent
building, facing west.

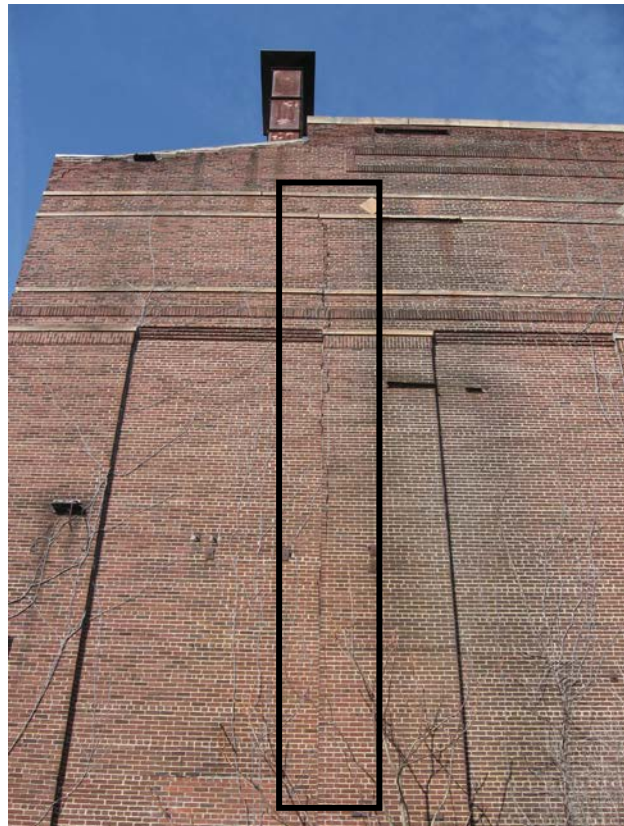
during the exterior reconnaissance of the buildings, START documented cracks along the exterior walls (Photograph 8) and crumbling concrete and brick near the base of a bay door (Photograph 9).

Official Photograph No.8:
Large crack in the eastern wall of the
Power House building. Facing west.

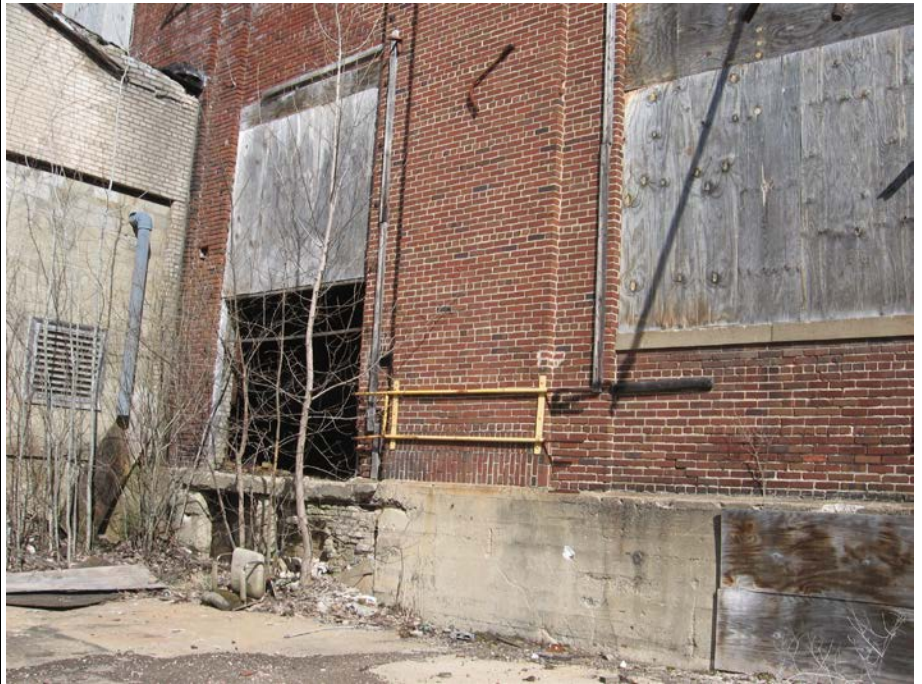
Official Photograph No.9:

Crumbling concrete at the base of the bay opening on the southern portion of the Power House building. Facing northwest.

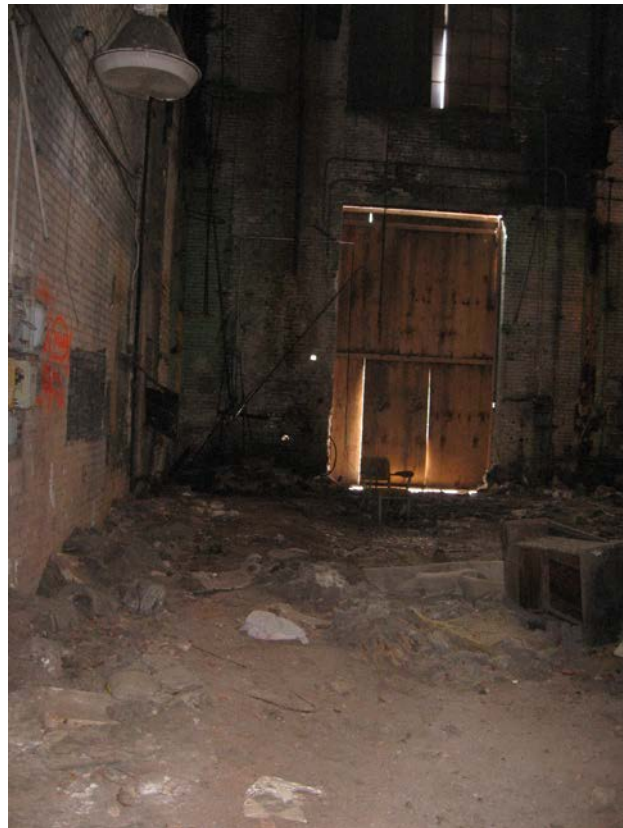
Official Photograph No. 10:

Along the eastern wall interior of the Power House building. Evidence of trespassers is verified by the graffiti on the east wall. Facing south.

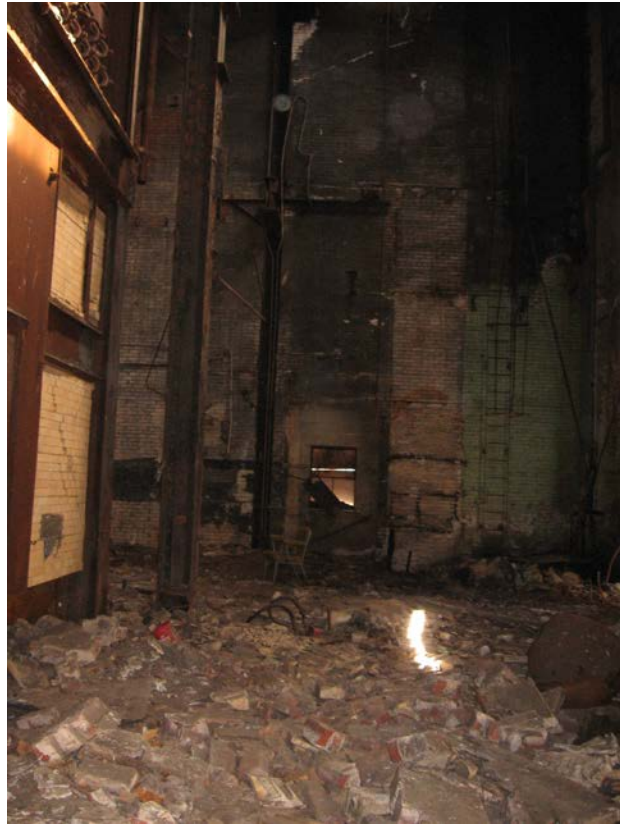
Official Photograph No.11:
Fallen debris throughout the first level. Near the center of the Power House interior. Facing north.

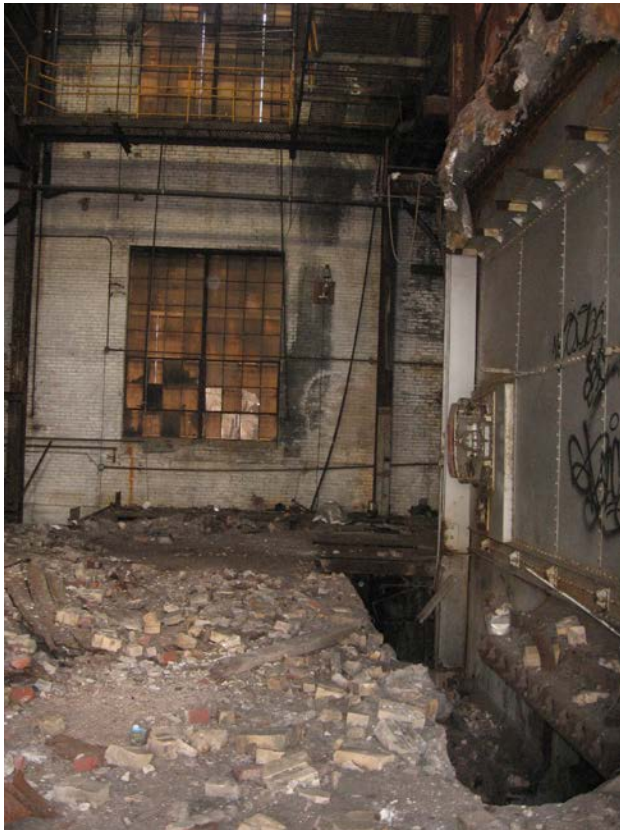
Official Photograph No.12:
Near the center of the Power House interior, floor missing next to boiler. Evidence of trespassers can be seen from the graffiti on the boiler. Facing north.

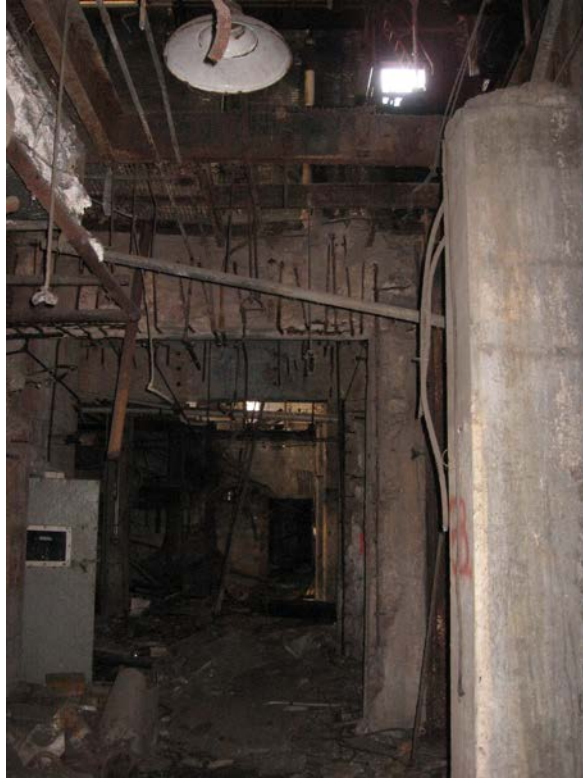
Official Photograph No.13:
Basement of the Power House interior.
Concrete crumbling from ceiling with
rebar exposed. Facing west.

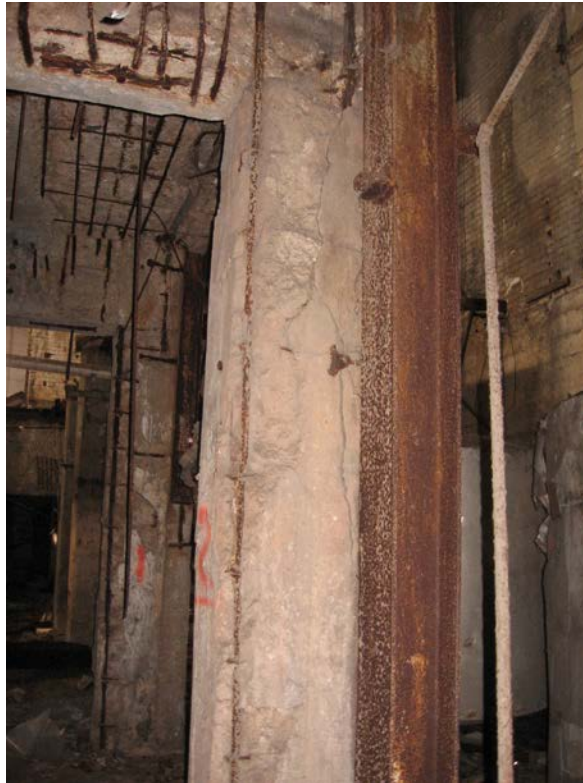
Official Photograph No. 14:
Basement of the Power House
interior. Concrete crumbling from
ceiling with rebar exposed. Facing
west.

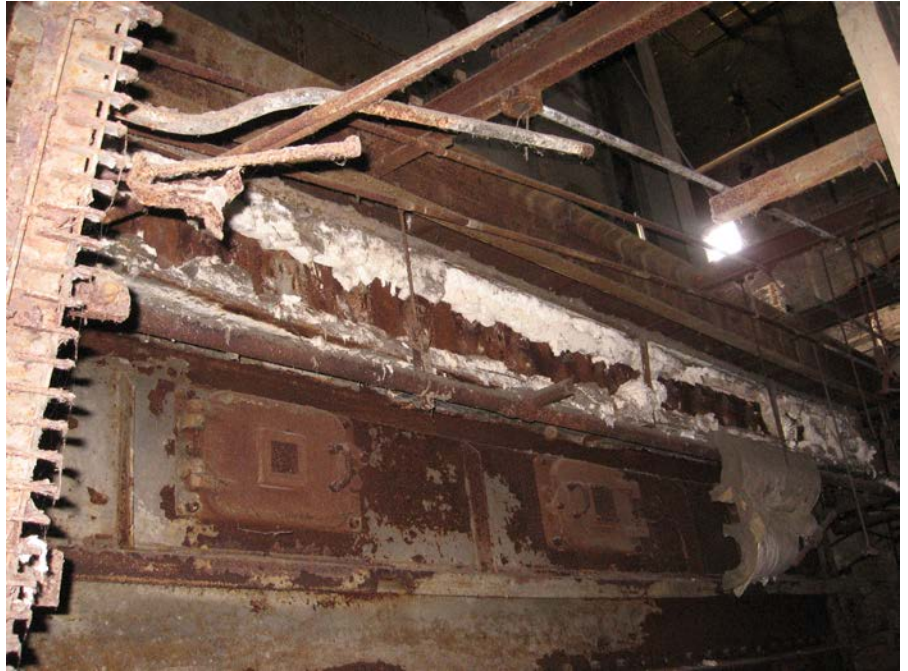
Official Photograph No.15:

START entered the building in Level “C” PPE to determine sampling locations with the OSC and document current conditions of the building prior to sample collection. The building has a main 1st level and basement level. The interior condition of the building was severely compromised with fallen debris such as brick, metal piping, and beams (Photograph 10 & 11). Large portions of the main floor were missing next to the boilers with evidence of trespassing throughout the building (Photograph 12). The basement area showed areas of wear in the concrete ceiling (main level) where the rebar was exposed and visible cracks along the posts that hold up the ceiling (Photographs 13 & 14). Potential ACM was observed on both levels of the building throughout both floors. Potential ACM was also observed crumbling from the boiler in the basement level (Photograph 15).

Basement of the Power House
interior. Possible ACM crumbling
on boilers. Facing southwest.
