September 17, 2018

Re: Structural Assessment – Power House Building
Rock TENN Site
Otsego, MI

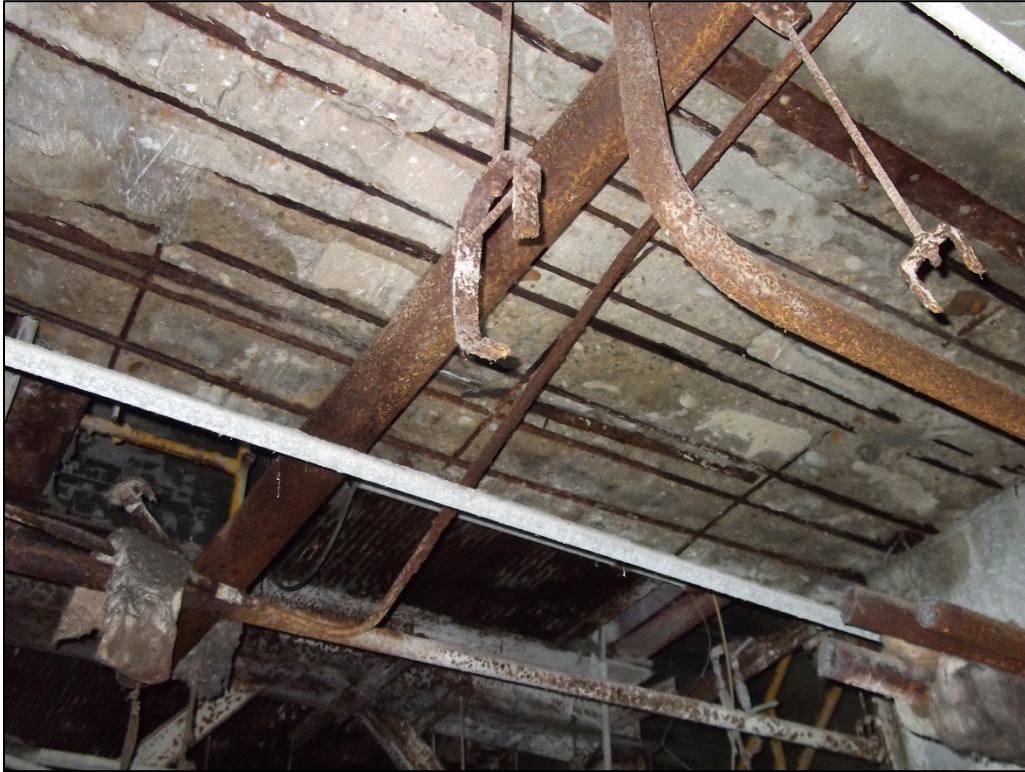
The basement area showed that a big portion of the concrete slab supporting the first floor is severely damaged. The concrete of the slab and beams is spalling and the reinforcing steel is exposed, rusted and lost its bond to concrete. The shear and flexural capacity of the slab and beams supporting the first floor are severely compromised. Some of the concrete columns supporting the first floor had concrete spalling with exposed rusted steel. The load capacity of the damaged columns is compromised. See photos 1 through 3, attached.

Photo 1: Concrete slab supporting the first floor.

- Provide decking and shoring to severely damaged 1st floor concrete slab where reinforcing is exposed. (see photos 1 through 3). This may involve removing piping and conduits under the slab (which may be required by abatement contractor if containing asbestos) to place the decking and the shoring posts. The decking and shoring posts should be designed to take the weight of the concrete slab as well as the construction load. The construction load would include any scaffolding above the slab that would be required for the abatement work. No construction heavy equipment should be allowed to operate on the first floor slab. No stockpiling of material should be allowed on 1st floor.

- Provide shoring posts supporting 1st floor concrete slab or steel framing supporting 1st floor decking for all areas on 1st floor to be used during the abatement work. All other areas of the 1st floor should have access restricted.

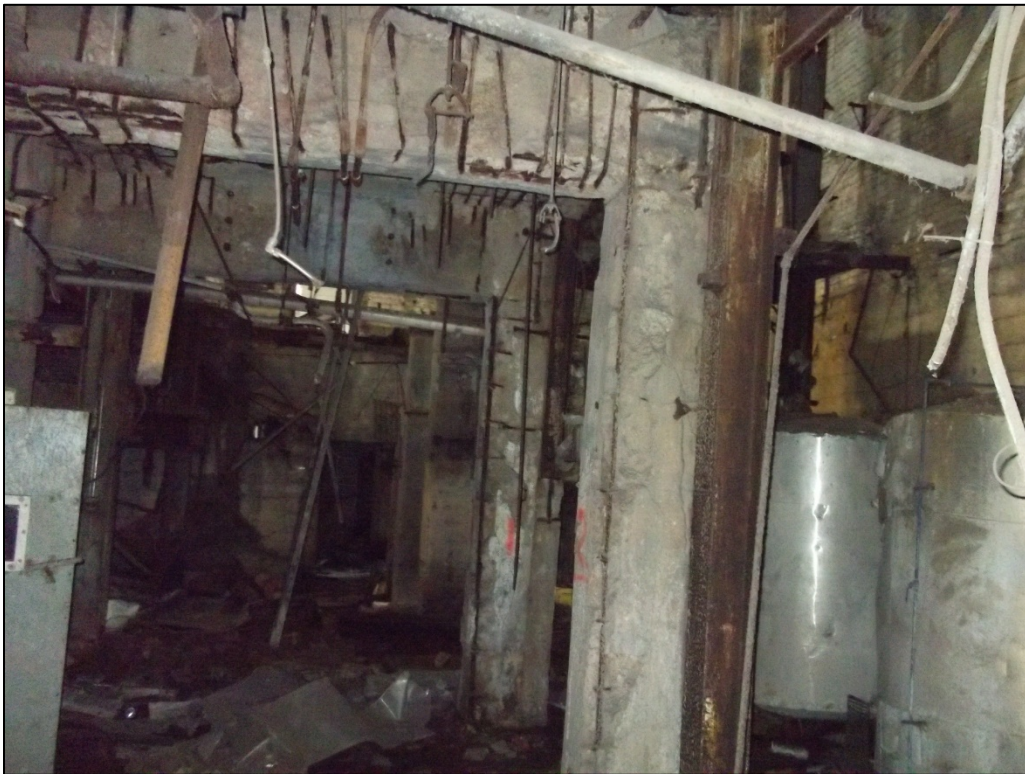
Photo 2: Exposed steel in beams and columns supporting the first floor.

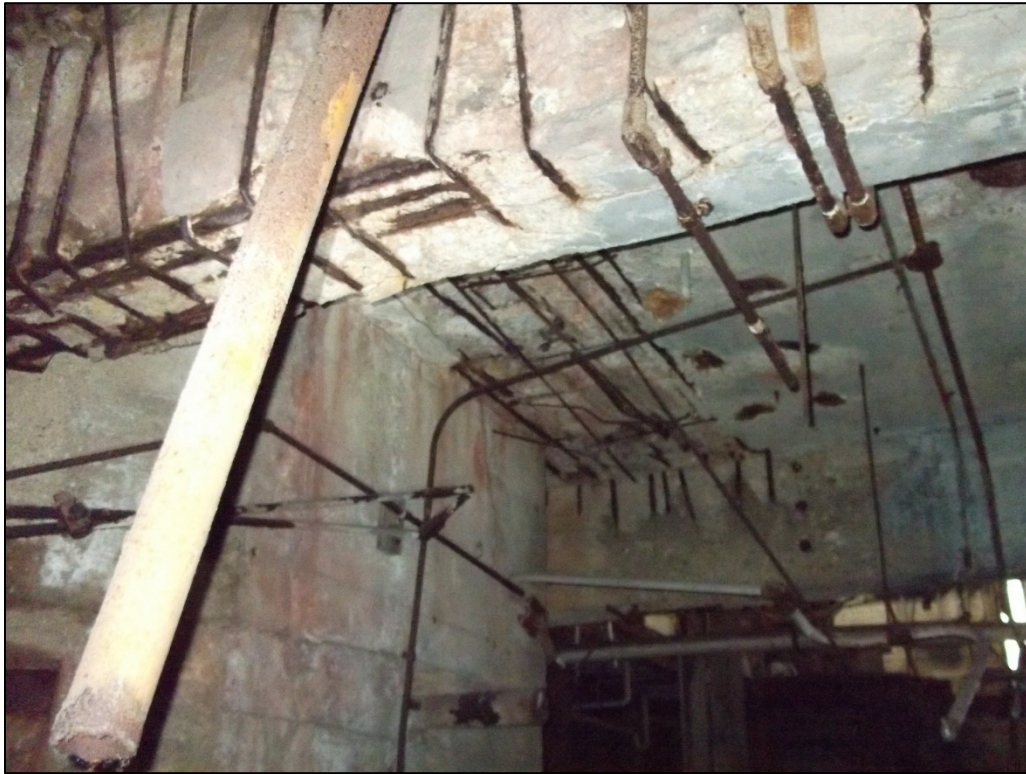
Photo 3: Exposed steel in beams and slab supporting the first floor.

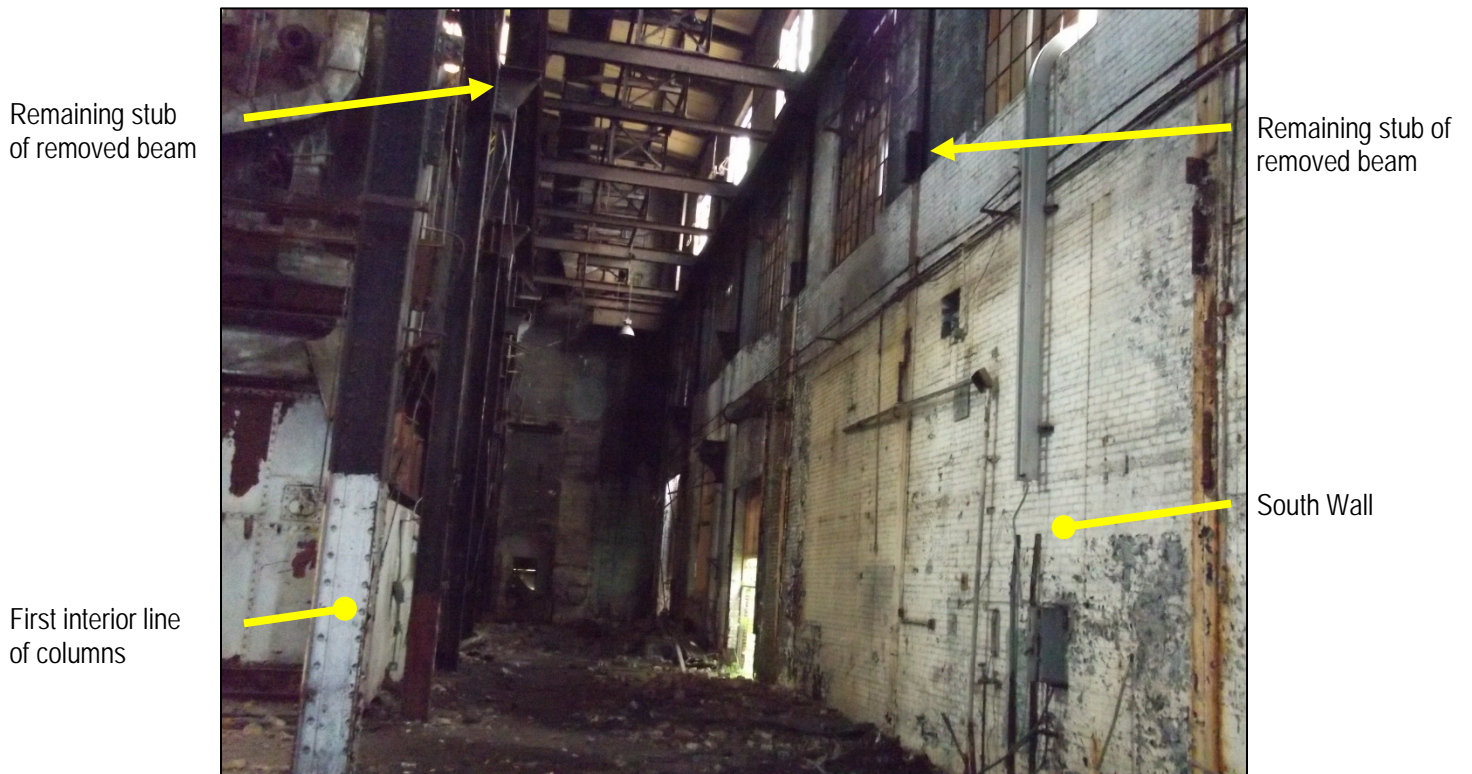
The structure above the first floor supporting the roof and the exterior walls of the building has been altered presumably by salvage operations conducted since operations in the building ceased. Steel beams have been cut off and removed. This has affected the capacity of the structure supporting the exterior walls of the building and the capacity of the columns to take the vertical load of the roof. See photo 4.

Photo 4: Removed beams in south building wall to first interior line of columns

- Provide supporting members in the north south direction from the south wall to the first line of columns north of the wall (see photo 4) to replace the cut and removed beams above the first floor. Attach to the remaining stubs of the removed beams in the wall and the columns.

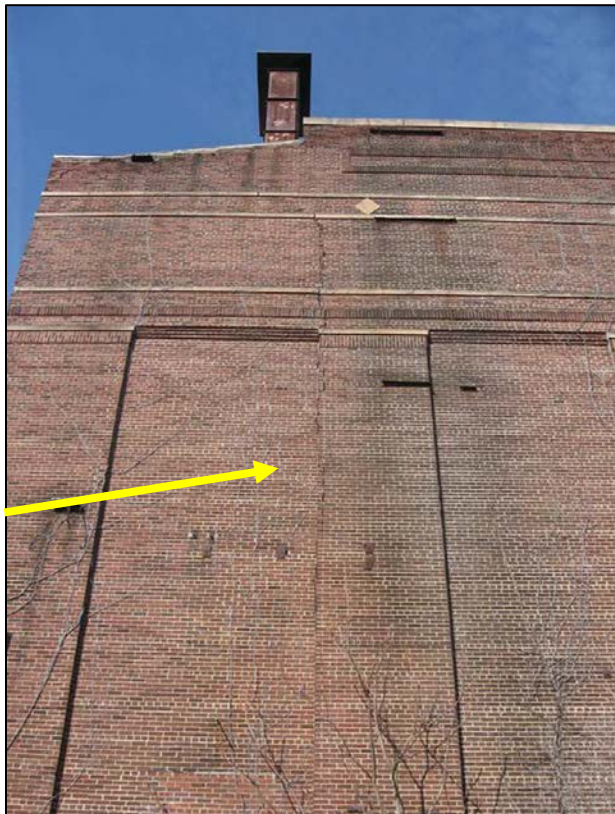
The exterior walls of building are showing cracks. This has been caused by the removal of structural members that were part of the bracing system for the walls. See photo 6.

Vertical crack
in wall

Photo 5: East building wall.

- Brace the four walls of the building. This may be done on the exterior of the building by providing horizontal supporting members mid height of the wall with struts down to ground.

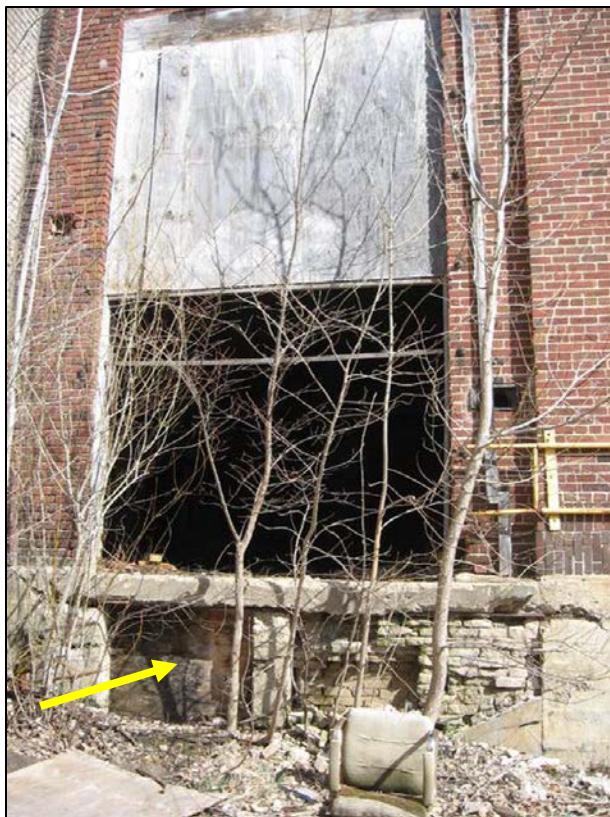
A portion of the foundation wall at the access opening in the south wall is missing and the concrete slab at the opening is not supported. See photo 5.

Missing foundation
wall

Photo 6: Access opening in south wall.

- Provide continuous support to edge of concrete slab at the opening in the south wall where the foundation wall below the slab is missing. (see photo 6)
