Re: May Creek Landfill Site Walk
Contract Number EP-S7-13-07, Task Order 68HE0718F0470

Observation Report

May Creek Landfill
Renton, Washington
Task Order 68HE0718F0470

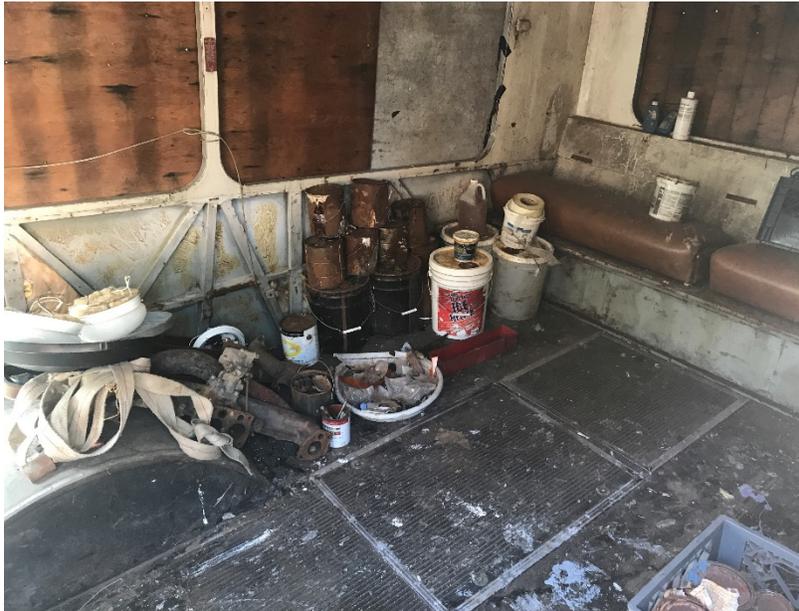
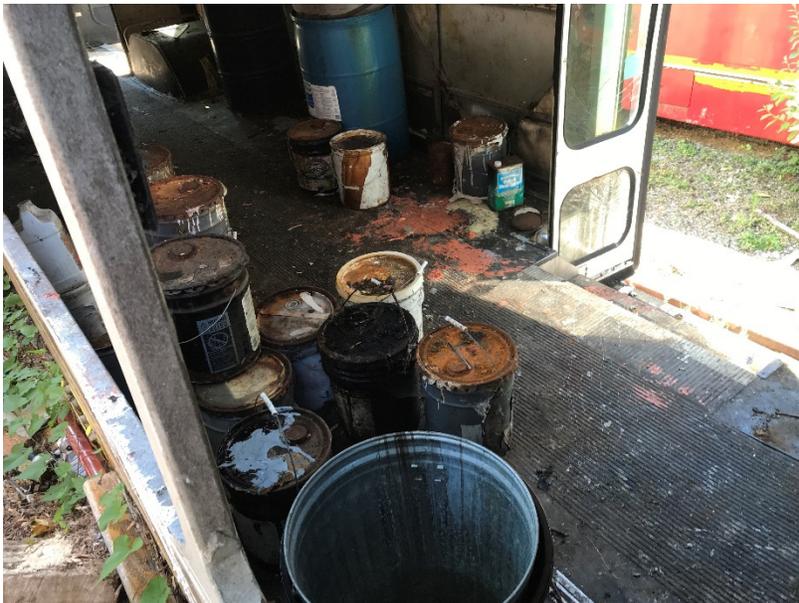
START observed approximately 30 containers in an old bus. The containers were mostly 1 and 5 gallons and appeared to be paint-related wastes. Two 55-gallon drums were observed in the bus. Many of the containers did not have markings and appeared to be in poor condition. No observable management system was apparent to prevent mixing of incompatible chemicals or to prevent release.

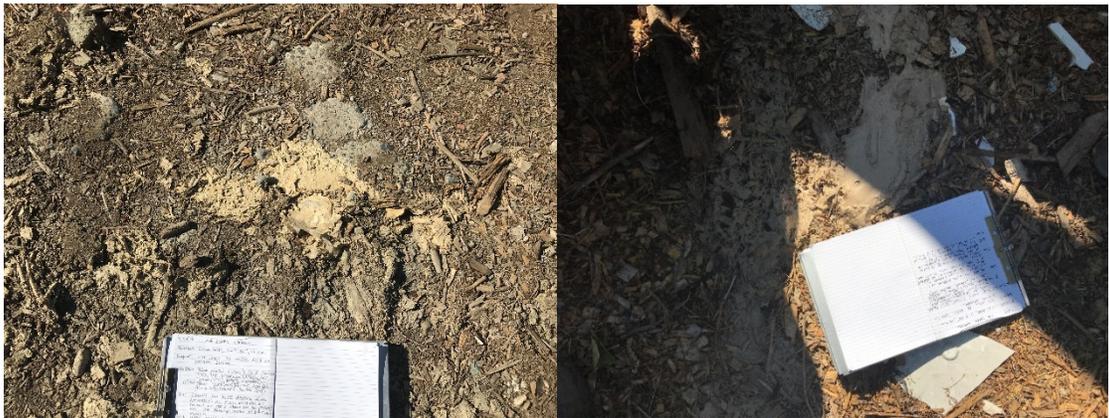
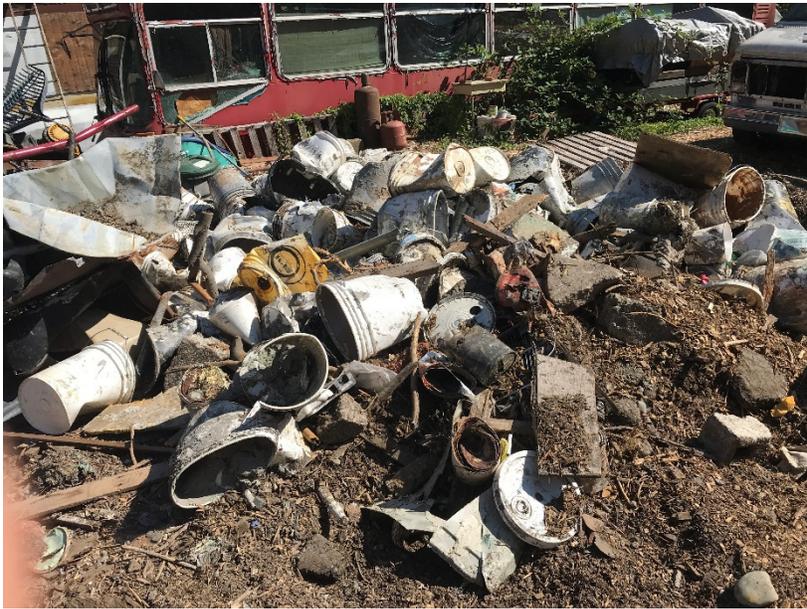
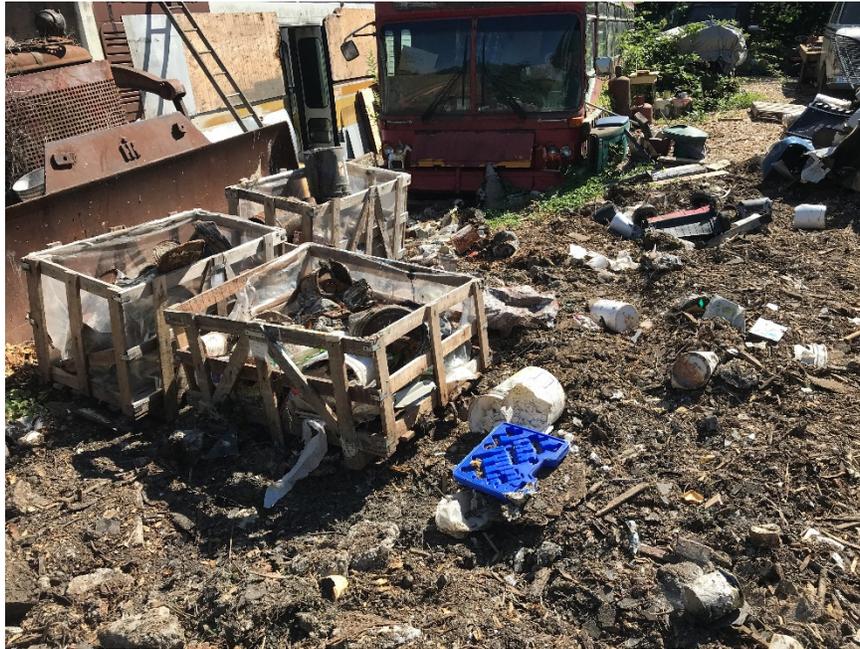
During the 2016 site visit, START had observed several hundred containers in this bus. The PRP explained that he had emptied the contents of those containers to the ground and mixed them with woodchips/sawdust. He reported that the containers he emptied contained only latex paint and that the containers with flammable waste were left in the bus. He crushed and stockpiled the empty containers next to the bus. ERRS observed latex and oil-based paint containers and reported a solvent smell near the stockpiles. See photos below of the spilled material and crushed containers.

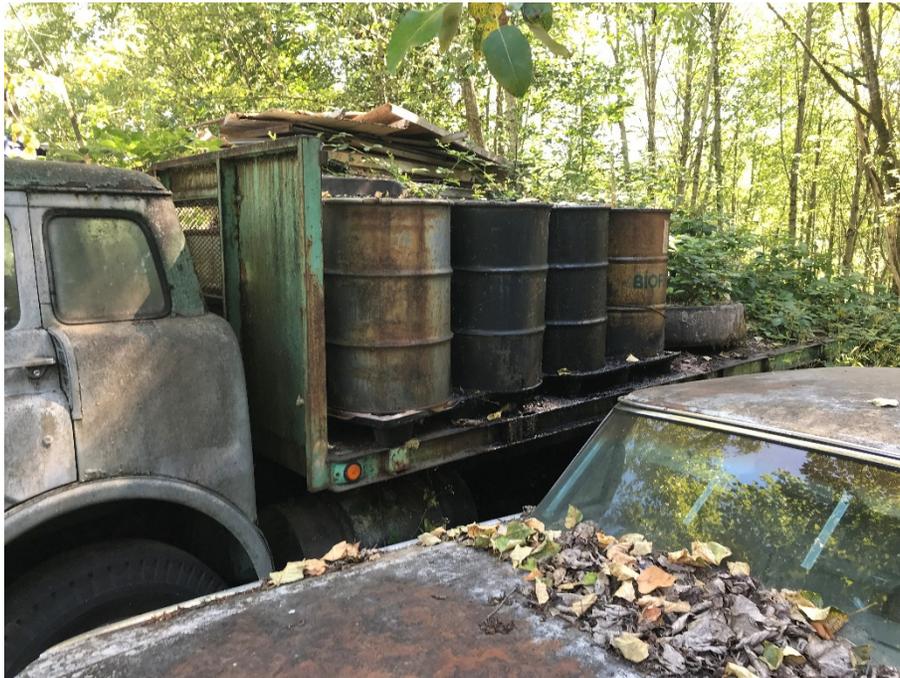
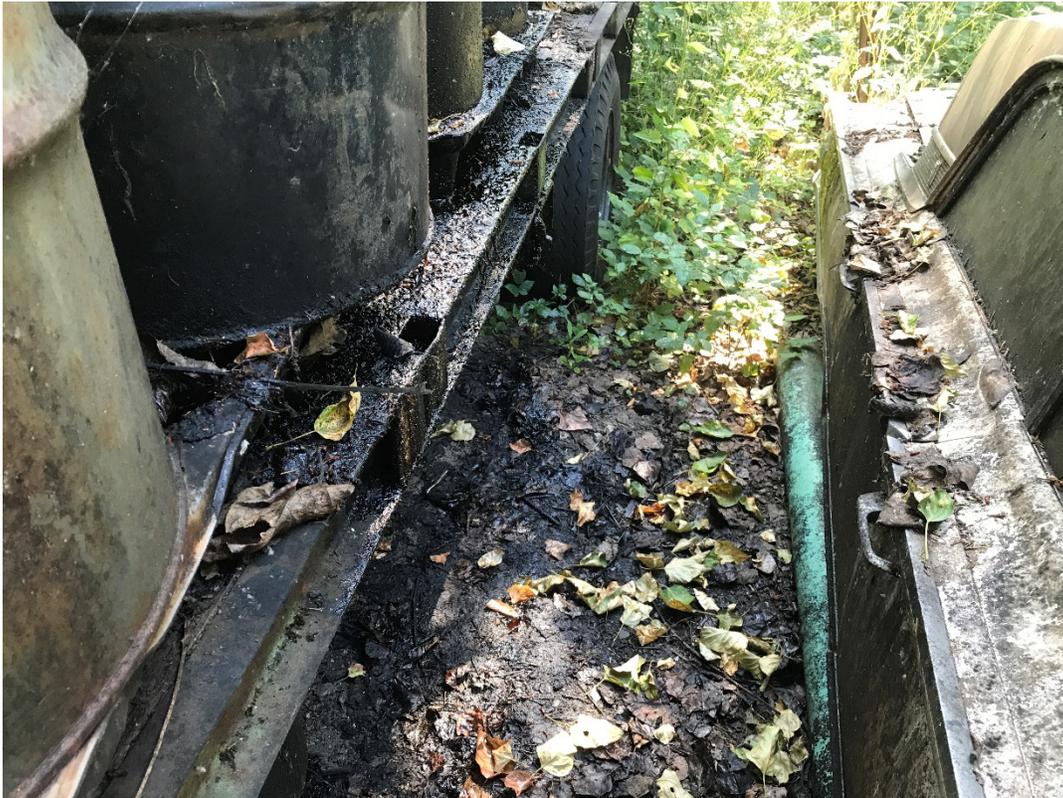
START observed approximately ten 55-gallon metal drums on the bed of a truck. These containers were also observed during the 2016 site visit. The drums had few if any labels and appeared to have contents in them. One drum was leaking a black liquid to the soil. Nearby an additional stainless steel drum with no labels was observed.

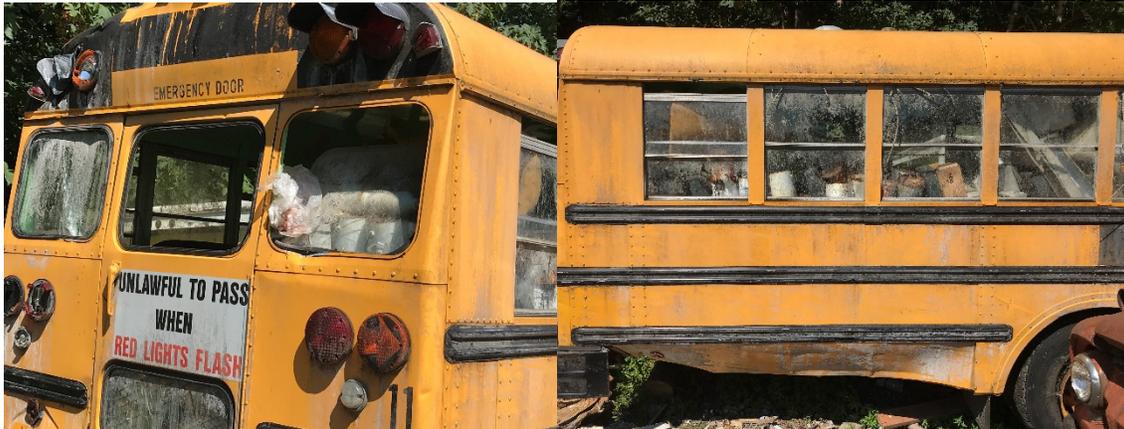
During the site walk in this area, START observed 20+ containers/cylinders laying on the ground or otherwise mixed with solid waste at various locations. Suspect ACM was also observed throughout this area. Of note in this area was a school bus that contained approximately 100+ 1-gallon containers. This bus was not present at this location during the 2016 site visit.

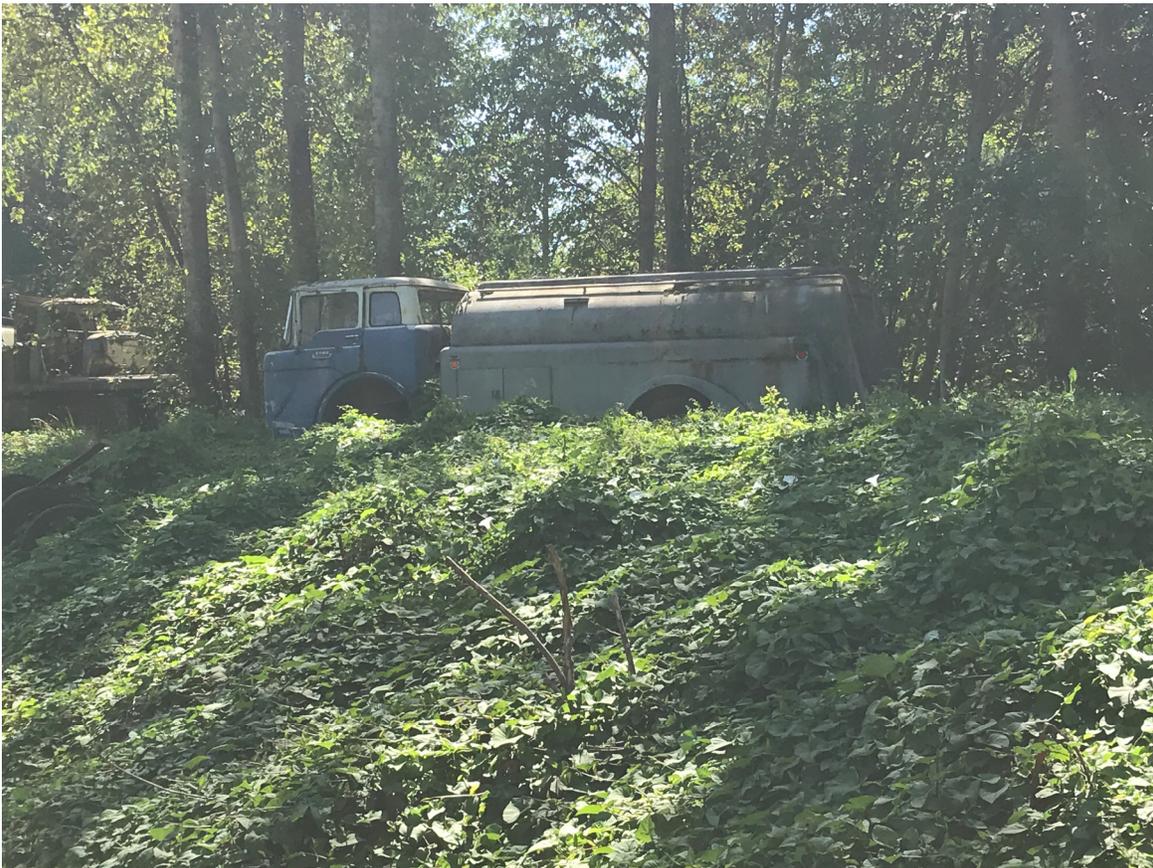
START also observed several junked/abandoned vehicles capable of carrying several thousand gallons of liquid throughout the site (including two fire trucks, a jet fuel carrier, and a small tanker truck). One such vehicle is pictured below but was not accessible to assess for contents. The PRP indicated it was a water truck and was empty.

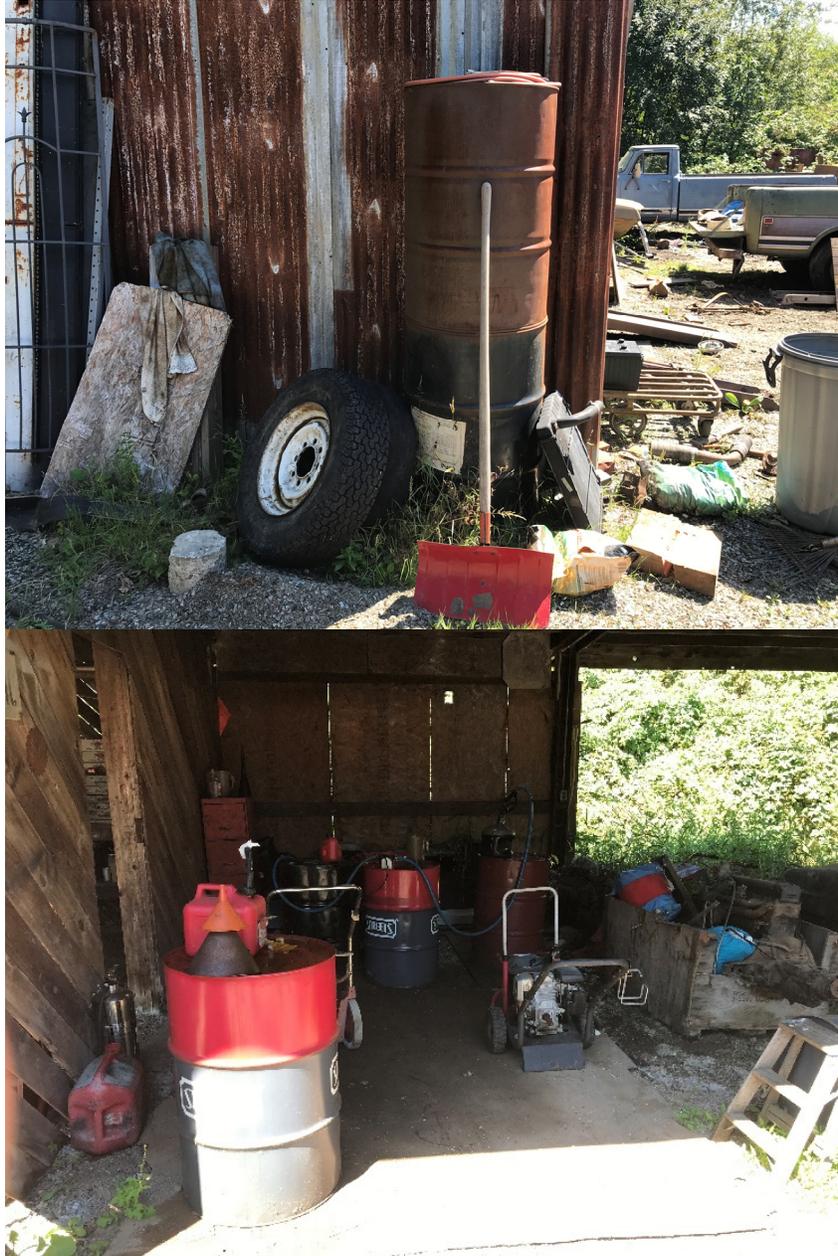
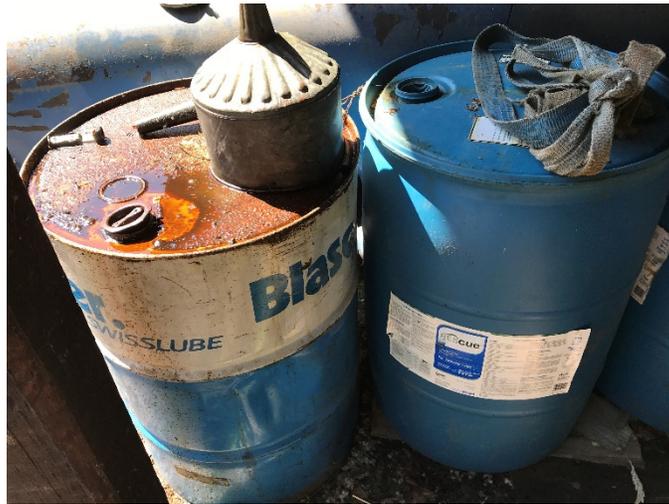
START observed approximately 10 drums in the workshop area. Many of the drums were being used to manage the PRP's used/waste oil and other materials from vehicle maintenance. Since these drums appeared to be actively in use, not all of them are accounted for in this report as being potentially subject to a TCRA. Assorted 1- and 5-gallon containers were also observed in this area.

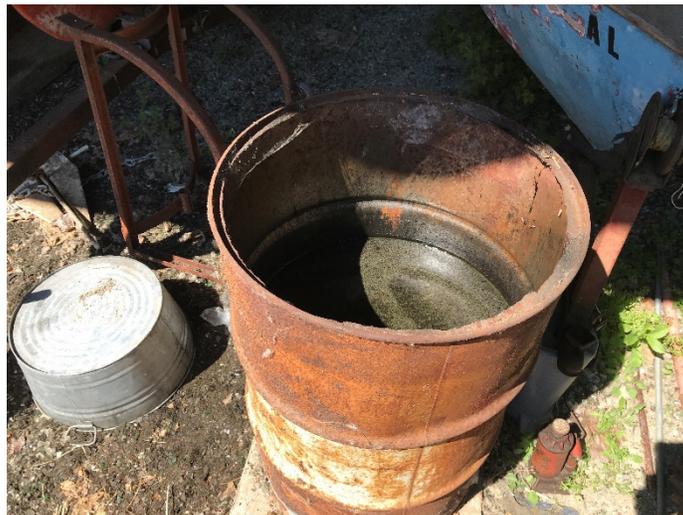
The container that contained a liquid with elevated pH (12.3) and that was a toxicity characteristic hazardous waste for lead in 2016 was still present on the site in this area, as shown in the photo below:
