SUBJECT: Calumet & Hecla (C&H) Mineral Building
Request for Assistance
Hubbell, Houghton County, Michigan
DEQ Site ID 31000081

Figure 1
Sample Analytical Result Map
Hubbell Processing Area - Mineral Building Property
Hubbell, Houghton County, Michigan

Waste Pile Photograph Log
Hubbell Processing Area – Mineral Building
Hubbell, Michigan

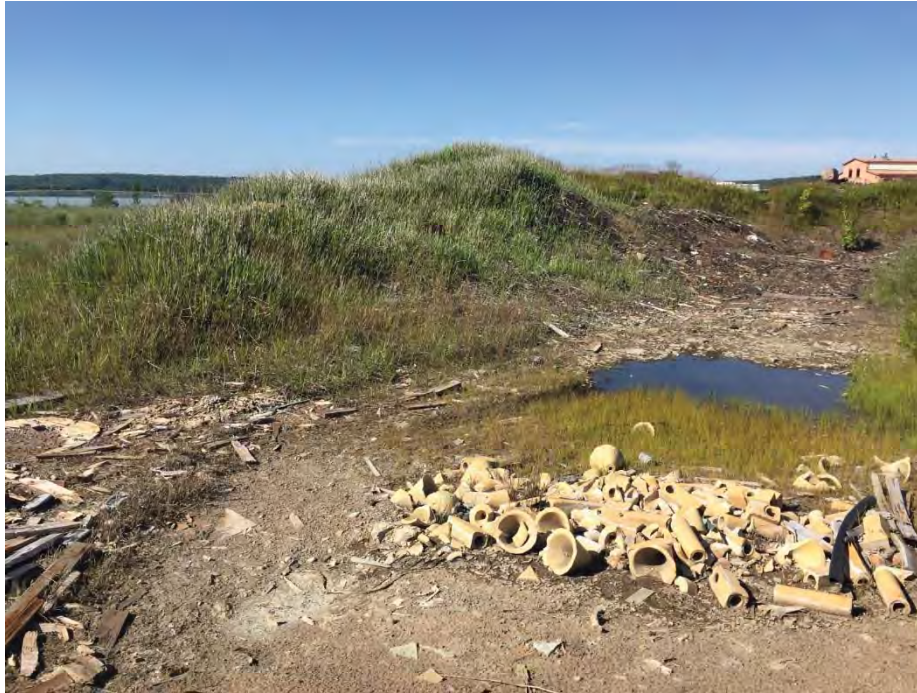
Photograph 1: Waste Pile 45 (WP-45) in the foreground (a small pile of refractory) with WP-01, containing soil, slag, and concrete in the background. The material appears to be “industrial” in nature. Photograph by J. Chrestensen, July 20, 2016.

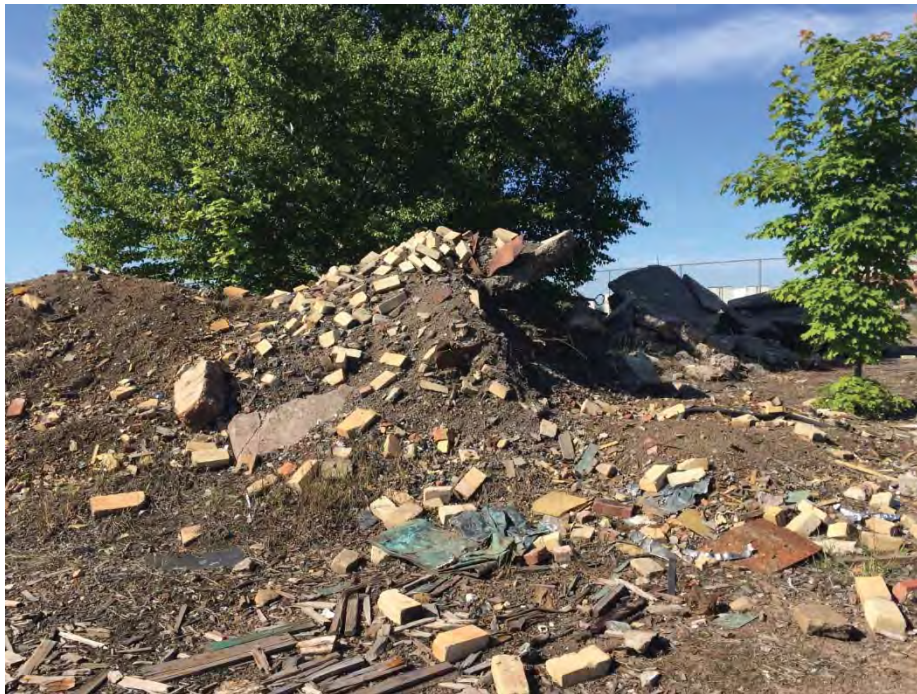
Photograph 2: WP-02 containing fire brick, metal, wood, concrete, and old appearing debris mixed with soil. Photograph by J. Chrestensen, July 20, 2016.

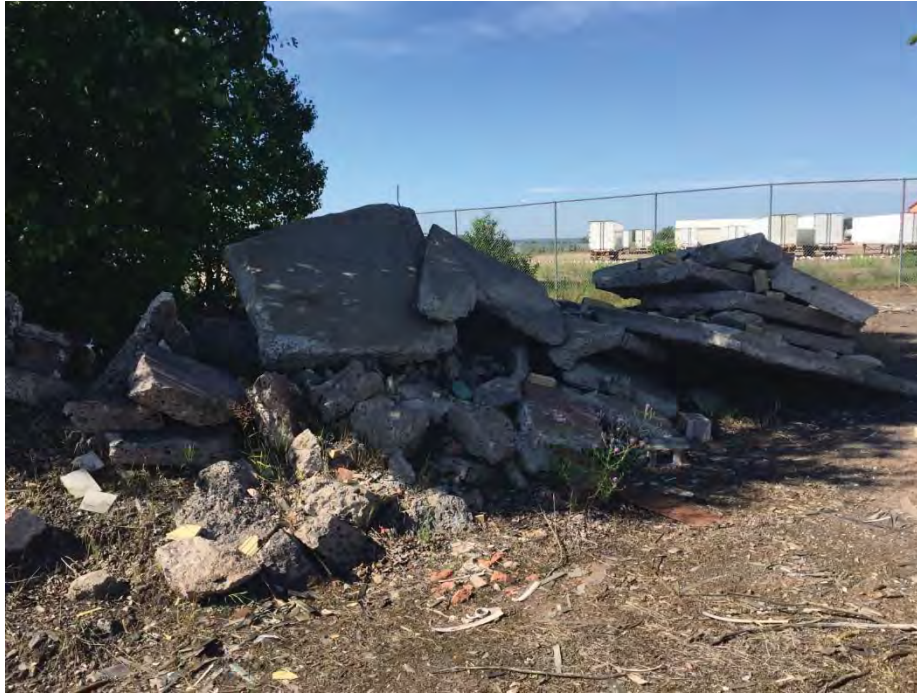
Photograph 3: WP-03 containing concrete slabs. Photograph by J. Chrestensen, July 20, 2016.

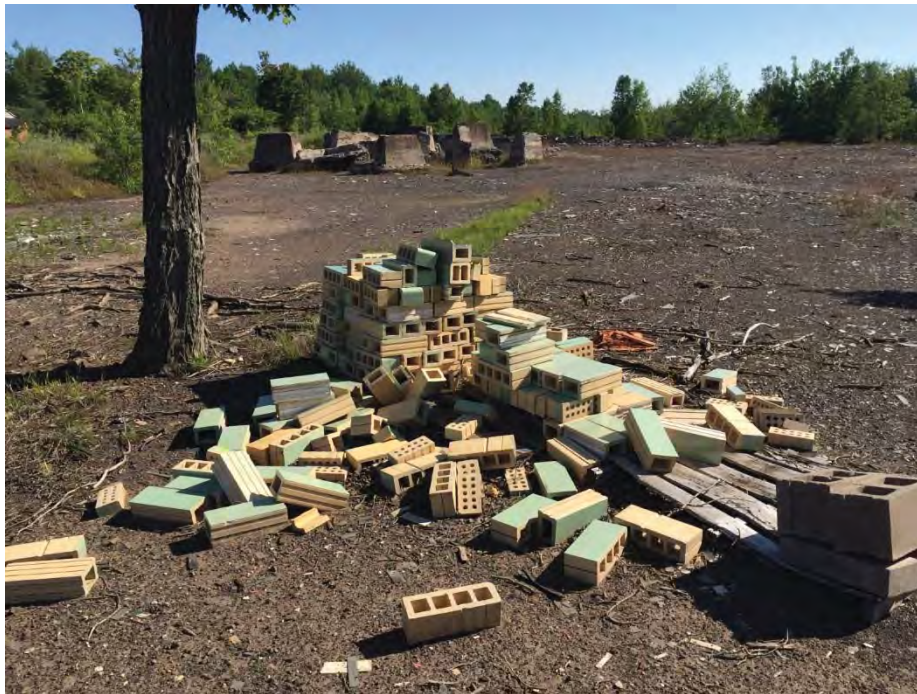
Photograph 4: WP-04 containing refractory. Photograph by J. Chrestensen, July 20, 2016.

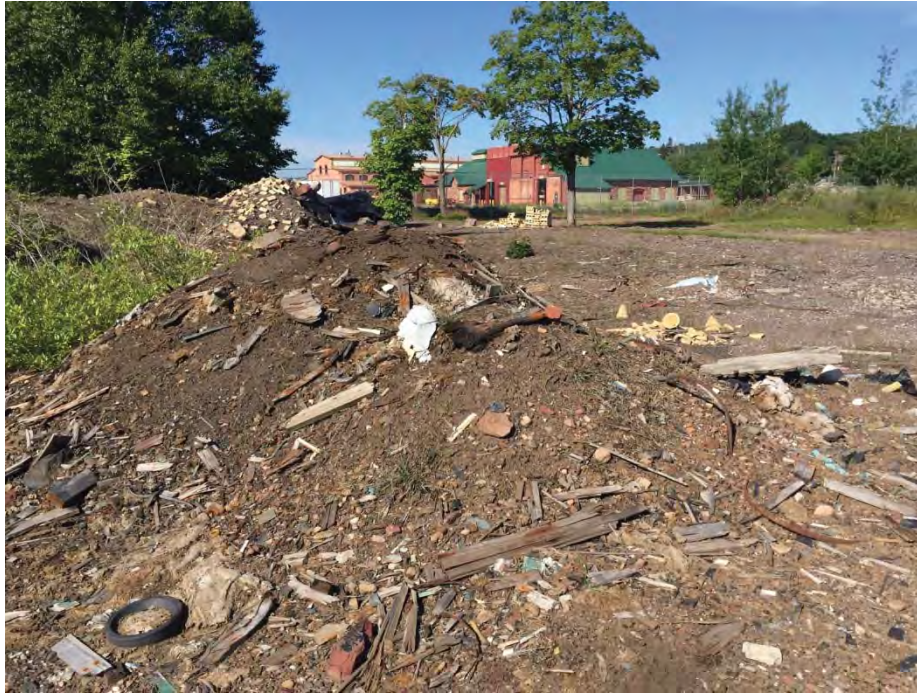
Photograph 5: WP-05 containing soil, rusted metal, wood, and corrugated paper. The material appears to be “industrial” in nature. Photograph by J. Chrestensen, July 20, 2016.

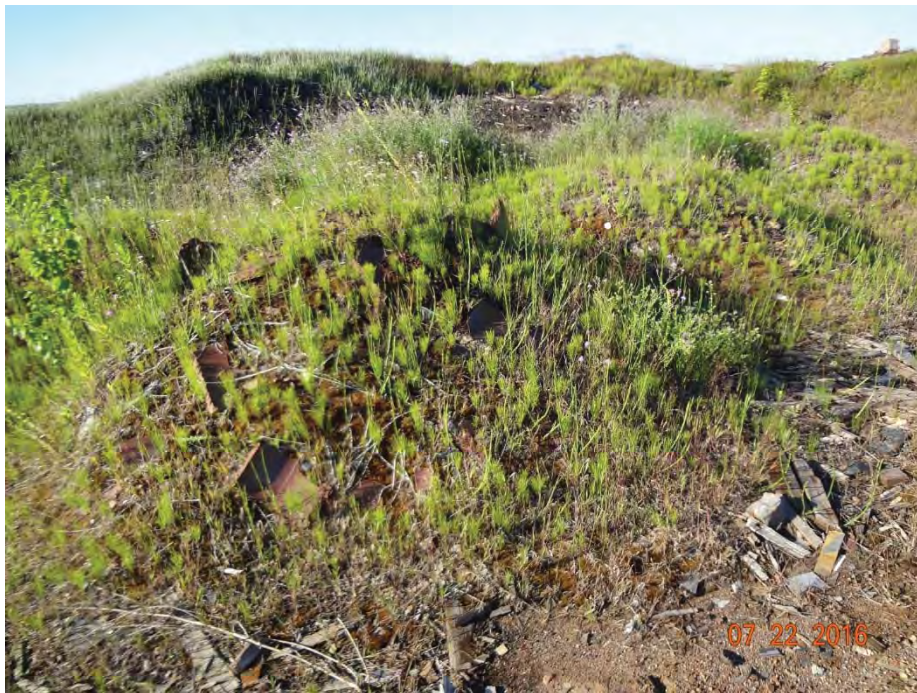
Photograph 6: WP-06 containing soil and clay pipe pieces. Photograph by MDEQ-GSU, July 22, 2016.

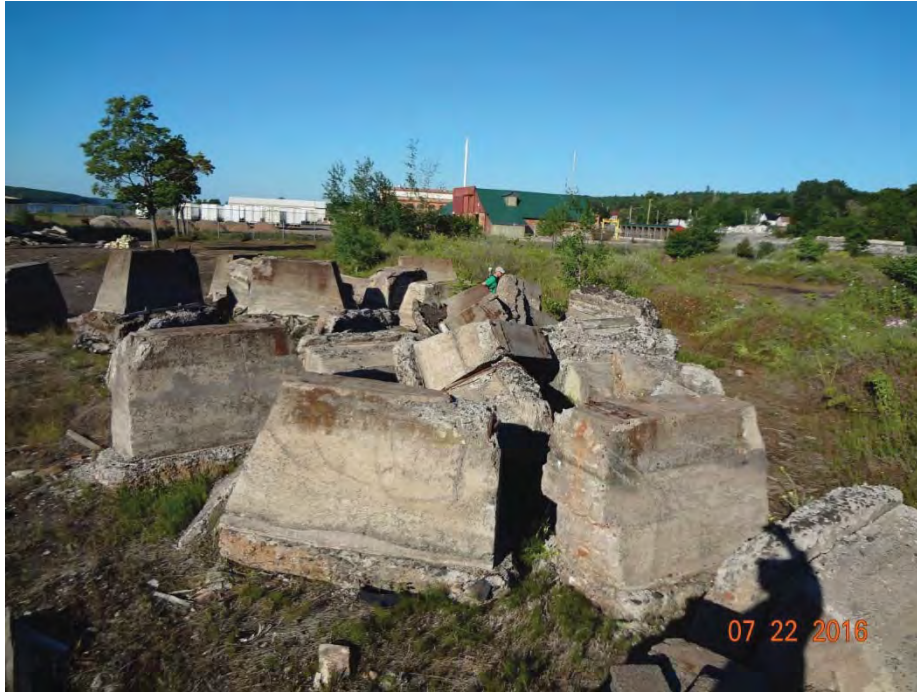
Photograph 7: WP-07 containing large concrete pieces (footers and base supports). Photograph by MDEQ-GSU, July 22, 2016.

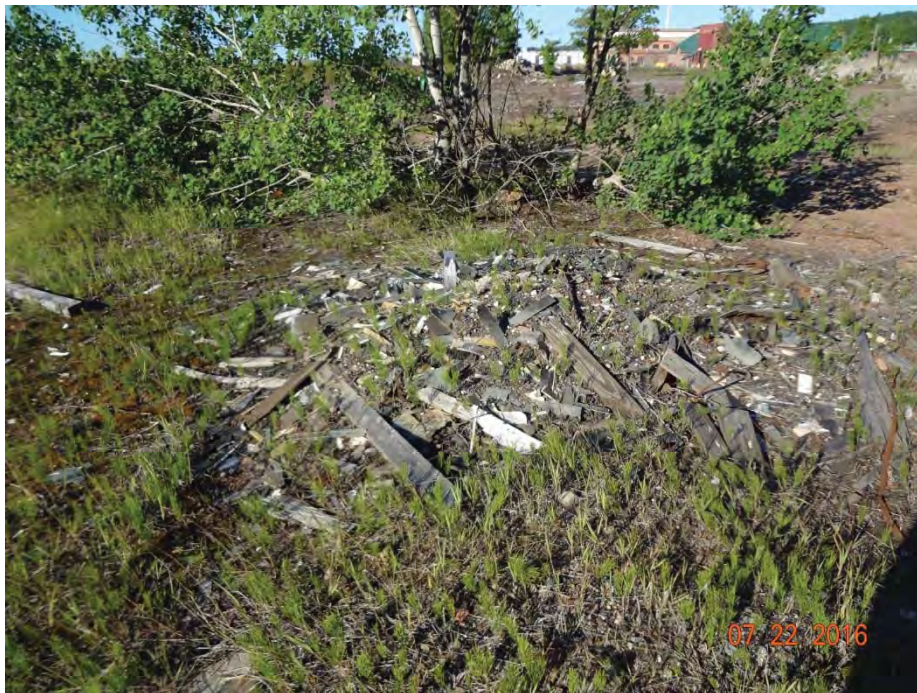
Photograph 8: WP-08 containing primarily wood, steel, and circuit board debris. Photograph by MDEQ-GSU, July 22, 2016.

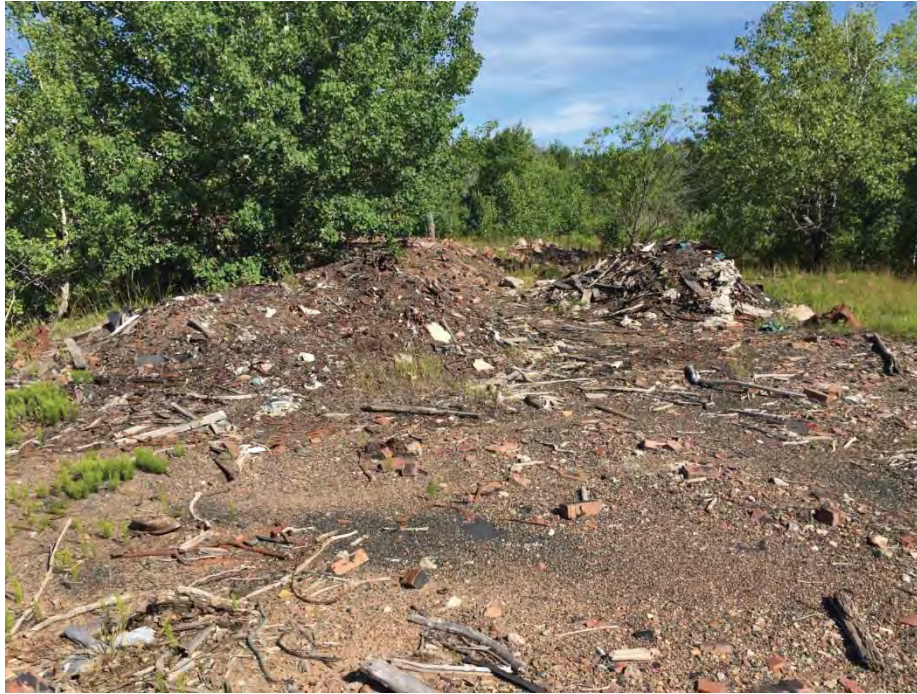
Photograph 9: WP-09 containing soil, rusty metal, fiberglass cloth, and charred wood. The material appears to be “industrial” in nature. Photograph by J. Chrestensen, July 20, 2016.

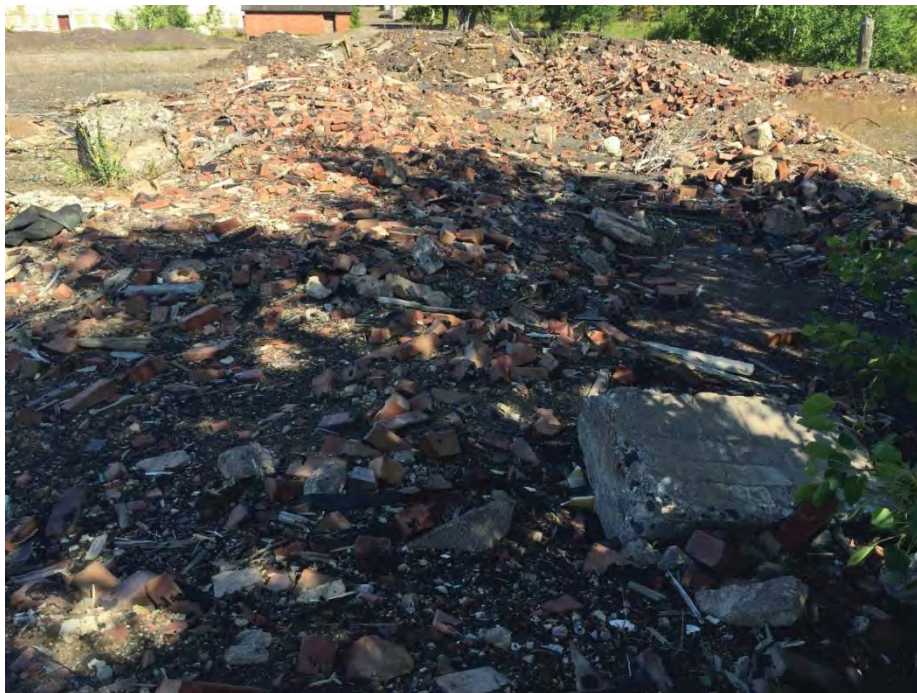
Photograph 10: WP-10 containing fire brick, much of which has a partial black coating, along with concrete, metal, and wood pieces. Photograph by J. Chrestensen, July 20, 2016.

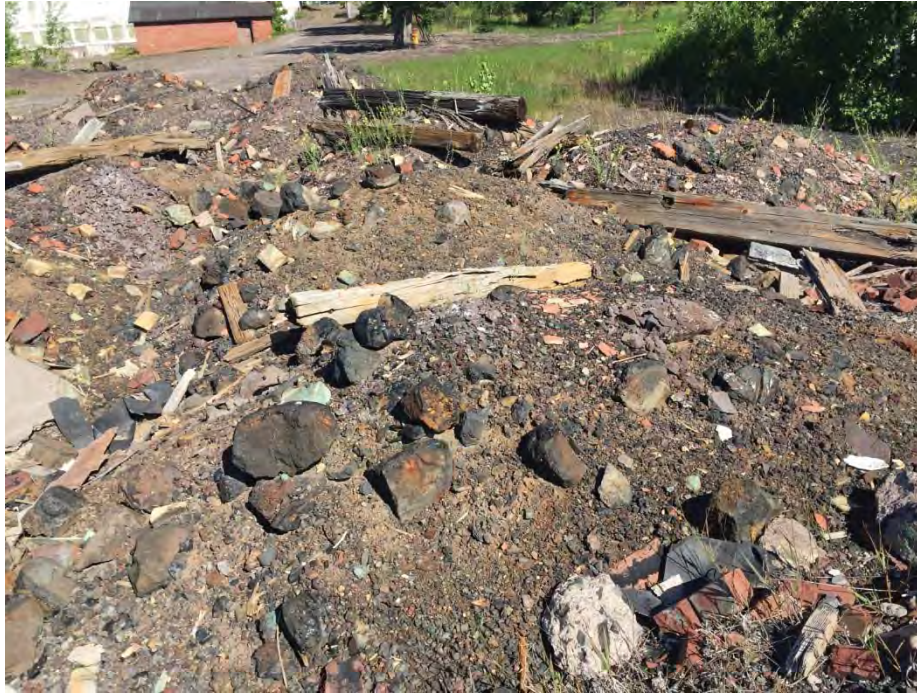
Photograph 11: WP-11 containing soil, slag, brick, concrete, metal, and wood timbers. Photograph by J. Chrestensen, July 20, 2016.

In 2017, the RRD disposed of 112 tons of smelter debris from a pile at the C&H Mineral Building, which we have referred to as Waste Pile 11 (WP-11). WP-11 contained PCBs (100 ppm), making it a Toxic Substances Control Act (TSCA) waste. Samples from WP-11 also leached lead via the TCLP at 110 mg/L, exceeding RCRA hazardous waste criteria. Due to the significant concentrations of contaminants present in WP-11 and its criteria as both TSCA and RCRA hazardous waste, the waste was disposed of at Chemical Waste Management's landfill in Arlington, Oregon. Based on additional RRD sampling conducted in August and October 2017, it is likely that similar waste still exists in other piles at the C&H Mineral Building. The RRD has also collected and disposed of nearly 13 tons of ACM through three abatement efforts. Recent aerial photographs indicate that the roof still has up to 3 layers of roofing material which continues to shed.

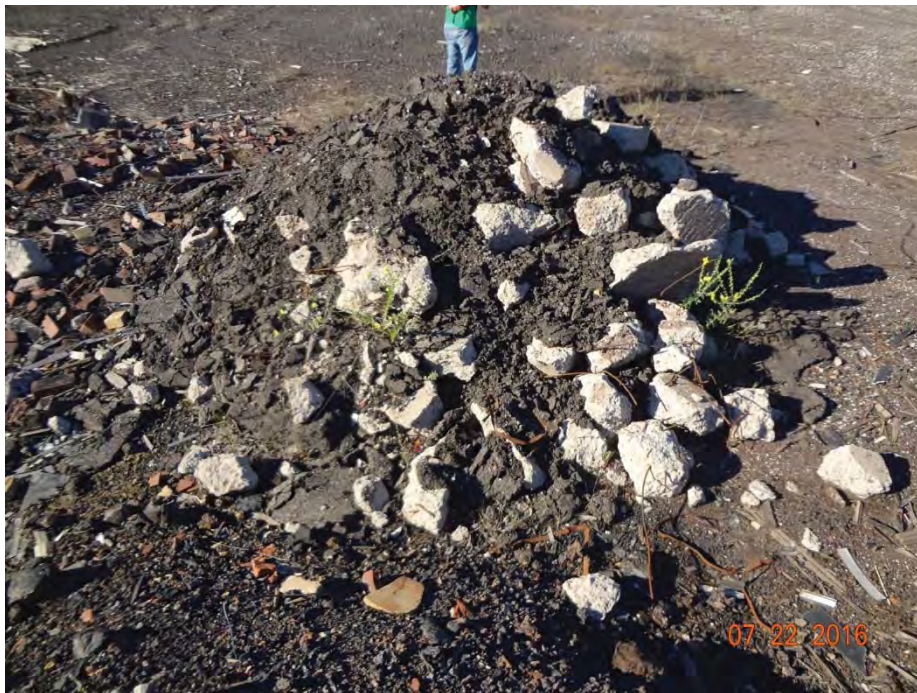
Photograph 12: WP-12 containing asphalt and concrete. Photograph by MDEQ-GSU, July 22, 2016.

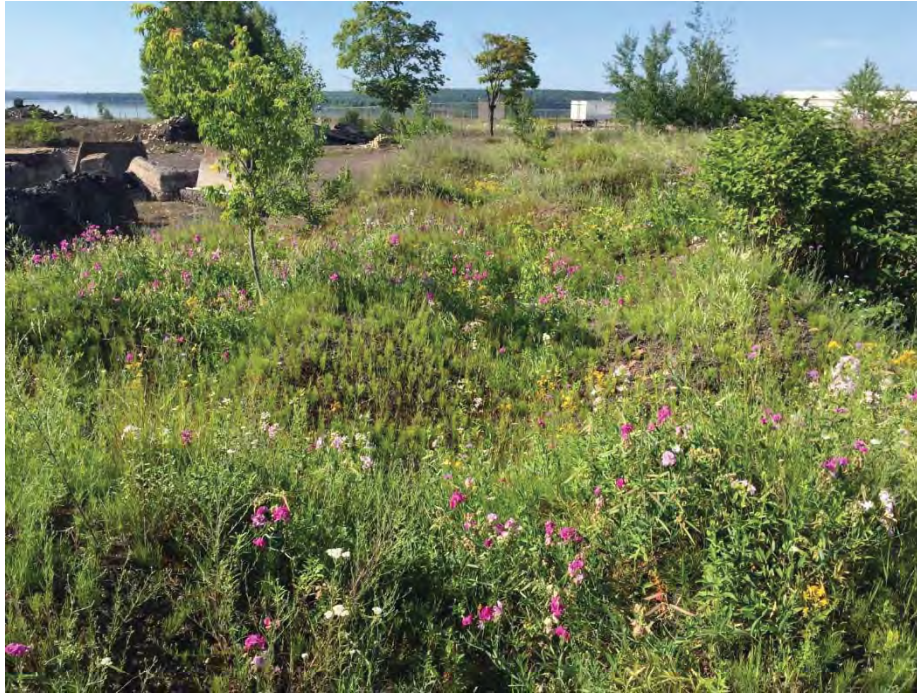
Photograph 13: Looking south across WP-13 which contains gravel and some minor amounts of asphalt and concrete. The material appears to be from road work. Photograph by J. Chrestensen, July 20, 2016.

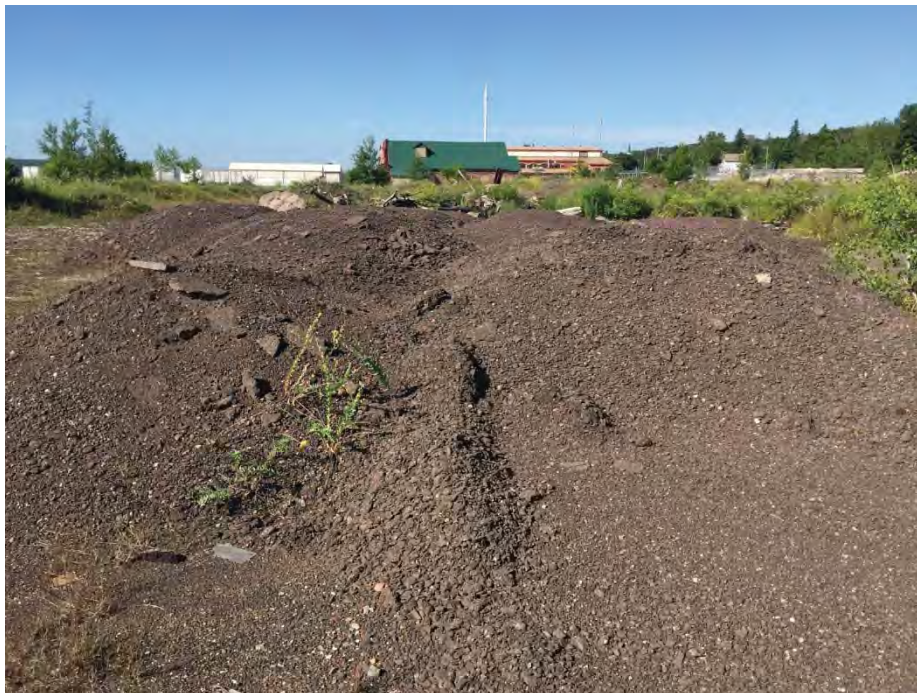
Photograph 14: WP-14 containing milled asphalt. Photograph by J. Chrestensen, July 20, 2016.

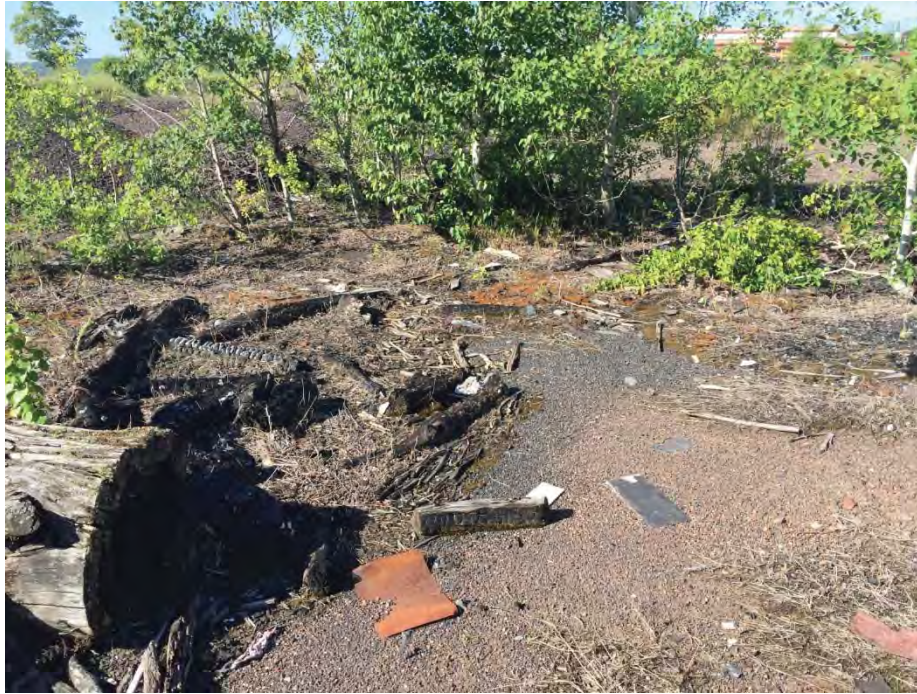
Photograph 15: WP-15 containing burnt wood, metal, and miscellaneous surface debris. Photograph by J. Chrestensen, July 20, 2016.

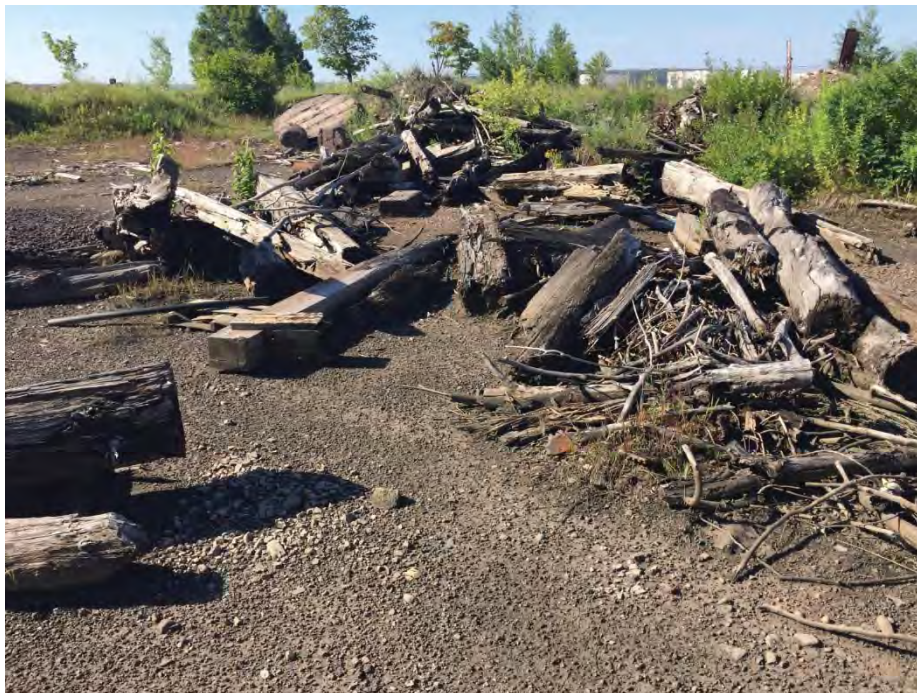
Photograph 16: WP-16 containing logs and timbers. Photograph by J. Chrestensen, July 20, 2016.

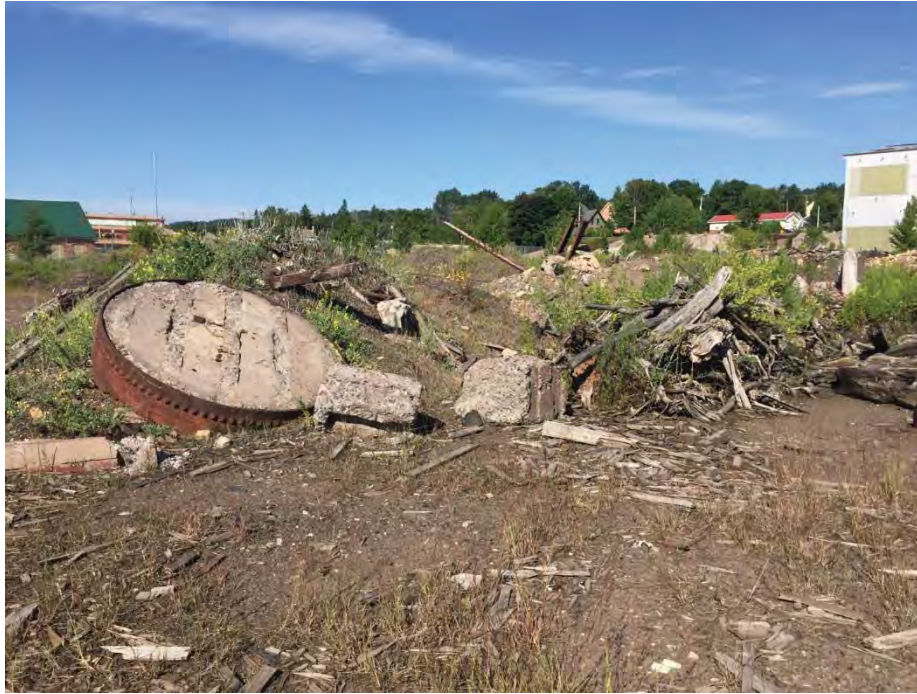
Photograph 17: WP-17 containing concrete pieces, wood, bricks, slag, and metal mixed with soil. The material appears older in nature. Photograph by J. Chrestensen, July 20, 2016.

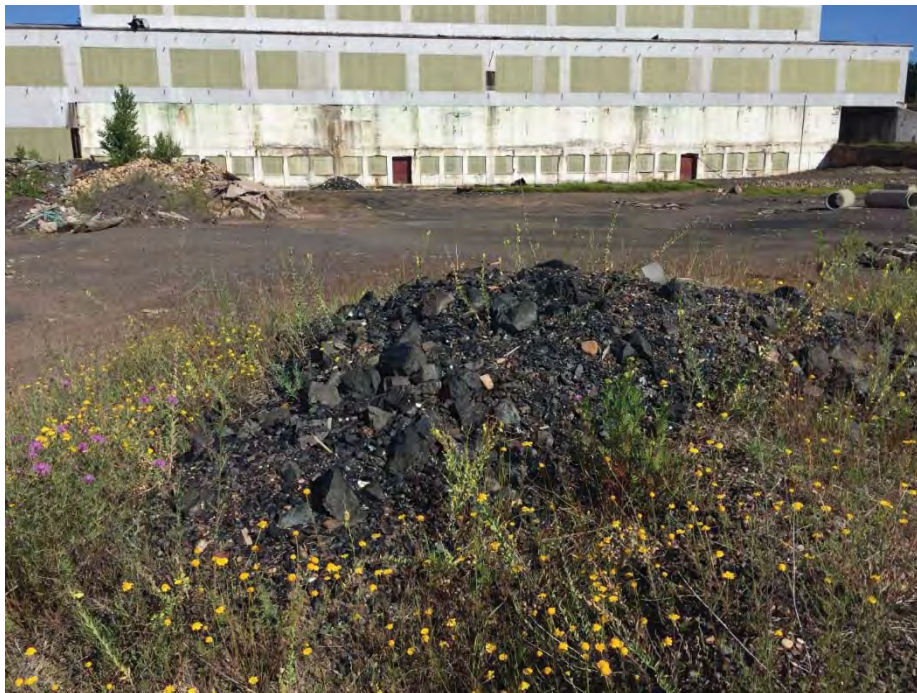
Photograph 18: WP-18 containing mostly slag with some soil and gravel. Photograph by J. Chrestensen, July 20, 2016.

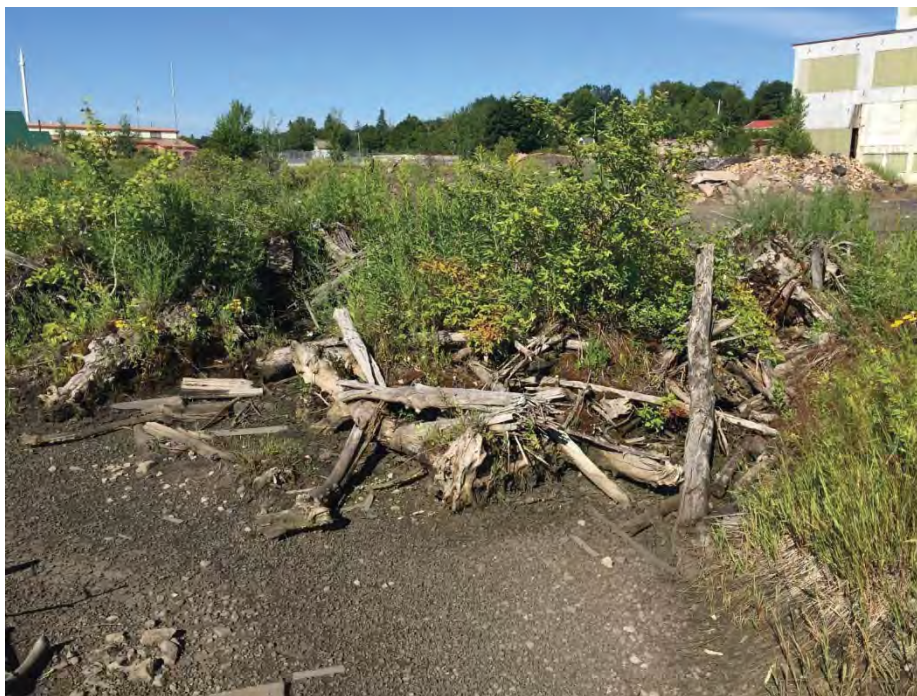
Photograph 19: WP-19 containing wood, stumps, and soil. Photograph by J. Chrestensen, July 20, 2016.

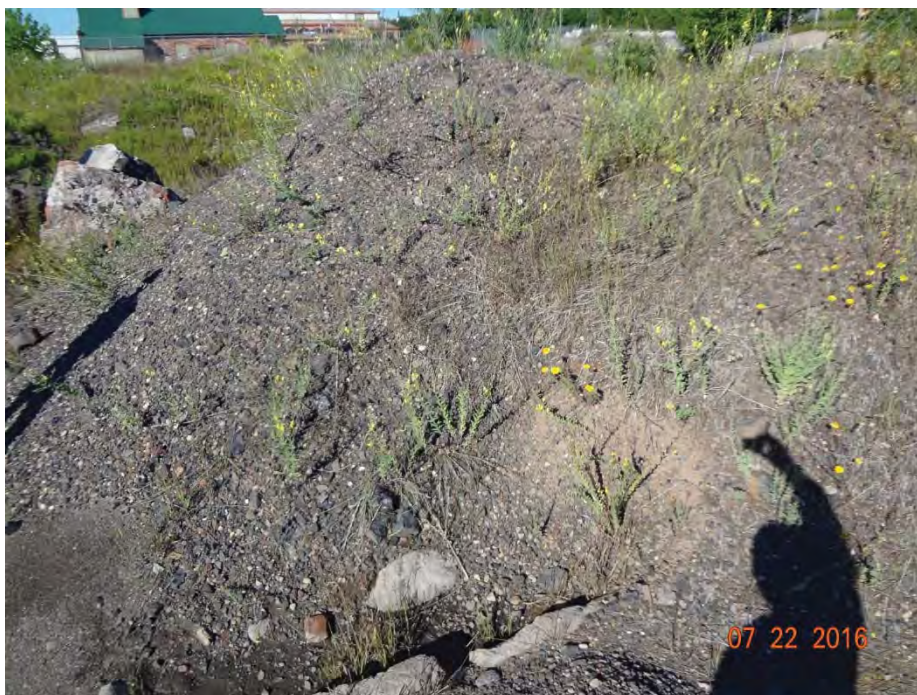
Photograph 20: WP-20 containing slag and gravel. Photograph by MDEQ-GSU, July 22, 2016.

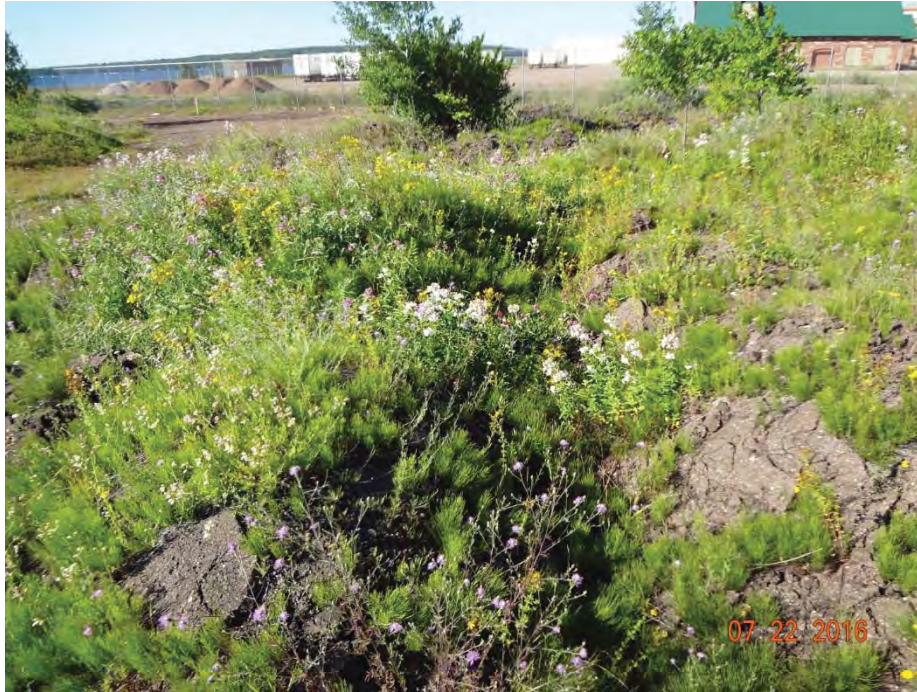
Photograph 21: WP-21 containing primarily asphalt with an area of gravel, soil, and concrete. Photograph by MDEQ-GSU, July 22, 2016.

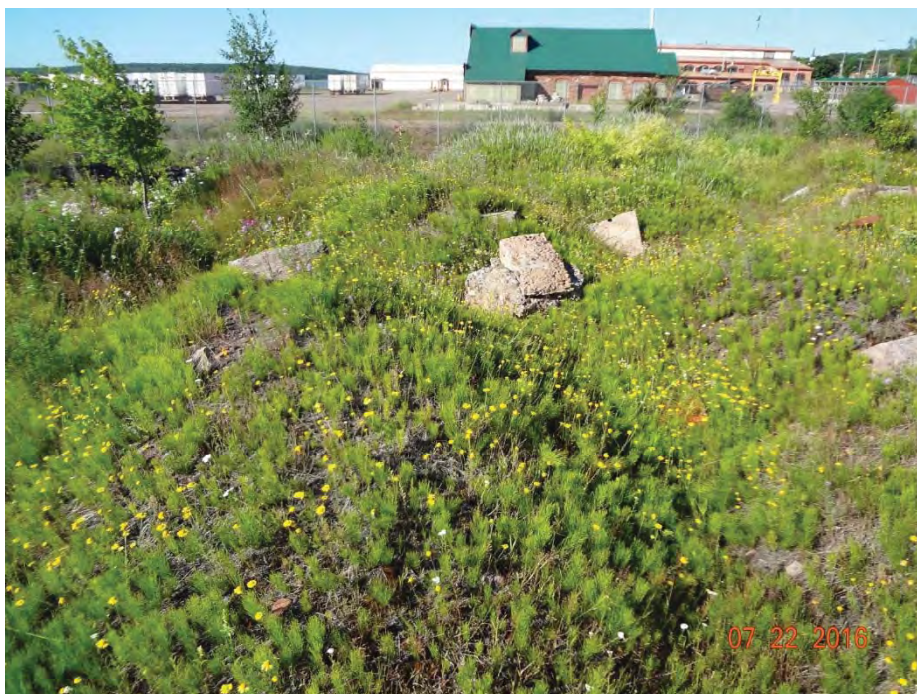
Photograph 22: WP-22 containing mostly soil and stamp sand with concrete pieces and some steel. Photograph by MDEQ-GSU, July 22, 2016.

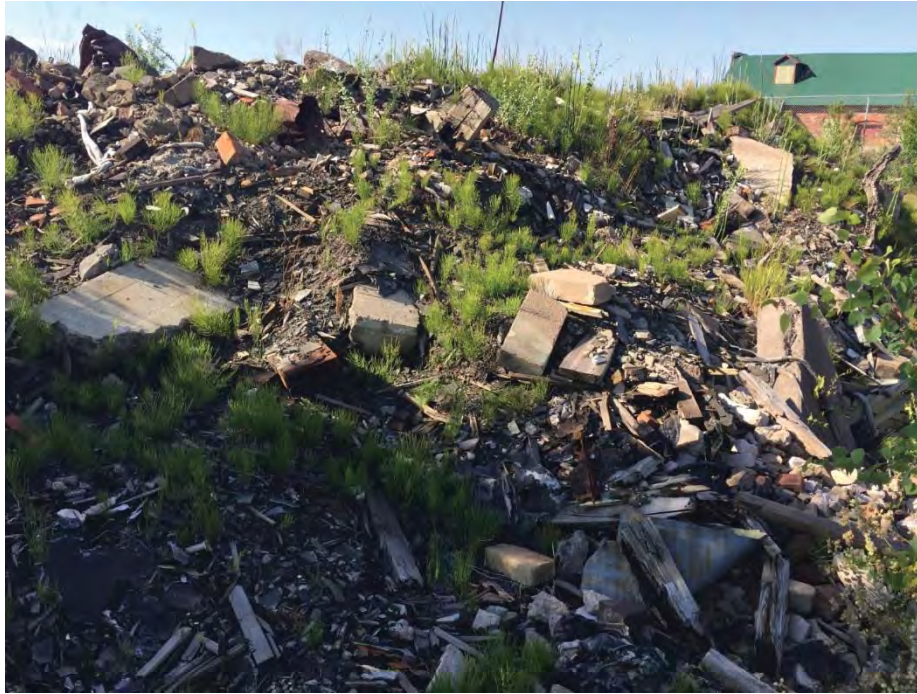
Photograph 23: WP-23 containing soil, concrete, roofing, metal, and other industrial appearing debris.
Photograph by J. Chrestensen, July 20, 2016.

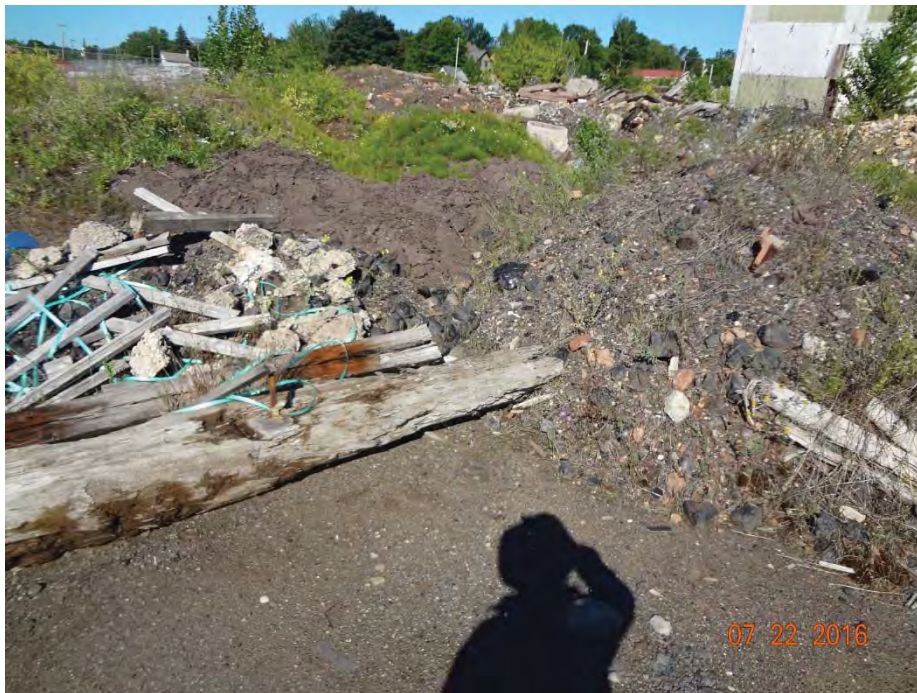
Photograph 24: WP-24 containing slag, gravel, wood, concrete, clay pipe pieces, cable, and wire. The asphalt in the background is WP-26. Photograph by MDEQ-GSU, July 22, 2016.

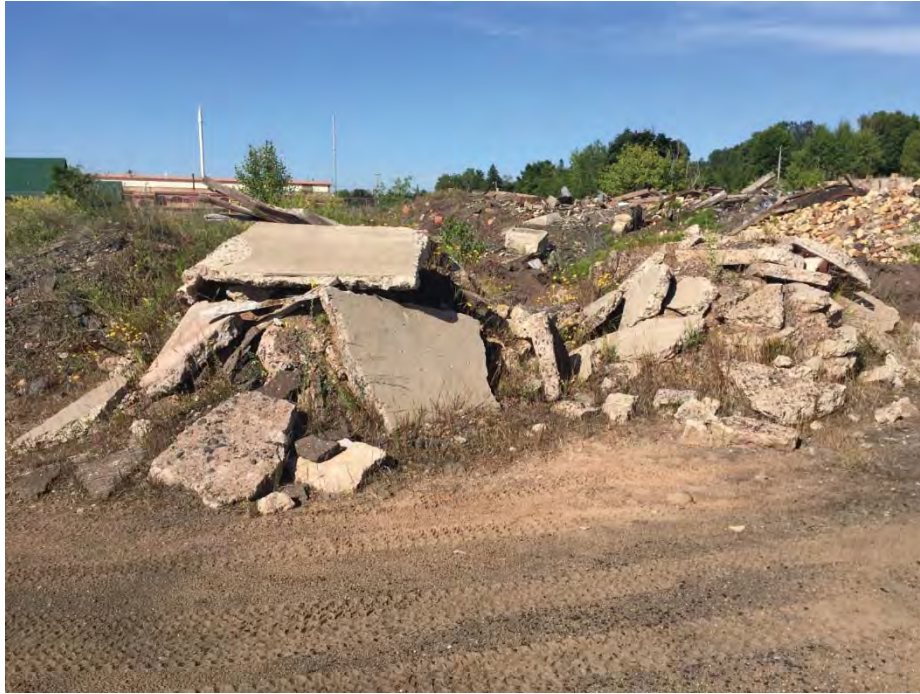
Photograph 25: WP-25 containing concrete slabs. Photograph by J. Chrestensen, July 20, 2016.

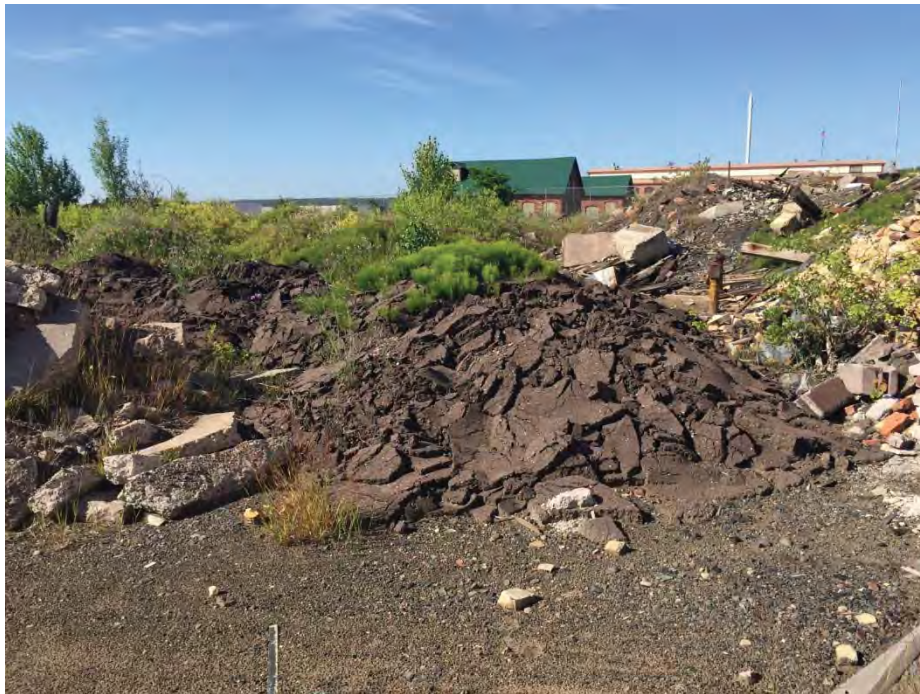
Photograph 26: WP-26 containing asphalt pieces. Photograph by J. Chrestensen, July 20, 2016.

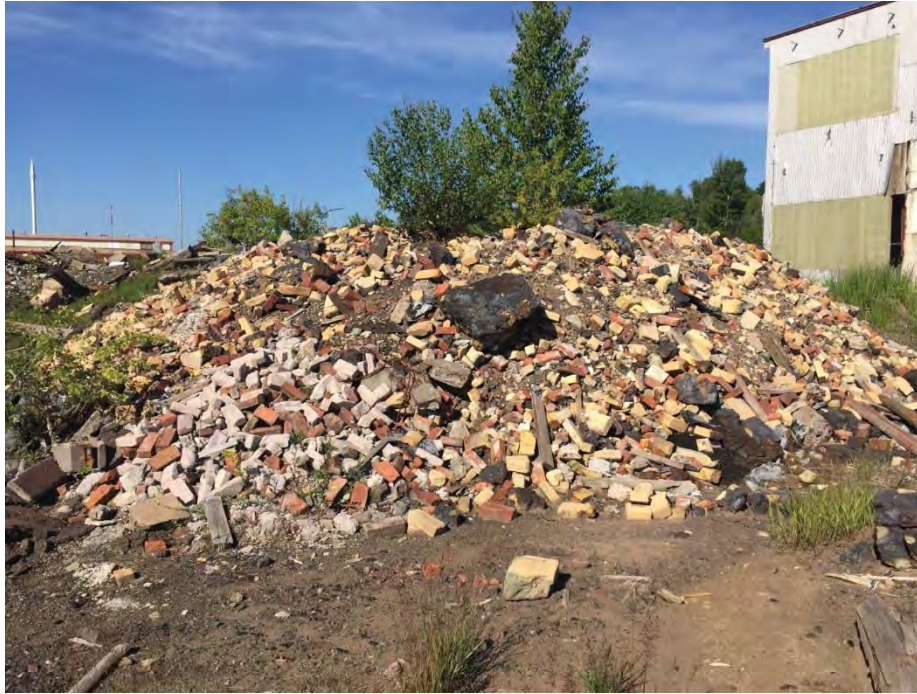
Photograph 27: WP-27 containing fire brick, slag, steel, and concrete pieces. The material appears older in nature. Photograph by J. Chrestensen, July 20, 2016.

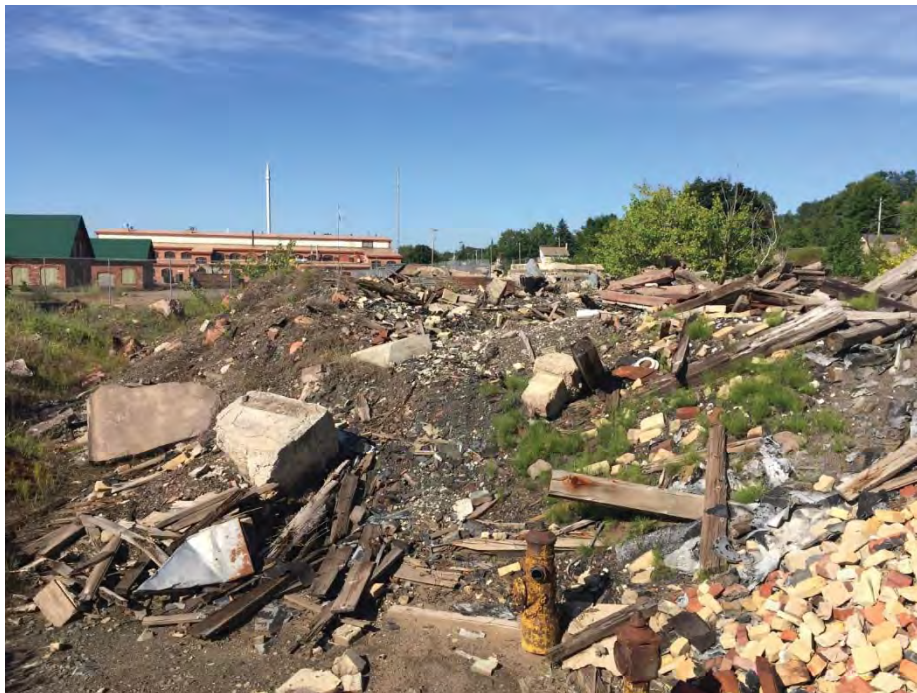
Photograph 28: WP-28 containing concrete, wood, metal, soil, fire brick, and transite pieces. The material appears older in nature. Photograph by J. Chrestensen, July 20, 2016.

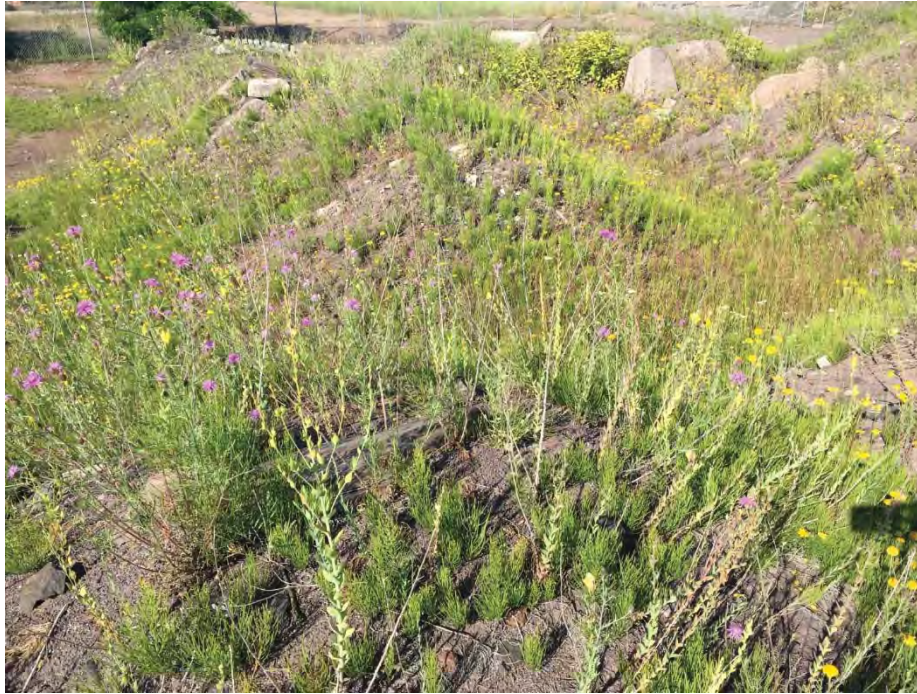
Photograph 29: WP-29 containing soil, stamp sand, concrete bases, and steel pieces. Photograph by J. Chrestensen, July 20, 2016.

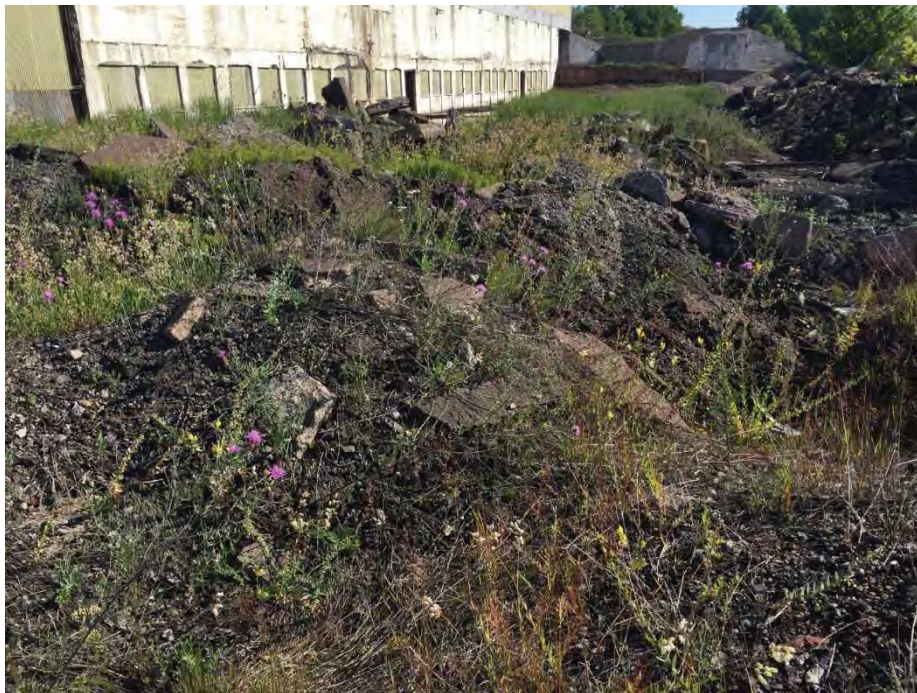
Photograph 30: WP-30 containing gravel, soil, concrete, and asphalt pieces. Photograph by J. Chrestensen, July 20, 2016.

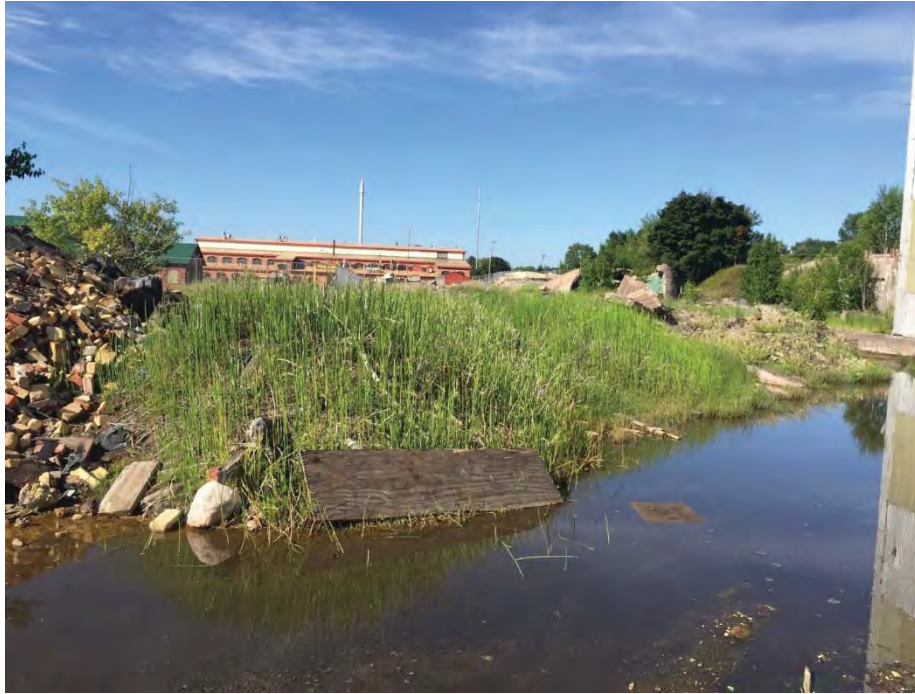
Photograph 31: WP-31 containing soil with metal and wood pieces. Photograph by J. Chrestensen, July 20, 2016.

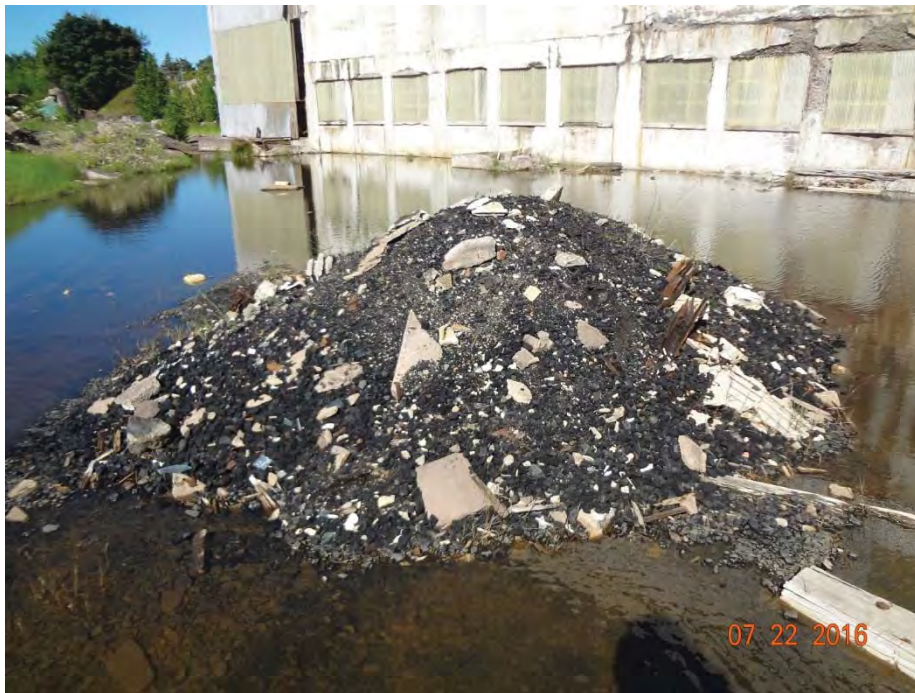
Photograph 32: WP-32 containing primarily coal, slag, and concrete refractory. Photograph by MDEQ-GSU, July 22, 2016.

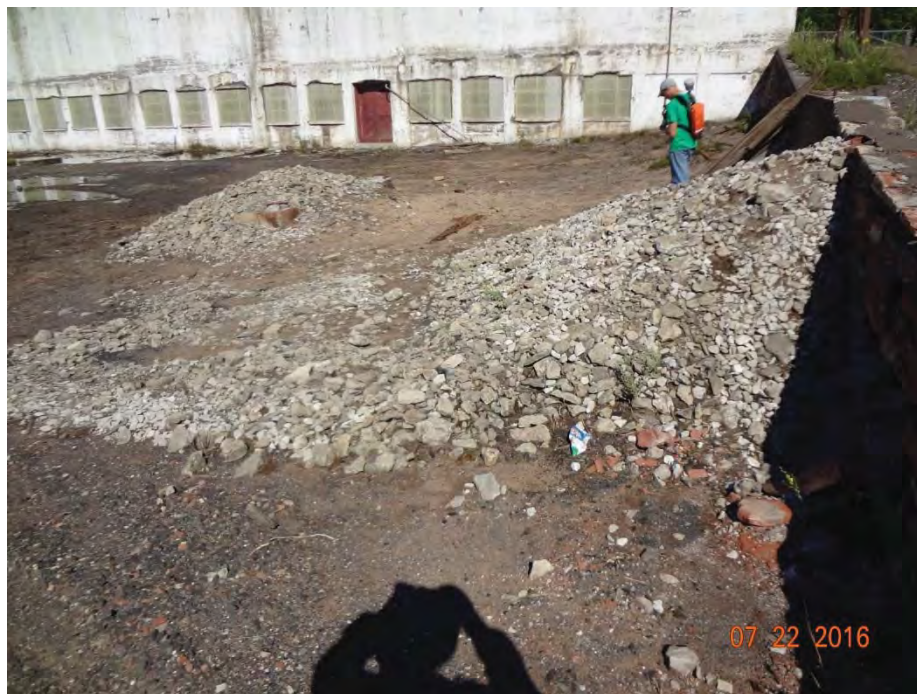
Photograph 33: WP-33 containing limestone. Photograph by MDEQ-GSU, July 22, 2016.

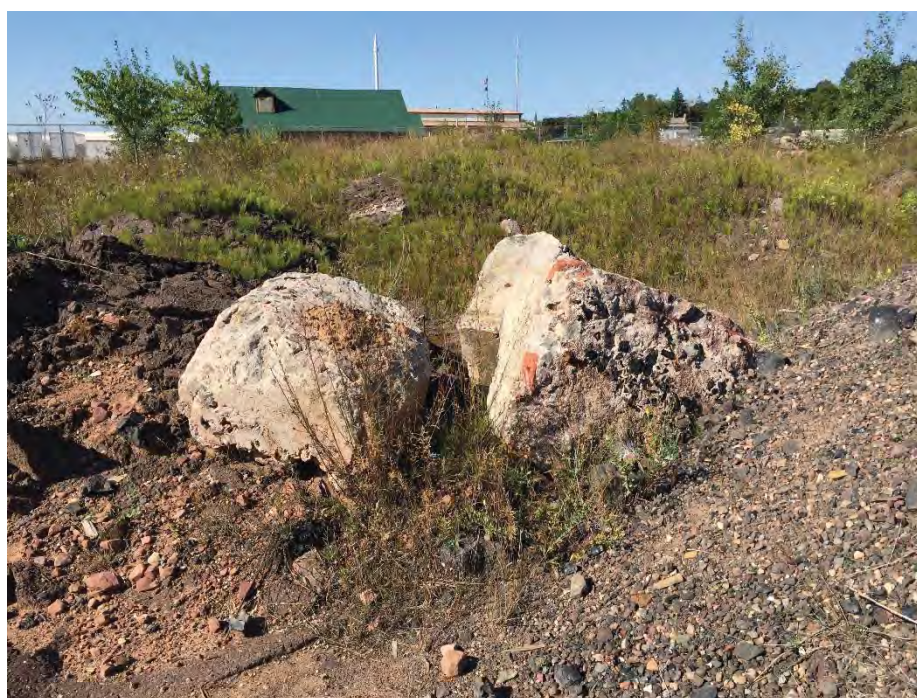
Photograph 34: WP-46 containing concrete pieces. Photograph by J. Chrestensen, August 25, 2016.
