**PHASE II ENVIRONMENTAL SITE ASSESSMENT  
FOR  
CRST PROPERTIES  
EAGLE BUTTE, DEWEY COUNTY, SOUTH DAKOTA**

Date Prepared	July 2018
TDD No.	0003/1711-09
Document Control No.	W0551.1A.01653
Contract No.	EP-S8-13-01
U.S. EPA Work Assignment Manager	Melisa Devincenzi

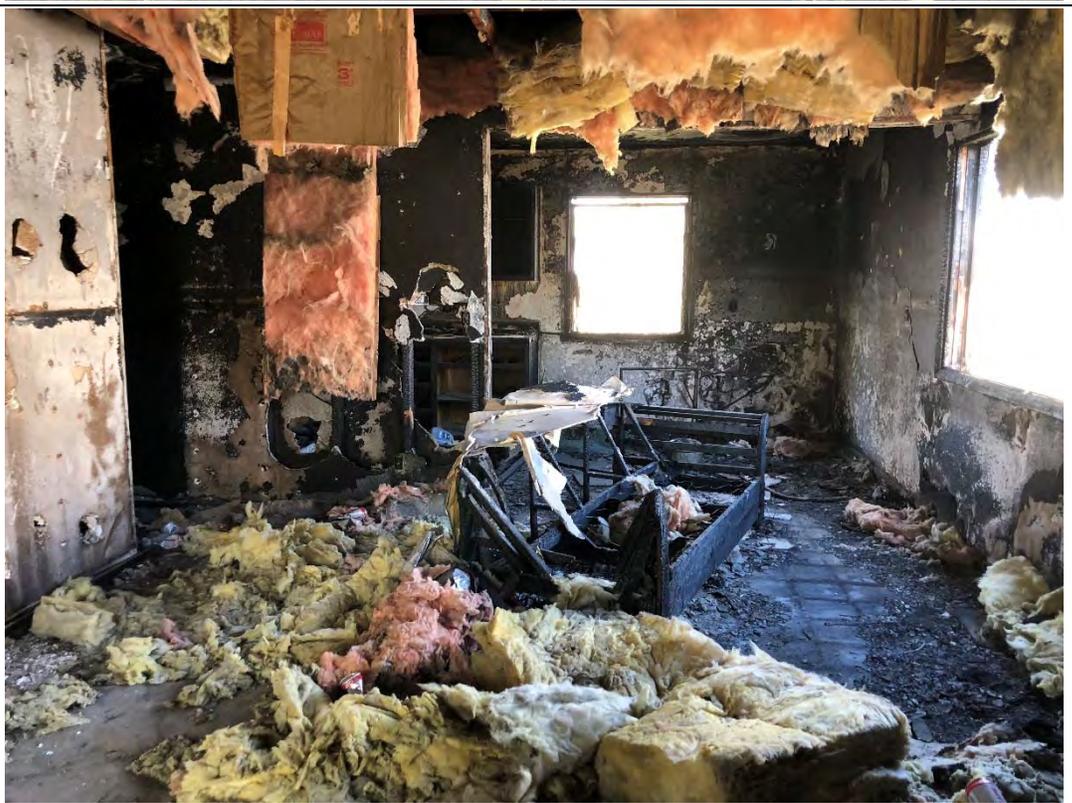
<b>Photo No.</b> <b>2</b>	<b>Date:</b> 05/08/2018
<b>Photo Coordinates</b>	
<b>Lat</b>	45.006267
<b>Long</b>	-101.229644
<b>Direction Photo Taken:</b> 208.964601769911	
<b>Description:</b> Interior of Property #1 with ACM drywall compound and floor tiles and fire damage.

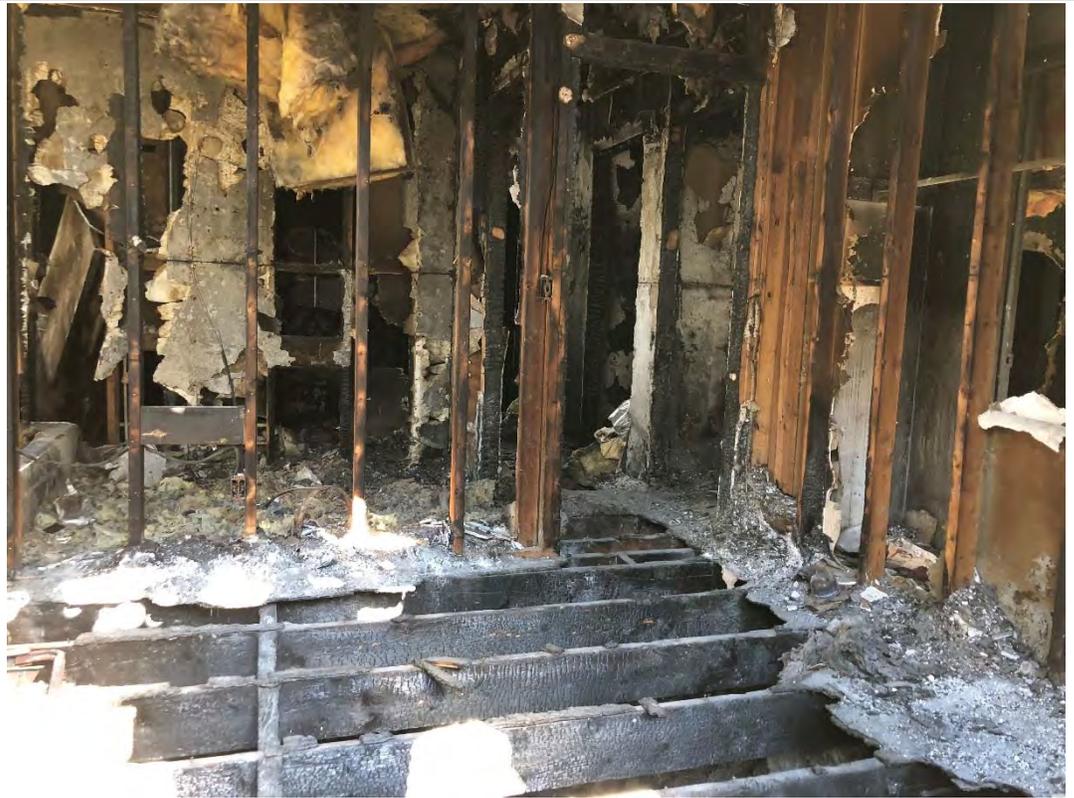
<b>Photo No.</b> <b>3</b>	<b>Date:</b> 05/08/2018
<b>Photo Coordinates</b>	
<b>Lat</b>	45.006128
<b>Long</b>	-101.229592
<b>Direction Photo Taken:</b> 342.334470989761	
<b>Description:</b>  Interior of Property #1 with ACM drywall compound and floor tiles and fire damage.

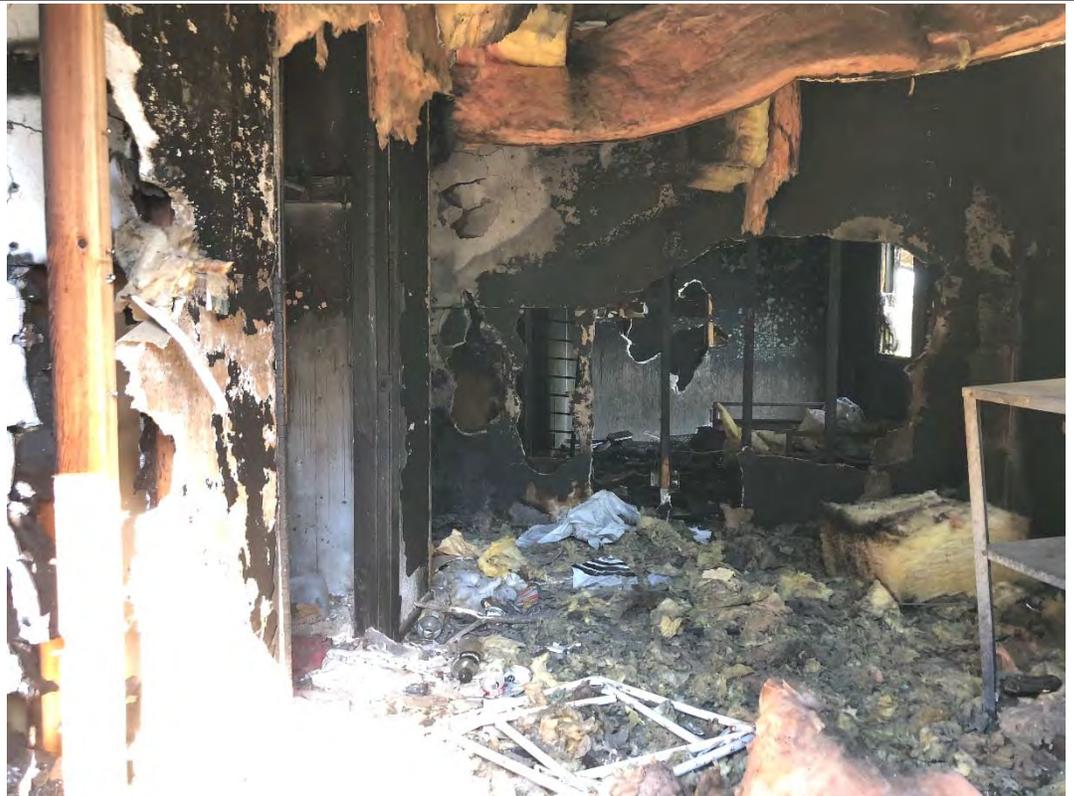
<b>Photo No.</b> <b>4</b>	<b>Date:</b> 05/08/2018
<b>Photo Coordinates</b>	
<b>Lat</b>	45.00615
<b>Long</b>	-101.229569
<b>Direction Photo Taken:</b> 314.83367983368	
<b>Description:</b>  Interior of Property #1 with ACM drywall compound and floor tiles and fire damage.

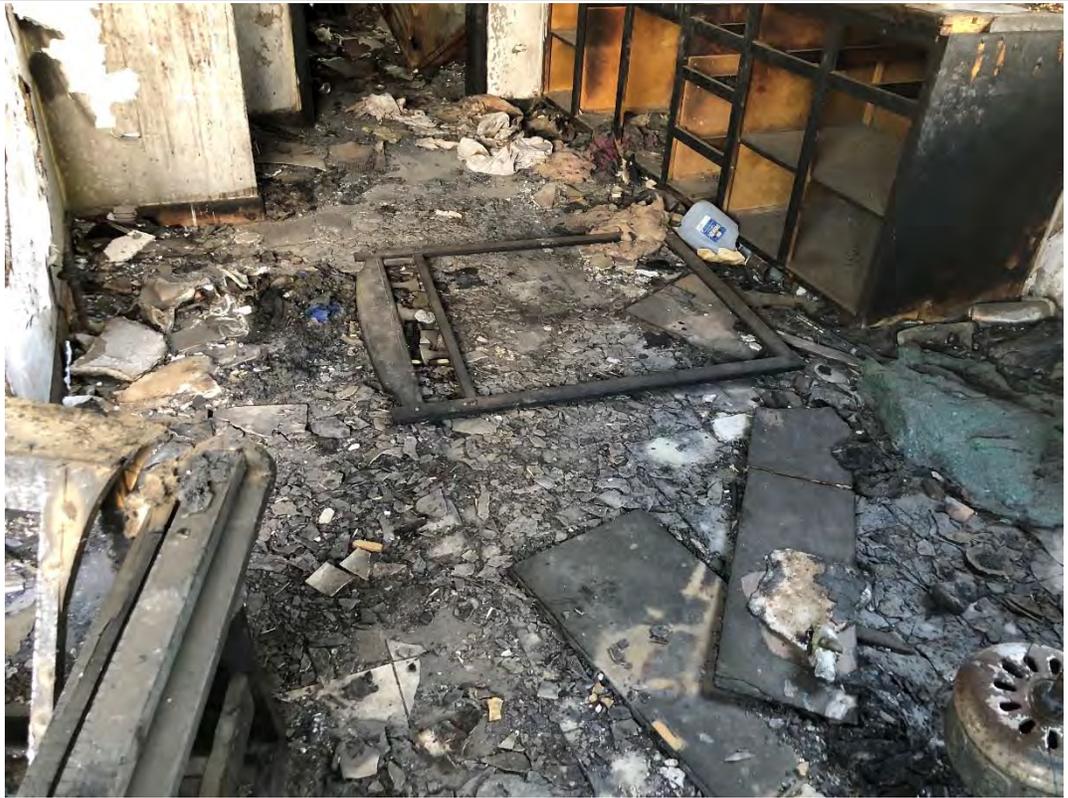
Interior of Property #1 with ACM drywall compound and floor tiles and fire damage.

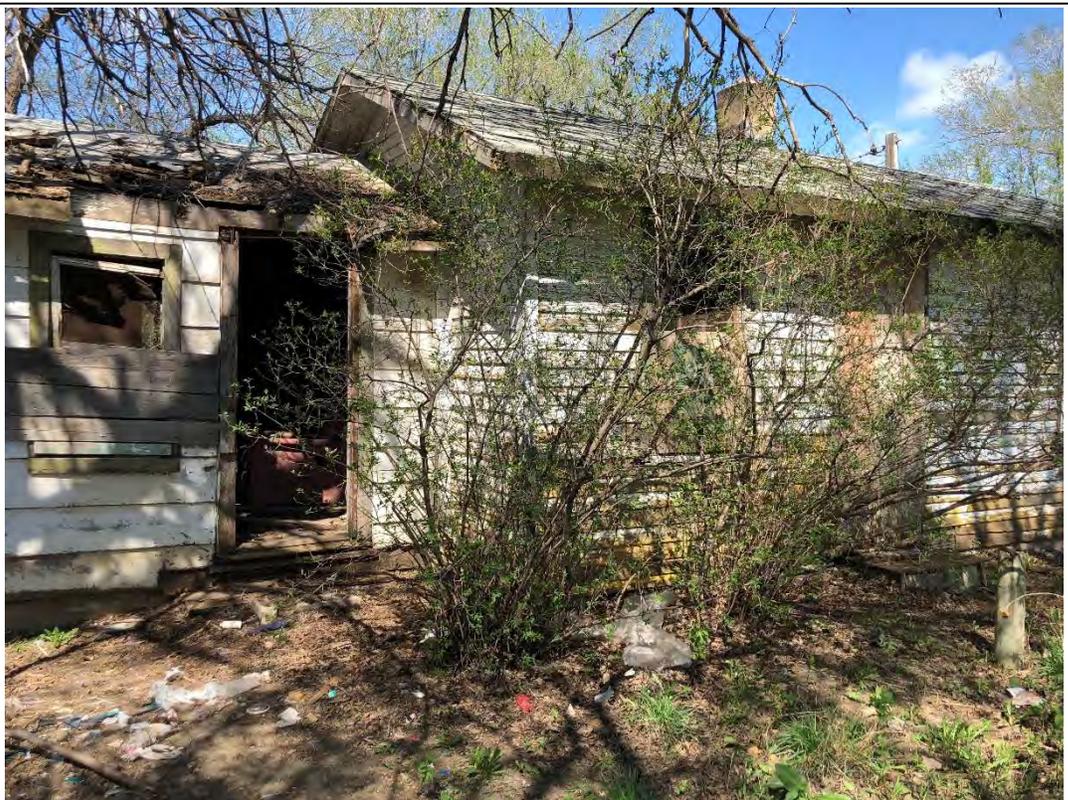
Exterior of Property #9 with LBP.

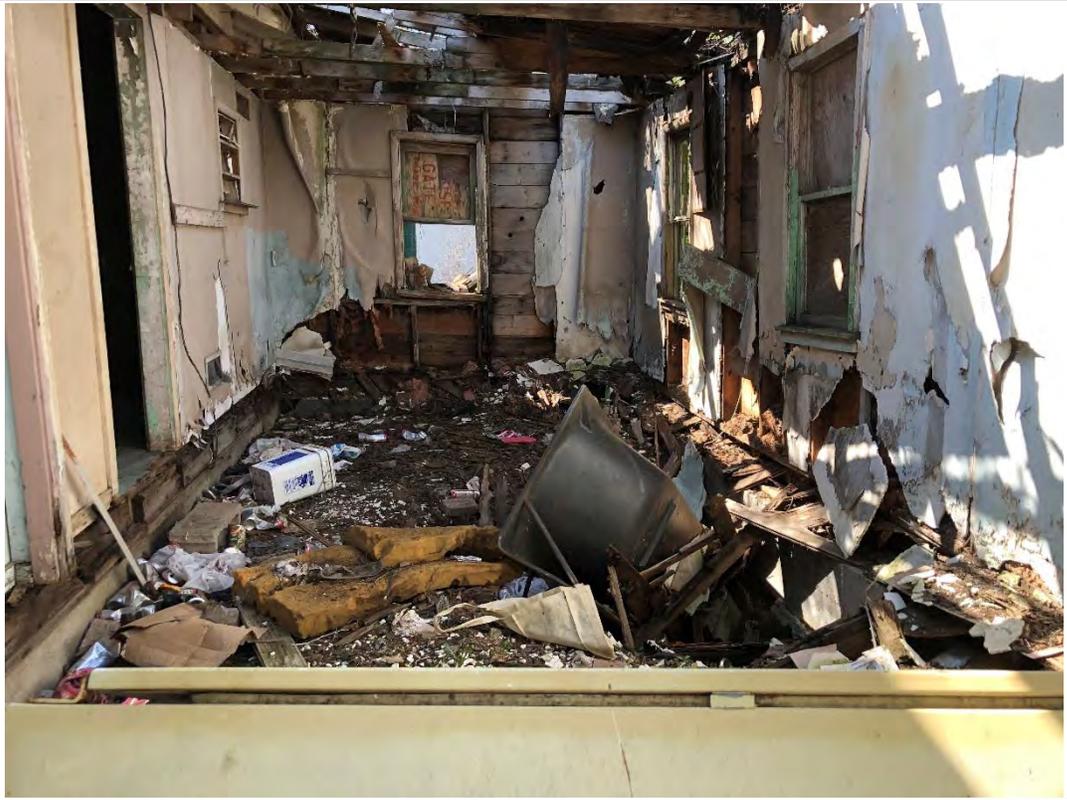
<b>Photo No.</b> <b>7</b>	<b>Date:</b> 05/08/2018
<b>Photo Coordinates</b>	
<b>Lat</b>	45.00275
<b>Long</b>	-101.227272
<b>Direction Photo Taken:</b> 184.532507739938	
<b>Description:</b>  Interior of Property #9 with ACM drywall compound.

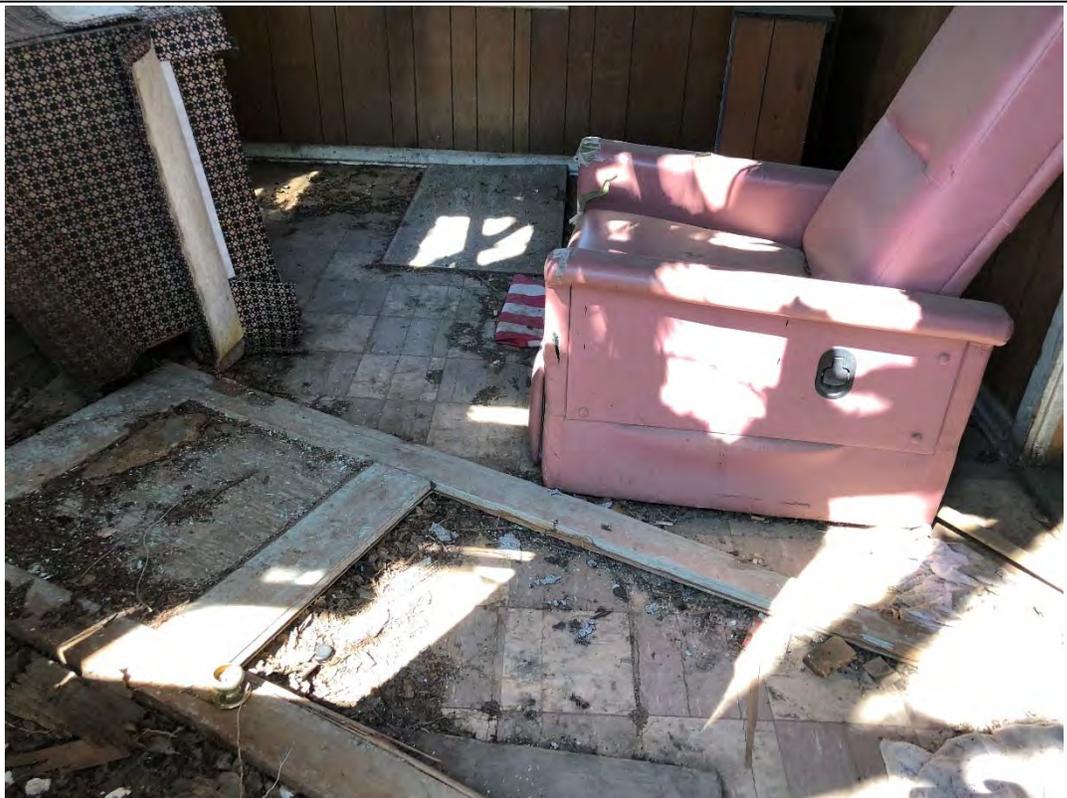
<b>Photo No.</b> <b>8</b>	<b>Date:</b> 05/08/2018
<b>Photo Coordinates</b>	
<b>Lat</b>	45.002658
<b>Long</b>	-101.227233
<b>Direction Photo Taken:</b> 261.533742331288	
<b>Description:</b>  Interior of Property #9 with ACM floor tiles.

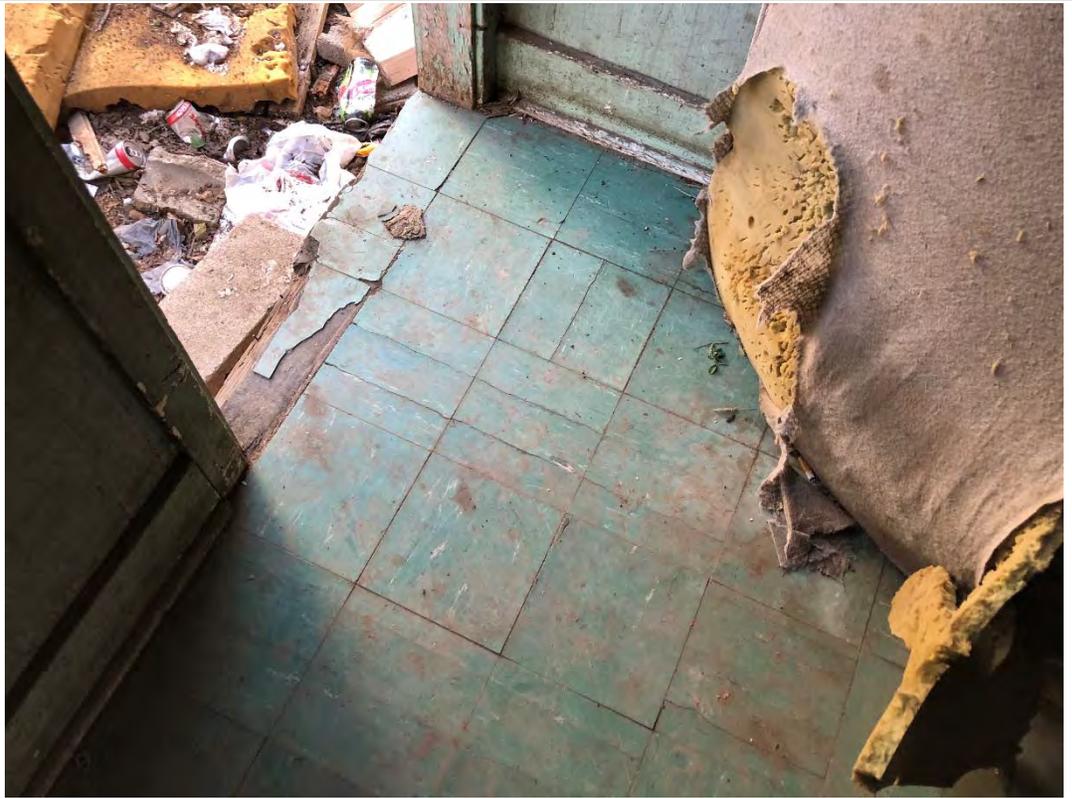
<b>Photo No.</b> <b>9</b>	<b>Date:</b> 05/08/2018
<b>Photo Coordinates</b>	
<b>Lat</b>	45.002675
<b>Long</b>	-101.227242
<b>Direction Photo Taken:</b> 244.564393939394	
<b>Description:</b>  Interior of Property #9 with ACM floor tiles.

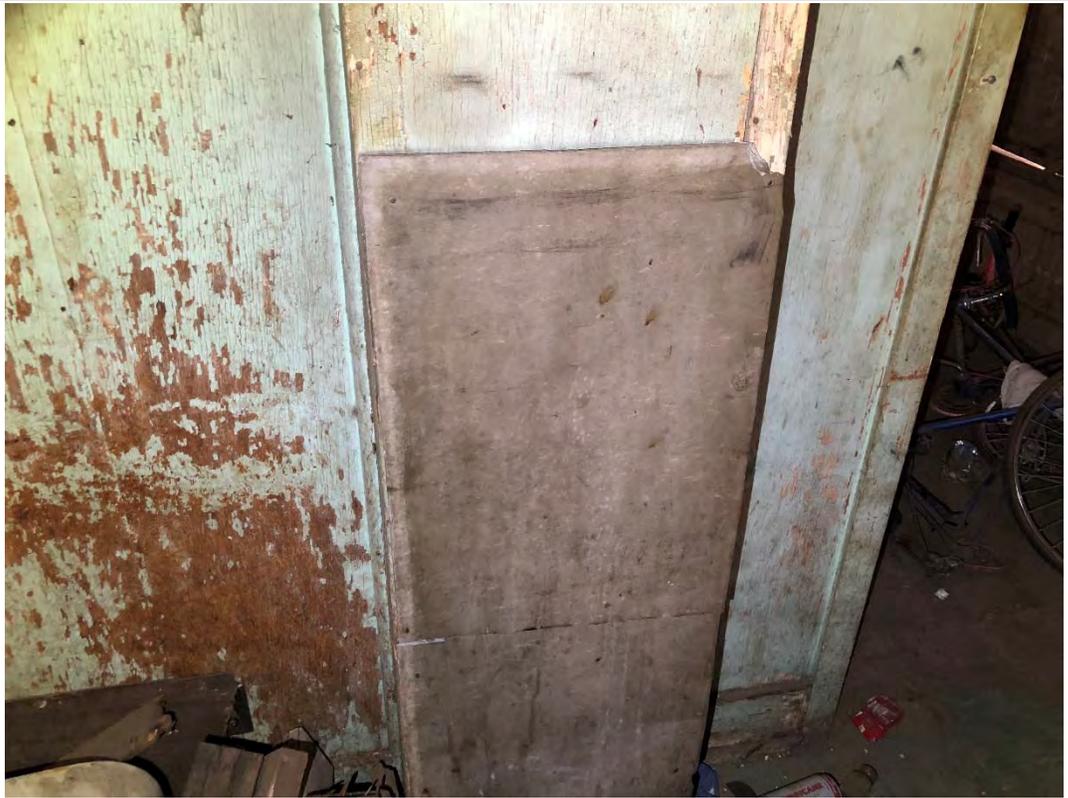
**Description:**  
Interior of Property #9 with ACM transite chimney backing.

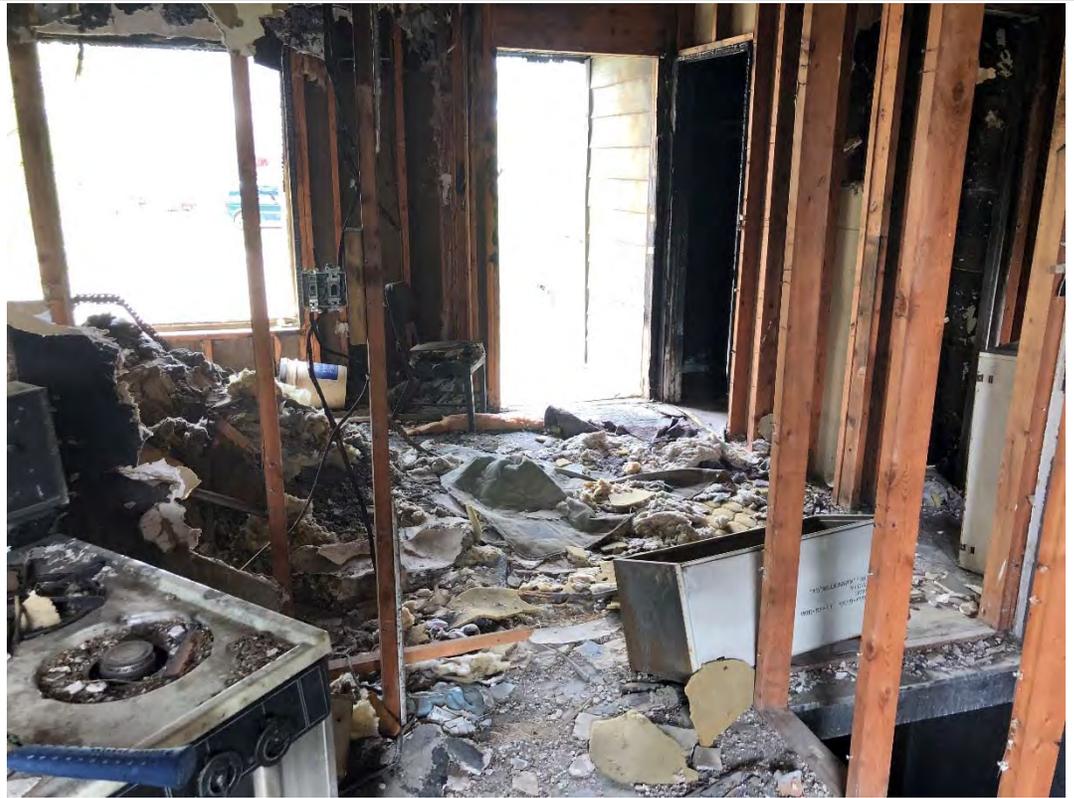
<b>Photo No.</b> <b>13</b>	<b>Date:</b> 05/08/2018
<b>Photo Coordinates</b>	
<b>Lat</b>	45.002186
<b>Long</b>	-101.228578
<b>Direction Photo Taken:</b> 179.311023622047	
<b>Description:</b>  Interior of Property #3 with ACM drywall compound and fire damage.

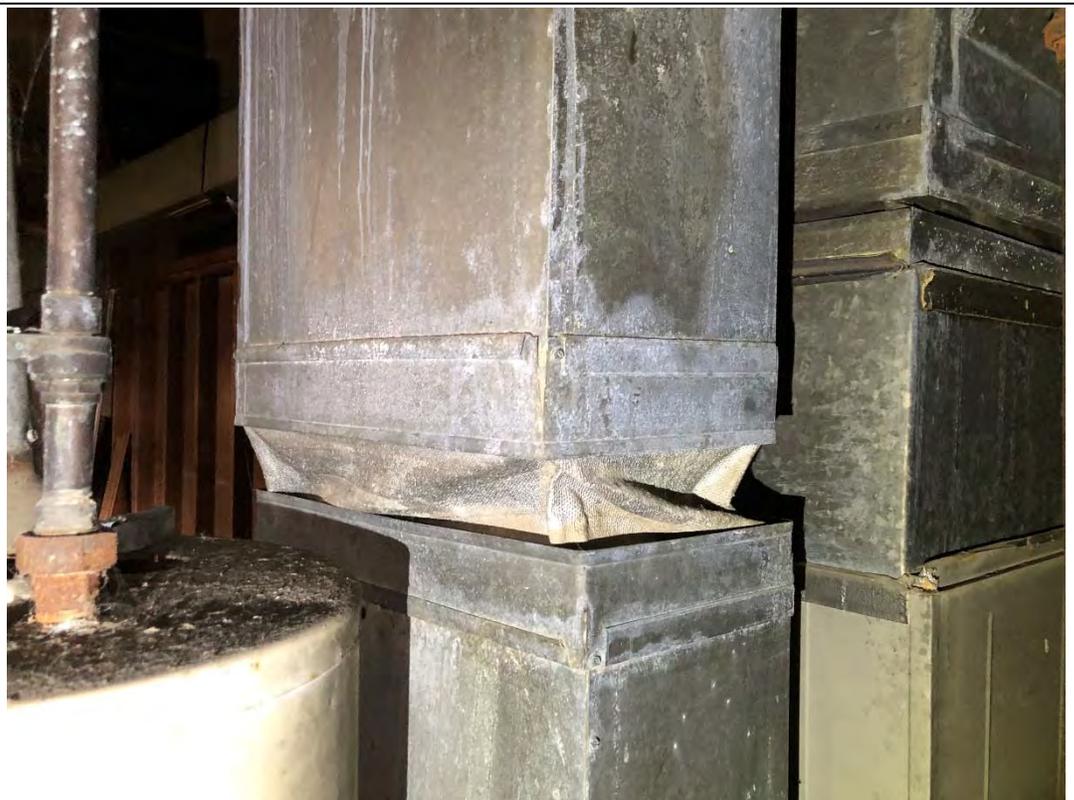
<b>Photo No.</b> <b>14</b>	<b>Date:</b> 05/08/2018
<b>Photo Coordinates</b>	
<b>Lat</b>	45.002128
<b>Long</b>	-101.228622
<b>Direction Photo Taken:</b> 359.764705882353	
<b>Description:</b>  Basement of Property #3 with ACM vibration dampener.

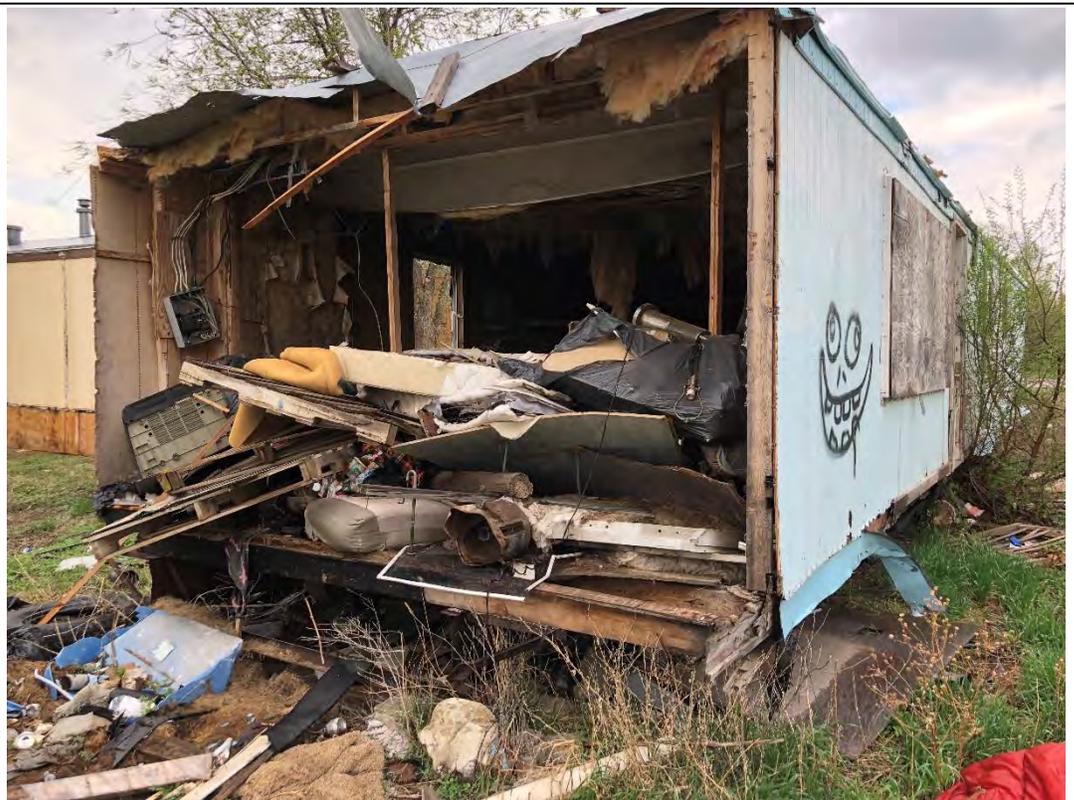
**Description:**  
Property #4 damage.

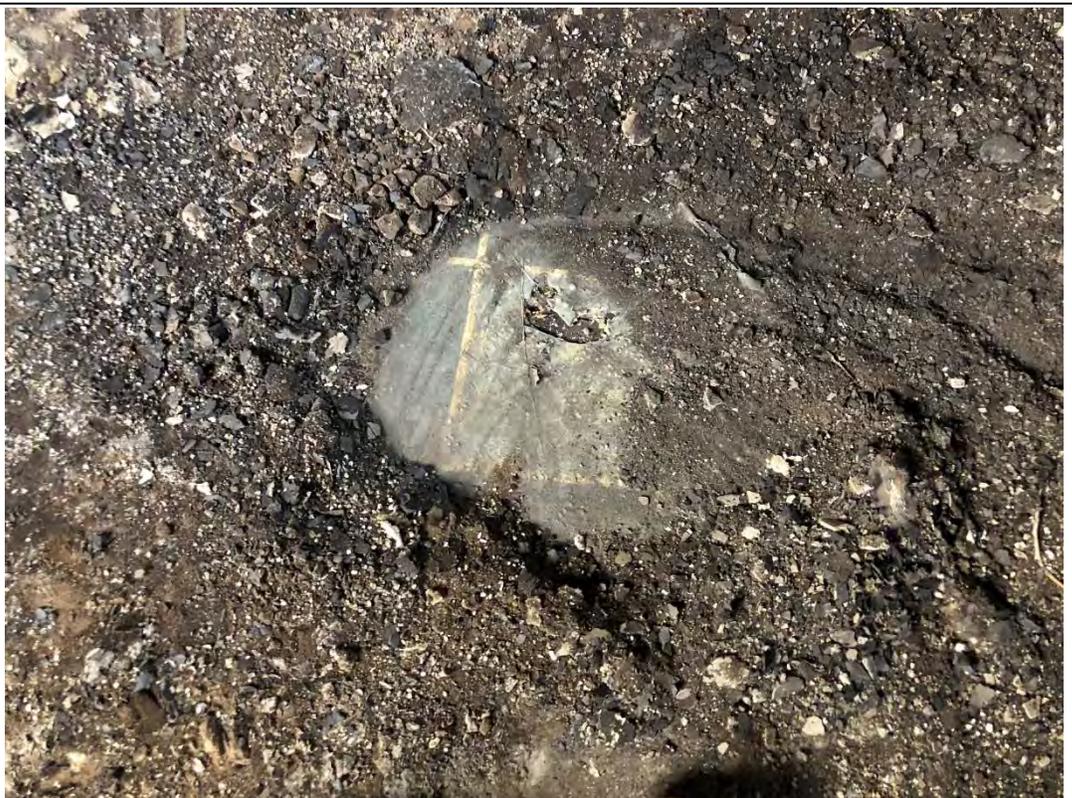
**Description:**  
Interior of Property #5 with ACM linoleum.

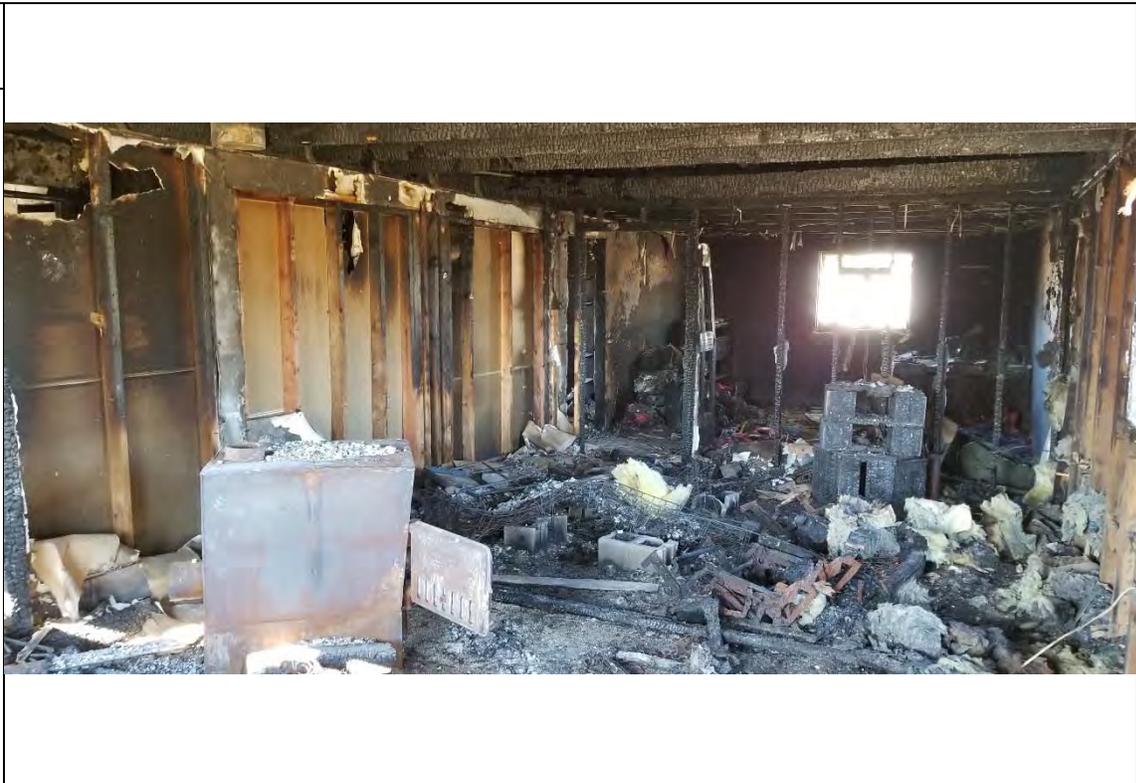
Interior of Property #5 with ACM drywall compound and fire damage.

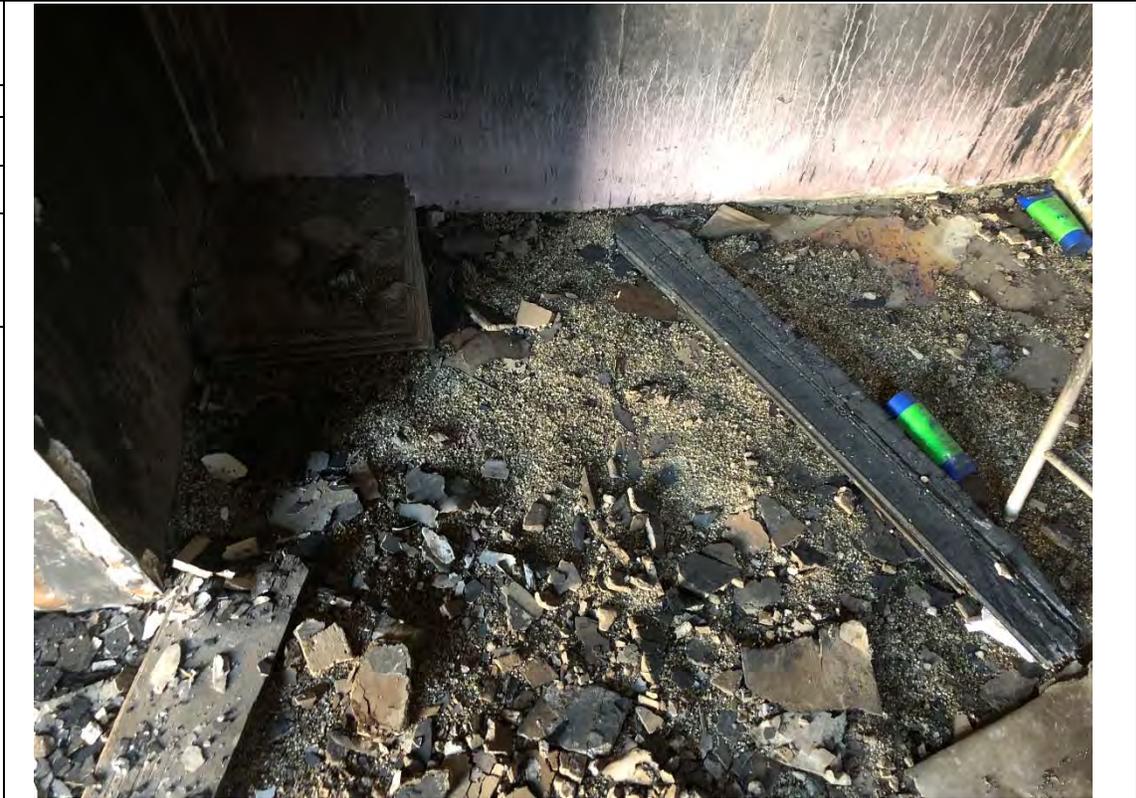
Interior of Property #5 with ACM vermiculite debris and fire damage.

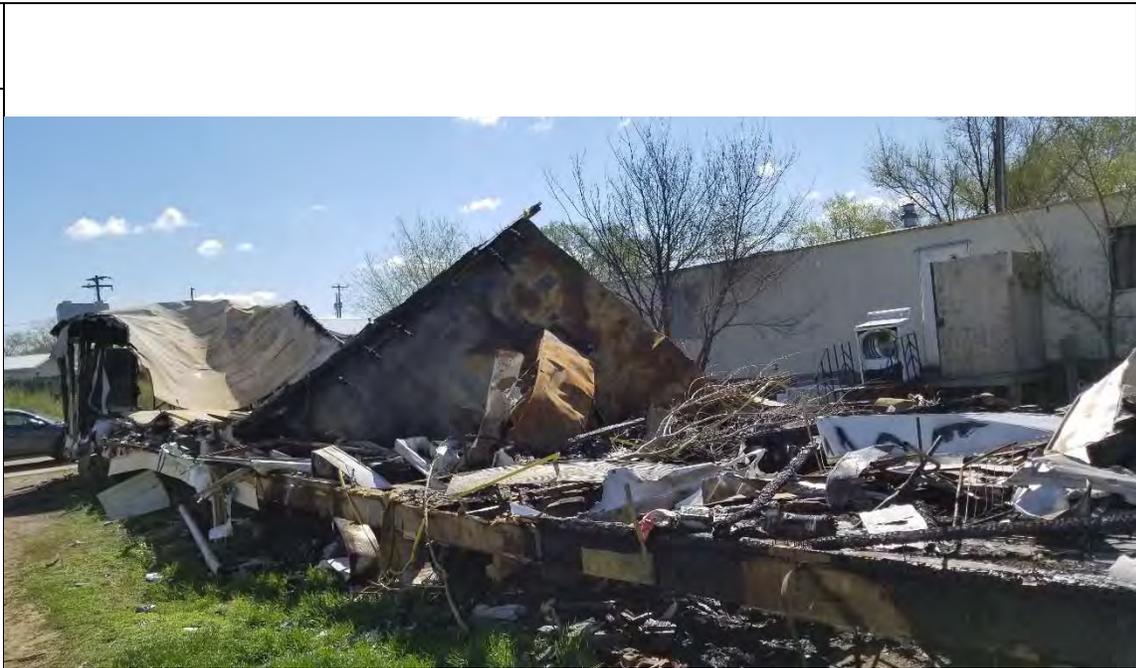
**Description:**  
Property #6 damages.

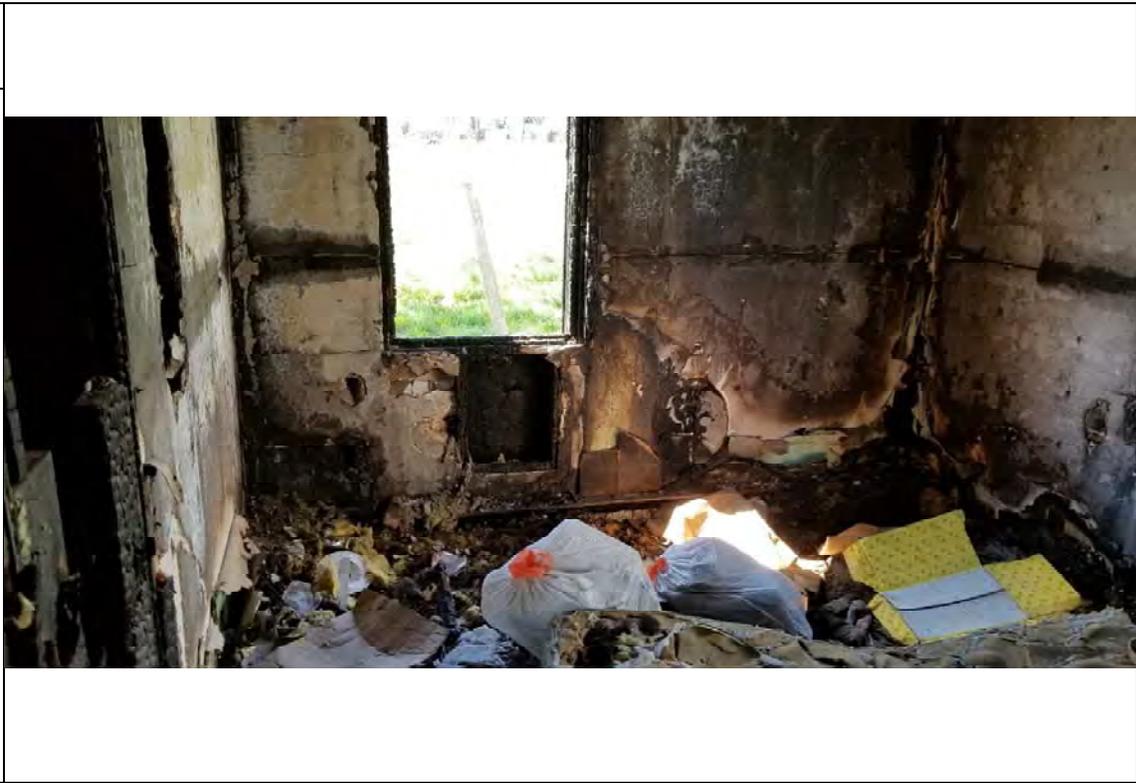
Interior of Property #2 with ACM drywall compound and fire damage.

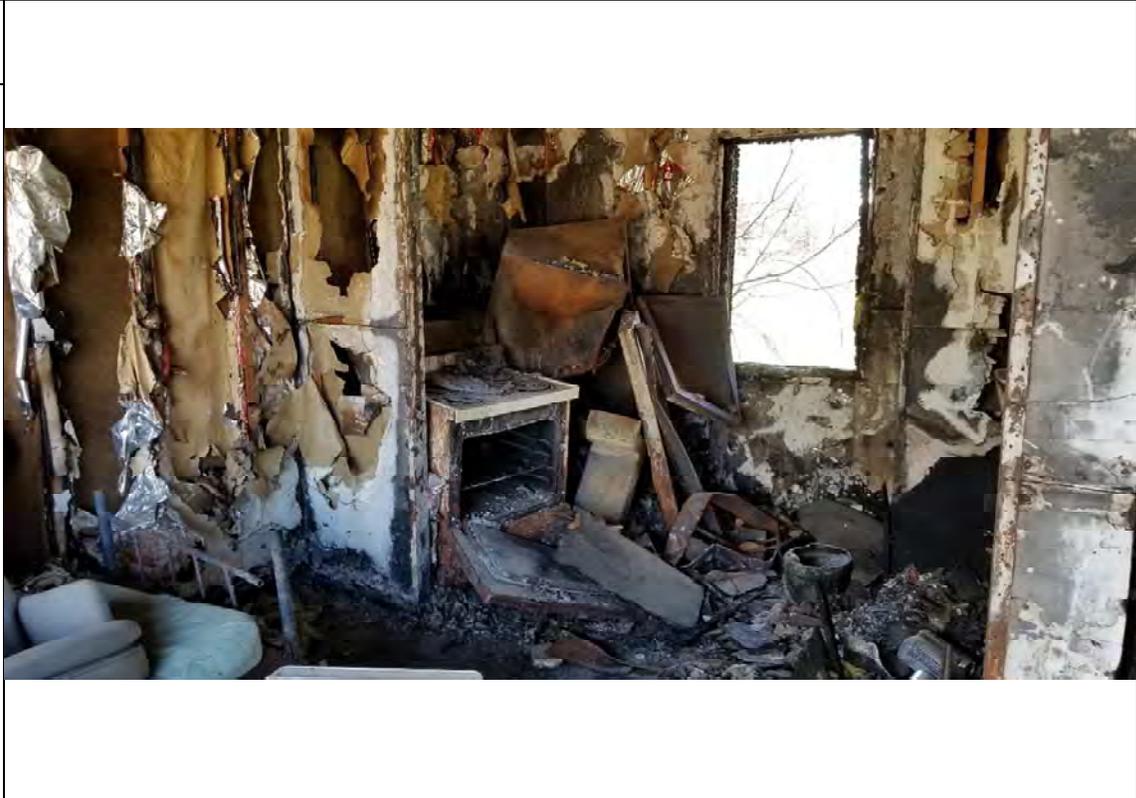
Interior of Property #2 with ACM drywall compound and fire damage.

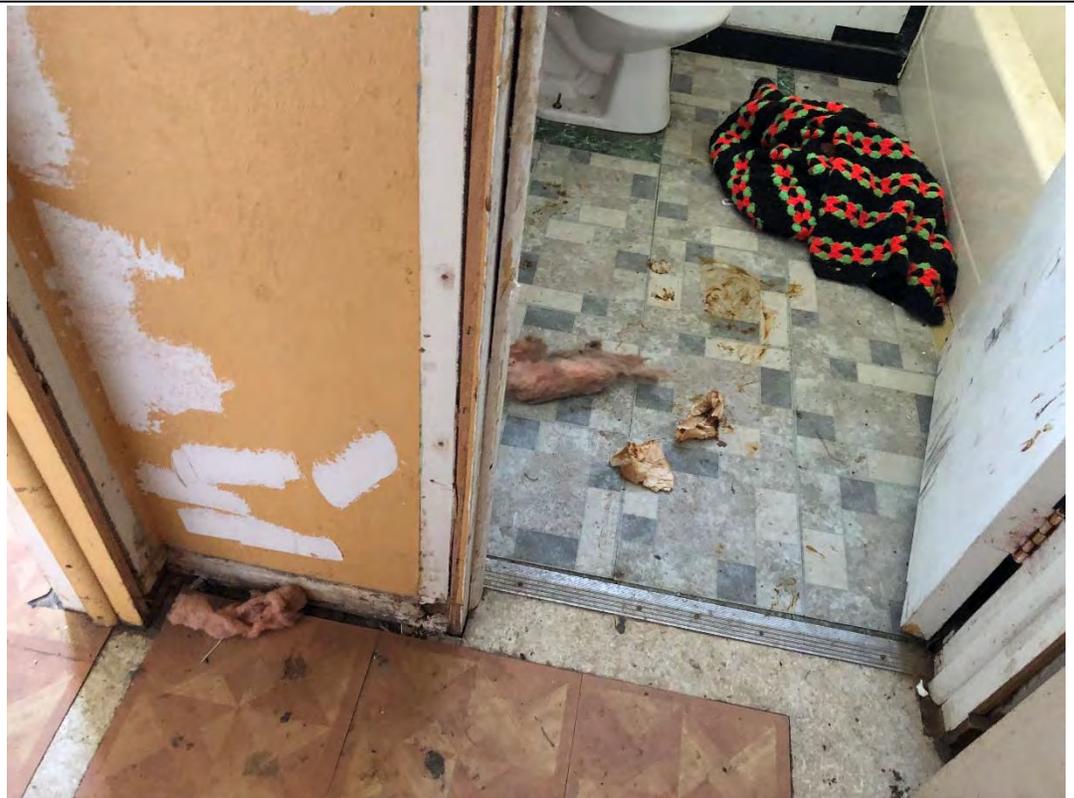
<b>Photo No.</b> <b>32</b>	<b>Date:</b> 05/09/2018
<b>Photo Coordinates</b>	
<b>Lat</b>	45.005031
<b>Long</b>	-101.233628
<b>Direction Photo Taken:</b> 225.974874371859	
<b>Description:</b>  Interior of Property #10 with ACM linoleum and drywall compound.

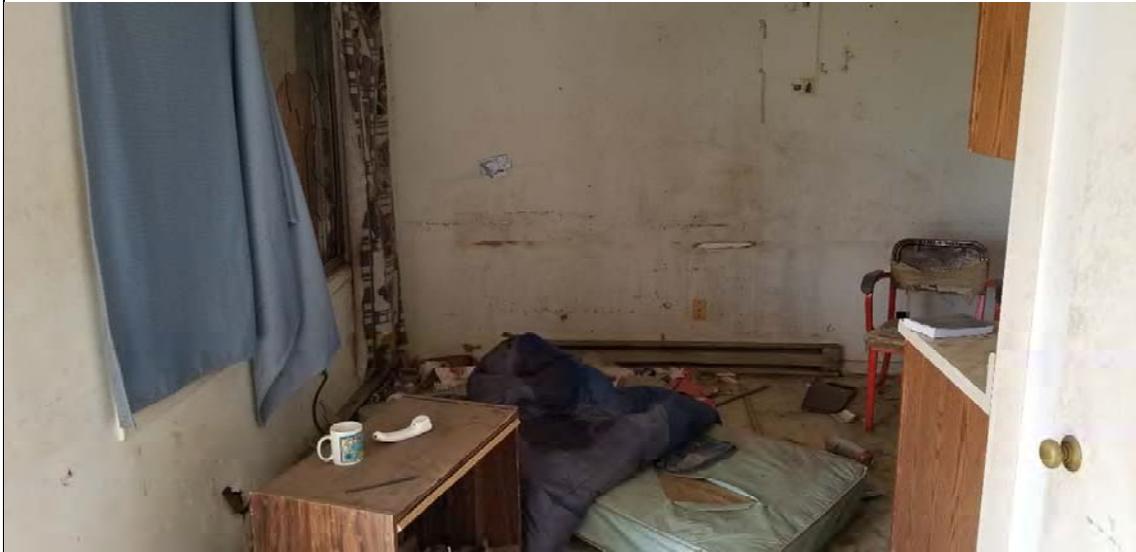
**Description:**  
Interior of Property #8 with ACM drywall compound.

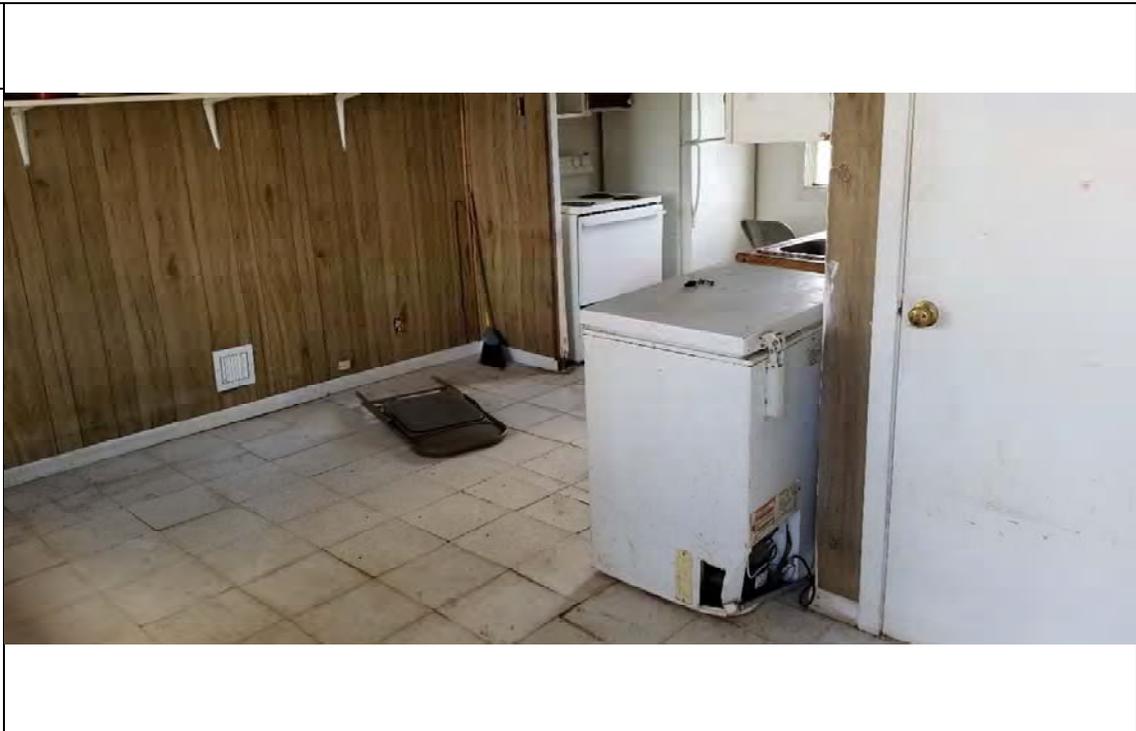
Interior of Property #7 with ACM drywall compound.

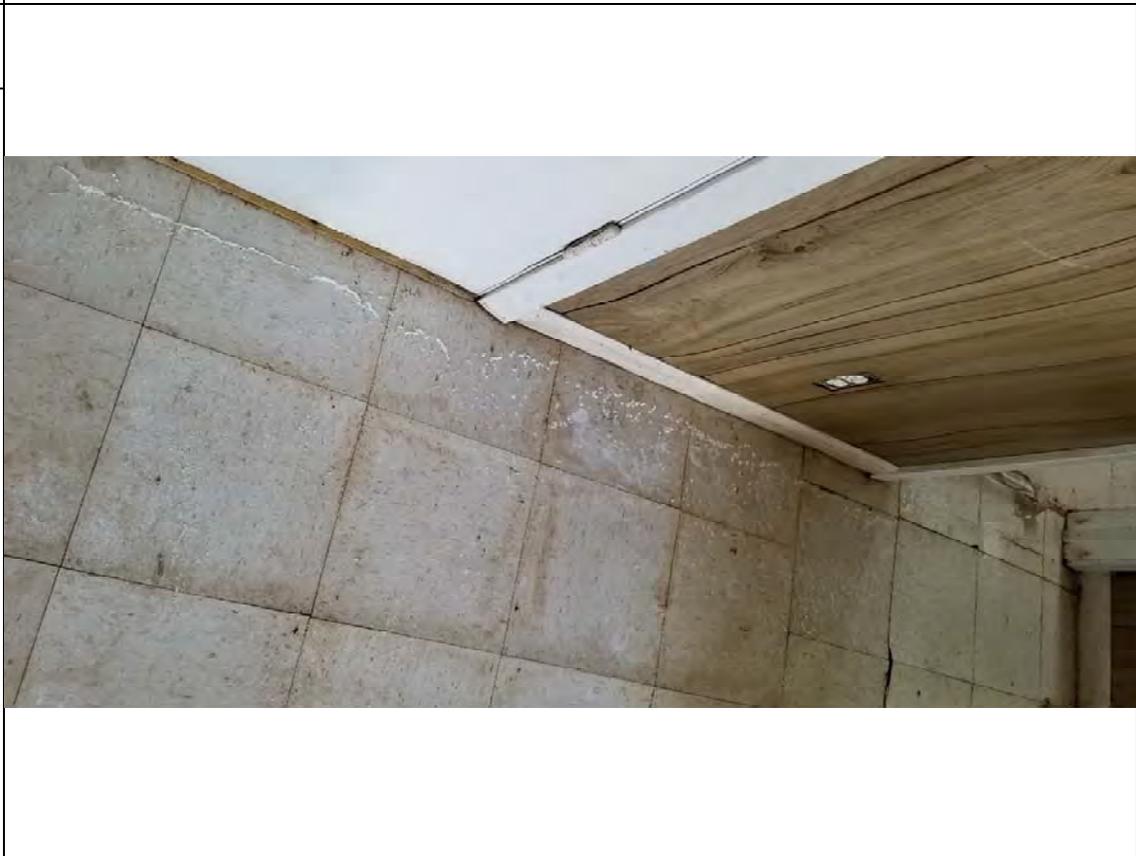
Interior of Property #7 with white mold observed throughout.
