# MicroFab, Inc. Amesbury, MA

## Hazardous Material Survey Report

**Amec Foster Wheeler Environment & Infrastructure, Inc.**  
271 Mill Road  
Chelmsford, MA 01824

December 2016

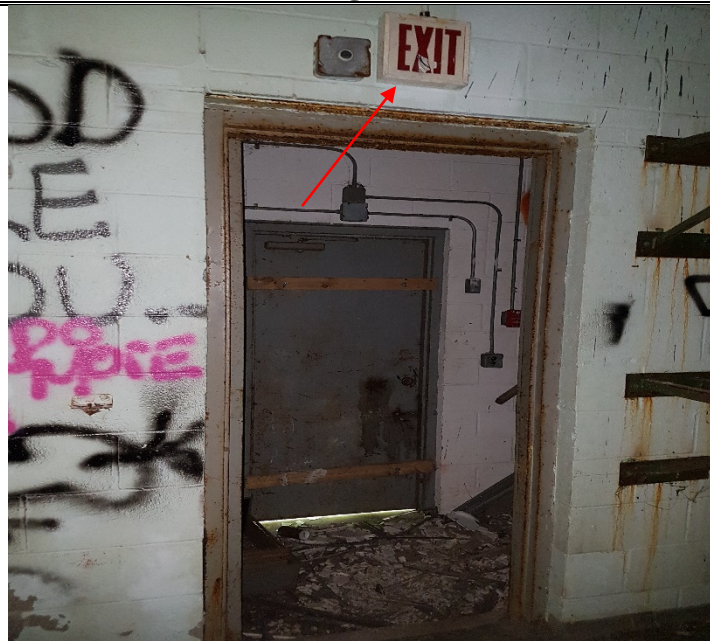
Emergency Lighting and exit sign

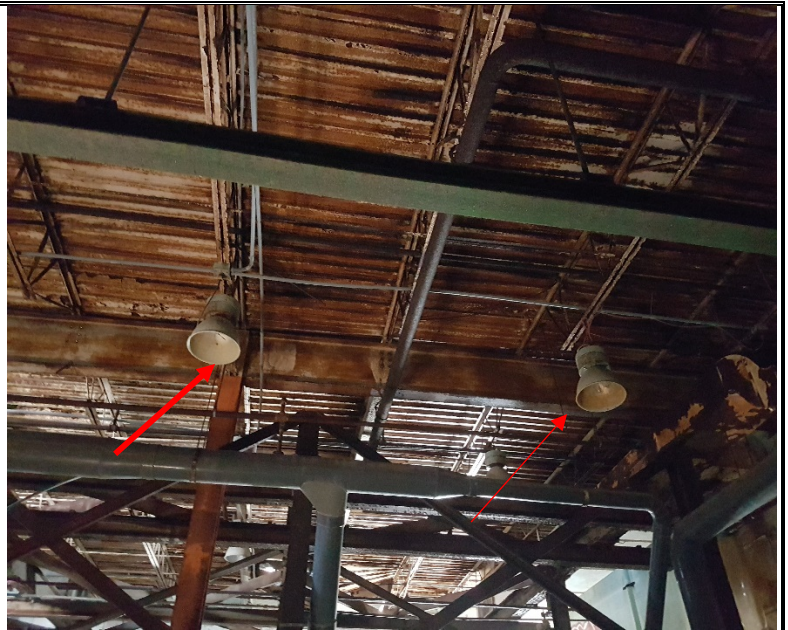
High-Intensity Discharge (HID) lamp

Total Number: 42

50% of bulbs are broken

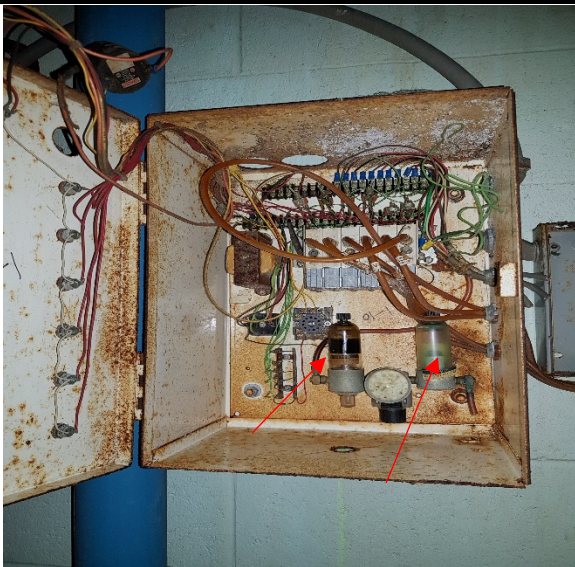
Hydraulic Oil on alarm box system

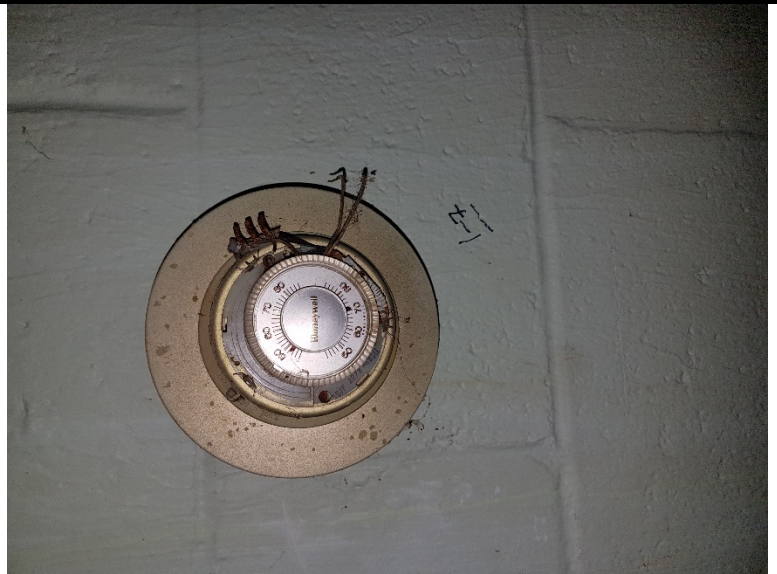
Wall mounted Mercury Thermostat

Total Number: 1

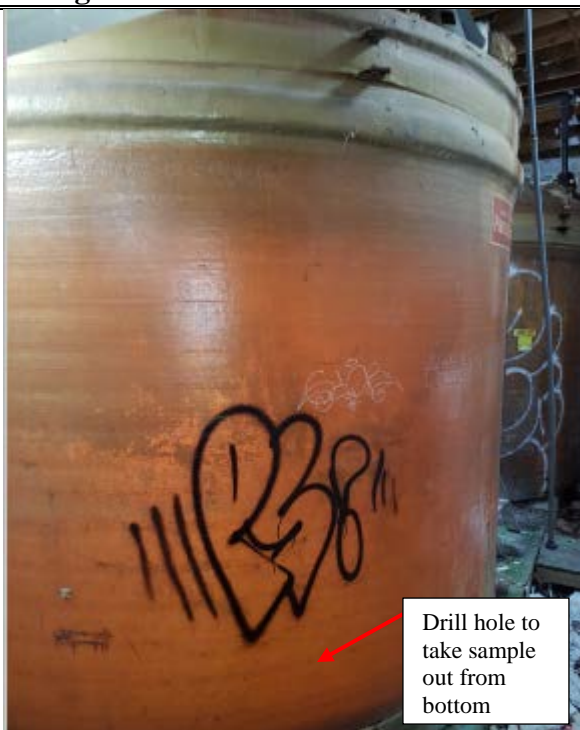
Bulk storage tank-1

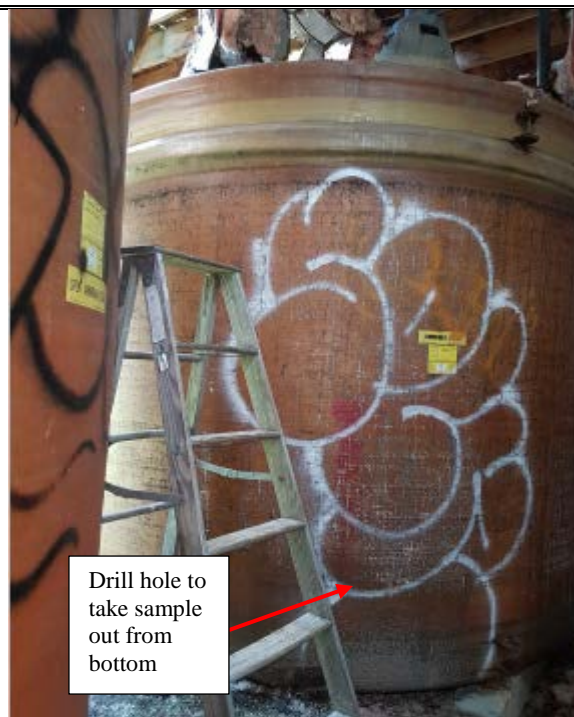
Bulk storage tank-2

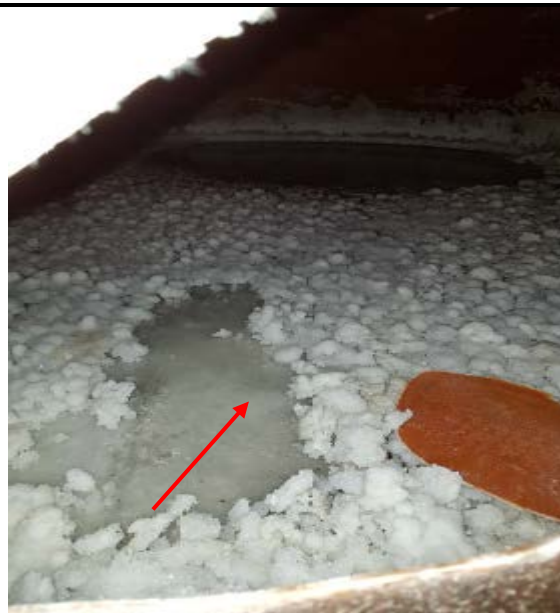
Solid ammonium hydroxide about 1 inch at bottom of tank-1  
Color: White  
Sample ID: 2-2

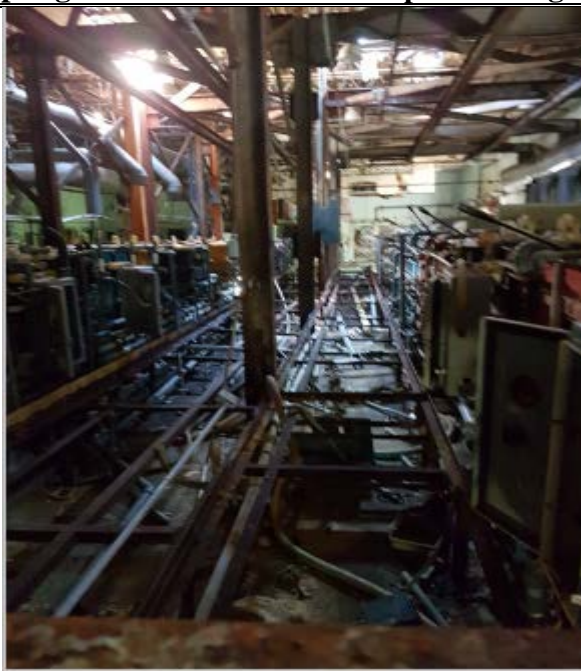
During survey and investigation of MicroFab building, Amec Foster Wheeler found two lines of plating baths. Each line contains 15 rectangular baths of volume about 36 cubic feet. Most of the tanks are filled with rain water (pH of about 8 s.u.) and a few tanks are filled with sludge. There are about ten storage or process tank. There are two bulk storage tanks containing about 1,350 pounds of ammonium hydroxide crystals in bulk storage area (Area #2). Lab results determined that the ammonium hydroxide crystals do not contain TCLP, and are not a regulated material. Amec Foster Wheeler will discuss with MassDEP whether it is safe to landfill this material. Details of other tanks

Two lines of plating bath.  
Each line contain 15 rectangular bath tank.

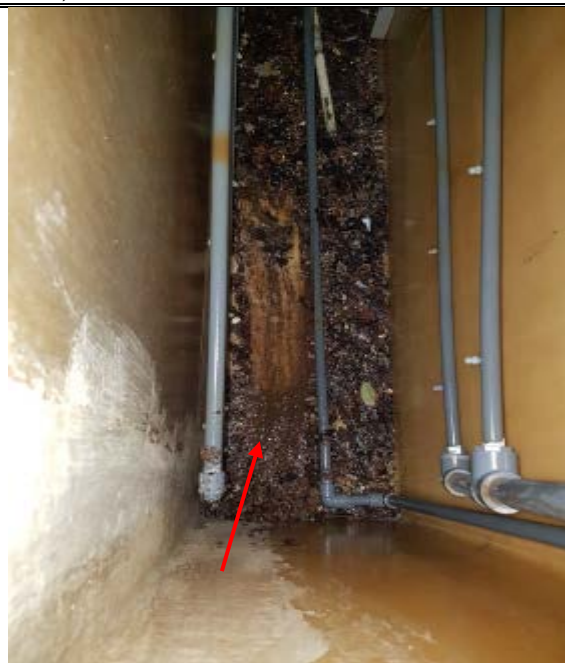
Solid remains inside rectangular bath tank of line 1  
Sample ID: 1-1, 1-2

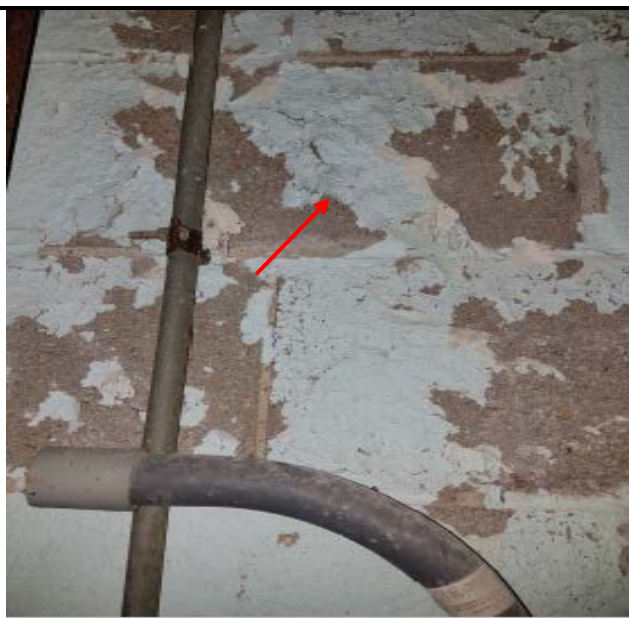
Wall blue paint  
Sample ID: 1-3

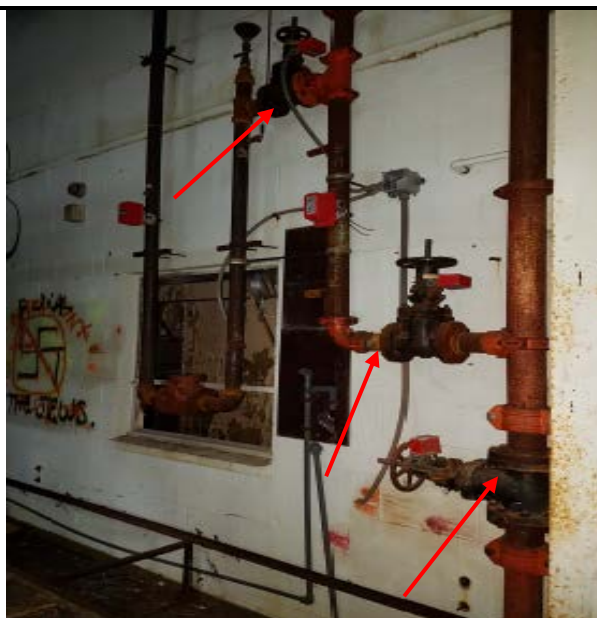
Gaskets between Flanges  
Total number of gaskets: 5

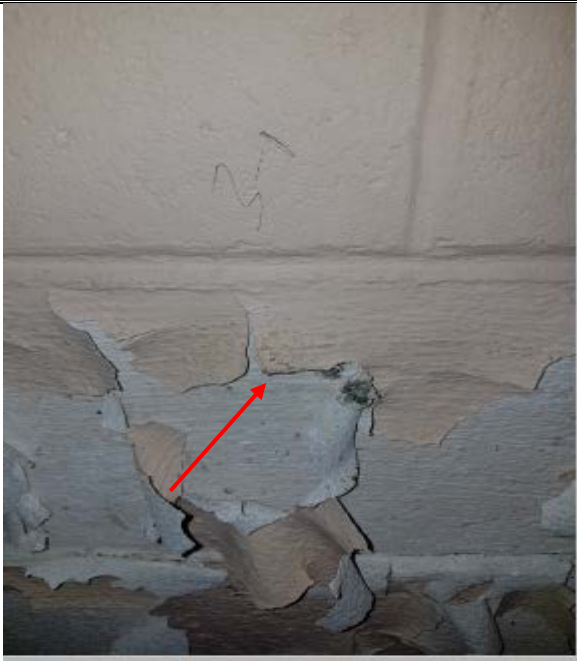
Wall paint on wall of corridor  
Sample ID: 3-1

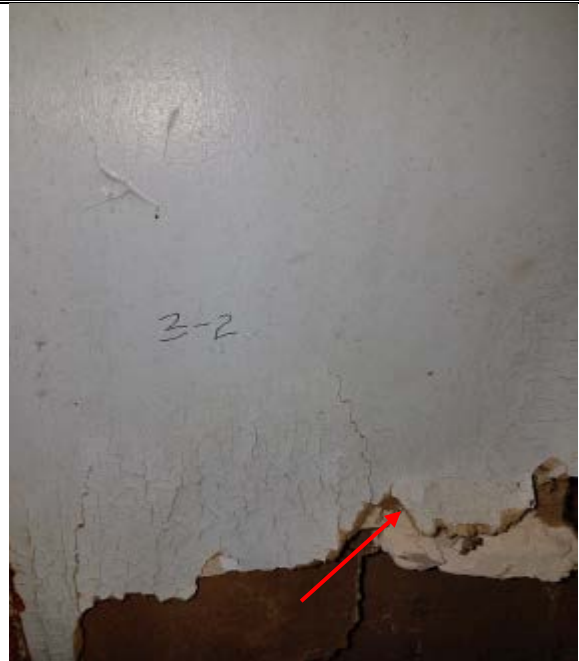
wall board paint  
Sample ID: 3-2

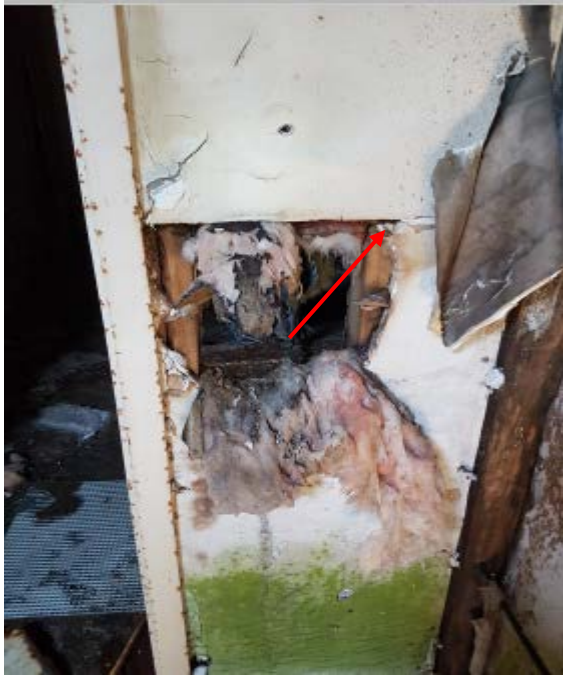
Wall paste on wall of quality manager room  
Sample ID: 6-1

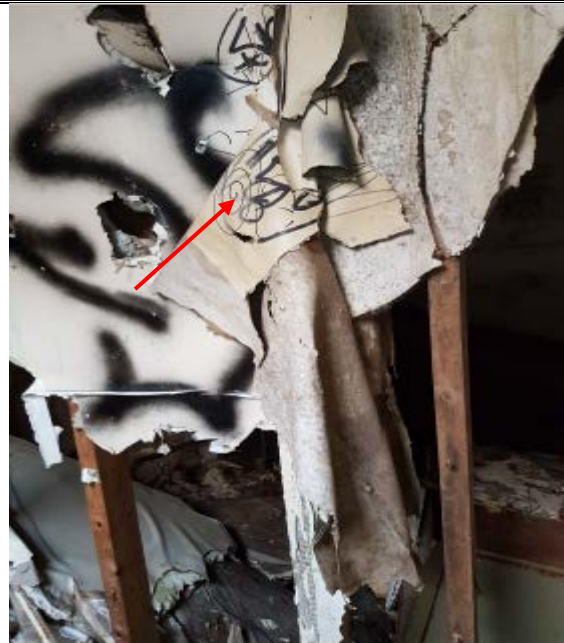
Wall paste on wall of men bathroom  
Sample ID: 6-1

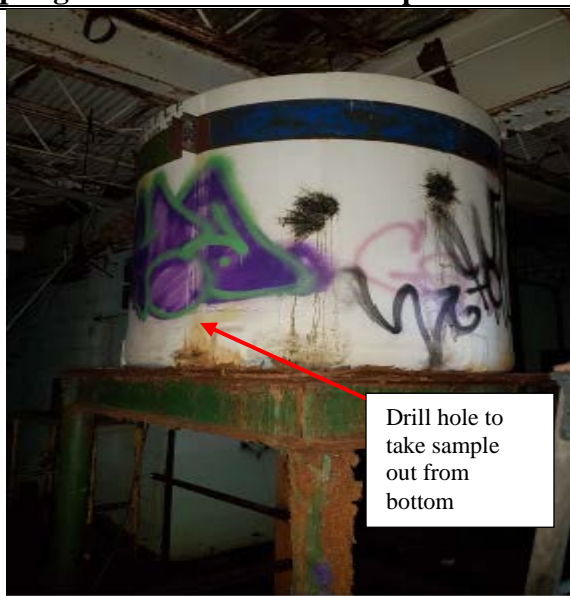
Drill hole to  
take sample  
out from  
bottom

White tank with iron stand in storage area of basement.

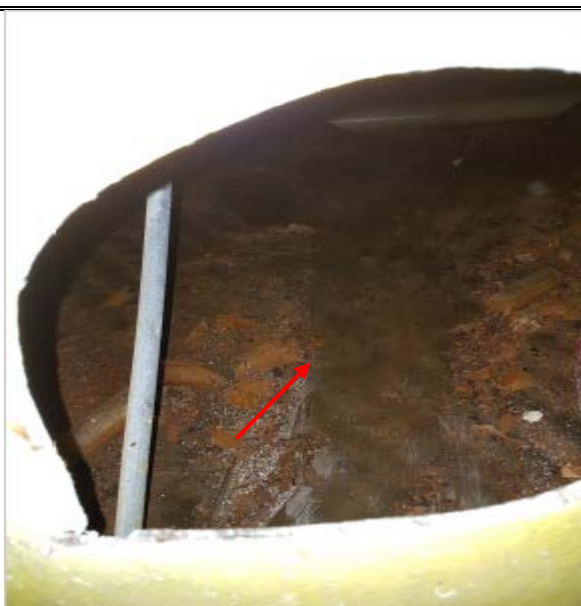
Bottom sludge from bottom of white tank  
Sample ID: 8-1

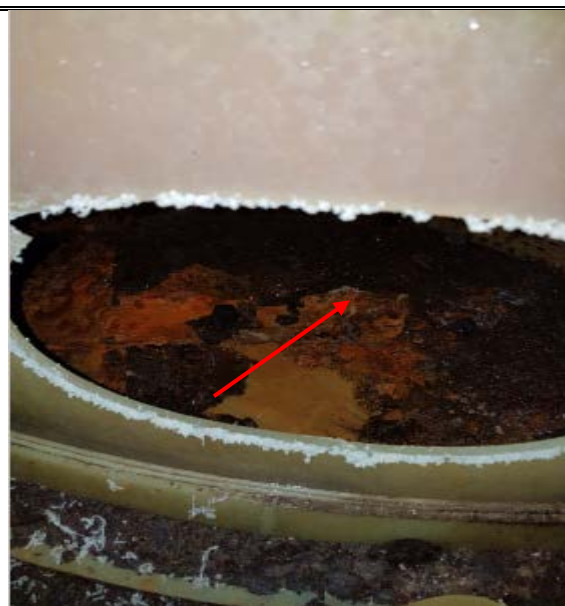
Bottom sludge from filtration process poly tank inside chemical  
make-up room of basement  
Sample ID: 8-3

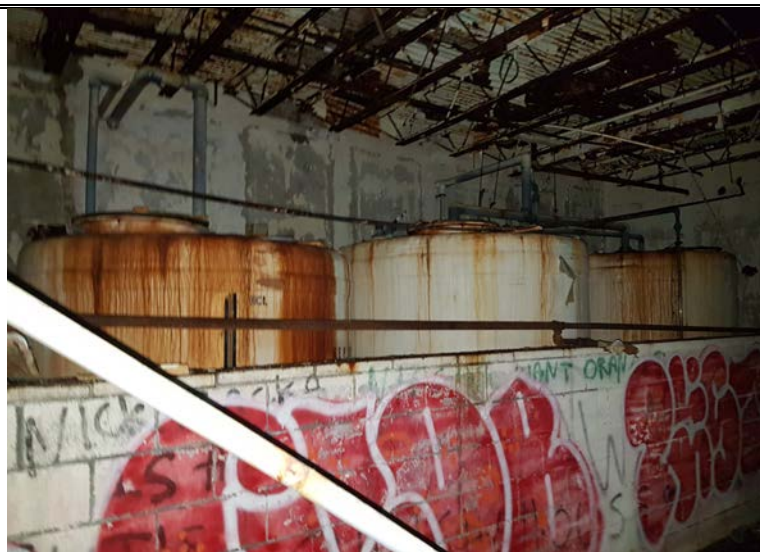
Three Poly tank with 1 inch of conc. acid pH of 1 at ground floor of new building (Location #7).  
Each Tank  
Volume ~ 7500 gallons  
Volume of acid~ 150 gallons (worse case)

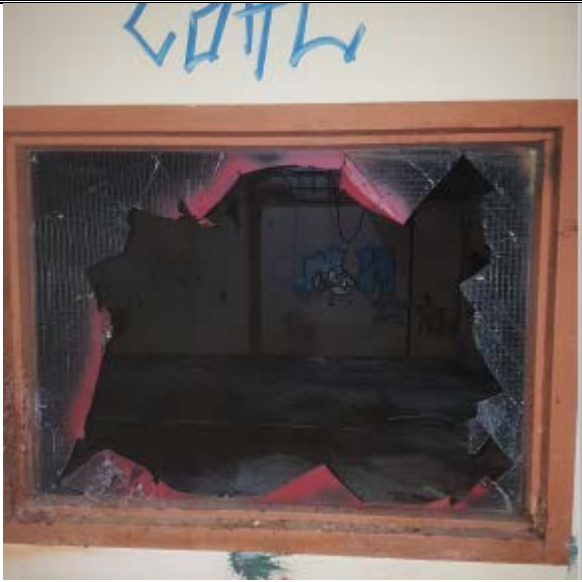
Window at corridor , new building (Location #5)

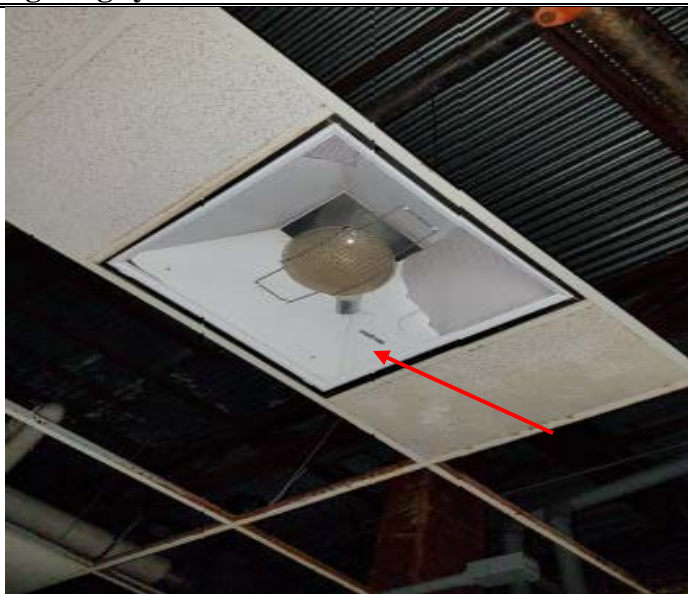
High-Intensity Discharge (HID) lamp  
Location: Touch-Up room, Location #5,  
Type: Universal waste.

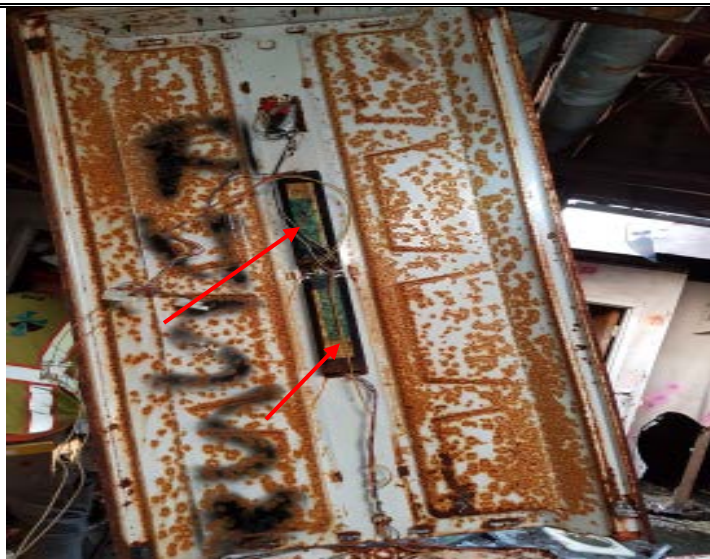
Ballasts attached with Fluorescent tube fixtures  
Location: throughout building  
Type: Universal waste.

- All light ballasts that do not have a clear “NO PCBs” label on them are to be considered PCB containing and, disposed of as PCB-containing material.
- All bulbs are to be packaged and disposed as a mercury (Hg) containing waste. Bulbs that are clearly labeled “NO Hg” may be disposed of as general construction debris. Care must be taken to not break the bulbs, as that may cause mercury exposure to individuals handling the bulbs.
- All thermostats are to be packaged and disposed as a mercury (Hg) containing waste. Care must be taken to not break the devices, as that may cause mercury exposure to individuals handling the devices.
- Elevator reservoir
- Transformer

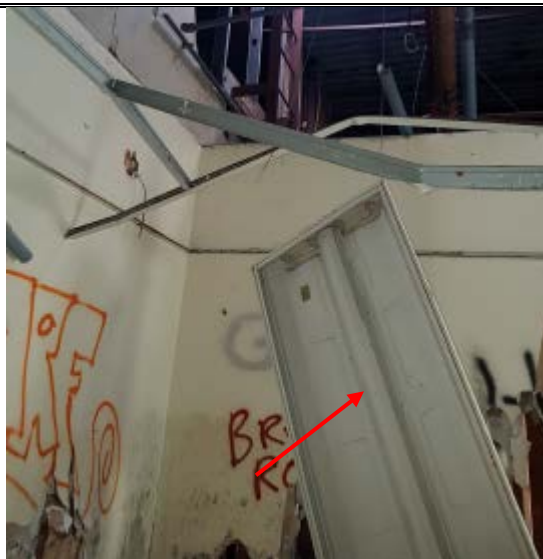
Fluorescent tube with fixtures  
Location: throughout building, about 50% tubes are broken  
Type: Universal waste.

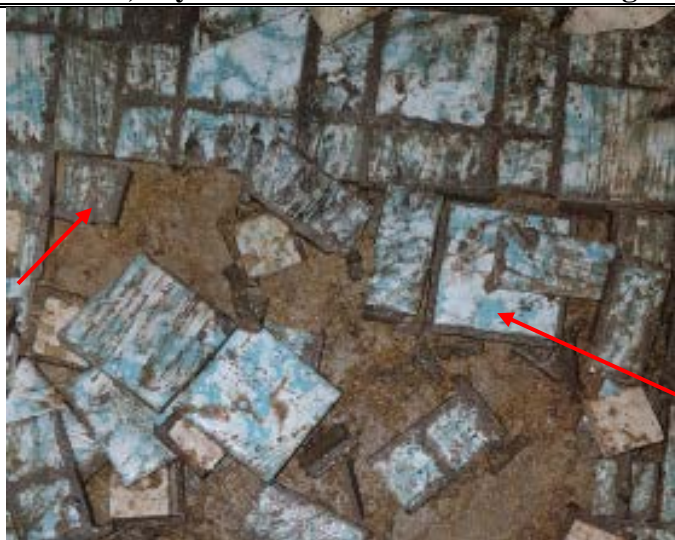
1/2 x 1/2 and 1x1 inches floor tiles with mastics in bathroom

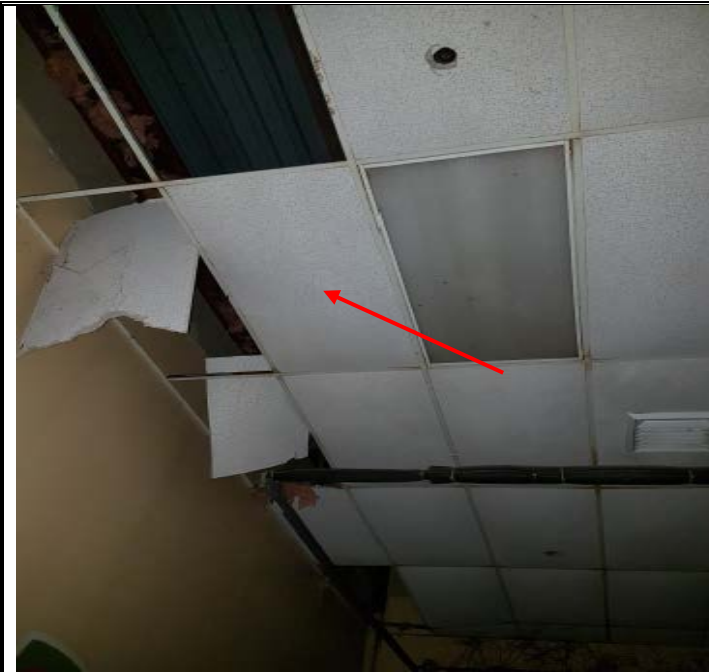
2 Ft .X 4 Ft. ceiling tiles from new building ( Area #5)

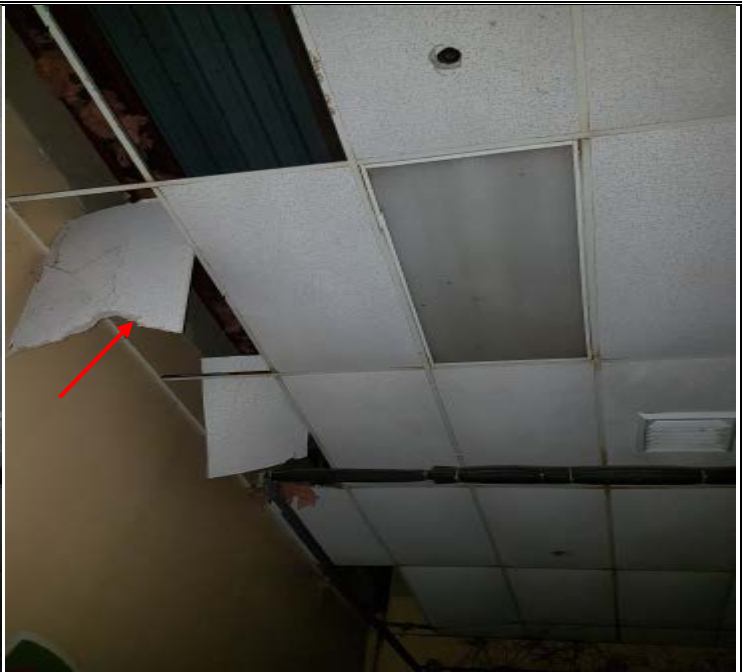
1 Ft .X 4 Ft. ceiling tiles from new building (Area # 5)

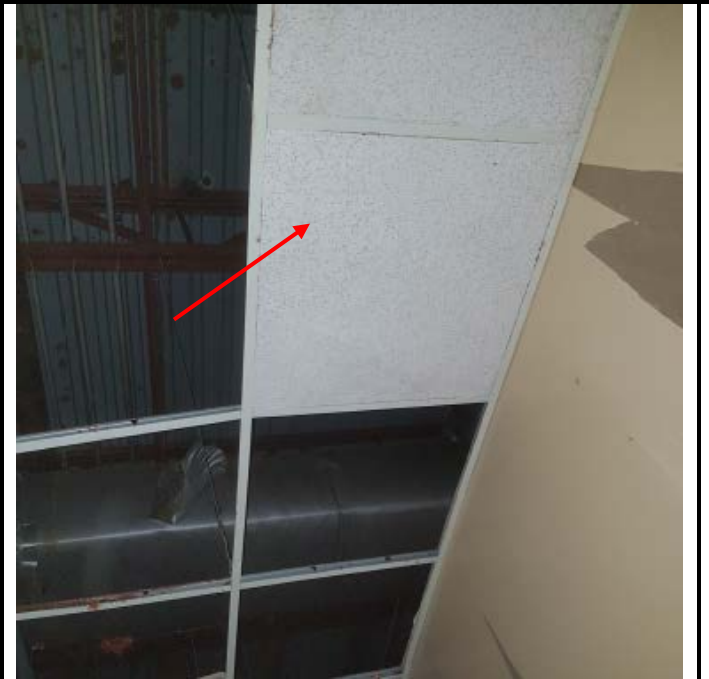
2 Ft .X 2 Ft. ceiling tiles from existing building

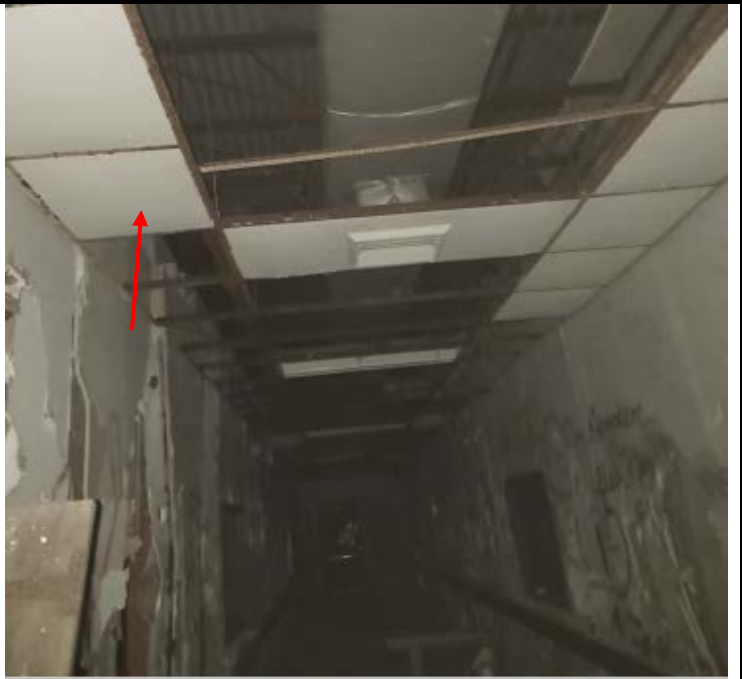
1 Ft .X 1 Ft. ceiling tiles from new building basement (Area # 7)

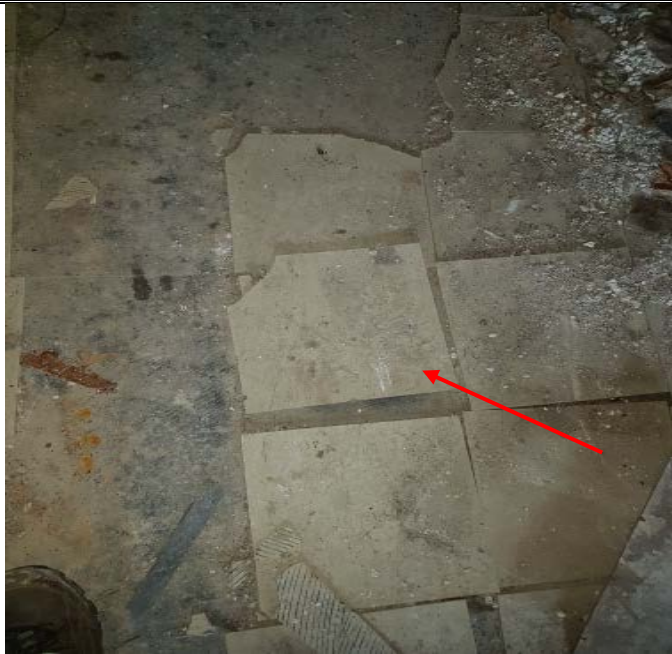
9 Inch .X 12 Inch. Floor tiles from corridor ( Area #3)

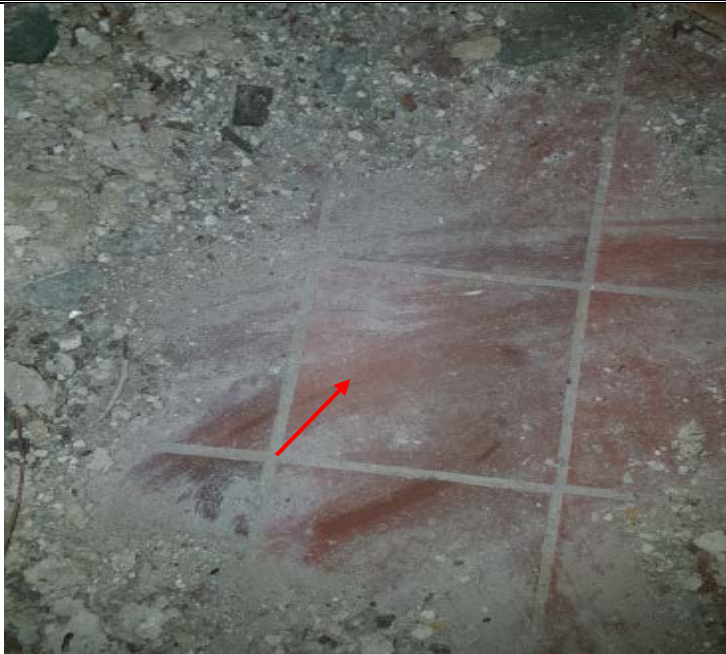
9 Inch .X 9 Inch. Floor tiles from men bathroom new building (Area # 5)

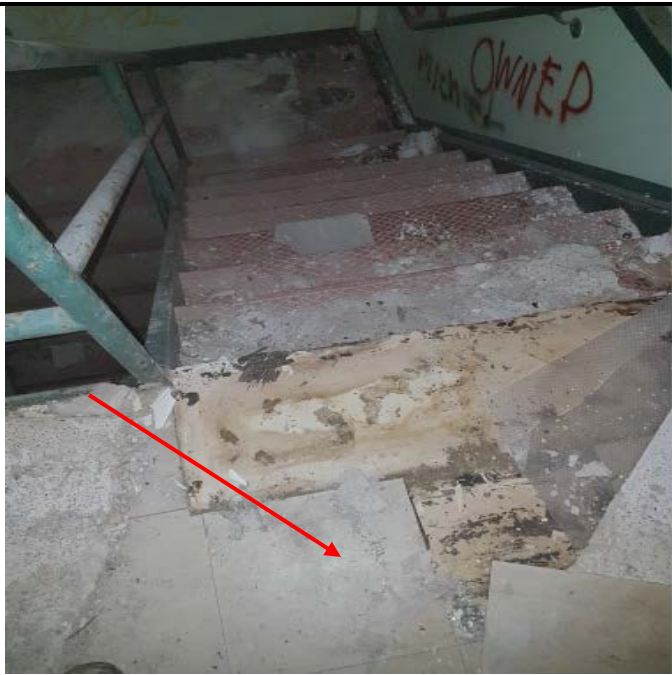
12 Inch .X 12 Inch. Floor tiles from corridor ( Area #5)

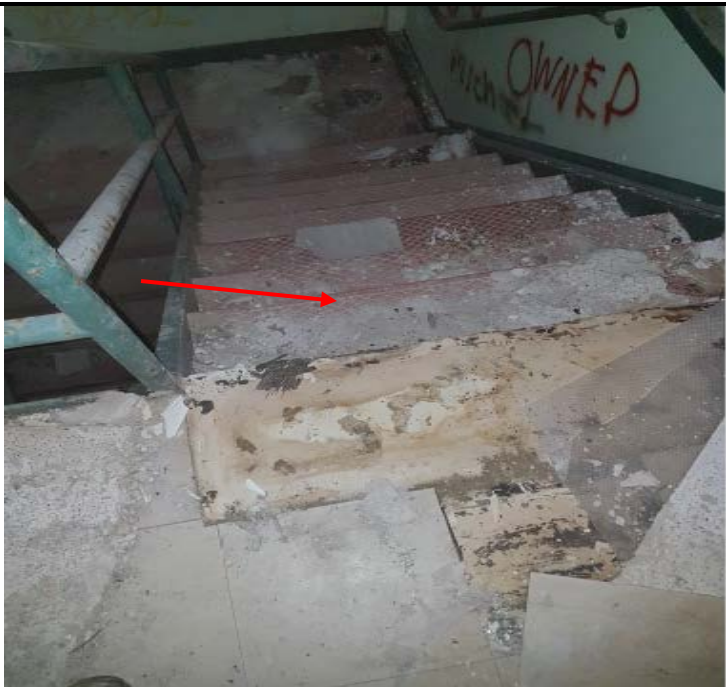
Rubber matted stairs for going to Area #7 from #5

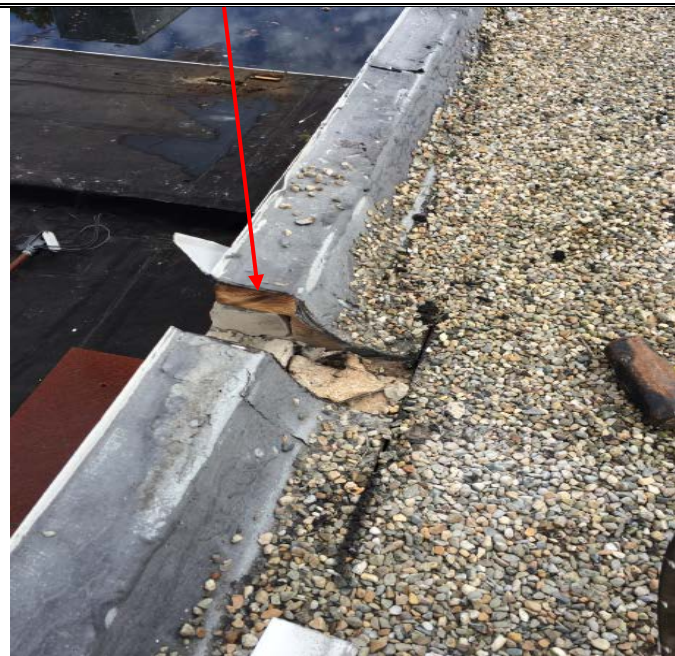
Equipment Flashing Materials - rubber, black tar material

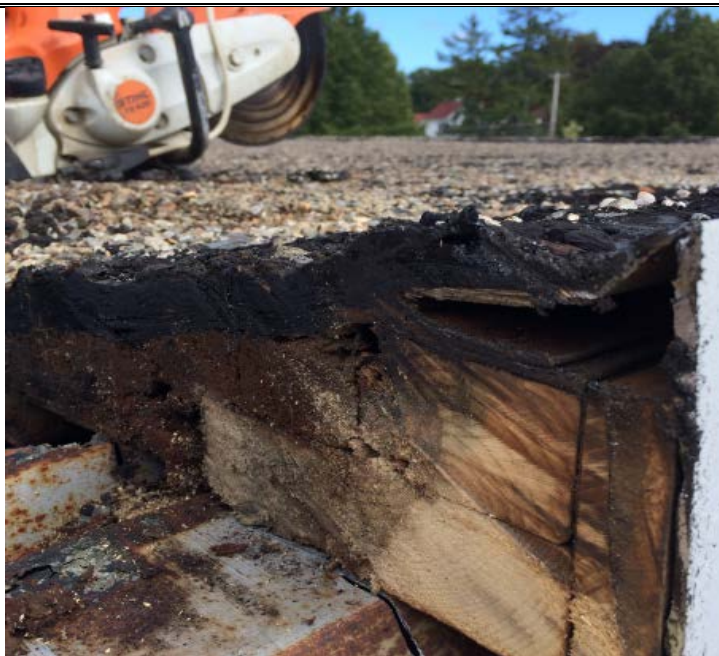
Roofing Materials- rubber, with tar, shingle, and particle board material

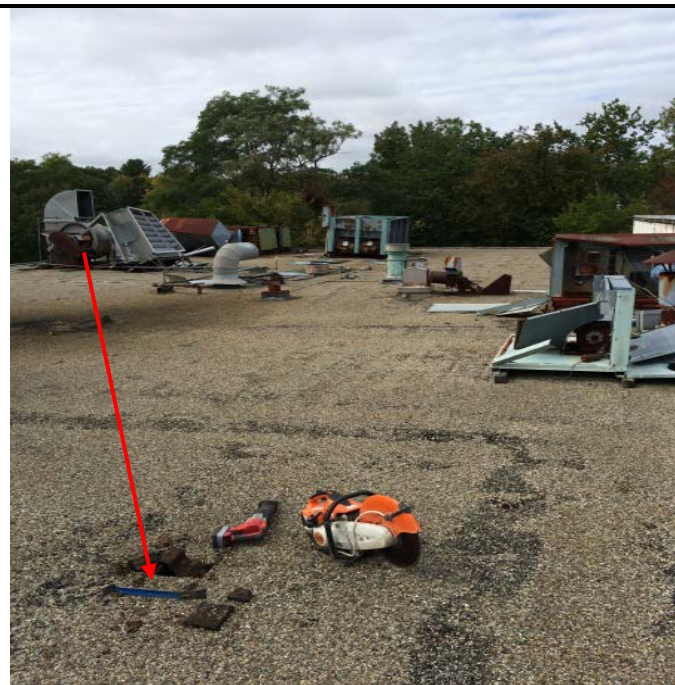
Roof Edge Flashing Materials - tar material with wood, concrete, metal, and shingles

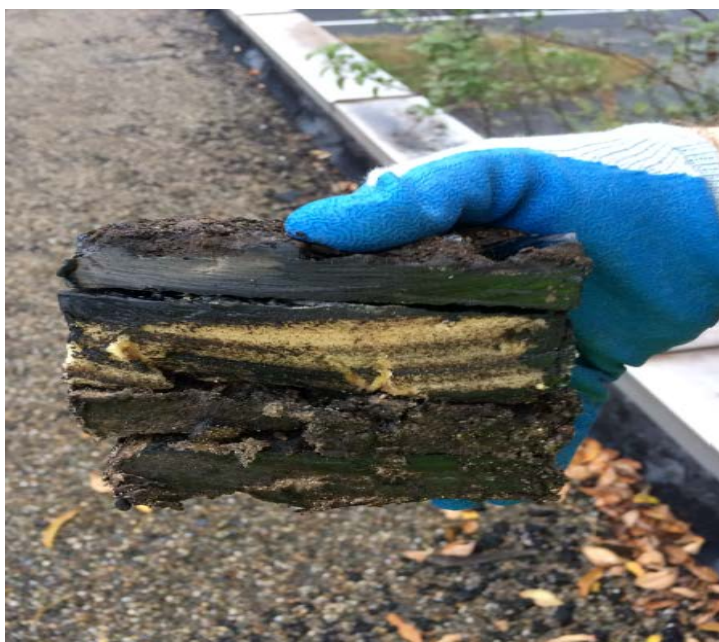
Roofing Materials- rubber, with tar, shingle, and particle board material

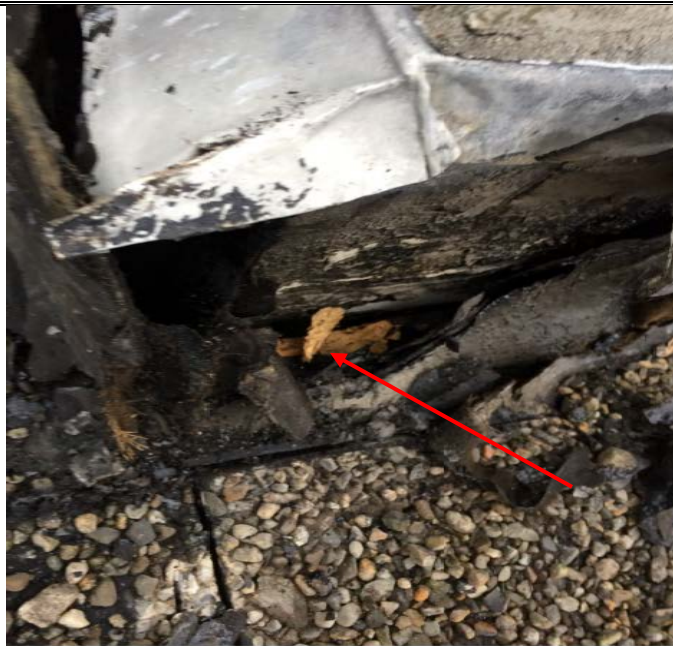
Interior Roof Edge Flashing Materials - tar material with wood, concrete, metal, and shingles

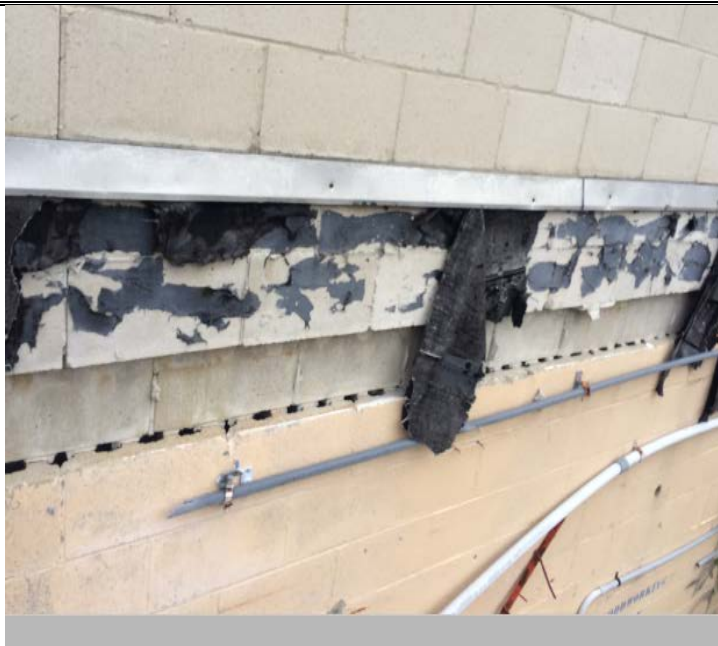
Exterior Wall Fiber Board

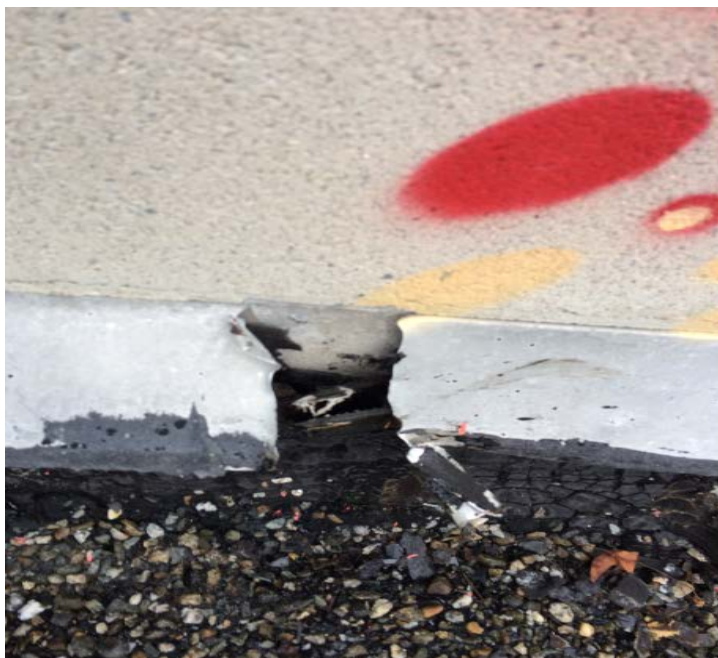
Roof Edge Flashing Materials

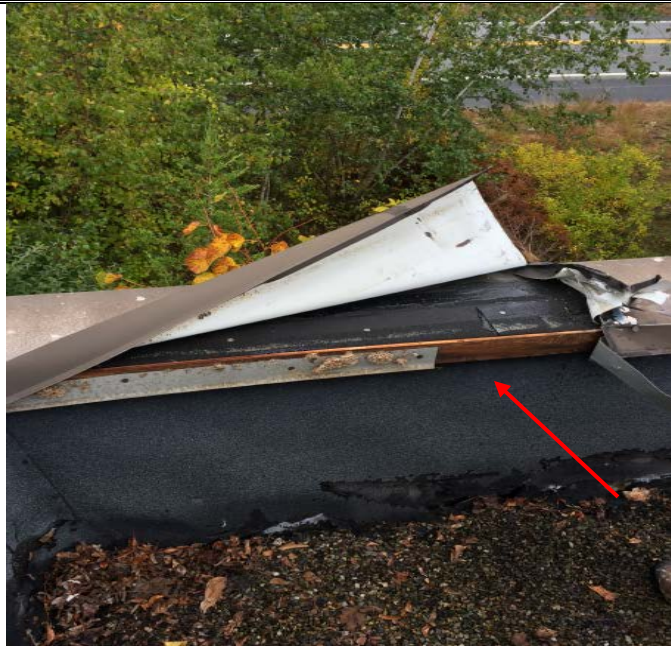
Roofing "Cap" Materials- rubber, tar with stone , and particle board material

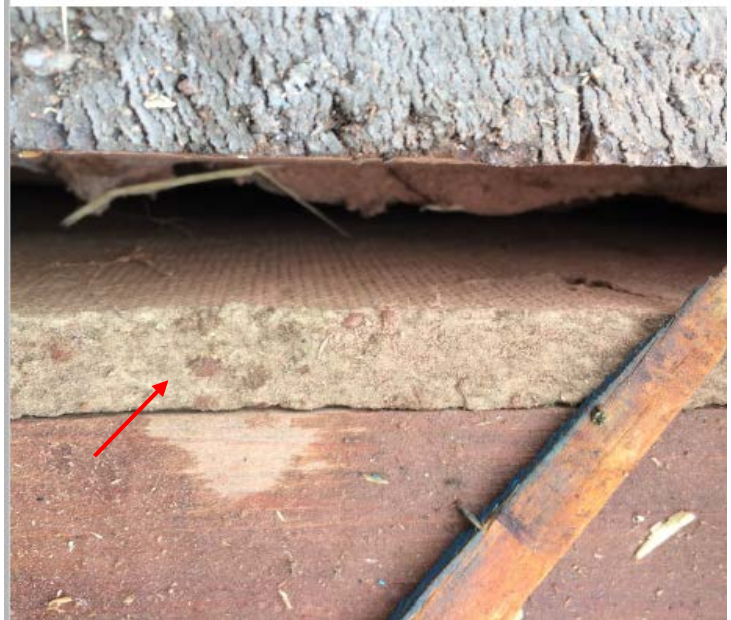
Sill Materials - copper flashing with fiber and adhesive

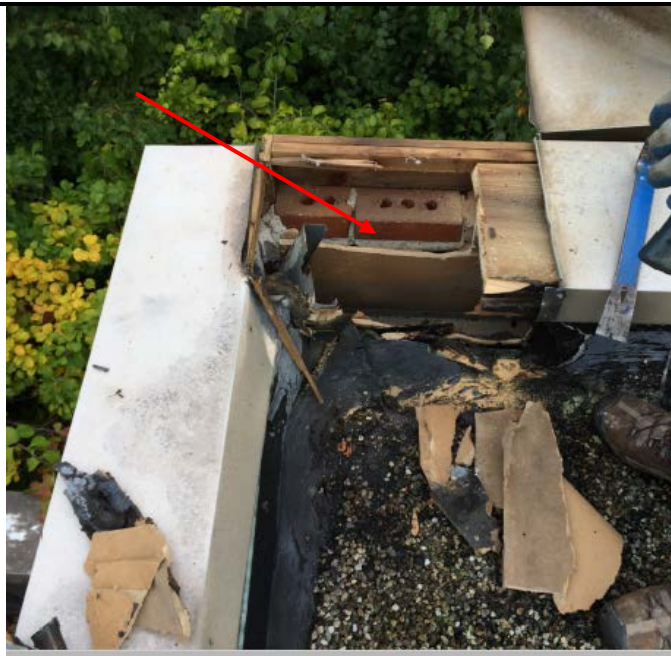
Interior Roof Edge Flashing Materials - tar material with shingles, drywall, and fibers

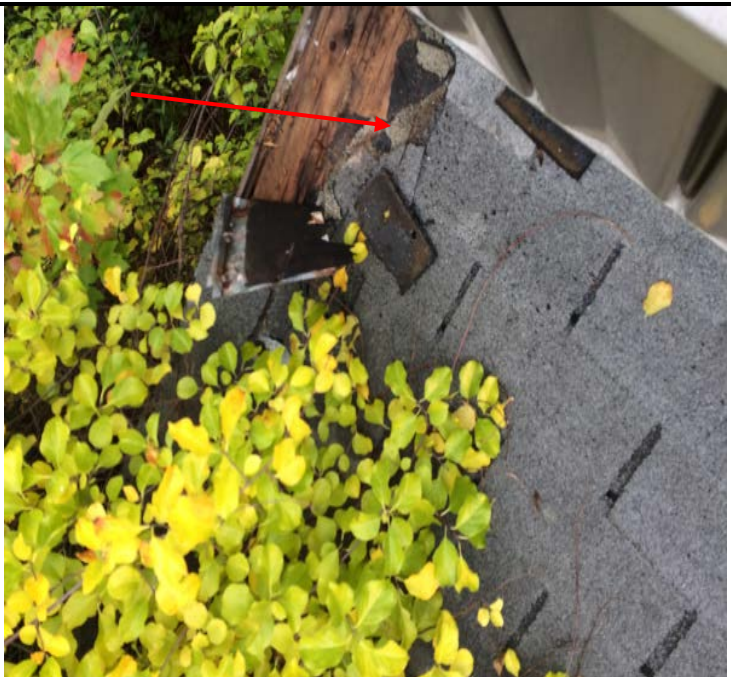
Roofing Materials- rubber and tar

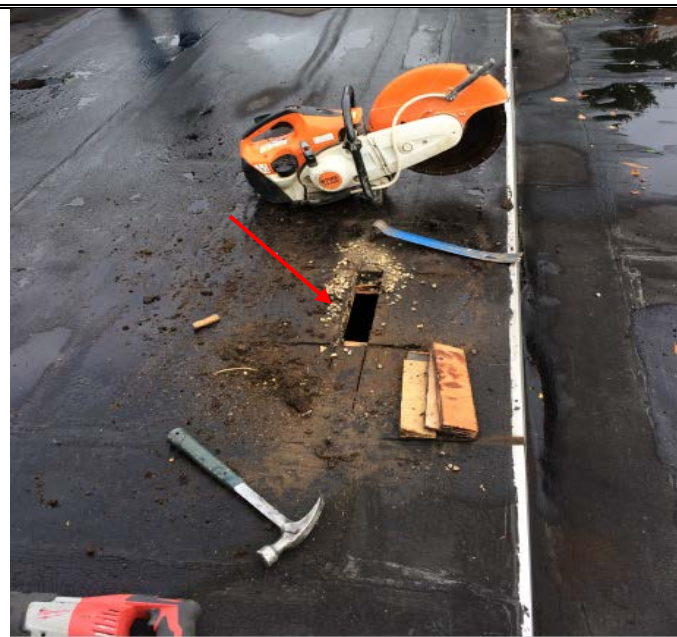
Roofing Materials- rubber, tar, and particle board material

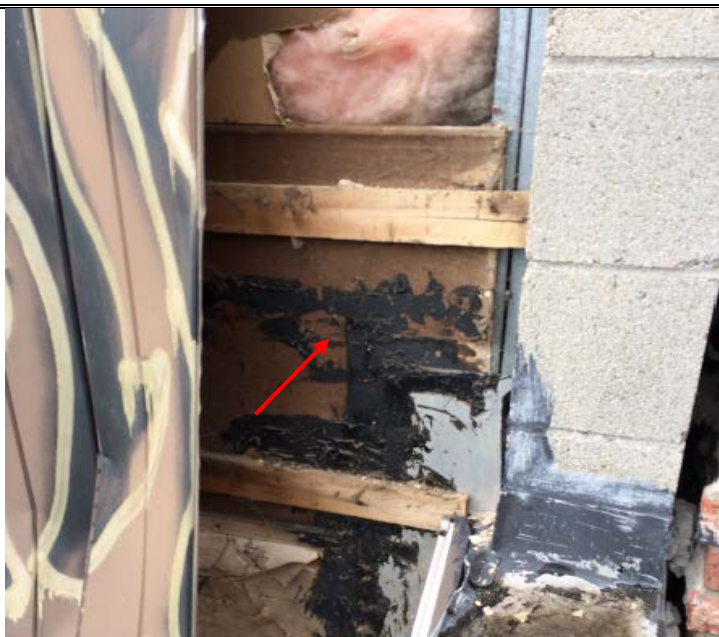
Sill Materials - fiber and adhesive

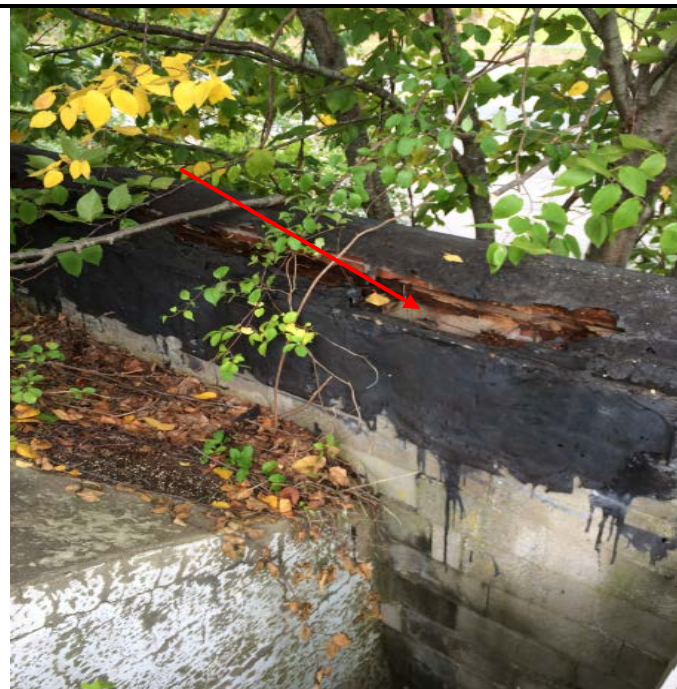
Wall Materials - tar material with shingles and drywall

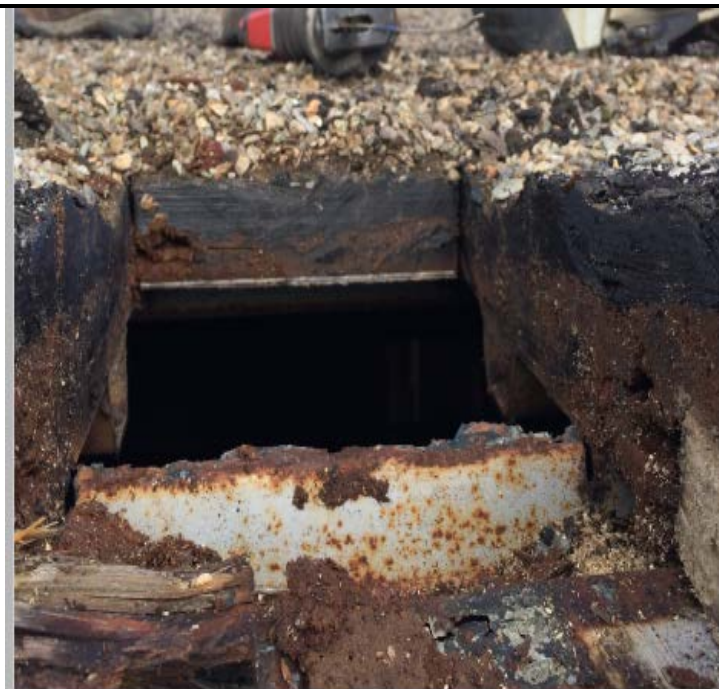
Roofing Materials- rubber, tar with stone , and particle board material

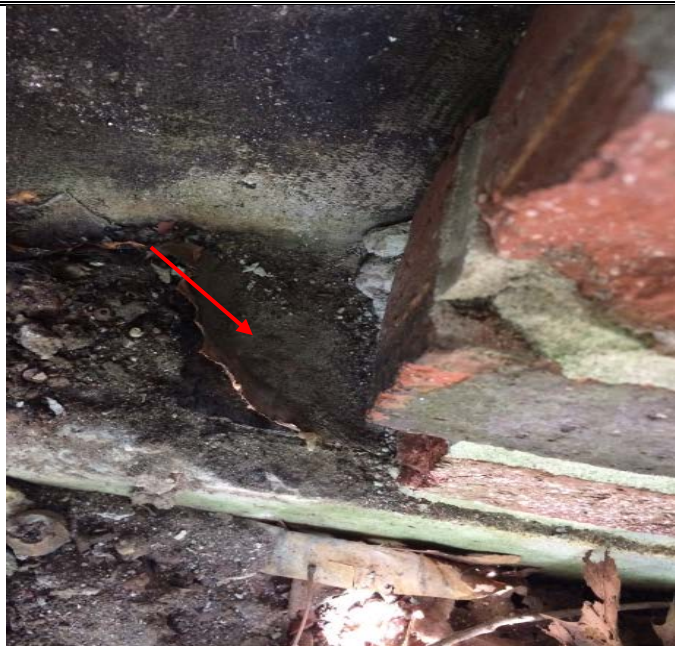
Block Wall Materials - loose insulation from block wall bay

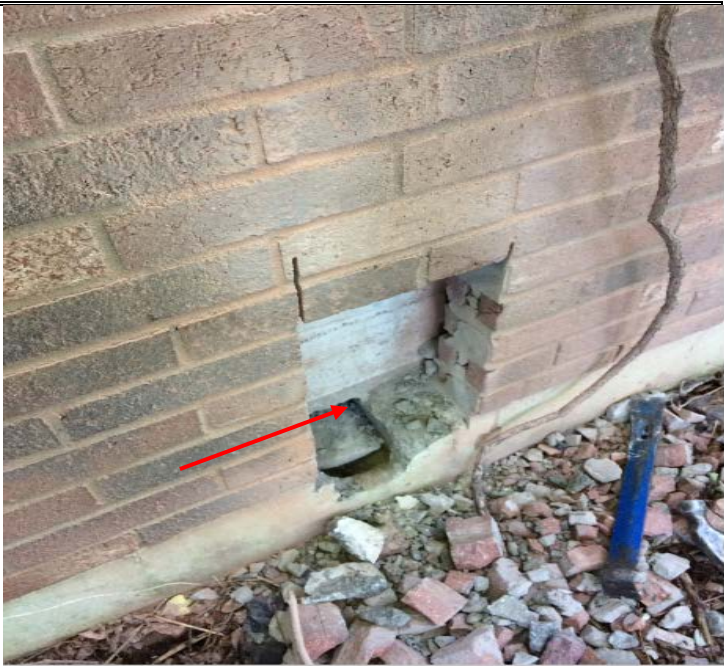
Brickwork Seam Material

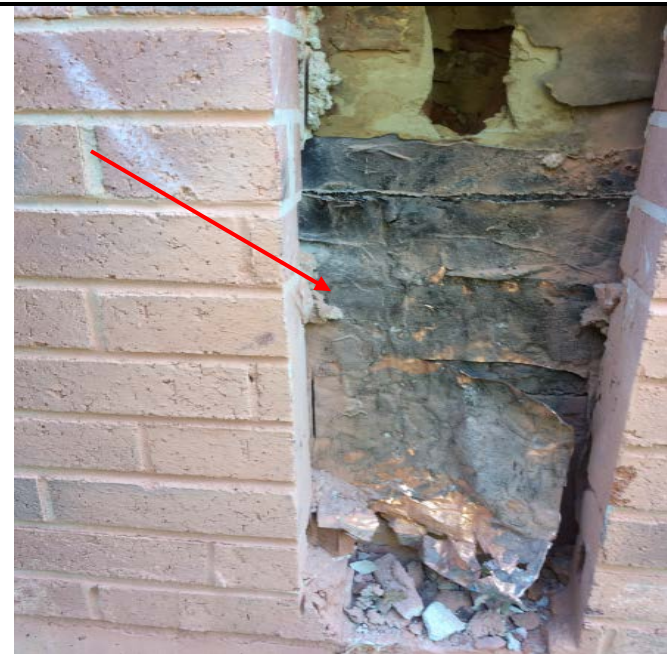
Block Wall Materials - loose insulation from block wall bay

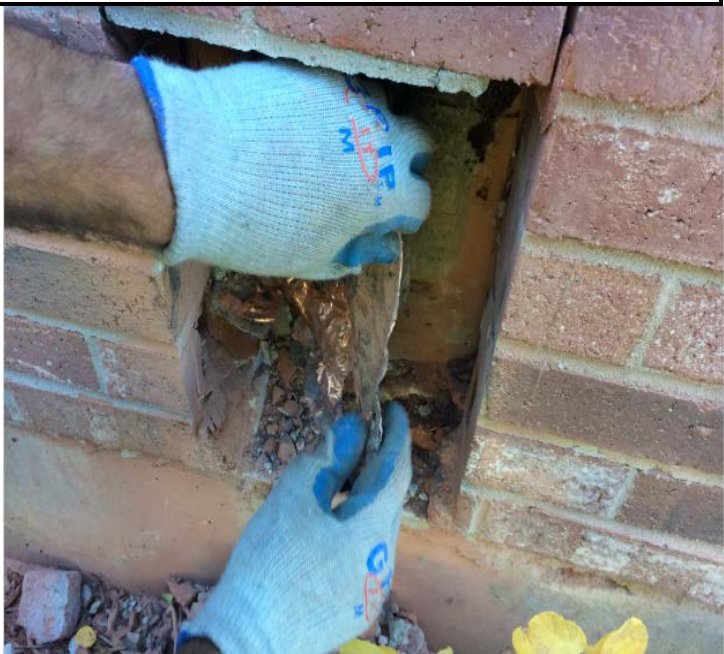
Block Wall Materials - loose insulation from block wall bay
