# MicroFab, Inc. Amesbury, MA

## Hazardous Material Survey Report

**Amec Foster Wheeler Environment & Infrastructure, Inc.**  
271 Mill Road  
Chelmsford, MA 01824

December 2016

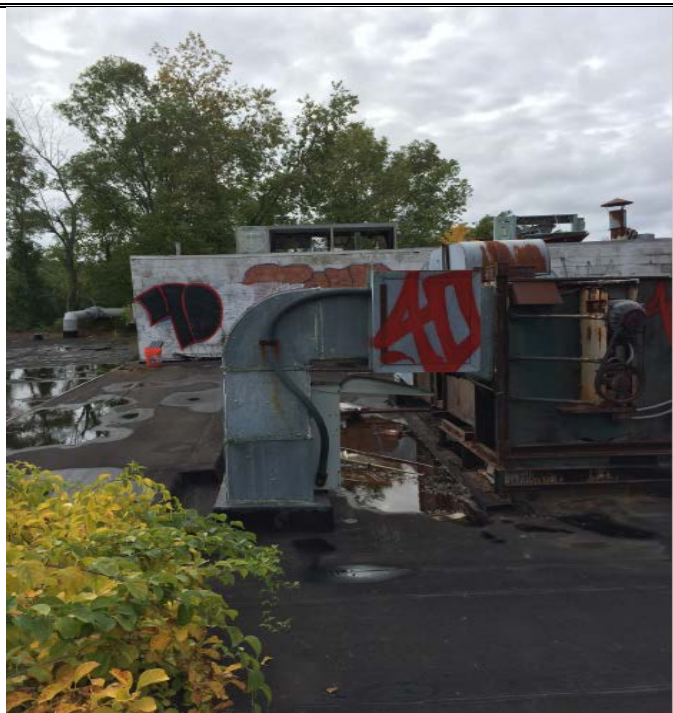
Miscellaneous equipment on the top of Area #6 roof

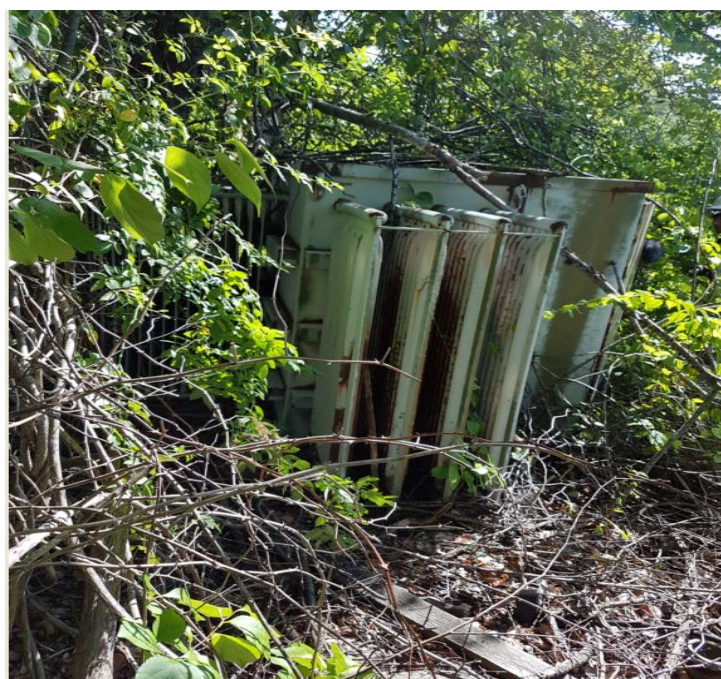
Transformer at exterior of Area # 2
