SITE VISIT REPORT
NAVAJO ABANDONED MINE LANDS RECLAMATION PROGRAM

DATE (S) OF VISIT:	04 February 2019
MINE/PROJECT NAME:	USEPA Region 9, Cove Mesa V Haul Shaft Closure Project
DURATION OF VISIT:	1:00 pm – 2:00 pm
PURPOSE OF VISIT:	Construction Progress Inspection

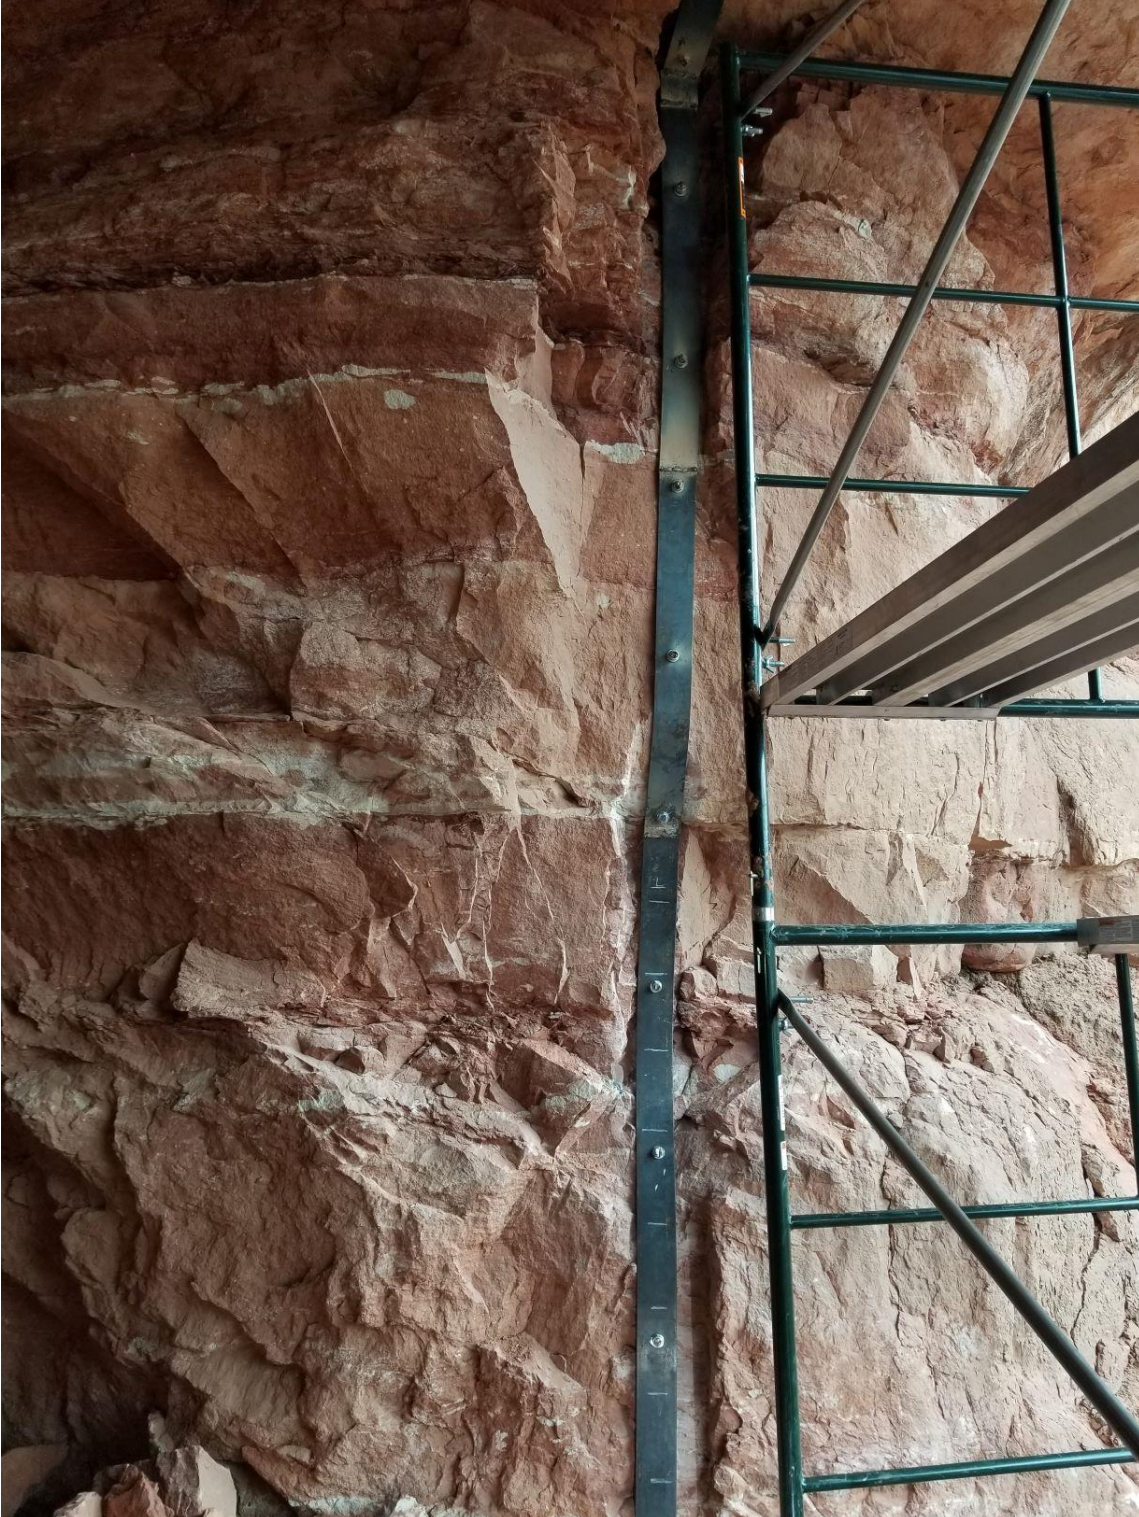
Right plate frame installed on Monday, 04 February 2019

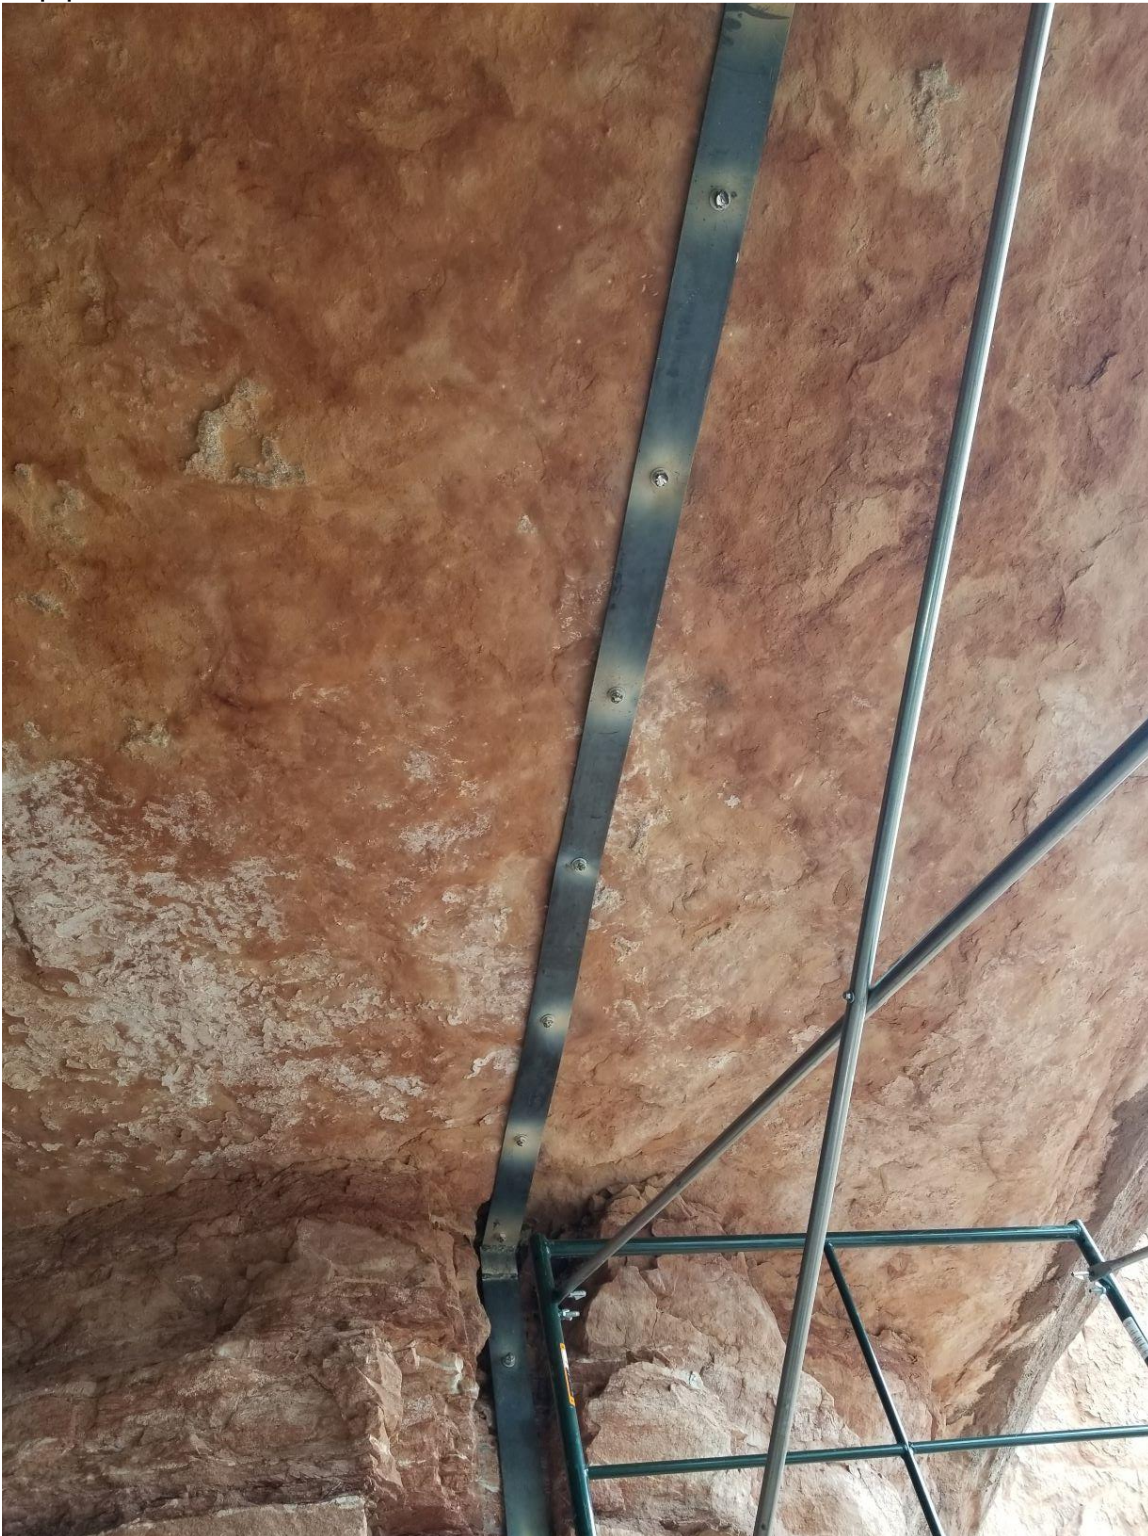
Top plate installed.

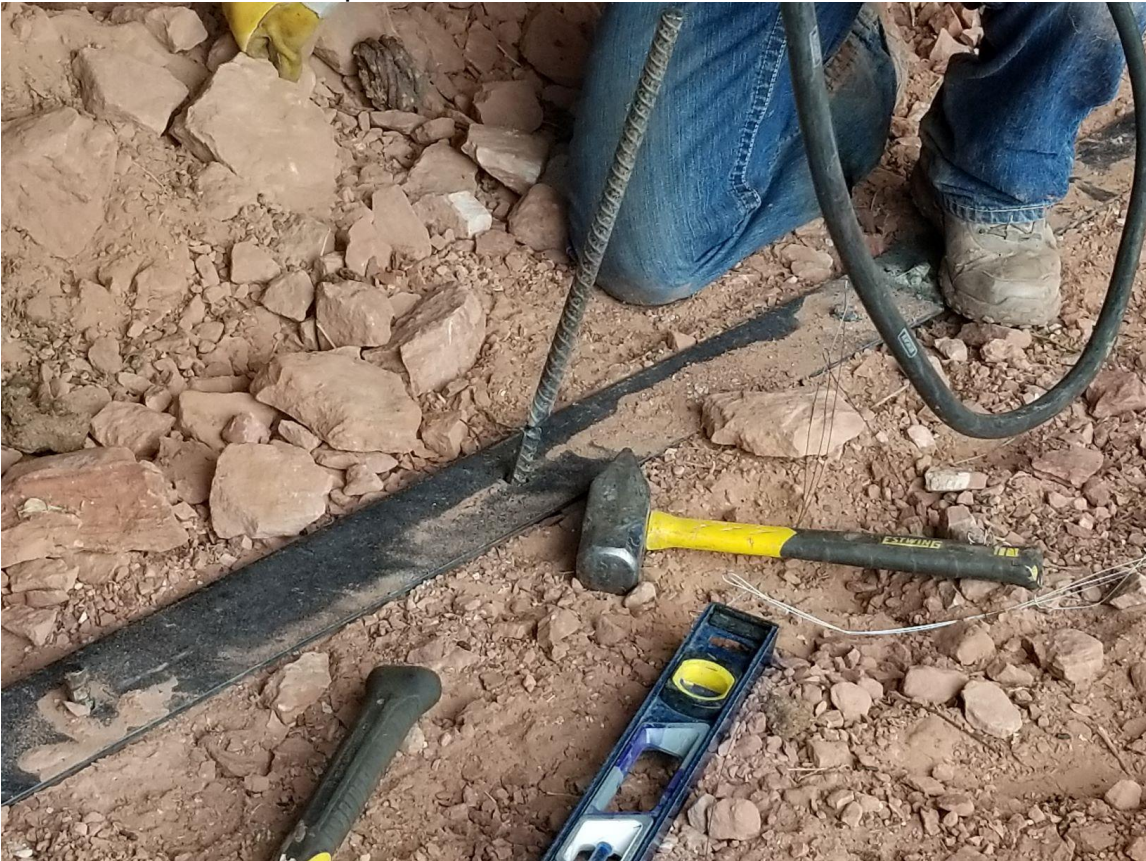
The contractor completed the outer frame of the wire rope (cable) closure. The contractor was securing the bottom plate to the floor of the haul shaft, but he could not find enough competent rock to drill, and secure the plate. He also mentioned that haul shaft ceiling was not hard enough to permanently secure the top plate. Since both the top and bottom plates were not positively secured to the haul shaft entry, NAMLRD staff inspection team recommend installing three vertical support columns. The contractor will install three 2" pipe 4 foot on center from the bottom plate to the top plates. When the wire rope (5/16" galvanized cable) is tighten in place both the top and bottom plates will be secured in place with the pipe taking the compression forces from the wire rope tension. In this manner the anchor bolts (top plate fasteners) and concrete reinforcing bars (bottom plate fasteners) will not be subject to any tension forces. The three vertical support columns will be added to the closure design and a field order will be issued to the contractor.

Rebar to secure bottom plate, not successful.
