**Subject: Targeted Brownfields Assessment
Hazardous Materials Survey
Oak Street City Hall Site
Poplar Bluff, Butler County, Missouri
U.S. EPA Region 7 START 5, Contract No. 68HE0719D0001
Task Order No. 19F0101.005
Task Monitor: Todd Davis, Site Assessment Manager**

**TARGETED BROWNFIELDS ASSESSMENT
HAZARDOUS MATERIALS SURVEY**

**OAK STREET CITY HALL
POPLAR BLUFF, BUTLER COUNTY, MISSOURI**

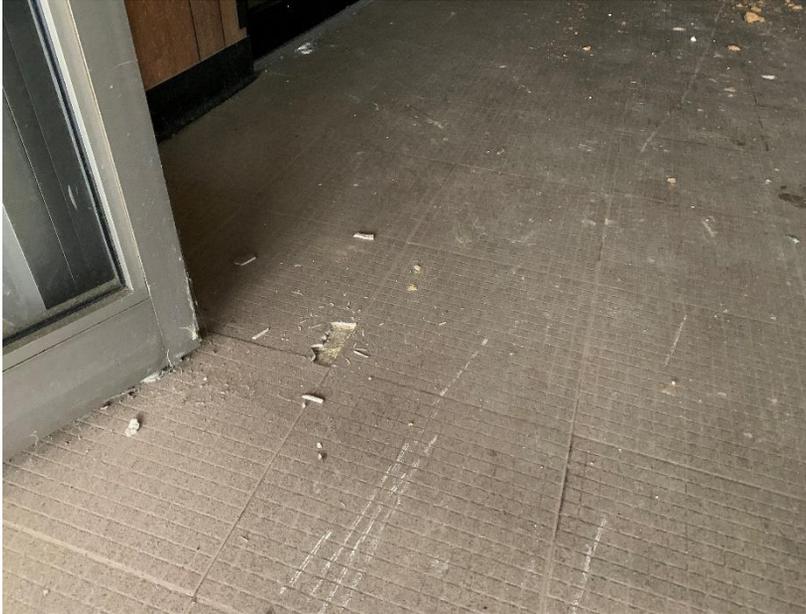
TETRA TECH PROJECT NO. X9030.19F.0101.005 Direction: NA	DESCRIPTION	This photograph shows 12" X 12" stick on grey floor tile and mastic in the south main entrance and Room 2.	1
	CLIENT	U.S. Environmental Protection Agency (EPA)	Date
	PHOTOGRAPHER	Zach Usher	11/6/2019

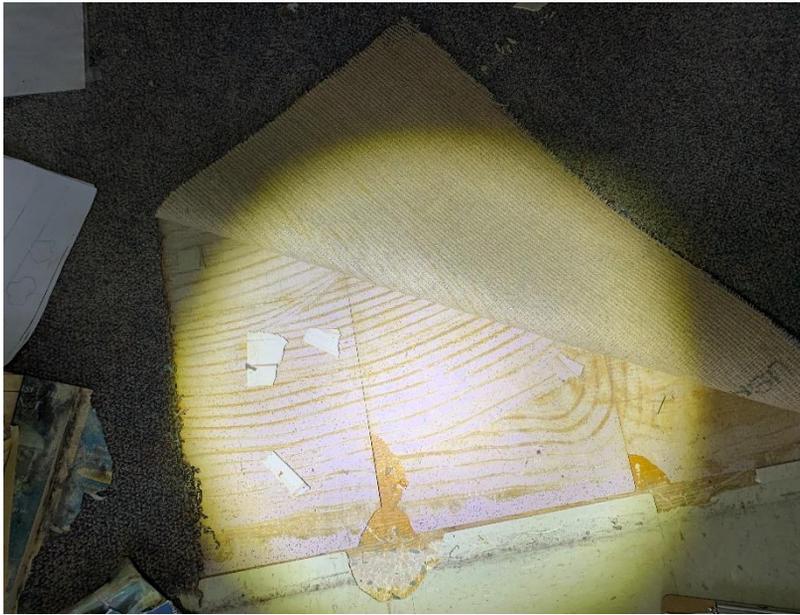
TETRA TECH PROJECT NO. X9030.19F.0101.005 Direction: NA	DESCRIPTION	This photograph shows 12" X 12" pink and black dots floor tile in Room 16.	3
	CLIENT	EPA	Date
	PHOTOGRAPHER	Zach Usher	11/6/2019

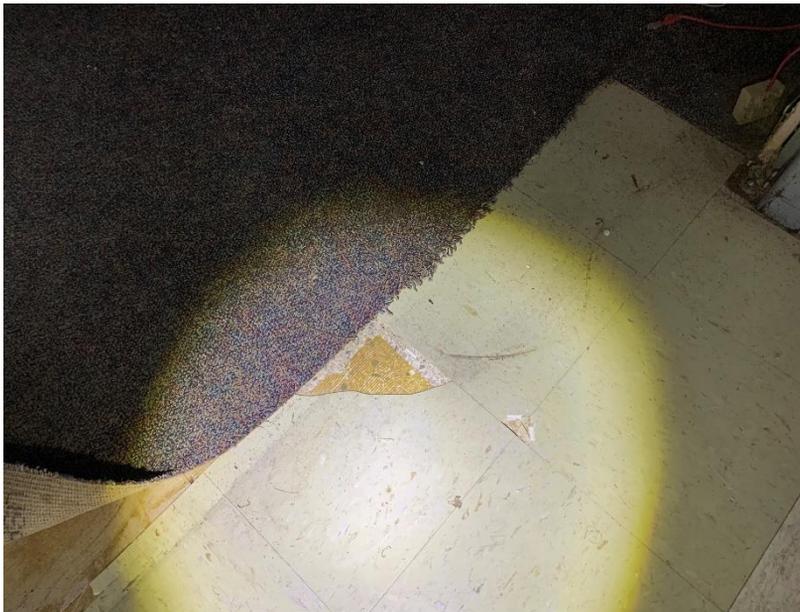
TETRA TECH PROJECT NO. X9030.19F.0101.005 Direction: NA	DESCRIPTION	This photograph shows 9" X 9" beige and tan streak floor tile in Room 16.	4
	CLIENT	EPA	Date
	PHOTOGRAPHER	Zach Usher	11/6/2019

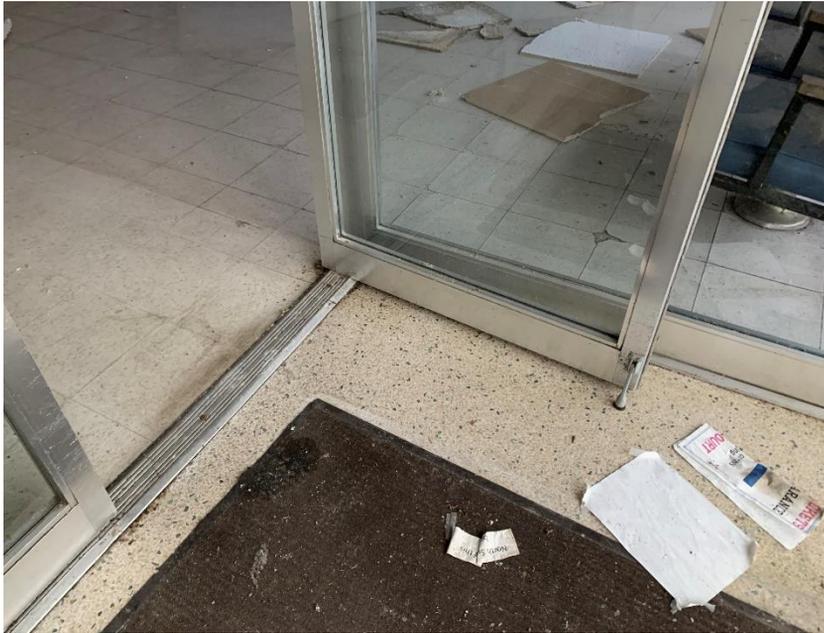
TETRA TECH PROJECT NO. X9030.19F.0101.005 Direction: NA	DESCRIPTION	This photograph shows terrazzo flooring in the west side of the first floor.	5
	CLIENT	EPA	Date
	PHOTOGRAPHER	Zach Usher	11/6/2019

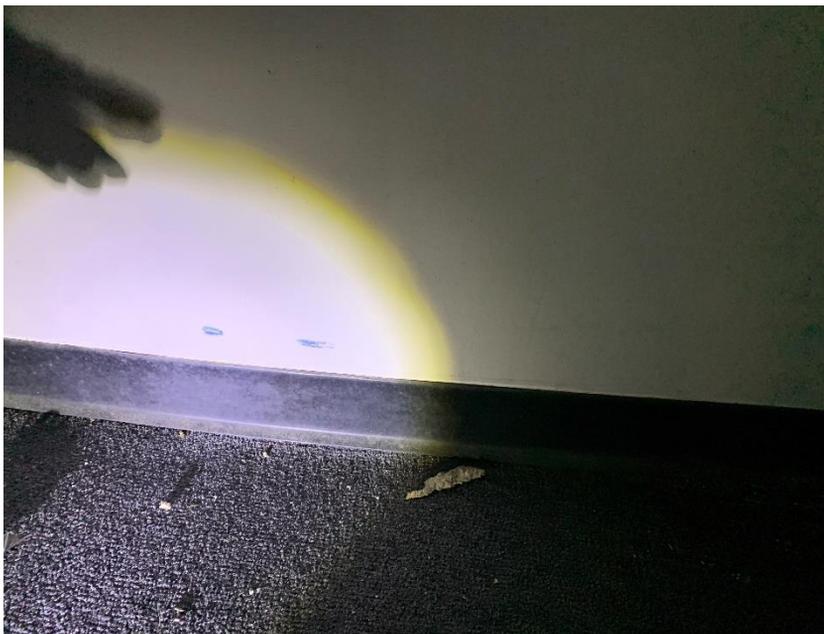
TETRA TECH PROJECT NO. X9030.19F.0101.005 Direction: NA	DESCRIPTION	This photograph shows 4" black cove base typical of Rooms 16, 27, 28, 31, and 32.	6
	CLIENT	EPA	Date
	PHOTOGRAPHER	Zach Usher	11/6/2019

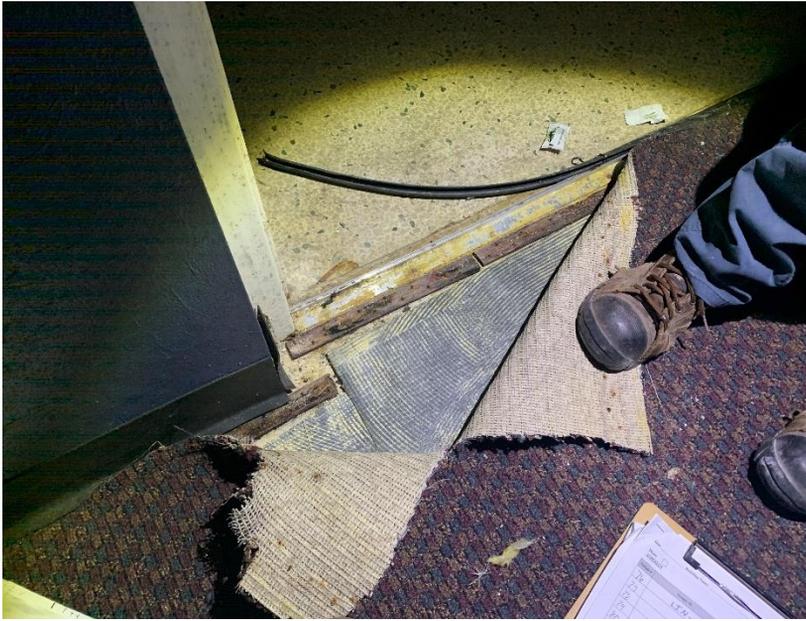
TETRA TECH PROJECT NO. X9030.19F.0101.005 Direction: NA	DESCRIPTION	This photograph shows yellow carpet mastic of a type found throughout the first floor.	9
	CLIENT	EPA	Date
	PHOTOGRAPHER	Zach Usher	11/6/2019

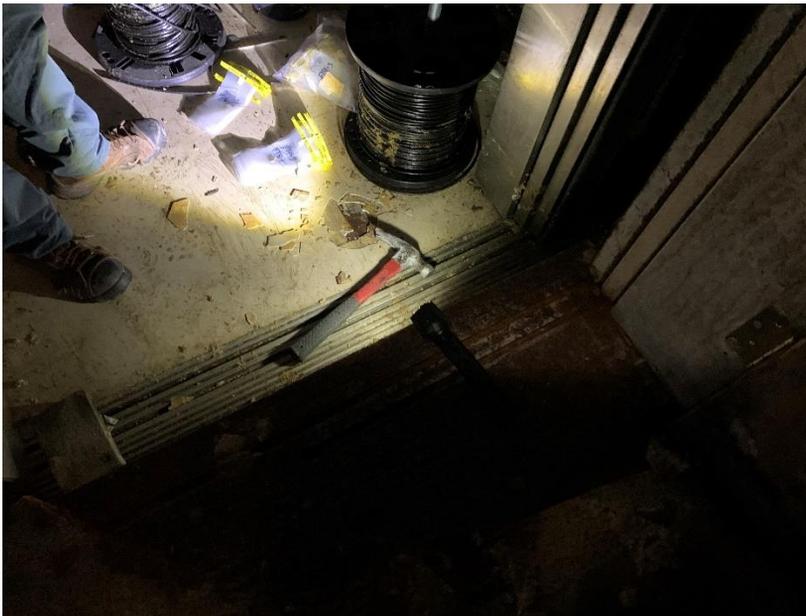
TETRA TECH PROJECT NO. X9030.19F.0101.005 Direction: NA	DESCRIPTION	This photograph shows 12" X 12" thin brown and tan streak floor tile in the elevator.	10
	CLIENT	EPA	Date
	PHOTOGRAPHER	Zach Usher	11/6/2019

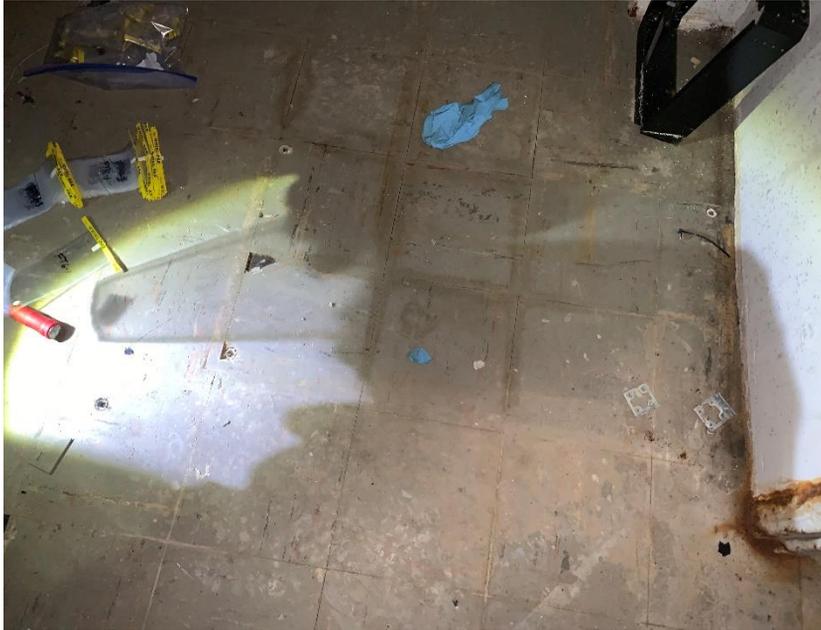
TETRA TECH PROJECT NO. X9030.19F.0101.005 Direction: NA	DESCRIPTION	This photograph shows 9" X 9" grey with red and brown streak floor tile typical of Room 12 and Room 23.	11
	CLIENT	EPA	Date
	PHOTOGRAPHER	Zach Usher	11/6/2019

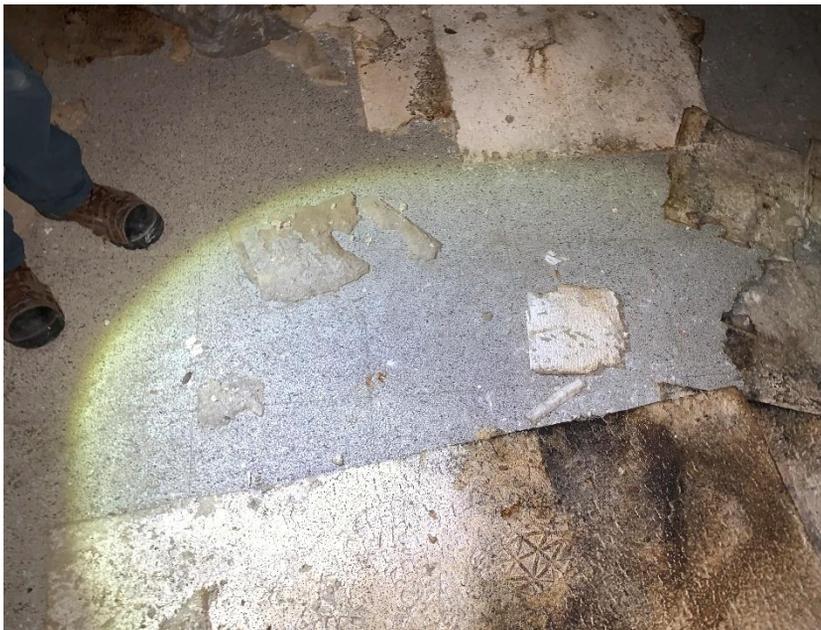
TETRA TECH PROJECT NO. X9030.19F.0101.005 Direction: NA	DESCRIPTION	This photograph shows 12" X 12" white and black dot floor tile in the holding cell area.	12
	CLIENT	EPA	Date
	PHOTOGRAPHER	Zach Usher	11/6/2019

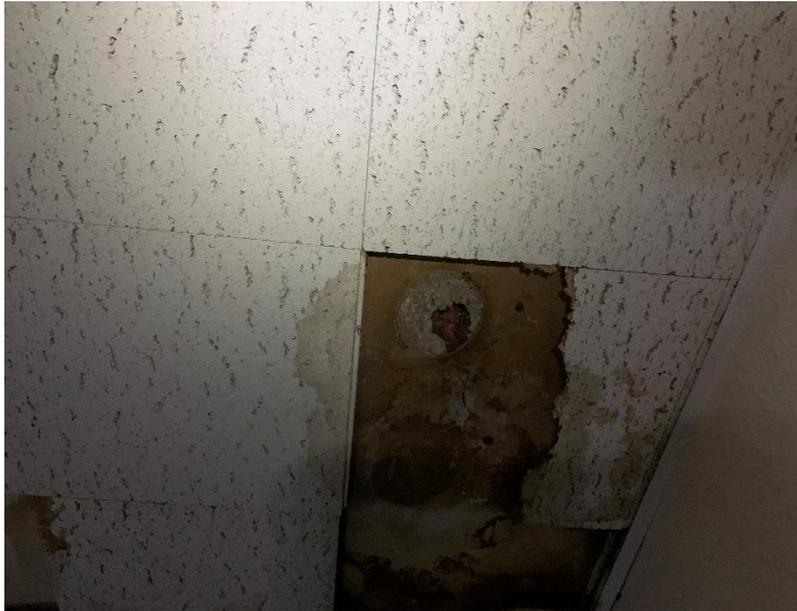
- Approximately 7,000 SF of 12" X 12" white fissure and pinhole ceiling tile mastic is presumed asbestos containing in room 20 and the east office area.

TETRA TECH PROJECT NO. X9030.19F.0101.005 Direction: NA	DESCRIPTION	This photograph shows 12" X 12" white fissured ceiling tile and mastic typical of the east office area and holding cell area.	13
	CLIENT	EPA	Date
	PHOTOGRAPHER	Zach Usher	11/6/2019

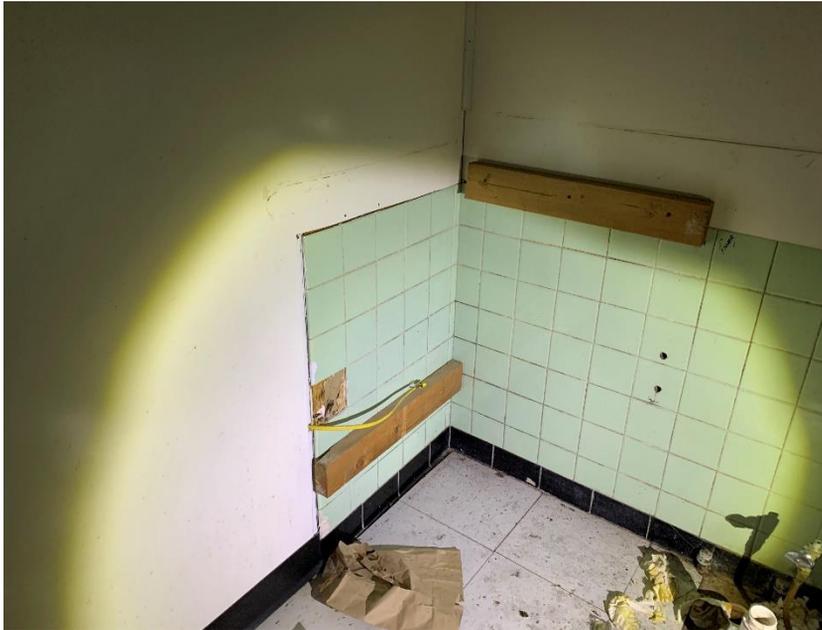
TETRA TECH PROJECT NO. X9030.19F.0101.005 Direction: NA	DESCRIPTION	This photograph shows green ceramic wall tile mastic in Room 22.	15
	CLIENT	EPA	Date
	PHOTOGRAPHER	Zach Usher	11/6/2019

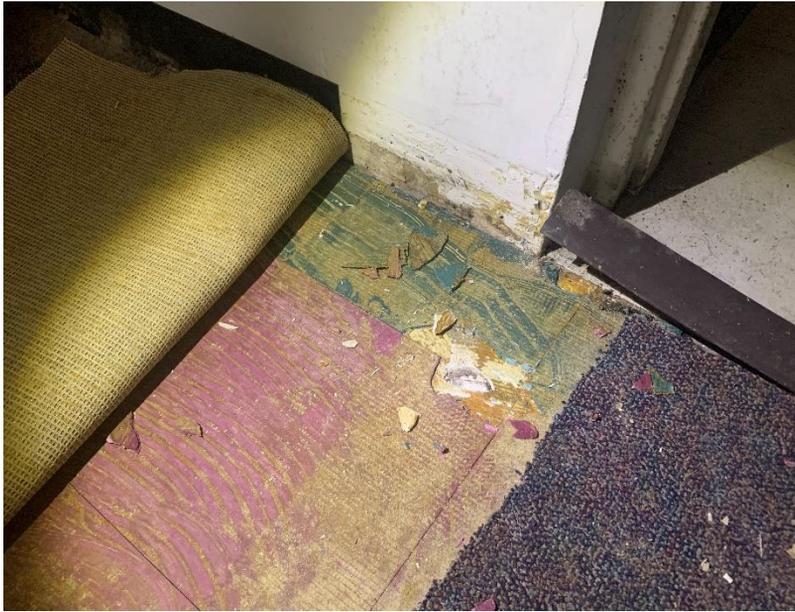
TETRA TECH PROJECT NO. X9030.19F.0101.005 Direction: NA	DESCRIPTION	This photograph shows 12" X 12" hot pink floor tile and 12" X 12" turquoise floor tile typical of Room 14 and Room 15.	17
	CLIENT	EPA	Date
	PHOTOGRAPHER	Zach Usher	11/6/2019

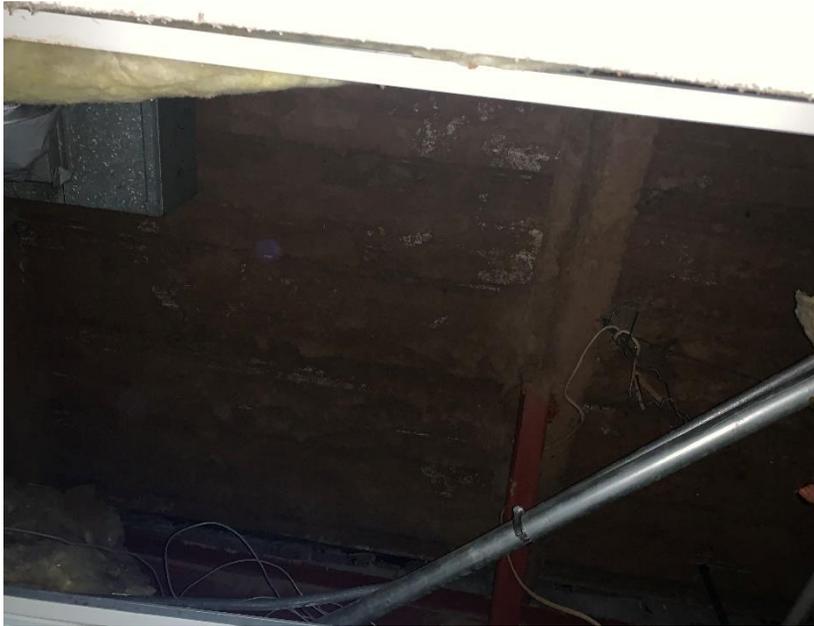
TETRA TECH PROJECT NO. X9030.19F.0101.005 Direction: North	DESCRIPTION	This photograph shows brown fireproofing of a type found throughout the first floor.	25
	CLIENT	EPA	Date
	PHOTOGRAPHER	Zach Usher	11/6/2019

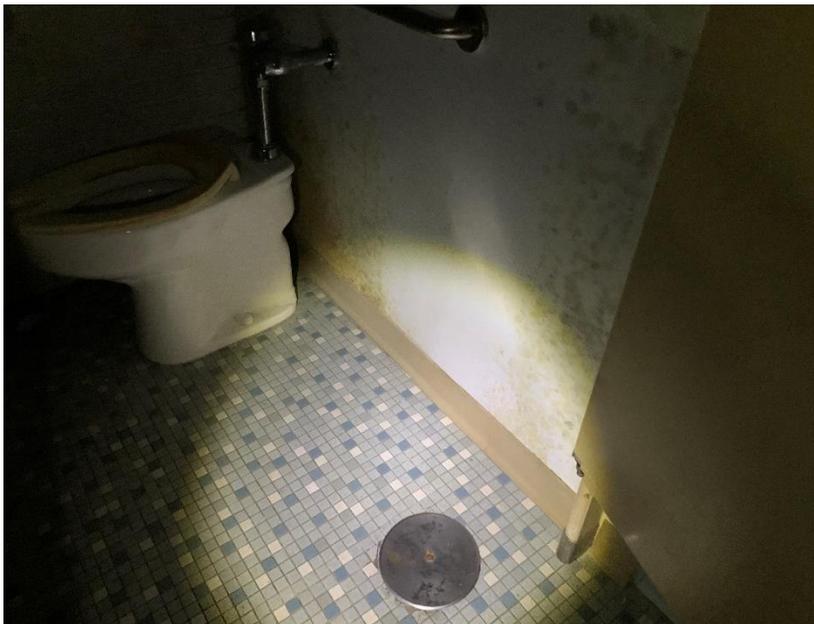
TETRA TECH PROJECT NO. X9030.19F.0101.005 Direction: NA	DESCRIPTION	This photograph shows ceramic tile grout typical of Rooms B34, B35, B45, B65, and B66.	26
	CLIENT	EPA	Date
	PHOTOGRAPHER	Zach Usher	11/6/2019

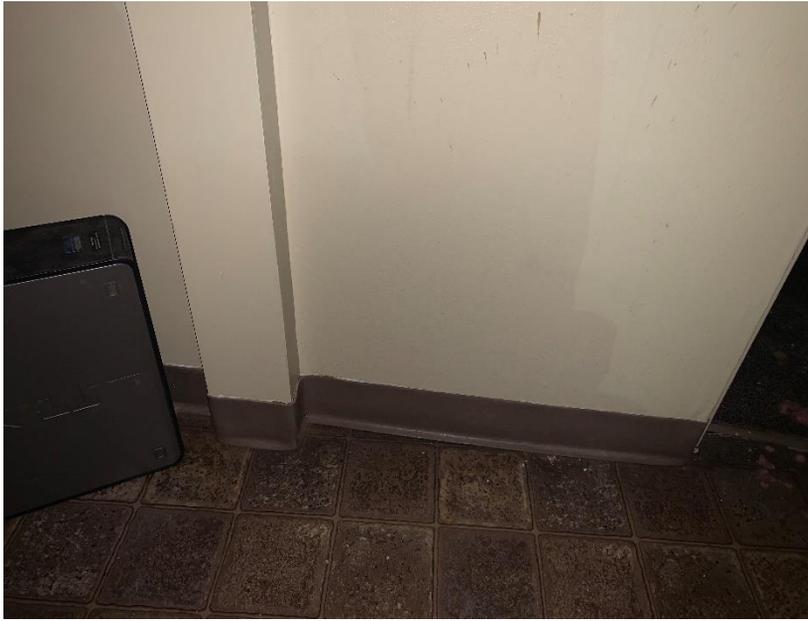
TETRA TECH PROJECT NO. X9030.19F.0101.005 Direction: NA	DESCRIPTION	This photograph shows 4" tan cove base typical of Rooms B67 and B68.	27
	CLIENT	EPA	Date
	PHOTOGRAPHER	Zach Usher	11/6/2019

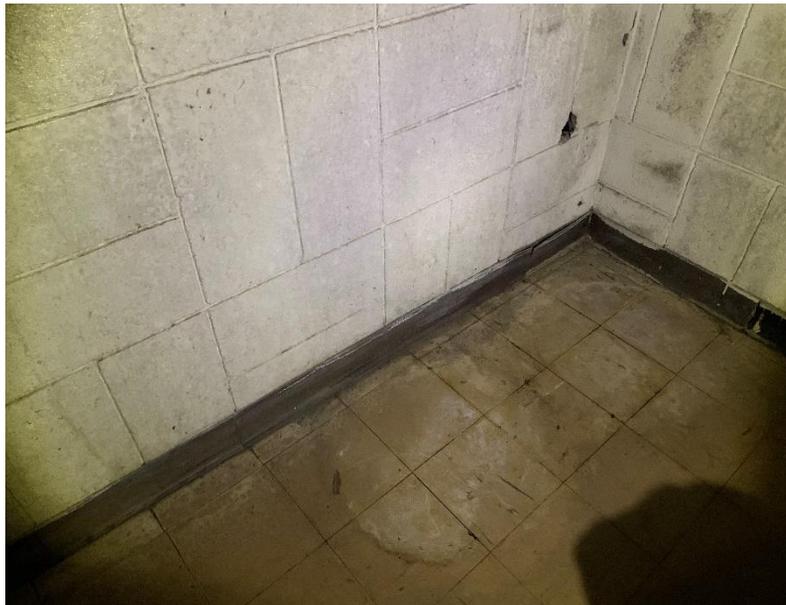
TETRA TECH PROJECT NO. X9030.19F.0101.005 Direction: NA	DESCRIPTION	This photograph shows 4" brown cove base in the second floor hallway.	30
	CLIENT	EPA	Date
	PHOTOGRAPHER	Zach Usher	11/6/2019

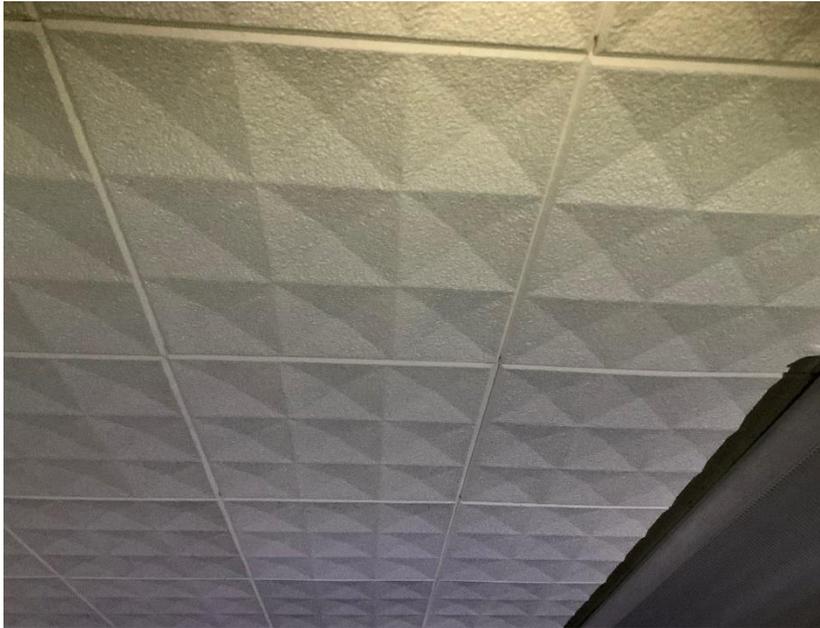
TETRA TECH PROJECT NO. X9030.19F.0101.005 Direction: NA	DESCRIPTION	This photograph shows 12" X 12" white divot ceiling tile in Room 39.	35
	CLIENT	EPA	Date
	PHOTOGRAPHER	Zach Usher	11/6/2019

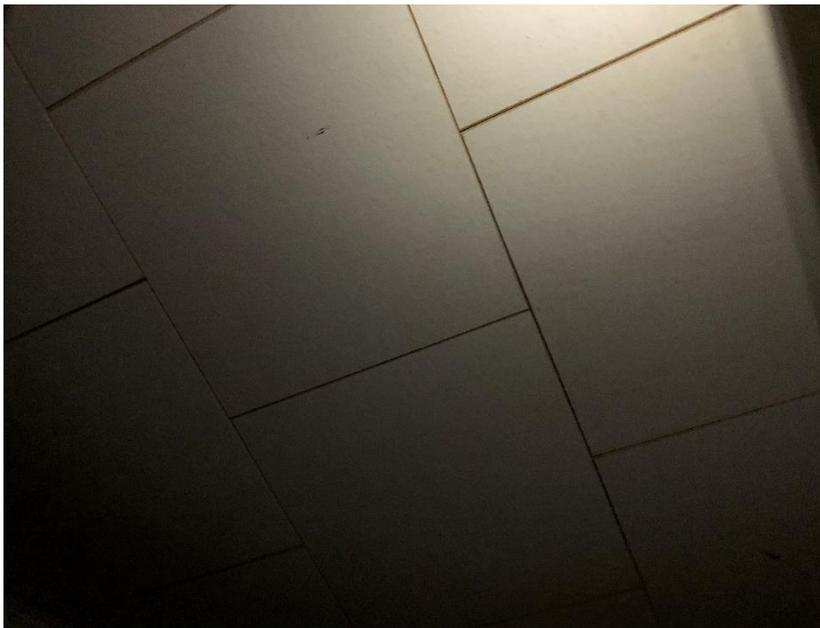
TETRA TECH PROJECT NO. X9030.19F.0101.005 Direction: NA	DESCRIPTION	This photograph shows 12" X 12" white smooth ceiling tile typical of Room 39 and Room 90.	36
	CLIENT	EPA	Date
	PHOTOGRAPHER	Zach Usher	11/6/2019

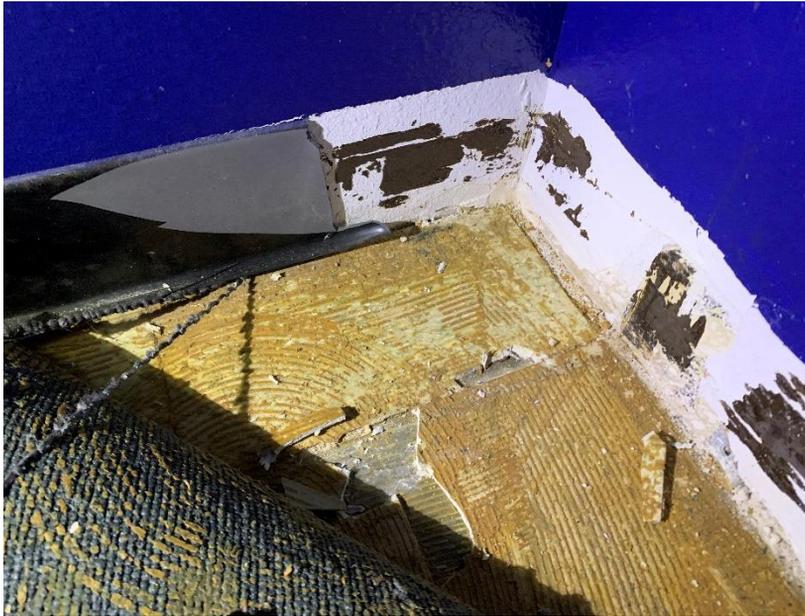
TETRA TECH PROJECT NO. X9030.19F.0101.005 Direction: NA	DESCRIPTION	This photograph shows 12" X 12" cream with green and white speck floor tile in the courtroom.	37
	CLIENT	EPA	Date
	PHOTOGRAPHER	Zach Usher	11/6/2019

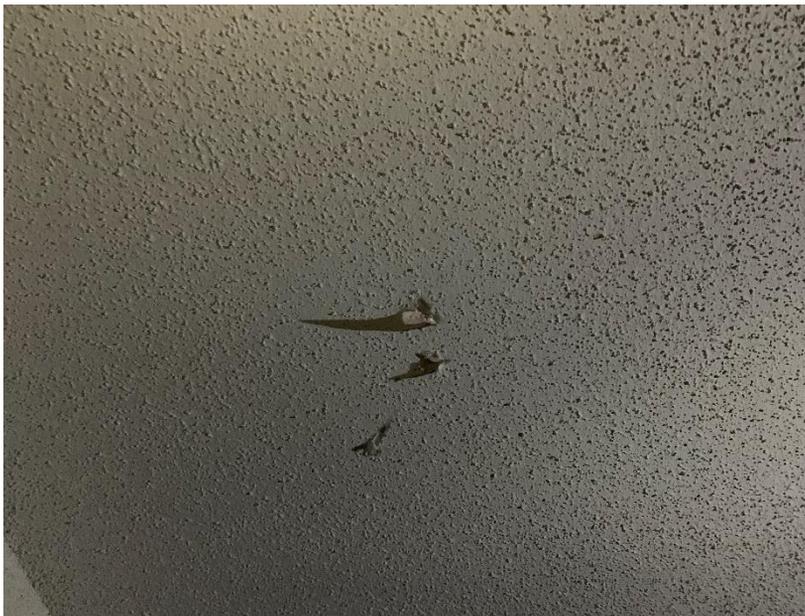
TETRA TECH PROJECT NO. X9030.19F.0101.005 Direction: NA	DESCRIPTION	This photograph shows ceiling texture on drywall in the courtroom.	38
	CLIENT	EPA	Date
	PHOTOGRAPHER	Zach Usher	11/6/2019

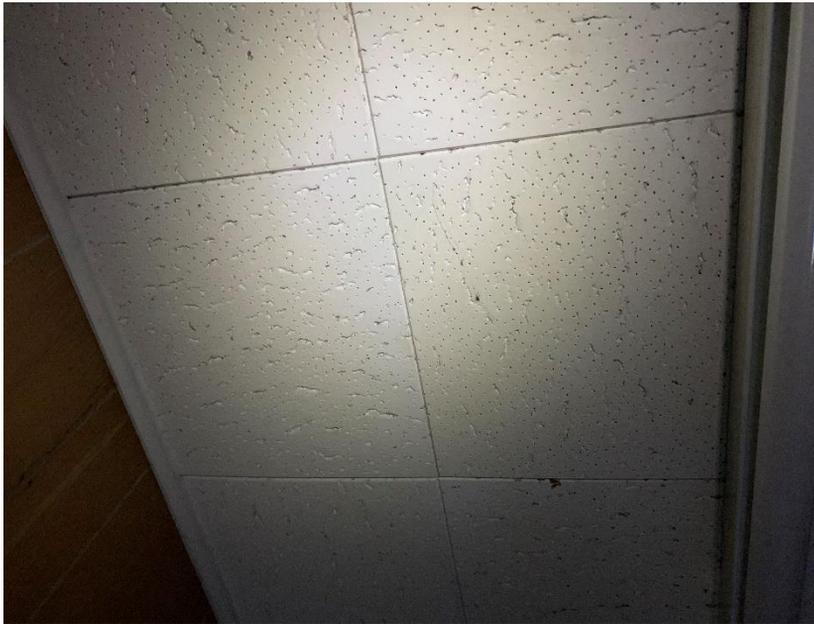
TETRA TECH PROJECT NO. X9030.19F.0101.005 Direction: NA	DESCRIPTION	This photograph shows 12" X 12" fissured pinhole ceiling tile in the courtroom hallway.	39
	CLIENT	EPA	Date
	PHOTOGRAPHER	Zach Usher	11/6/2019

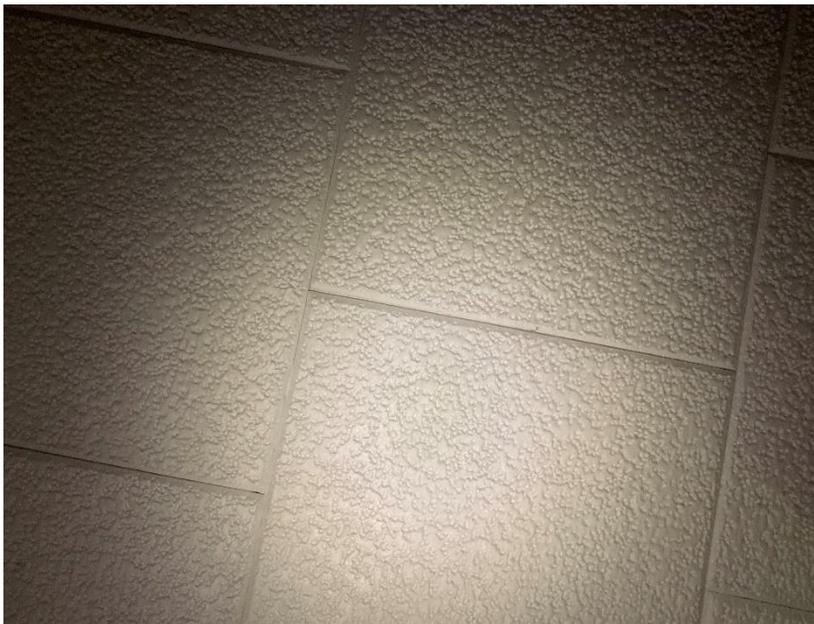
TETRA TECH PROJECT NO. X9030.19F.0101.005 Direction: NA	DESCRIPTION	This photograph shows 12" X 12" bubbled ceiling tile in Room 90.	40
	CLIENT	EPA	Date
	PHOTOGRAPHER	Zach Usher	11/6/2019

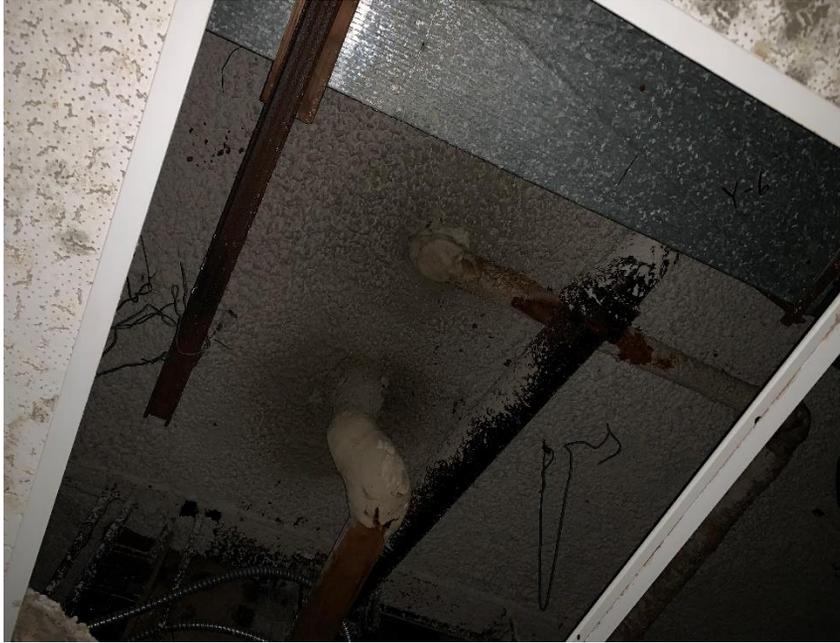
TETRA TECH PROJECT NO. X9030.19F.0101.005 Direction: NA	DESCRIPTION	This photograph shows mudded pipe joints in the west building area.	43
	CLIENT	EPA	Date
	PHOTOGRAPHER	Zach Usher	11/6/2019

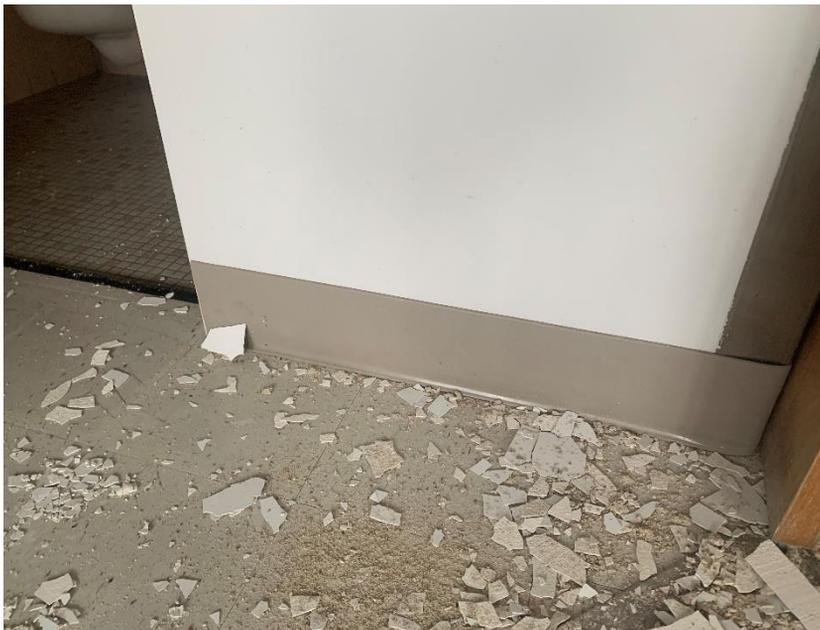
TETRA TECH PROJECT NO. X9030.19F.0101.005 Direction: NA	DESCRIPTION	This photograph shows 8" grey cove base in Room 71.	44
	CLIENT	EPA	Date
	PHOTOGRAPHER	Zach Usher	11/6/2019

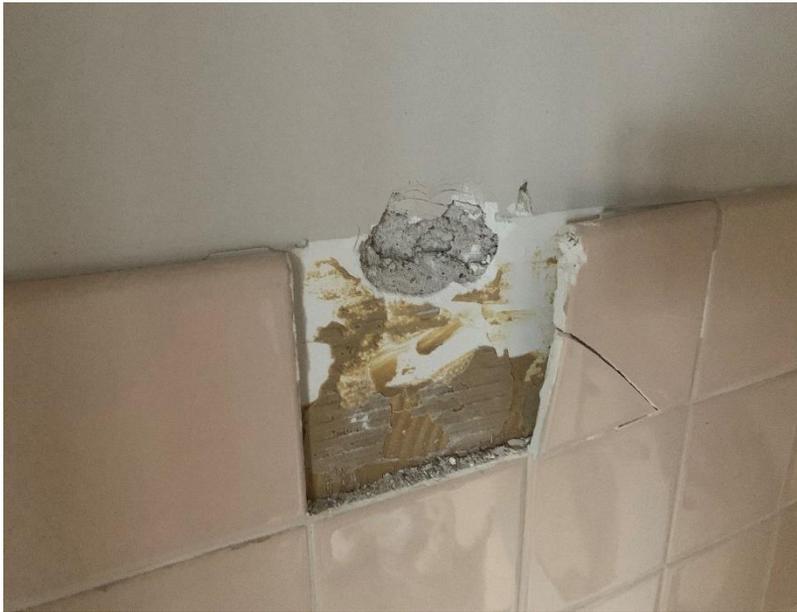
TETRA TECH PROJECT NO. X9030.19F.0101.005 Direction: NA	DESCRIPTION	This photograph shows grey grout and ceramic tile mastic in the second floor bathrooms.	45
	CLIENT	EPA	Date
	PHOTOGRAPHER	Zach Usher	11/6/2019

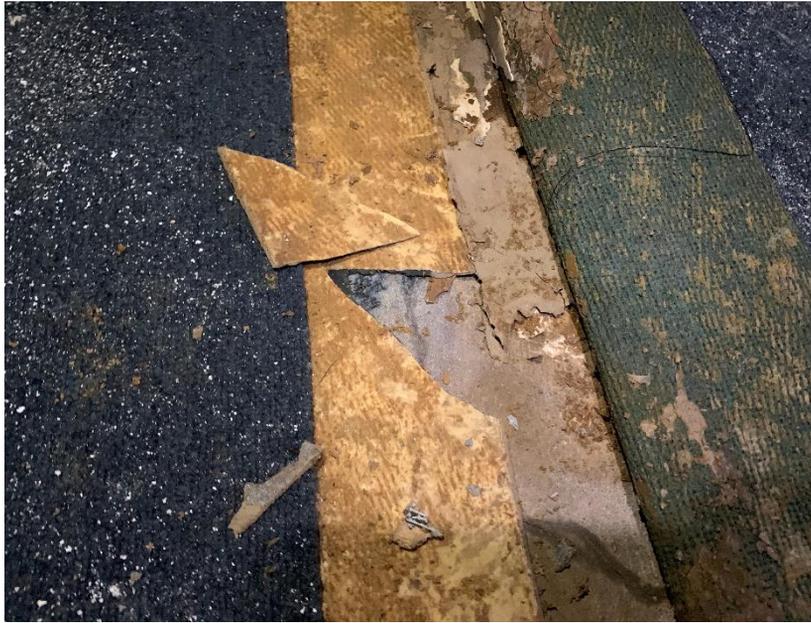
TETRA TECH PROJECT NO. X9030.19F.0101.005 Direction: NA	DESCRIPTION	This photograph shows carpet mastic on top of yellow linoleum and grey linoleum in the narcotics room.	47
	CLIENT	EPA	Date
	PHOTOGRAPHER	Zach Usher	11/6/2019

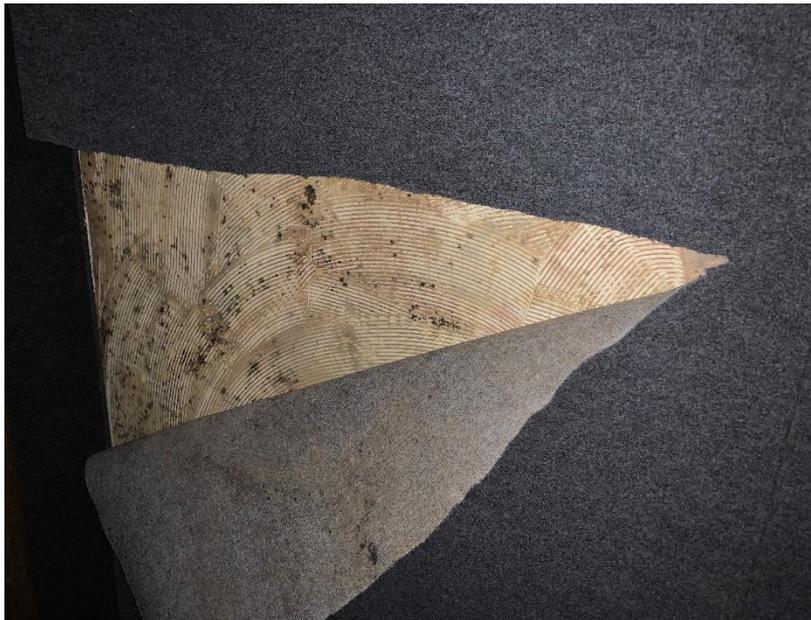
TETRA TECH PROJECT NO. X9030.19F.0101.005 Direction: NA	DESCRIPTION	This photograph shows wall carpet mastic typical of the interview room and Room 79.	48
	CLIENT	EPA	Date
	PHOTOGRAPHER	Zach Usher	11/6/2019

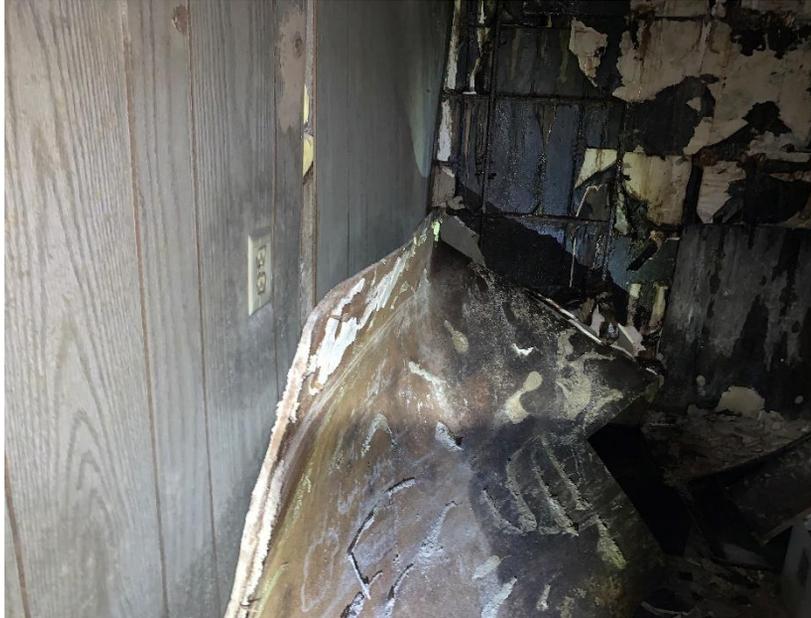
TETRA TECH PROJECT NO. X9030.19F.0101.005 Direction: NA	DESCRIPTION	This photograph shows wood wall panel mastic in the storage room off of main second floor hallway.	49
	CLIENT	EPA	Date
	PHOTOGRAPHER	Zach Usher	11/6/2019

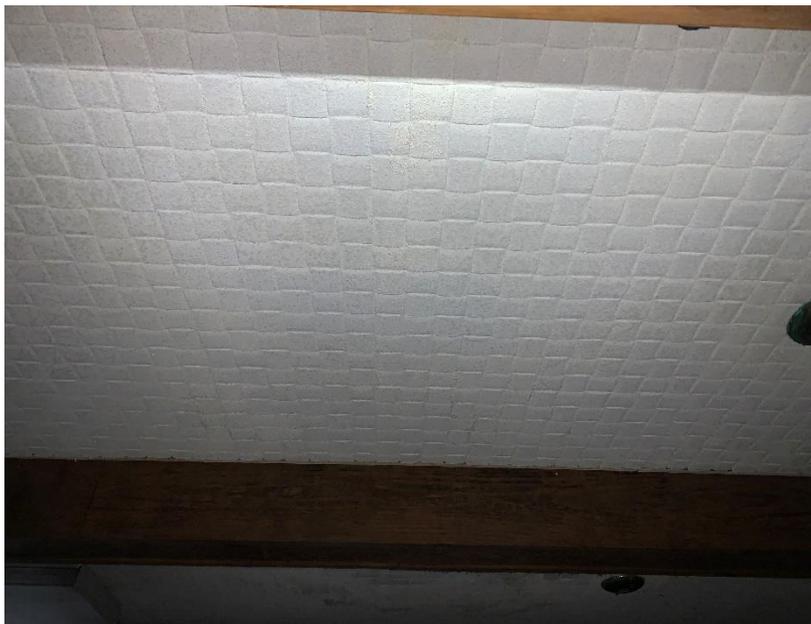
TETRA TECH PROJECT NO. X9030.19F.0101.005 Direction: NA	DESCRIPTION	This photograph shows 12" X 12" white square divot ceiling tile typical of the narcotics room and bathroom.	50
	CLIENT	EPA	Date
	PHOTOGRAPHER	Zach Usher	11/6/2019

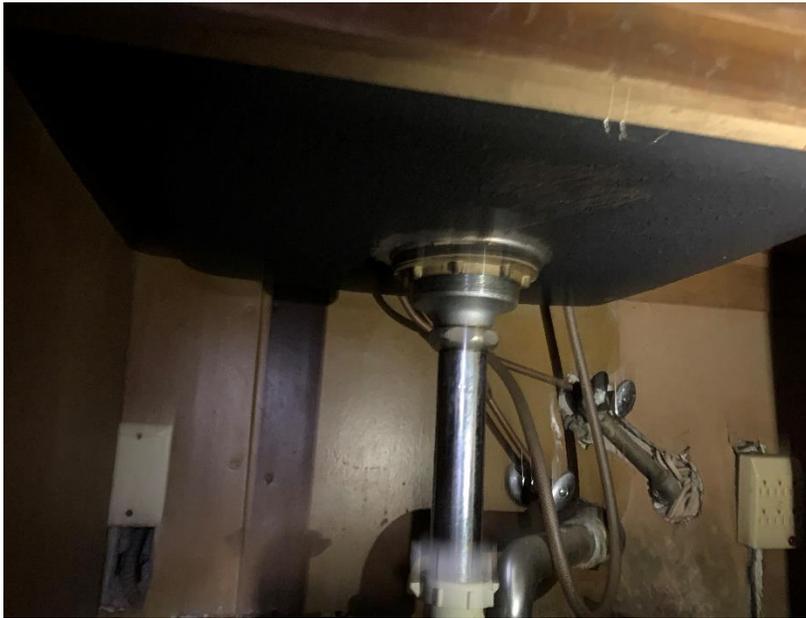
TETRA TECH PROJECT NO. X9030.19F.0101.005 Direction: NA	DESCRIPTION	This photograph shows black sink coating in the narcotics room.	51
	CLIENT	EPA	Date
	PHOTOGRAPHER	Zach Usher	11/6/2019

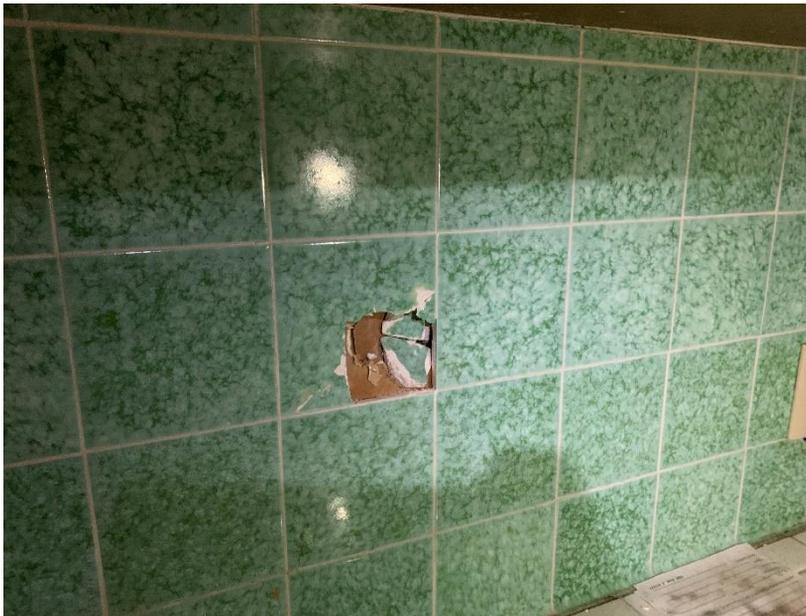
TETRA TECH PROJECT NO. X9030.19F.0101.005 Direction: NA	DESCRIPTION	This photograph shows green ceramic tile mastic in the narcotics room.	52
	CLIENT	EPA	Date
	PHOTOGRAPHER	Zach Usher	11/6/2019

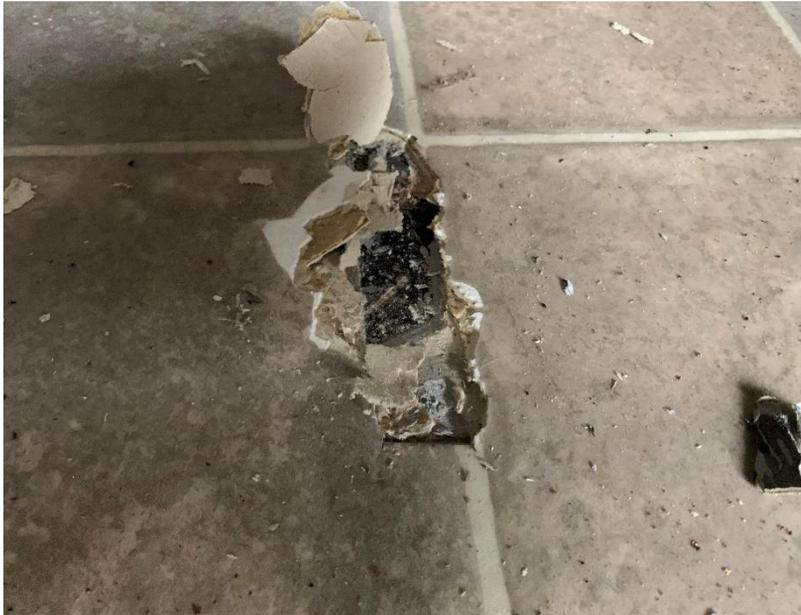
TETRA TECH PROJECT NO. X9030.19F.0101.005 Direction: NA	DESCRIPTION	This photograph shows grey floor tile under linoleum in the men's locker room.	53
	CLIENT	EPA	Date
	PHOTOGRAPHER	Zach Usher	11/6/2019

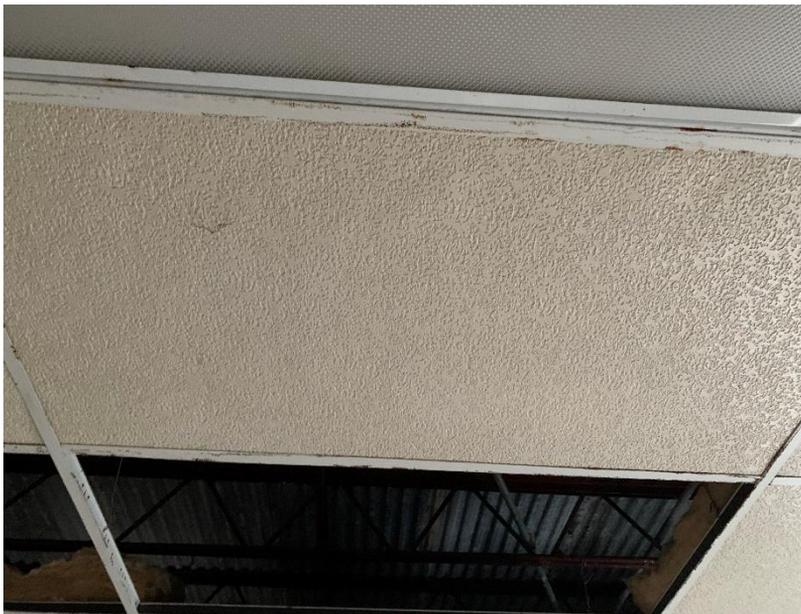
TETRA TECH PROJECT NO. X9030.19F.0101.005 Direction: NA	DESCRIPTION	This photograph shows cream 2' X 4' pinhole texture ceiling tile in the men's locker room.	54
	CLIENT	EPA	Date
	PHOTOGRAPHER	Zach Usher	11/6/2019

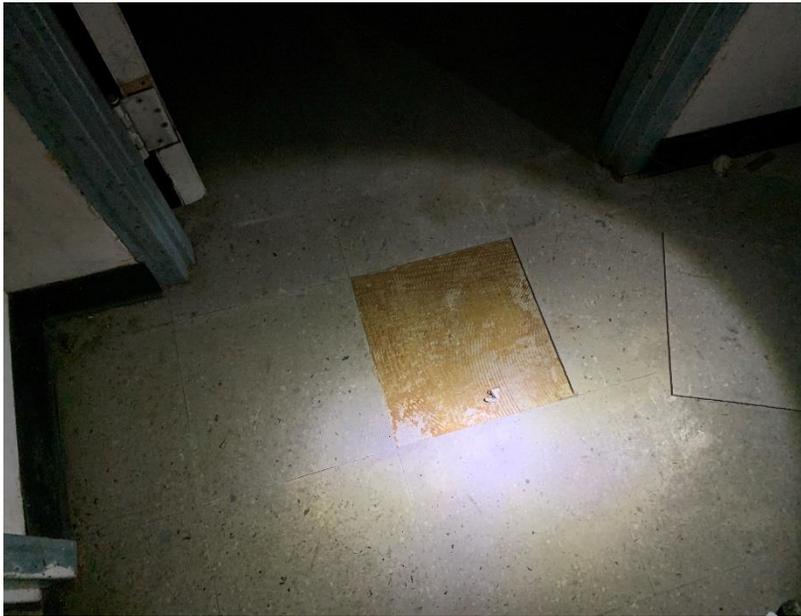
TETRA TECH PROJECT NO. X9030.19F.0101.005 Direction: NA	DESCRIPTION	This photograph shows 12" X 12" grey with white and black speck floor tile in Room 81.	55
	CLIENT	EPA	Date
	PHOTOGRAPHER	Zach Usher	11/6/2019

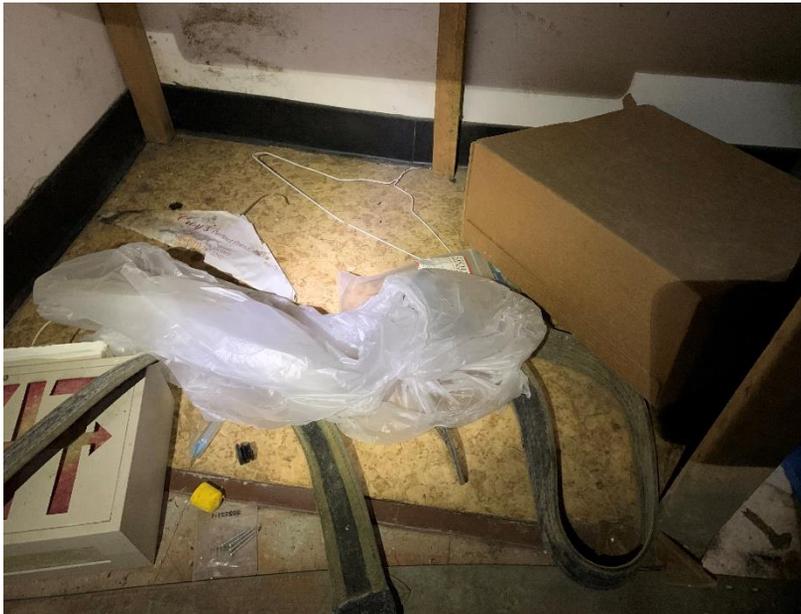
TETRA TECH PROJECT NO. X9030.19F.0101.005 Direction: NA	DESCRIPTION	This photograph shows brown and tan pattern linoleum in Room 81.	56
	CLIENT	EPA	Date
	PHOTOGRAPHER	Zach Usher	11/6/2019

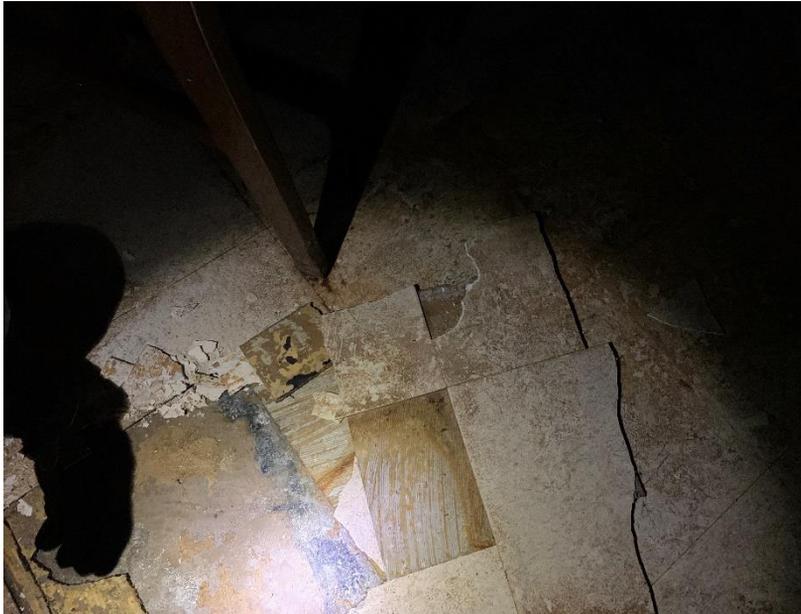
TETRA TECH PROJECT NO. X9030.19F.0101.005 Direction: NA	DESCRIPTION	This photograph shows 12" X 12" blue with black and white speck floor tile under 12" X 12" white floor tile on linoleum typical of the second floor north hallway; the hallway east of Room 85; the hallway closet bathroom; Rooms 84 and 81; the armory; and women's locker room.	57
	CLIENT	EPA	Date
	PHOTOGRAPHER	Zach Usher	11/6/2019

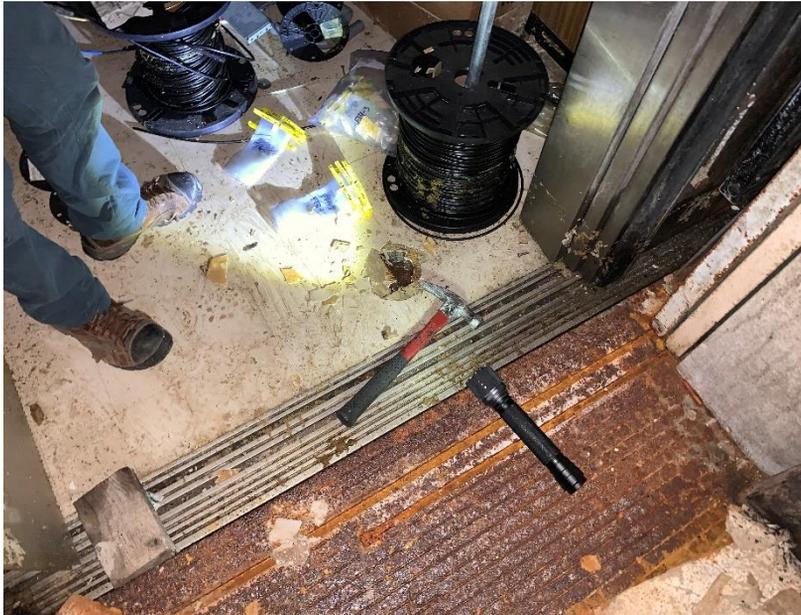
TETRA TECH PROJECT NO. X9030.19F.0101.005 Direction: NA	DESCRIPTION	This photograph shows 12" X 12" thin tan floor tile on top of grey floor tile in the elevator.	61
	CLIENT	EPA	Date
	PHOTOGRAPHER	Zach Usher	11/6/2019

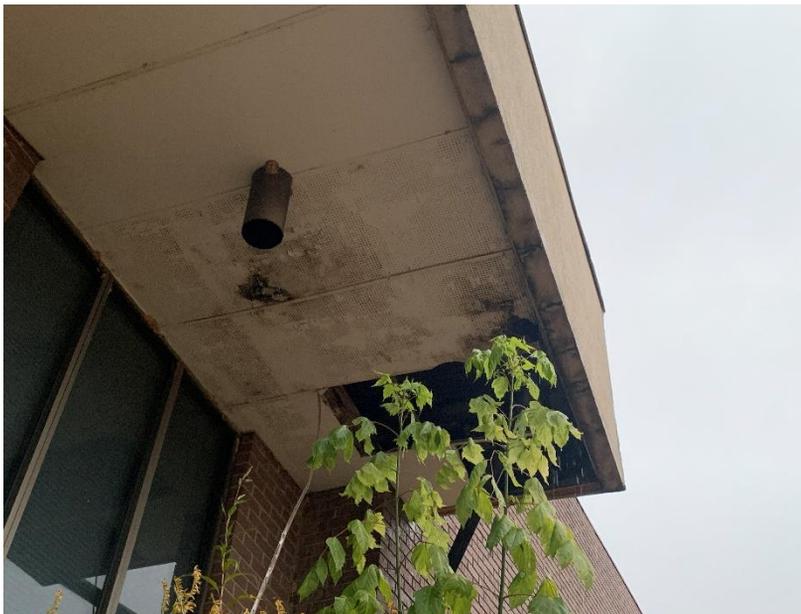
TETRA TECH PROJECT NO. X9030.19F.0101.005 Direction: NA	DESCRIPTION	This photograph shows transite panels on south soffit of the building.	62
	CLIENT	EPA	Date
	PHOTOGRAPHER	Zach Usher	11/6/2019

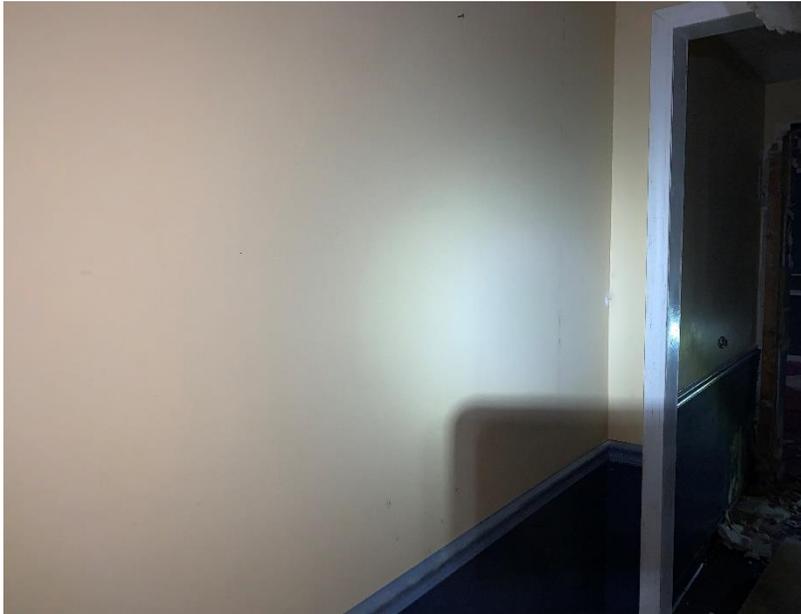
TETRA TECH PROJECT NO. X9030.19F.0101.005 Direction: NA	DESCRIPTION	This photograph shows drywall in the original west side of the building.	63
	CLIENT	EPA	Date
	PHOTOGRAPHER	Zach Usher	11/6/2019

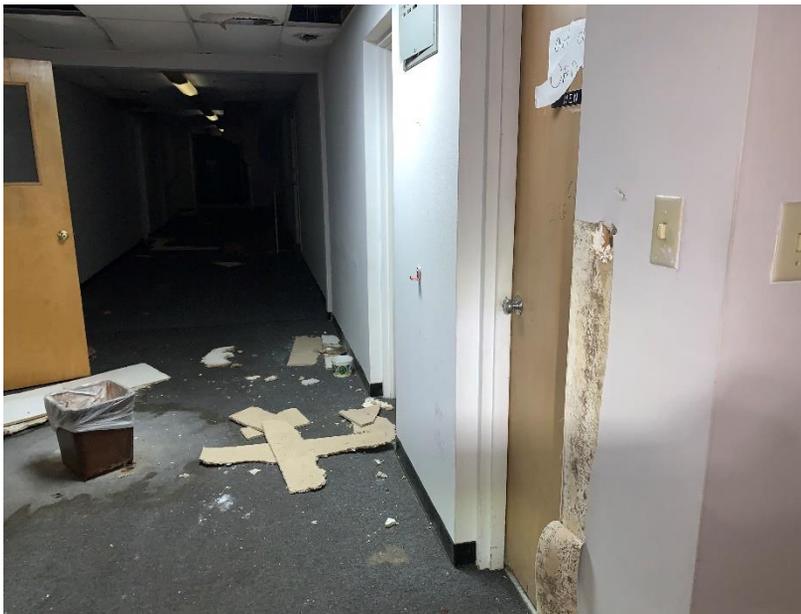
TETRA TECH PROJECT NO. X9030.19F.0101.005 Direction: NA	DESCRIPTION	This photograph shows drywall in the east side of the first floor.	64
	CLIENT	EPA	Date
	PHOTOGRAPHER	Zach Usher	11/6/2019

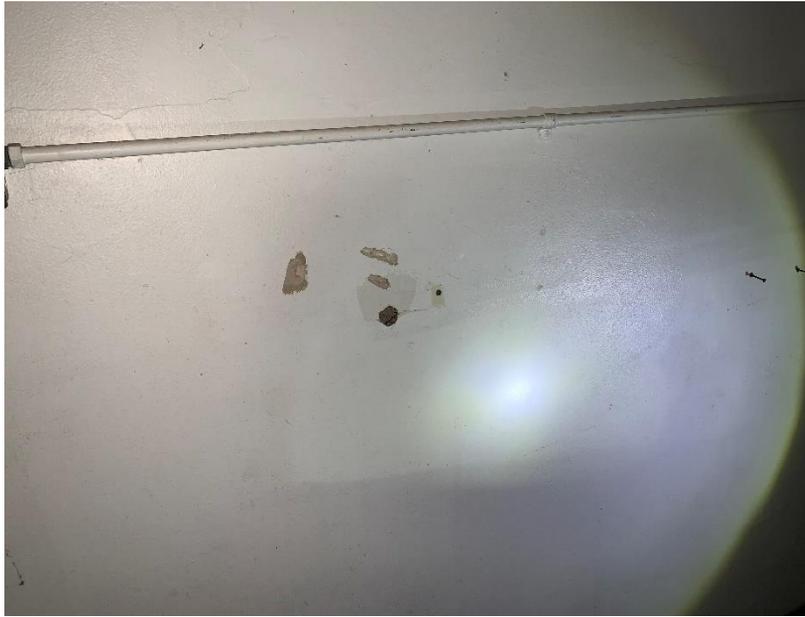
TETRA TECH PROJECT NO. X9030.19F.0101.005 Direction: NA	DESCRIPTION	This photograph shows plaster on the first floor.	65
	CLIENT	EPA	Date
	PHOTOGRAPHER	Zach Usher	11/6/2019
