**Subject: Targeted Brownfields Assessment
Hazardous Materials Survey
Oak Street City Hall Site
Poplar Bluff, Butler County, Missouri
U.S. EPA Region 7 START 5, Contract No. 68HE0719D0001
Task Order No. 19F0101.005
Task Monitor: Todd Davis, Site Assessment Manager**

**TARGETED BROWNFIELDS ASSESSMENT
HAZARDOUS MATERIALS SURVEY**

**OAK STREET CITY HALL
POPLAR BLUFF, BUTLER COUNTY, MISSOURI**

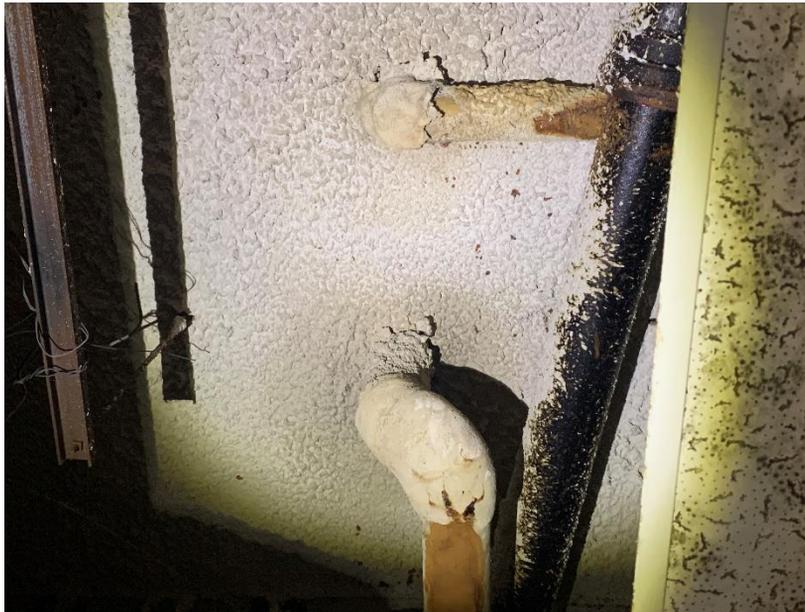
TETRA TECH PROJECT NO. X9030.19F.0101.005 Direction: NA	DESCRIPTION	This photograph shows spray-on plaster ceiling in west side of first floor.	66
	CLIENT	EPA	Date
	PHOTOGRAPHER	Zach Usher	11/6/2019

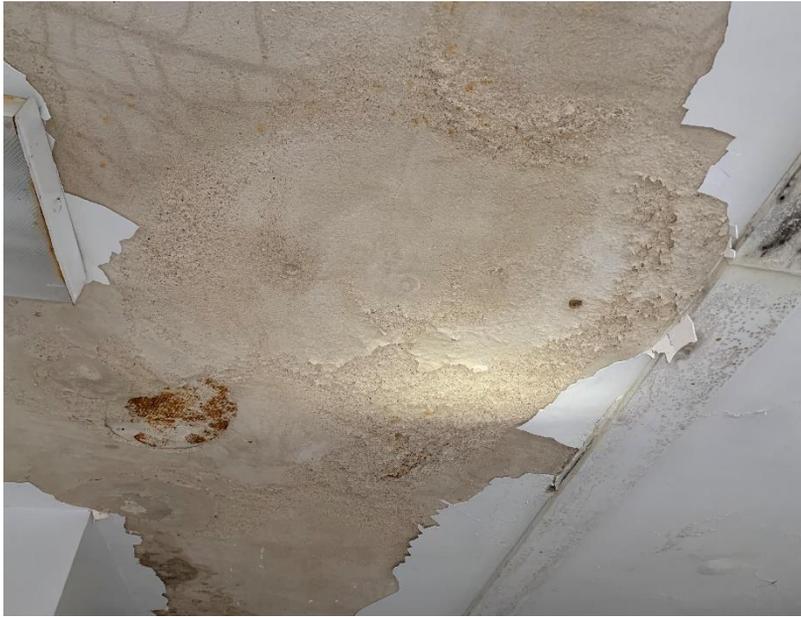
TETRA TECH PROJECT NO. X9030.19F.0101.005 Direction: NA	DESCRIPTION	This photograph shows plaster on the second floor.	67
	CLIENT	EPA	Date
	PHOTOGRAPHER	Zach Usher	11/6/2019

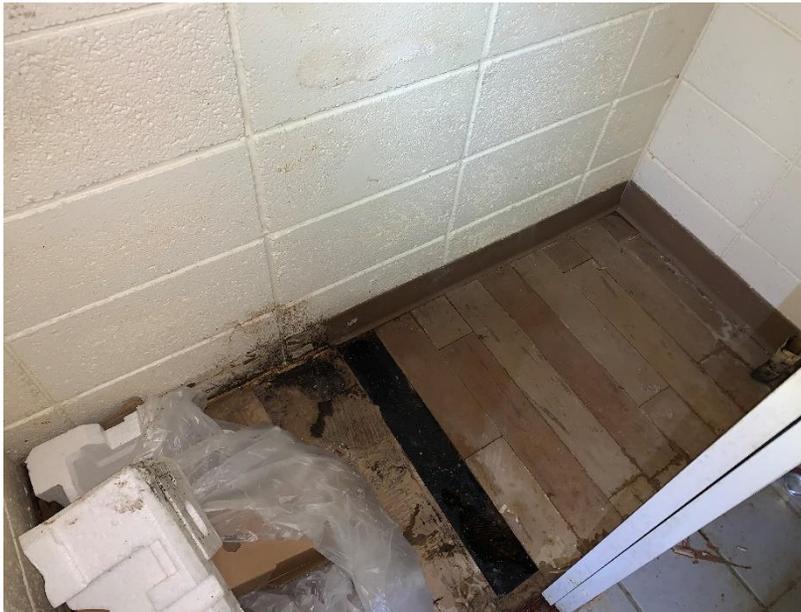
TETRA TECH PROJECT NO. X9030.19F.0101.005 Direction: NA	DESCRIPTION	This photograph shows 4" X 12" brown floor tile and pink cove base in the closet southwest of Room 48.	68
	CLIENT	EPA	Date
	PHOTOGRAPHER	Zach Usher	11/6/2019

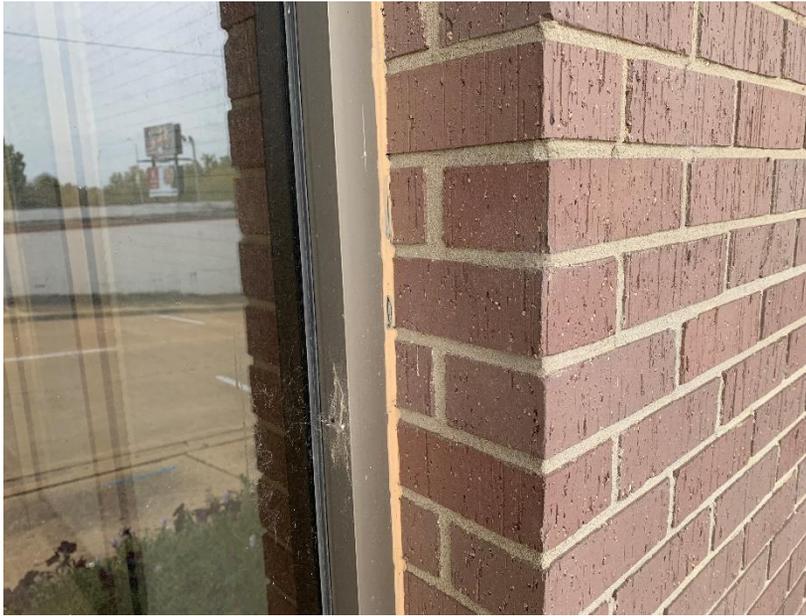
TETRA TECH PROJECT NO. X9030.19F.0101.005 Direction: NA	DESCRIPTION	This photograph shows brown caulk typical of south exterior windows.	69
	CLIENT	EPA	Date
	PHOTOGRAPHER	Zach Usher	11/6/2019

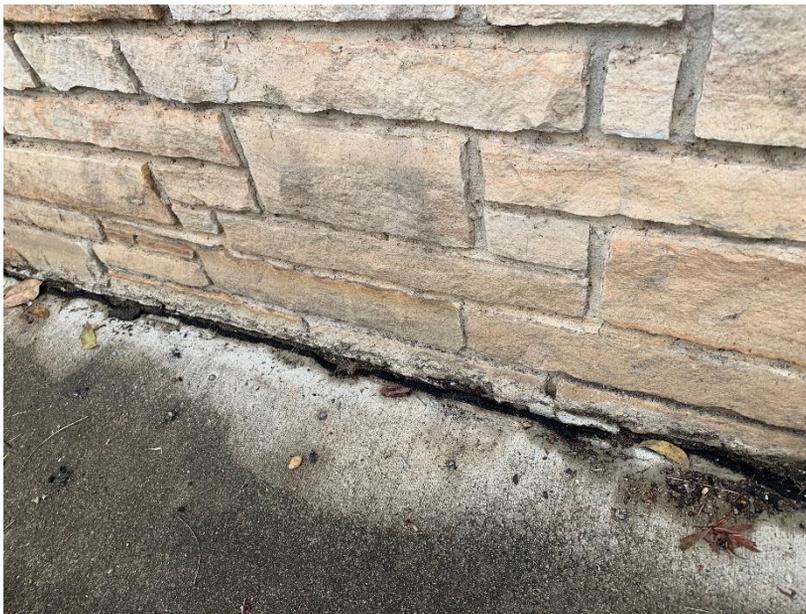
TETRA TECH PROJECT NO. X9030.19F.0101.005 Direction: NA	DESCRIPTION	This photograph shows black expansion caulk typical of the east exterior and west entrance of the building.	70
	CLIENT	EPA	Date
	PHOTOGRAPHER	Zach Usher	11/6/2019

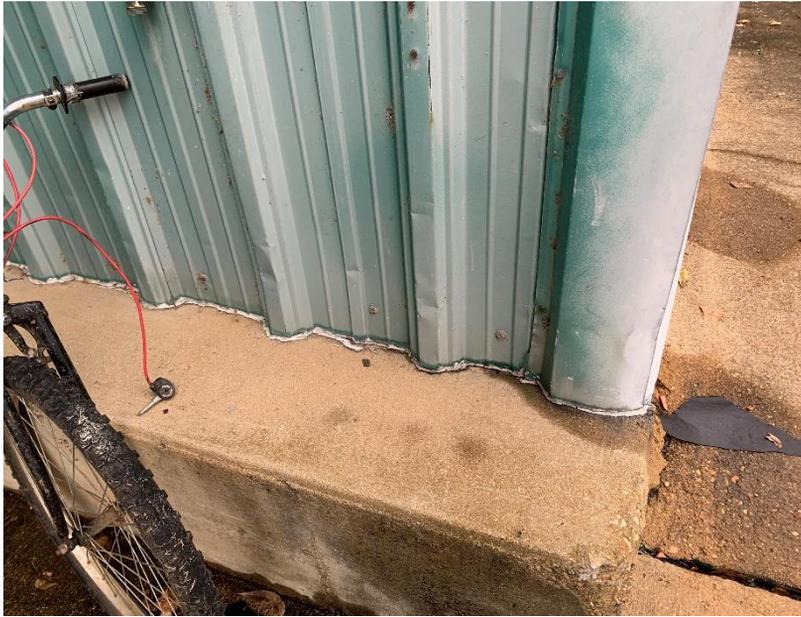
TETRA TECH PROJECT NO. X9030.19F.0101.005 Direction: NA	DESCRIPTION	This photograph shows white expansion caulk on the south exterior of the evidence building.	71
	CLIENT	EPA	Date
	PHOTOGRAPHER	Zach Usher	11/6/2019

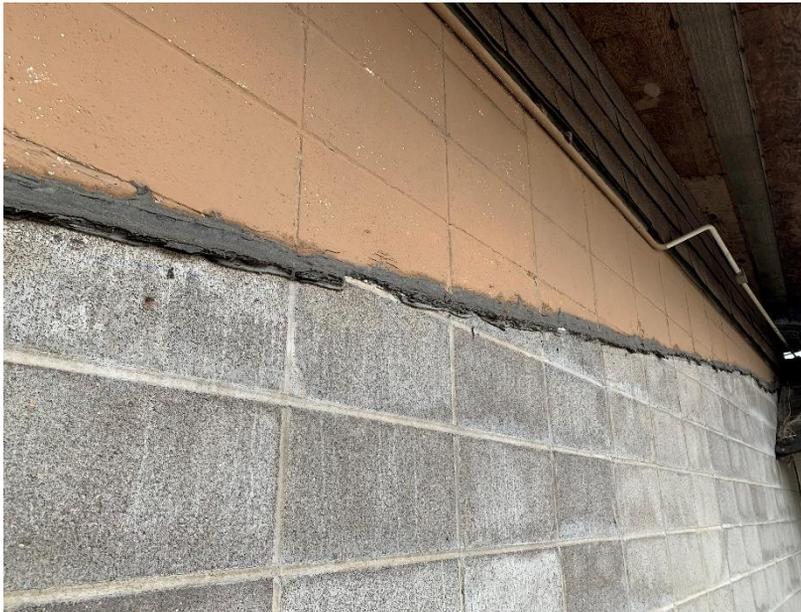
TETRA TECH PROJECT NO. X9030.19F.0101.005 Direction: NA	DESCRIPTION	This photograph shows black expansion caulk on the exterior loading dock on the north side of the building.	72
	CLIENT	EPA	Date
	PHOTOGRAPHER	Zach Usher	11/6/2019

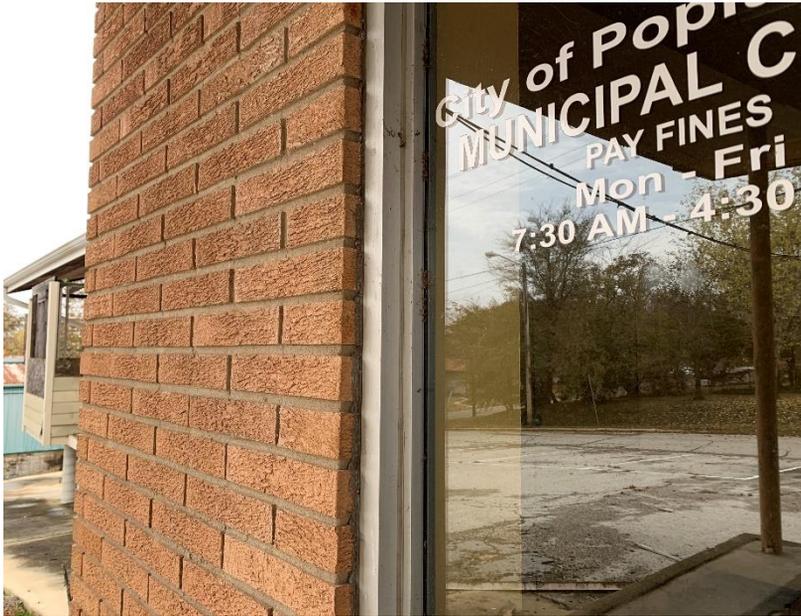
TETRA TECH PROJECT NO. X9030.19F.0101.005 Direction: NA	DESCRIPTION	This photograph shows grey caulk typical of north exterior doors.	73
	CLIENT	EPA	Date
	PHOTOGRAPHER	Zach Usher	11/6/2019

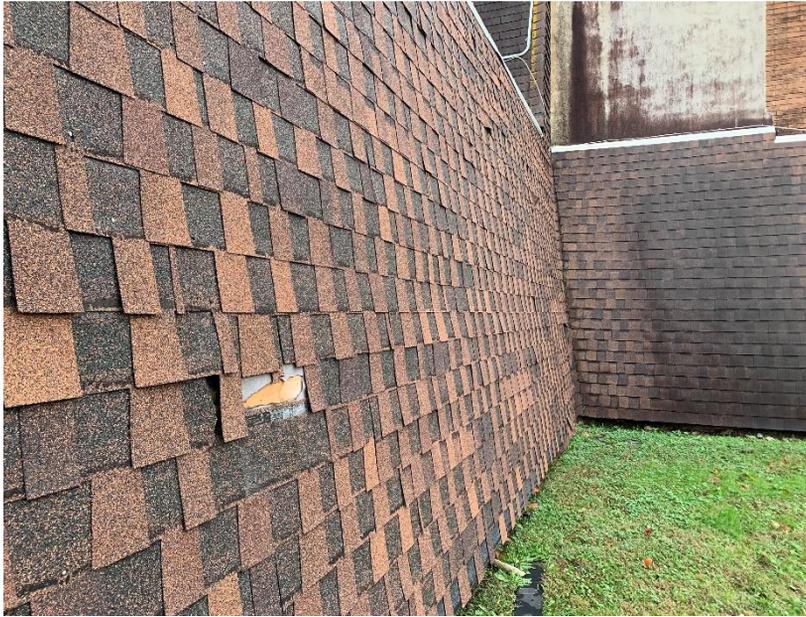
TETRA TECH PROJECT NO. X9030.19F.0101.005 Direction: NA	DESCRIPTION	This photograph shows siding shingles on top of the vapor barrier on the west exterior of the building.	75
	CLIENT	EPA	Date
	PHOTOGRAPHER	Zach Usher	11/6/2019

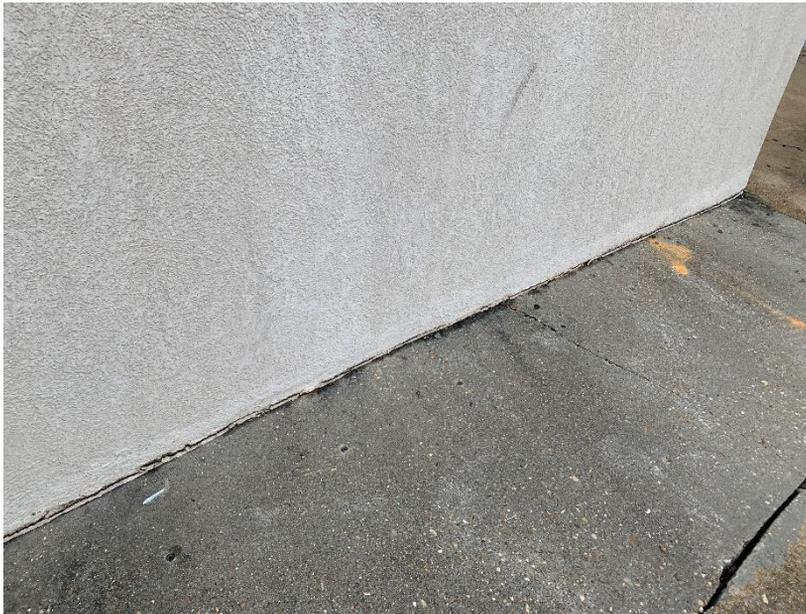
TETRA TECH PROJECT NO. X9030.19F.0101.005 Direction: NA	DESCRIPTION	This photograph shows tan expansion caulk on the west exterior of the building.	76
	CLIENT	EPA	Date
	PHOTOGRAPHER	Zach Usher	11/6/2019

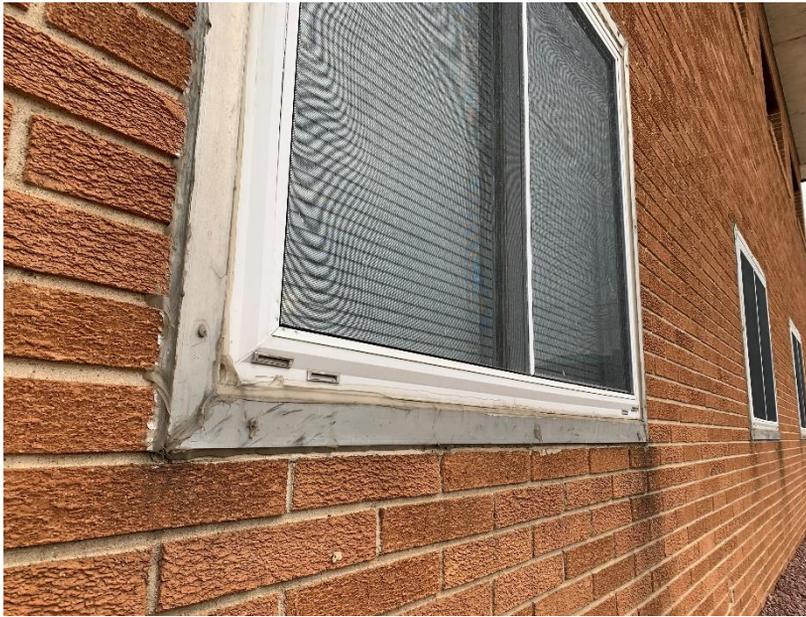
TETRA TECH PROJECT NO. X9030.19F.0101.005 Direction: NA	DESCRIPTION	This photograph shows clear caulk typical of exterior first floor west windows.	77
	CLIENT	EPA	Date
	PHOTOGRAPHER	Zach Usher	11/6/2019

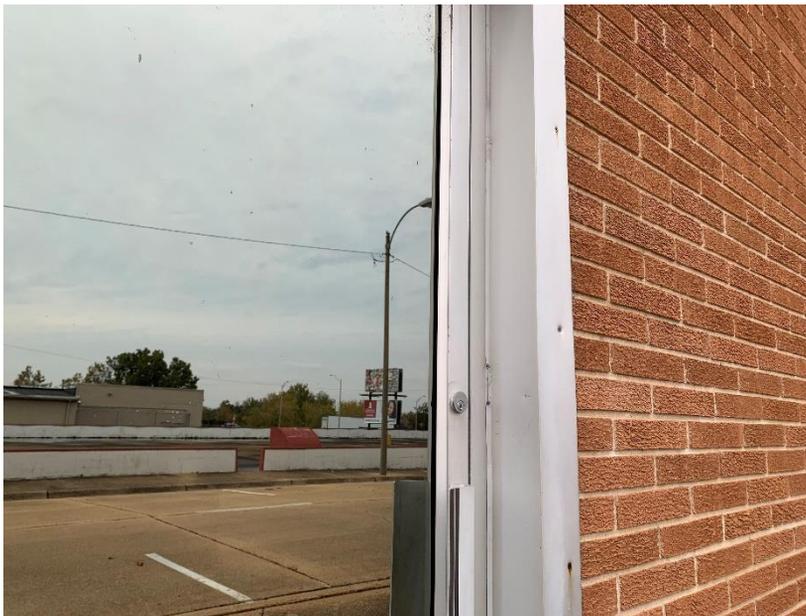
TETRA TECH PROJECT NO. X9030.19F.0101.005 Direction: NA	DESCRIPTION	This photograph shows grey caulk typical of south exterior police department doors.	78
	CLIENT	EPA	Date
	PHOTOGRAPHER	Zach Usher	11/6/2019

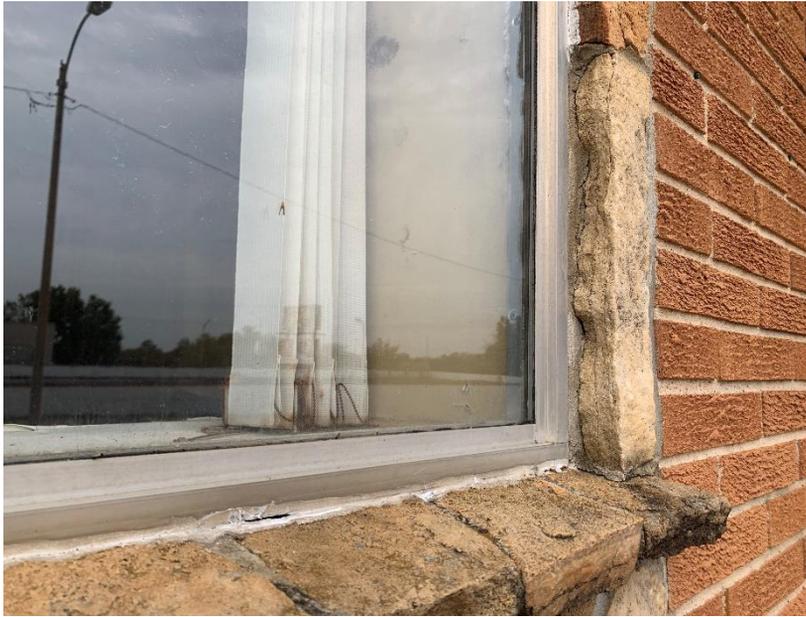
TETRA TECH PROJECT NO. X9030.19F.0101.005 Direction: NA	DESCRIPTION	This photograph shows black glazing typical of south exterior windows.	79
	CLIENT	EPA	Date
	PHOTOGRAPHER	Zach Usher	11/6/2019

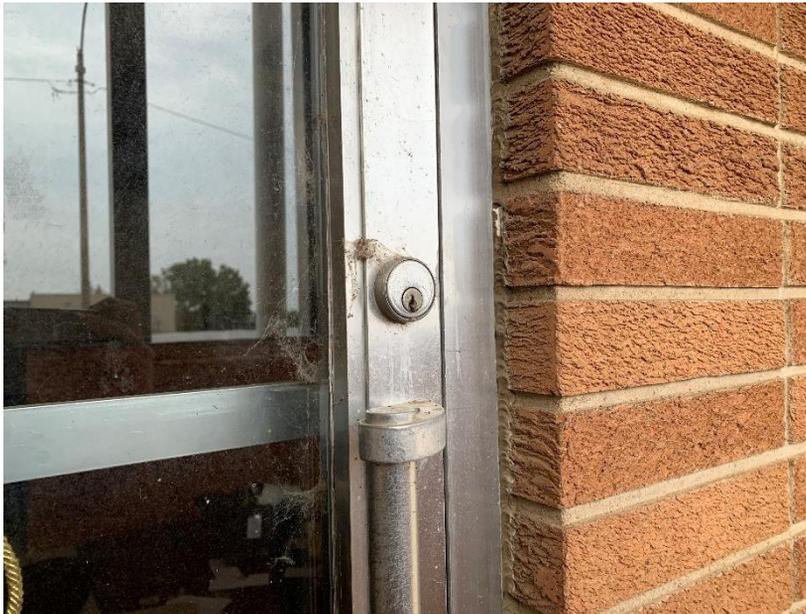
TETRA TECH PROJECT NO. X9030.19F.0101.005 Direction: NA	DESCRIPTION	This photograph shows light brown caulk on south exterior door.	80
	CLIENT	EPA	Date
	PHOTOGRAPHER	Zach Usher	11/6/2019
