Weston Solutions, Inc.
2300 Clayton Road, Suite 900
Concord, CA 94520
www.westonsolutions.com

August 12, 2019

**Subject: Navajo Forest Product Industry (NFPI) 2019 Removal Assessment
Red Lake Chapter, Navajo Nation, New Mexico
TDD No.: 0020/1302-T20-R9-19-05-0001
Document Control No.: 0231-08-ACHS**

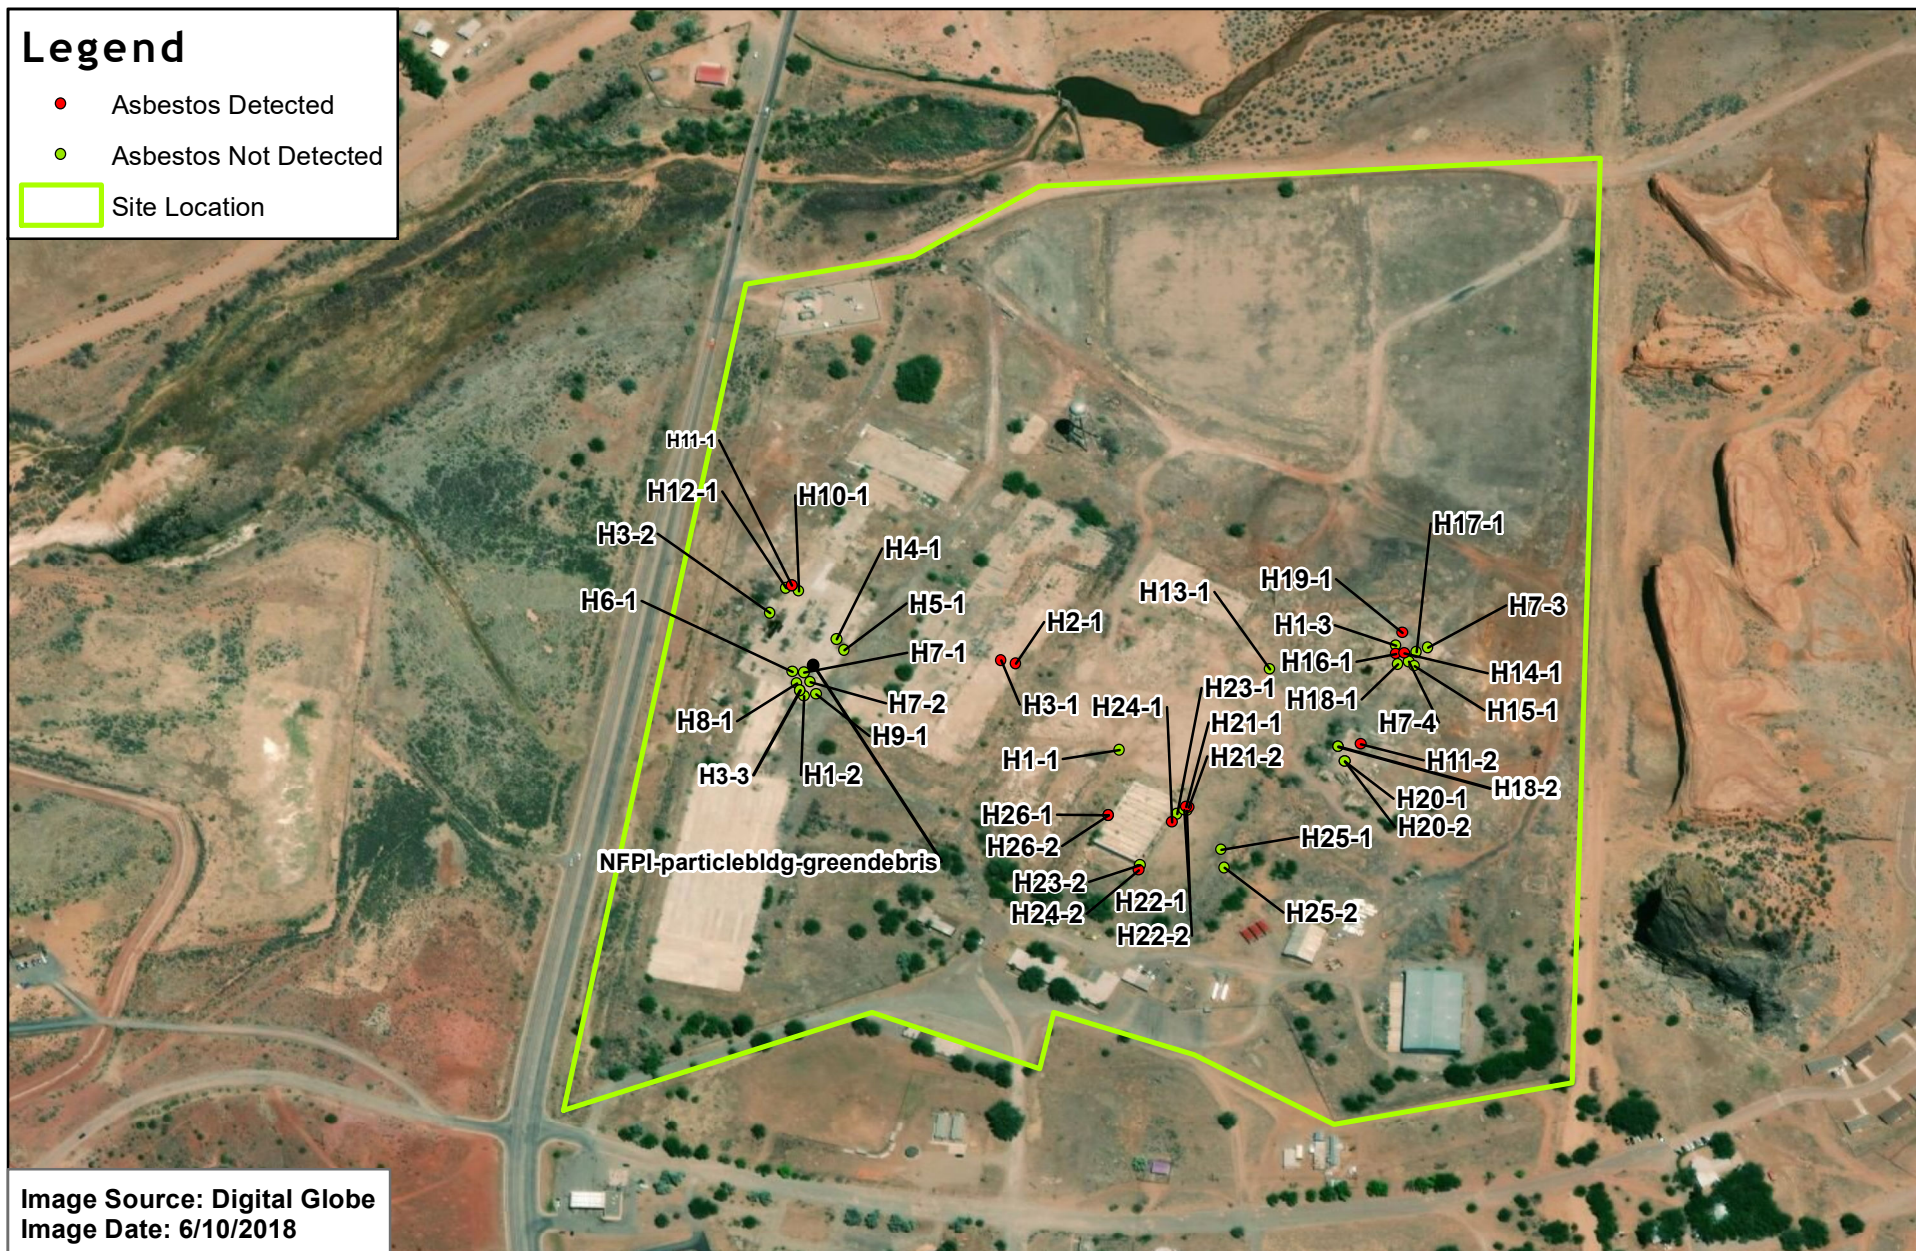
FIGURE 3
JUNE 2019
MATERIAL SAMPLING LOCATIONS
Former Navajo Forest Products Industries
Navajo, McKinley County, New Mexico

A total of 42 bulk samples were collected and 46 separate layers were analyzed. Of the 13 bulk samples collected to further evaluate the building materials associated with the former Drying Kiln Building, six samples contained asbestos at concentrations ranging from 2% to 15% chrysotile. Of the remaining 29 bulk samples collected from the debris located throughout the Site, seven samples contained asbestos at concentrations ranging from 3% to 60% chrysotile. Chrysotile, positive detections are show below in Table 1. **Figure 3** and **Figure 4** show the location of the asbestos bulk samples collected at the Site.

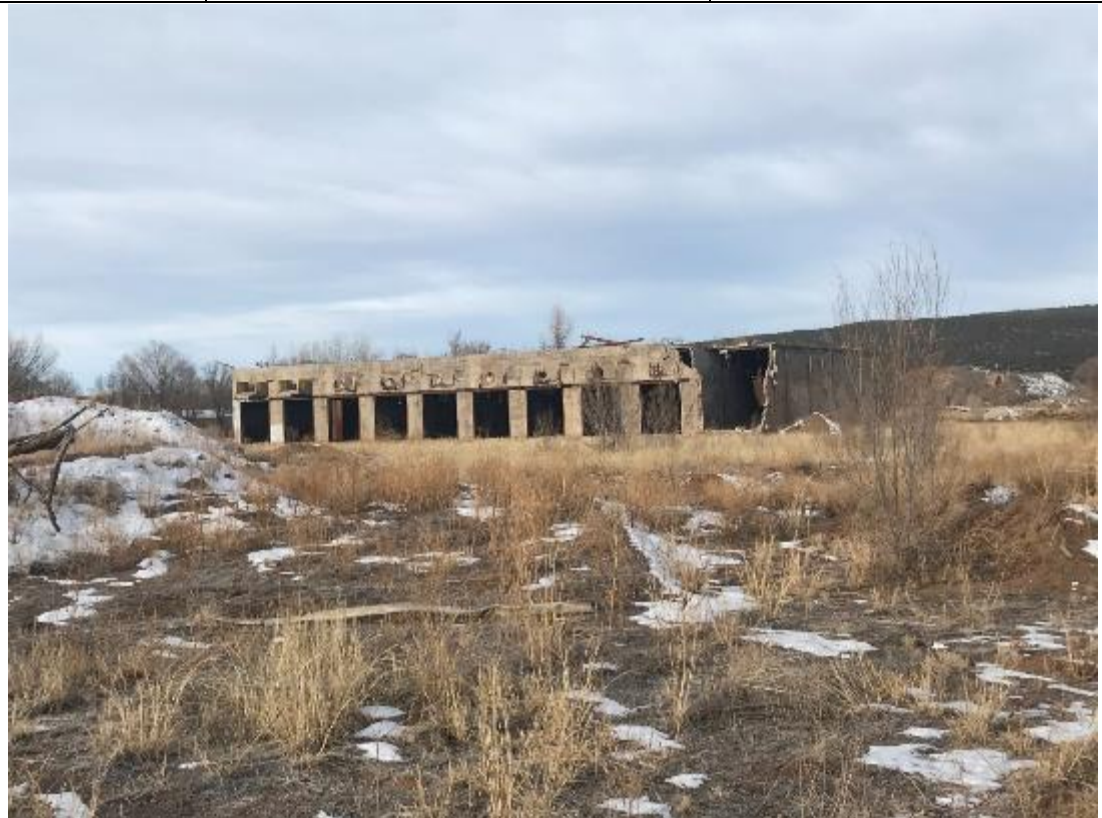
Drying Kiln Building at Former NFPI.

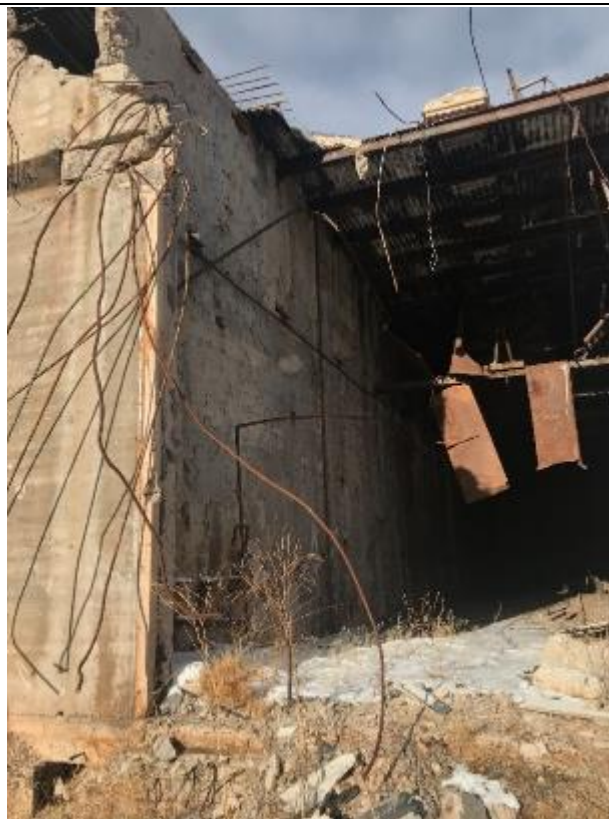
Photo No.
2

Bay 10 of the Drying Kiln Building.

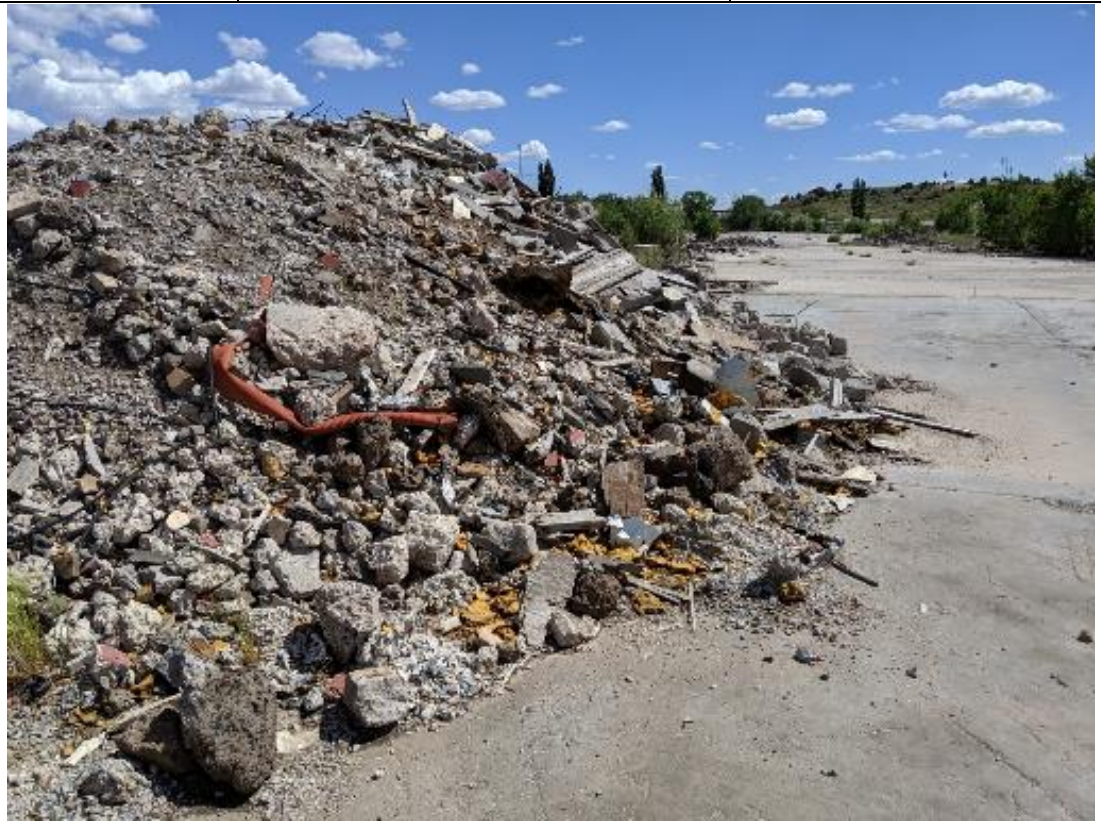
Photo No. 3	Date: 6/18/2019
Direction Photo Taken: South	
Description: Debris pile located on the concrete slab of the former Particle Building.

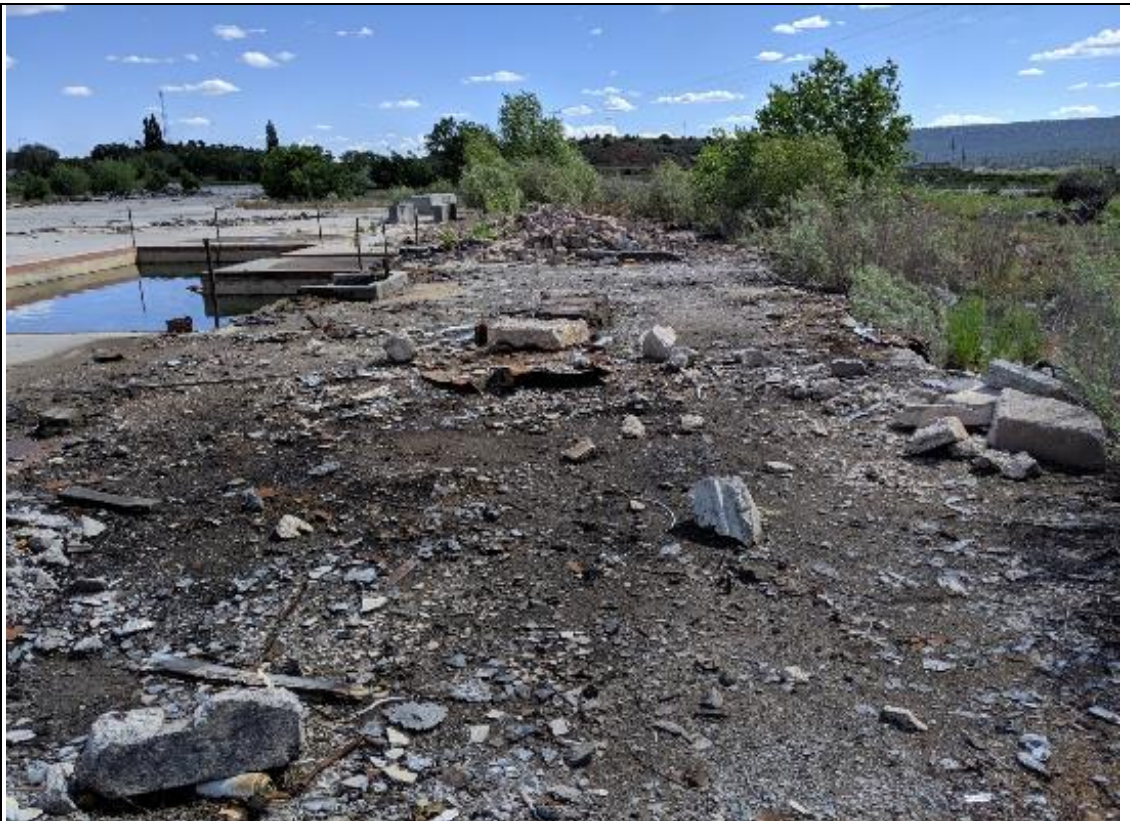
Photo No. 4	Date: 6/18/2019
Direction Photo Taken: South	
Description: Small debris pile on the northern portion of the former Particle Building.

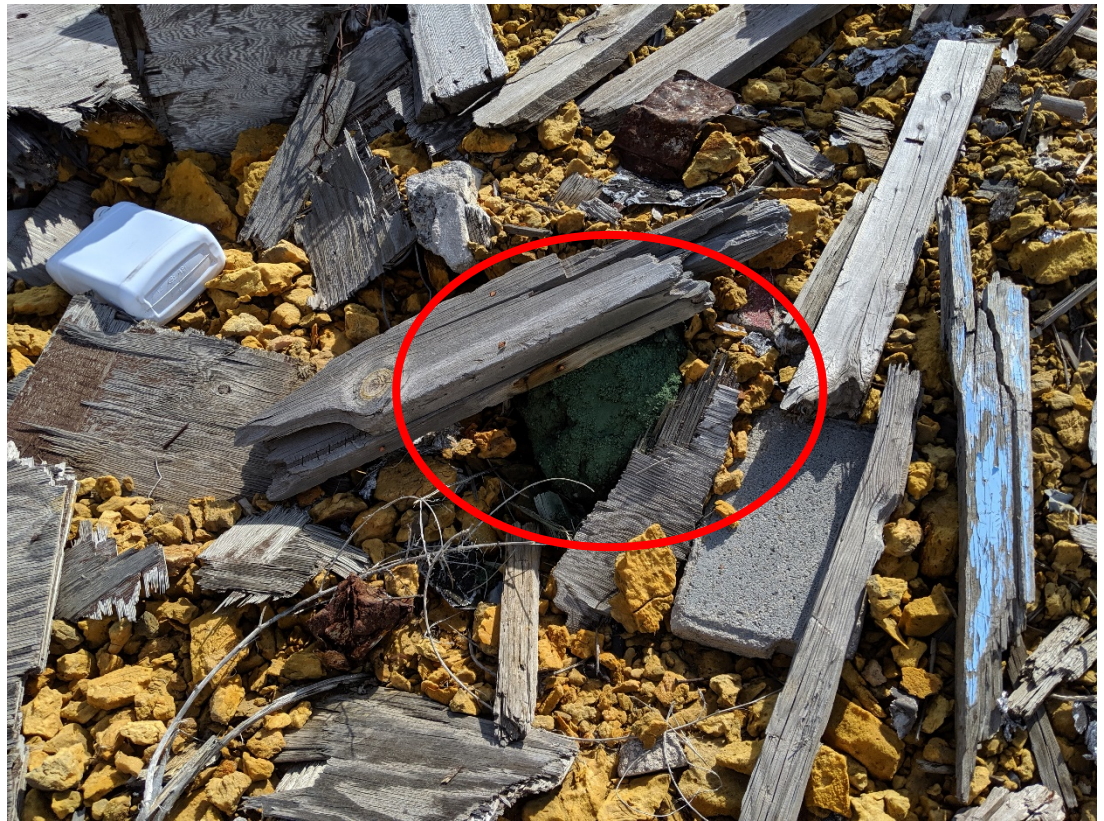
One grab sample was collected of a green discolored, unknown solid located in a waste pile at the demolished Main Particle Building and analyzed for TAL metals and TCLP RCRA 8 metals. Based on the analytical data obtained, it appears the material does not exhibit the toxicity characteristic of a hazardous waste.

Sample NFPI-particlebldg-greendebris collected from the large debris pile in the former Particle Debris building.

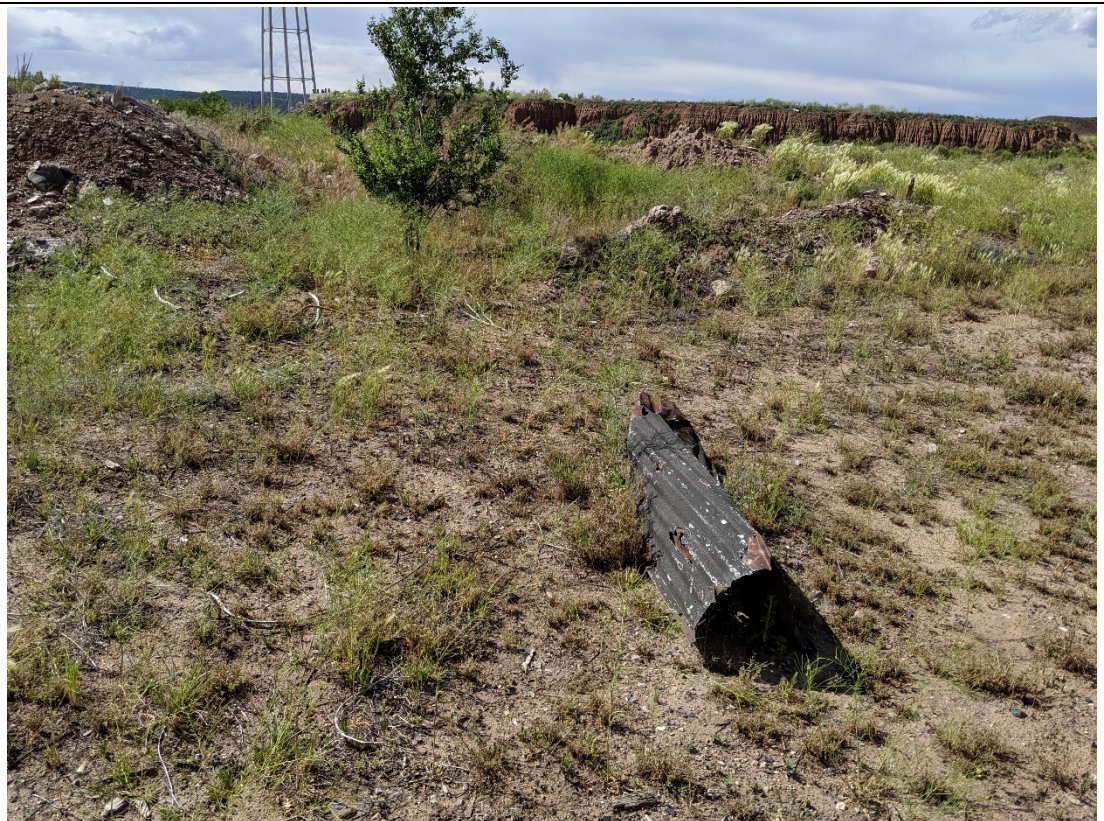
Photo No.
6

Sample H14-1, black coating on metal panel, located near former Power House.

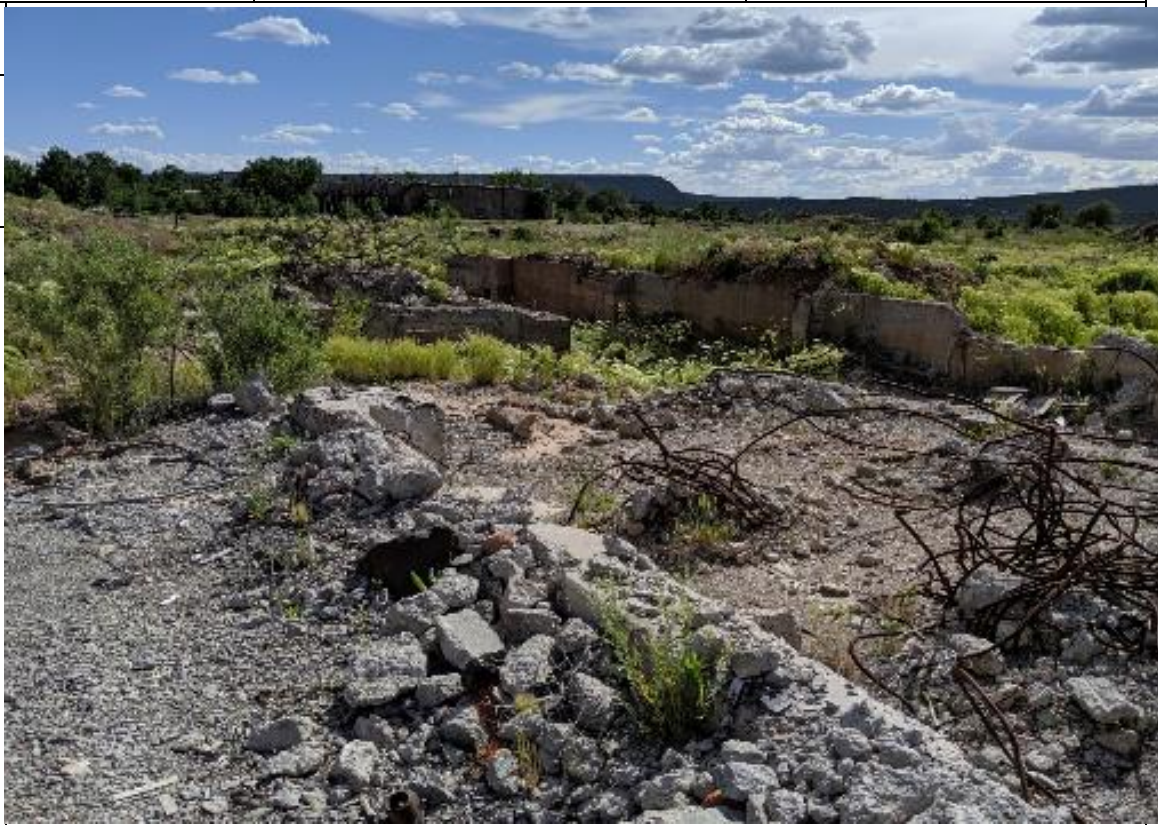
Overview of former Power House Building.

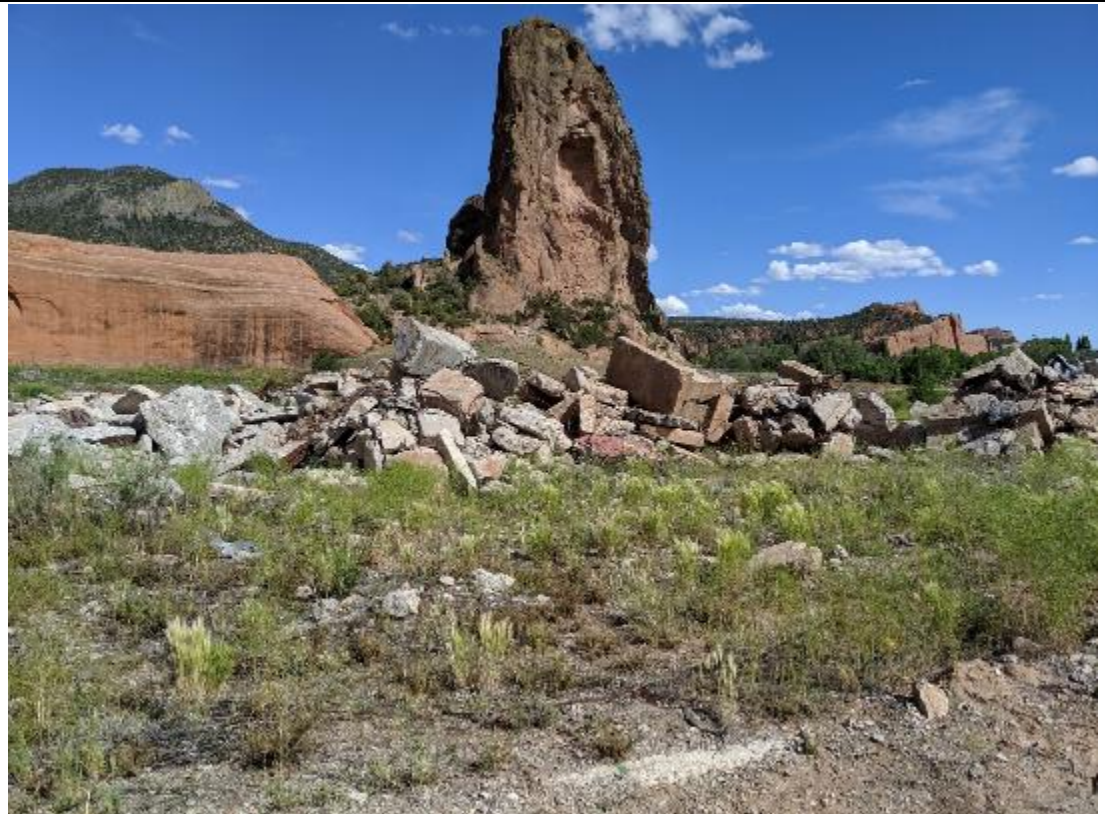
Photo No.
8

Debris pile adjacent to the former Power House Building.

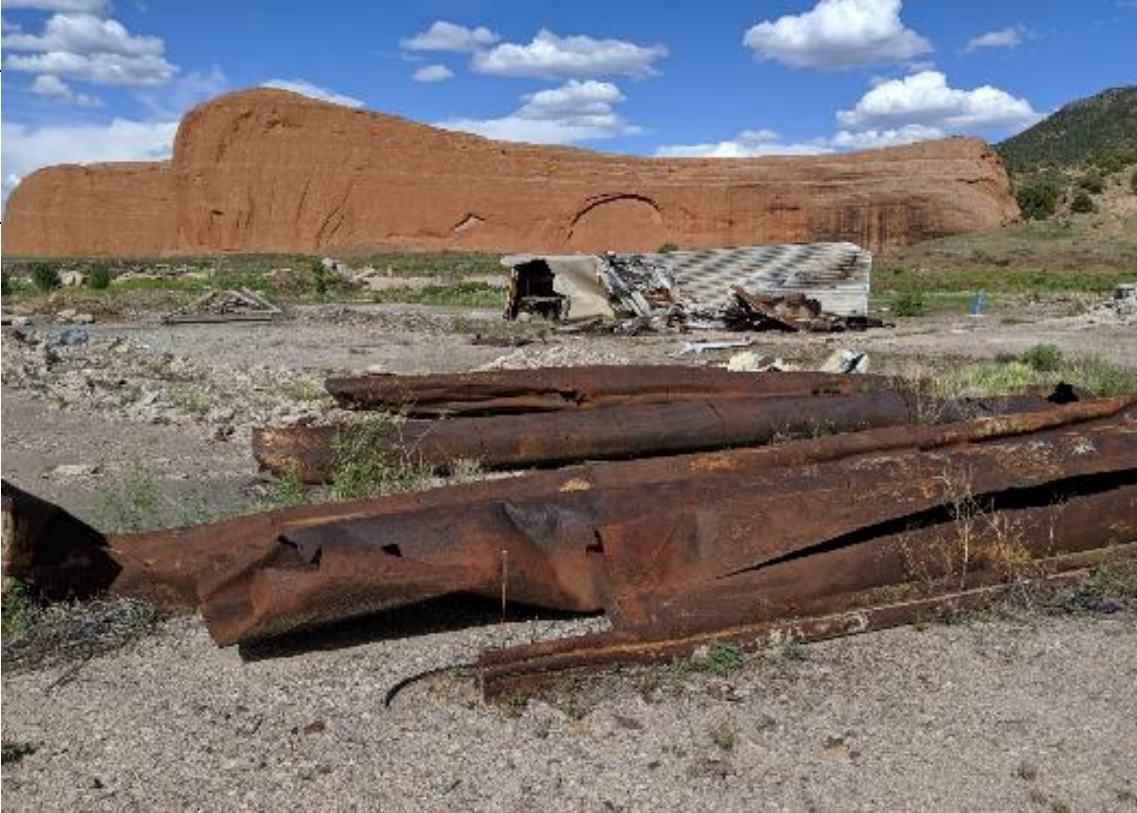
Direction Photo Taken: North			
Description: Trailer and large metal pipes on the former Warehouse Building. Sample H11-2 located on trailer.

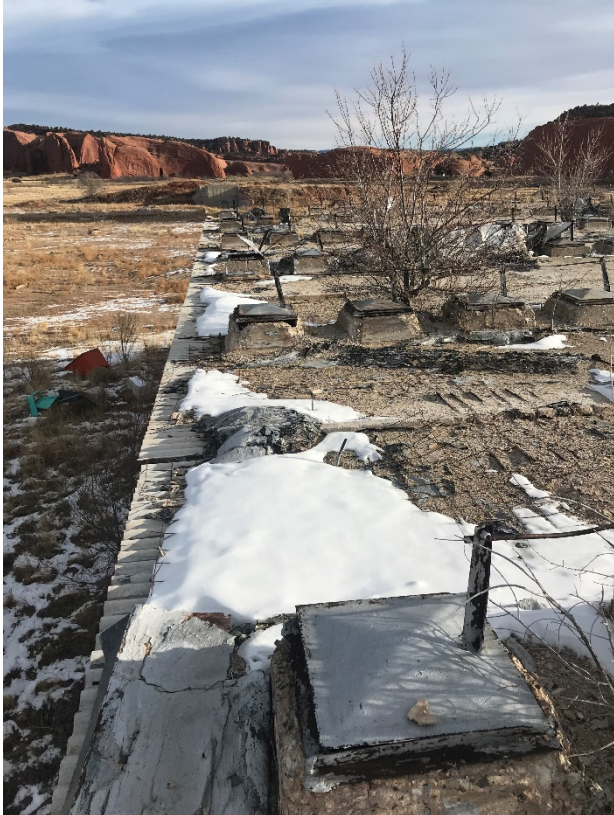
Direction Photo Taken: North			
Description: Roof of the Drying Kiln Building.

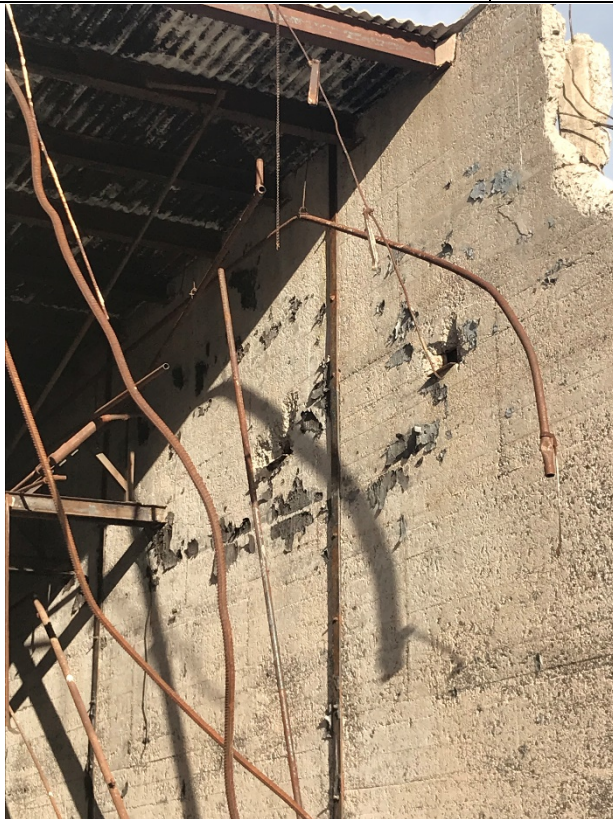
Direction Photo Taken: Northwest			
Description: View inside Bay 10 of the former Drying Kiln building with the black coating peeling off the walls (Sample H24-1 and H24-2).

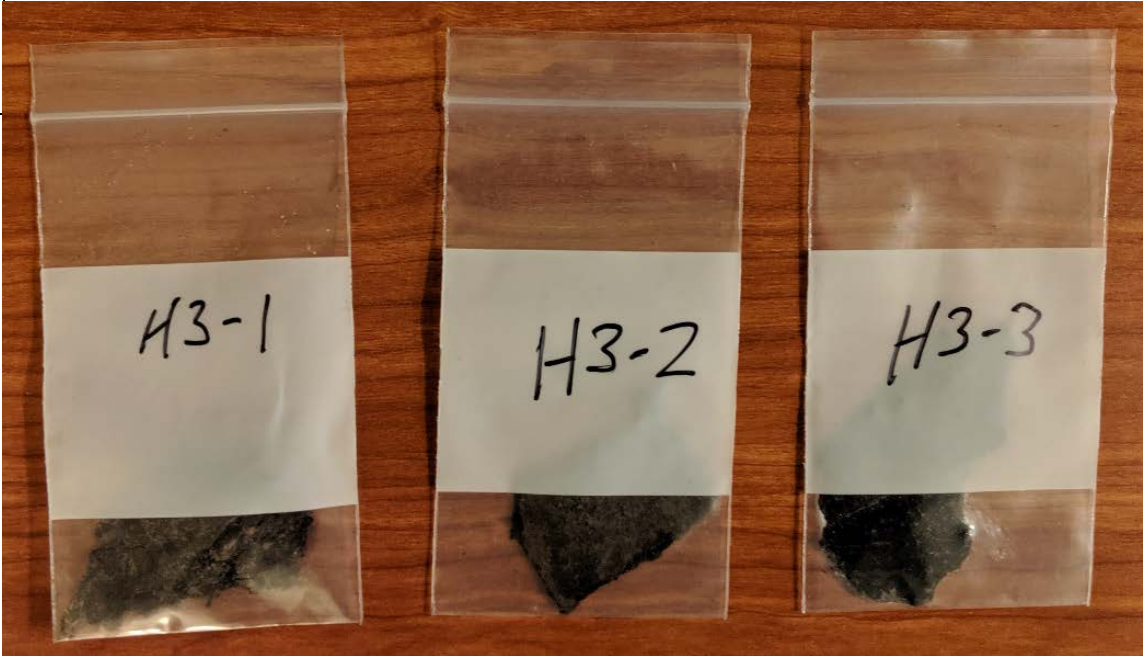
Direction Photo Taken: Down			
Description: Examples of black asphaltic roofing identified throughout the site. Results for H3-1 are 60% Chrysotile, H3-2 and H3-3 were ND.
