F/V
A.E. CLIFFORD
RESPONSE
JANUARY 2019

MSU Duluth Case Study

*F/V
A.E.
CLIFFORD*

*Hughitt Slip
Superior, WI*

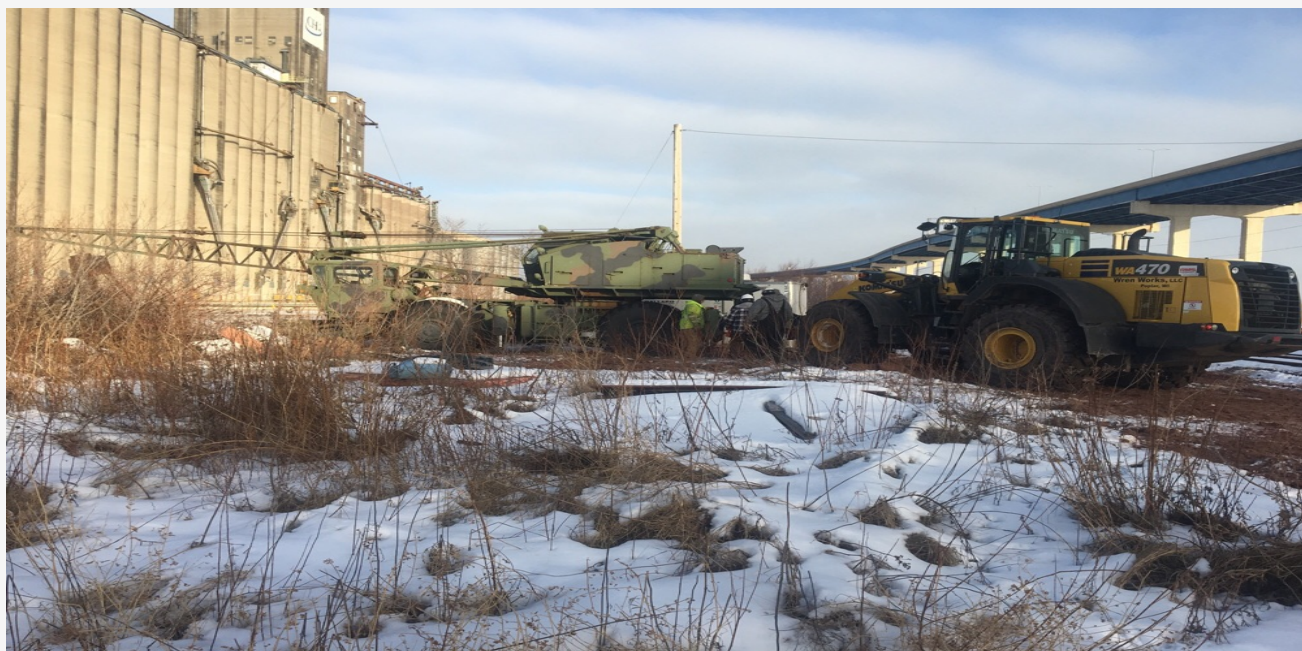
- An old army crane was blocking the access to the vessel for the placement of the heavy lift crane
- CHS Facility Security Officer did not know the owner of the crane and two small work barges on shore at the location outside the secure/restricted area

- Subcontractor able to relocate the derelict crane
- Owner of derelict crane located
