TECHNICAL MEMORANDUM

Morrow Reservoir – Preliminary Observations of Downstream Sedimentation

PREPARED FOR: David Fox Director, Licensing and Compliance
Eagle Creek Renewable Energy
PREPARED BY: Rob Myllyoja
Stantec
DATE: August 31, 2020

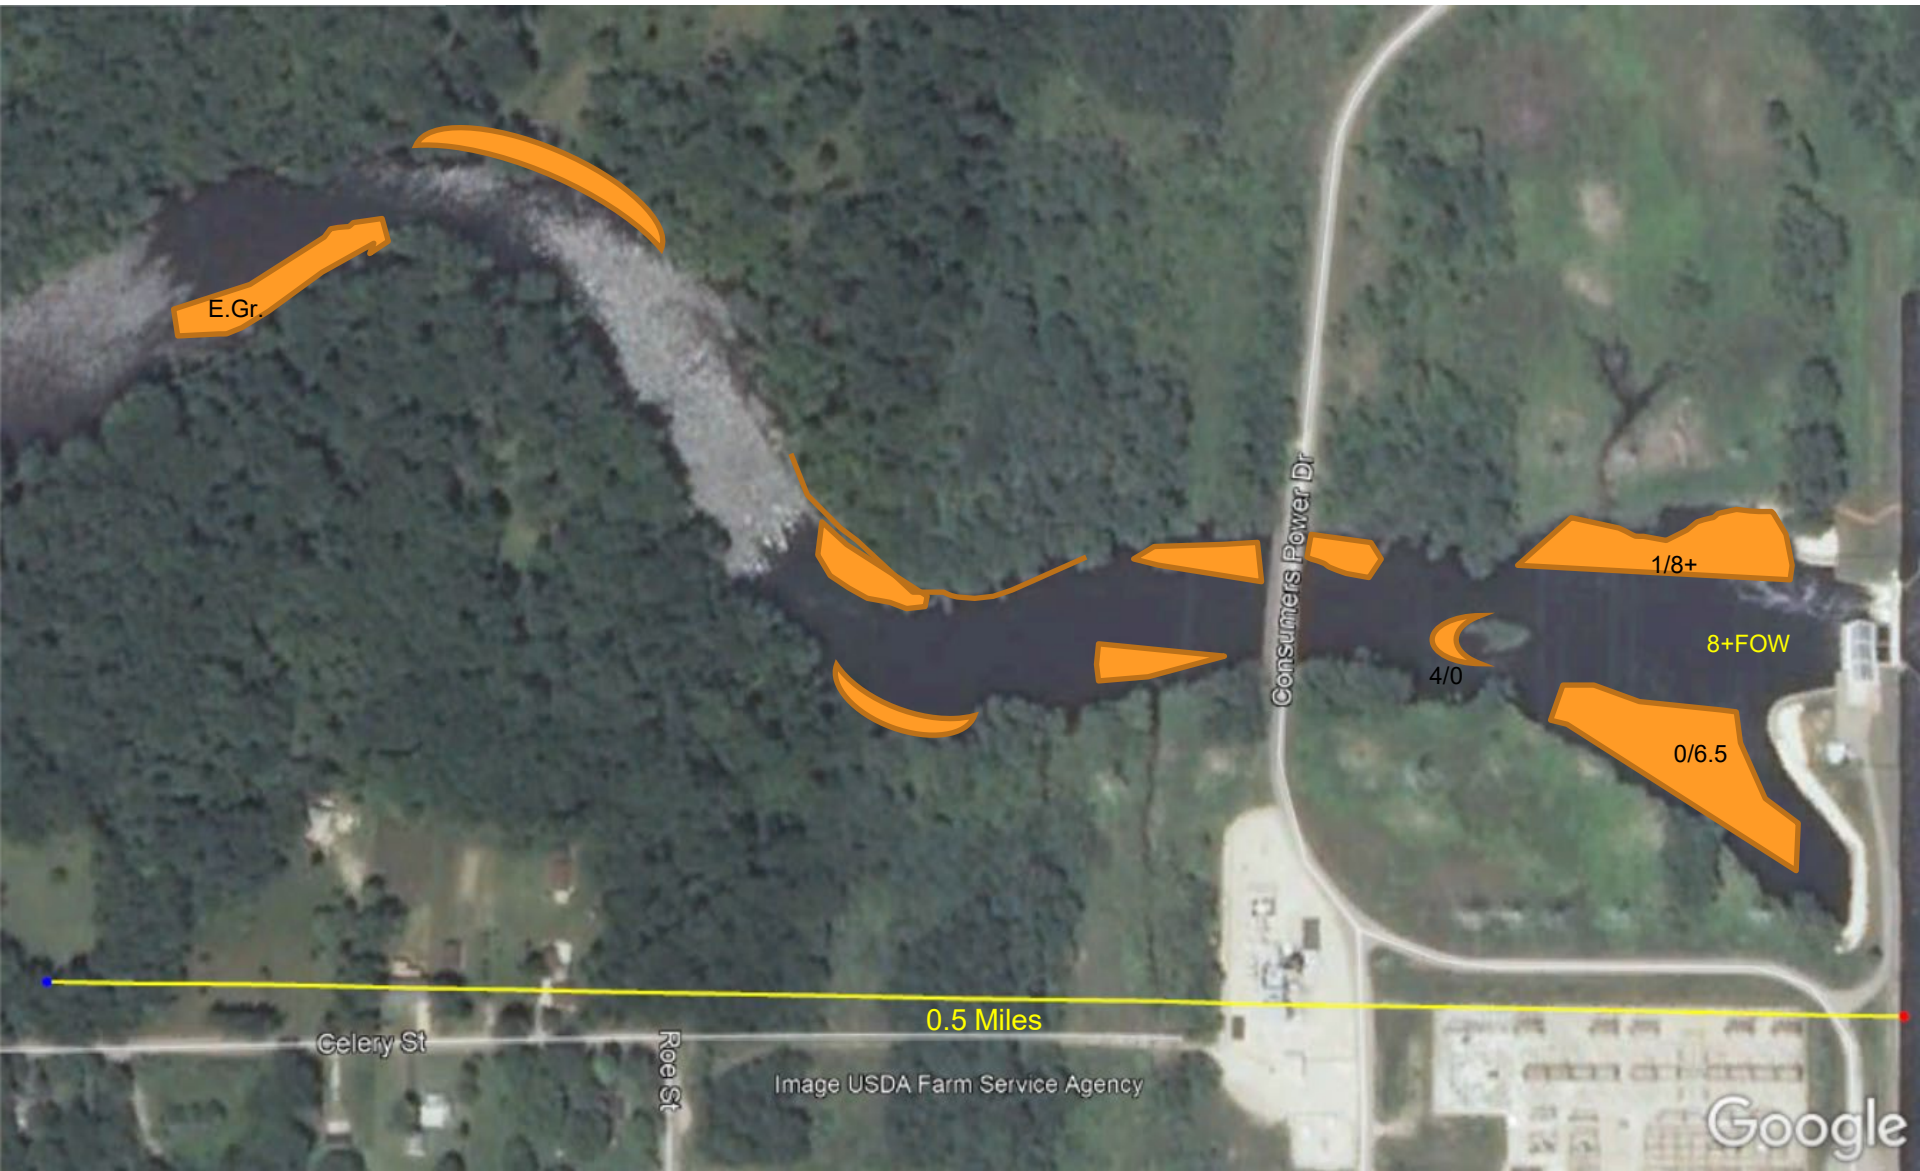
Sheet 1

- Immediately downstream of the dam, there are significant deposits of fine sediment in the side channel on the left descending bank (LDB) to 6.5 ft deep. Deposits are >8 ft deep along the bank erosion area on the RDB and the channel center.

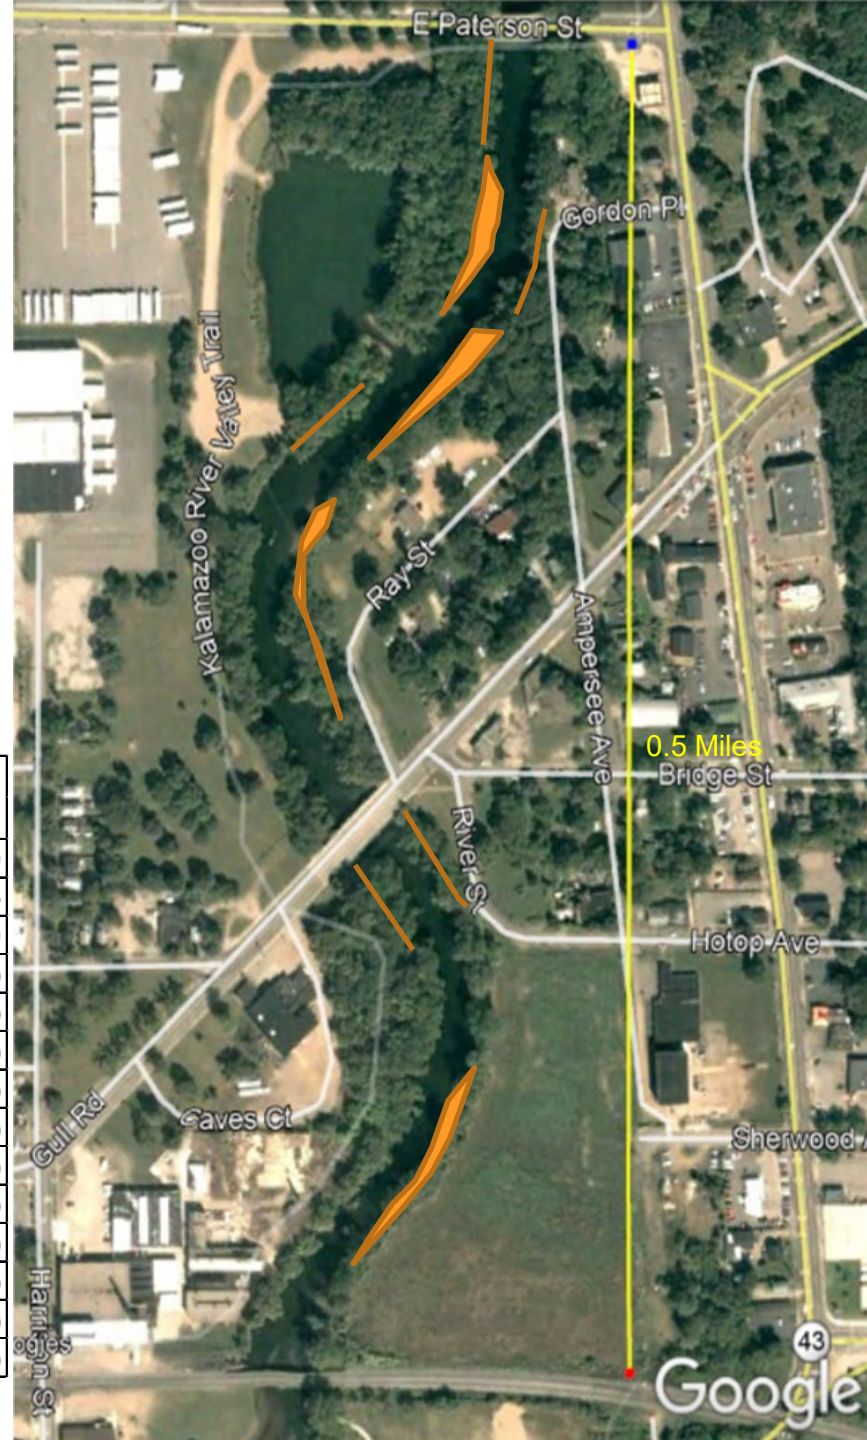
- Turbidity levels are visibly higher in Kalamazoo, possibly due to re-suspension
- Approx. 10.5 miles downstream of Morrow Dam at East D Ave. in Cooper Twp, turbidity is visibly lower and there appears to be fewer lateral bars along the river banks.
