**PHASE II ENVIRONMENTAL SITE ASSESSMENT  
FOR  
SAN HAVEN  
DUNSEITH, ROULETTE COUNTY, NORTH DAKOTA  
TURTLE MOUNTAIN BAND OF CHIPPEWA INDIANS  
RESERVATION**

Date Prepared	October 2020
TDD No.	0003/2006-05
Document Control No.	W0820.1A.02377
Contract No.	EP-S8-13-01
U.S. EPA Work Assignment Manager	Ted Lanzano

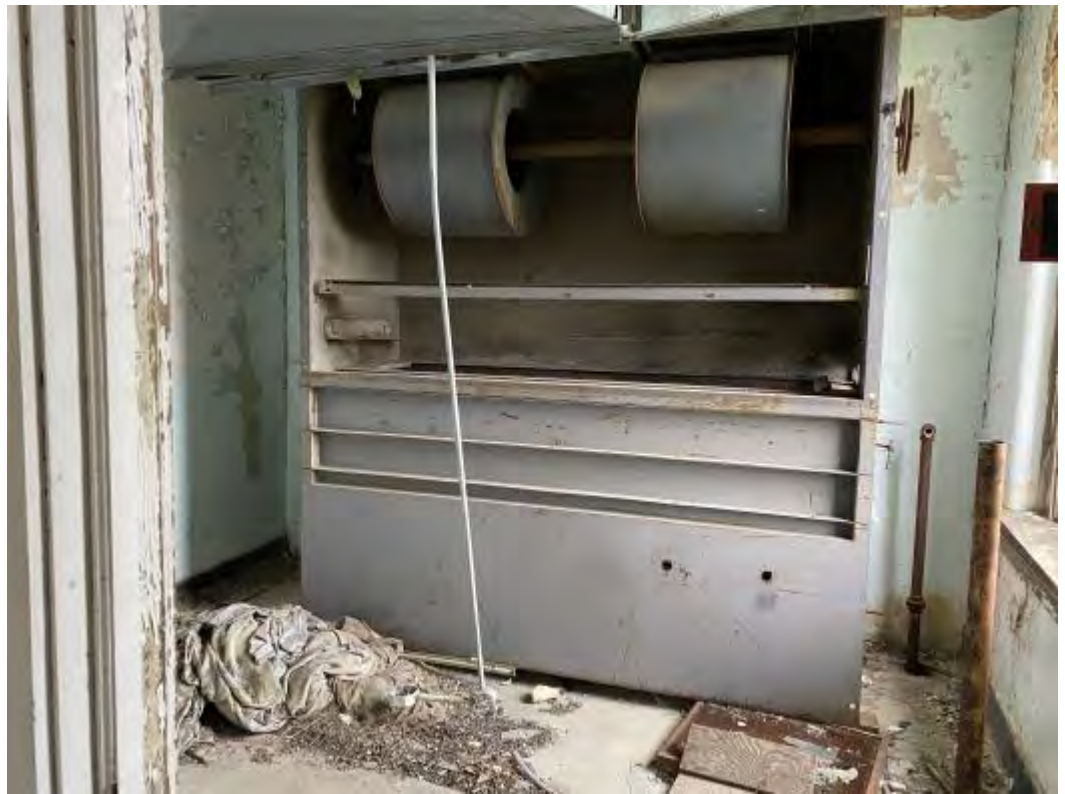
<b>Photo No.</b> <b>4</b>	<b>Date:</b> 08/14/2020
<b>Photo Coordinates</b>	
<b>Lat</b>	48.835378
<b>Long</b>	-100.041092
<b>Direction Photo Taken:</b> 216.025848398351	
<b>Description:</b>  Asbestos in flooring mastic.

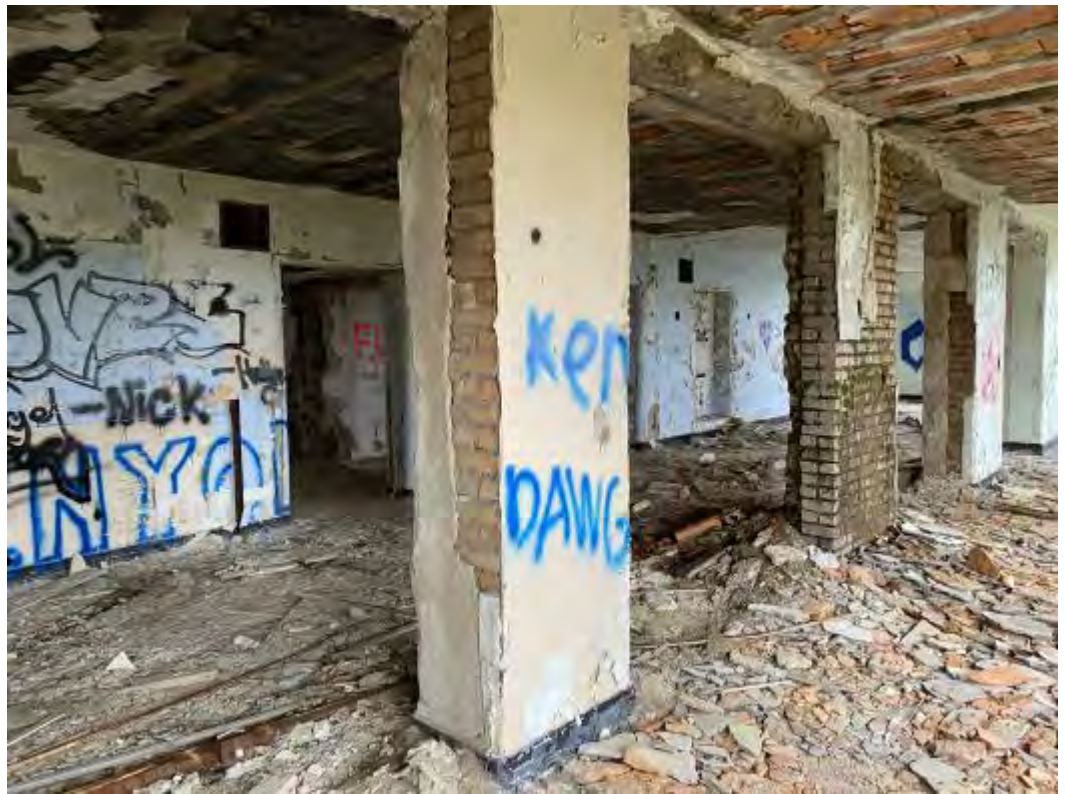
<b>Photo No.</b> <b>6</b>	<b>Date:</b> 08/14/2020
<b>Photo Coordinates</b>	
<b>Lat</b>	48.835583
<b>Long</b>	-100.041619
<b>Direction Photo Taken:</b> 69.1119995117188	
<b>Description:</b>  Hallway of the building.

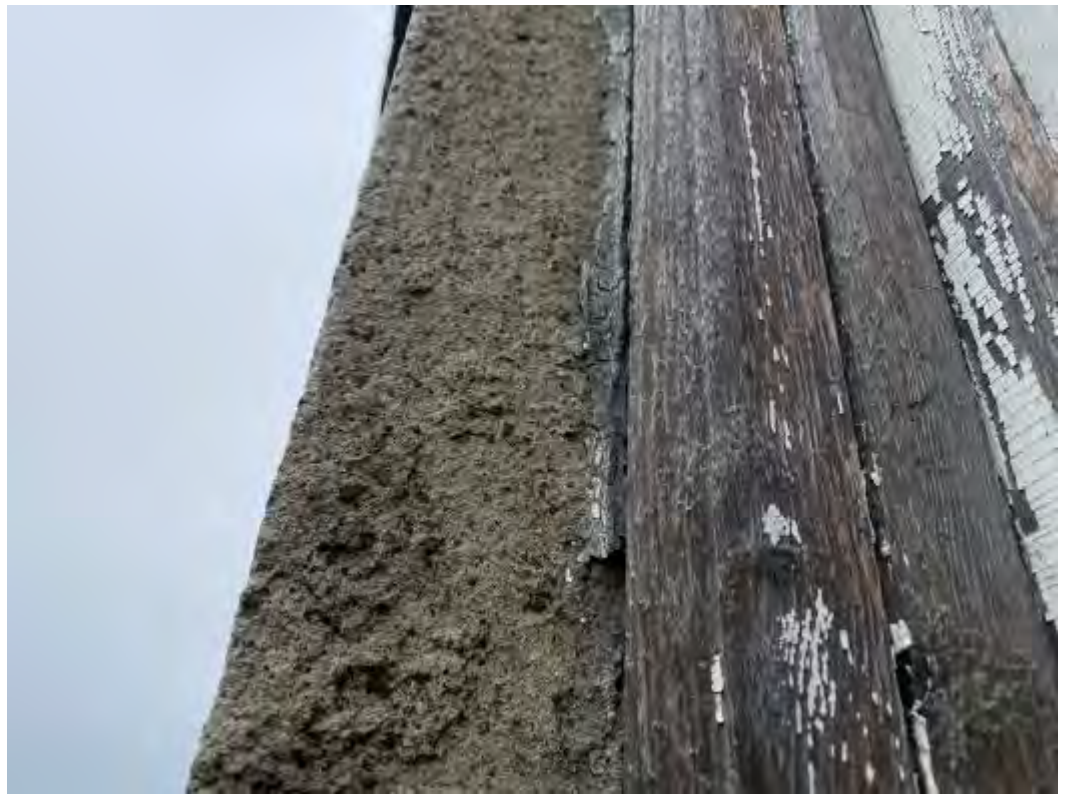
<b>Photo No.</b> <b>8</b>	<b>Date:</b> 08/14/2020
<b>Photo Coordinates</b>	
<b>Lat</b>	48.835442
<b>Long</b>	-100.041161
<b>Direction Photo Taken:</b> 155.53512575889	
<b>Description:</b>  Asbestos in roofing material and sealant.

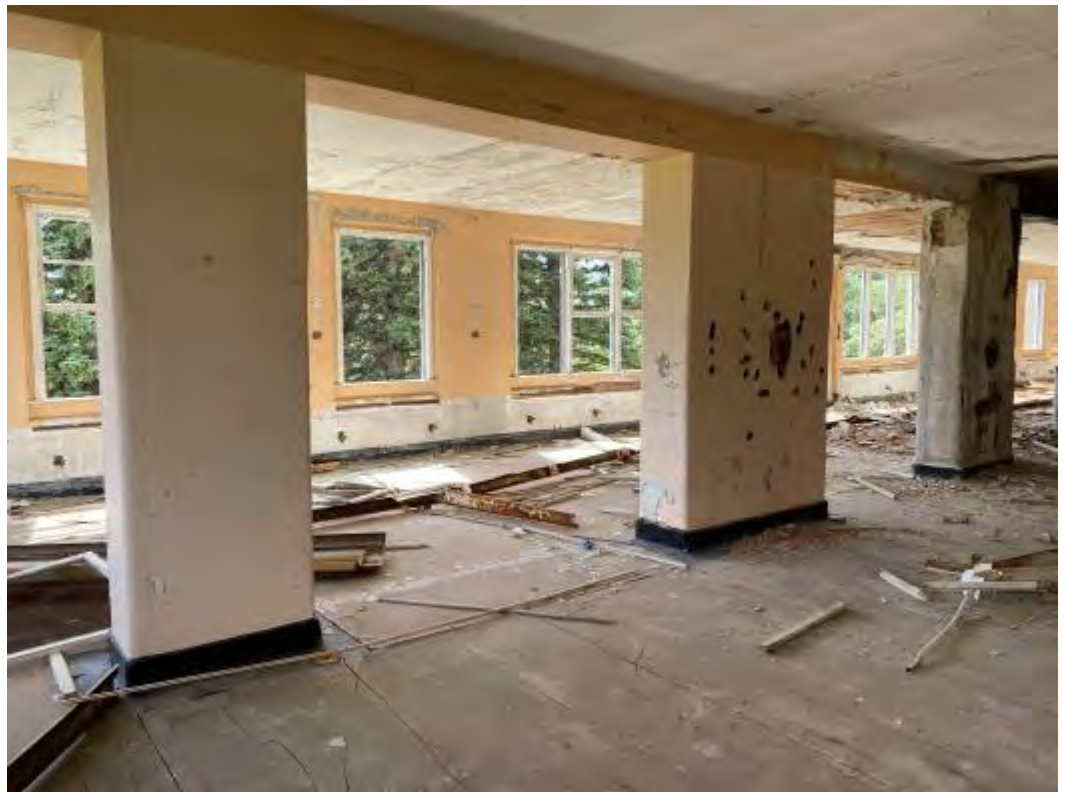
<b>Photo No.</b> <b>10</b>	<b>Date:</b> 08/14/2020
<b>Photo Coordinates</b>	
<b>Lat</b>	48.808978
<b>Long</b>	-100.067353
<b>Direction Photo Taken:</b> 305.209182736455	
<b>Description:</b>  Typical room in the building with water damage.

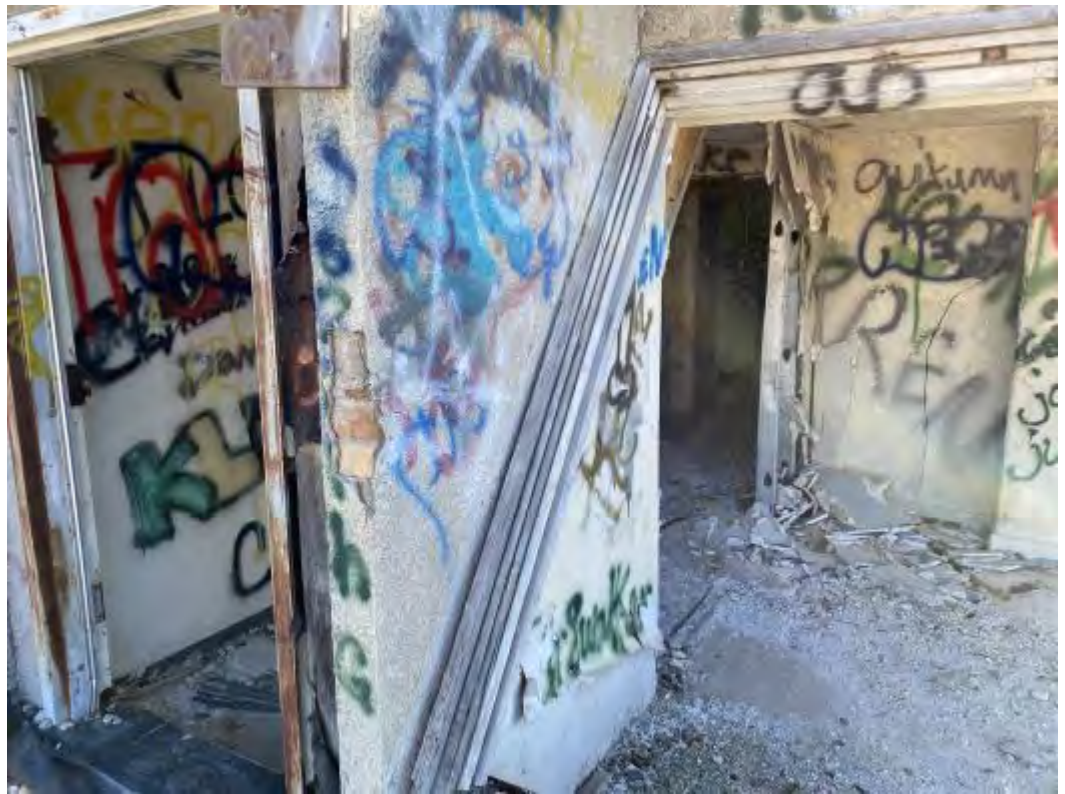
<b>Photo No.</b> <b>4</b>	<b>Date:</b> 08/16/2020
<b>Photo Coordinates</b>	
<b>Lat</b>	48.835369
<b>Long</b>	-100.041642
<b>Direction Photo Taken:</b> 234.318817204301	
<b>Description:</b>  Asbestos in black mastic on the 4 <sup>th</sup> floor.

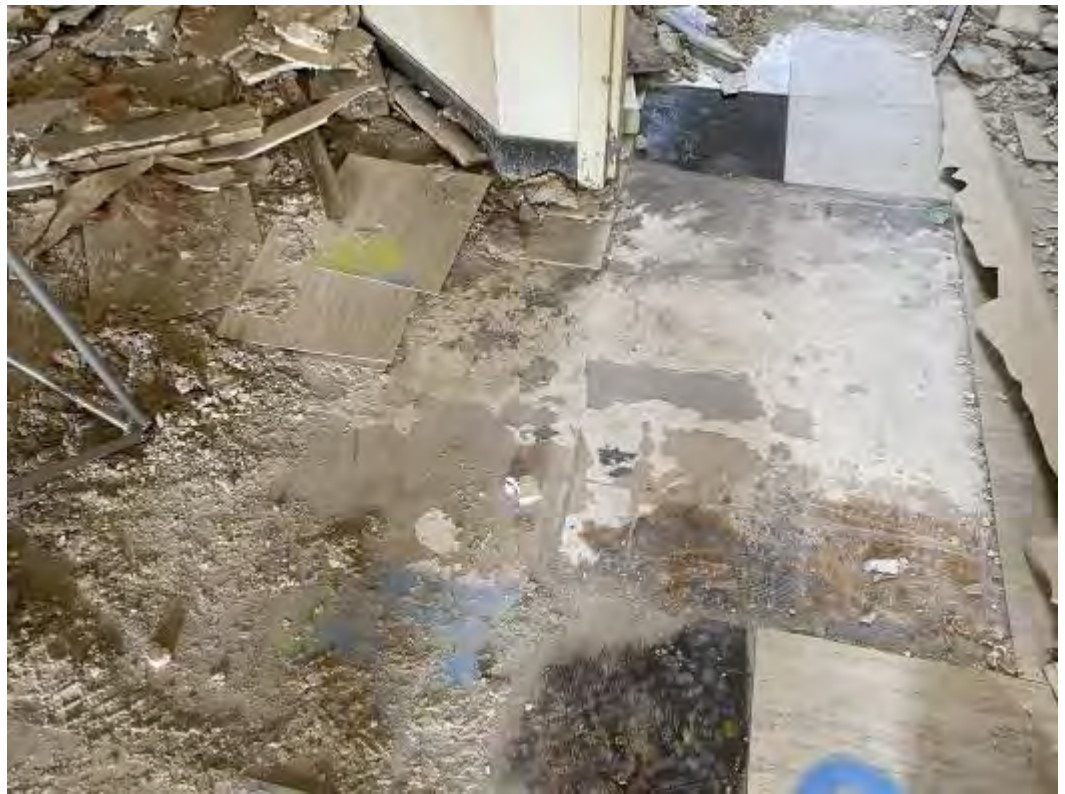
<b>Photo No.</b> <b>6</b>	<b>Date:</b> 08/16/2020
<b>Photo Coordinates</b>	
<b>Lat</b>	48.835311
<b>Long</b>	-100.04135
<b>Direction Photo Taken:</b> 347.583252190847	
<b>Description:</b>  Asbestos in floor tiles on the 3 <sup>rd</sup> floor.

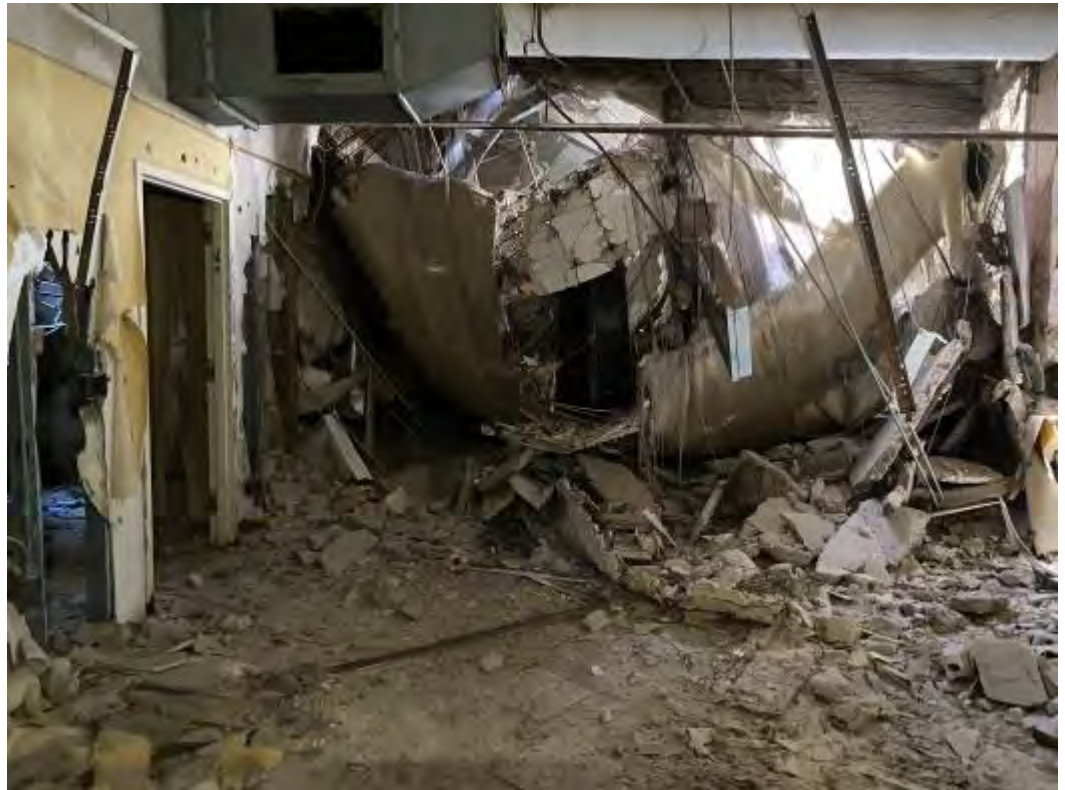
<b>Photo No.</b> <b>11</b>	<b>Date:</b> 08/17/2020
<b>Photo Coordinates</b>	
<b>Lat</b>	48.808769
<b>Long</b>	-100.067664
<b>Direction Photo Taken:</b> 183.378257632167	
<b>Description:</b>  Collapsed area observed from the 1 <sup>st</sup> floor.

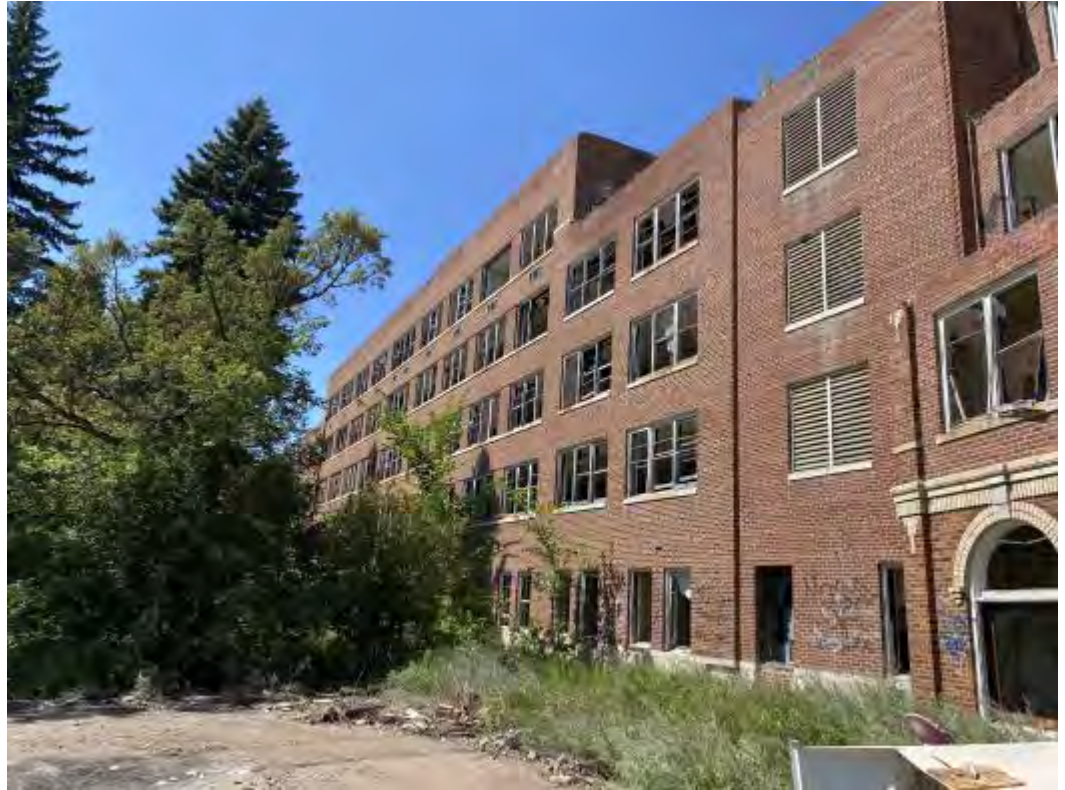
- **Building 3:** Air cell pipe insulation and associated throughout the building. Additional pipe insulation may be present in walls or ceilings which could not be observed. All window caulk and glazing. Linoleum on the 3<sup>rd</sup> and 4<sup>th</sup> floors. Ceramic tile mastic on the 3<sup>rd</sup> floor. Black mastic associated with 12"×12" floor tiles on the 5<sup>th</sup> floor. Stair tread material on stairs leading up to the elevator room. Door caulk on the roof egress.

<b>Photo No.</b> <b>1</b>	<b>Date:</b> 08/18/2020
<b>Photo Coordinates</b>	
<b>Lat</b>	48.835281
<b>Long</b>	-100.041497
<b>Direction Photo Taken:</b>	
<b>Description:</b>  Exterior of Building 3 with asbestos in window caulk and glazing.

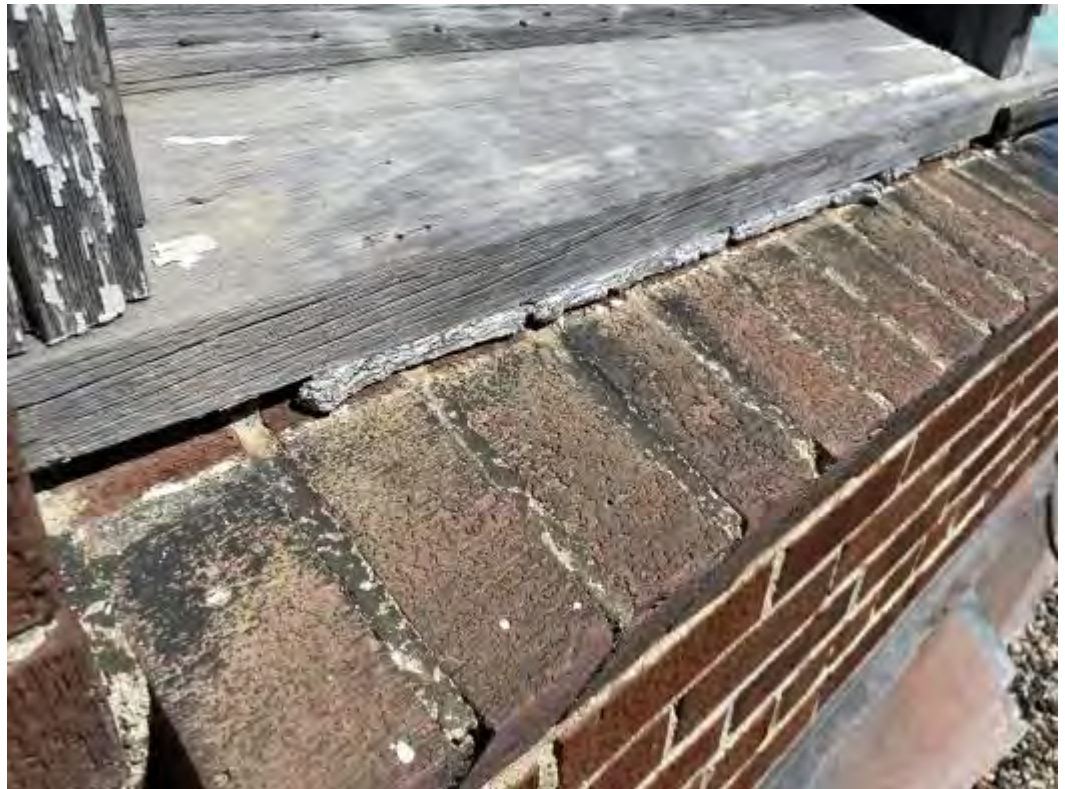
<b>Photo No.</b> <b>2</b>	<b>Date:</b> 08/17/2020
<b>Photo Coordinates</b>	
<b>Lat</b>	48.835247
<b>Long</b>	-100.042167
<b>Direction Photo Taken:</b> 59.3779907226563	
<b>Description:</b>  Asbestos window caulk observed on the roof level.

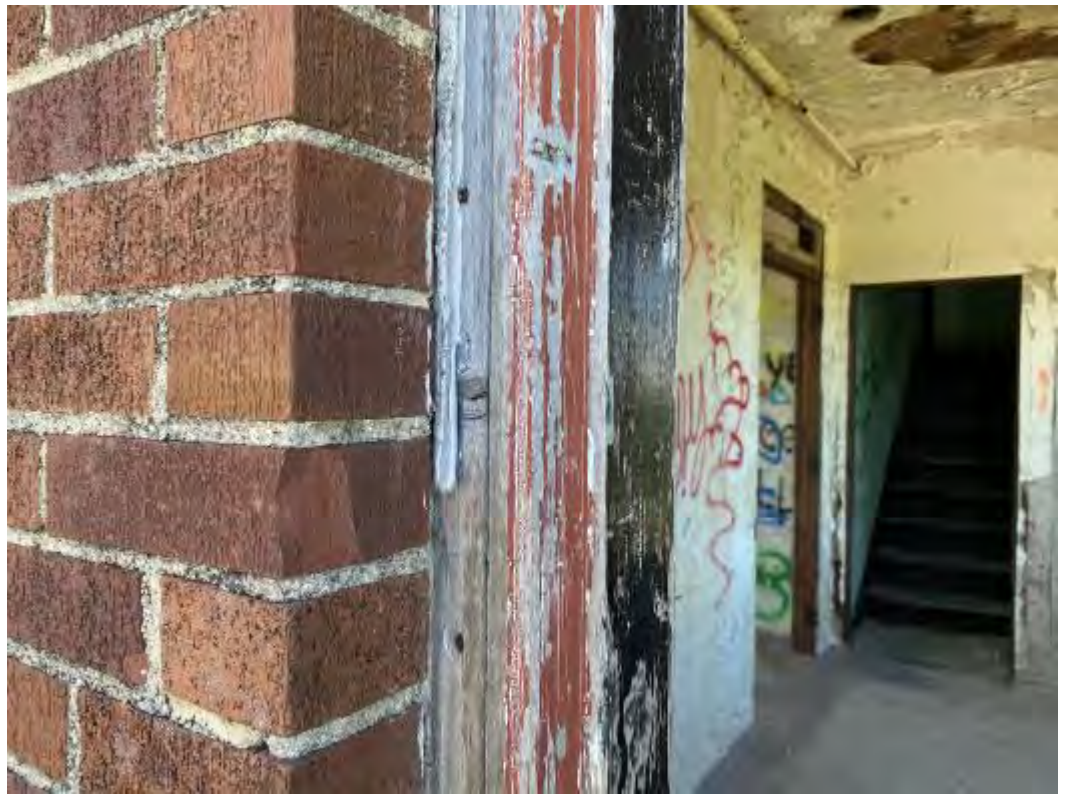
<b>Photo No.</b> <b>3</b>	<b>Date:</b> 08/17/2020
<b>Photo Coordinates</b>	
<b>Lat</b>	48.835342
<b>Long</b>	-100.042075
<b>Direction Photo Taken:</b> 235.984481688392	
<b>Description:</b>  Asbestos door caulk on the roof level.

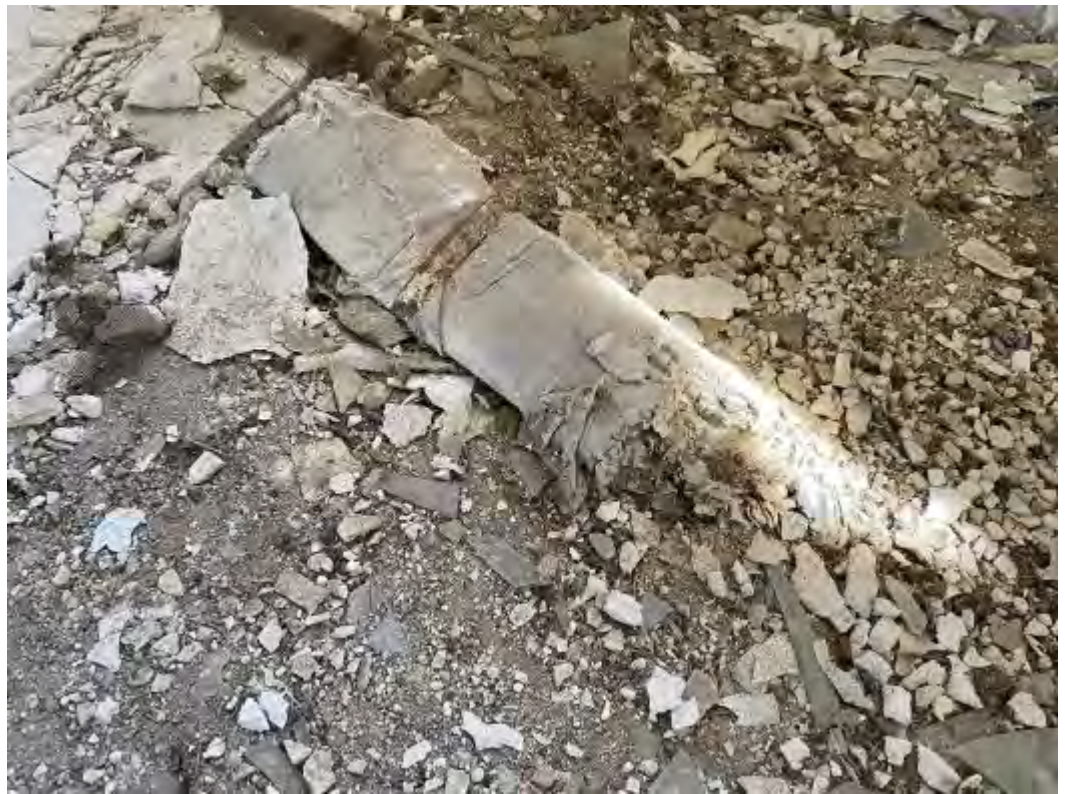
<b>Photo No.</b> <b>9</b>	<b>Date:</b> 08/17/2020
<b>Photo Coordinates</b>	
<b>Lat</b>	48.835186
<b>Long</b>	-100.042122
<b>Direction Photo Taken:</b> 60.0262451535938	
<b>Description:</b>  Air cell debris observed.

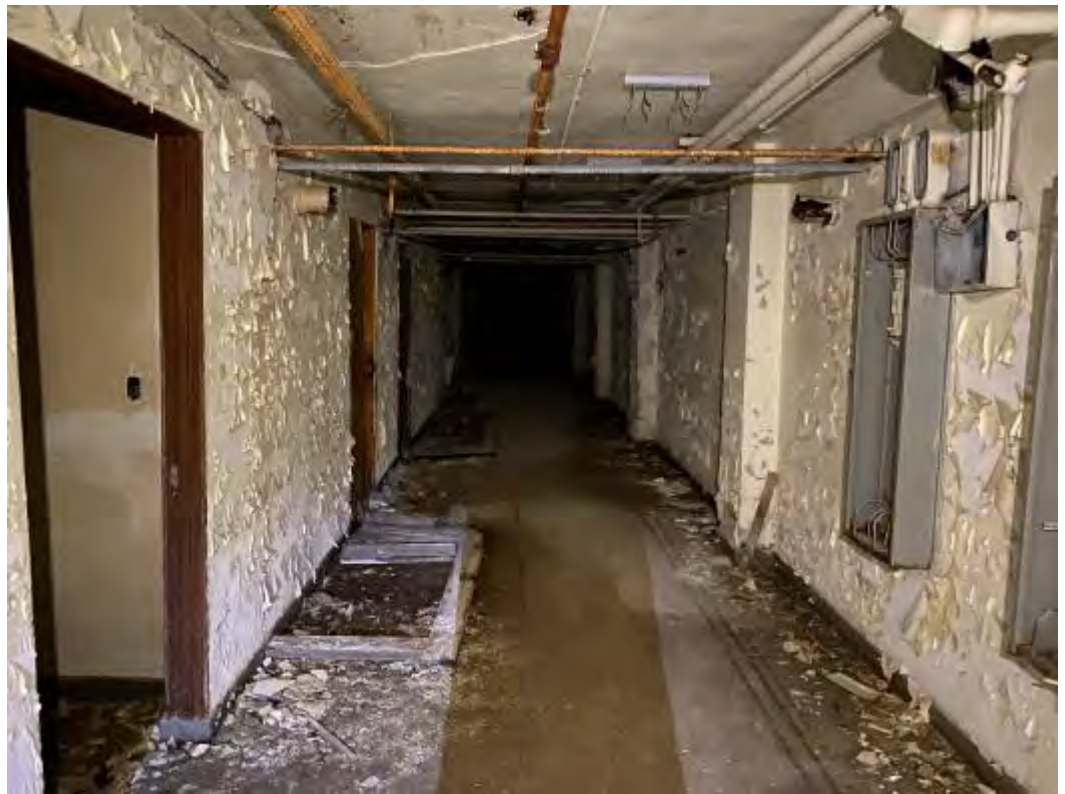
<b>Photo No.</b> <b>16</b>	<b>Date:</b> 08/18/2020
<b>Photo Coordinates</b>	
<b>Lat</b>	48.808769
<b>Long</b>	-100.067664
<b>Direction Photo Taken:</b>	
<b>Description:</b>  Air cell pipe insulation in the basement.

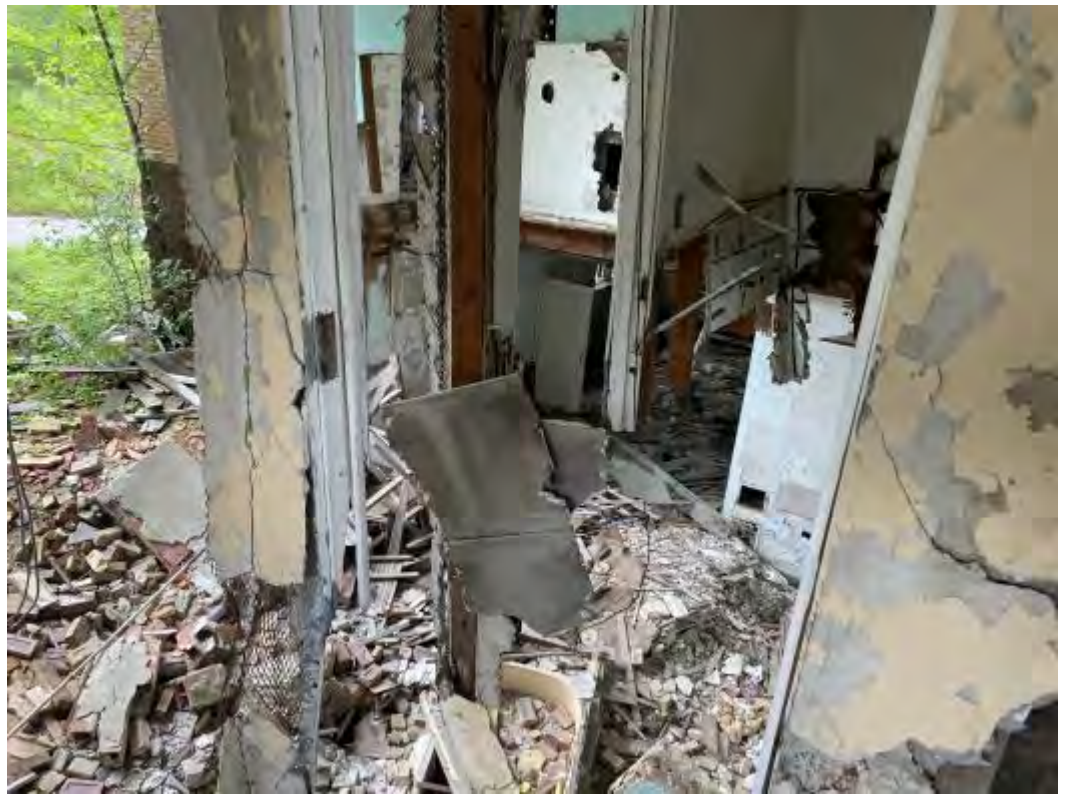
<b>Photo No.</b> <b>14</b>	<b>Date:</b> 08/21/2020
<b>Photo Coordinates</b>	
<b>Lat</b>	48.834964
<b>Long</b>	-100.040367
<b>Direction Photo Taken:</b> 311.528228924981	
<b>Description:</b>  Air cell debris observed.
