Environmental Monitoring Report or Work Activities Associated with the Replacement of Tainter Gates 3 and 4

STS Hydropower
Morrow Dam
7000 East Michigan Avenue Consumers Power Drive
Comstock Township, Michigan

Project Number: 60644031

February 2021

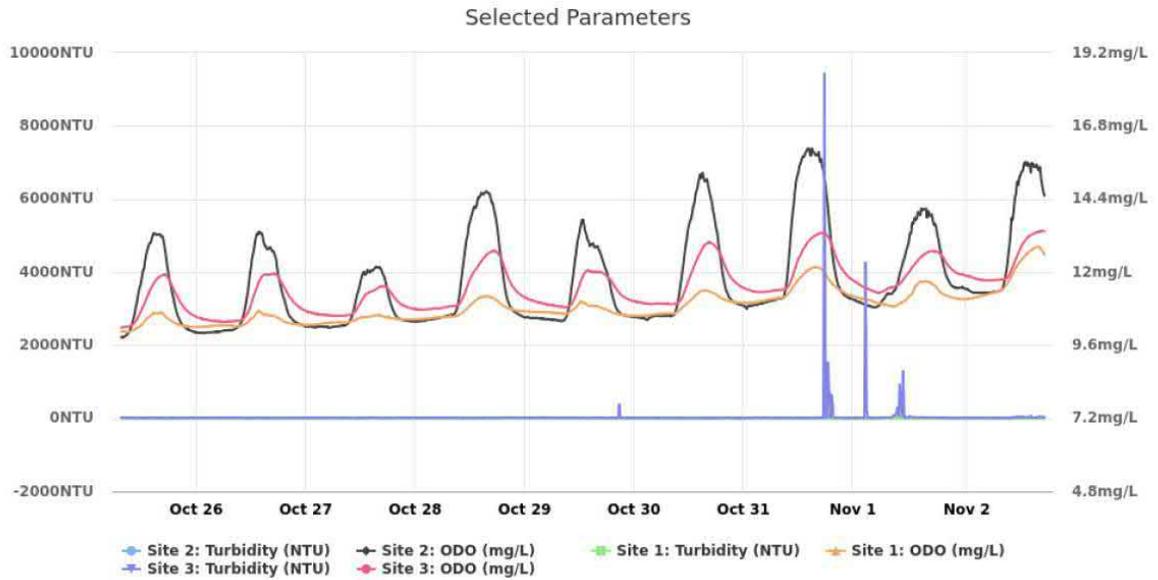
Exhibit 1. Graphical Representation of Real-time Turbidity Monitoring Data during the Period of Dredging

Dredging activities commenced on October 25, 2020 and continued through November 2, 2020. While active dredge operations occurred, environmental monitoring of turbidity downstream of Morrow Dam continued on an hourly basis at the Consumers Bridge location and every two hours at the River Street Bridge location, along with real-time water quality monitoring. Please refer to the Bi-weekly Turbidity Monitoring Reports for data associated with the real-time monitoring during this timeframe. To summarize, the turbidity spot measurements had no turbidity exceedances of 100 NTU and the real-time data collected during this period only included one period of exceedance of 100 NTU associated with work being conducted at Gate 1 on October 31. This was due to a short duration trend of increased turbidity lasting approximately 1.5 hours related to the removal of an upstream sediment control boom in preparation for the first water flow reduction event, see **Exhibits 1 & 2**. Other exceedances observed are likely attributable to debris or other environmental conditions related to changes in weather and not associated with work activities.

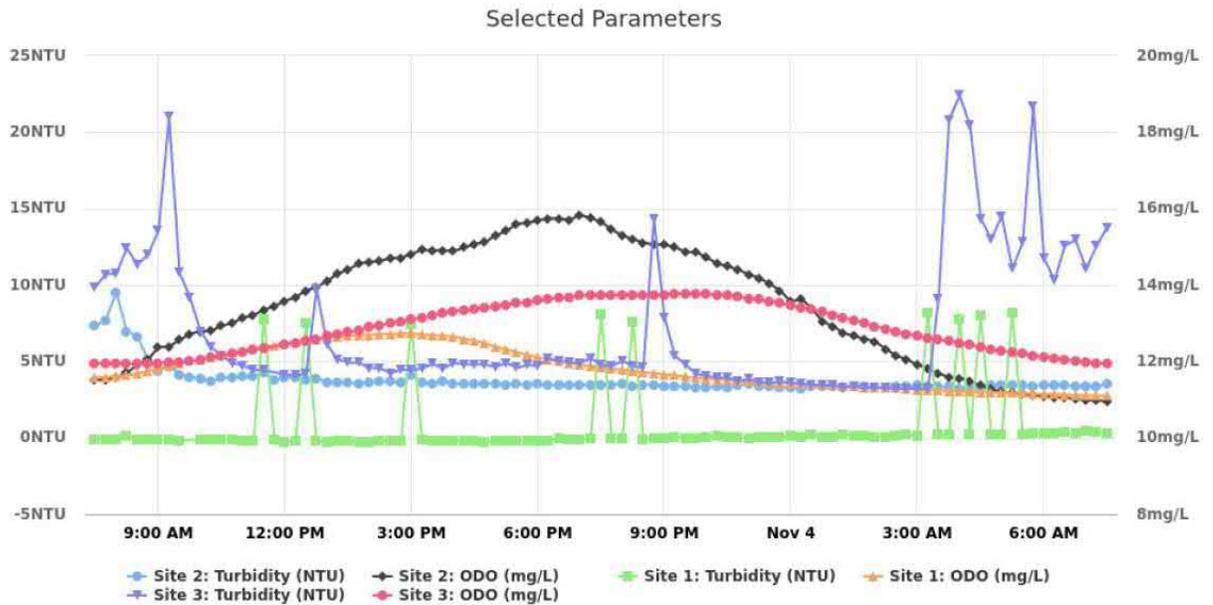
Exhibit 3. Graphical Representation of Real-time Turbidity Monitoring Data during the First Water Flow Reduction

The first flow reduction activity began November 3, 2020 at 7:30am and continued until November 4, 2020 at 3:45am. Due to the extended duration and unanticipated overnight hours, spot measurements were not collected through the entire duration. However, real-time monitoring continued, and a graphical representation is provided in **Exhibit 3**. Please refer to the Bi-weekly

Turbidity Monitoring Reports for detailed data summary associated with the real-time monitoring during this timeframe. To summarize, both the turbidity spot measurements and the real-time data taken during these work activities indicated no turbidity exceedances of 100 NTU.

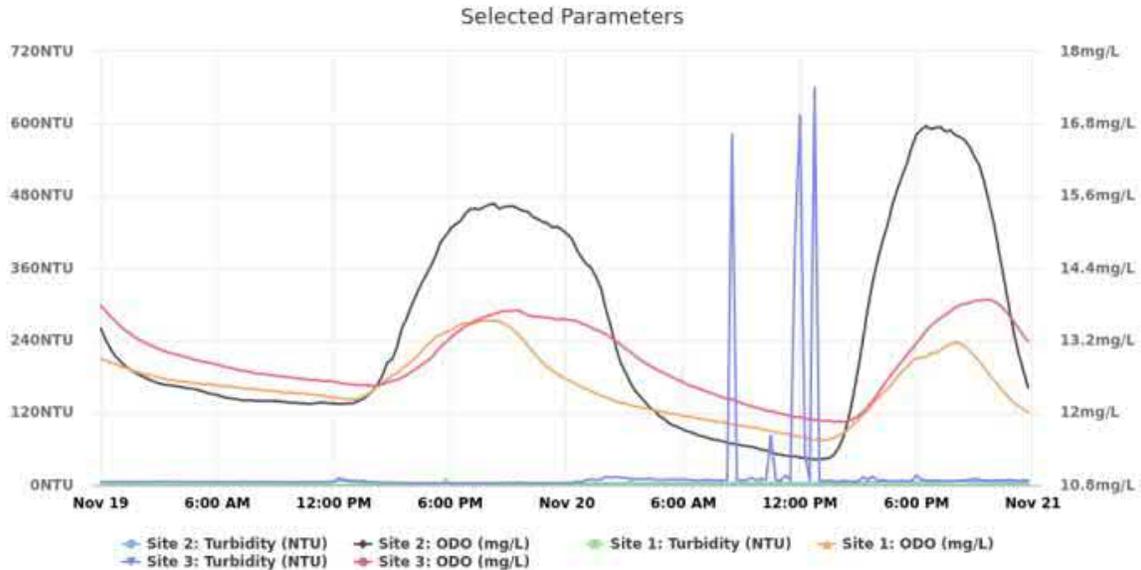
Exhibit 4. Graphical Representation of Real-time Turbidity Monitoring Data during the Second Water Flow Reduction

The second flow reduction activity began November 19, 2020 at 12:00pm and continued until 7:00pm. Spot measurements were not collected through the entire duration, however, real-time monitoring continued, and a graphical representation is provided in **Exhibit 4**. Please refer to the Bi-weekly Turbidity Monitoring Reports for detailed data summary associated with the real-time monitoring during this timeframe. To summarize, the turbidity spot measurements indicated no exceedances while there was a short duration trend of increased turbidity on November 20, 2020 in the morning. The event was an aggregate of turbidity spikes that may be related to a turbidity curtain downstream of the dam that became loose and was quickly fixed.

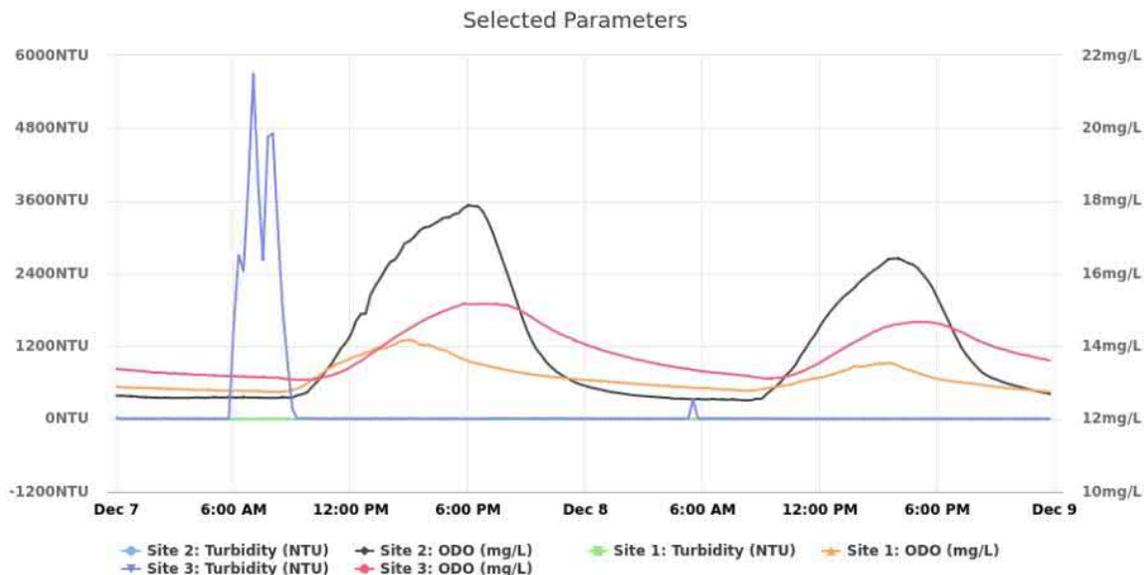
Exhibit 5. Graphical Representation of Real-time Turbidity Monitoring Data during the Third Water Flow Reduction

The third flow reduction activity began December 7, 2020 at 6:00am and continued until December 8, 2020 at 3:00pm. Spot measurements were not collected through the entire duration, however, real-time monitoring continued, and a graphical representation is provided in **Exhibit 5**. Please refer to the Bi-weekly Turbidity Monitoring Reports for detailed data summary associated with the real-time monitoring during this timeframe. To summarize, the turbidity spot measurements indicated no turbidity exceedances. The real-time data taken during these work activities indicated a short trend of increased turbidity prior to the start of the flow change that was likely related to debris on the sensor as there was no visual observations of turbid conditions by onsite personnel.

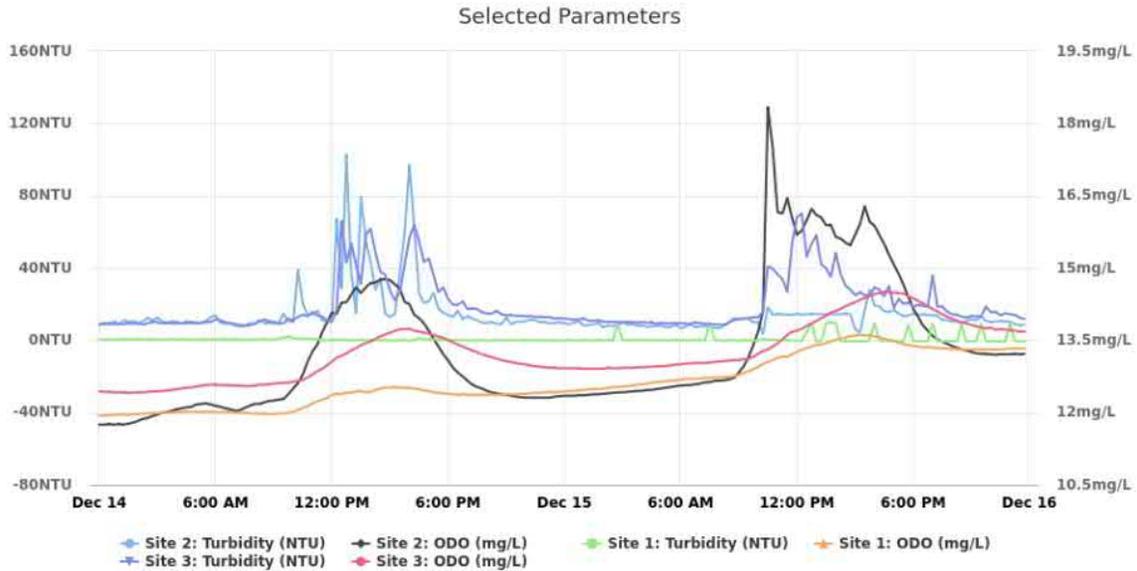
Exhibit 6. Graphical Representation of Real-time Turbidity Monitoring Data during the Upstream Turbidity Curtain and Boom Removal Activities

Upstream turbidity curtain and boom removal activities began on December 14, 2020 and continued until December 15, 2020. Spot measurements were collected during active work activities during

each day and real-time monitoring continued throughout. A graphical representation is provided in **Exhibit 6**. Please refer to the Bi-weekly Turbidity Monitoring Reports for detailed data summary associated with the real-time monitoring during this timeframe. To summarize, the turbidity spot measurements and real-time monitoring location downstream of Morrow Lake indicated no turbidity exceedances of 100 NTU.

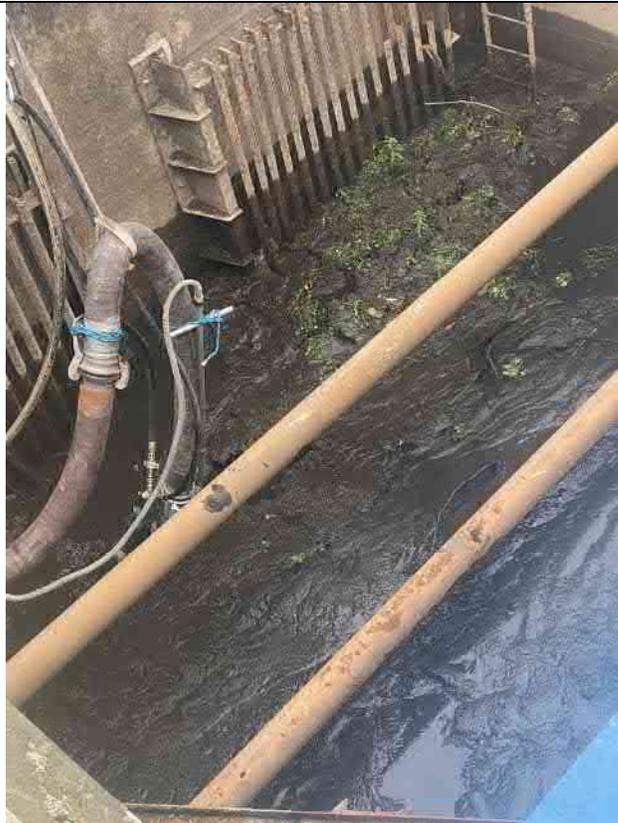
6

Description:Sediment exposed
in Bay 1 after
dewatering.

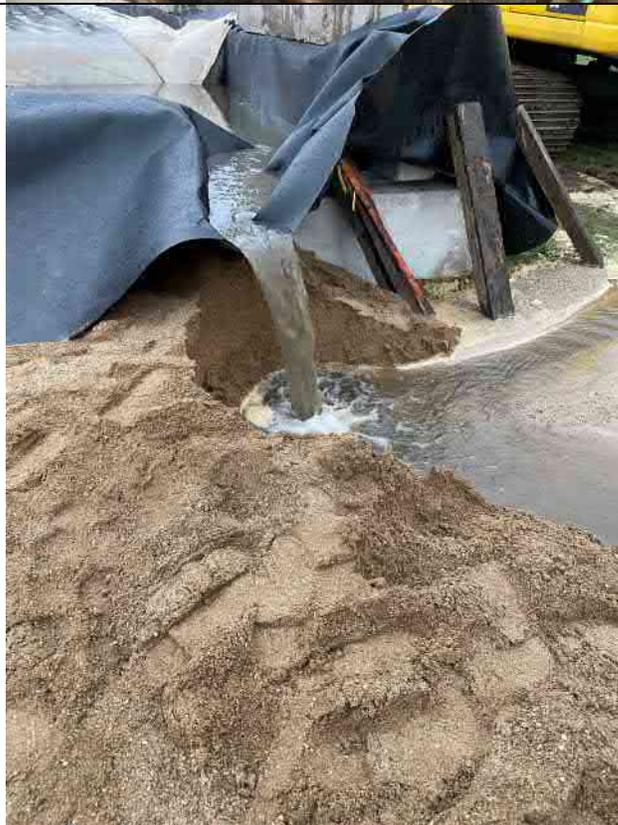
Photo No.
10

Description:
Water overflow in
dredge
containment.

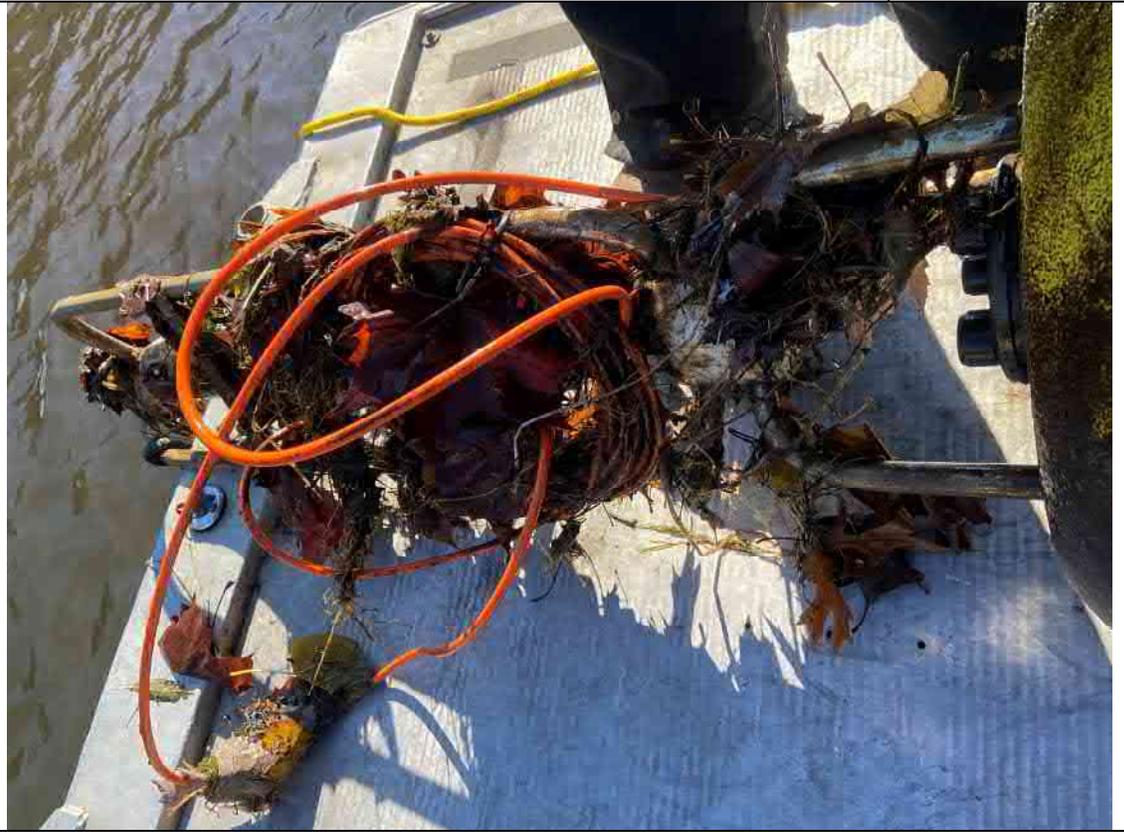
17

Description:
Sonde 3 before
cleaning.

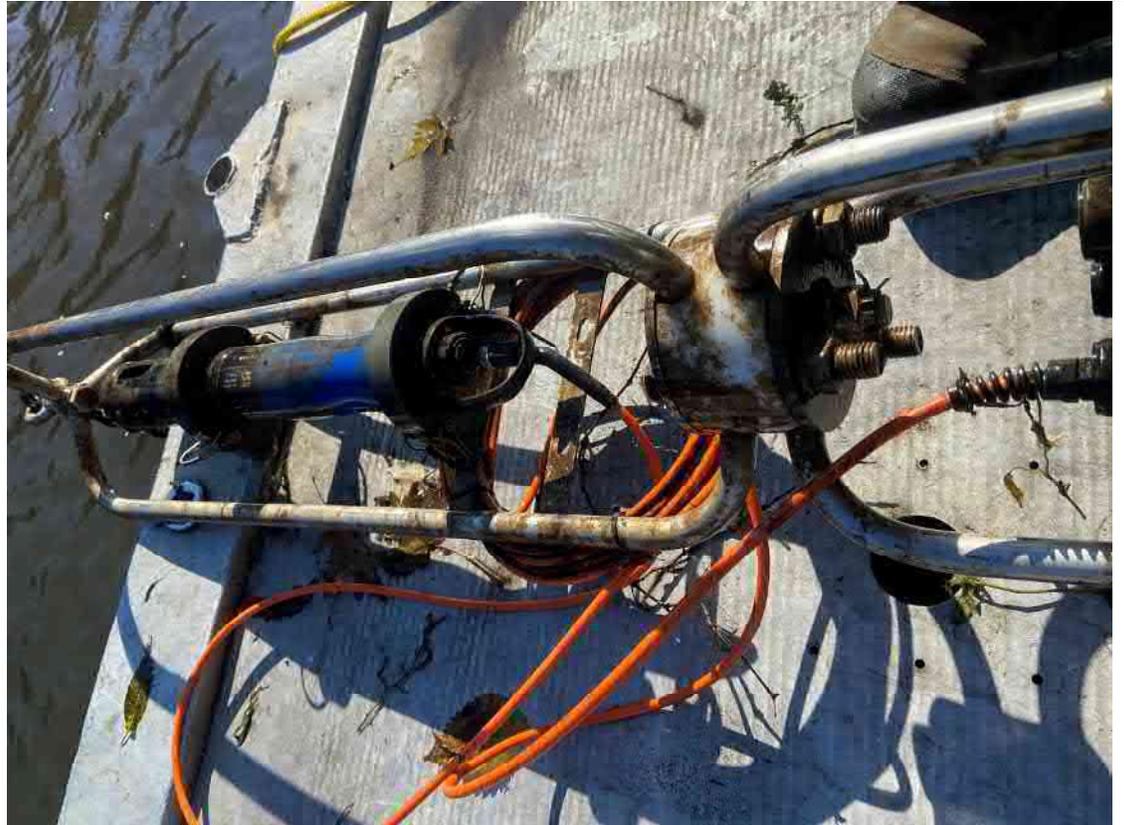
18

Description:
Sonde 3 after
cleaning.

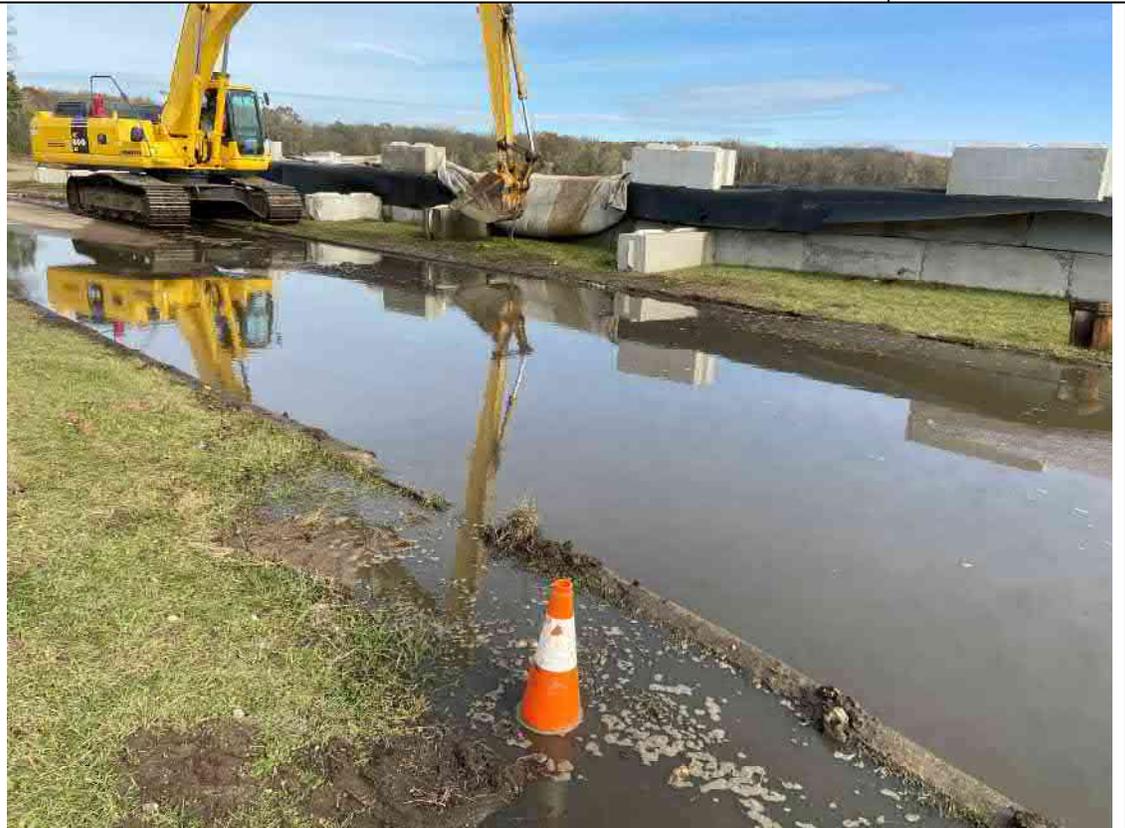
Photo No.
21

Description:
Sediment bag leak

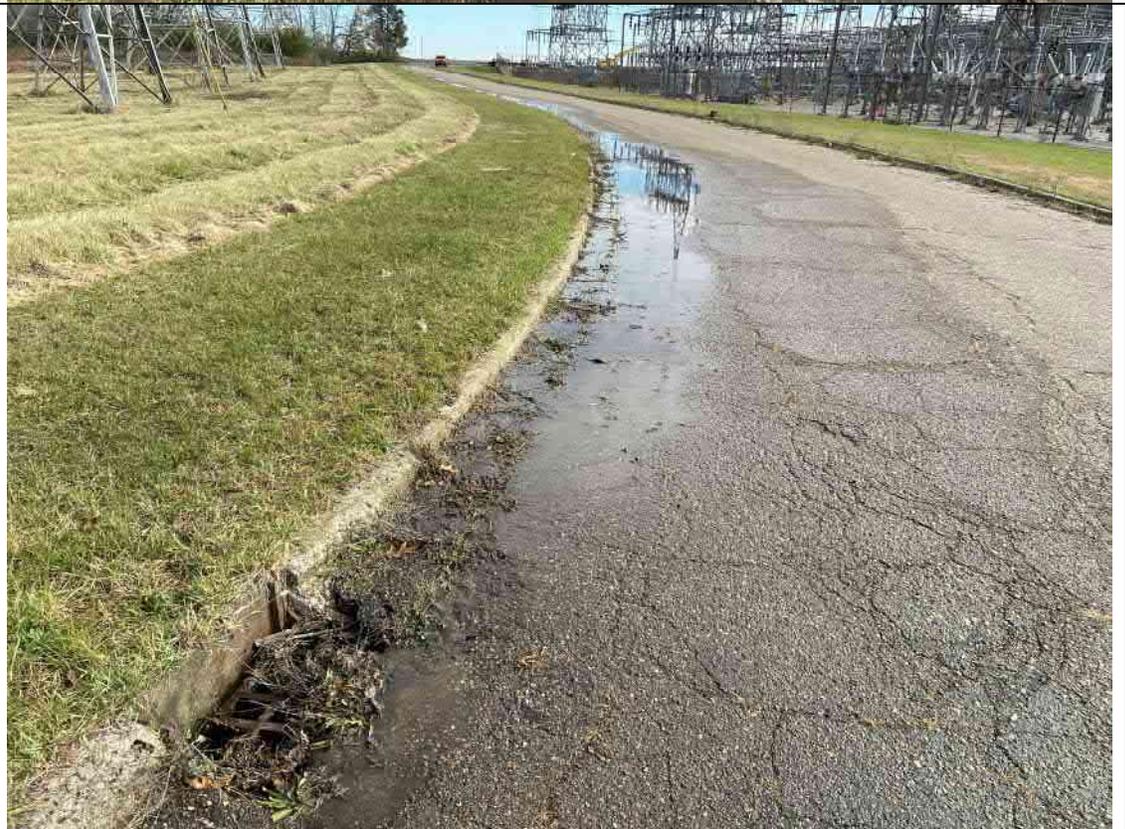
Photo No.
22

Description:
Sediment bag leak

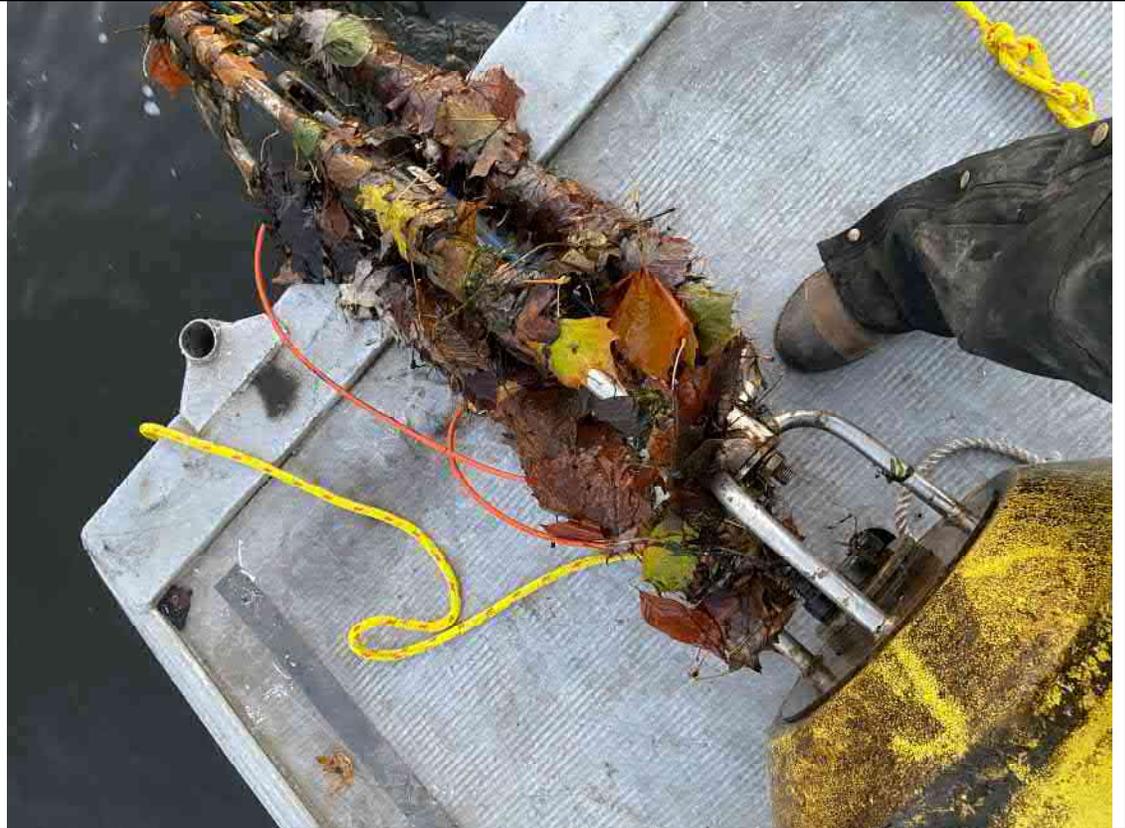
Photo No.
23

Description:
Sonde 3 before
cleaning.

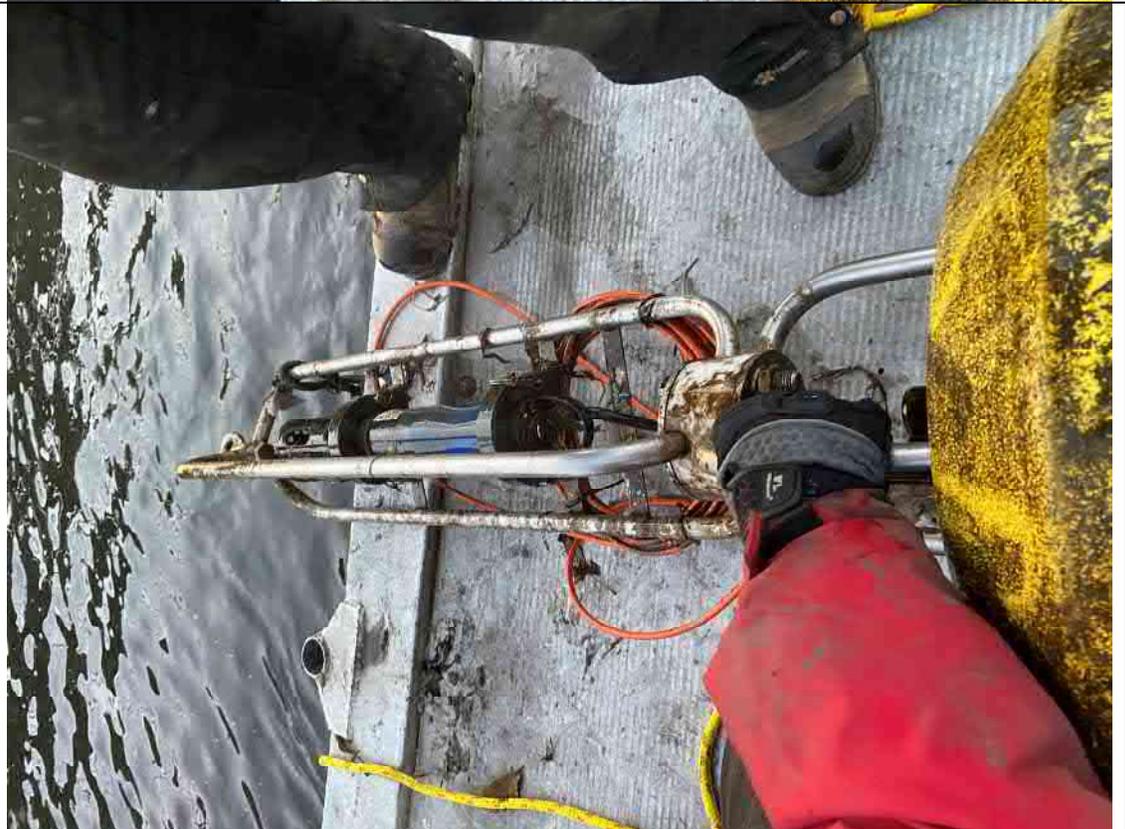
Photo No.
24

Description:
Sonde 3 after
cleaning.
