**Subject: Contract No. 68HERH19D0018; Task Order (TO) No. 68HE0719F0190
Cyclonic Building, 3201-3207 Locust Street, St. Louis, Missouri
Targeted Brownfields Assessment Hazardous Materials Survey**

**TARGETED BROWNFIELDS ASSESSMENT
HAZARDOUS MATERIALS SURVEY**

**CYCLONIC BUILDING
3201-3207 LOCUST BOULEVARD, ST. LOUIS, MISSOURI**

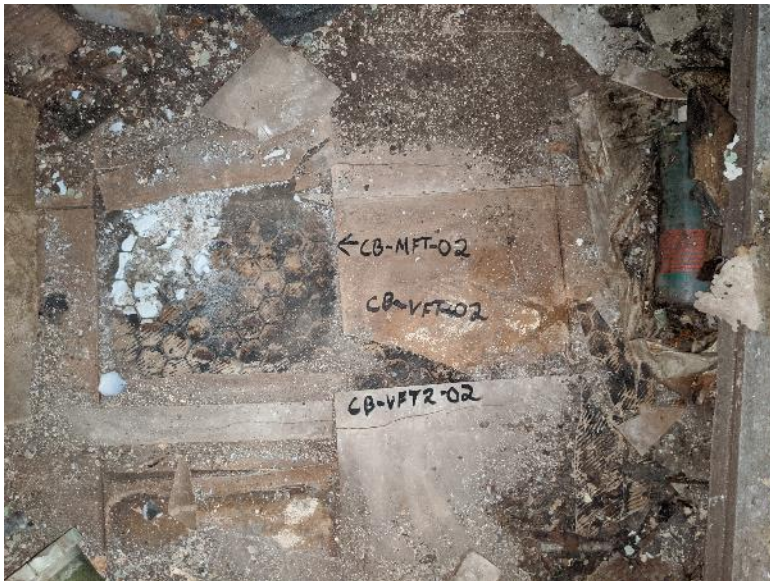
<p>SUBTASK NO. 01.05</p> <p>Direction: NA</p>	DESCRIPTION	This photograph shows marble floor tile with asbestos-containing black mastic, asbestos-containing 9" X 9" beige floor tile, and asbestos-containing 12" X 12" beige floor tile in the southwest room on the first floor.	2
	CLIENT	EPA	Date
	PHOTOGRAPHER	Ryan Slanczka	9/14/2020

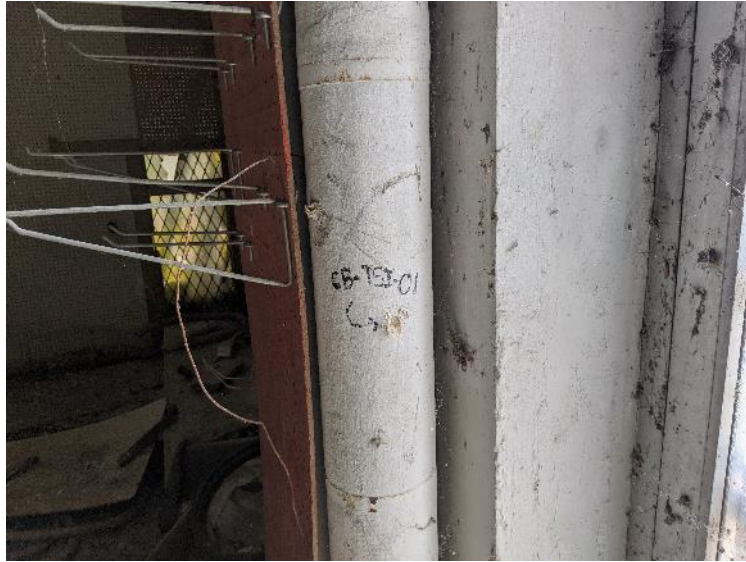
SUBTASK NO. 01.05 Direction: NA	DESCRIPTION	This photograph shows white lead-based paint (LBP) and asbestos-containing pipe insulation, found in the northeast, southeast, and southwest rooms on the first floor.	3
	CLIENT	EPA	Date
	PHOTOGRAPHER	Ryan Slanczka	9/14/2020

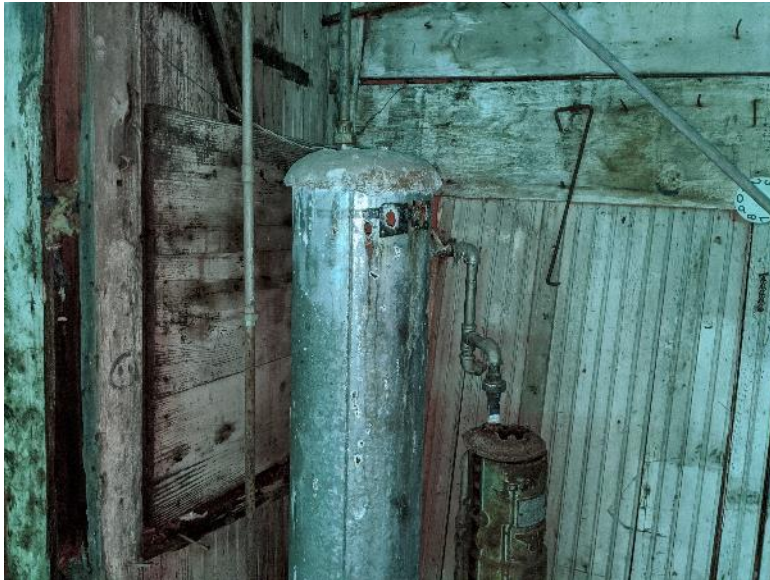
SUBTASK NO. 01.05 Direction: NA	DESCRIPTION	This photograph shows asbestos-containing water heater insulation in the northeast room on the second floor.	4
	CLIENT	EPA	Date
	PHOTOGRAPHER	Ryan Slanczka	9/14/2020

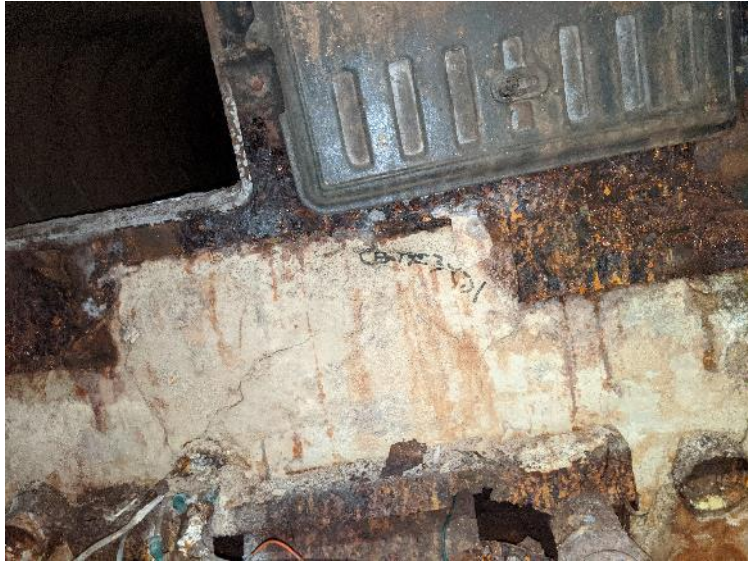
SUBTASK NO. 01.05 Direction: NA	DESCRIPTION	This photograph shows asbestos-containing boiler insulation, found in the northeast room of the basement.	5
	CLIENT	EPA	Date
	PHOTOGRAPHER	Ryan Slanczka	9/14/2020

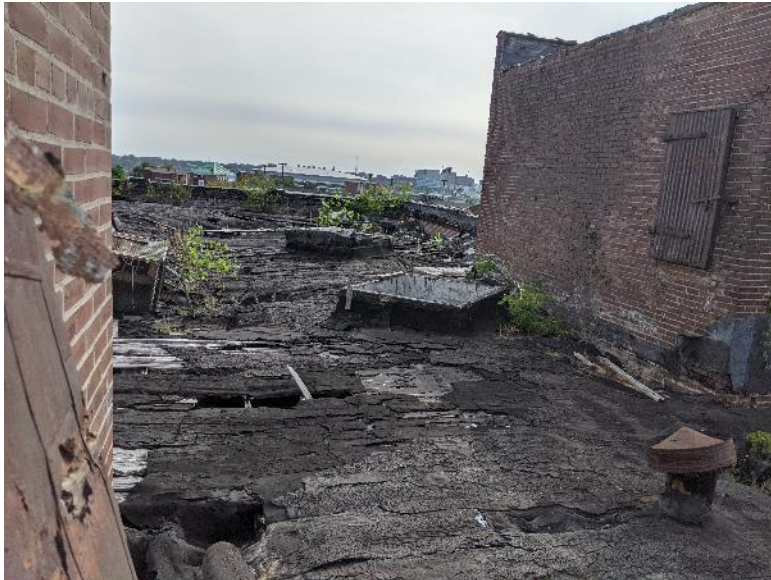
SUBTASK NO. 01.05 Direction: South	DESCRIPTION	This photograph shows asbestos-containing roofing material.	6
	CLIENT	EPA	Date
	PHOTOGRAPHER	Ryan Slanczka	9/14/2020

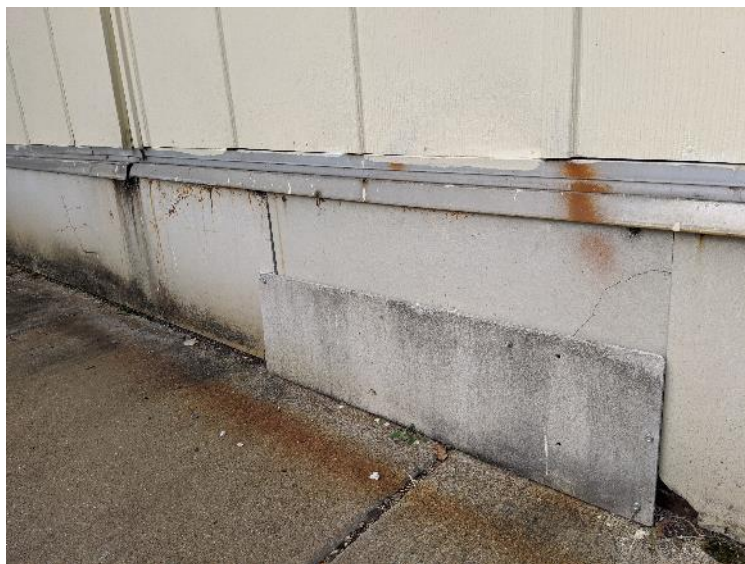
- Regulated ACM was identified in caulk (approximately 150 LF) around exterior doors and window panes along the south wall.
- Regulated ACM was identified in cement board (approximately 40 SF) along the exterior building foundation.

SUBTASK NO. 01.05 Direction: Northwest	DESCRIPTION	This photograph shows asbestos-containing cement board, found at the base of the south exterior wall.	7
	CLIENT	EPA	Date
	PHOTOGRAPHER	Ryan Slanczka	9/14/2020

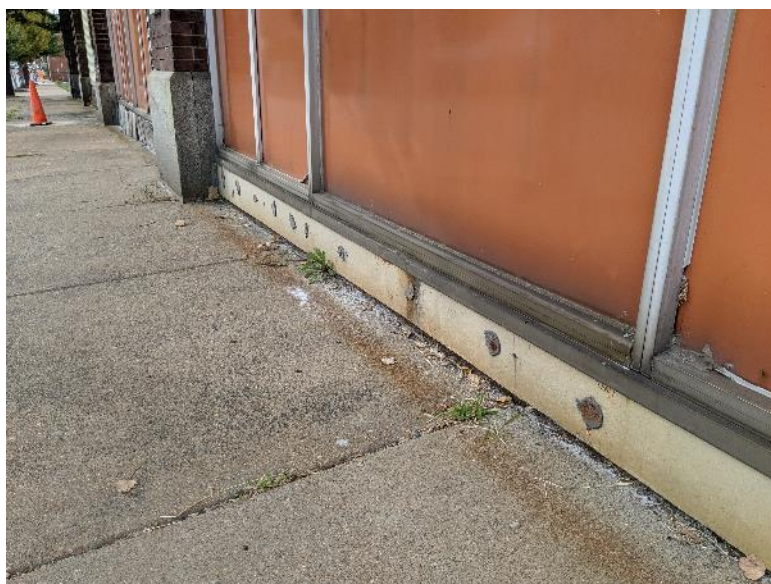
SUBTASK NO. 01.05 Direction: Northwest	DESCRIPTION	This photograph shows asbestos-containing glue puck, found at the base of the south exterior wall.	8
	CLIENT	EPA	Date
	PHOTOGRAPHER	Ryan Slanczka	9/14/2020

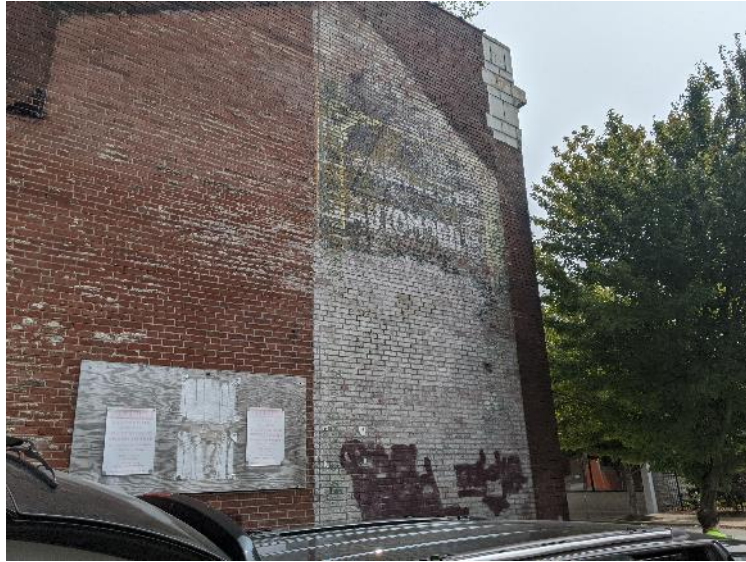
<p>SUBTASK NO. 01.05</p> <p>Direction: Southeast</p>	DESCRIPTION	This photograph shows purple and white LBP on the west exterior wall.	9
	CLIENT	EPA	Date
	PHOTOGRAPHER	Ryan Slanczka	9/14/2020

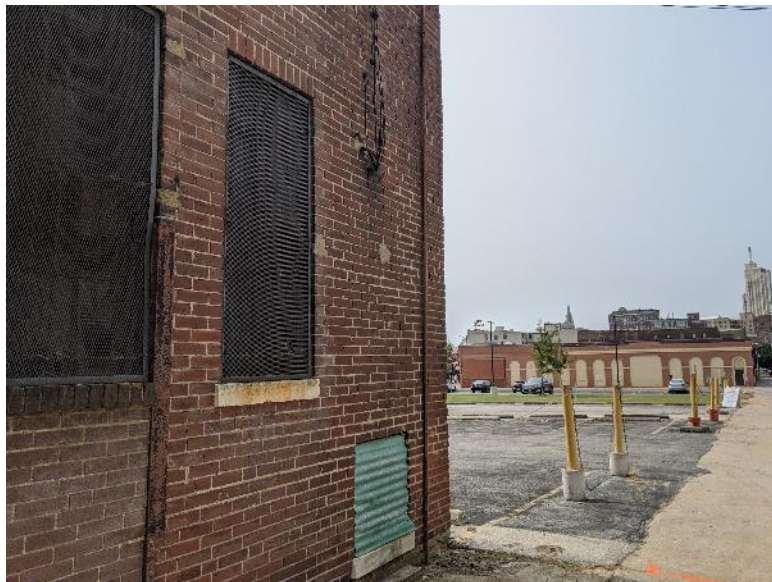
<p>SUBTASK NO. 01.05</p> <p>Direction: Southwest</p>	DESCRIPTION	This photograph shows red LBP on a pipe, brown LBP on a bar along the window perimeter, and black LBP on the window grate of the north exterior wall.	10
	CLIENT	EPA	Date
	PHOTOGRAPHER	Ryan Slanczka	9/14/2020

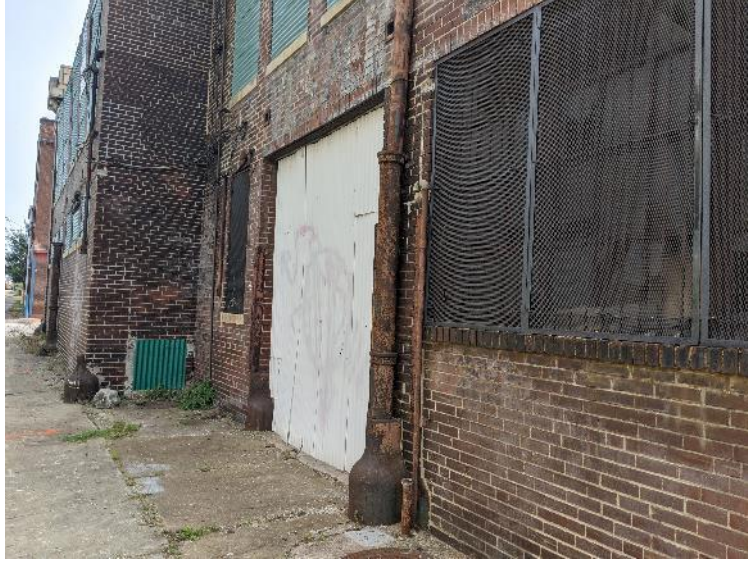
SUBTASK NO. 01.05 Direction: Southeast	DESCRIPTION	This photograph shows red LBP on a metal cover over a gutter along the north exterior wall.	11
	CLIENT	EPA	Date
	PHOTOGRAPHER	Ryan Slanczka	9/14/2020

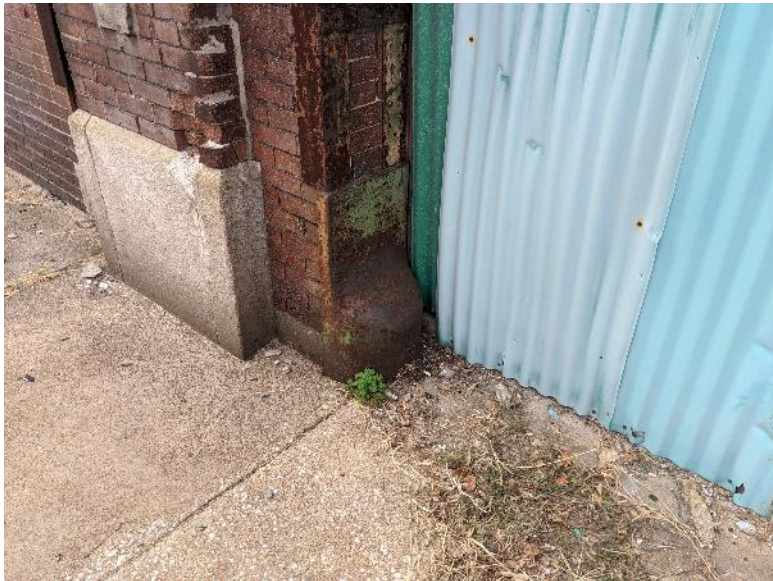
SUBTASK NO. 01.05 Direction: Southwest	DESCRIPTION	This photograph shows green LBP on a metal barrier-plate at the perimeter of a building entryway at the east exterior wall.	12
	CLIENT	EPA	Date
	PHOTOGRAPHER	Ryan Slanczka	9/14/2020

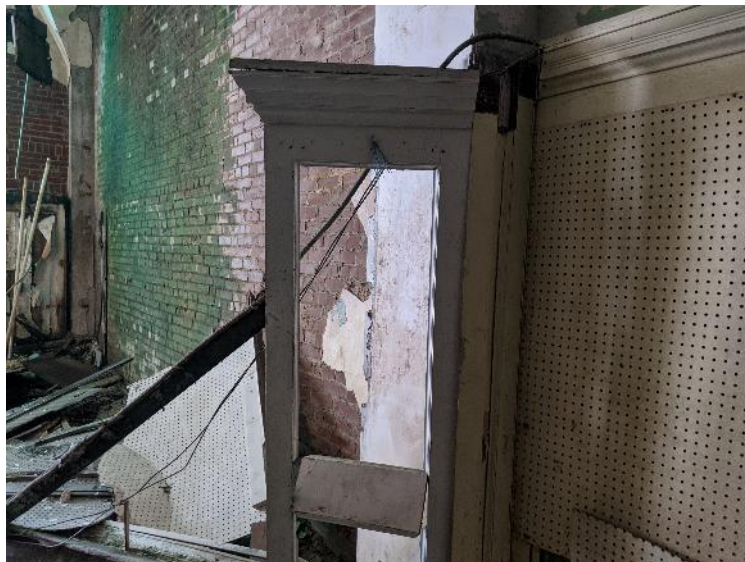
SUBTASK NO. 01.05 Direction: NA	DESCRIPTION	This photograph shows white LBP on wood trim of the columns and walls in the southwest room on the first floor.	13
	CLIENT	EPA	Date
	PHOTOGRAPHER	Ryan Slanczka	9/14/2020

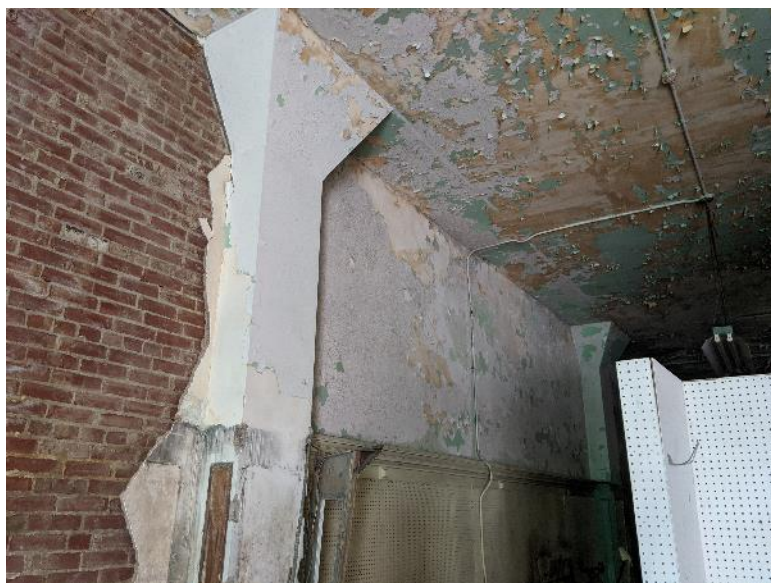
SUBTASK NO. 01.05 Direction: NA	DESCRIPTION	This photograph shows white and beige LBP on the plaster walls and ceilings of the building.	14
	CLIENT	EPA	Date
	PHOTOGRAPHER	Ryan Slanczka	9/14/2020

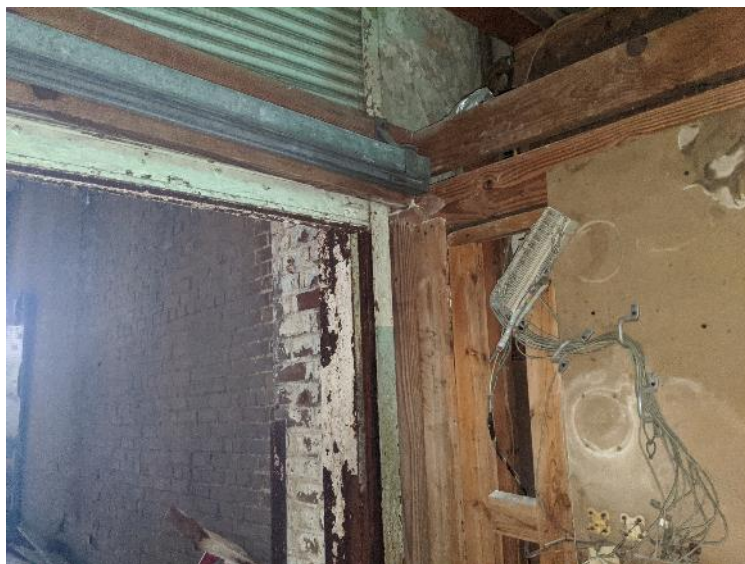
SUBTASK NO. 01.05 Direction: NA	DESCRIPTION	This photograph shows white and green LBP on an overhead door and its frame in the southwest room on the first floor.	15
	CLIENT	EPA	Date
	PHOTOGRAPHER	Ryan Slanczka	9/14/2020

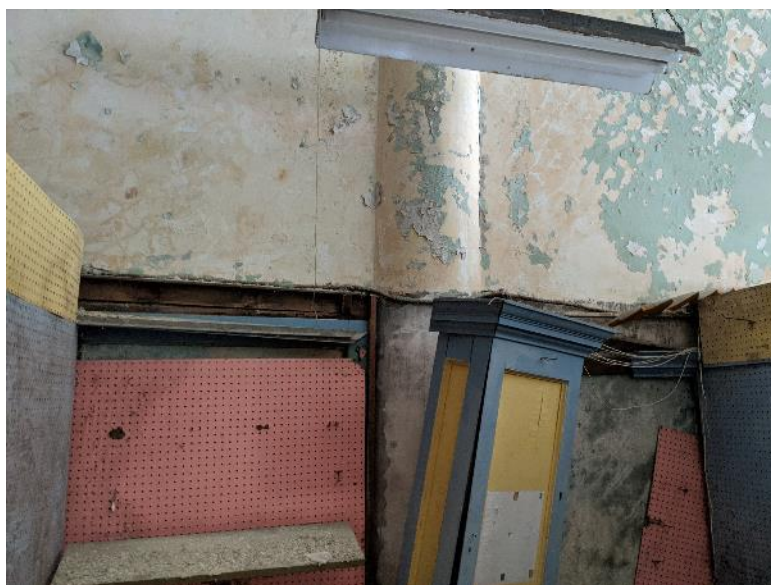
SUBTASK NO. 01.05 Direction: NA	DESCRIPTION	This photograph shows light blue LBP on the wooden trim of the columns and wall in the southwest room on the first floor.	16
	CLIENT	EPA	Date
	PHOTOGRAPHER	Ryan Slanczka	9/14/2020

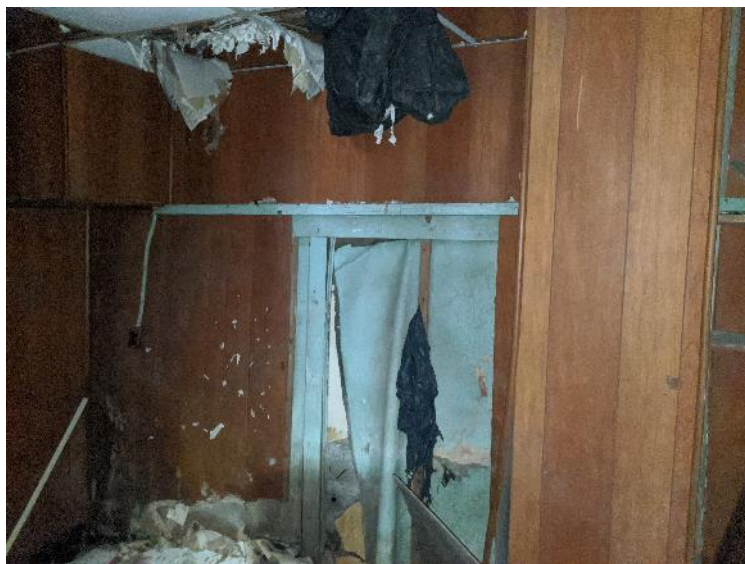
SUBTASK NO. 01.05 Direction: NA	DESCRIPTION	This photograph shows light green LBP on the north wall and wall trim in the southwest room on the first floor.	17
	CLIENT	EPA	Date
	PHOTOGRAPHER	Ryan Slanczka	9/14/2020

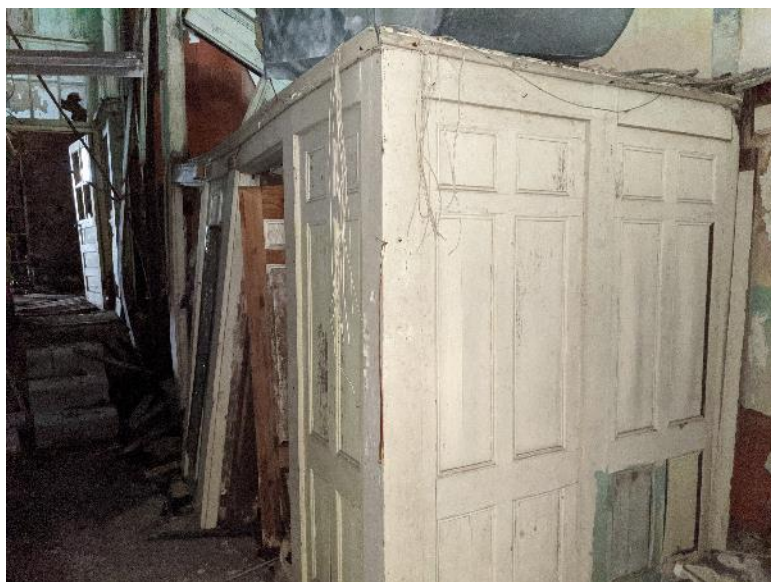
SUBTASK NO. 01.05 Direction: NA	DESCRIPTION	This photograph shows white LBP on wall panels in the southwest room on the first floor.	18
	CLIENT	EPA	Date
	PHOTOGRAPHER	Ryan Slanczka	9/14/2020

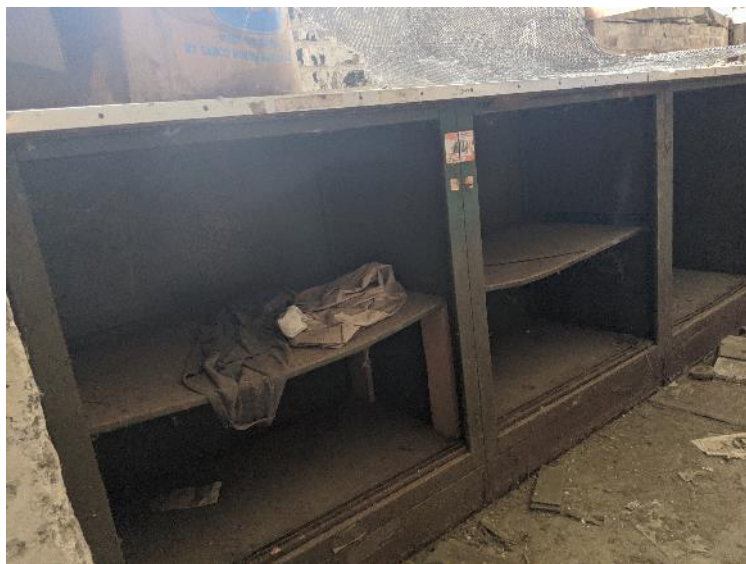
SUBTASK NO. 01.05 Direction: NA	DESCRIPTION	This photograph shows green LBP on a cupboard in the northwest room on the first floor.	19
	CLIENT	EPA	Date
	PHOTOGRAPHER	Ryan Slanczka	9/14/2020

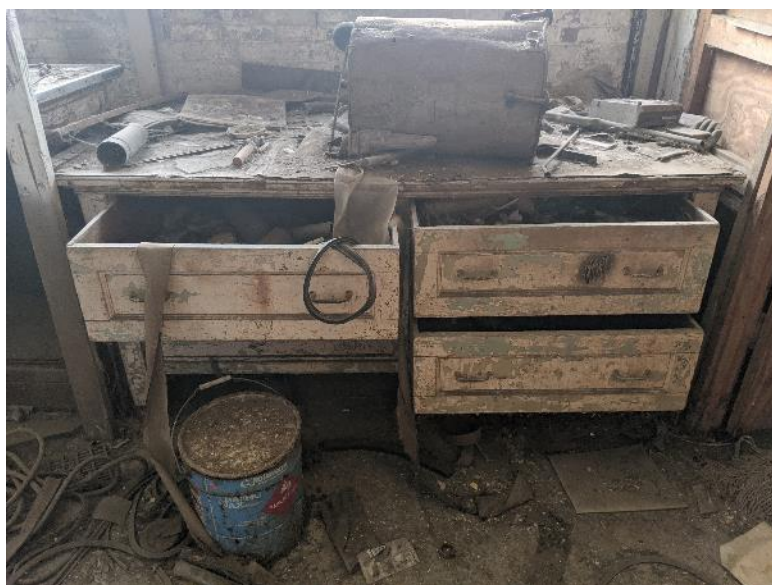
SUBTASK NO. 01.05 Direction: NA	DESCRIPTION	This photograph shows white LBP on a cupboard in the northwest room on the first floor.	20
	CLIENT	EPA	Date
	PHOTOGRAPHER	Ryan Slanczka	9/14/2020

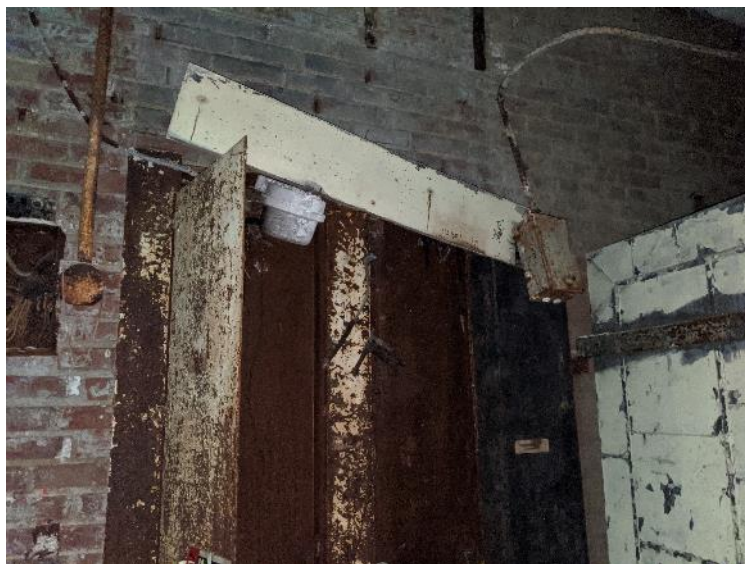
SUBTASK NO. 01.05 Direction: NA	DESCRIPTION	This photograph shows off-white and black LBP on an electrical panel, and off-white LBP on a board along the top perimeter of the electrical panel in the east-central room on the first floor.	21
	CLIENT	EPA	Date
	PHOTOGRAPHER	Ryan Slanczka	9/14/2020

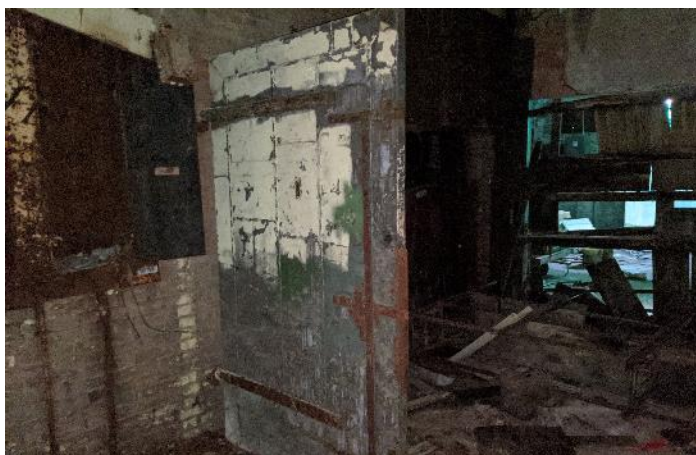
SUBTASK NO. 01.05 Direction: NA	DESCRIPTION	This photograph shows off-white and green LBP on a stairwell door in the east-central room on the first floor.	22
	CLIENT	EPA	Date
	PHOTOGRAPHER	Ryan Slanczka	9/14/2020

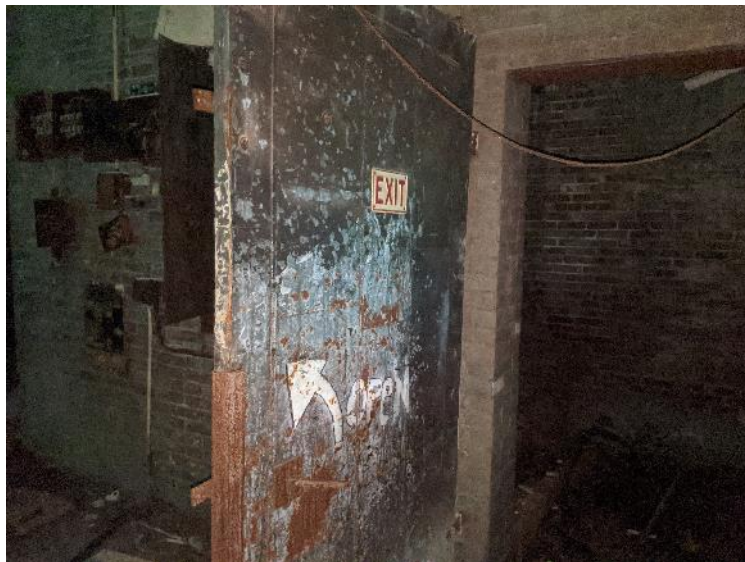
<p>SUBTASK NO. 01.05</p> <p>Direction: NA</p>	DESCRIPTION	This photograph shows black LBP on a stairwell in the east-central room on the first floor.	23
	CLIENT	EPA	Date
	PHOTOGRAPHER	Ryan Slanczka	9/14/2020

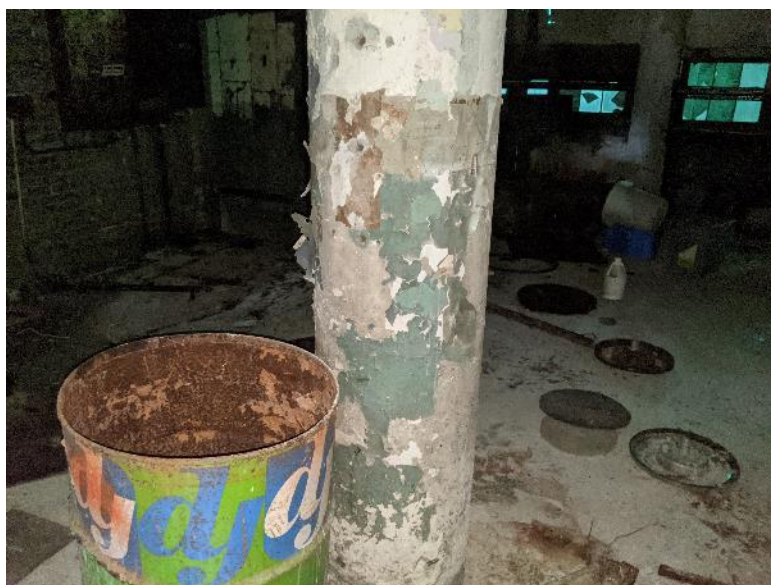
<p>SUBTASK NO. 01.05</p> <p>Direction: NA</p>	DESCRIPTION	This photograph shows green LBP on a column in the east-central room on the first floor.	24
	CLIENT	EPA	Date
	PHOTOGRAPHER	Ryan Slanczka	9/14/2020

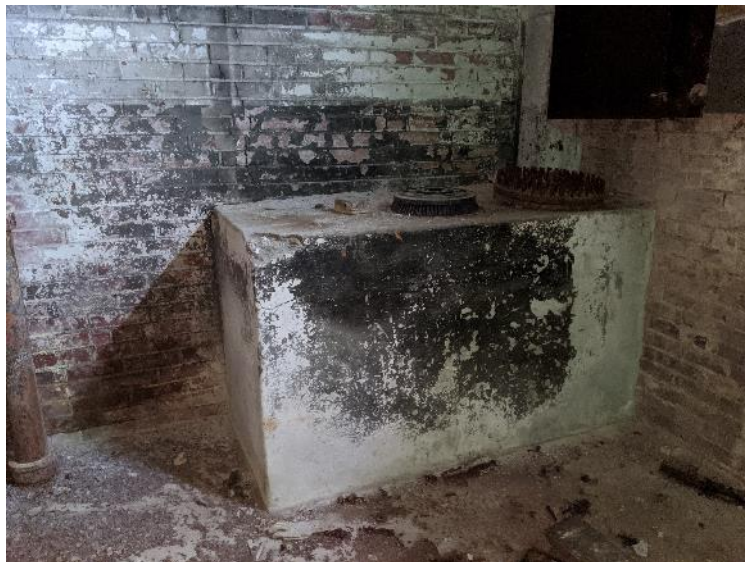
SUBTASK NO. 01.05 Direction: NA	DESCRIPTION	This photograph shows black LBP on a concrete block structure and on the wall in the northeast room on the first floor.	25
	CLIENT	EPA	Date
	PHOTOGRAPHER	Ryan Slanczka	9/14/2020

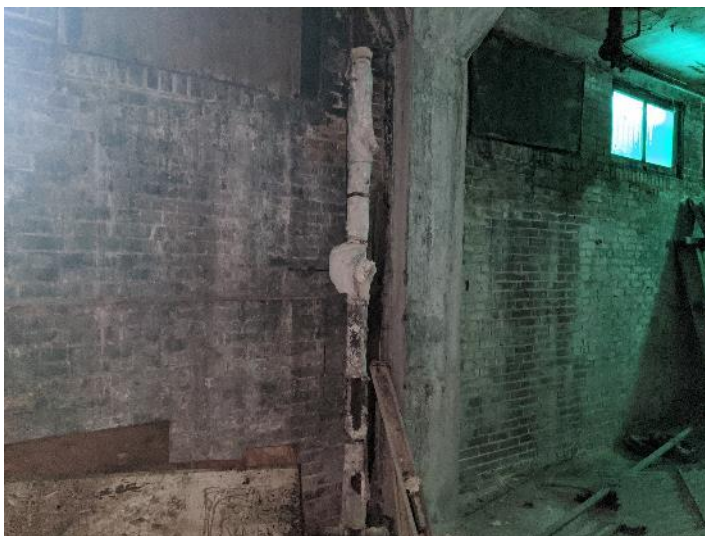
SUBTASK NO. 01.05 Direction: NA	DESCRIPTION	This photograph shows black LBP on asbestos-containing pipe insulation in the northeast room on the first floor.	26
	CLIENT	EPA	Date
	PHOTOGRAPHER	Ryan Slanczka	9/14/2020

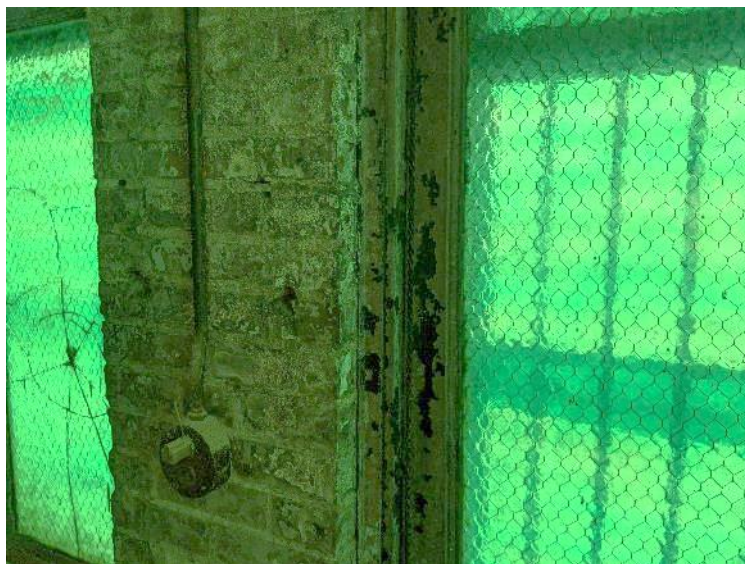
<p>SUBTASK NO. 01.05</p> <p>Direction: NA</p>	DESCRIPTION	This photograph shows black LBP on window frames in the northeast room on the second floor.	27
	CLIENT	EPA	Date
	PHOTOGRAPHER	Ryan Slanczka	9/14/2020

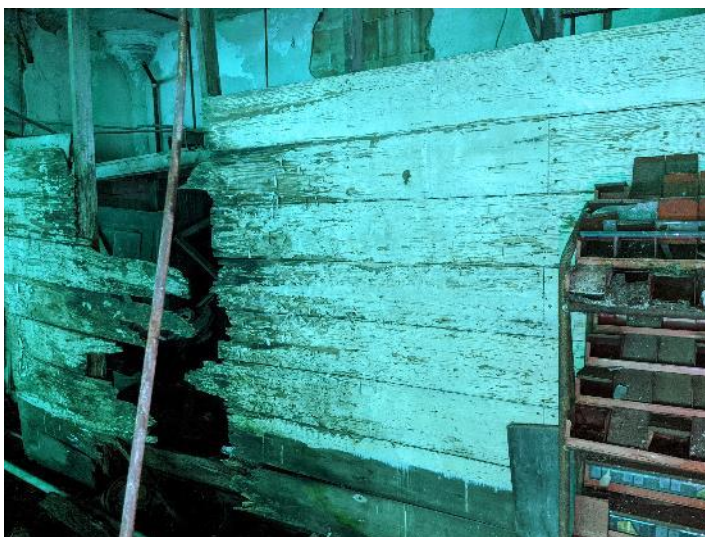
<p>SUBTASK NO. 01.05</p> <p>Direction: NA</p>	DESCRIPTION	This photograph shows white LBP on horizontal wall boards in the northeast room on the second floor.	28
	CLIENT	EPA	Date
	PHOTOGRAPHER	Ryan Slanczka	9/14/2020

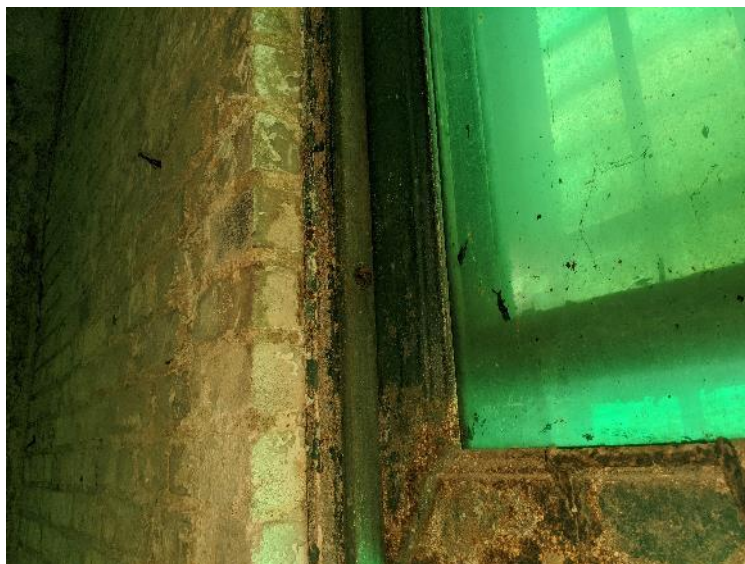
SUBTASK NO. 01.05 Direction: NA	DESCRIPTION	This photograph shows green LBP on window frames in the west room on the second floor.	29
	CLIENT	EPA	Date
	PHOTOGRAPHER	Ryan Slanczka	9/14/2020

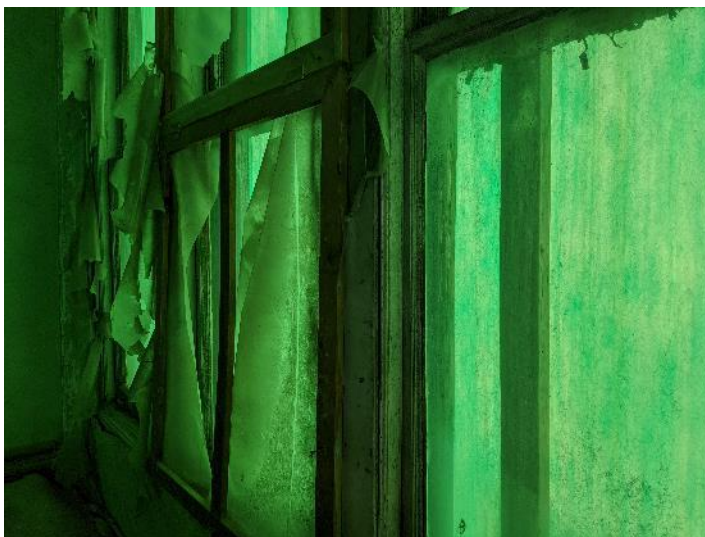
SUBTASK NO. 01.05 Direction: NA	DESCRIPTION	This photograph shows white LBP on window frames in the southeast room on the second floor.	30
	CLIENT	EPA	Date
	PHOTOGRAPHER	Ryan Slanczka	9/14/2020

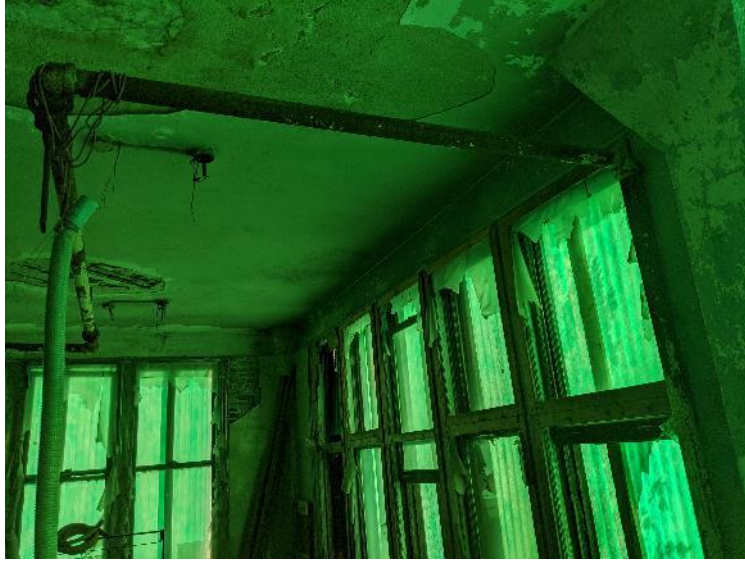
SUBTASK NO. 01.05 Direction: NA	DESCRIPTION	This photograph shows white LBP on a pipe in the southeast room on the second floor.	31
	CLIENT	EPA	Date
	PHOTOGRAPHER	Ryan Slanczka	9/14/2020

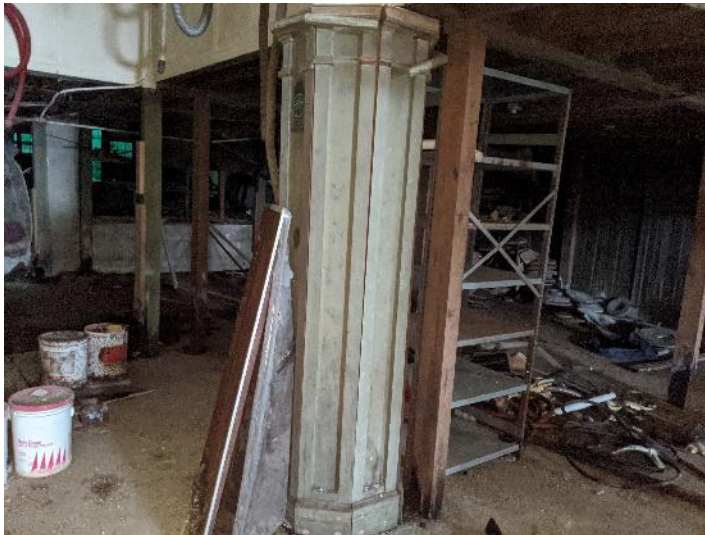
SUBTASK NO. 01.05 Direction: NA	DESCRIPTION	This photograph shows gray LBP on a column frame in the southeast room on the first floor.	32
	CLIENT	EPA	Date
	PHOTOGRAPHER	Ryan Slanczka	9/14/2020

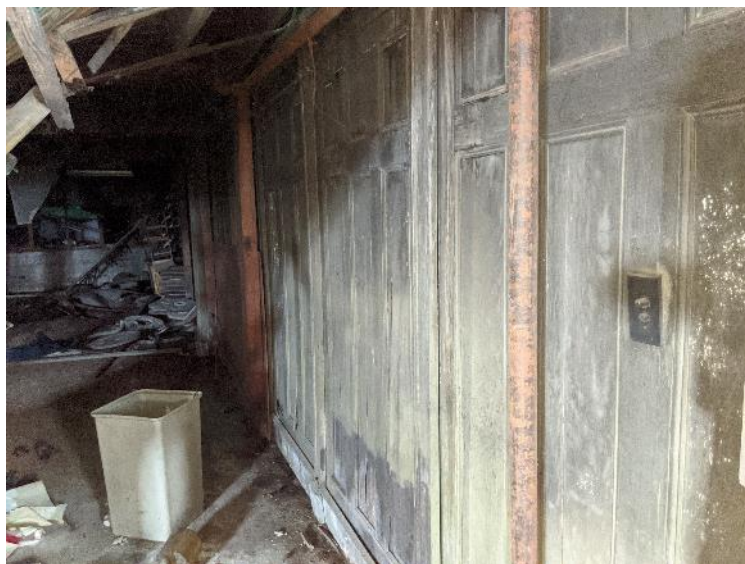
<p>SUBTASK NO. 01.05</p> <p>Direction: NA</p>	DESCRIPTION	This photograph shows grey LBP on wall panels in the southeast room on the first floor.	33
	CLIENT	EPA	Date
	PHOTOGRAPHER	Ryan Slanczka	9/14/2020

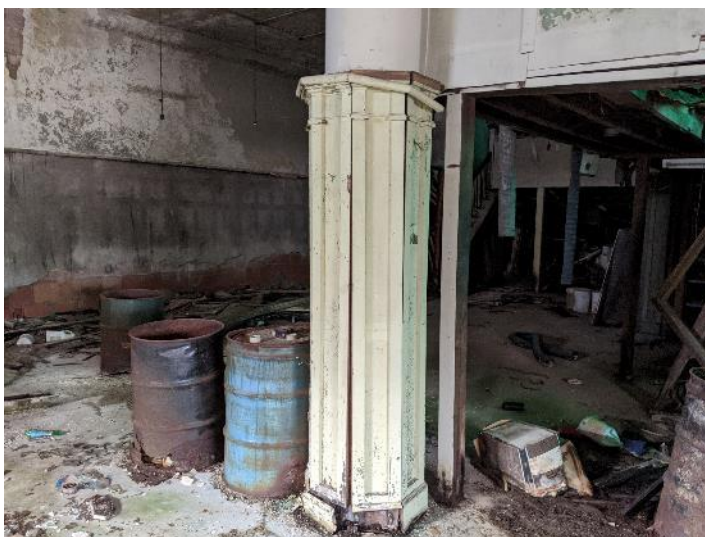
<p>SUBTASK NO. 01.05</p> <p>Direction: NA</p>	DESCRIPTION	This photograph shows off-white LBP on a column frame in the southeast room on the first floor.	34
	CLIENT	EPA	Date
	PHOTOGRAPHER	Ryan Slanczka	9/14/2020

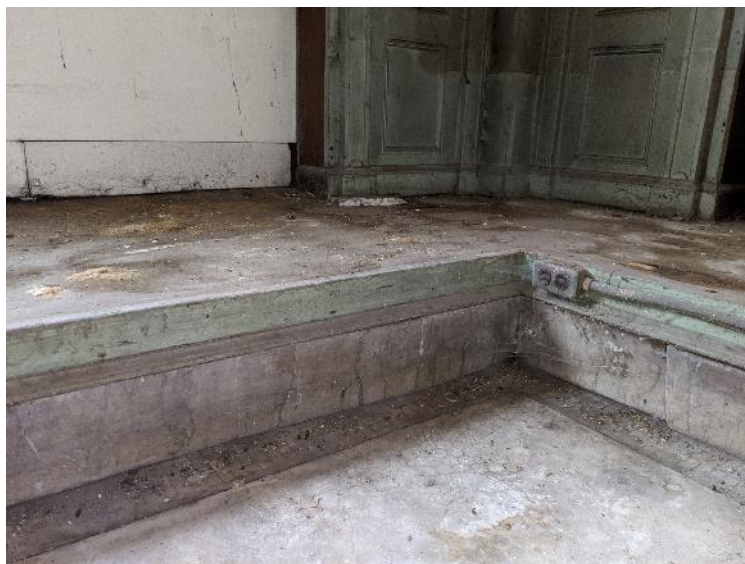
SUBTASK NO. 01.05 Direction: NA	DESCRIPTION	This photograph shows green LBP on a step baseboard in the southeast room on the first floor.	35
	CLIENT	EPA	Date
	PHOTOGRAPHER	Ryan Slanczka	9/14/2020

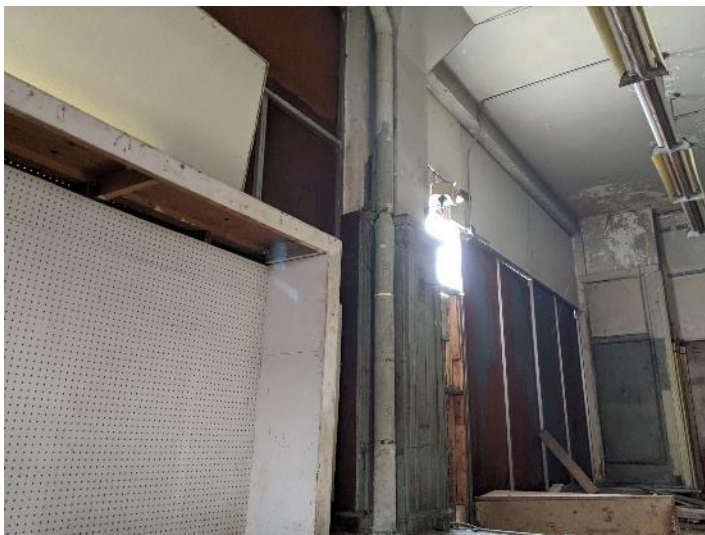
SUBTASK NO. 01.05 Direction: NA	DESCRIPTION	This photograph shows grey LBP on pipe insulation in the southeast room on the first floor.	36
	CLIENT	EPA	Date
	PHOTOGRAPHER	Ryan Slanczka	9/14/2020

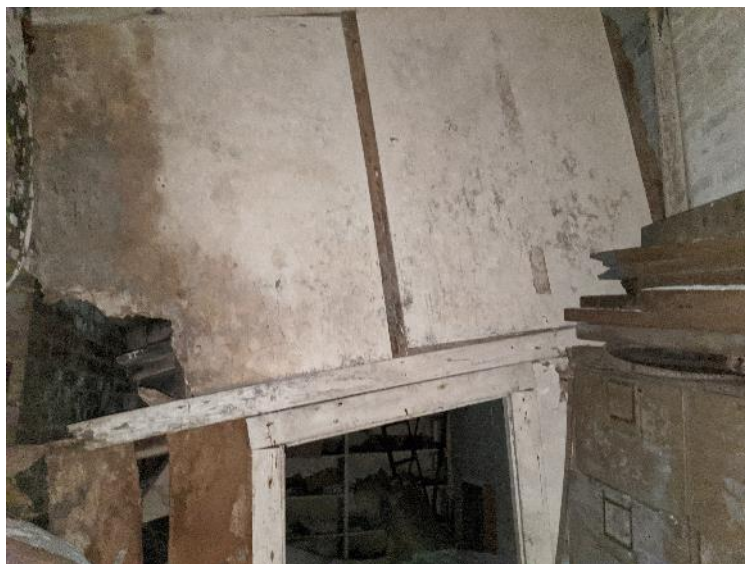
SUBTASK NO. 01.05 Direction: NA	DESCRIPTION	This photograph shows white LBP on a wall and door trim in the southwest room in the basement.	37
	CLIENT	EPA	Date
	PHOTOGRAPHER	Ryan Slanczka	9/14/2020

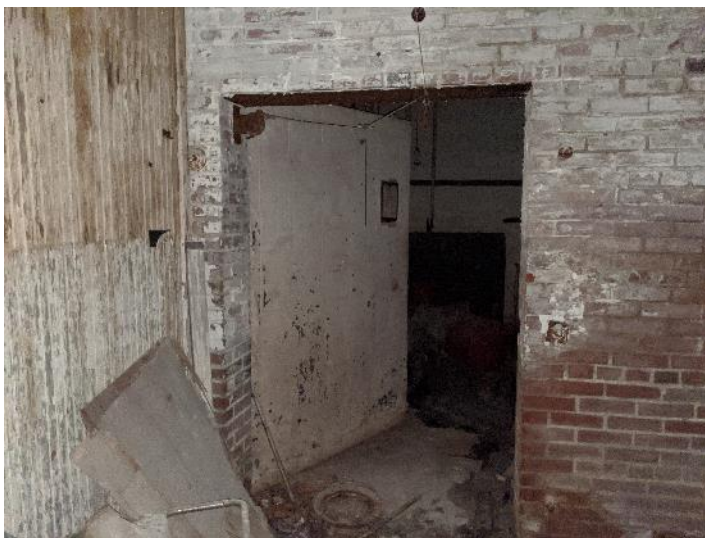
SUBTASK NO. 01.05 Direction: NA	DESCRIPTION	This photograph shows white LBP on a door to the northwest rooms in the basement.	38
	CLIENT	EPA	Date
	PHOTOGRAPHER	Ryan Slanczka	9/14/2020

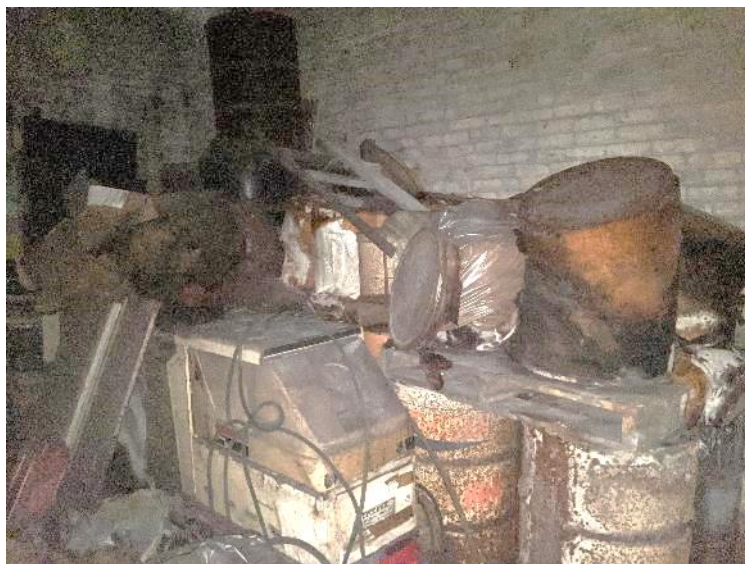
SUBTASK NO. 01.05 Direction: NA	DESCRIPTION	This photograph shows miscellaneous equipment, debris, and 55-gallon drums in the northeast room in the basement.	39
	CLIENT	EPA	Date
	PHOTOGRAPHER	Ryan Slanczka	9/14/2020

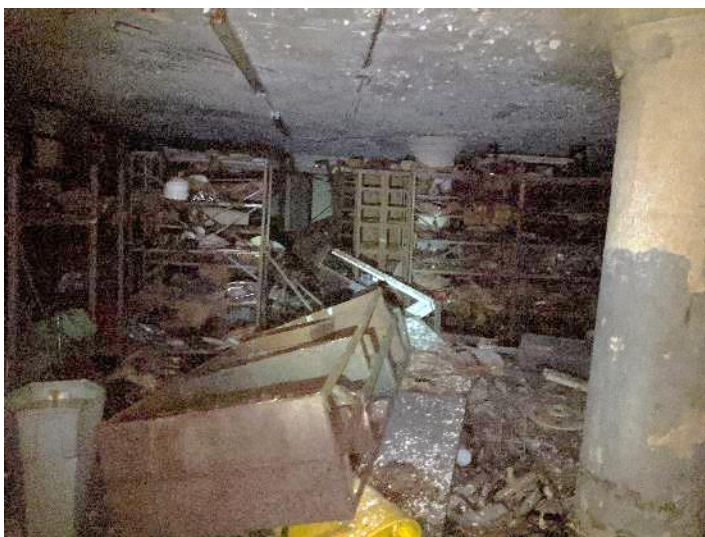
SUBTASK NO. 01.05 Direction: NA	DESCRIPTION	This photograph shows miscellaneous debris and containers in the southwest room in the basement.	40
	CLIENT	EPA	Date
	PHOTOGRAPHER	Ryan Slanczka	9/14/2020

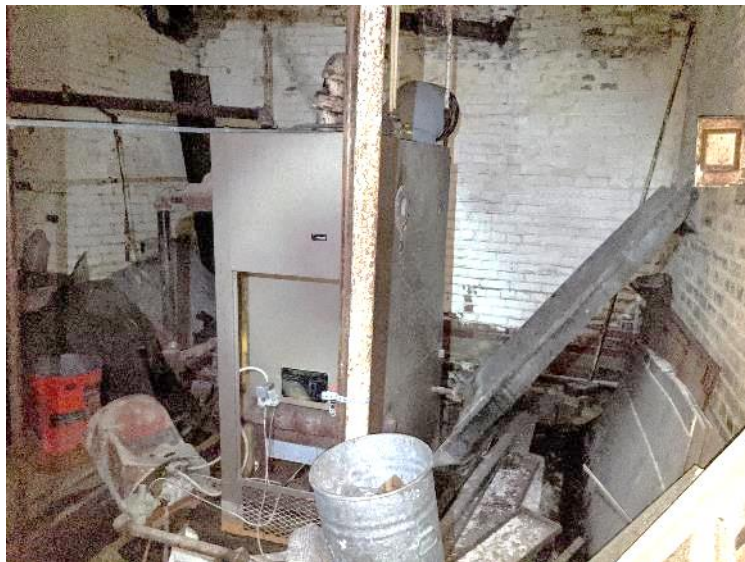
SUBTASK NO. 01.05 Direction: NA	DESCRIPTION	This photograph shows miscellaneous equipment and debris in the northwest room in the basement.	41
	CLIENT	EPA	Date
	PHOTOGRAPHER	Ryan Slanczka	9/14/2020

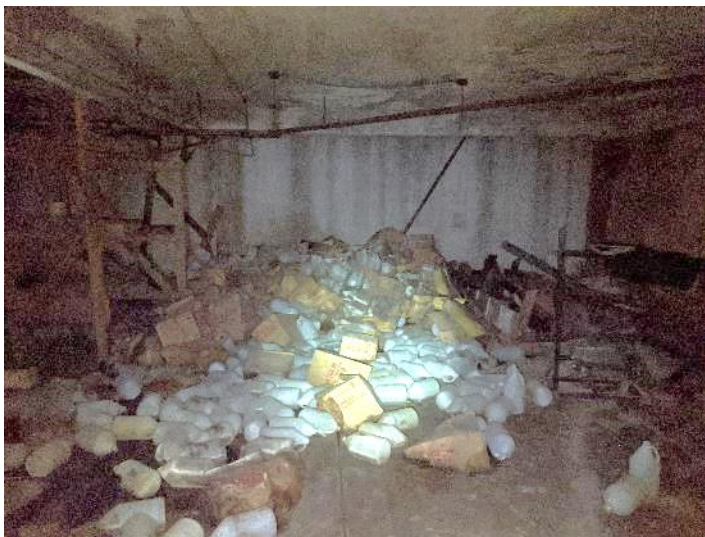
SUBTASK NO. 01.05 Direction: NA	DESCRIPTION	This photograph shows miscellaneous debris and containers in the southeast room in the basement.	42
	CLIENT	EPA	Date
	PHOTOGRAPHER	Ryan Slanczka	9/14/2020

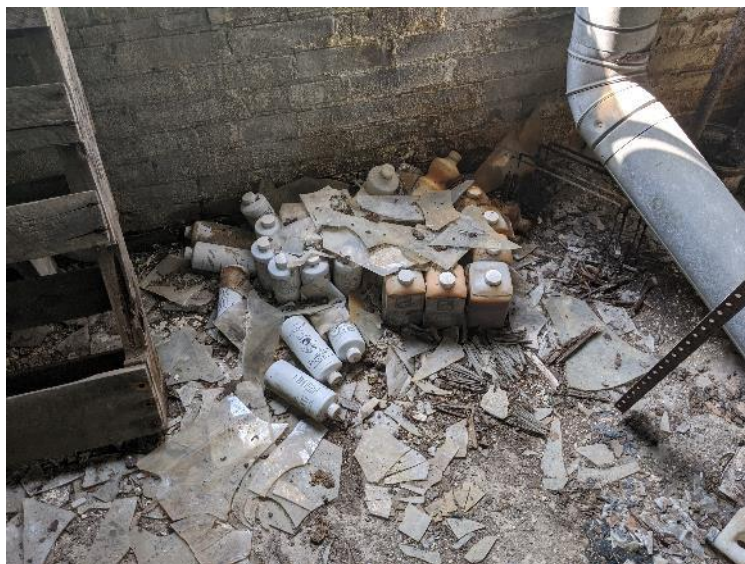
SUBTASK NO. 01.05 Direction: NA	DESCRIPTION	This photograph shows miscellaneous containers in the west room on the second floor.	43
	CLIENT	EPA	Date
	PHOTOGRAPHER	Ryan Slanczka	9/14/2020

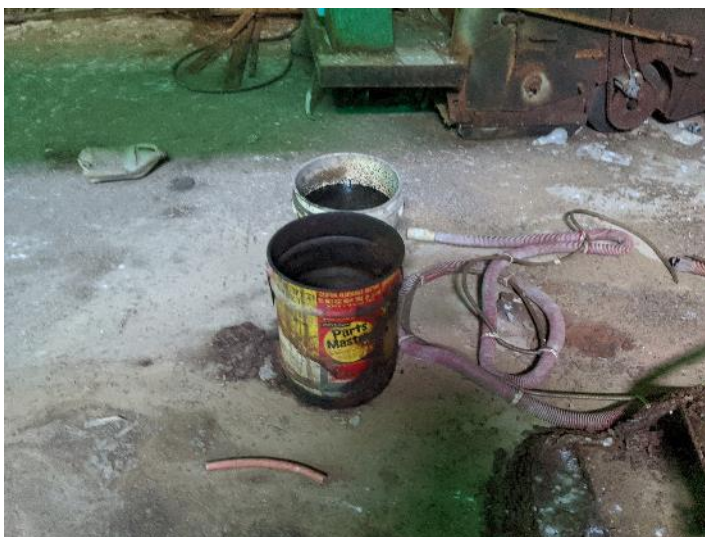
SUBTASK NO. 01.05 Direction: NA	DESCRIPTION	This photograph shows 5-gallon buckets filled with oil in the basement.	44
	CLIENT	EPA	Date
	PHOTOGRAPHER	Ryan Slanczka	9/14/2020
