**Subject: Contract No. 68HERH19D0018; Task Order (TO) No. 68HE0719F0190
WE Building, 3230-3232 Washington Boulevard, St. Louis, Missouri
Targeted Brownfields Assessment Hazardous Materials Survey**

**TARGETED BROWNFIELDS ASSESSMENT
HAZARDOUS MATERIALS SURVEY**

**WE BUILDING
3230-3232 WASHINGTON BOULEVARD, ST. LOUIS, MISSOURI**

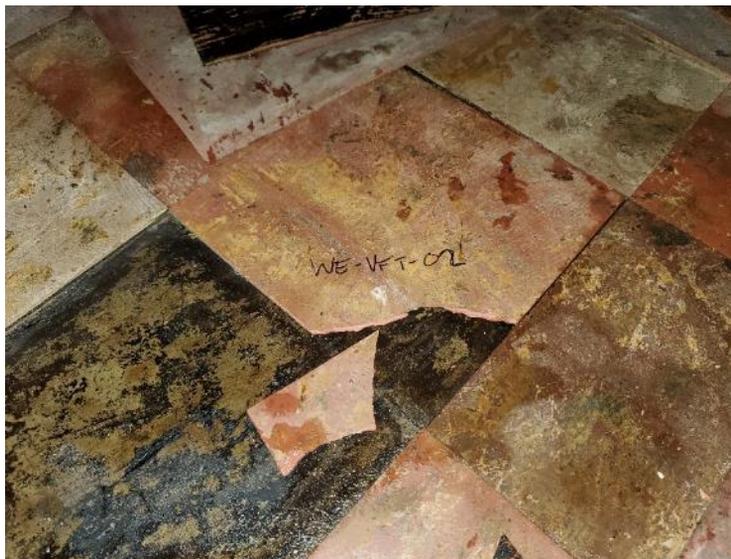
SUBTASK NO. 03.05 DIRECTION: NA	DESCRIPTION	This photograph shows asbestos-containing 9" X 9" red/beige floor tile with black mastic throughout the north room on the first floor.	2
	CLIENT	EPA	Date
	PHOTOGRAPHER	Ryan Slanczka	9/17/2020

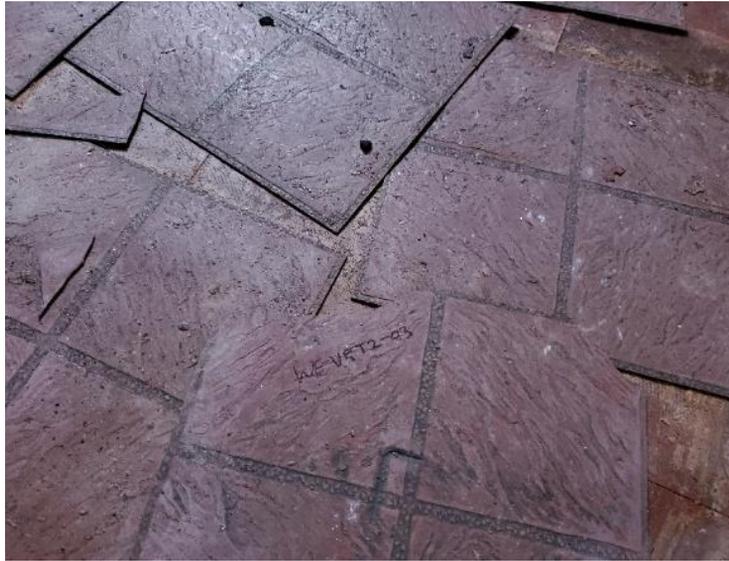
SUBTASK NO. 03.05	DESCRIPTION	This photograph shows asbestos-containing 12" X 12" red, natural façade floor tile with dark brown mastic in the western portion of the north room on the first floor.	3
	CLIENT	EPA	Date
DIRECTION: NA	PHOTOGRAPHER	Ryan Slanczka	9/17/2020

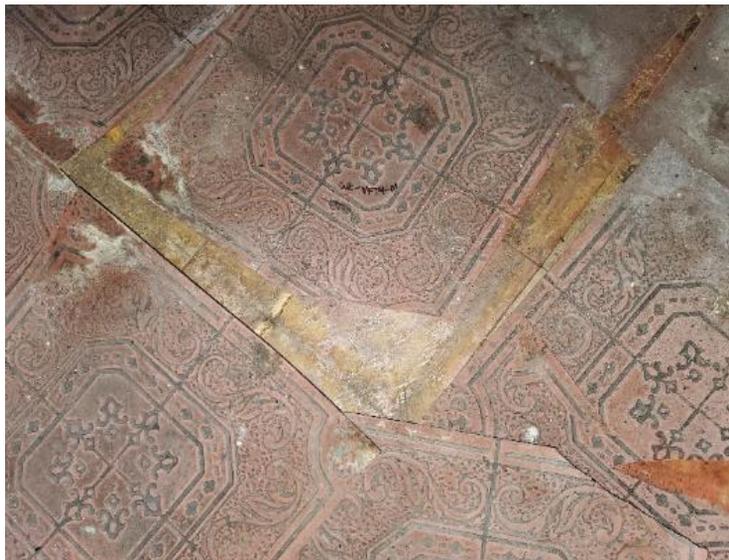
SUBTASK NO. 03.05	DESCRIPTION	This photograph shows asbestos-containing 12" X 12" red, ornate façade floor tile with yellow/brown mastic in the offices and the southeast portion of the north room on the first floor.	4
	CLIENT	EPA	Date
DIRECTION: NA	PHOTOGRAPHER	Ryan Slanczka	9/17/2020

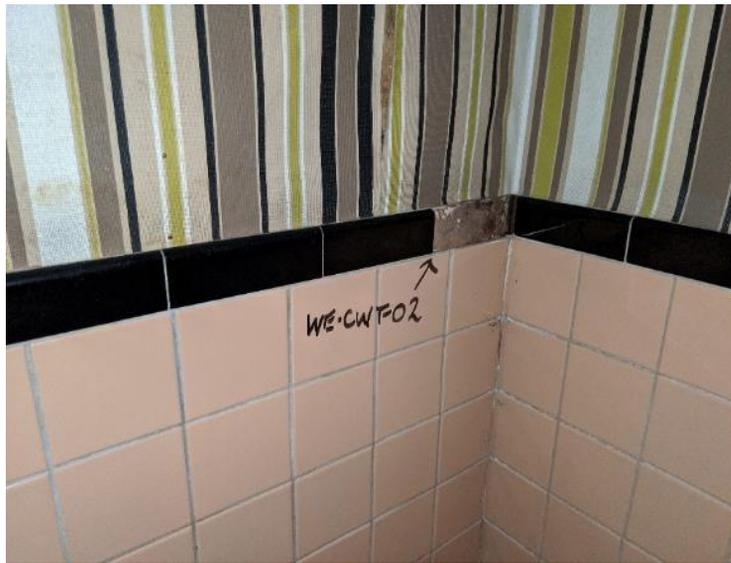
SUBTASK NO. 03.05	DESCRIPTION	This photograph shows ceramic wall tile with grout and asbestos-containing adhesive in the west restroom in the north room on the first floor.	5
	CLIENT	EPA	Date
DIRECTION: NA	PHOTOGRAPHER	Ryan Slanczka	9/17/2020

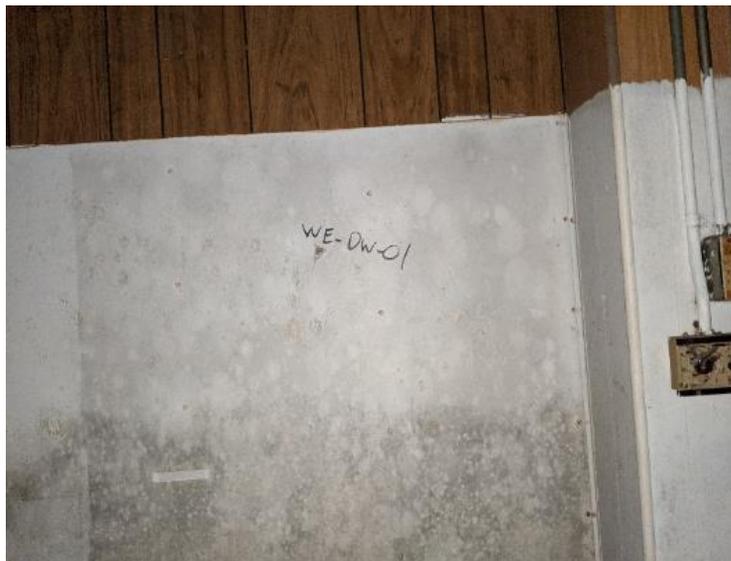
SUBTASK NO. 03.05	DESCRIPTION	This photograph shows drywall with asbestos-containing joint compound as the wall system of the northwest office and east restroom in the north room on the first floor.	6
	CLIENT	EPA	Date
DIRECTION: NA	PHOTOGRAPHER	Ryan Slanczka	9/17/2020

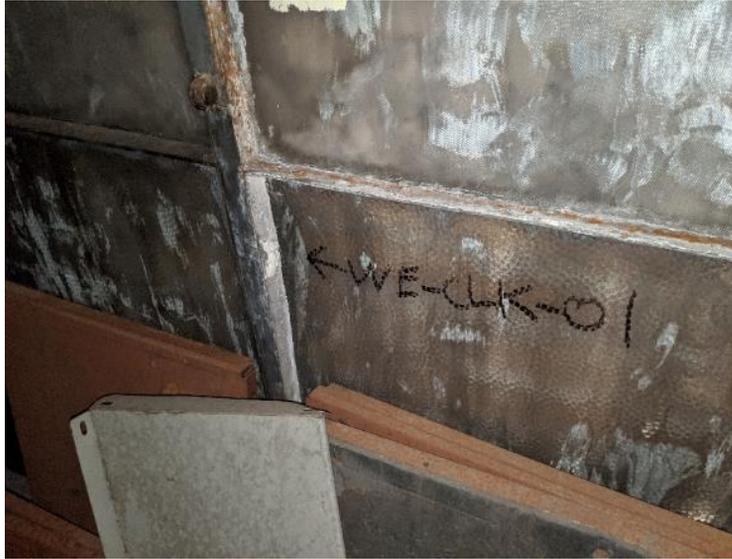
SUBTASK NO. 03.05 DIRECTION: NA	DESCRIPTION	This photograph shows asbestos-containing white caulk on the interior frames of windows throughout the WE Building, except office room windows.	7
	CLIENT	EPA	Date
	PHOTOGRAPHER	Ryan Slanczka	9/17/2020

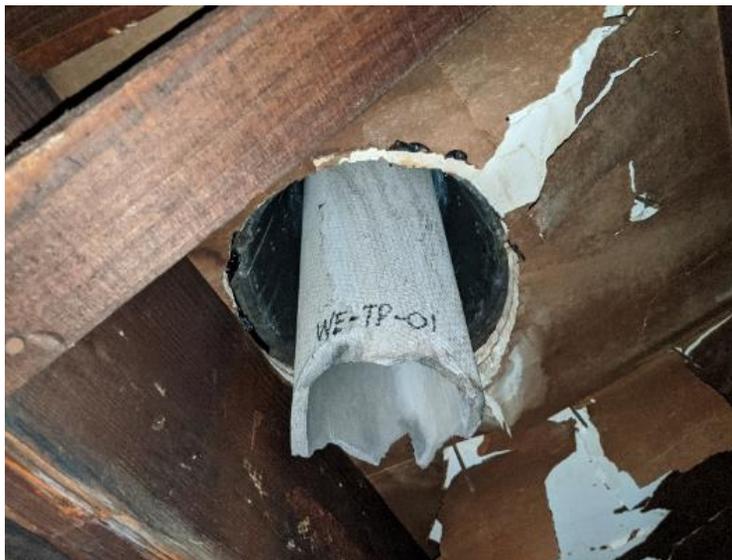
SUBTASK NO. 03.05 DIRECTION: NA	DESCRIPTION	This photograph shows asbestos-containing grey transite piping protruding through the roof at multiple locations in the central and south rooms on the second floor.	8
	CLIENT	EPA	Date
	PHOTOGRAPHER	Ryan Slanczka	9/17/2020

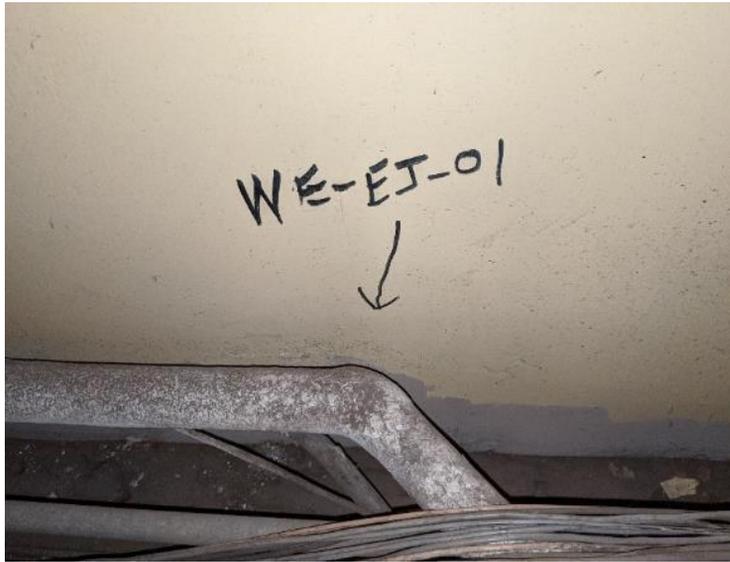
SUBTASK NO. 03.05	DESCRIPTION	This photograph shows asbestos-containing insulation on a 2" pipe running along the north wall in the central room on the second floor, east of the stairwell. (Sample ID incorrect--should be WE-TSI-01)	9
	CLIENT	EPA	Date
DIRECTION: NA	PHOTOGRAPHER	Ryan Slanczka	9/17/2020

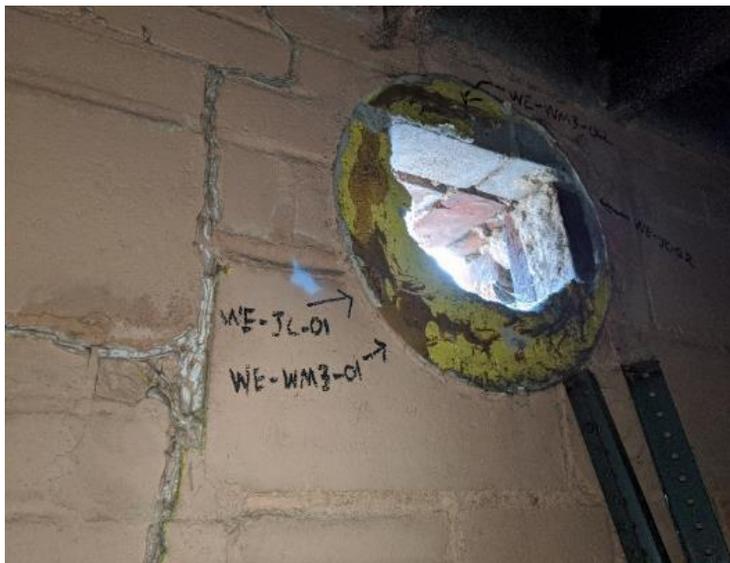
SUBTASK NO. 03.05	DESCRIPTION	This photograph shows asbestos-containing joint compound along the perimeter of a hole in the south wall of the south room on the second floor.	10
	CLIENT	EPA	Date
DIRECTION: NA	PHOTOGRAPHER	Ryan Slanczka	9/17/2020

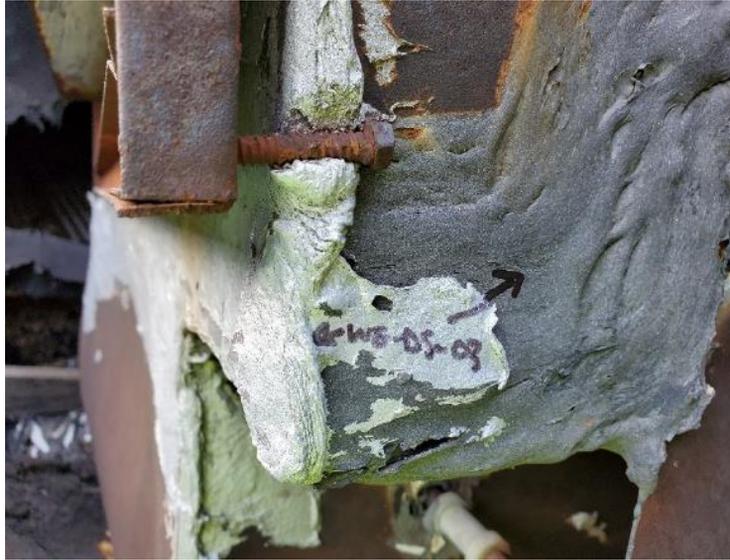
SUBTASK NO. 03.05	DESCRIPTION	This photograph shows asbestos-containing duct sealant on equipment at the collapsed portion of roofing on the second floor.	11
	CLIENT	EPA	Date
DIRECTION: NA	PHOTOGRAPHER	Ryan Slanczka	9/17/2020

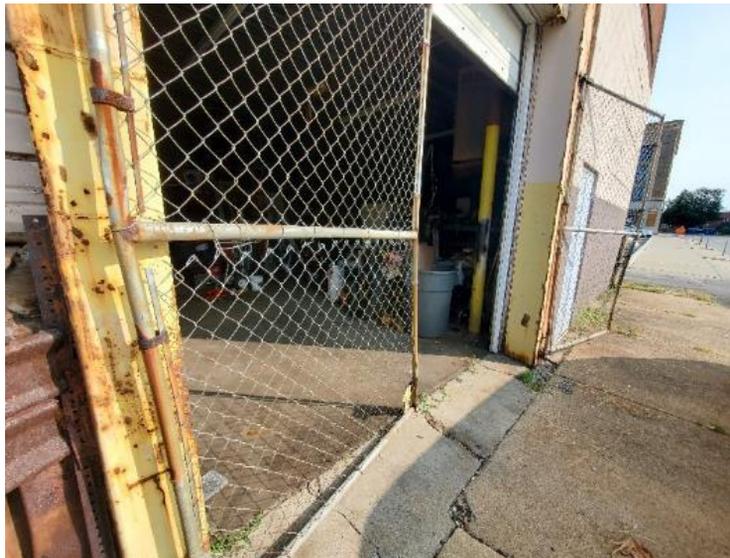
SUBTASK NO. 03.05	DESCRIPTION	This photograph shows yellow and beige lead-based paint (LBP) on the garage door frame on the west side of the building.	12
	CLIENT	EPA	Date
DIRECTION: South	PHOTOGRAPHER	Ryan Slanczka	9/17/2020

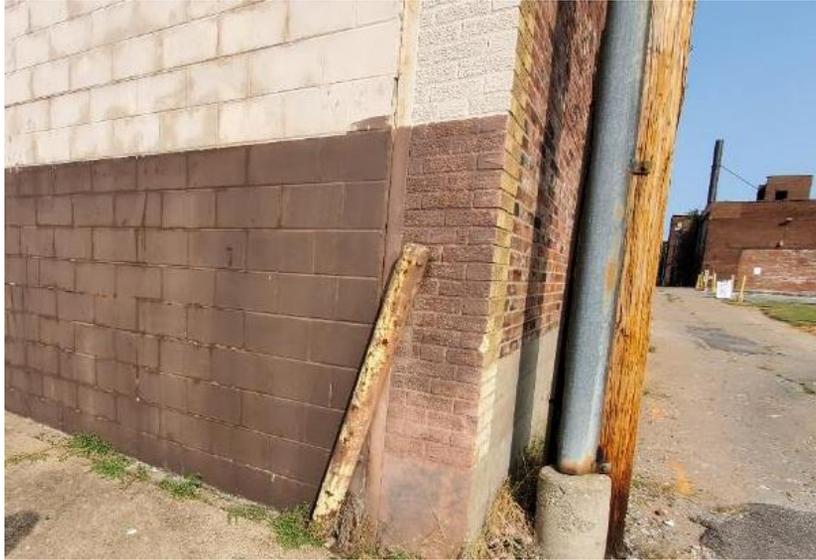
SUBTASK NO. 03.05 DIRECTION: East	DESCRIPTION	This photograph shows yellow LBP on a bollard at the southwest corner of the building's exterior perimeter.	13
	CLIENT	EPA	Date
	PHOTOGRAPHER	Ryan Slanczka	9/17/2020

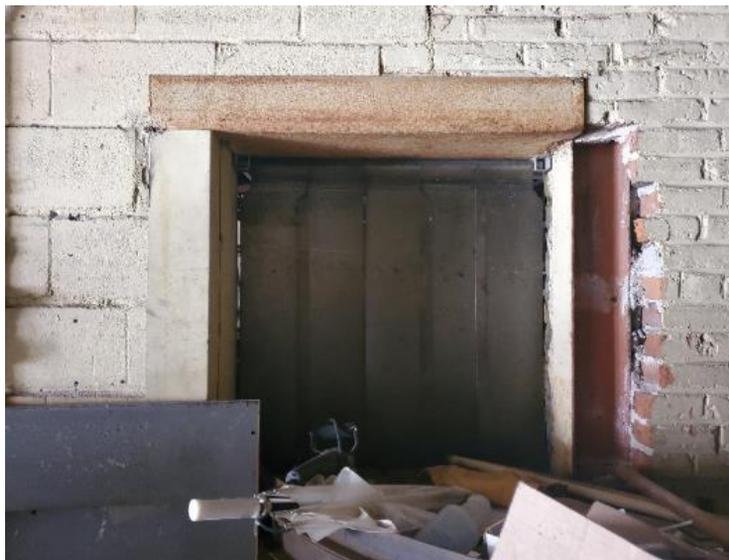
SUBTASK NO. 03.05 DIRECTION: NA	DESCRIPTION	This photograph shows red LBP on I-beams forming the perimeter of an opening in the wall between the south and central rooms on the first floor.	14
	CLIENT	EPA	Date
	PHOTOGRAPHER	Ryan Slanczka	9/17/2020

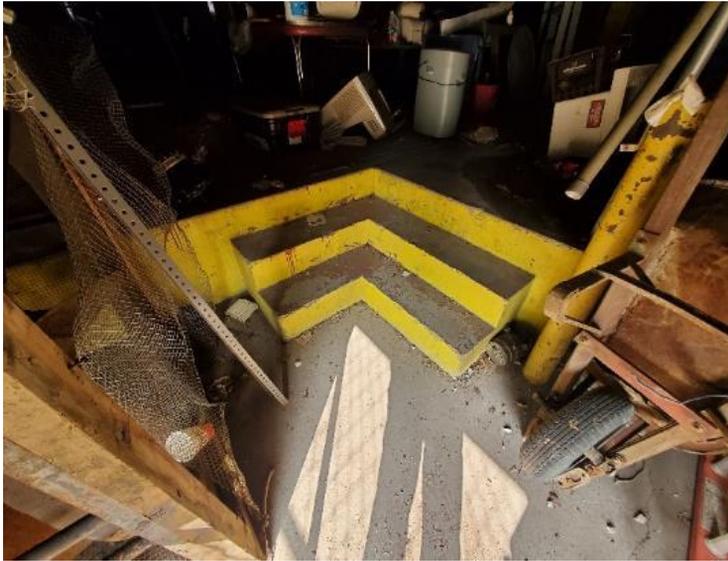
SUBTASK NO. 03.05	DESCRIPTION	This photograph shows yellow LBP on steps and the concrete slab surrounding the parking area at the southwest corner of the central room on the first floor.	15
	CLIENT	EPA	Date
DIRECTION: NA	PHOTOGRAPHER	Ryan Slanczka	9/17/2020

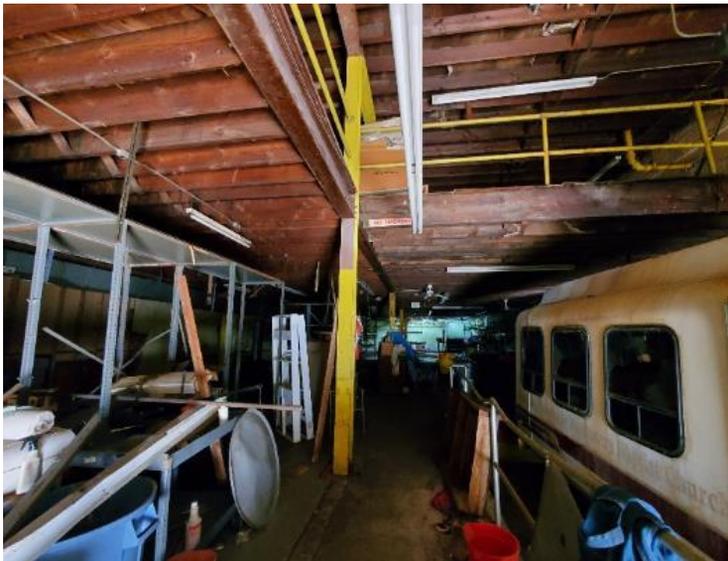
SUBTASK NO. 03.05	DESCRIPTION	This photograph shows yellow LBP on I-beams in the central room on the first and second floors.	16
	CLIENT	EPA	Date
DIRECTION: NA	PHOTOGRAPHER	Ryan Slanczka	9/17/2020

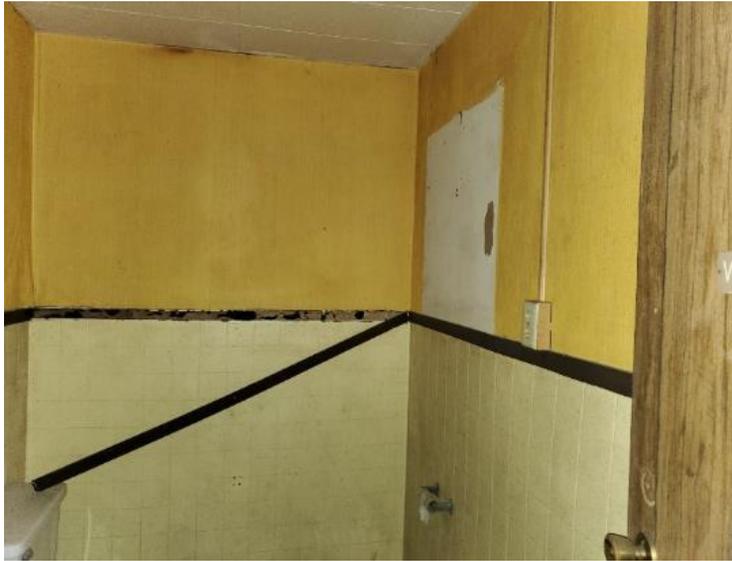
SUBTASK NO. 03.05 DIRECTION: NA	DESCRIPTION	This photograph shows white LBP on the wall in the east restroom within the north room on the first floor.	17
	CLIENT	EPA	Date
	PHOTOGRAPHER	Ryan Slanczka	9/17/2020

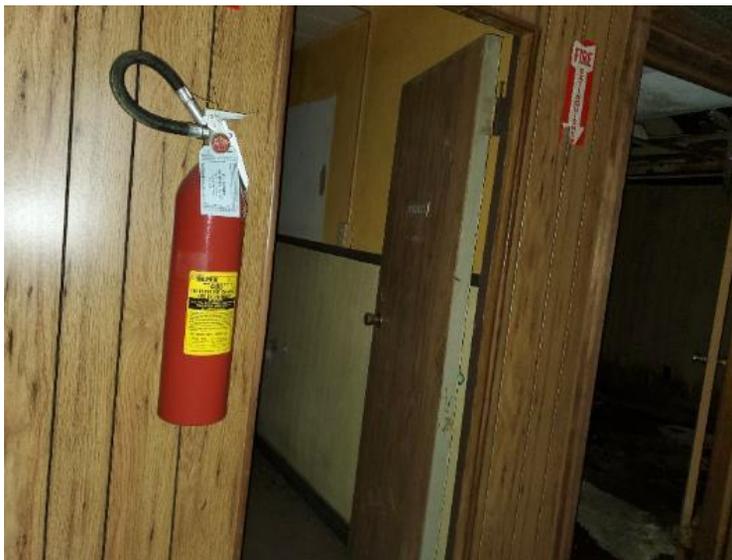
SUBTASK NO. 03.05 DIRECTION: NA	DESCRIPTION	This photograph shows lead-containing wood varnish on the door to the east restroom within the north room on the first floor.	18
	CLIENT	EPA	Date
	PHOTOGRAPHER	Ryan Slanczka	9/17/2020

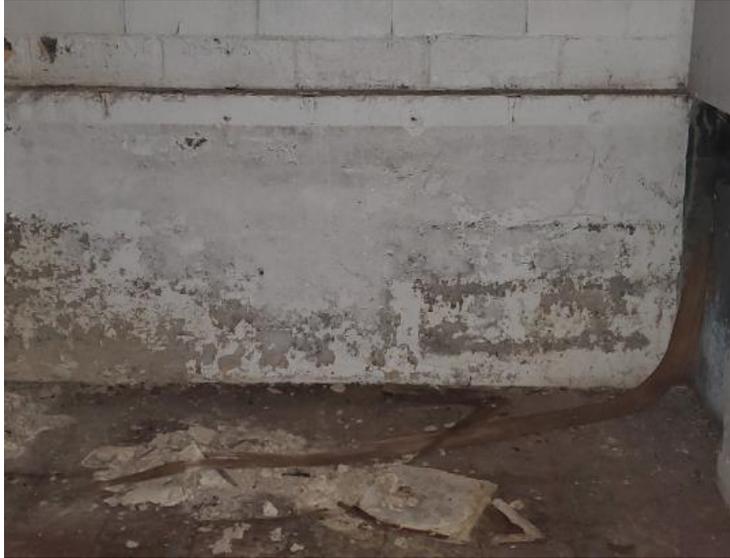
SUBTASK NO. 03.05 DIRECTION: NA	DESCRIPTION	This photograph shows white LBP on the foundation portion of the north wall within the north room on the first floor.	19
	CLIENT	EPA	Date
	PHOTOGRAPHER	Ryan Slanczka	9/17/2020

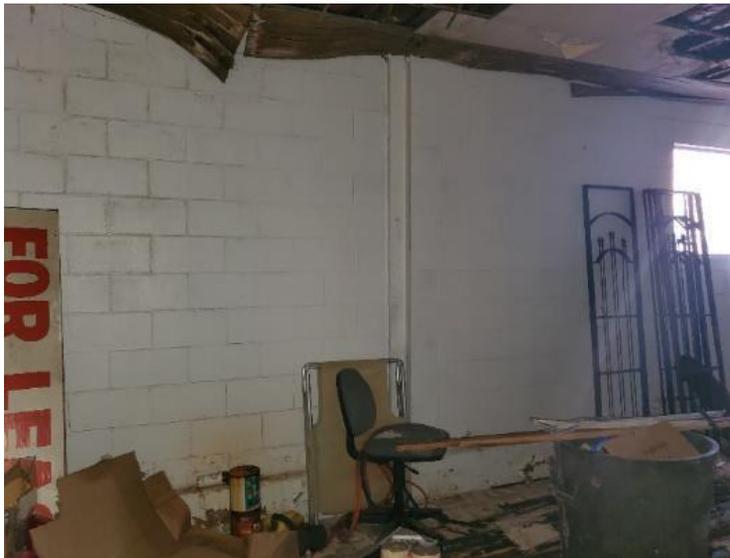
SUBTASK NO. 03.05 DIRECTION: NA	DESCRIPTION	This photograph shows white LBP on an I-beam in the north wall near the northwest entryway, within the north room on the first floor.	20
	CLIENT	EPA	Date
	PHOTOGRAPHER	Ryan Slanczka	9/17/2020

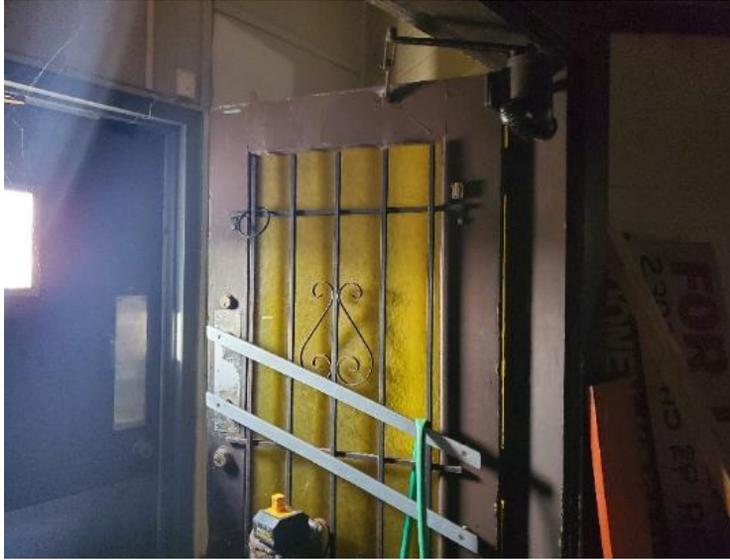
SUBTASK NO. 03.05	DESCRIPTION	This photograph shows brown LBP on the inner door and doorframe of the northwest entryway, within the north room on the first floor.	21
	CLIENT	EPA	Date
DIRECTION: NA	PHOTOGRAPHER	Ryan Slanczka	9/17/2020

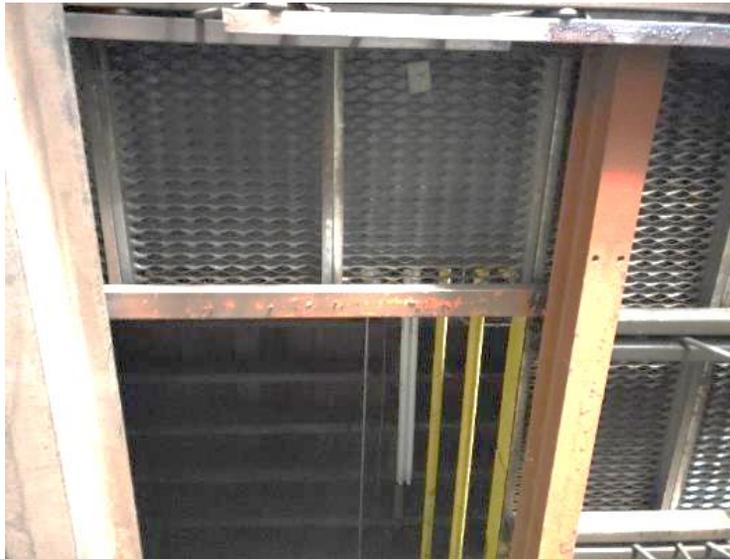
SUBTASK NO. 03.05	DESCRIPTION	This photograph shows orange LBP on beams near the stairwell in the south room.	22
	CLIENT	EPA	Date
DIRECTION: NA	PHOTOGRAPHER	Ryan Slanczka	9/17/2020

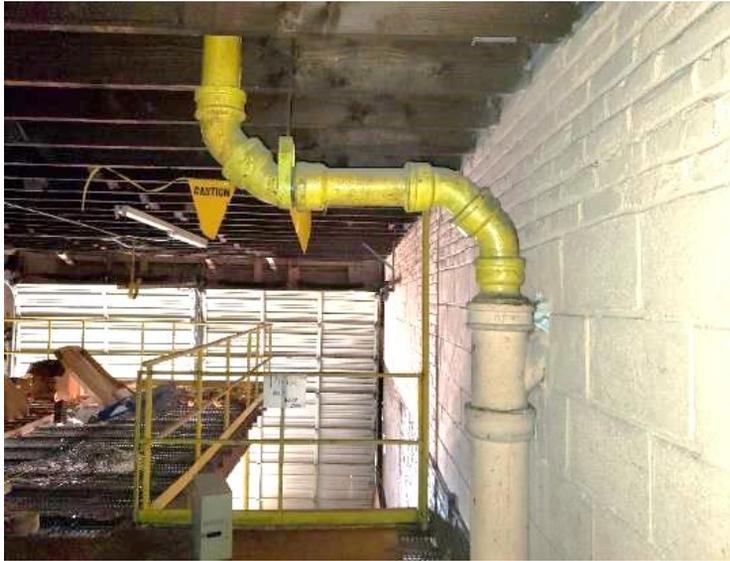
SUBTASK NO. 03.05 DIRECTION: NA	DESCRIPTION	This photograph shows yellow LBP on a pipe near the north wall in the south room on the second floor.	23
	CLIENT	EPA	Date
	PHOTOGRAPHER	Ryan Slanczka	9/17/2020

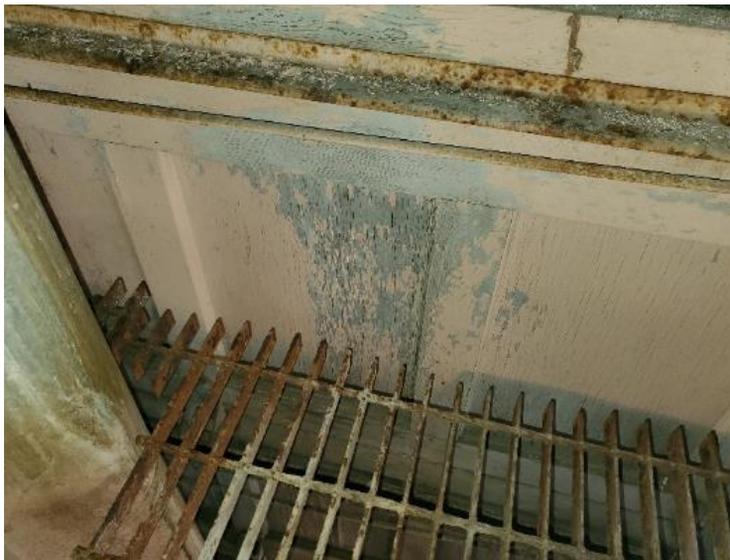
SUBTASK NO. 03.05 DIRECTION: NA	DESCRIPTION	This photograph shows peach/pink LBP on a garage door at the west wall in the south room.	24
	CLIENT	EPA	Date
	PHOTOGRAPHER	Ryan Slanczka	9/17/2020

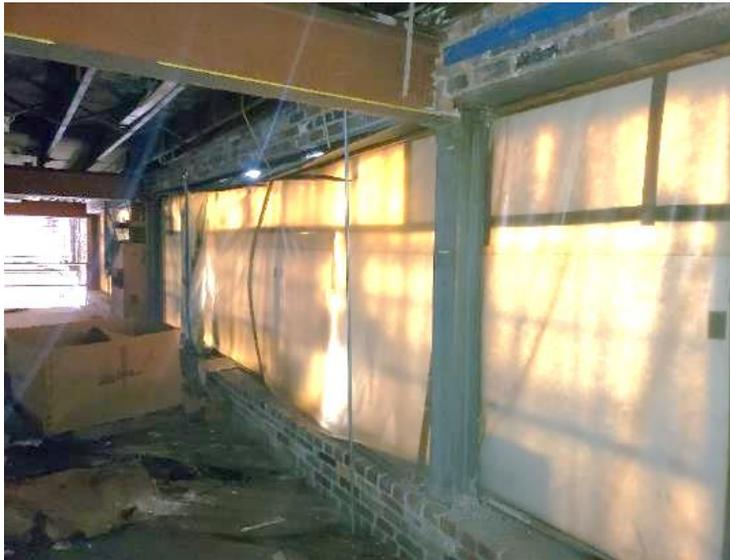
SUBTASK NO. 03.05	DESCRIPTION	This photograph shows grey LBP on an I-beam along the north wall within the north room on the second floor.	25
	CLIENT	EPA	Date
	DIRECTION: NA	PHOTOGRAPHER	Ryan Slanczka

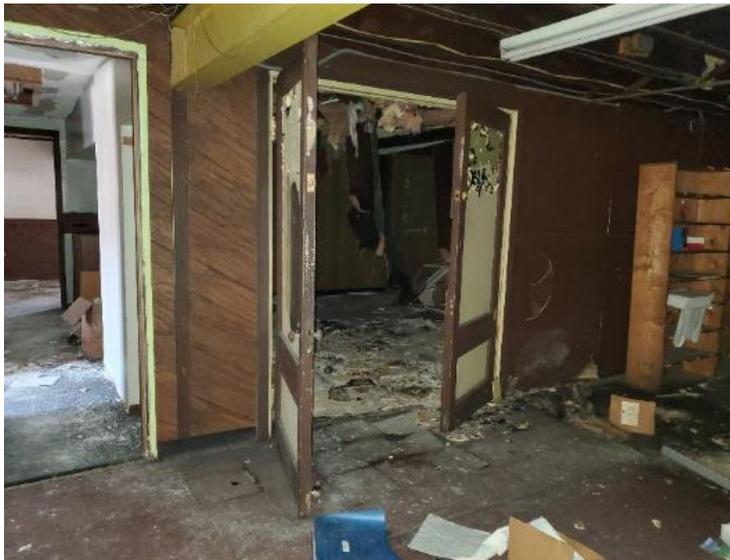
SUBTASK NO. 03.05	DESCRIPTION	This photograph shows dark brown LBP on a door frame at the eastern office room area within the north room on the second floor.	26
	CLIENT	EPA	Date
	DIRECTION: NA	PHOTOGRAPHER	Ryan Slanczka

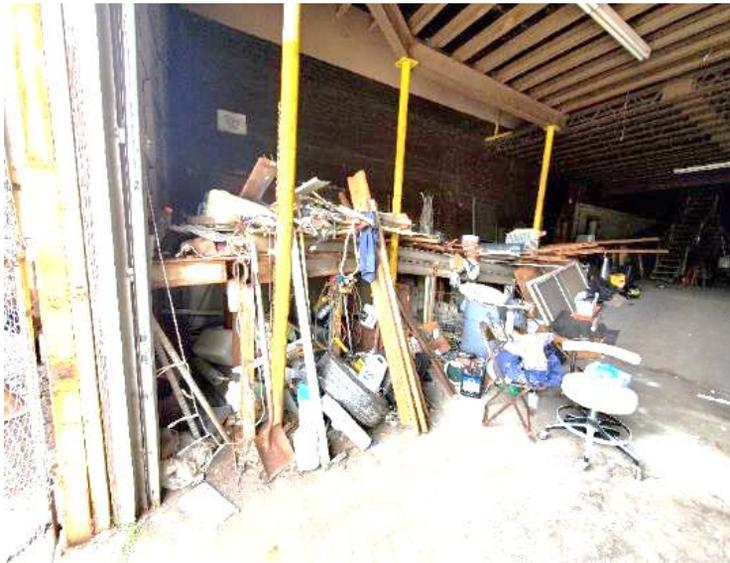
SUBTASK NO. 03.05 DIRECTION: NA	DESCRIPTION	This photograph shows miscellaneous debris, equipment, and containers in the western portion of the south room on the first floor.	27
	CLIENT	EPA	Date
	PHOTOGRAPHER	Ryan Slanczka	9/17/2020

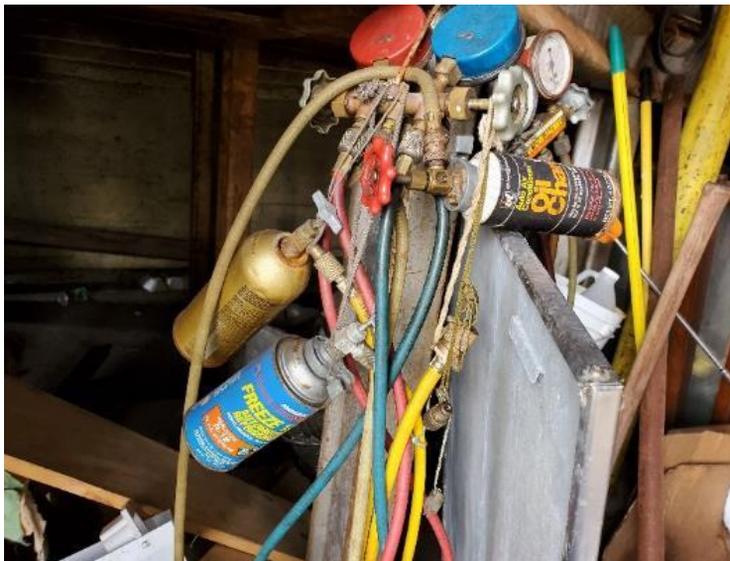
SUBTASK NO. 03.05 DIRECTION: NA	DESCRIPTION	This photograph shows aerosol containers in the western portion of the south room on the first floor.	28
	CLIENT	EPA	Date
	PHOTOGRAPHER	Ryan Slanczka	9/17/2020

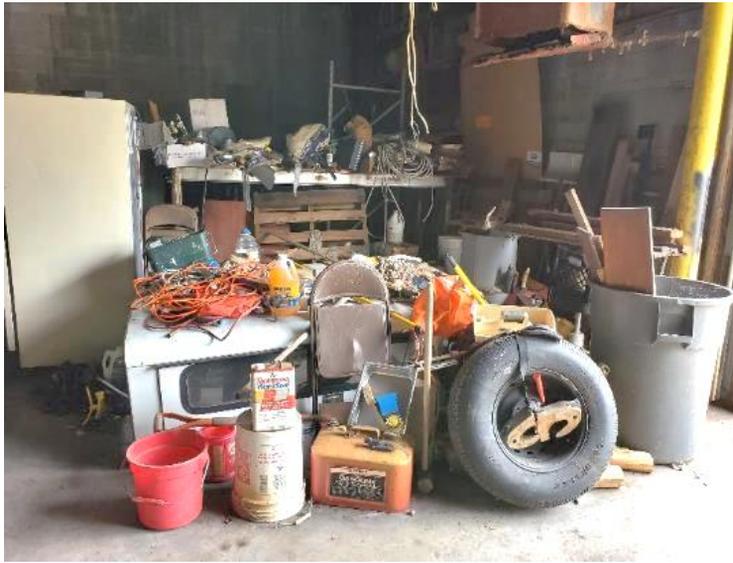
SUBTASK NO. 03.05 DIRECTION: NA	DESCRIPTION	This photograph shows miscellaneous debris, equipment, white goods, and containers in the western portion of the south room on the first floor.	29
	CLIENT	EPA	Date
	PHOTOGRAPHER	Ryan Slanczka	9/17/2020

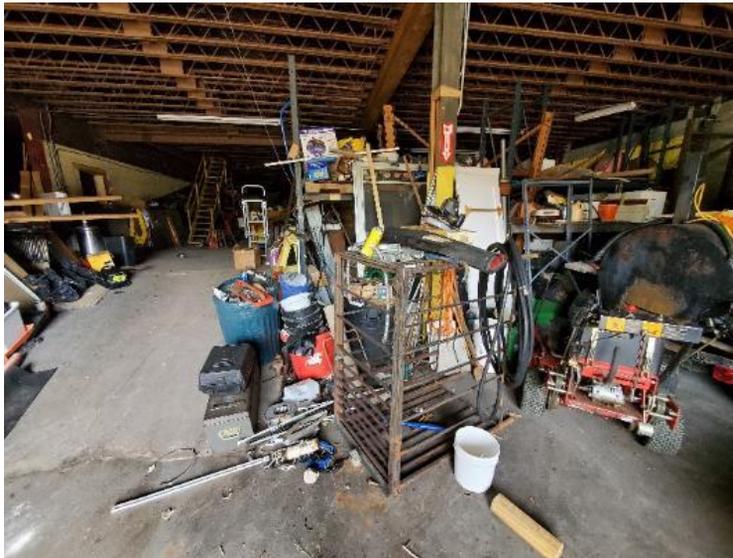
SUBTASK NO. 03.05 DIRECTION: NA	DESCRIPTION	This photograph shows miscellaneous debris, equipment, and containers in the western portion of the south room on the first floor.	30
	CLIENT	EPA	Date
	PHOTOGRAPHER	Ryan Slanczka	9/17/2020

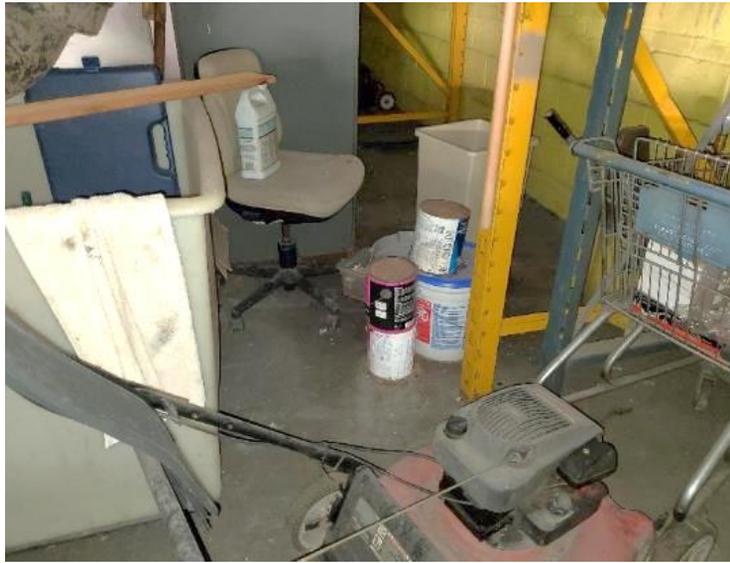
SUBTASK NO. 03.05 DIRECTION: NA	DESCRIPTION	This photograph shows miscellaneous debris, equipment, and containers in the south room on the first floor.	31
	CLIENT	EPA	Date
	PHOTOGRAPHER	Ryan Slanczka	9/17/2020

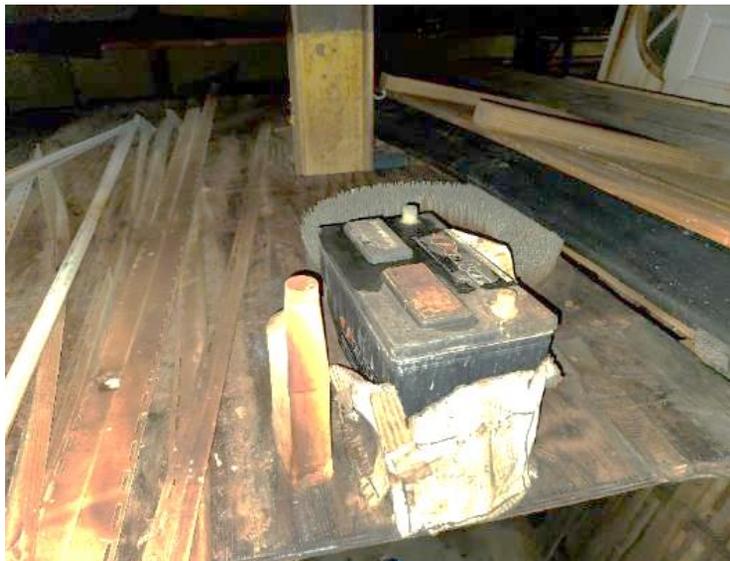
SUBTASK NO. 03.05 DIRECTION: NA	DESCRIPTION	This photograph shows an automotive battery in the south room on the first floor.	32
	CLIENT	EPA	Date
	PHOTOGRAPHER	Ryan Slanczka	9/17/2020

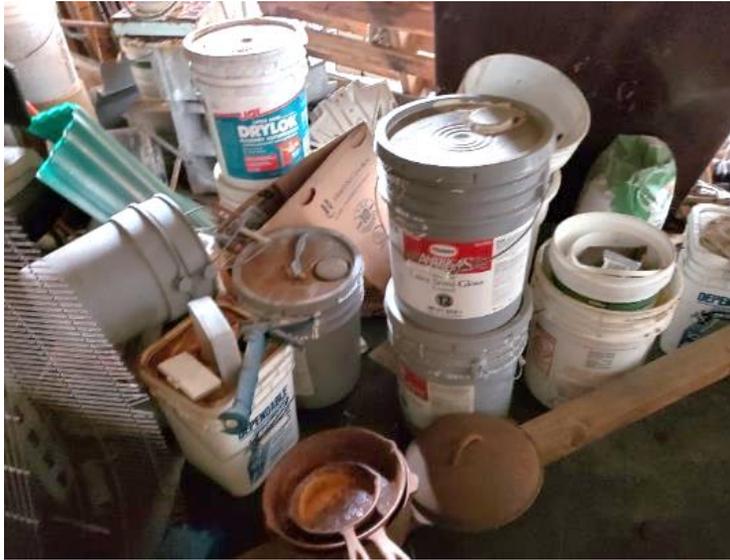
SUBTASK NO. 03.05 DIRECTION: NA	DESCRIPTION	This photograph shows 5-gallon buckets and other miscellaneous containers in the south room on the first floor.	33
	CLIENT	EPA	Date
	PHOTOGRAPHER	Ryan Slanczka	9/17/2020

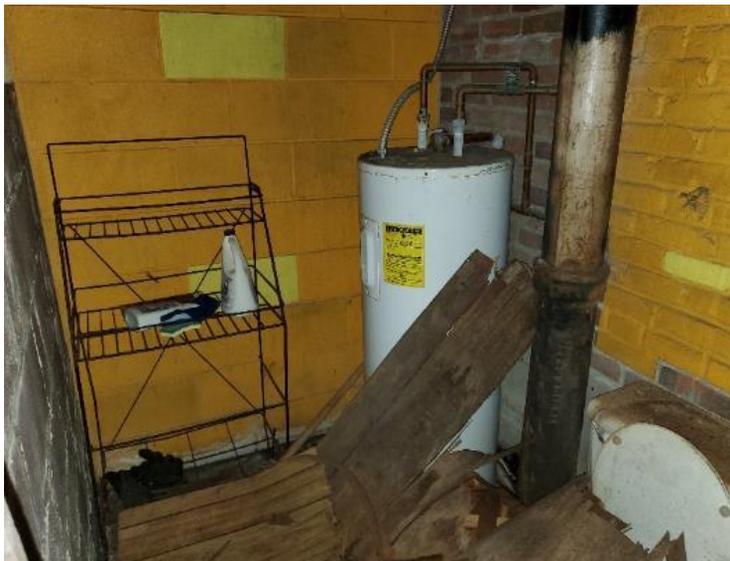
SUBTASK NO. 03.05 DIRECTION: NA	DESCRIPTION	This photograph shows a water heater in the south room on the first floor.	34
	CLIENT	EPA	Date
	PHOTOGRAPHER	Ryan Slanczka	9/17/2020

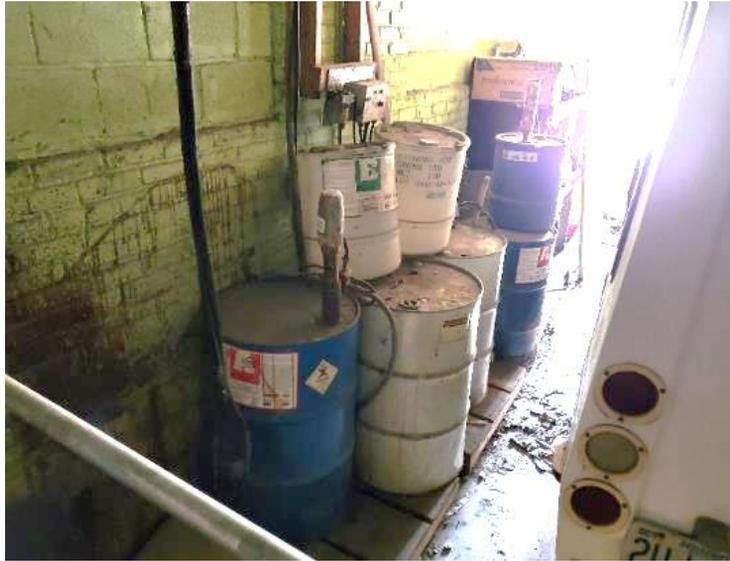
SUBTASK NO. 03.05	DESCRIPTION	This photograph shows 55-gallon drums and other miscellaneous containers next to a non-functioning bus in the western portion of the central room on the first floor.	35
	CLIENT	EPA	Date
DIRECTION: NA	PHOTOGRAPHER	Ryan Slanczka	9/17/2020

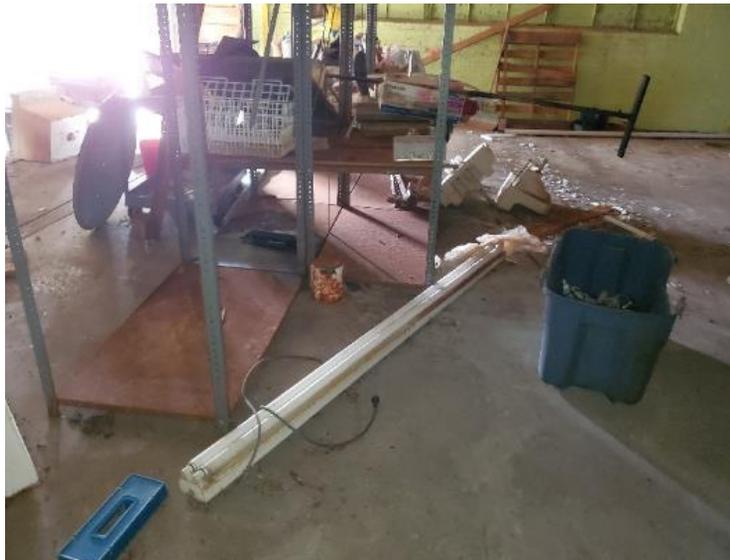
SUBTASK NO. 03.05	DESCRIPTION	This photograph shows miscellaneous debris (including intact and broken fluorescent lamps), equipment, and containers in the western portion of the central room on the first floor.	36
	CLIENT	EPA	Date
DIRECTION: NA	PHOTOGRAPHER	Ryan Slanczka	9/17/2020

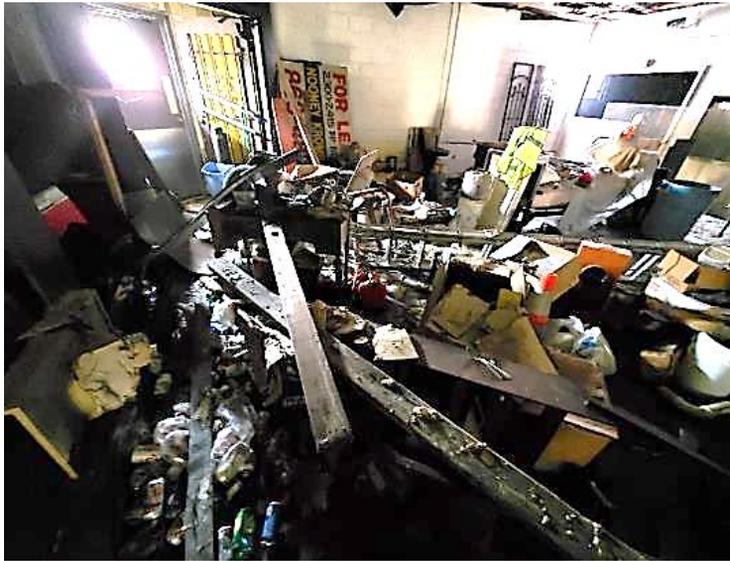
SUBTASK NO. 03.05	DESCRIPTION	This photograph shows miscellaneous debris, equipment, and containers in the western portion of the north room on the first floor.	37
	CLIENT	EPA	Date
DIRECTION: NA	PHOTOGRAPHER	Ryan Slanczka	9/17/2020

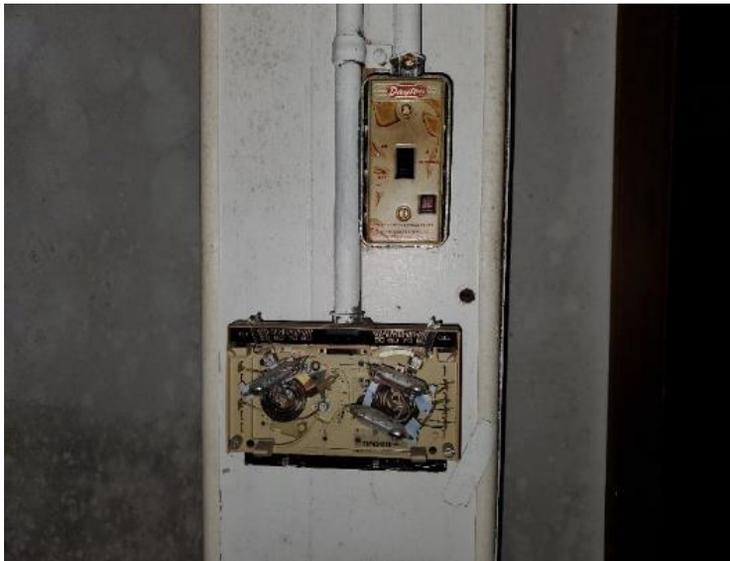
SUBTASK NO. 03.05	DESCRIPTION	This photograph shows a mercury-containing thermostat in the north room on the first floor.	38
	CLIENT	EPA	Date
DIRECTION: NA	PHOTOGRAPHER	Ryan Slanczka	9/17/2020

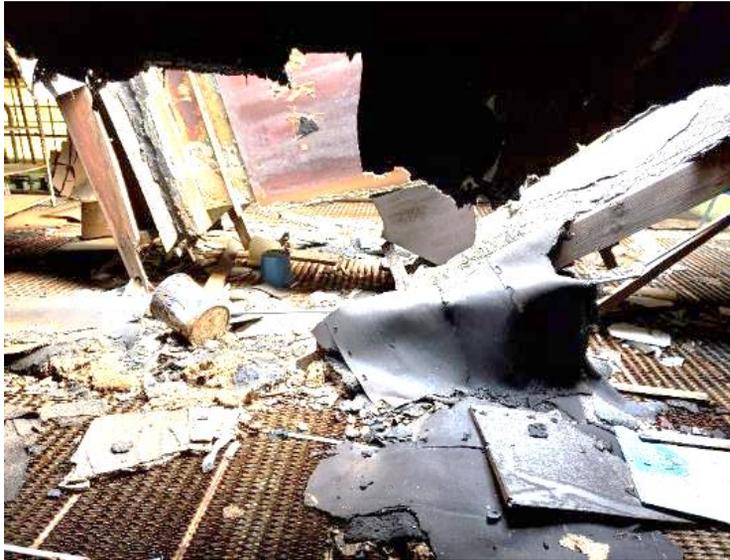
SUBTASK NO. 03.05	DESCRIPTION	This photograph shows a heating, ventilation, and air conditioning (HVAC) unit that has collapsed through the roof onto the second floor in the central room.	39
	CLIENT	EPA	Date
	DIRECTION: NA	PHOTOGRAPHER	Ryan Slanczka

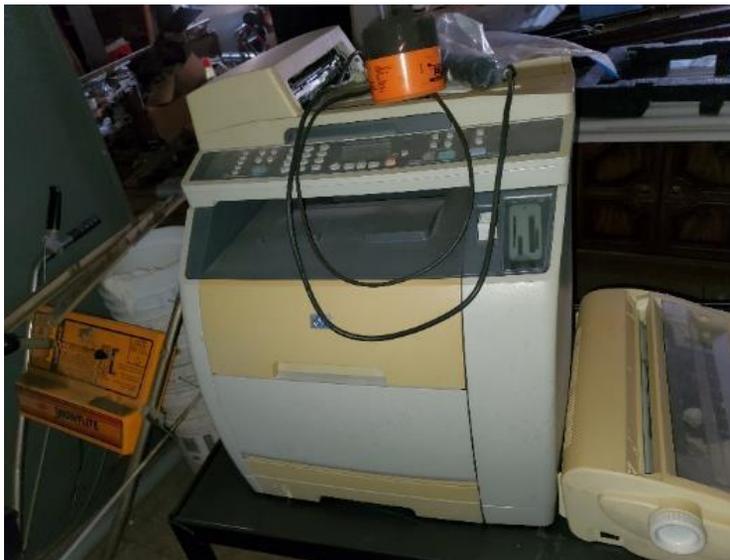
SUBTASK NO. 03.05	DESCRIPTION	This photograph shows a printer/scanner and other miscellaneous debris in the north room on the first floor.	40
	CLIENT	EPA	Date
	DIRECTION: NA	PHOTOGRAPHER	Ryan Slanczka
