**Subject: Contract No. 68HERH19D0018; Task Order (TO) No. 68E0719F0190
Pine Lawn, 6109 Natural Bridge Road, Pine Lawn, Missouri
Targeted Brownfields Assessment Hazardous Materials Survey**

**TARGETED BROWNFIELDS ASSESSMENT
HAZARDOUS MATERIALS SURVEY**

**PINE LAWN
6109 NATURAL BRIDGE ROAD, PINE LAWN, MISSOURI**

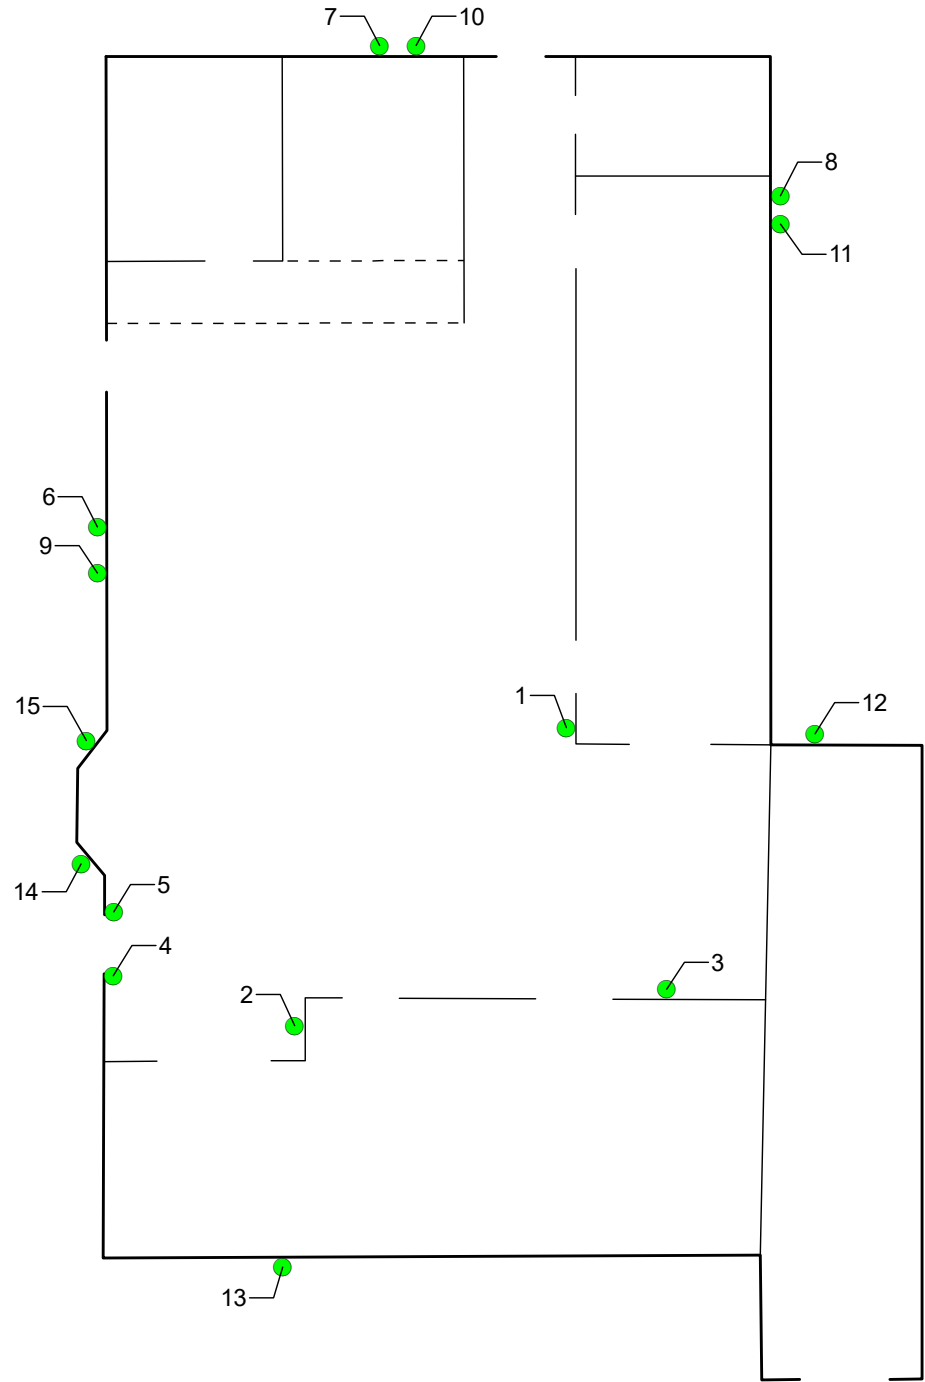
Figure 2
Sample Location Map

PLM results from samples of suspect ACM collected at the building on the subject property, are presented in the laboratory report in Appendix D and summarized in Table 1 below. None of the materials sampled contained detectable asbestos. Sample locations are shown on Figure 2 in Appendix A.

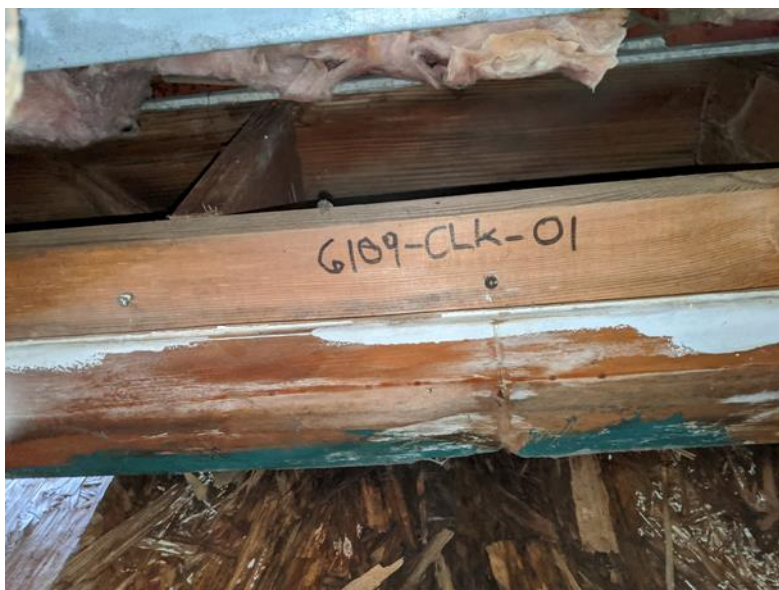
SUBTASK NO. 02.05 Direction: NA	DESCRIPTION	This photograph shows the location of caulk sampled as suspected asbestos-containing material (ACM).	2
	CLIENT	EPA	Date
	PHOTOGRAPHER	Ryan Slanczka	9/29/2020

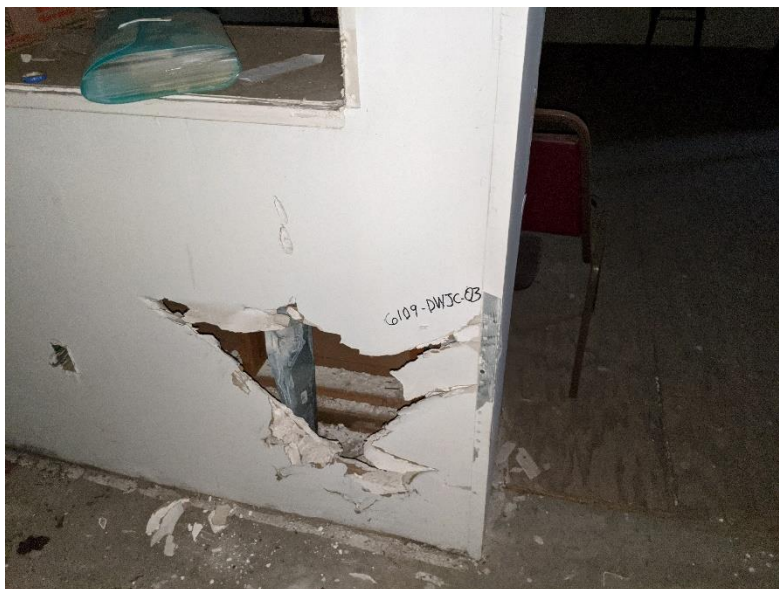
SUBTASK NO. 02.05 Direction: NA	DESCRIPTION	This photograph shows a location where sampling occurred of drywall and joint compound suspected to be ACM.	3
	CLIENT	U.S. Environmental Protection Agency (EPA)	Date
	PHOTOGRAPHER	Ryan Slanczka	9/29/2020

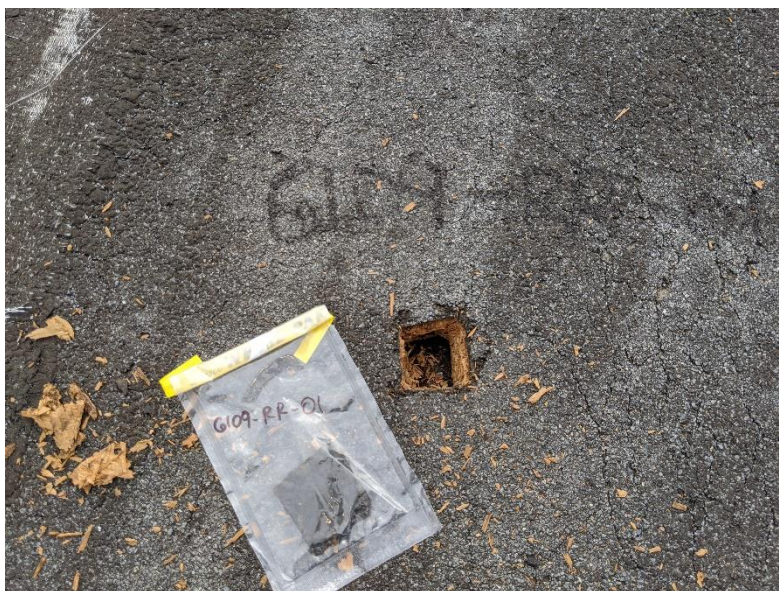
SUBTASK NO. 02.05 Direction: NA	DESCRIPTION	This photograph shows a location where sampling occurred of rolled roofing suspected to be ACM.	4
	CLIENT	EPA	Date
	PHOTOGRAPHER	Ryan Slanczka	9/29/2020

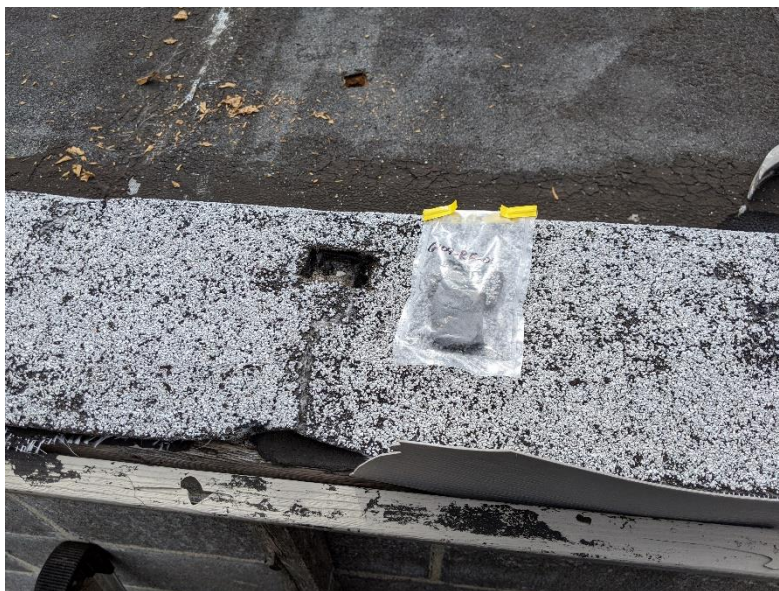
SUBTASK NO. 02.05 Direction: NA	DESCRIPTION	This photograph shows a location where sampling occurred of roof flashing suspected to be ACM.	5
	CLIENT	U.S. Environmental Protection Agency (EPA)	Date
	PHOTOGRAPHER	Ryan Slanczka	9/29/2020

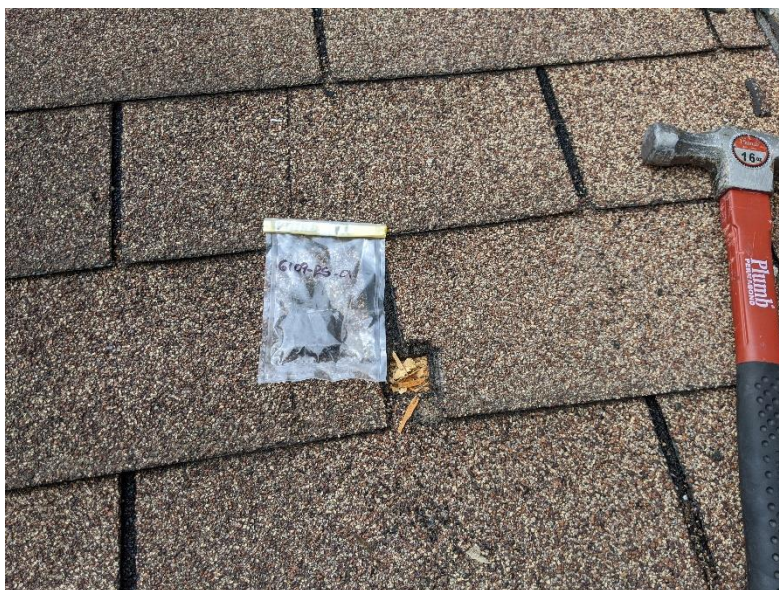
SUBTASK NO. 02.05 Direction: NA	DESCRIPTION	This photograph shows a location where sampling occurred of a roof shingle suspected to be ACM.	6
	CLIENT	EPA	Date
	PHOTOGRAPHER	Ryan Slanczka	9/29/2020
