**Subject: Contract No. 68HERH19D0018; Task Order (TO) No. 68E0719F0190
Pine Lawn, 6261 Natural Bridge Road, Pine Lawn, Missouri
Targeted Brownfields Assessment Hazardous Materials Survey**

**TARGETED BROWNFIELDS ASSESSMENT
HAZARDOUS MATERIALS SURVEY**

**PINE LAWN
6261 NATURAL BRIDGE ROAD, PINE LAWN, MISSOURI**

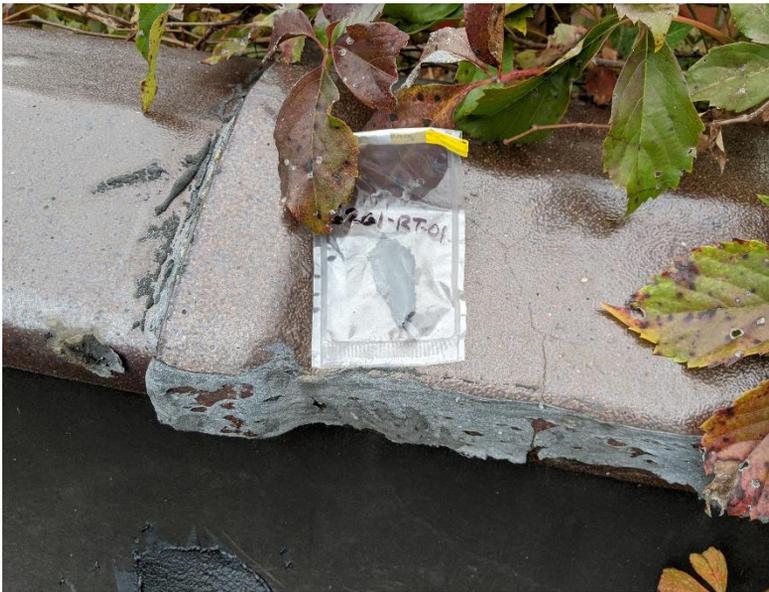
Regulated ACM was identified in black roofing tar around the chimney (approximately 20 SF) and on the east, south, and west roof perimeters (approximately 210 LF).

SUBTASK NO. 02.05 Direction: NA	DESCRIPTION	This photograph shows asbestos-containing roofing tar on the perimeter of the building roof.	3
	CLIENT	EPA	Date
	PHOTOGRAPHER	Ryan Slanczka	9/29/2020

All regulated ACM listed above should be removed by a licensed asbestos abatement contractor before demolition work disturbs the material. The removed waste must be transported to a disposal site approved to accept non-friable ACM. If the building is to be renovated, the above ACM materials are not to be disturbed and may remain in place.

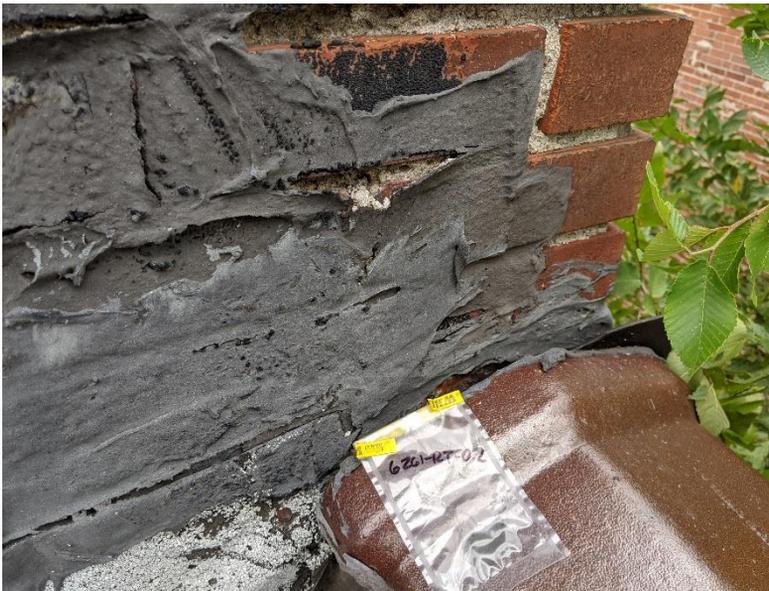
SUBTASK NO. 02.05 Direction: South	DESCRIPTION	This photograph shows asbestos-containing roofing tar around the chimney on the building roof.	4
	CLIENT	EPA	Date
	PHOTOGRAPHER	Ryan Slanczka	9/29/2020

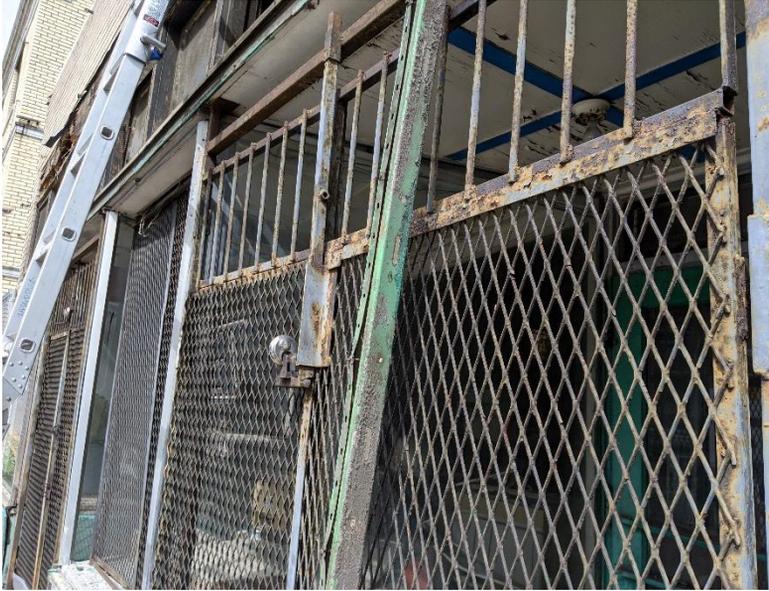
14	Green	Exterior – South Perimeter	Frame (former building sign)	Metal	1.32	Yes	100 SF
15	White	Exterior – South Perimeter	Soffit	Wood	>5.00	Yes	200 SF
16	Blue	Exterior – South Perimeter	Soffit Trim	Wood	0.07	NA	NA
17	Grey	Exterior – South Perimeter	Entry Gate	Metal	0.01	NA	NA
18	Red	Exterior – South Perimeter	Siding	Wood	0.00	NA	NA

Approximately 300 SF of various colors of LBP on multiple substrates was identified on the exterior of the building.

SUBTASK NO. 02.05	DESCRIPTION	This photograph shows green lead-based paint (LBP) on the metal sign frame and white LBP on the wood soffit at the south perimeter (front entrance) of the building.	5
	CLIENT	EPA	Date
Direction: NA	PHOTOGRAPHER	Ryan Slanczka	9/29/2020

HUD Guidelines consider LBP as paint with lead levels above 1.0 mg/cm². If the LBP surfaces are impacted during renovations or during demolition, the Toeroek Team recommends that the contractor conducting the renovations comply with the OSHA Lead in Construction Standard, Title 29 of *Code of Federal Regulations* (29 CFR), Part 1926.62. If the materials containing LBP are removed during renovation activities, a sample should be collected from the debris pile for a Toxicity Characteristic Leaching Procedure (TCLP) analysis (40 CFR 261.24); representative samples should be collected and analyzed for all eight metals specified in 40 CFR Part 261.24 (arsenic, barium, cadmium, chromium, lead, mercury, selenium, and silver). This will allow determination of the proper method of disposal of these materials.

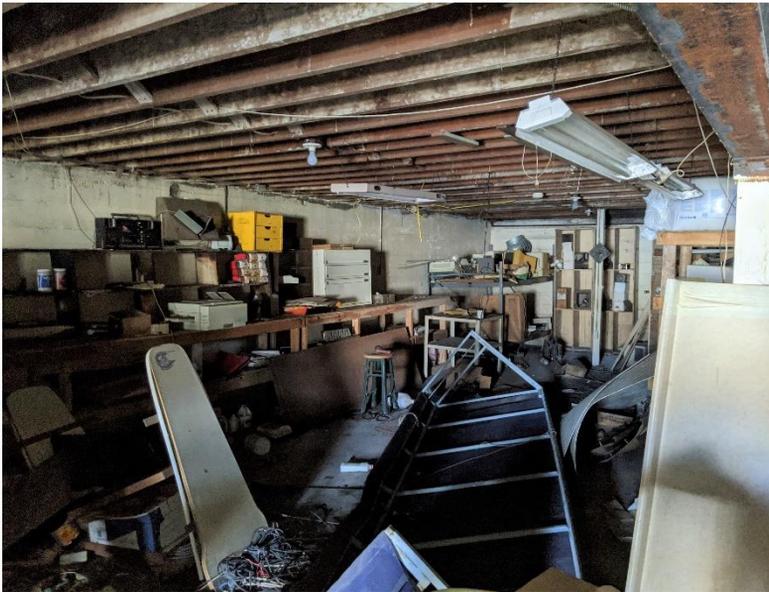
SUBTASK NO. 02.05	DESCRIPTION	This photograph shows miscellaneous debris in the basement of the building.	6
	CLIENT	EPA	Date
Direction: NA	PHOTOGRAPHER	Ryan Slanczka	9/29/2020

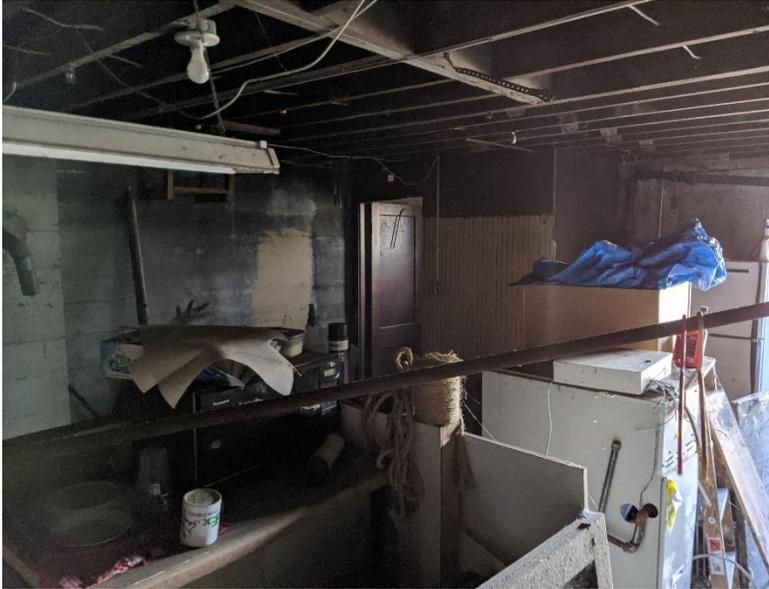
SUBTASK NO. 02.05 Direction: NA	DESCRIPTION	This photograph shows miscellaneous debris in the basement of the building.	7
	CLIENT	EPA	Date
	PHOTOGRAPHER	Ryan Slanczka	9/29/2020

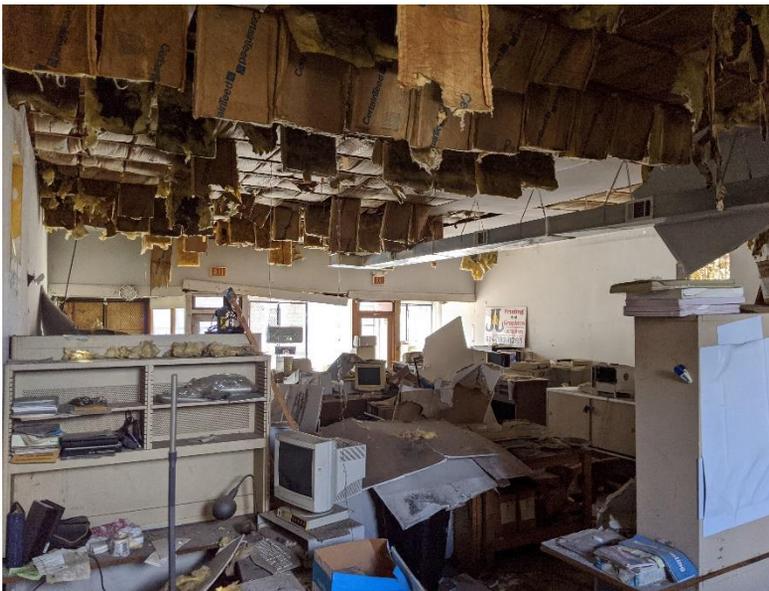
SUBTASK NO. 02.05 Direction: NA	DESCRIPTION	This photograph shows miscellaneous debris on the first floor (main room) of the building.	8
	CLIENT	EPA	Date
	PHOTOGRAPHER	Ryan Slanczka	9/29/2020

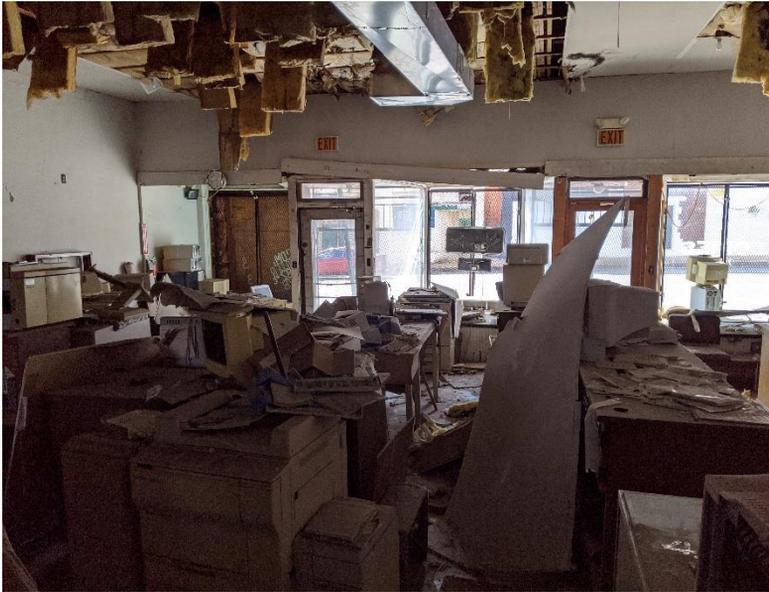
SUBTASK NO. 02.05 Direction: NA	DESCRIPTION	This photograph shows various commercial printing equipment and debris on the first floor of the building.	9
	CLIENT	EPA	Date
	PHOTOGRAPHER	Ryan Slanczka	9/29/2020
