October 20, 2006

**Subject: Site Activity/Removal Report – Anaconda Mine Site, Yerington, Nevada
TDD TO1-09-06-04-0004**

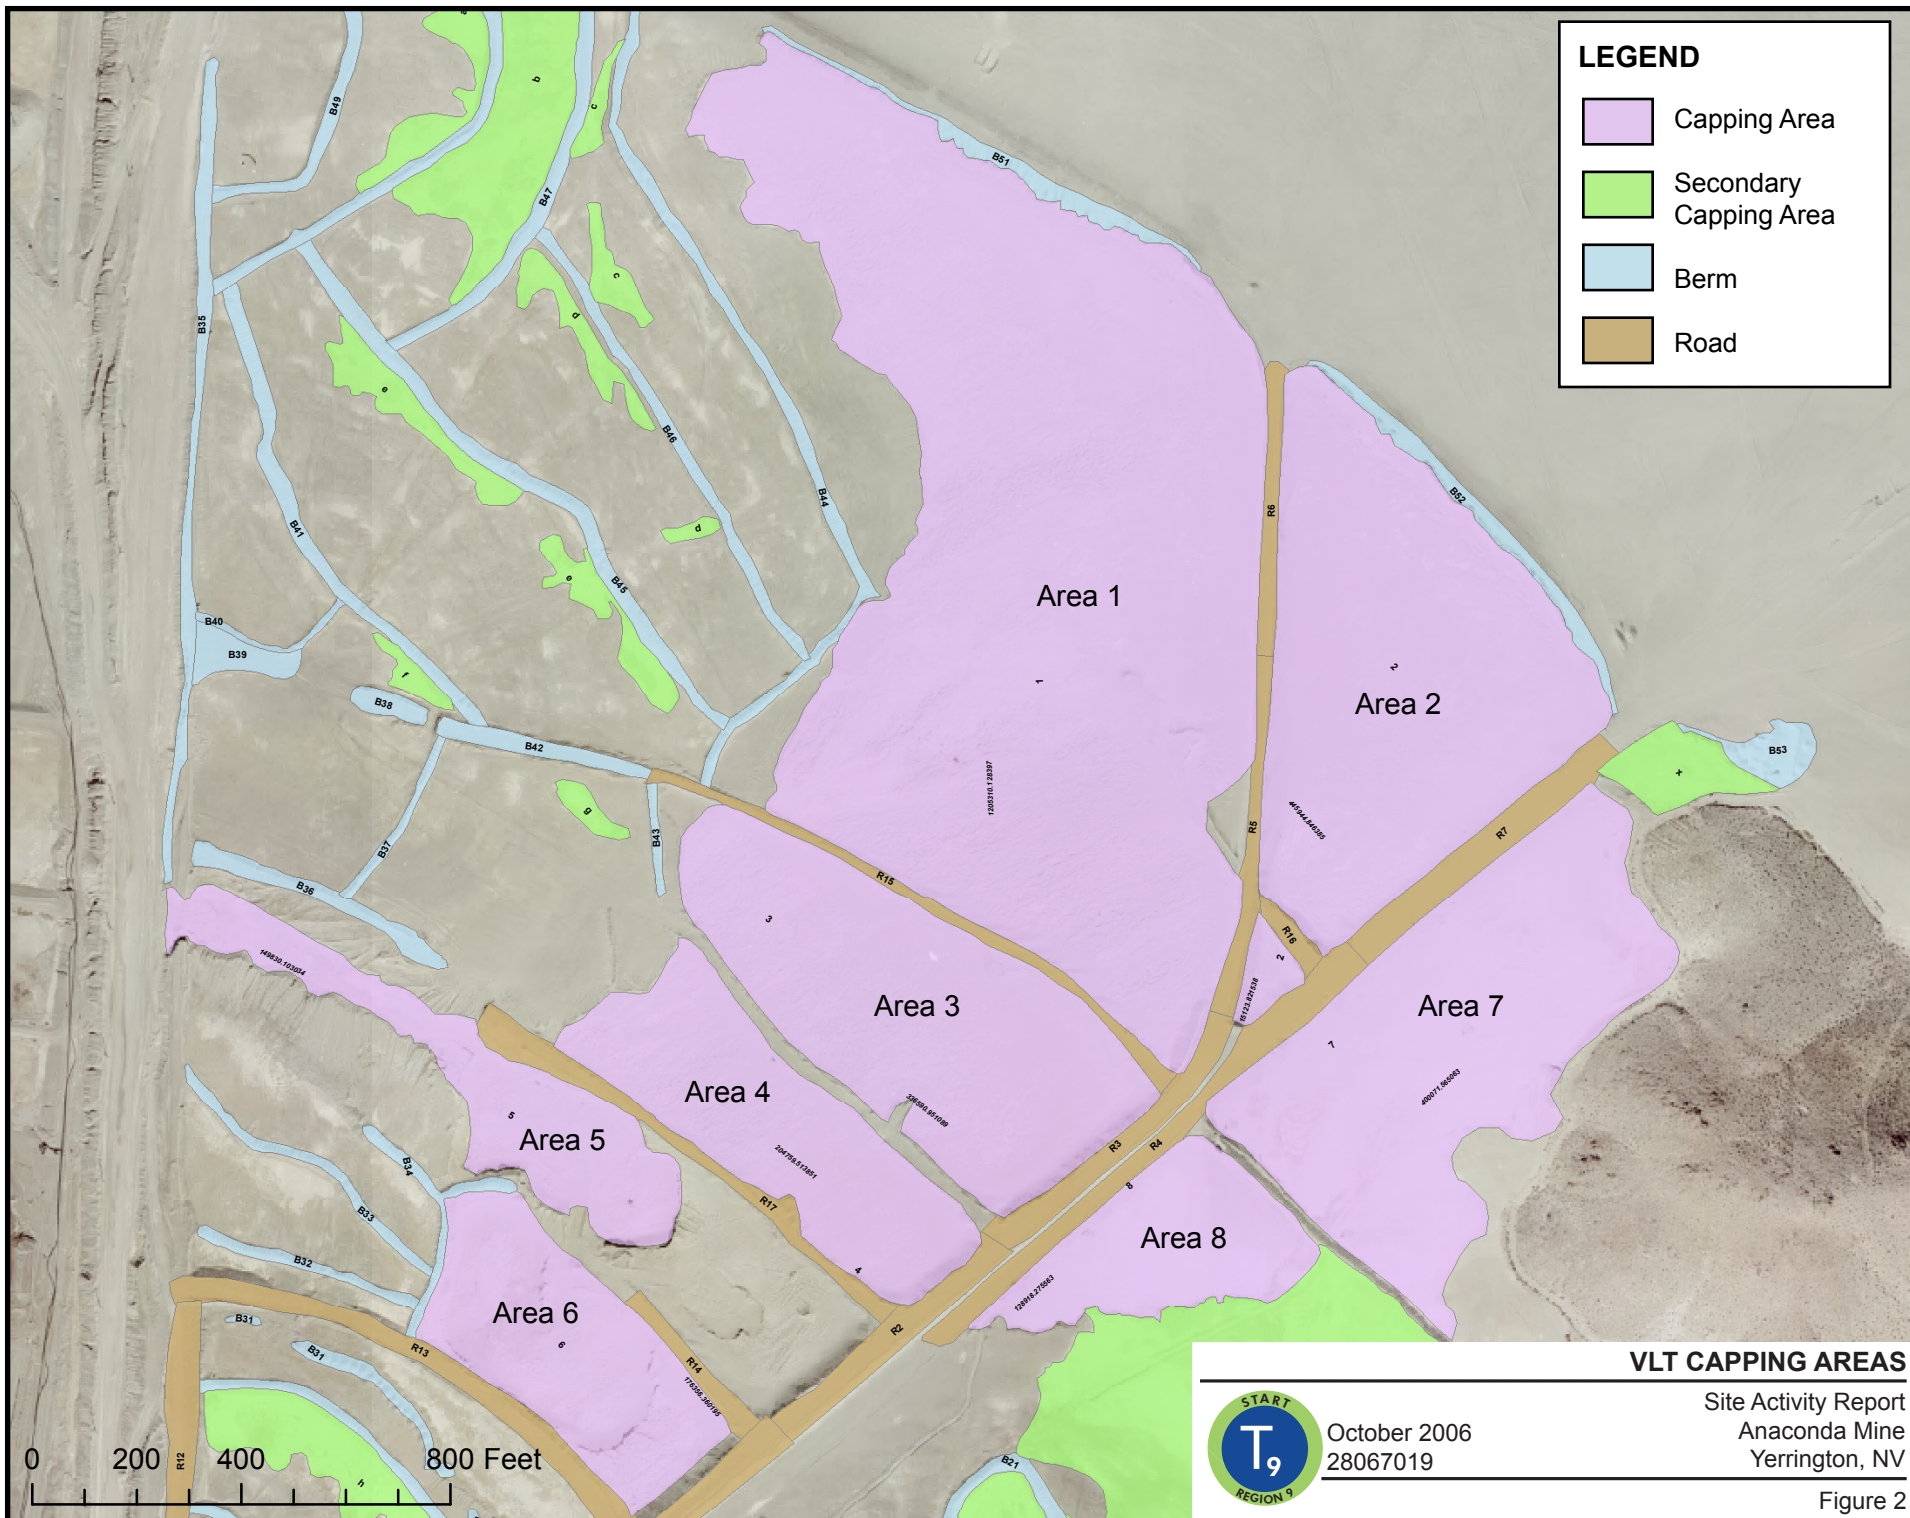
Figure 2

Areas 1 through 8 on Figure 2, were capped by EPA using the VLT material. The sulfide tailings, being very fine grained, were prone to wind dispersion. Sand dunes surrounding the areas of exposed sulfide tailings were indicative of ongoing aerial transport of the sulfide tailings.

- Area 1 (approximately 48,641 square feet [ft^2]);
- Area 2 (approximately 16,516 ft^2);
- Area 3 (approximately 12,466 ft^2);
- Area 4 (approximately 17,583 ft^2);
- Area 5 (approximately 8,000 ft^2);
- Area 6 (approximately 6,531 ft^2);
- Area 7 (approximately 14,817 ft^2); and
- Area 8 (approximately 4,774 ft^2).

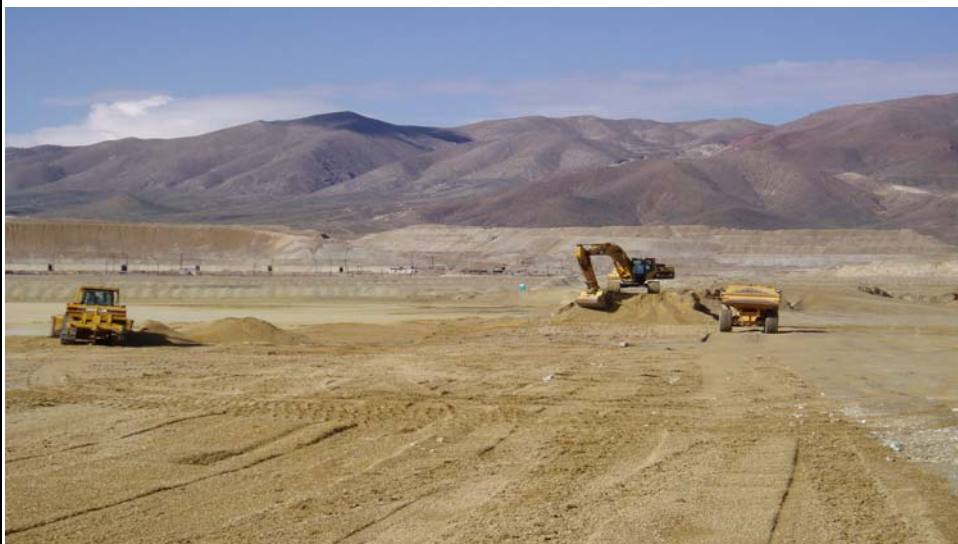
PHOTOGRAPH 1.:
Excavator (center), dump truck (right), and bulldozer (left) spreading out VLT material in Area 1 as part of the capping activities. (Facing Southwest)

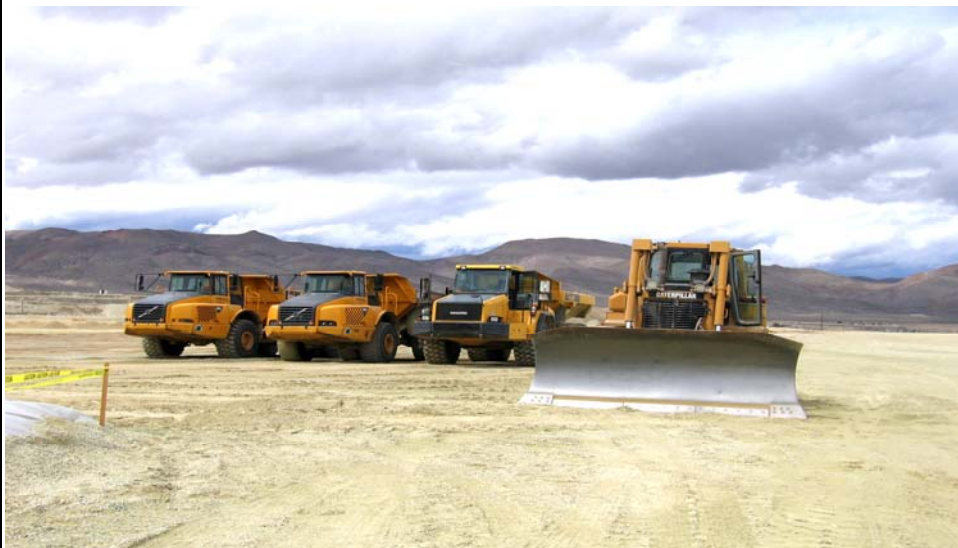
PHOTOGRAPH 2.:
Dump trucks and bulldozer used by ERRS personnel for capping activities.

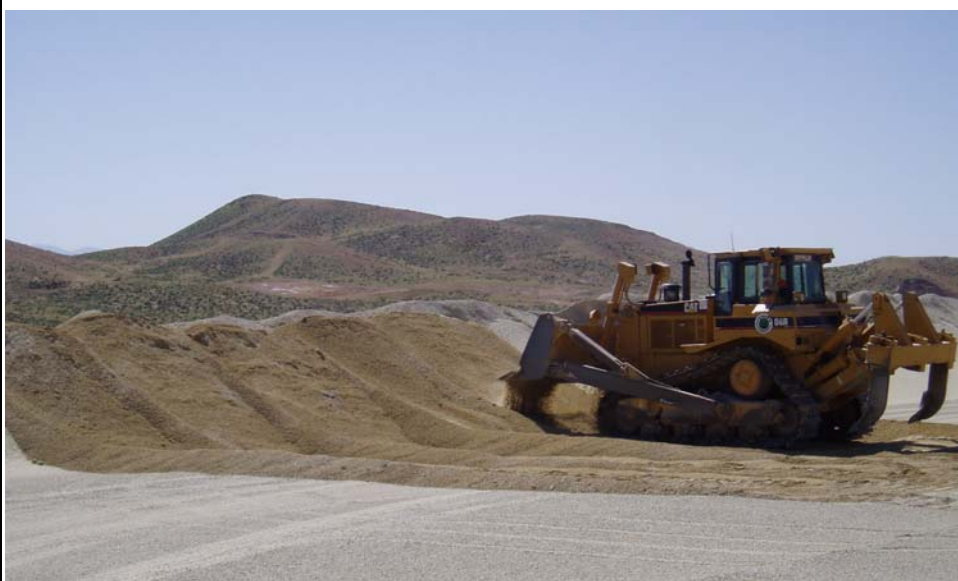
PHOTOGRAPH 3.:
Excavator reworking sand sized material at lip of tailings pile along interstate 95 ALT. (Facing East)

Areas 5, 6, and 8 were capped by ERRS during the week of May 8, 2006. Once capping was completed in Areas 1 through 8, a bulldozer was sent to the top of a tailings pile furthest north along Highway 95A. The bulldozer reworked the top lip of the tailings pile to cover and cap fine, loose sand material, which was built up along the lip of the tailings pile (Photos 3 and 4).

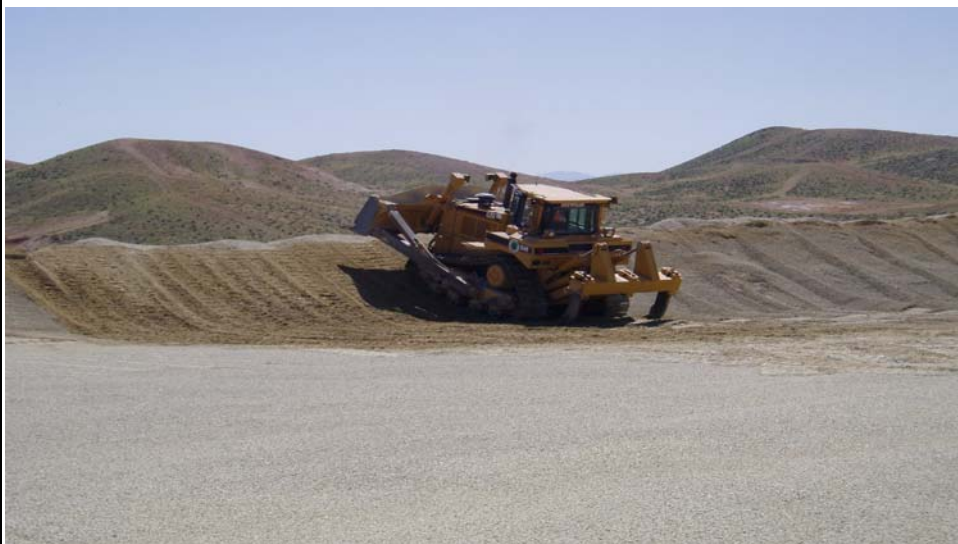
PHOTOGRAPH 4.:
Bulldozer reworking loose sand material along the north edge of tailings pile, along interstate 95 ALT. (Facing East)

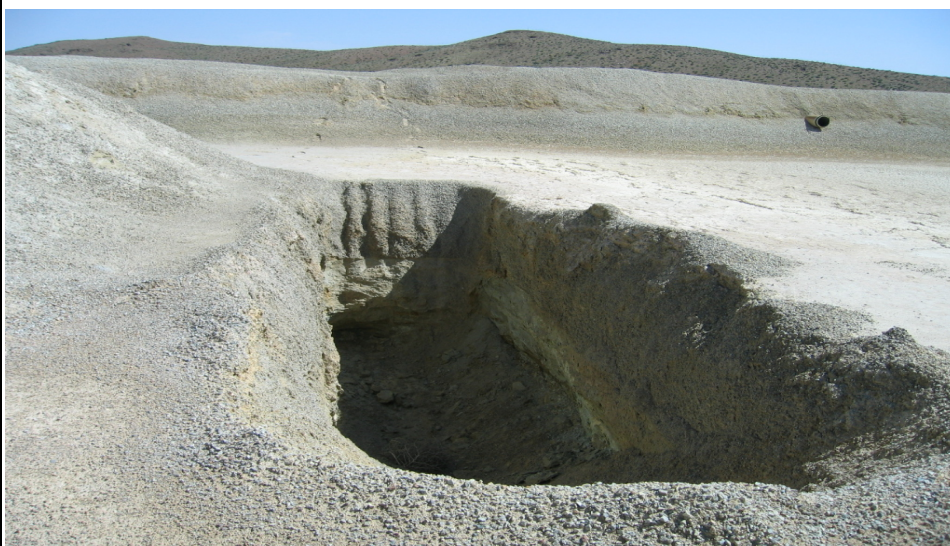
Two excavations were located in the southernmost pond, Area S3. The first excavation, in the northwest corner of the pond, is the deepest, at approximately 10 feet. This pit indicates that there were at least 3 feet of VLT originally placed on top of the evaporation ponds (Photo 5). The ponds then had more slurry pumped out of them for evaporation, resulting in a minimal amount of evaporate deposition on top of the VLT material. The second pit is in the northeast corner of the pond and is approximately 3 feet in deep. The excavation does not penetrate through the VLT material. Areas S2, S3, and S4 were sprayed with the soil sealant on May 11, 2006 (Photo 6 and 7; Figure 5). In addition, ERRS also sprayed Basin q, which is directly north of Area S2, with the soil sealant. The entire basin was covered during the application (Figure 5).

PHOTOGRAPH 5.:
Photo taken standing in southernmost pond (Area S3) looking northeast at excavation in northwestern corner. This excavation shows at least 3 feet of VLT material on top of the pre-existing evaporation pond.

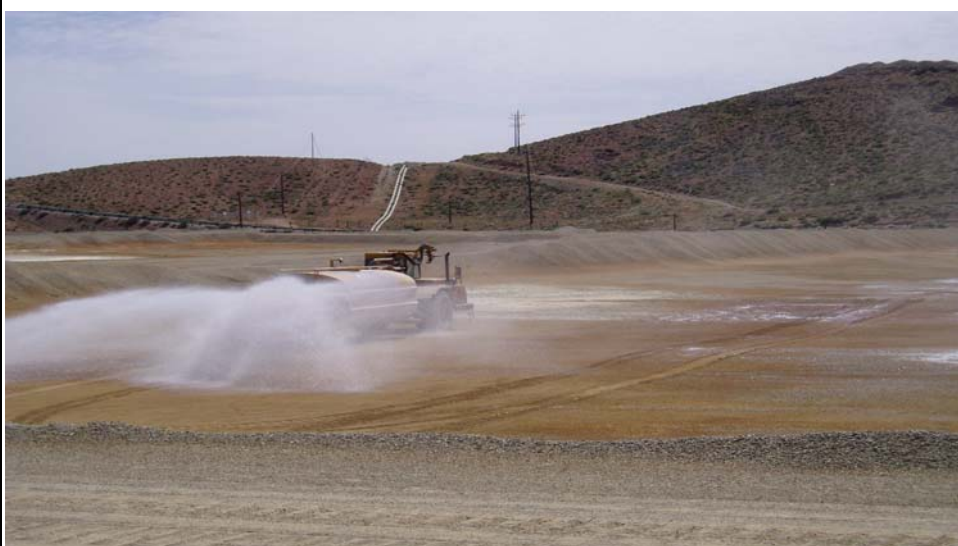
PHOTOGRAPH 6.:
Water Truck applying sealant at the northwest corner of Area S3. (Facing Southeast)

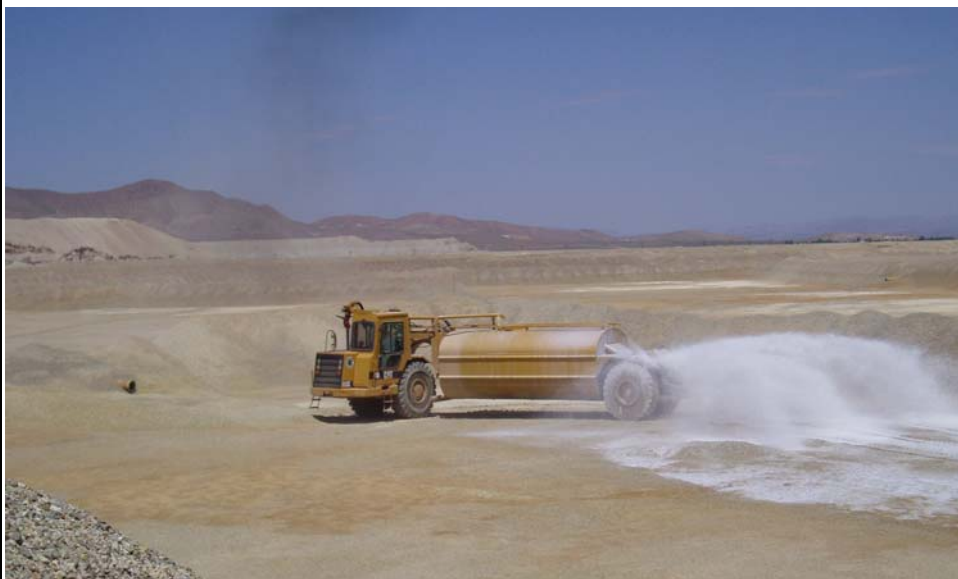
PHOTOGRAPH 7.:
Water Truck applying soil sealant in small sulfide basin, Area S4.
(Facing West)

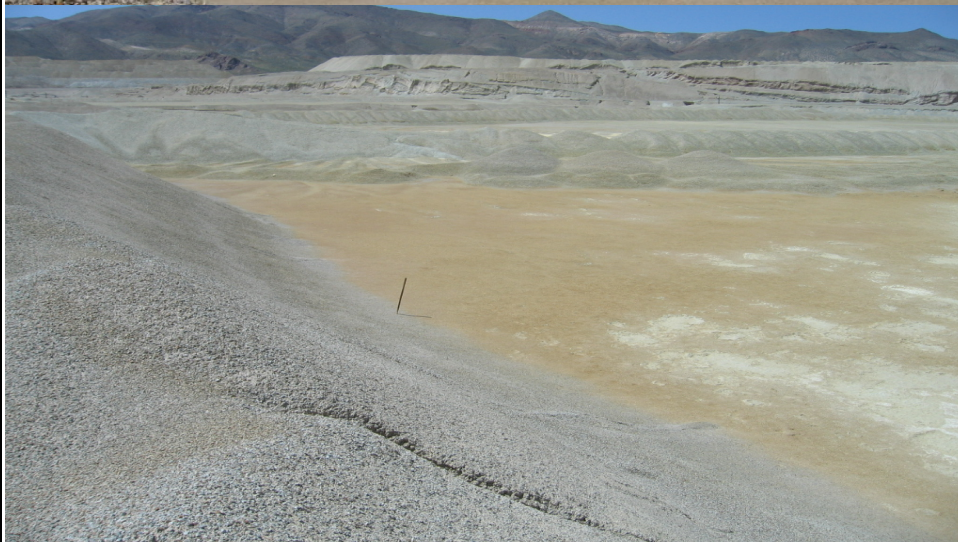
This area also has the medium- to coarse- grained sandy material identified in the first area. This material is brown and does not shade to the dark red color as in the first area, but the walk-around survey confirmed the difference between the brown material and the surrounding light gray and white material. The readings taking at up to 0.5 foot above ground level showed radiation at levels five times that of background (0.03 mR/hr). The light gray material had readings around 0.15 mR/hr. The brown areas had readings above 0.20 mR/hr and up to 0.30 mR/hr. The center of the pond area had VLT piles, which were deposited but never spread out. These VLT piles had radiation readings just above background levels, with all readings under 0.08 mR/hr (Photos 8 and 9). Soil Sealant was applied to the entire S1 basin area on May 11, 2006 (Photo 10; Figure 5).

PHOTOGRAPH 8.:
Photo taken from road R1 looking southwest into the pond (Area S1), showing the brown material all the way to the southwest edge of the basin.
(Facing Northwest)

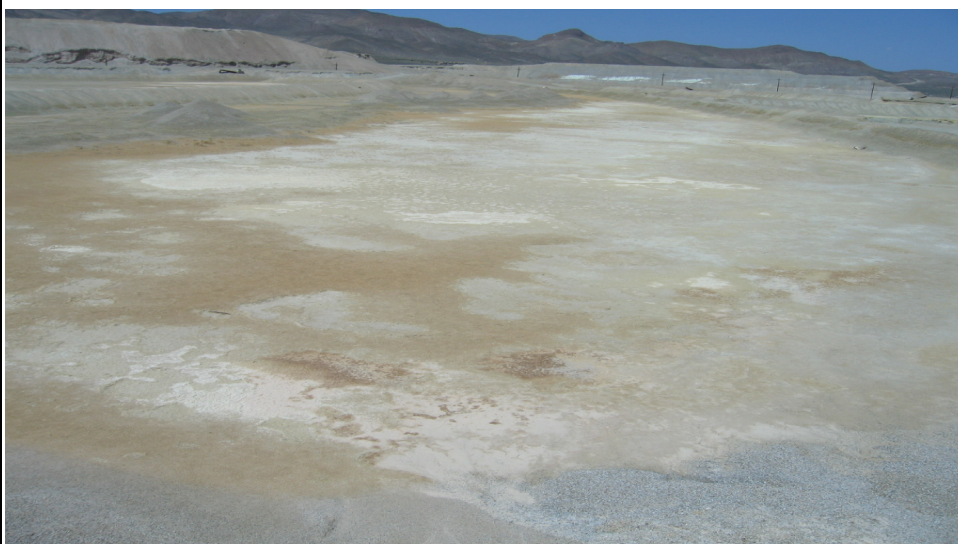
PHOTOGRAPH 9.:
Photo taken from road R1 looking west into the basin showing the brown material along the southern edge of the basin. The brown material in the western corner had a reading of 0.30 mR/hr.
(Facing Northwest)

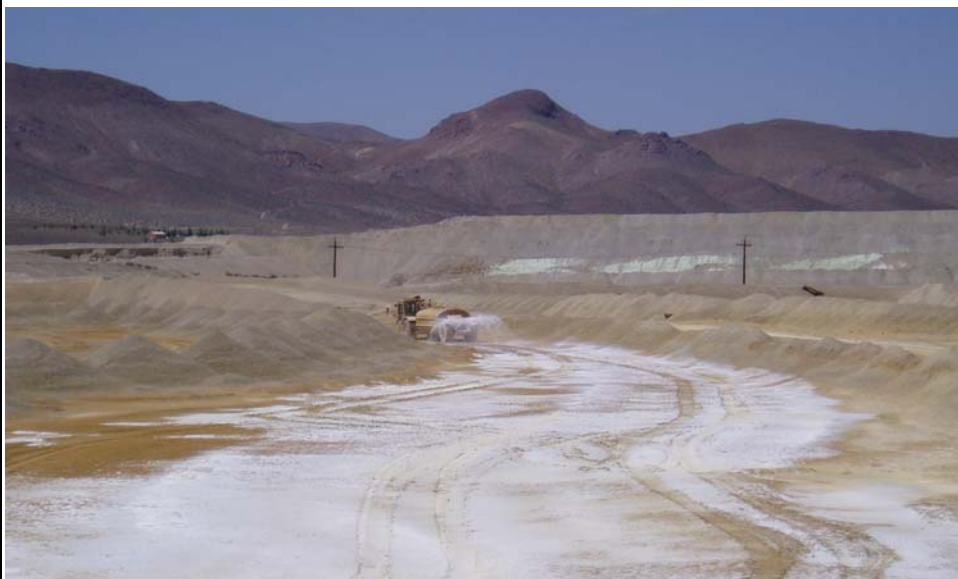
PHOTOGRAPH 10.:
Sealant applied along the northern portion of the S1 basin. From the northeast corner of the basin looking west.
(Facing West)

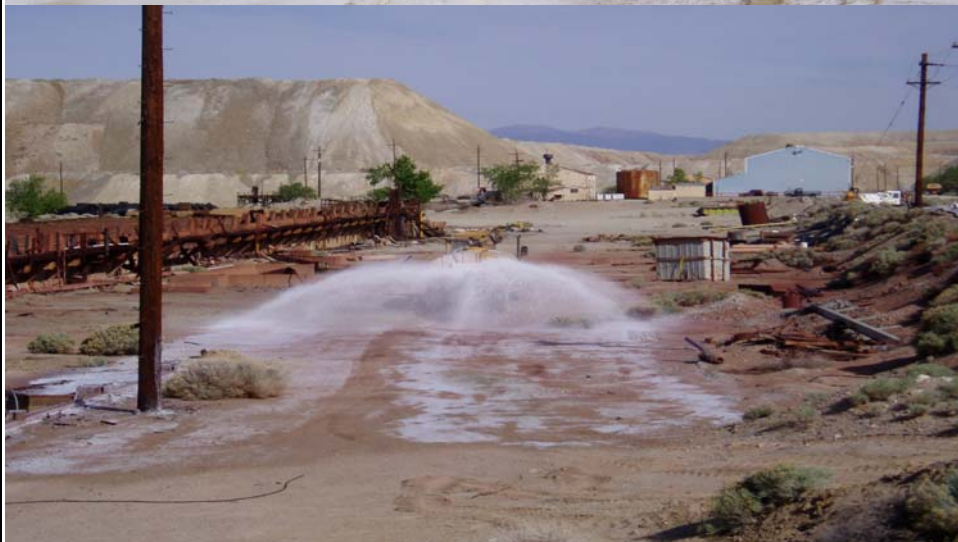
PHOTOGRAPH 11.:
Application of Soil Sealant in Process Area S5.
(Facing Southeast)

Process area S5 consists of a rectangular area of approximately 60,000 ft², and S6 is a small basin to the north, referred to as Basin KK, of approximately 50,000 ft² (Figure 3). The two areas—S5 and S6—were sprayed with the soil sealant on May 10 and 11, 2006 (Photos 11 and 12; Figure 5).

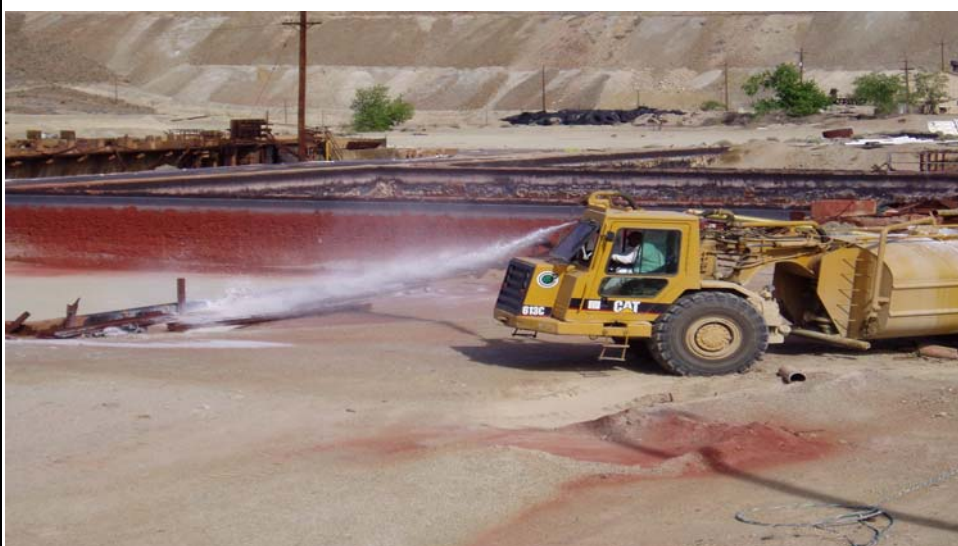
PHOTOGRAPH 12.:
Application of Soil Sealant in Process Area S5.
(Facing East)

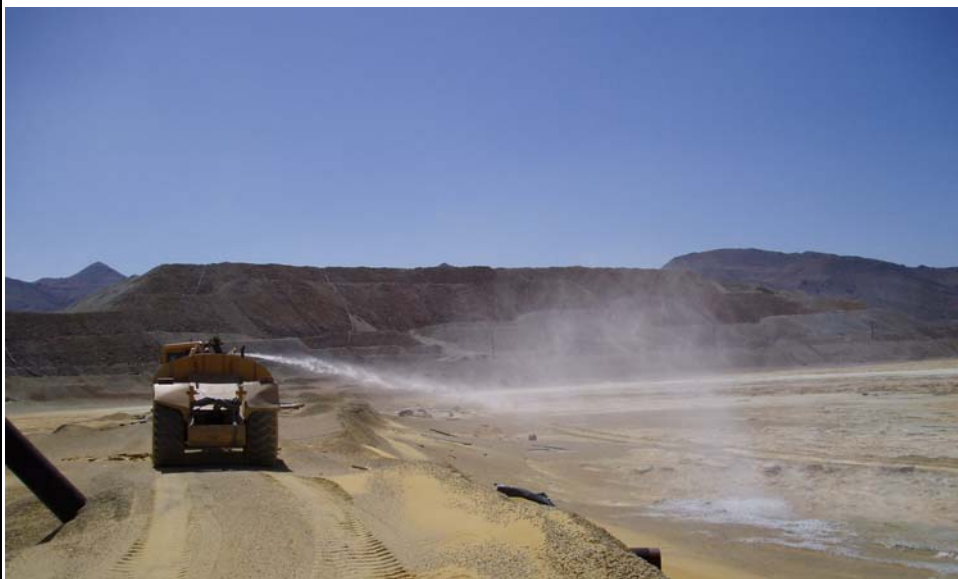
PHOTOGRAPH 13.:
Application of soil sealant
along west portion of Area
S7.
(Facing Northwest)

Area S7 is the southern corner of the North Evaporation Pond and consists of approximately 150,000 ft² (Figure 4). Area S8 is a small basin south of the North Evaporation Pond, just south of Area S7, and consists of approximately 60,000 ft² (Figure 4). Both areas contain fine, loose-gained sandy material that was discovered to potentially contribute to off-site dust migration. Both areas were sprayed with the soil sealant on May 11, 2006; however, the North Evaporation Pond was wet in the area of S7, and the water truck got stuck in the soft material. As a result, only portions of Area S7 accessible from the roadway were sprayed with the soil sealant (Photos 13 and 14).

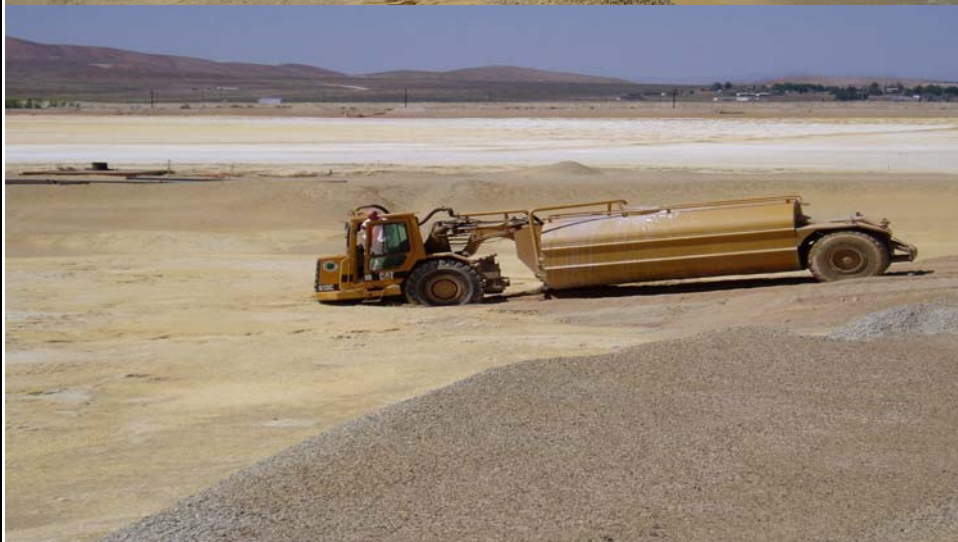
PHOTOGRAPH 14.:
Water truck stuck in soft
material of North
Evaporation Pond, Area S7.
(Facing North)

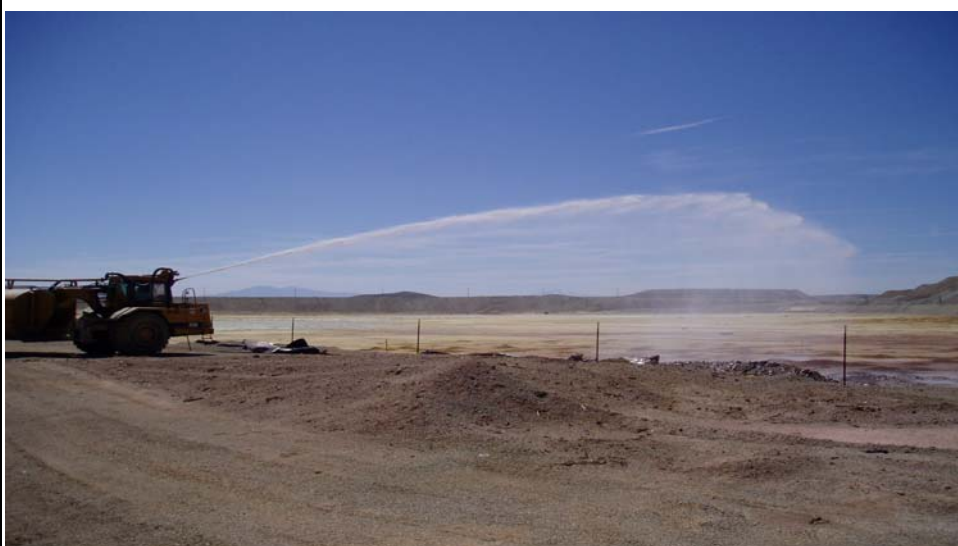
Area S12, located at the northern corner of the Northern Evaporation Pond, is approximately 40,000 ft², and contains areas with dark red dirt material, which is thought to have elevated levels of radiation (Figure 4) based on the Scanner Van Survey. Area S13 contains loose, sandy material along the western side wall of the evaporation pond, just south of area S12, and consists of a rectangular area of approximately 30,000 ft² (Figure 4). Both areas were sprayed with the soil sealant on May 12, 2006; however, due to soft, wet material inside the North Evaporation Pond, areas of S12 and S13 were only sprayed in portions that were accessible from the roadway (Photos 15 and 16).

PHOTOGRAPH 15.:
Application of soil sealant
of north portion of North
Evaporation Pond, Area
S12.
(Facing Northeast)

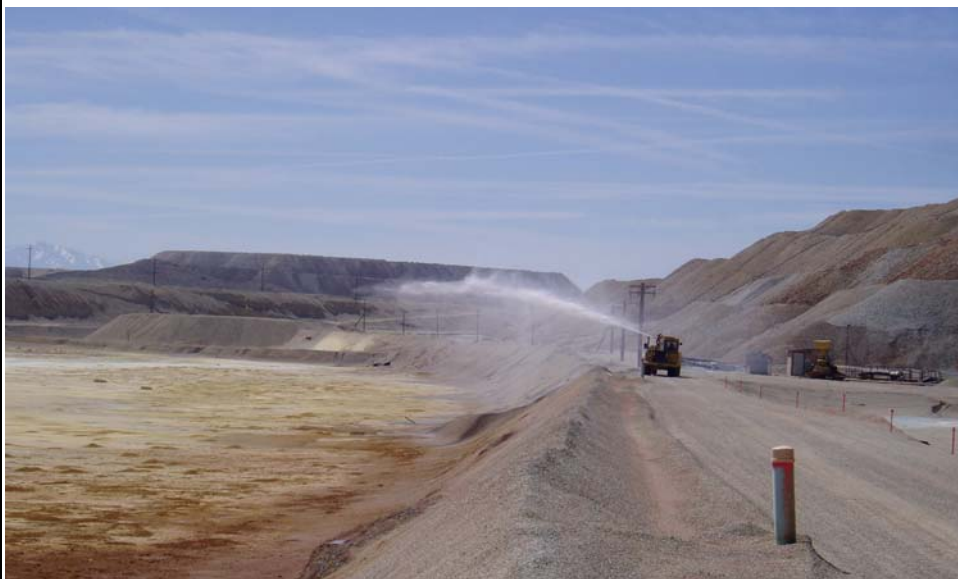
PHOTOGRAPH 16.:
Application of soil sealant
along west edge of North
Evaporation Pond, covering
dark reddish material, Area
S13.
(Facing South-southeast)

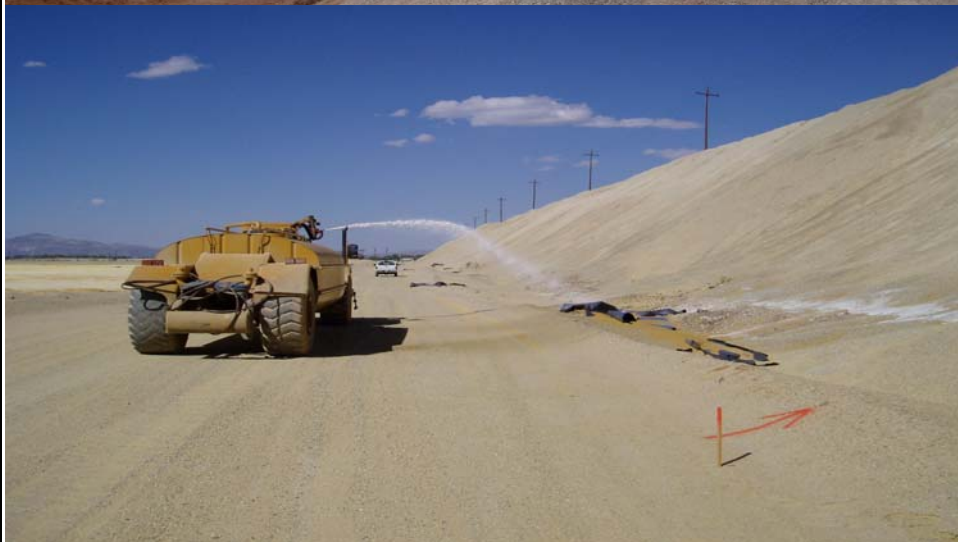
Area S9 is located at the toe of the sulfide tailings along the western edge or face, just east of the eastern edge of the North Evaporation Pond, and contains a long rectangular area of loose, sandy material. Area S9 is approximately 60,000ft² (Figure 4). Area S10 is located just northeast of Area S9, along the northern face of the Sulfide Tailings, facing the neighboring Peri property to the north (Figure 4). Area S10 is approximately 6,000 ft². Areas S9 and S10 were determined to potentially contribute to fugitive dust migration at the site. Area S9 and S10 were sprayed with soil sealant on May 11, 2006 (Photo 17).

PHOTOGRAPH 17.:
Application of Soil Sealant
along west toe of Sulfide
Tailings, Area S9.
(Facing Northeast)

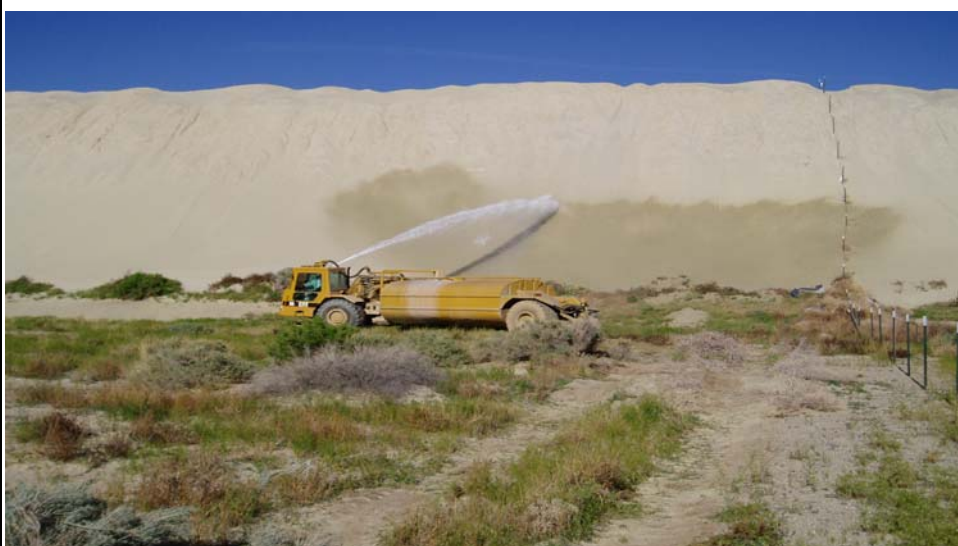
Area S11 is at the base of the Sulfide Tailings along the northern edge, which fronts Highway 95A, and is approximately 40,000 ft² (Figure 4). The face of the Sulfide Tailings along Interstate 95 Alt, Area S11, consists of loose, sandy material that is believed to contribute to fugitive dust migration offsite. Area S11 was sprayed with soil sealant on May 12, 2006 (Photo 18).

PHOTOGRAPH 18.:
Application of soil sealant
along the northern face of
the Sulfide Tailings, Area
S11.
(Facing West)

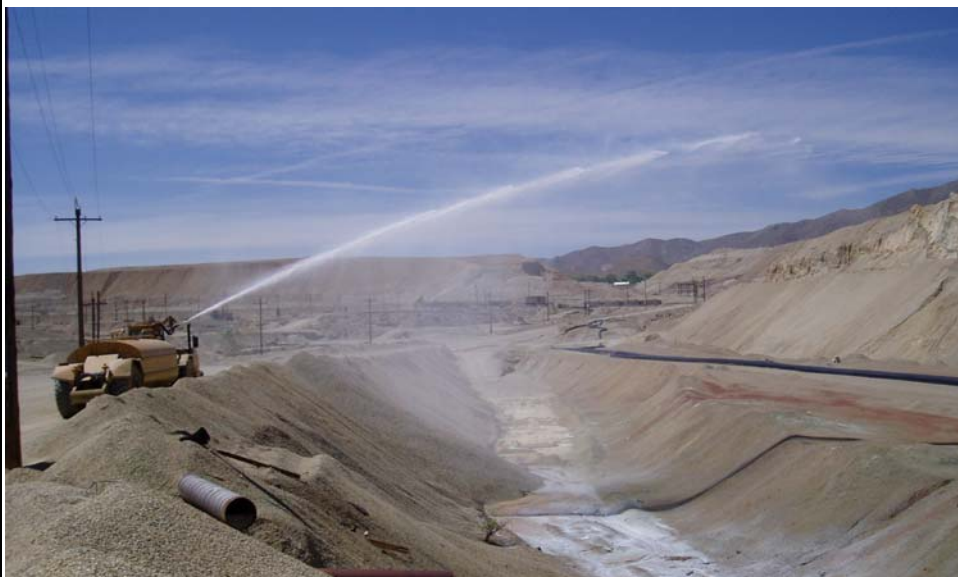
PHOTOGRAPH 19.:
Application of soil sealant along west toe of road R12, Area R2.
(Facing South)

Additional areas that were sprayed with the soil sealant include Area R2, located on either side of and at the base of road R12. Road R12 leads to the VLT pond and is located west of Area S1. ERRS sprayed both the east and west toes of the roadway on May 12, 2006 (Photos 19 and 20; Figure 5).

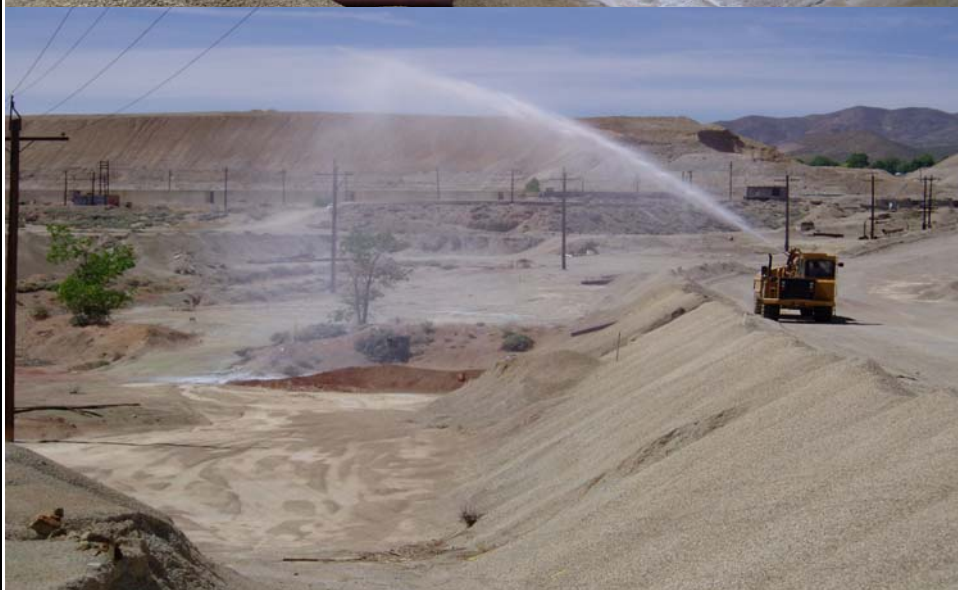
PHOTOGRAPH 20.:
Application of soil sealant along east toe of road R12, Area R2.
(Facing South)

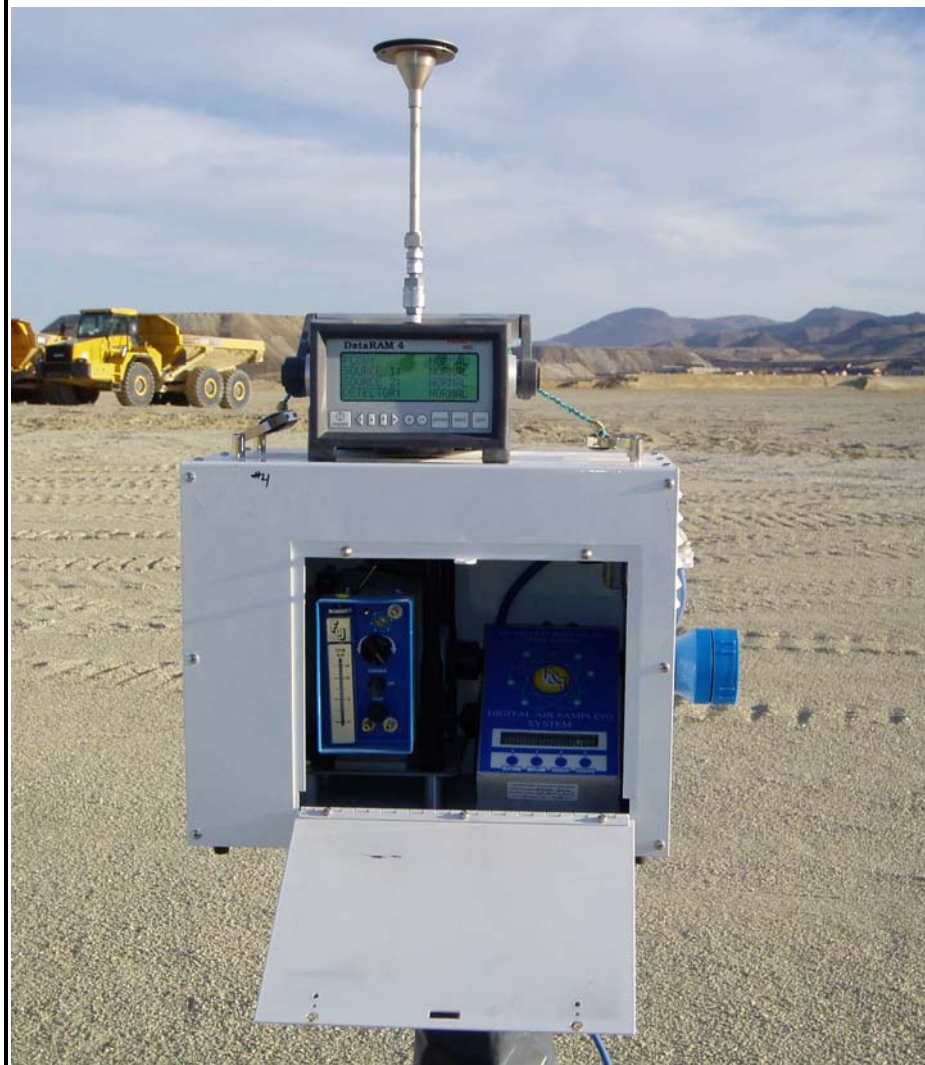
During capping activities, DataRam particulate samples were run every day by START and EPA personnel, from April 13, 2006 to May 9, 2006 (Photo 21). High-volume F&J air samplers were also run during 10 days of the excavation and capping activities and filter samples were collected each day by ERT personnel. The DataRam data and F&J filter samples and data were collected and downloaded by ERT personnel, who will report on the air sampling activities and sample results under separate cover.

PHOTOGRAPH 21.:
Air monitoring station with
DataRAM 4 particulate
sampler above and F&J
high volume sampler below.
