NAVAJO FOREST **PRODUCTS BUILDING** **ASSESSMENT**

VISUAL STRUCTURAL EVALUATION

JULY 2018

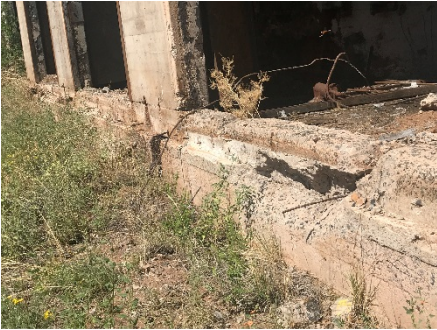
TYPICAL FOUNDATION @
EXTERIOR WALL 12

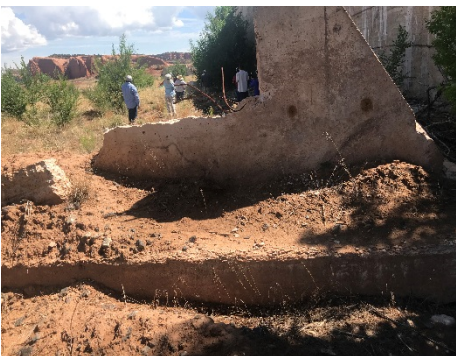
TYPICAL CONCRETE DEBRIS
AROUND PERIMETER

The foundations were not visible; however, there was debris adjacent to the facility that suggests the building more than likely is supported by a system of reinforced concrete spread and continuous footings bearing on compacted subgrade. See photo to left labeled "CONCRETE DEBRIS AROUND PERIMETER". Also, during the walk, no trenches or basements were observed. The slab on grade within the facility is of unknown thickness and reinforcement.

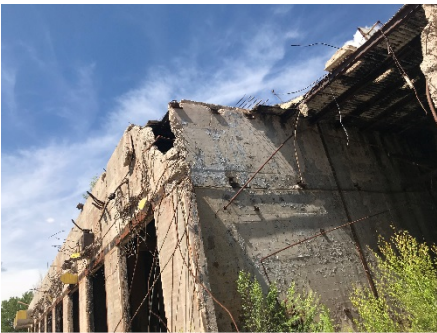
DAMAGE TO WALL 1, 2 AND 12

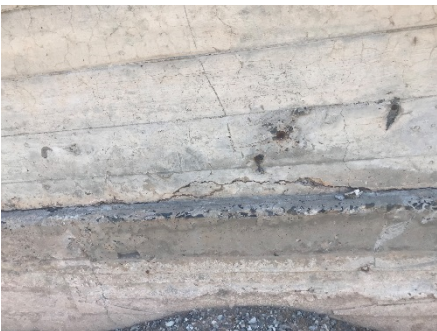
TYPICAL COLD JOINT BETWEEN
CONCRETE WALL AND STEM
WALL

and moisture issues. Also, the walls had approximately 4 inch wide continuous vertical plates bolted to the surface at approximately 10 feet to 12 feet on center. It is thought these plates cover the construction joints between concrete panels. See photo 8. Furthermore, the condition of the reinforcement connecting the foundation stem wall to the concrete wall is unknown.

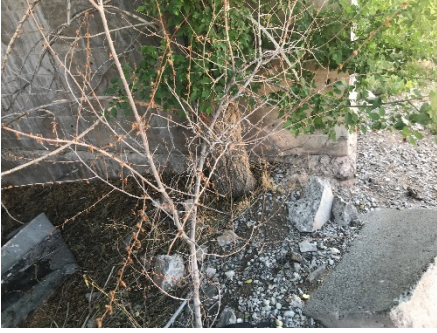
TREE ADJACENT TO FOUNDATION

1. No foundation settling was observed; however, there was quite a bit of concrete spalling, cracking and deterioration at wall 12 stem walls. It is recommended to remove all vegetation from the perimeter of the building to prevent future damage or heaving of the foundation. Trees were also observed directly adjacent to the facility (see photo to left); it is recommended to have those carefully removed to avoid any potential heaving/damage/etc. to the foundations. If undermining is a possibility during removal, underpinning might be required. If the building is repurposed, additional studies may be required to determine foundation type/capacity.

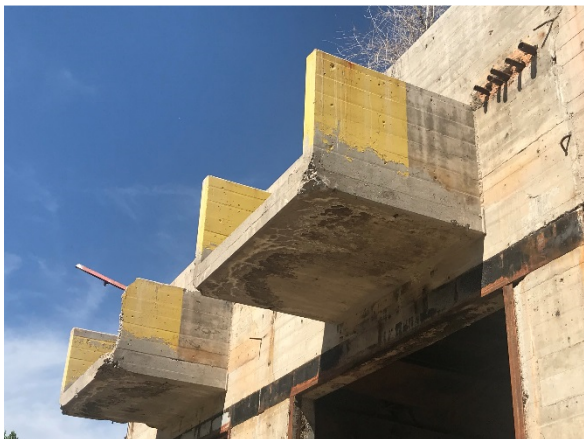
Wall 12 is 12 inches thick and reinforcement was observed at the top of the wall on the northeast side. The rebar that was exposed appeared to be reinforcement for a lintel that was removed. The diameter of the bars were between 1/2 inch and 5/8 inch. As far as jamb reinforcement between the openings, it is unknown. The jamb width was approximately 5 feet to 6 feet wide, and the openings were approximately 10 feet wide by 14 feet tall. Another characteristic of wall 12 is the embed channels on the lower portion of the lintel, and angle embeds on the sides of the jambs. They appear to have been installed to prevent damage to the jamb and lintel. The wall had concrete chutes over the openings; however, only two exist today at the southeast side; see photo 5.

Photo 5 (CONCRETE CHUTES)

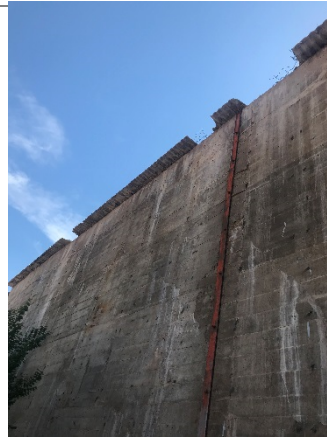
Photo 8 (TYPICAL STEEL PLATE @ JTS)

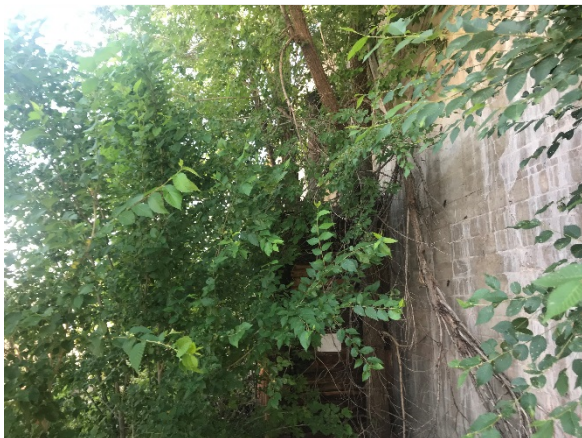
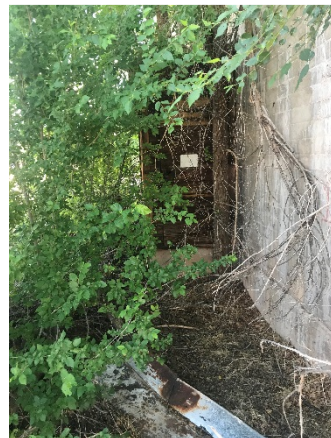
Photo 17 (TREES ADJACENT TO BUILDING)

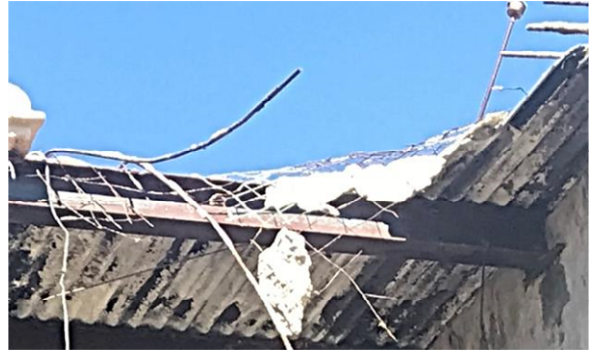
The building could only be observed from outside of the facility due to asbestos contamination and safety concerns. At the northeast side, the roof beams were observed at approximately 4'-0" OC. Between each beam was a skylight. See photo 27, 28 and 29. The beams support a corrugated asbestos roof, with what appeared to be a gypsum or lightweight concrete topping, reinforced with welded wire fabric. See photo 26.

3. The corrugated asbestos roof, with what appeared to be a gypsum or lightweight concrete topping reinforced with welded wire fabric, appeared to be in poor condition and not positively attached to the beams or walls. The underside of the deck exhibited a varied amount of deterioration and distress, with signs of damage to both the deck, topping and wire mesh. Not only is the structural roof deck in very poor condition, it does not act as an engineered diaphragm. A lateral diaphragm is an essential element in providing support for structural elements subject to wind or seismic elements and distributing those

Photo 26 (ROOF DECK)

Lastly, the roof deck is in poor condition and does not act as an engineered roof diaphragm. It is recommended the roof diaphragm be removed and replaced with a properly designed diaphragm.

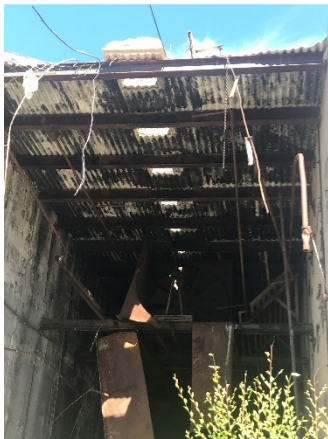
The roof and catwalk beams appeared to have some corrosion; however, without directly measuring the beams, it was not possible to determine the amount deterioration. See photo 29. Furthermore, without additional structural analysis and testing it is unknown whether the catwalk beams provide intermediate support for the concrete walls. The connections from the beams to the concrete walls appear to be distressed, possibly due to thermal movement and exposure to moisture. Once the facility has been decontaminated, a more thorough observation can be completed to determine if the connections and

Below the roof superstructure, there are steel beams that appear to be a utility support and catwalk structure; see photos 31 thru 35. The catwalk supports have been removed at the front of the bay between wall 1 and 2. Looking at photo 29, it appears that the miscellaneous steel utility

and catwalk structure does not support the roof and is independent of the roof superstructure; however, it is unclear if the intermediate beams provide wall support. This will need to be confirmed if this building undergoes modifications.

Photo 29 (BAY BETWEEN WALLS 1 AND 2)

2. The beams supporting the corrugated asbestos roof appeared to have some corrosion. To what extent is unknown, since the beams could not be measured or closely observed. If the beams are to be reused or repurposed, we recommend further studies after decontamination to ensure they are adequate.

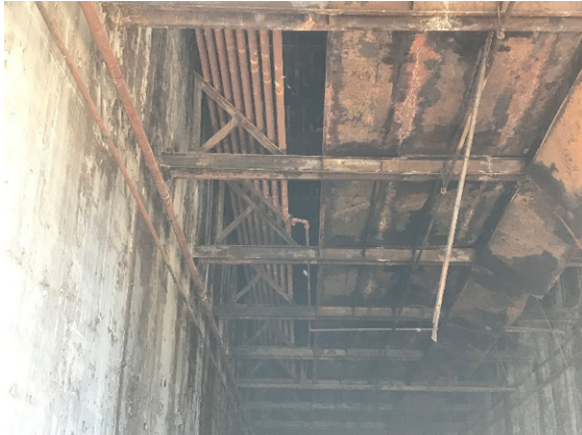
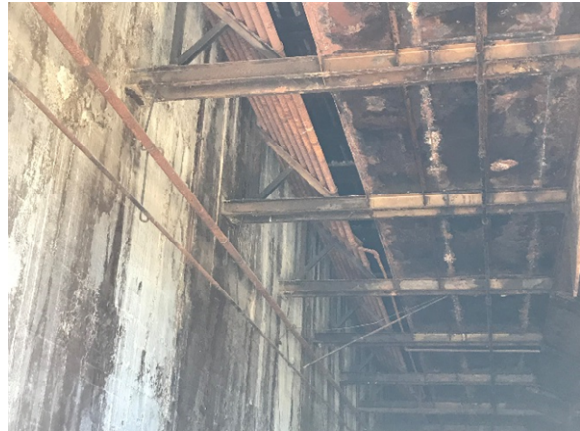
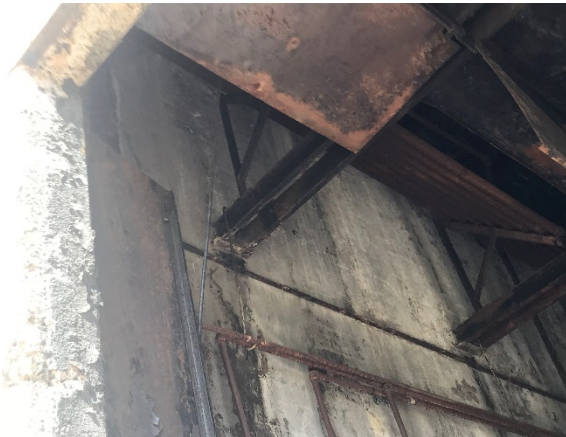
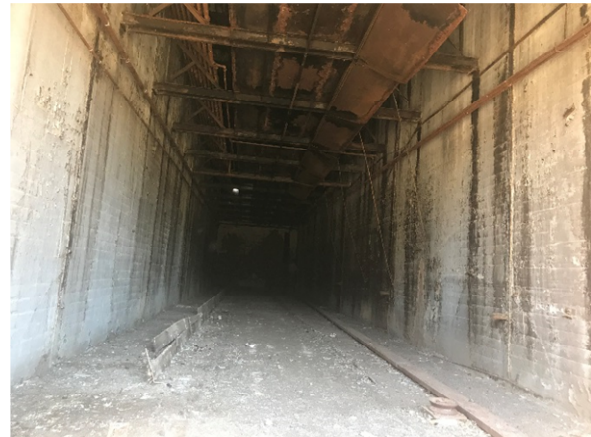
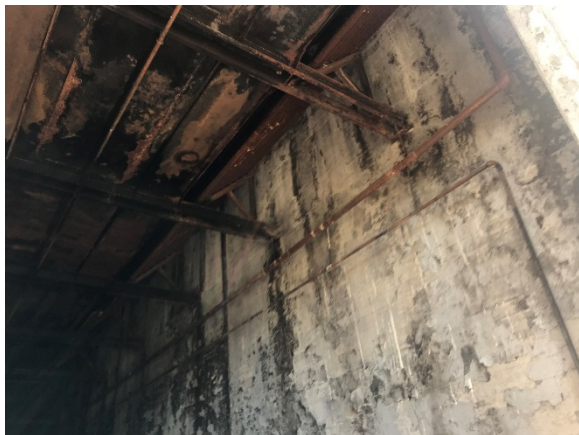
The structure supporting the roof was exposed and was visible at the far north end of the facility; however, due to asbestos lining the walls and roof, as well as the overall condition of the facility, direct observation/measurement of the structural framing was not permitted. At other locations, supplemental framing that was used to process wood products was obstructing any direct observation of the roof beams or deck. See photos 31 through 35.

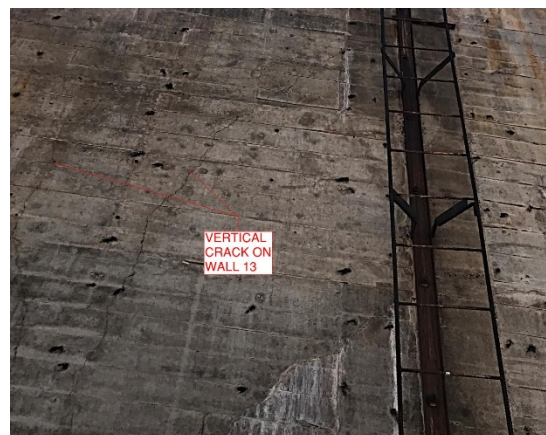
5. Overall, the concrete walls are in fair to poor condition. No distress or lateral movement was observed; however, a moderate amount of spalling and cracking is present. Wall cracks were observed to be roughly 1/16 inches to 1/8 inches wide; some localized areas were wider. Based upon the rebar spacing measurements taken in the field, it appears wall 12 does not meet ACI crack control criteria. Given this information, and the observed cracking, it appears that many of the walls may not have adequate crack control reinforcement. The issue with some of the cracks, is the potential for moisture to infiltrate and corrode rebar; therefore, reducing the capacity of the wall. If the walls are repurposed, testing may be required to determine if the rebar has experienced an excessive amount of corrosion. Also, without doing a detailed model based structural analysis, it is unknown whether the walls are braced by only the roof beams or the roof beams and the catwalk structure. In conclusion, future structural studies should ensure the concrete walls meets code requirements.

Photo 36 (TYPICAL WALL CRACK)
