**ACTION MEMORANDUM AMENDMENT 2**

**SUBJECT:** Request for a Ceiling and Scope Increase and Continued Exemption from the 12-month and \$2 million Statutory Limits for Removal Action at the Nelson Tunnel/Commodore Waste Rock Site in Mineral County, Colorado

Site ID# 08MB

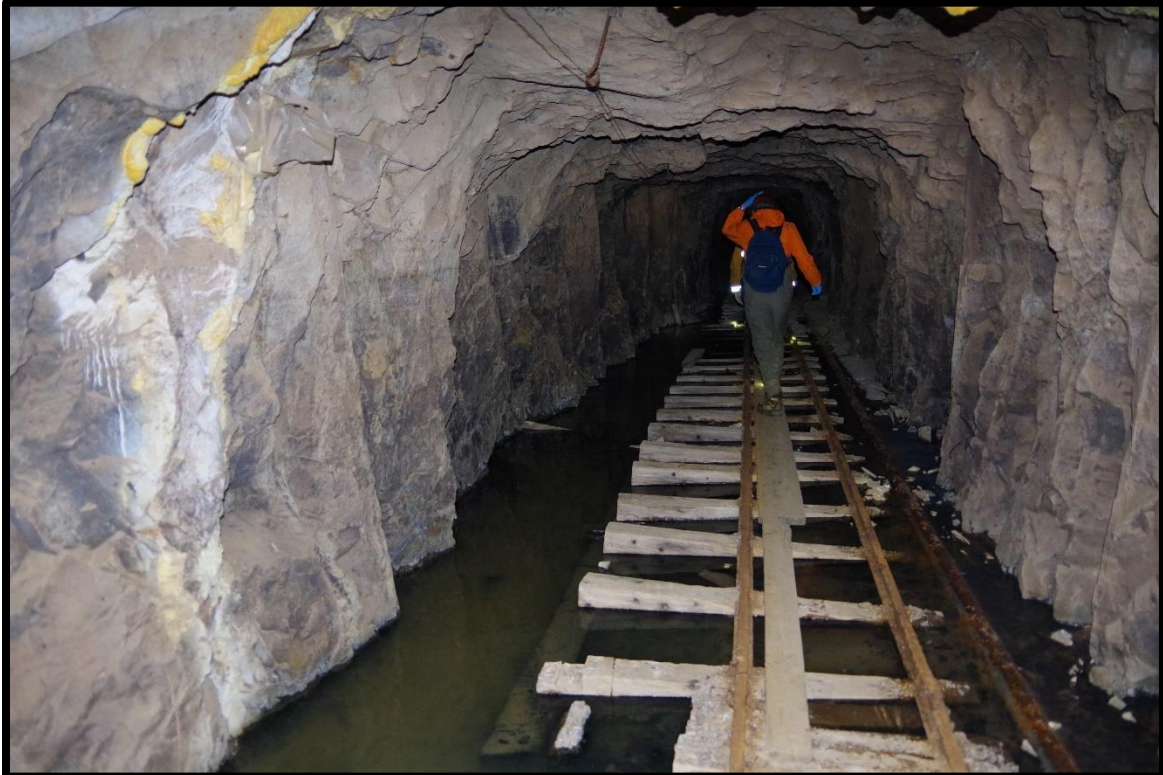
**Photo 7: Floating rail ties and poor drainage near 1+00**

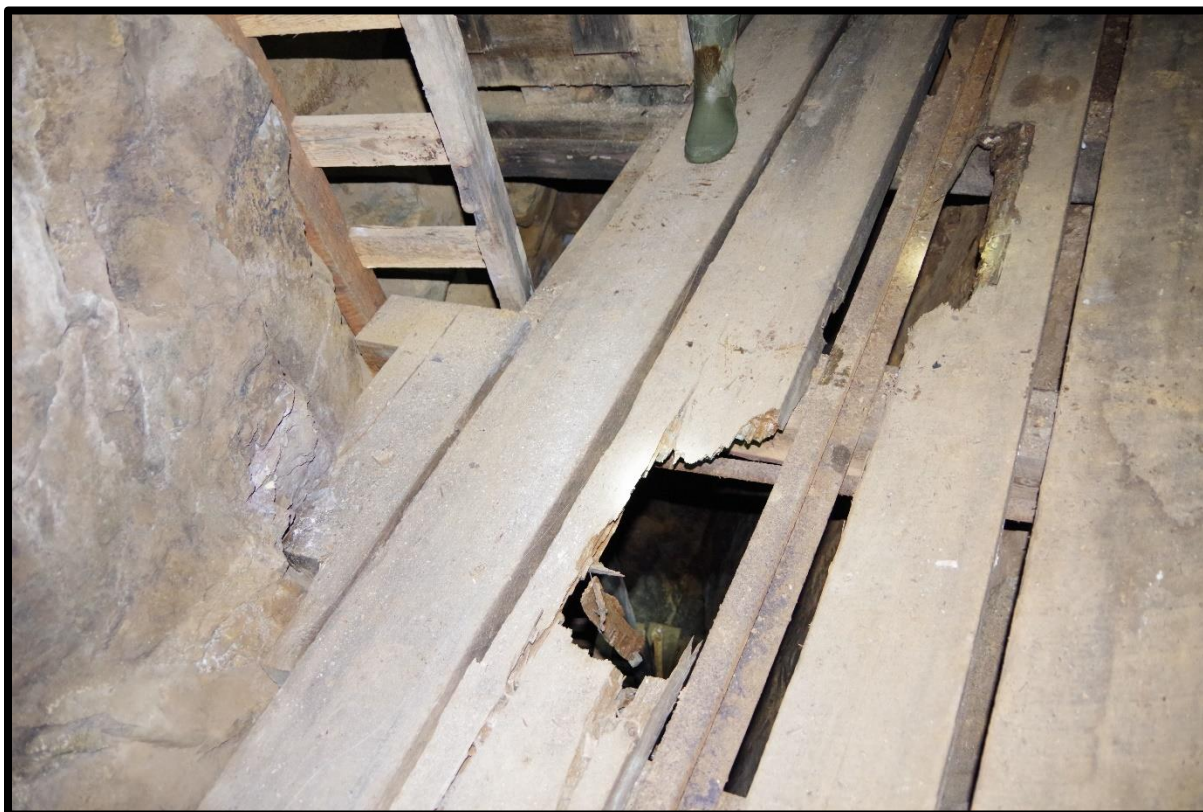
Photo 17: Daylight Winze with rotten wood cover

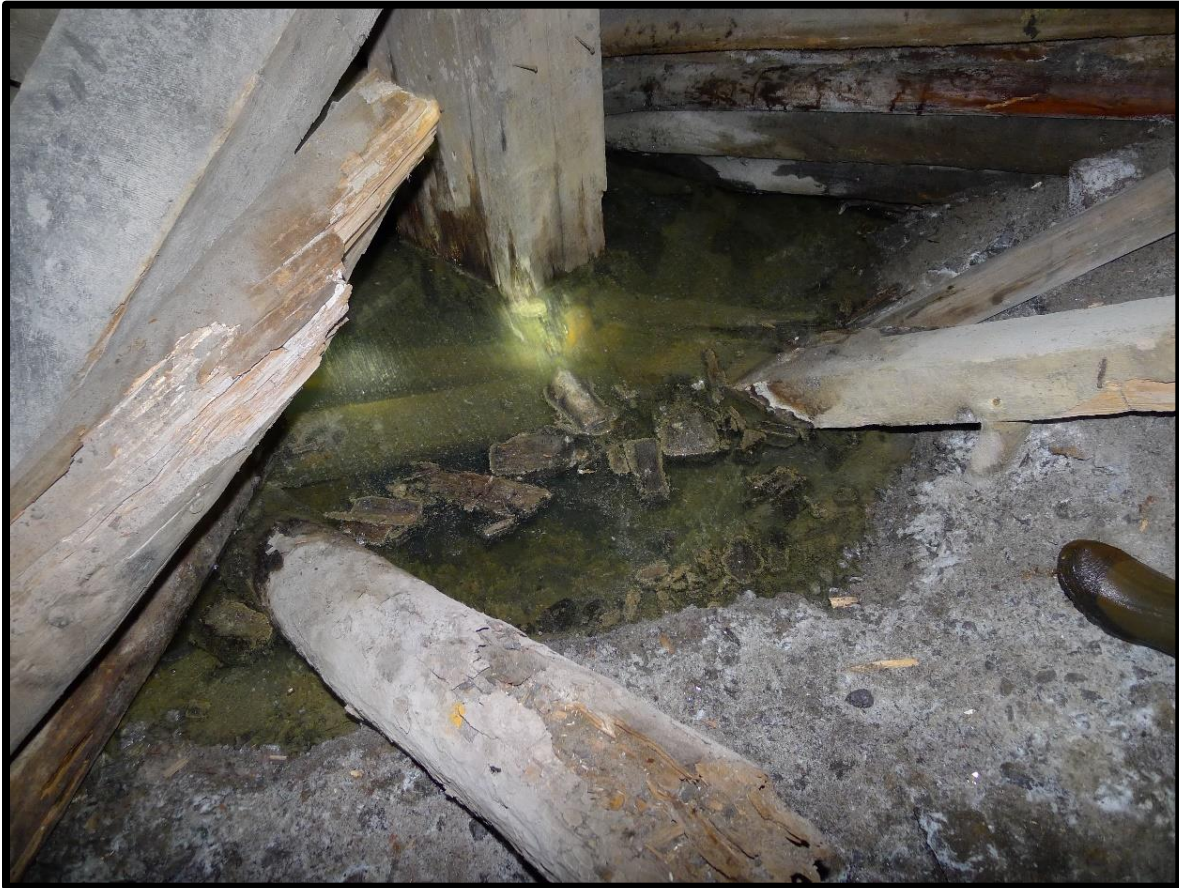
**Photo 31: Collapsed Timbers at Bachelor Shaft Nelson Tunnel landing**

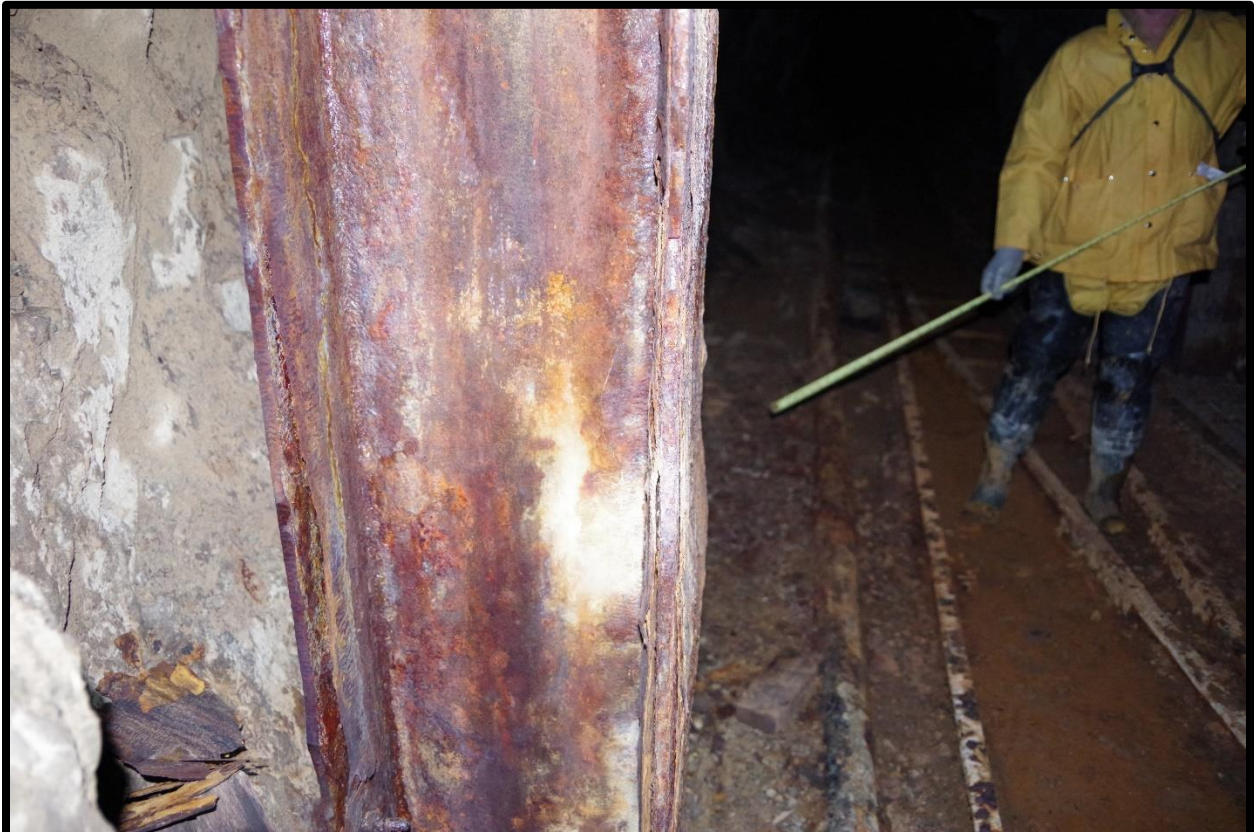
**Photo 34: Close up of Archimedes Raise steel posts; Note corrosion and delamination**

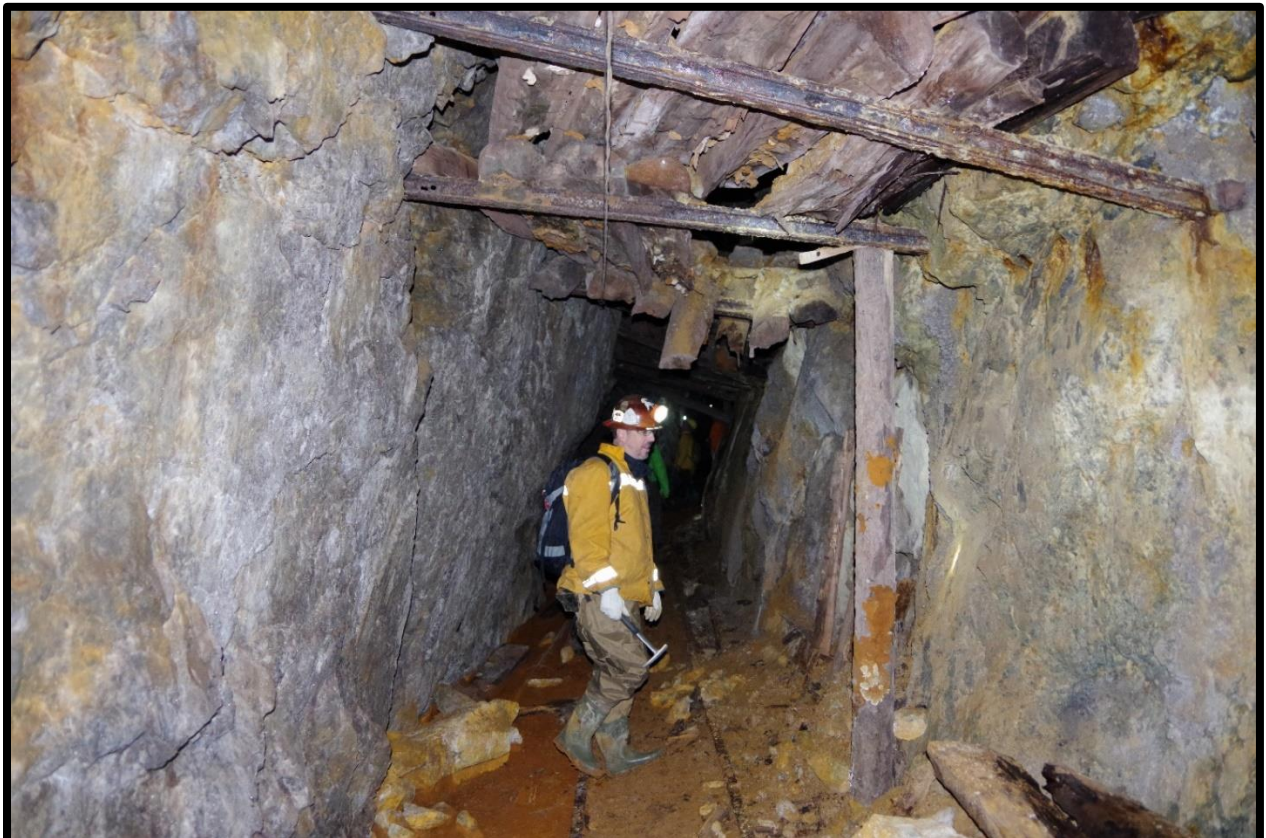
Photo 36: Steel rail stulls with rotten timber lagging 30+50

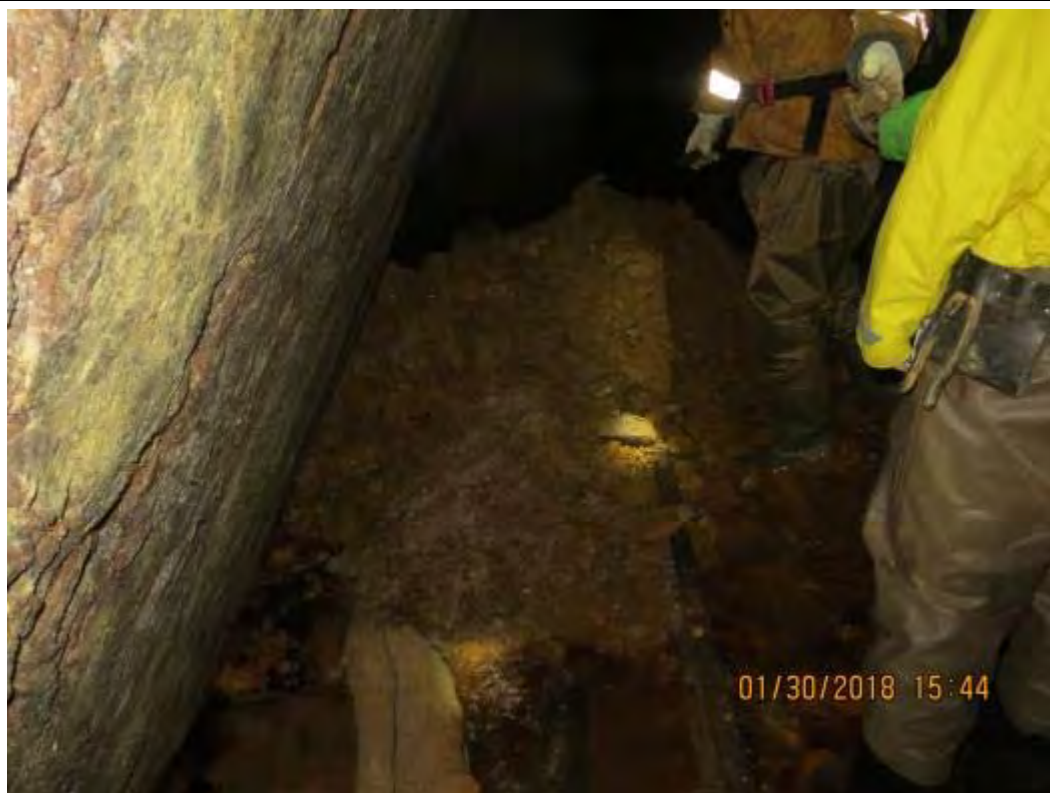
<b>Photo No.</b> <b>14</b>	<b>Date:</b> 01/30/2018
<b>Photo Coordinates</b>	
<b>Lat</b>	--
<b>Long</b>	--
<b>Direction Photo Taken:</b> <b>Southeast</b>	
<b>Description:</b>  Looking back at fresh roof fall material. Note small amount of water retained behind roof fall.

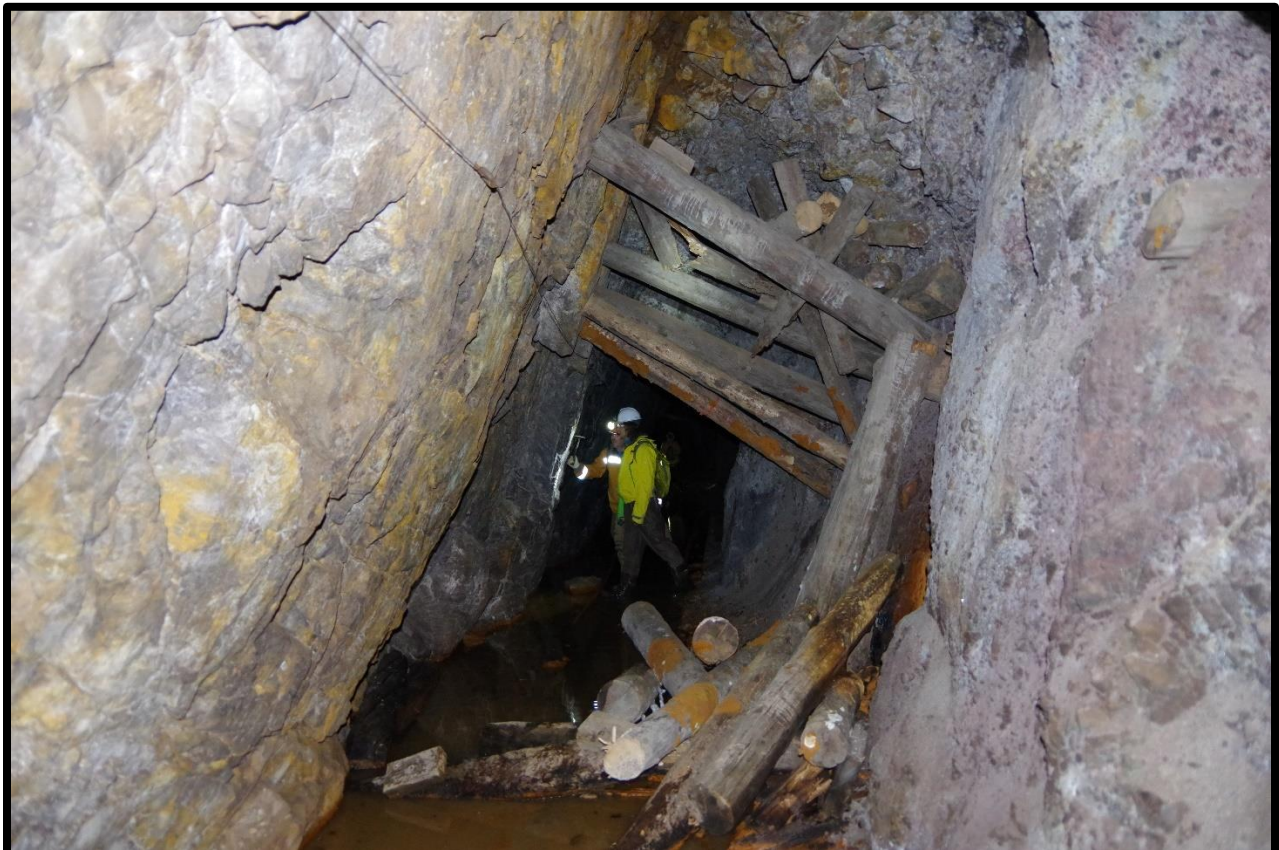
**Photo 40: Failed timber stulls near 32+80**

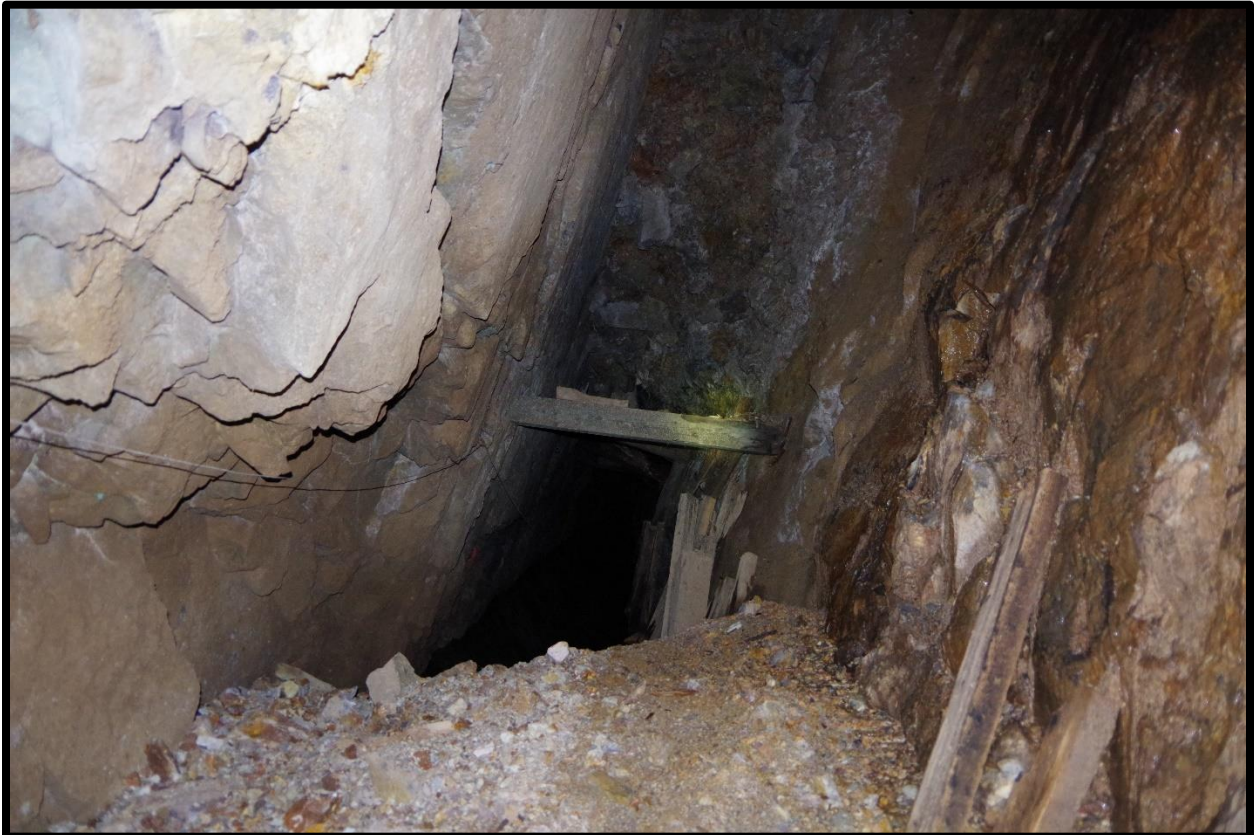
Photo 41: Debris pile at very active 44 Raise 36+82

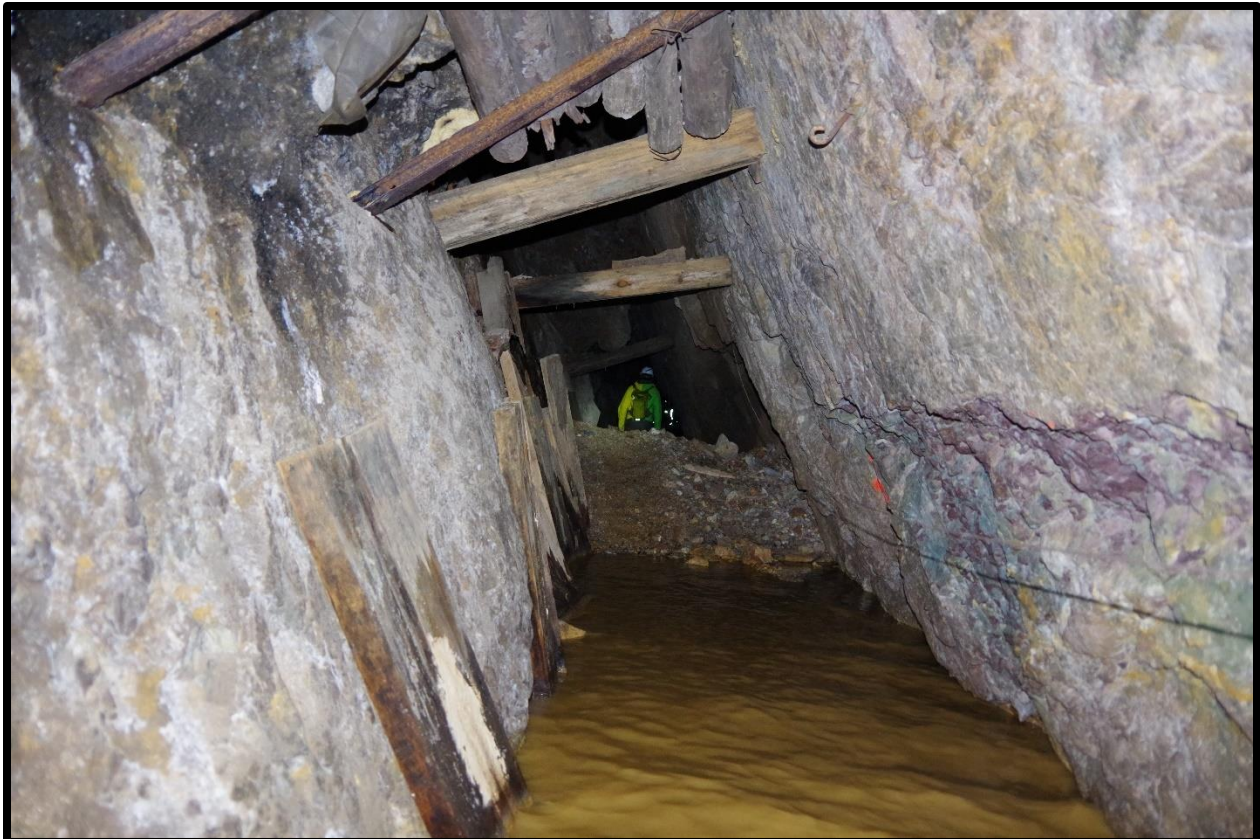
Photo 42: Debris pile at 44 Raise 36+82 looking outby; Note water ponded behind pile

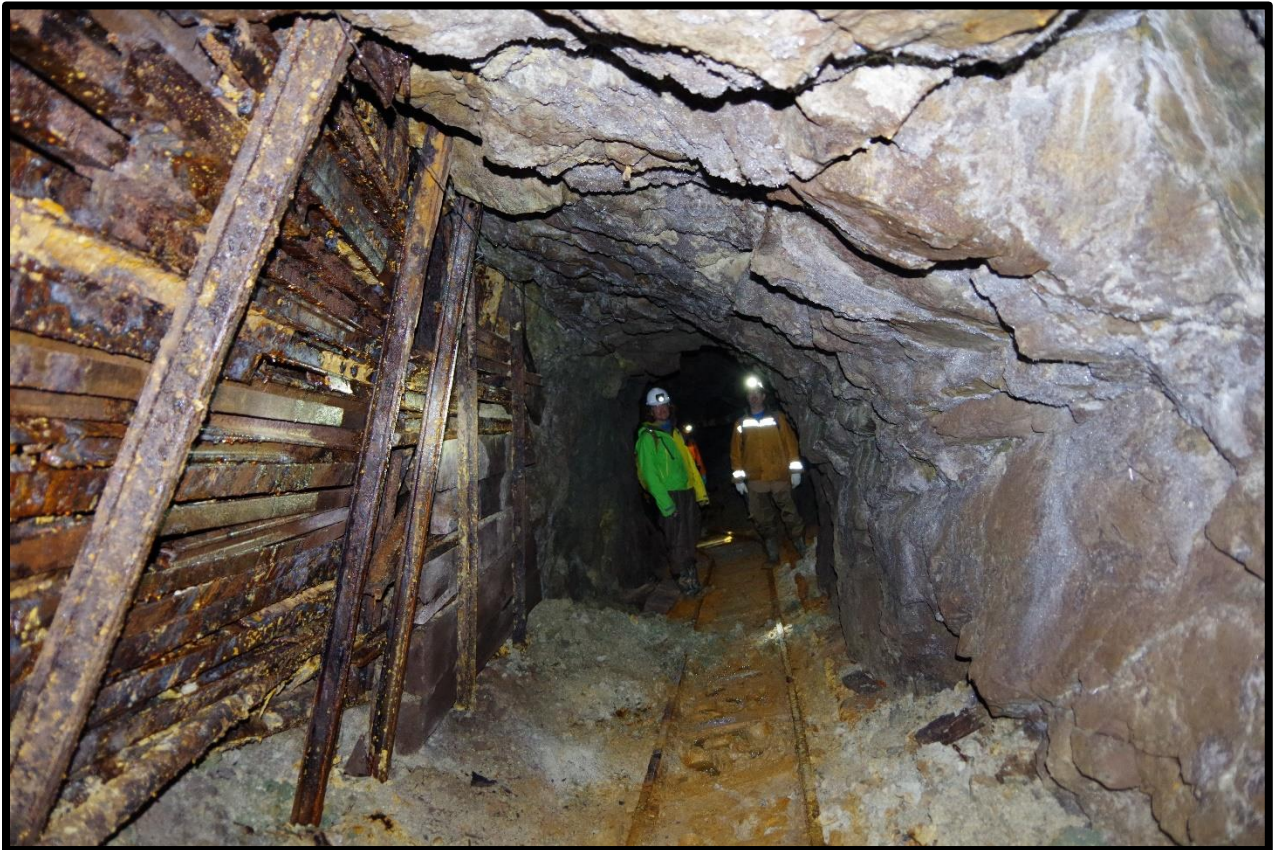
**Photo 57: Area of clay gouge in left rib near 47+10; Note heavy steel rail lagging**

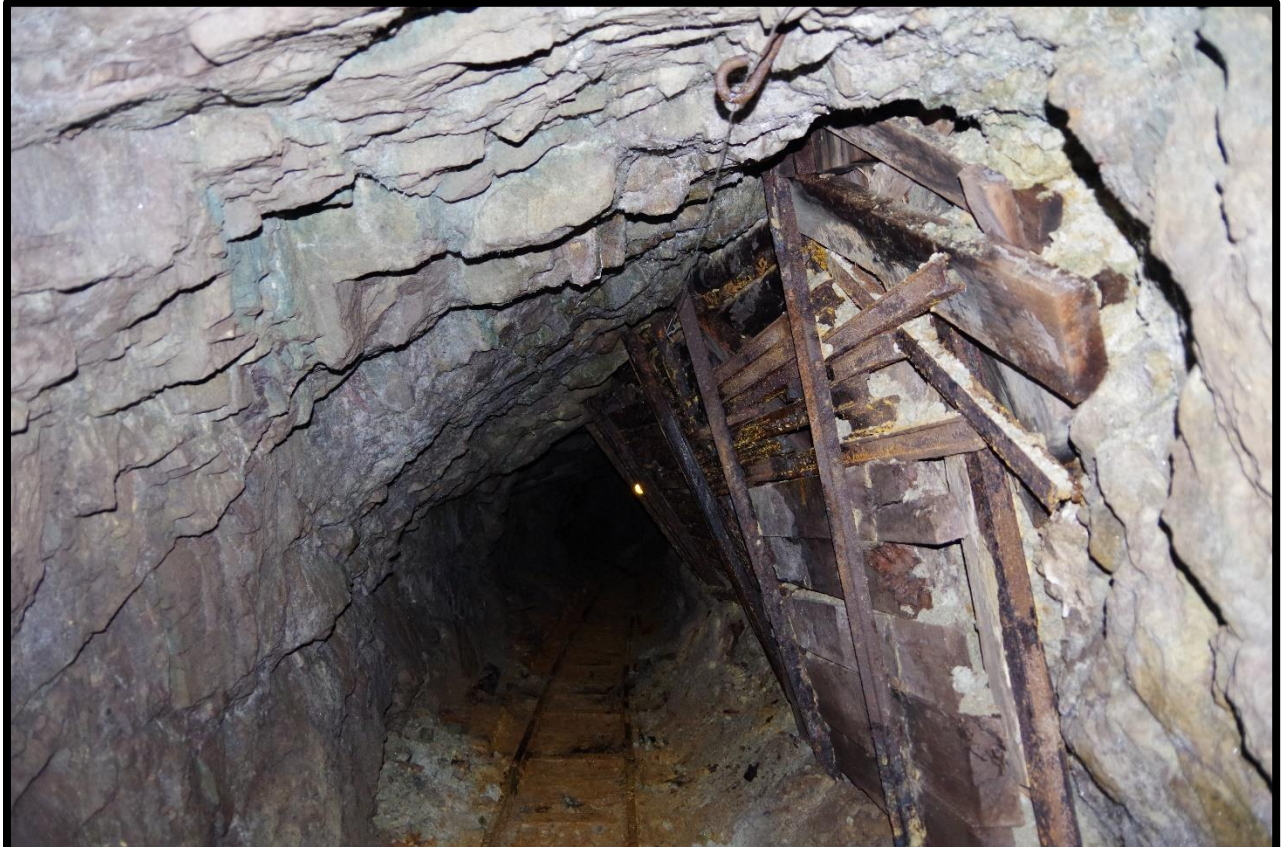
**Photo 58: Area of clay gouge in left rib near 47+10 looking outby; Note timber lagging**

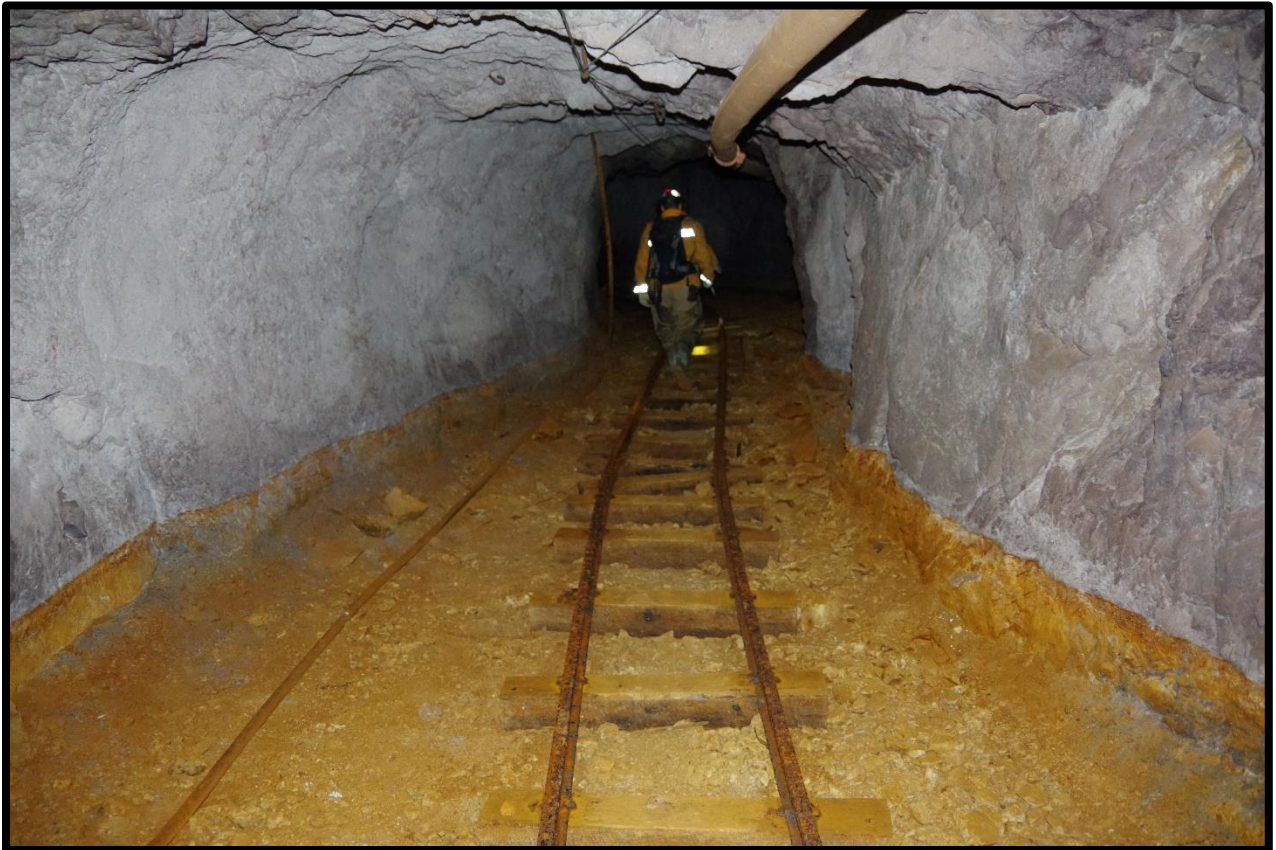
Photo 59: Typical draft near 50+00; Note high water line from upper mine pool overflow

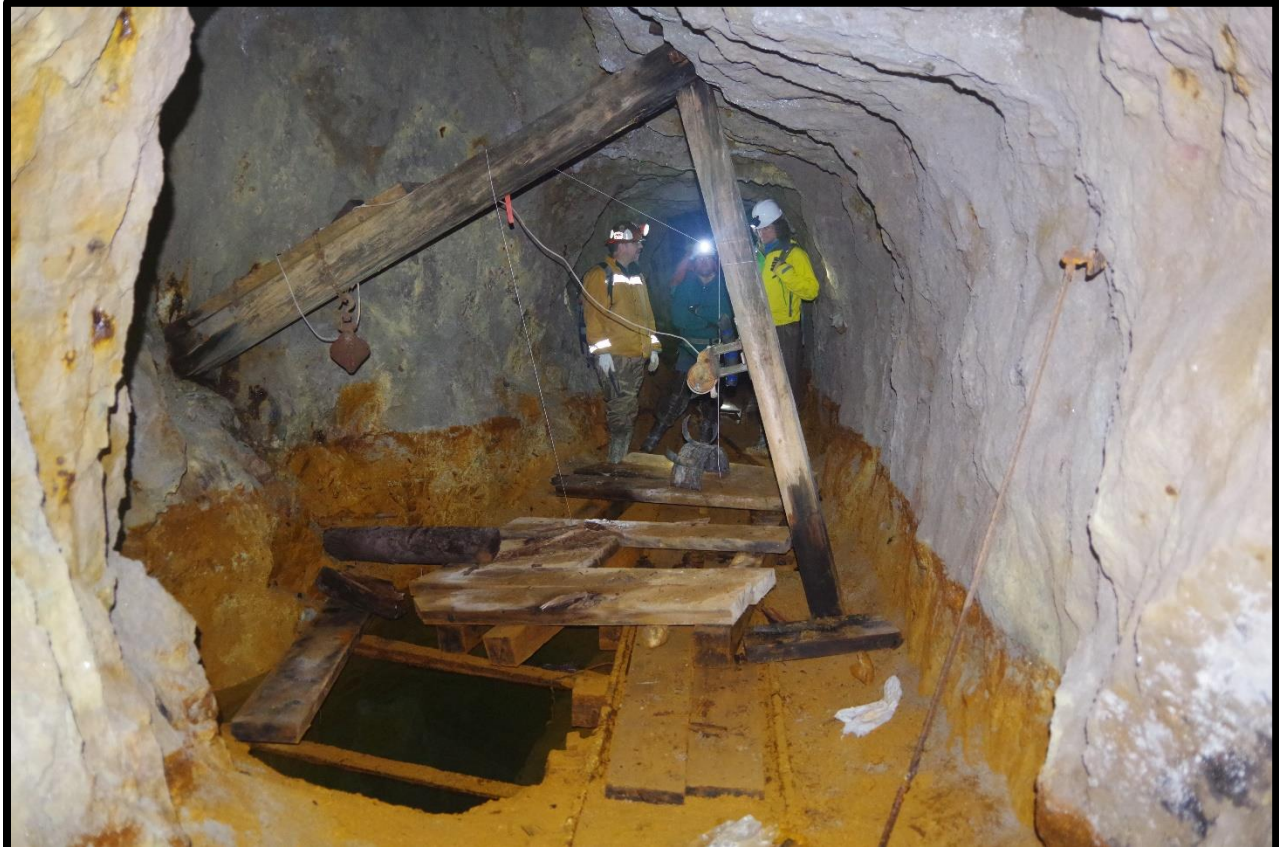
Photo 60: Del Monte Raise 53+15; Note sampling platform

The collar at the Del Monte Raise should have an elevated platform installed above the high water line to allow safe and efficient sampling without hindering the flow of the mine pool. This platform would also be made of FRP or similar material.

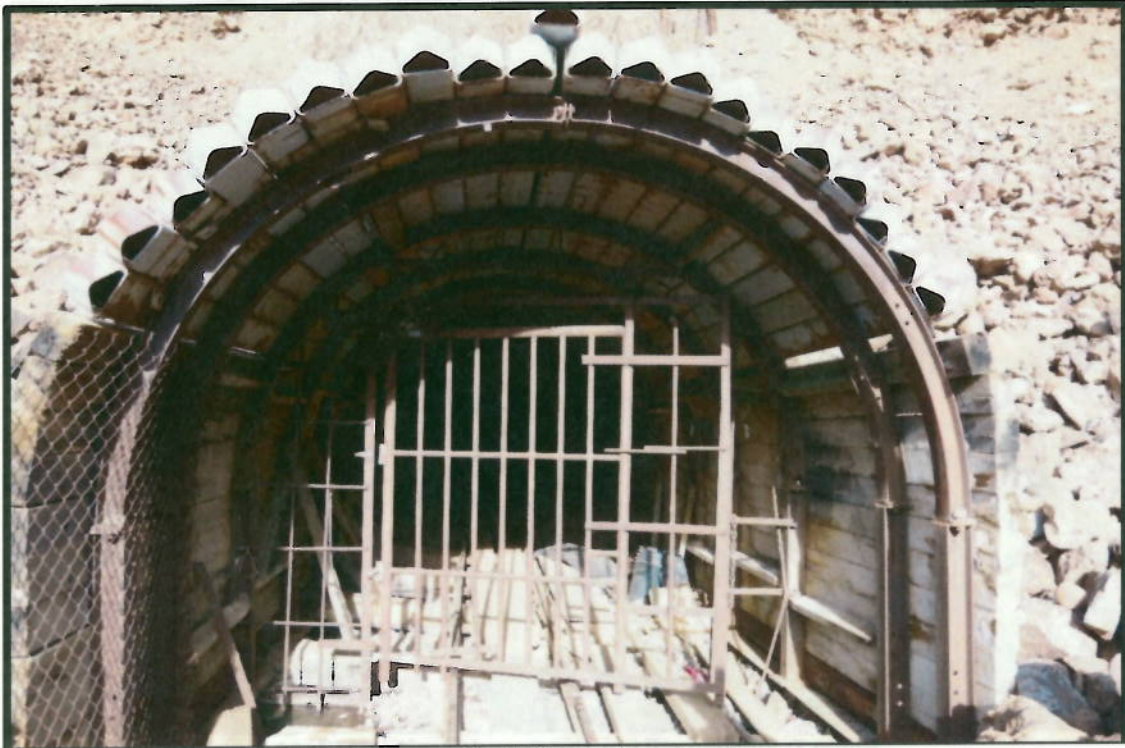
Photo 5: Portal Gate to be replaced

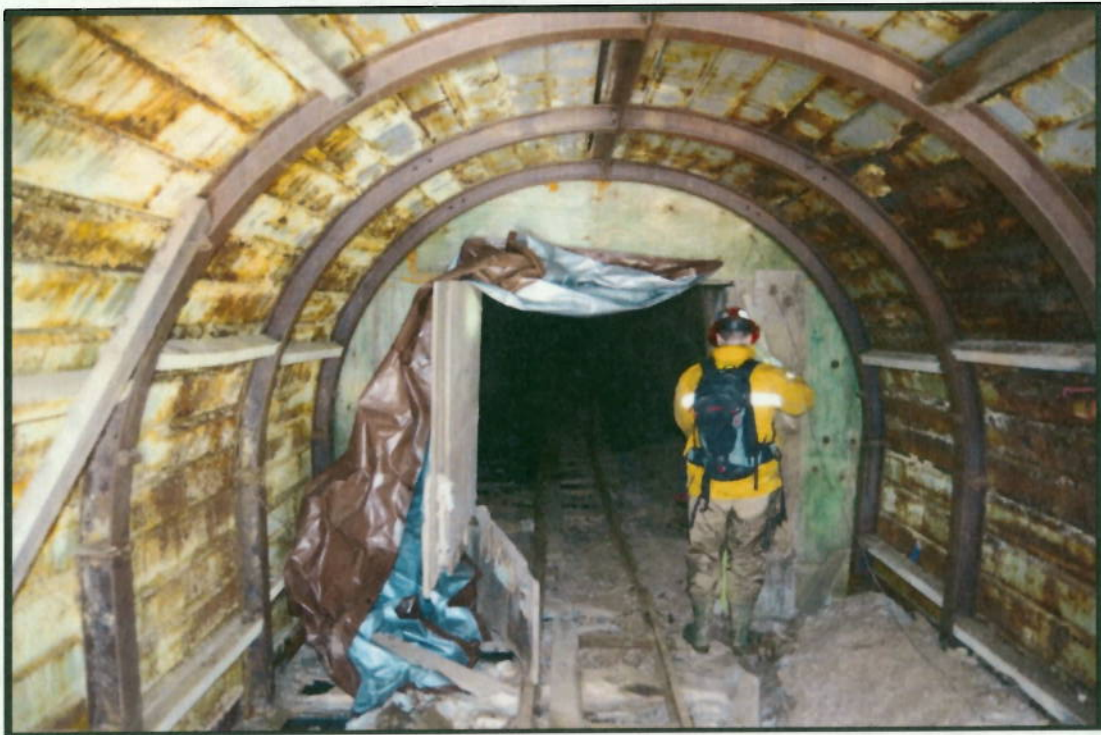
Photo 6: First Air Door to be replaced

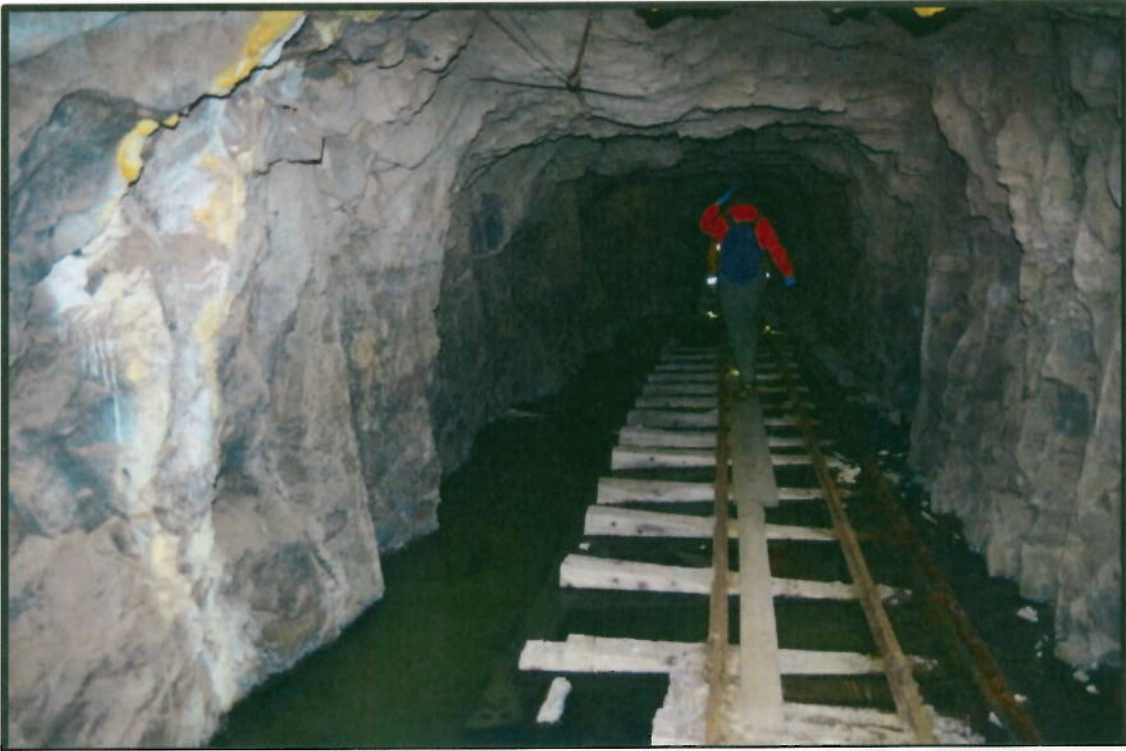
**Photo 7: Floating rail ties and poor drainage near 1+00**

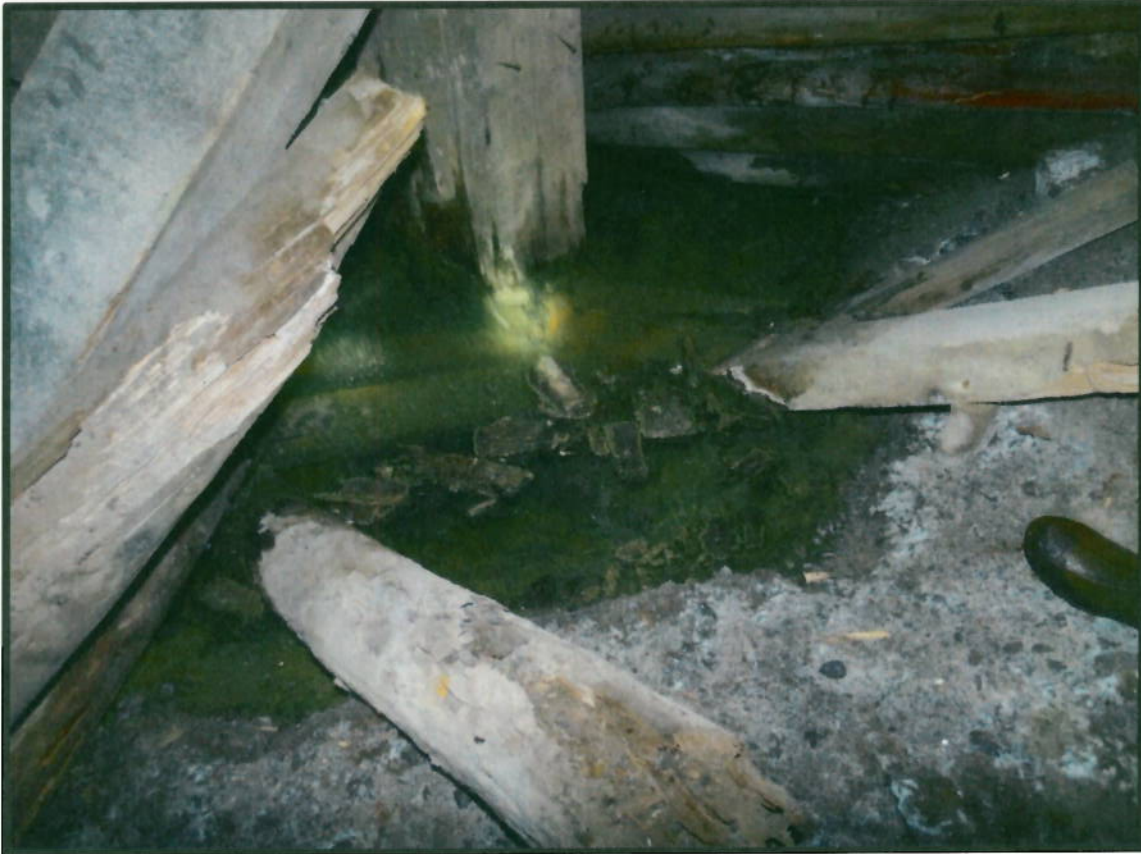
Photo 31: Collapsed Timbers at Bachelor Shaft Nelson Tunnel landing

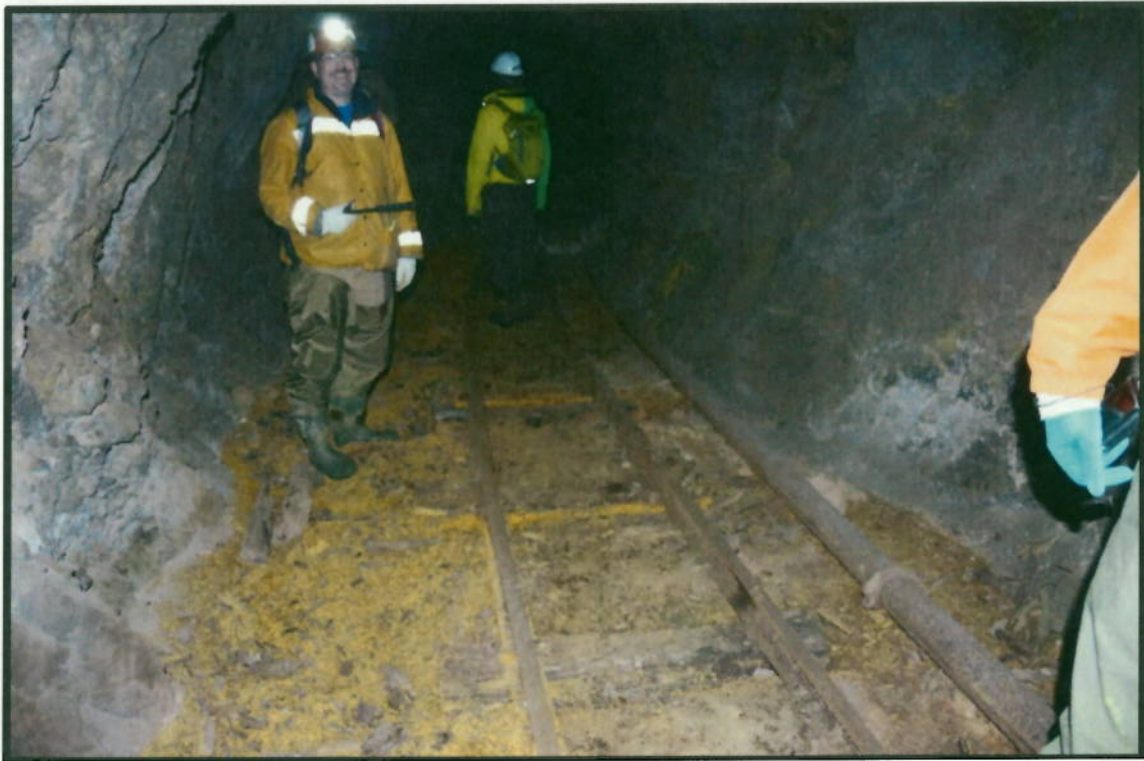
Photo 32: Decayed rail ties near 25+00; Note staining from water

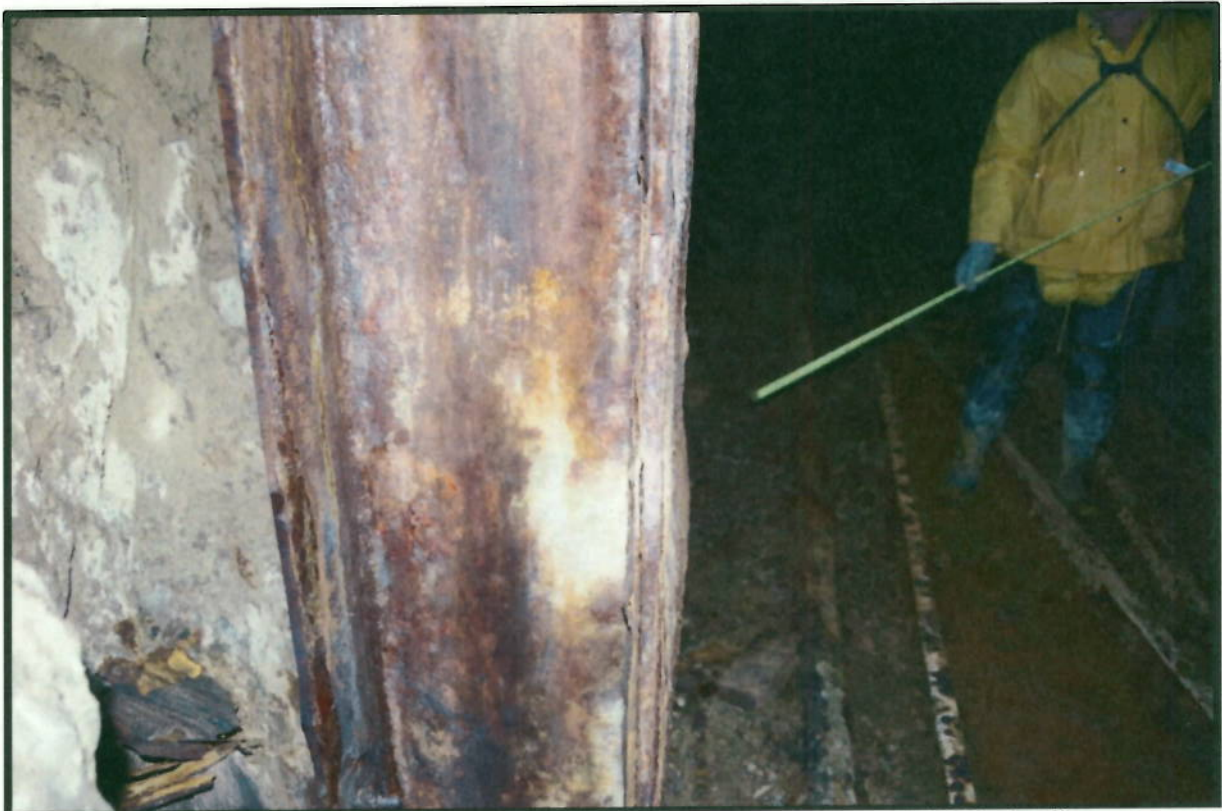
Photo 34: Close up of Archimedes Raise steel posts; Note corrosion and delamination

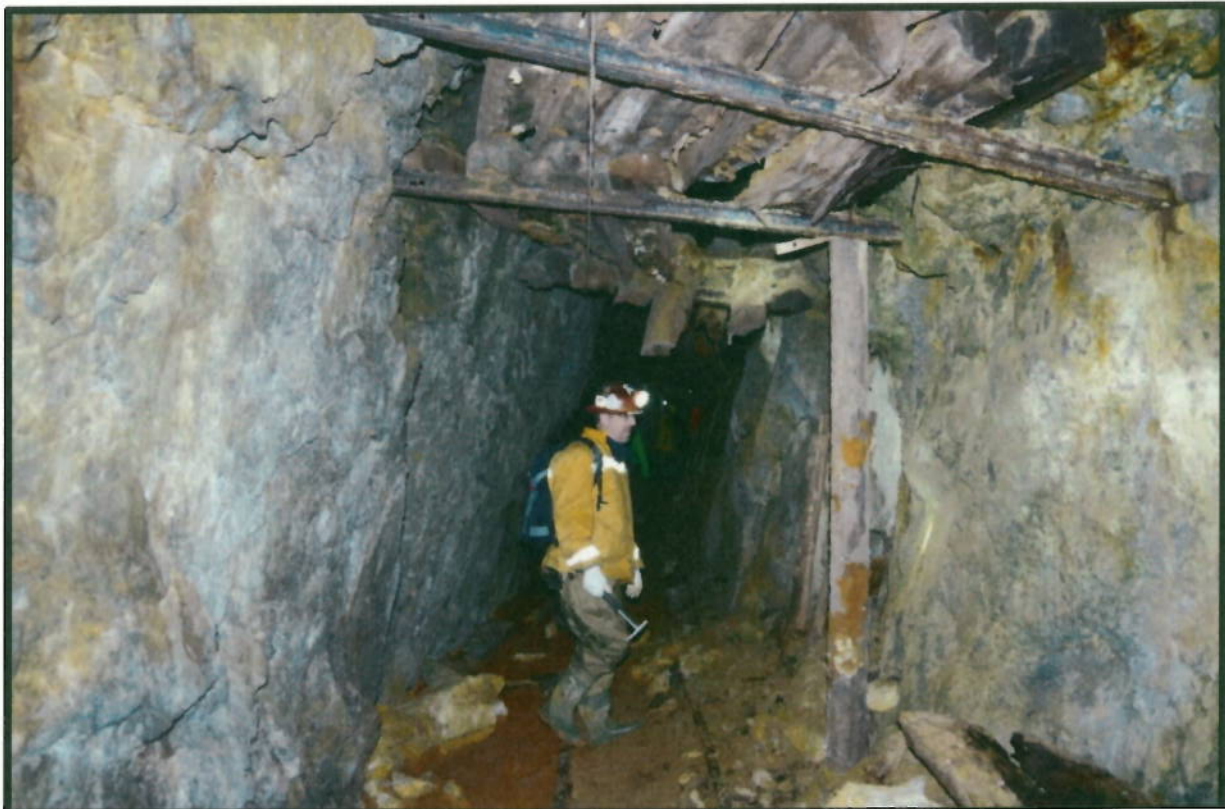
Photo 36: Steel rail stulls with rotten timber lagging 30+50

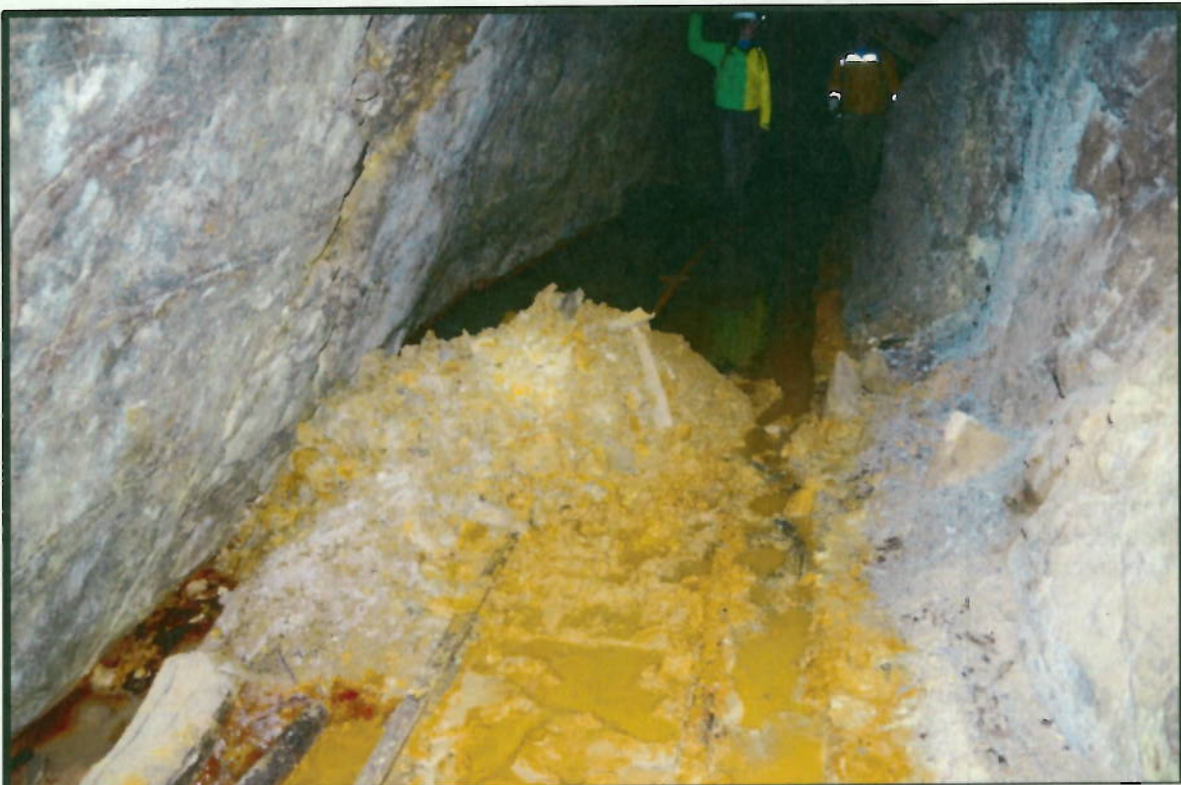
Photo 38: Debris from actively raveling raise near 32+00; Note water backed up behind

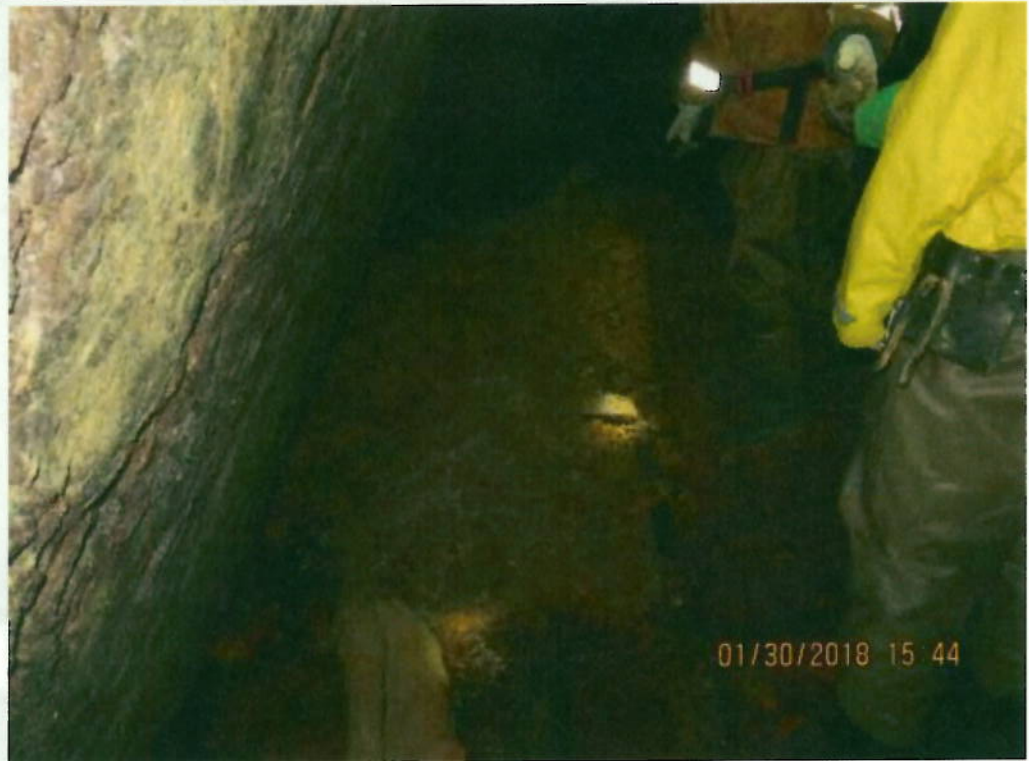
**Photo No.**  
**14**

Roof fall material in the tunnel. DRMS noted that this is fresh material since the last entry in November 2017.

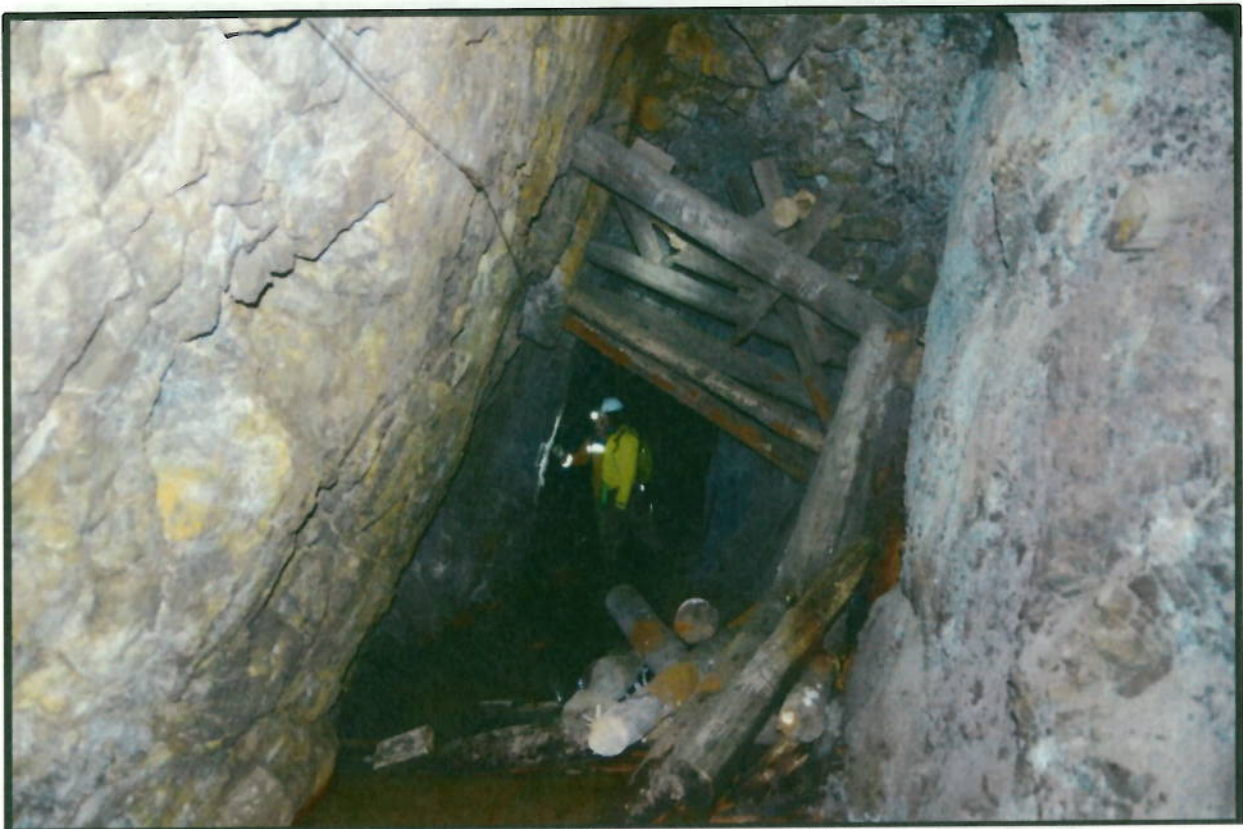
Photo 40: Failed timber stulls near 32+80
