**ACTION MEMORANDUM AMENDMENT 2**

**SUBJECT:** Request for a Ceiling and Scope Increase and Continued Exemption from the 12-month and \$2 million Statutory Limits for Removal Action at the Nelson Tunnel/Commodore Waste Rock Site in Mineral County, Colorado

Site ID# 08MB

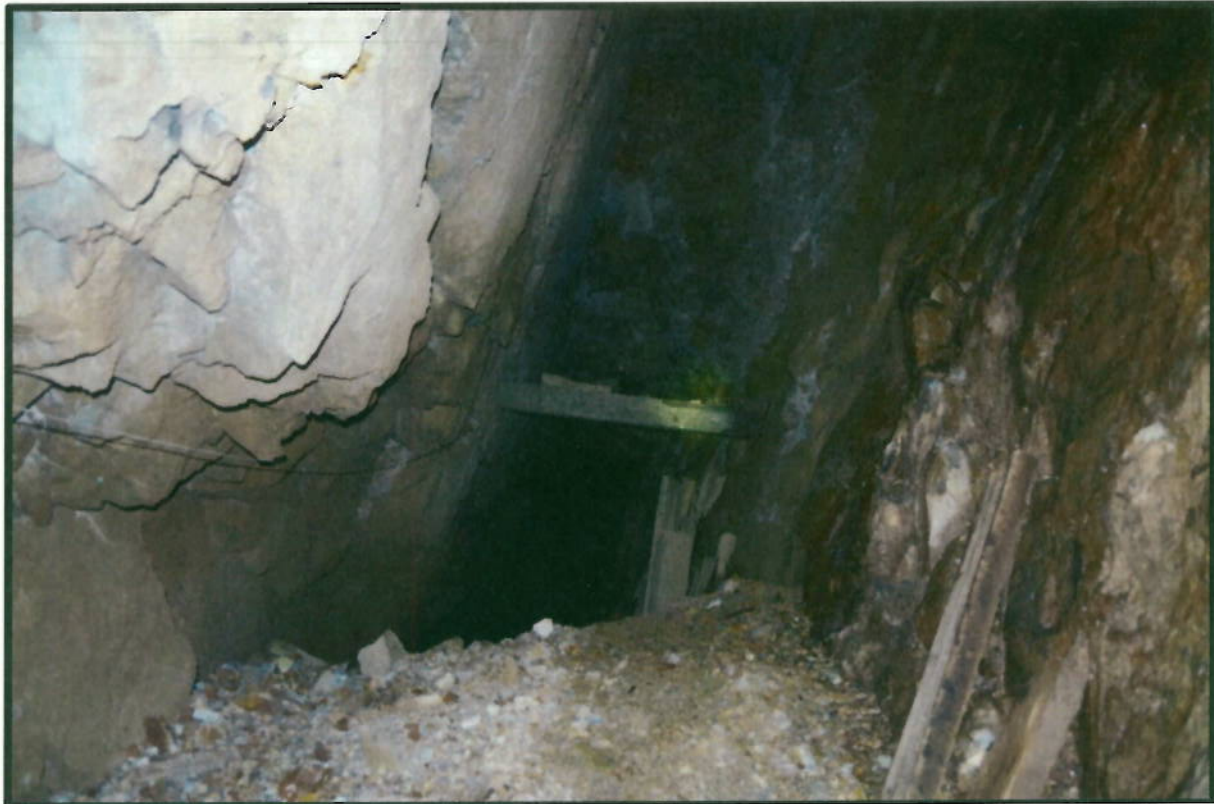
Photo 41: Debris pile at very active 44 Raise 36+82

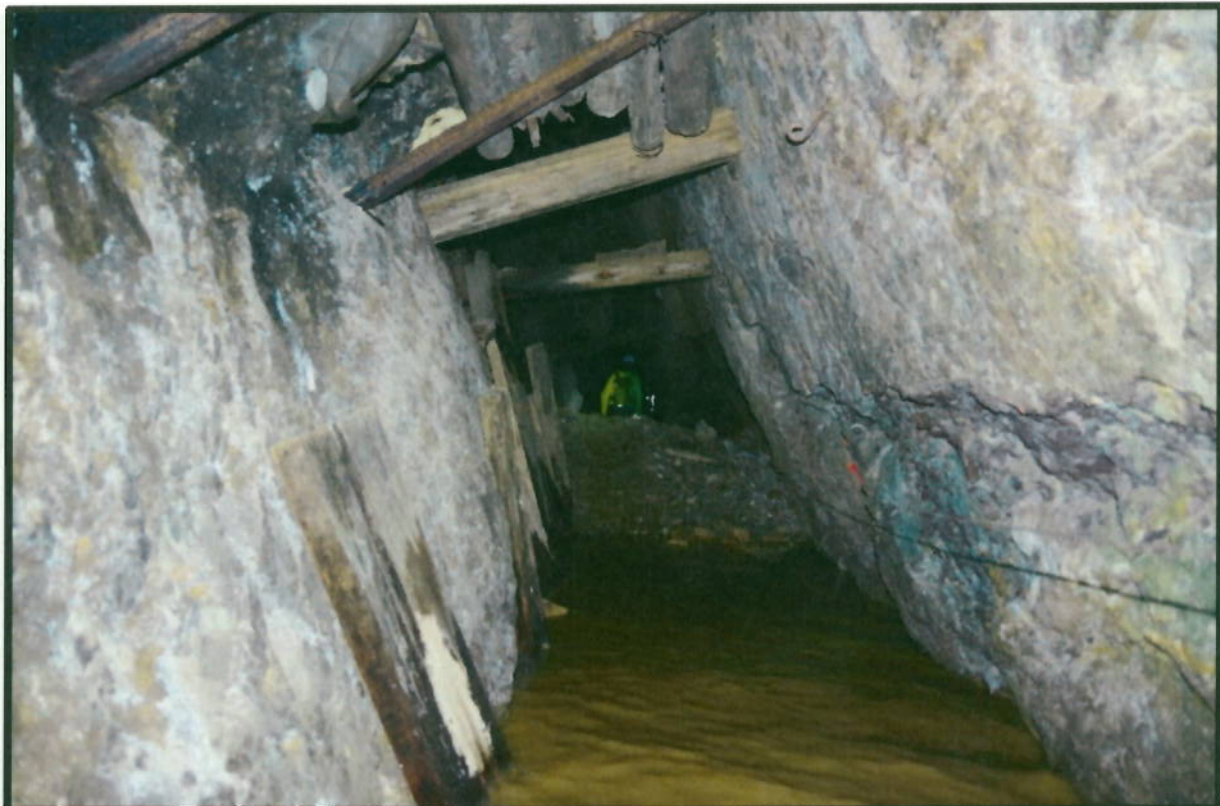
Photo 42: Debris pile at 44 Raise 36+82 looking outby; Note water ponded behind pile

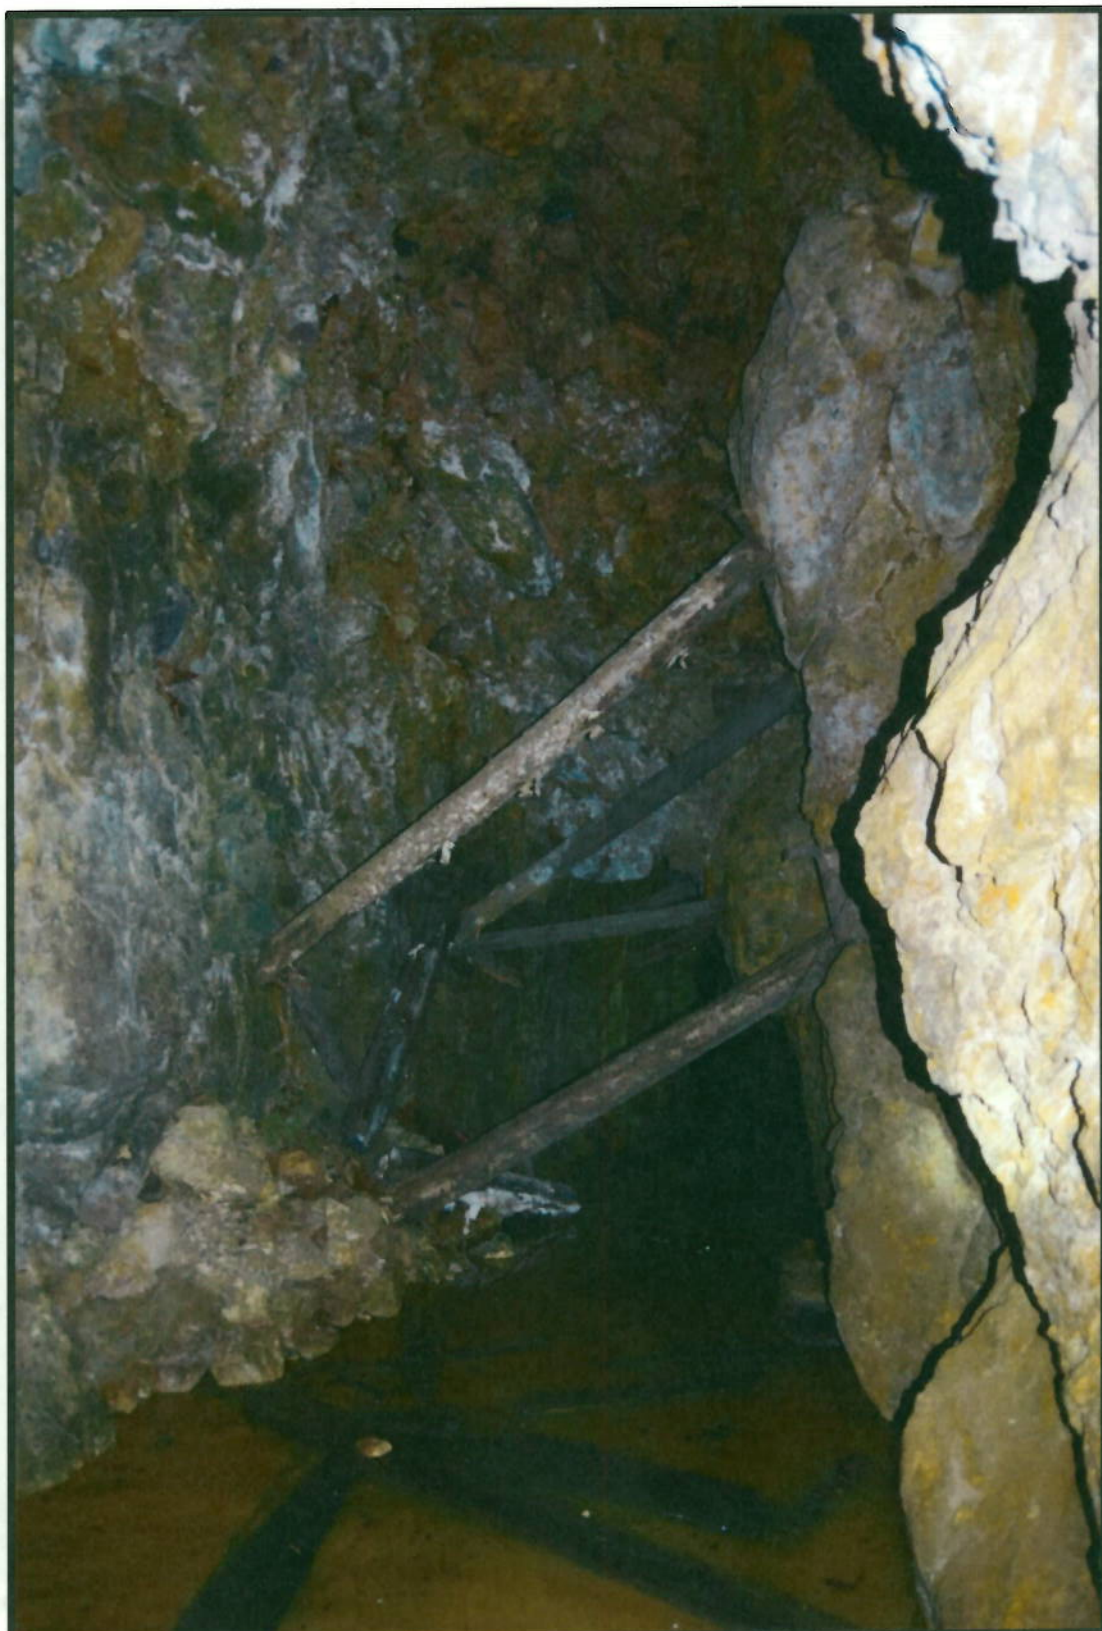
Photo 44: Large loose slabs in hanging wall near 38+10; View is outby

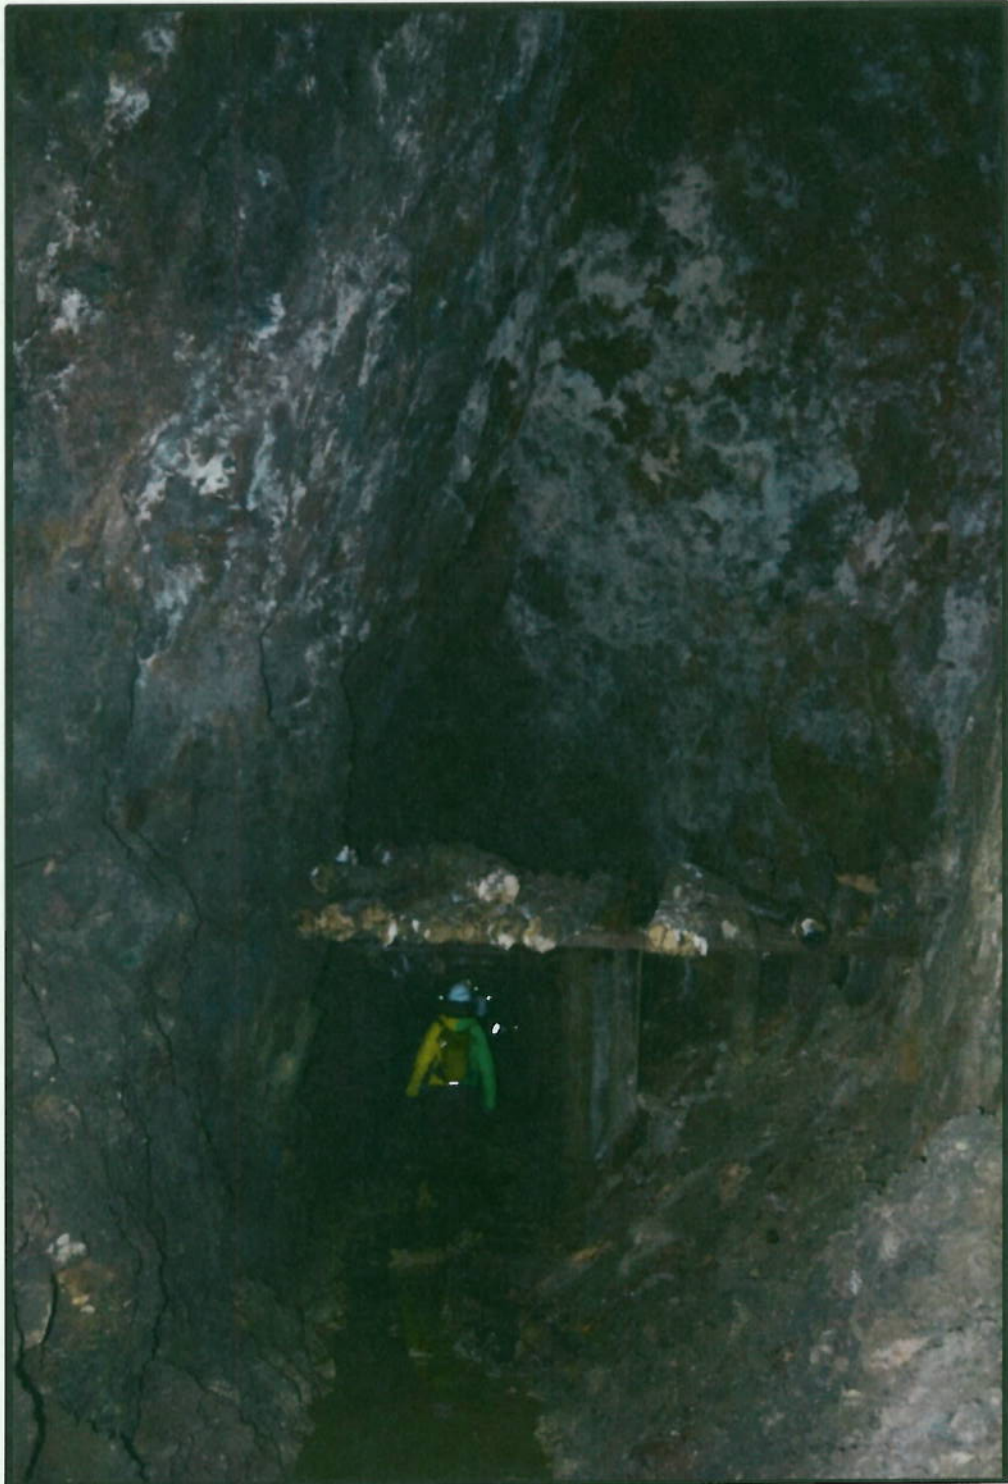
Photo 50: Cathedral near 43+50; Note loose muck in right rib and rotten timber lagging

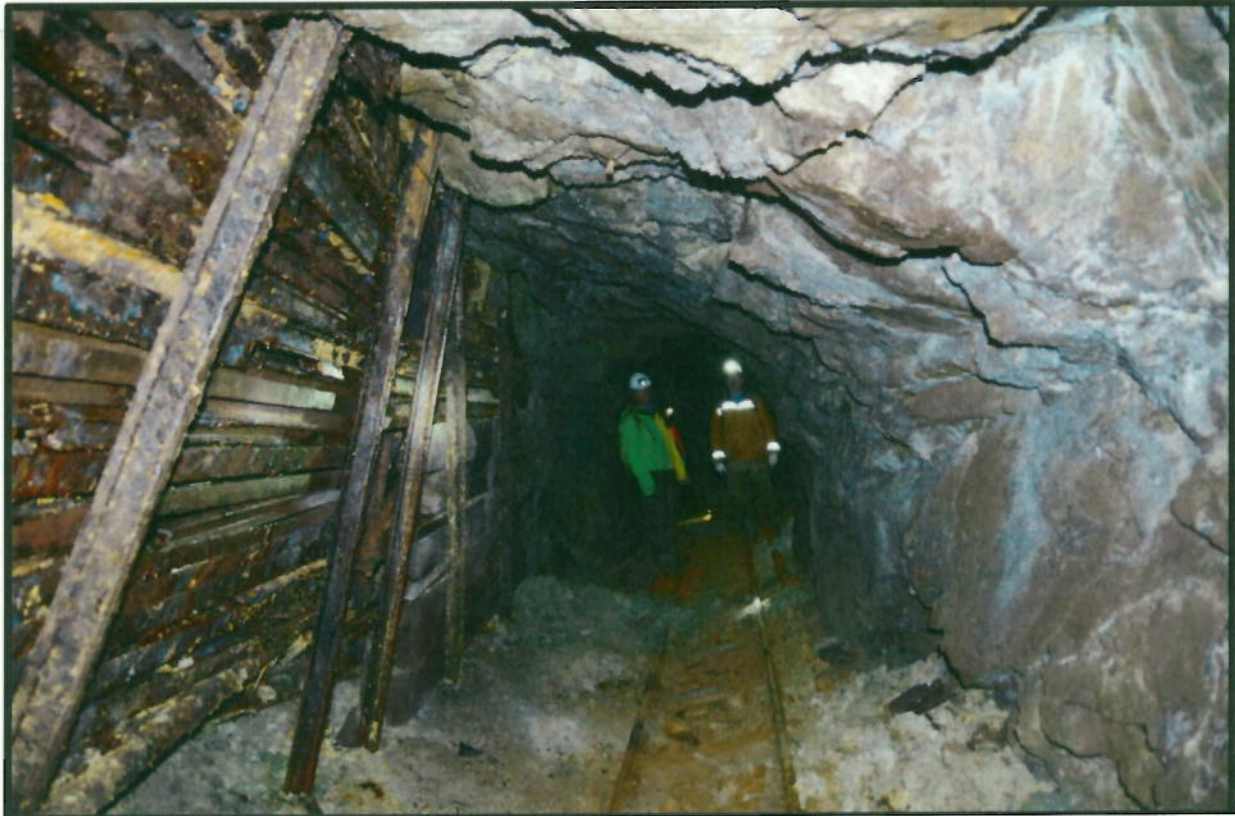
Photo 57: Area of clay gouge in left rib near 47+10; Note heavy steel rail lagging

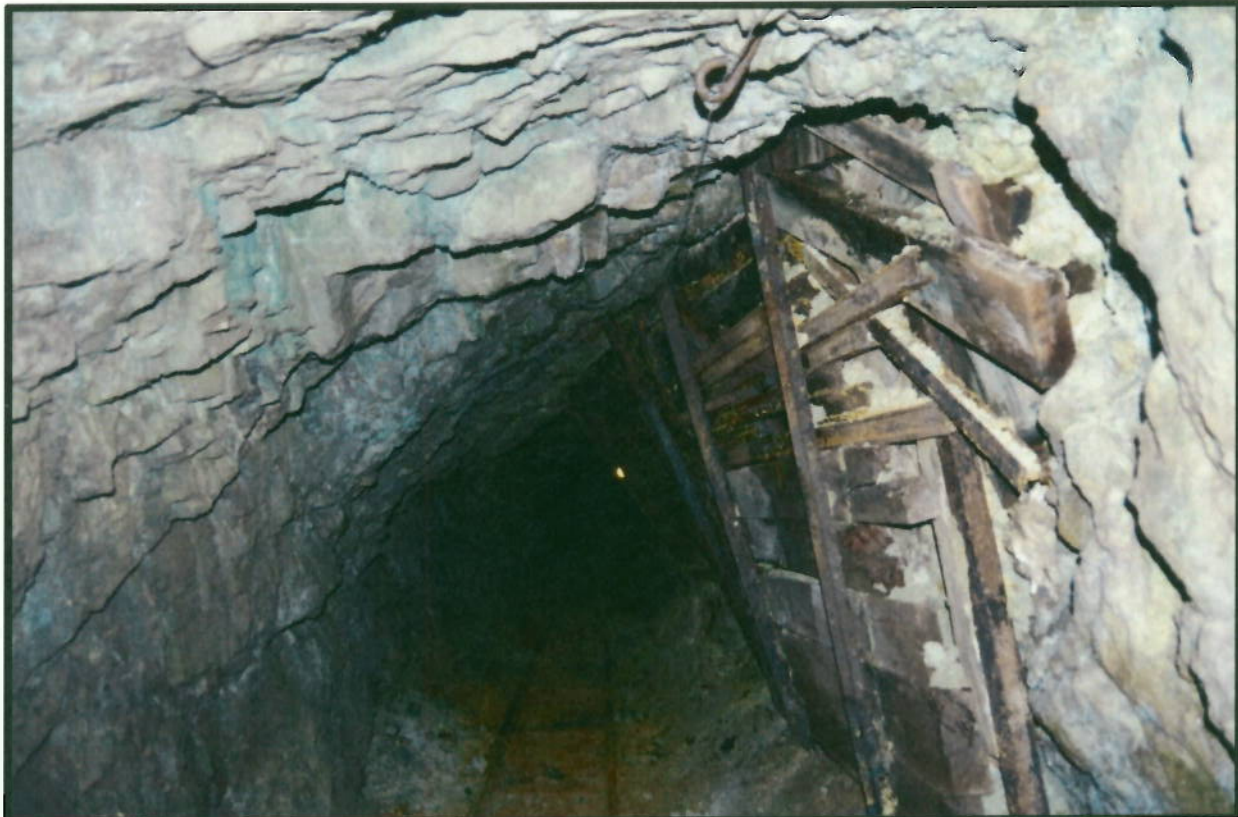
Photo 58: Area of clay gouge in left rib near 47+10 looking outby; Note timber lagging

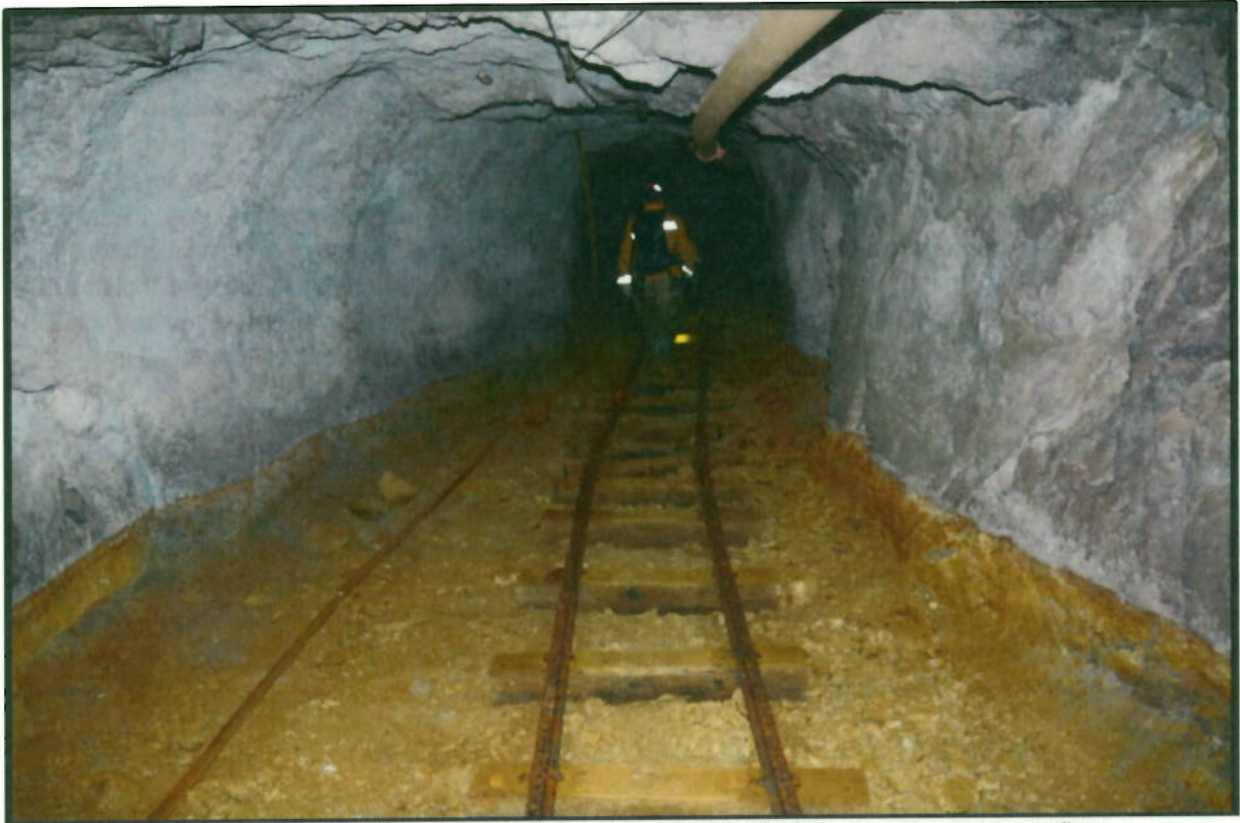
Photo 59: Typical draft near 50+00; Note high water line from upper mine pool overflow

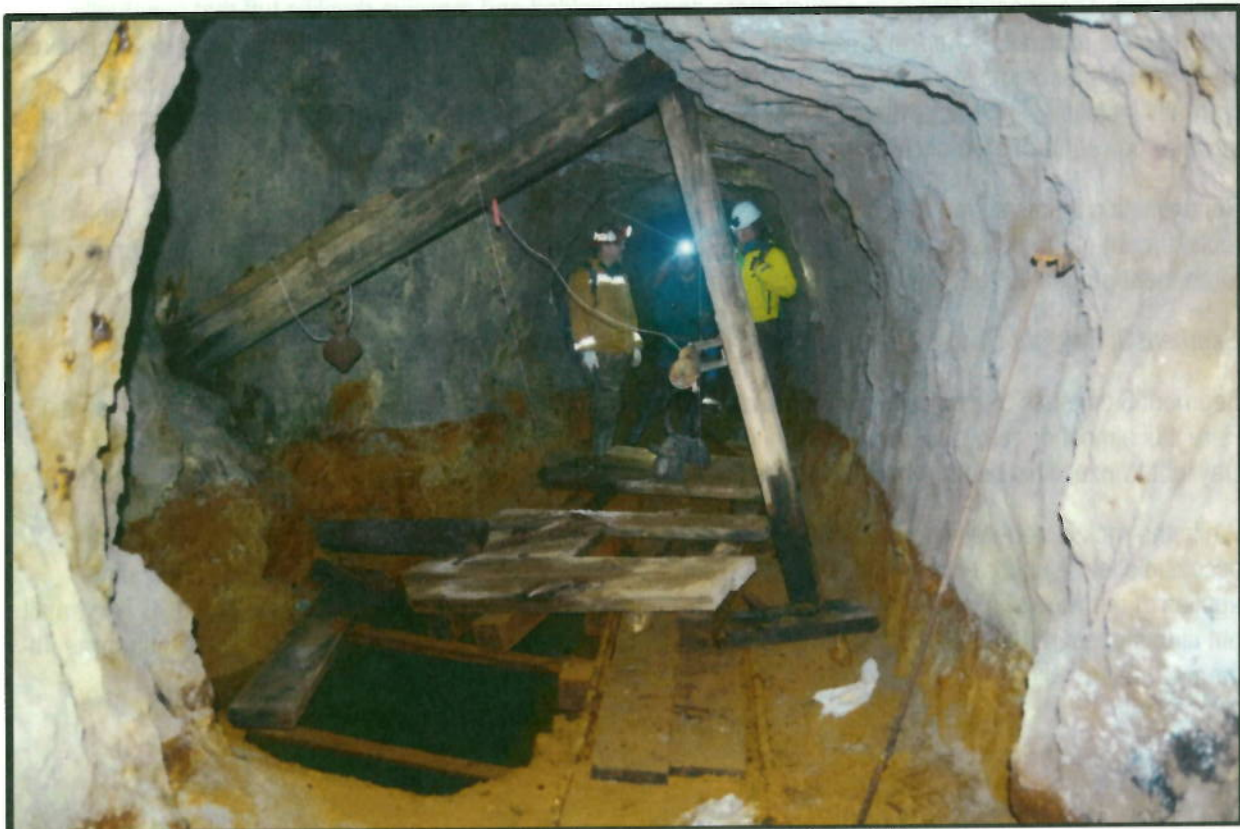
Photo 60: Del Monte Raise 53+15; Note sampling platform

The collar at the Del Monte Raise should have an elevated platform installed above the high water line to allow safe and efficient sampling without hindering the flow of the mine pool. This platform would also be made of FRP or similar material.
