# **TIME-CRITICAL REMOVAL ACTION REPORT**

*Onalaska Wood Pyrolysis  
Onalaska, Lewis County, Washington*

Prepared by:

December 2021

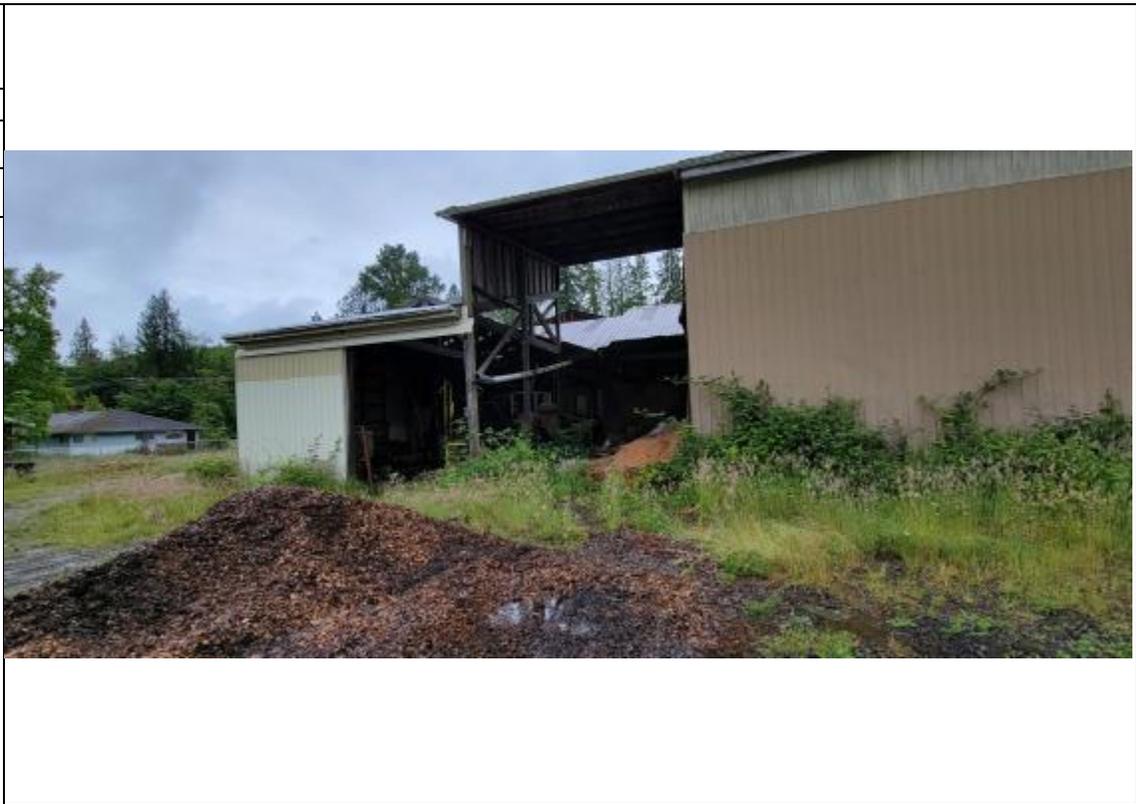
<b>Photo No.</b> <b>20</b>	<b>Date:</b> 06/14/2021
<b>Photo Coordinates</b>	
<b>Lat</b>	46.57193
<b>Long</b>	-122.729974
<b>Direction Photo Taken:</b> <b>NE</b>	
<b>Description:</b>  South Warehouse TG02 Tote Area exposed at center. Dry Kiln Building in the background.

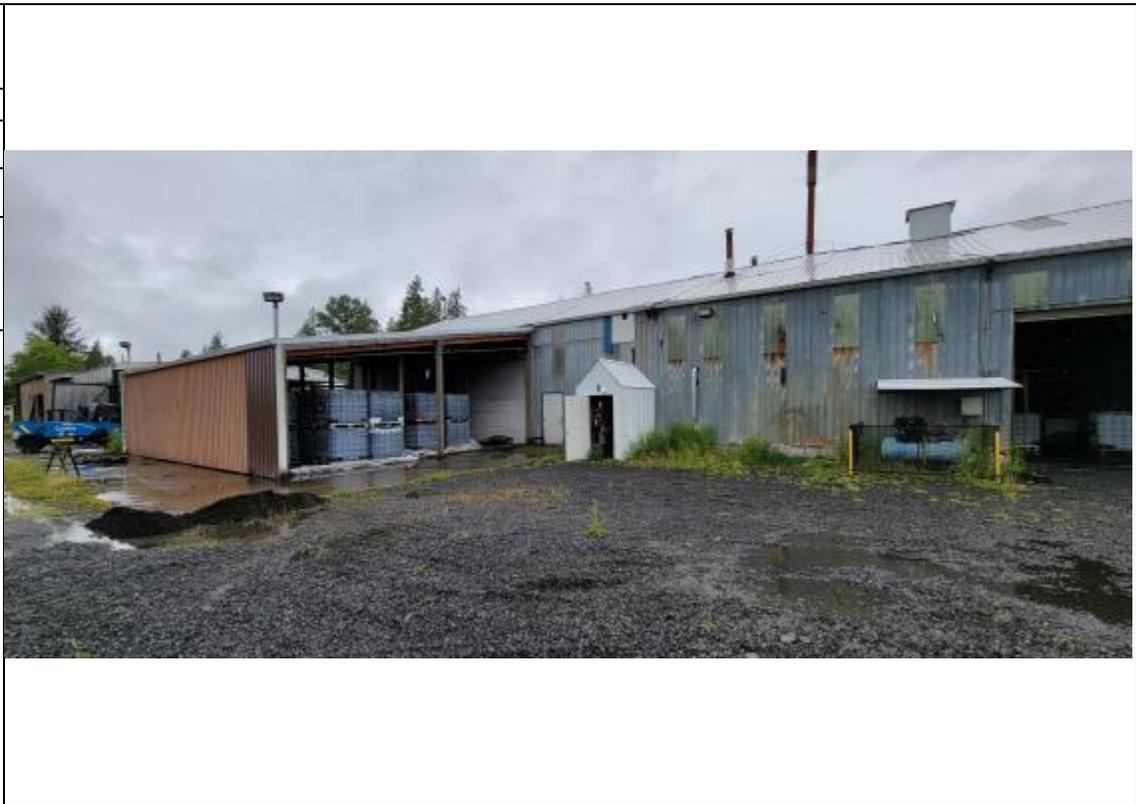
<b>Photo No.</b> <b>42</b>	<b>Date:</b> 06/14/2021
<b>Photo Coordinates</b>	
<b>Lat</b>	46.572092
<b>Long</b>	-122.728898
<b>Direction Photo Taken:</b> <b>N</b>	
<b>Description:</b>  Exposed interior seen through the south door of the Pyrolysis Building. Two totes located at center. Tank Farm located in the Secondary Containment Area at right.

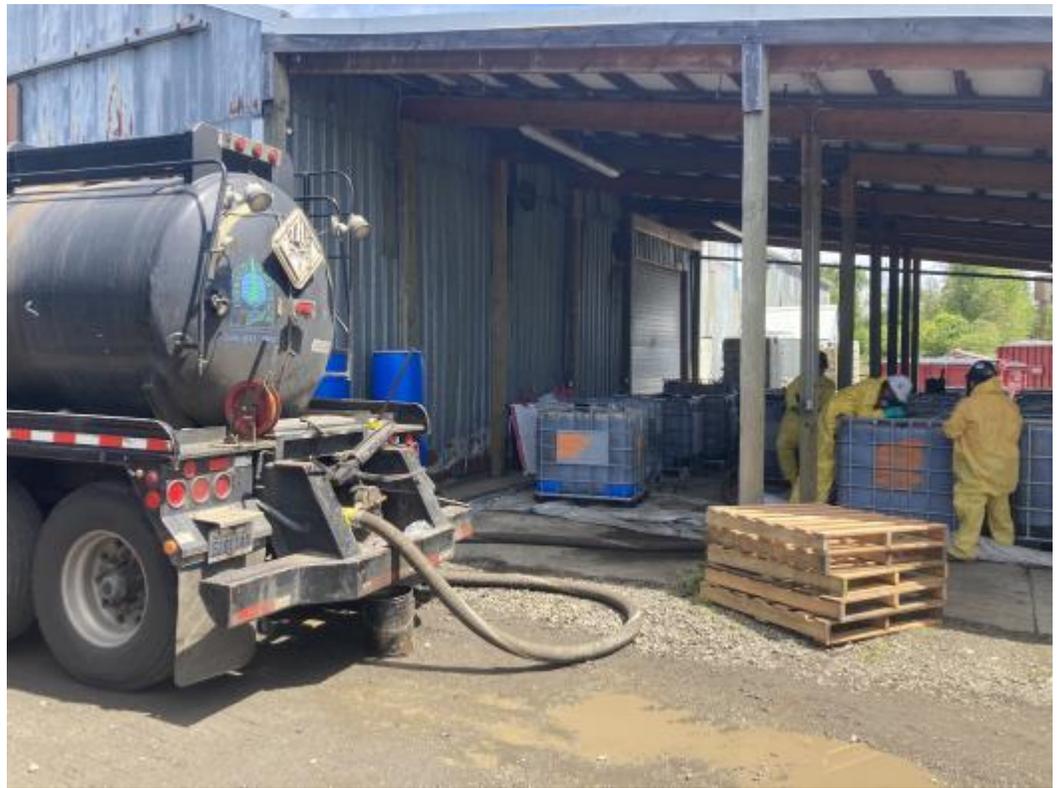
<b>Photo No.</b> <b>94</b>	<b>Date:</b> 06/16/2021
<b>Photo Coordinates</b>	
<b>Lat</b>	46.572381
<b>Long</b>	-122.728911
<b>Direction Photo Taken:</b> <b>SE</b>	
<b>Description:</b>  ERRS contractors cutting up empty totes and scraping settled material from the bottom panels.

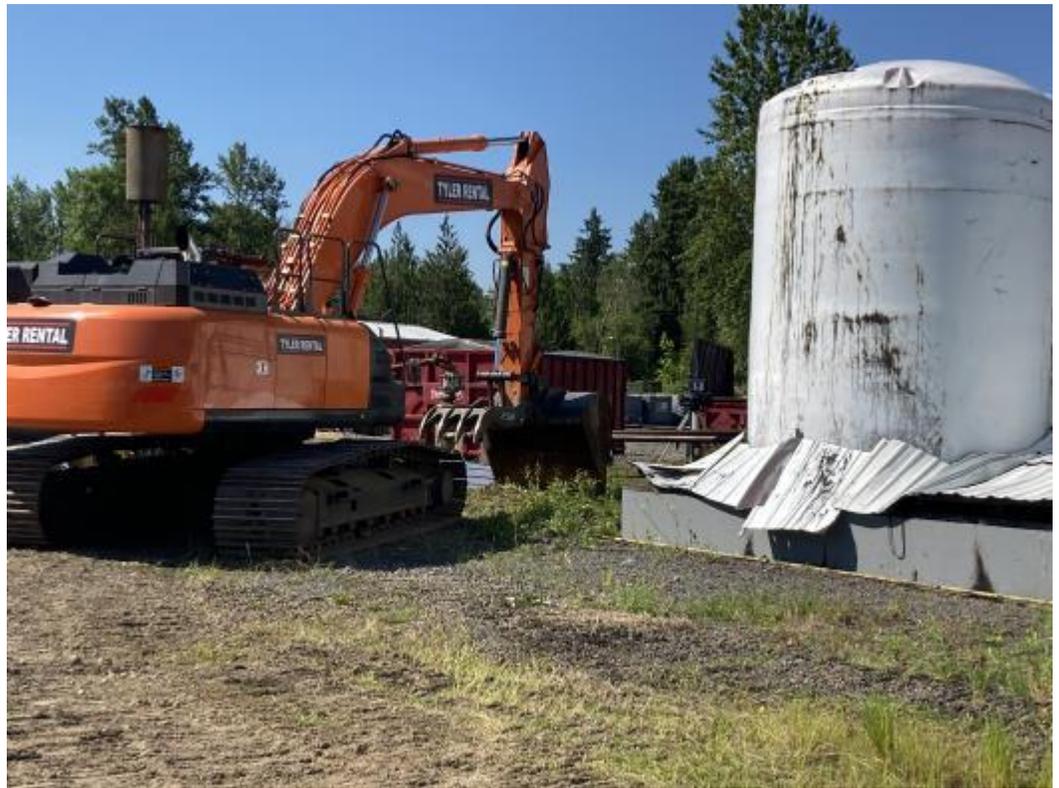
<b>Photo No.</b> <b>118</b>	<b>Date:</b> 06/21/2021
<b>Photo Coordinates</b>	
<b>Lat</b>	46.572505
<b>Long</b>	-122.728657
<b>Direction Photo Taken:</b> <b>N</b>	
<b>Description:</b>  Uncovered Secondary Containment Area reveals debris.

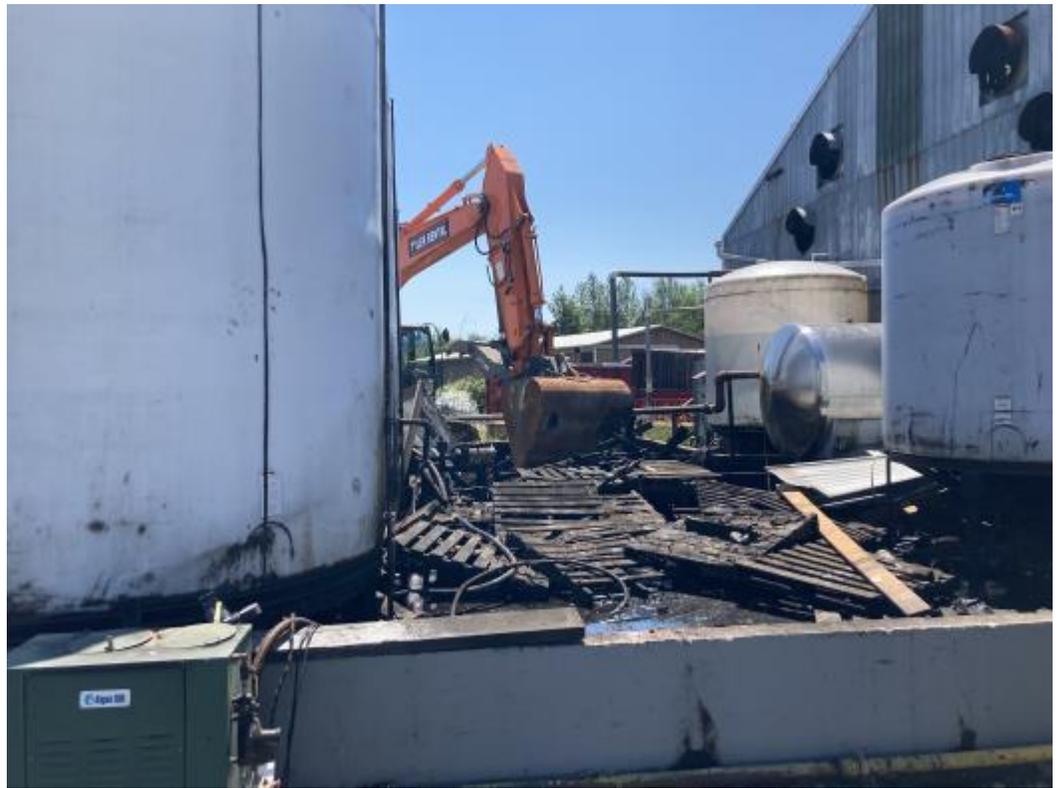
<b>Photo No.</b> <b>128</b>	<b>Date:</b> 06/21/2021
<b>Photo Coordinates</b>	
<b>Lat</b>	46.572464
<b>Long</b>	-122.728522
<b>Direction Photo Taken:</b> <b>N</b>	
<b>Description:</b>  Debris being removed from the Secondary Containment Area.

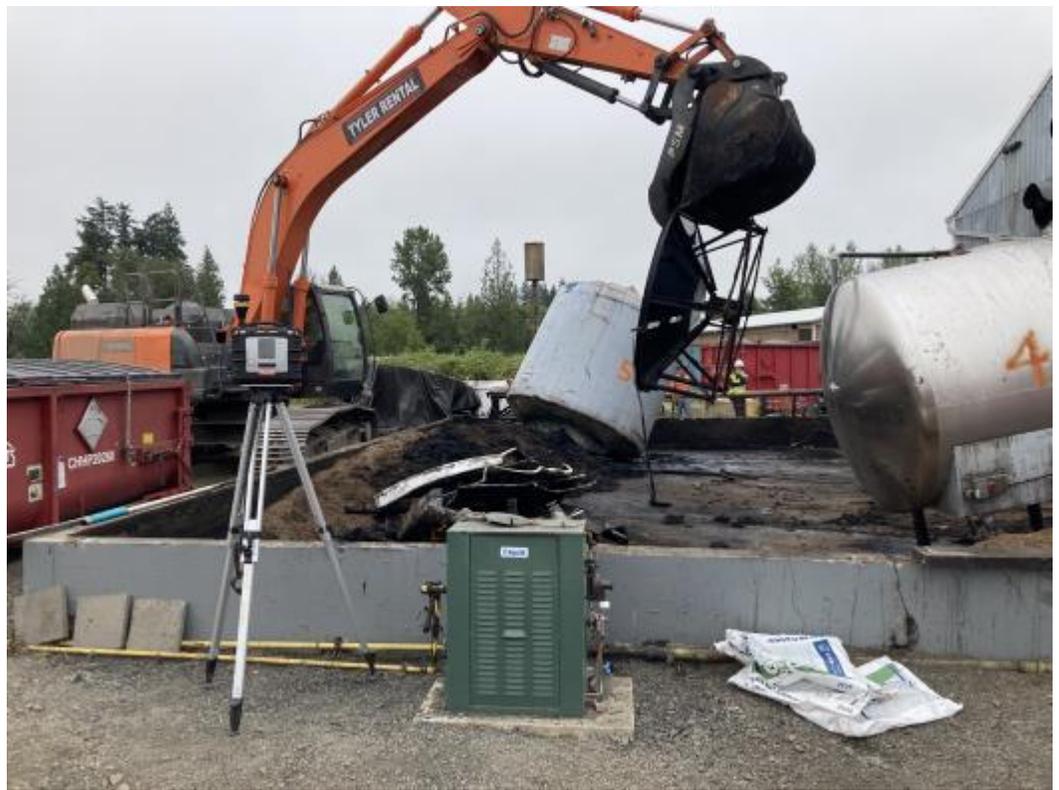
<b>Photo No.</b> <b>250</b>	<b>Date:</b> 07/13/2021
<b>Photo Coordinates</b>	
<b>Lat</b>	46.572578
<b>Long</b>	-122.728806
<b>Direction Photo Taken:</b> <b>SE</b>	
<b>Description:</b>  Excavator demolishing AST5.

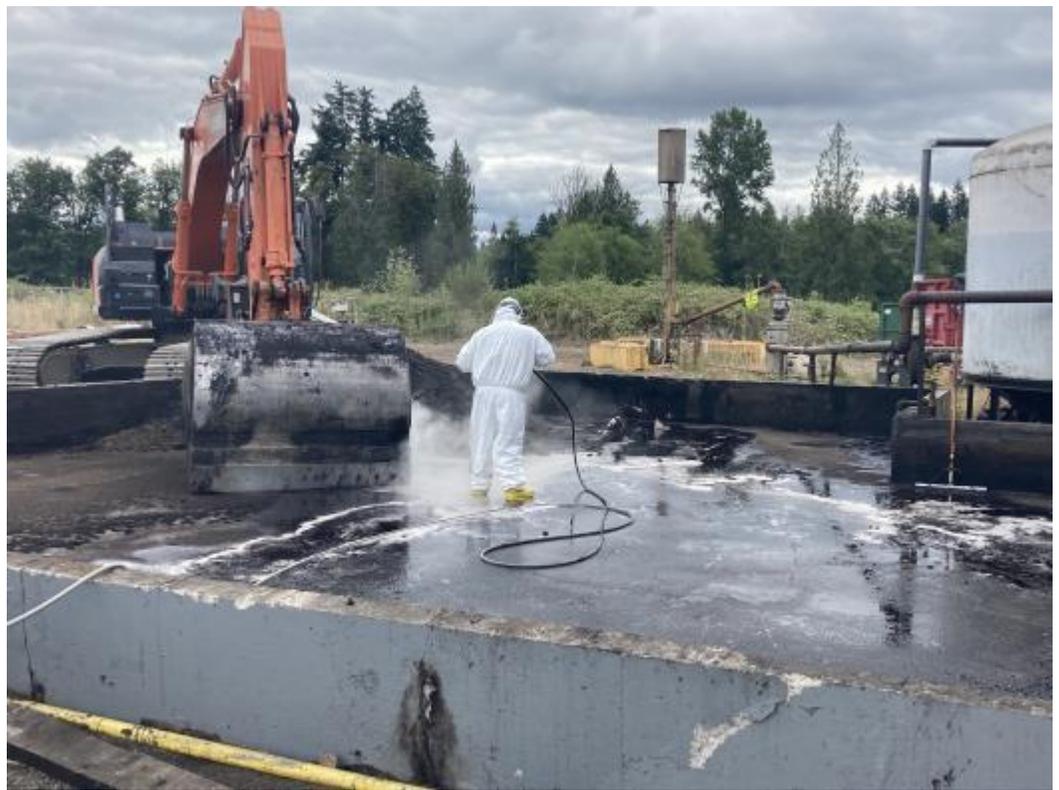
<b>Photo No.</b> <b>298</b>	<b>Date:</b> 07/21/2021
<b>Photo Coordinates</b>	
<b>Lat</b>	46.572578
<b>Long</b>	-122.728806
<b>Direction Photo Taken:</b> <b>E</b>	
<b>Description:</b>  ERRS contractor power washing the Secondary Containment Area.

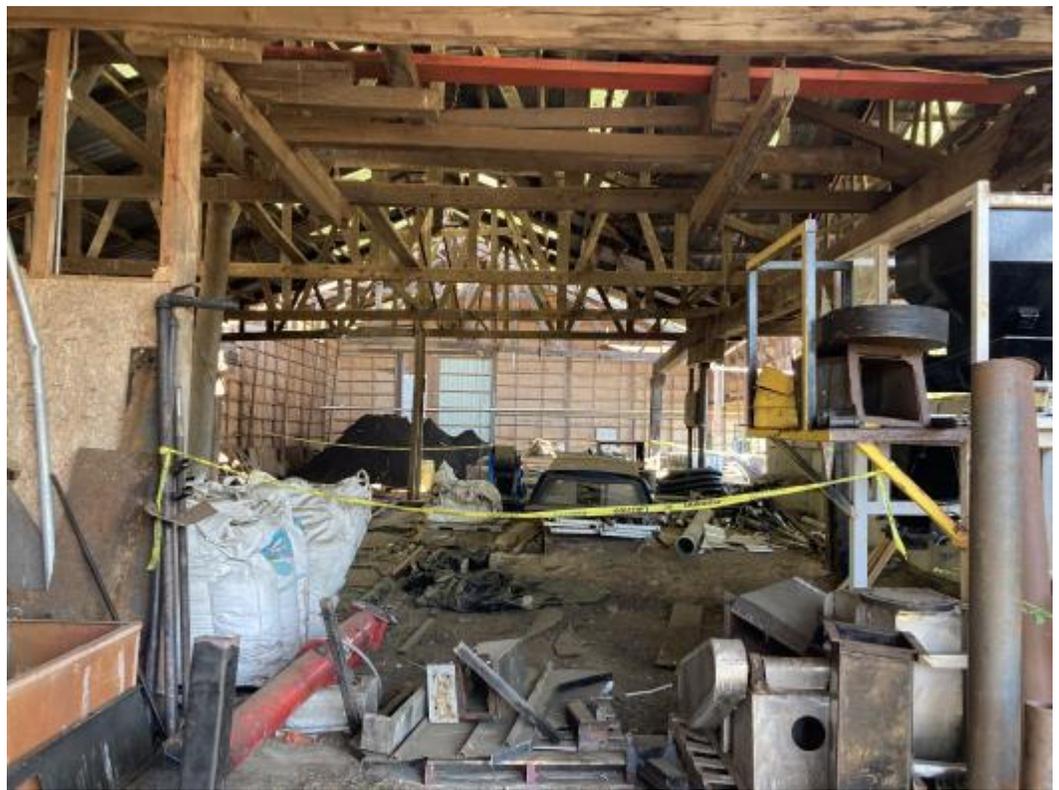
<b>Photo No.</b> <b>386</b>	<b>Date:</b> 07/29/2021
<b>Photo Coordinates</b>	
<b>Lat</b>	46.572047
<b>Long</b>	-122.730064
<b>Direction Photo Taken:</b> <b>N</b>	
<b>Description:</b>  Final site walk. Exposed back area of the condemned warehouse area. Abandoned pallets are at left.
