Broadway Hotel

Photo Category: Admin Record

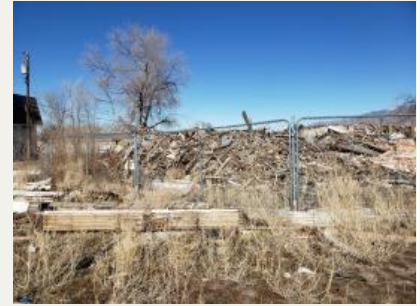
Description: Debris pile of the former Broadway Hotel. Temporary fencing has been placed to deter trespassing but has been inadequate. Debris and friable asbestos containing materials are open to the air and environment. Facing east to showcase extent of debris pile.

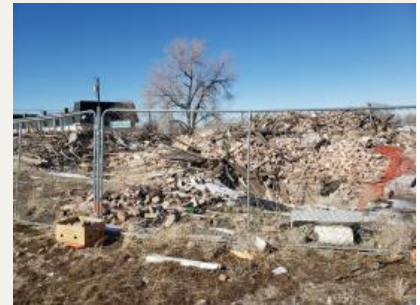
Description: Debris pile of the former Broadway Hotel. Temporary fencing has been placed to deter trespassing but has been inadequate. Debris and friable asbestos containing materials are open to the air and environment. Facing northwest to showcase extent of debris pile.

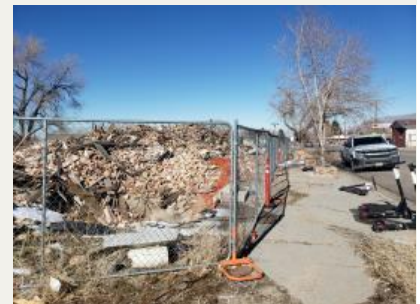
Description: Debris pile of the former Broadway Hotel. Temporary fencing has been placed to deter trespassing but has been inadequate. Debris and friable asbestos containing materials are open to the air and environment. Facing north to showcase extent of debris pile and proximity to public walkways.

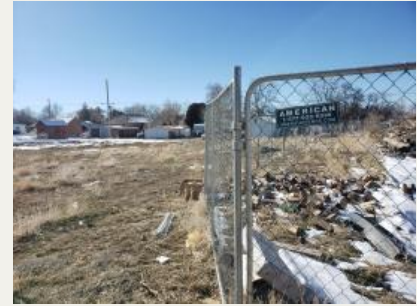
Description: Debris pile of the former Broadway Hotel. Temporary fencing has been placed to deter trespassing but has been inadequate. Debris and friable asbestos containing materials are open to the air and environment. Facing west to showcase extent of debris pile.

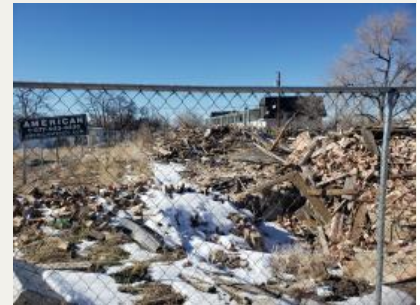
Description: Debris pile of the former Broadway Hotel. Temporary fencing has been placed to deter trespassing but has been inadequate. Debris and friable asbestos containing materials are open to the air and environment. Facing south to showcase extent of debris pile.
