September 17, 2019

RE: P19-0459 ASBESTOS BULK SAMPLE COLLECTION & ANALYSIS REPORT
FORMER MOTEL & IMPLEMENT DEALERSHIP
SOUTH MAIN STREET
SELFRIDGE, ND 58568

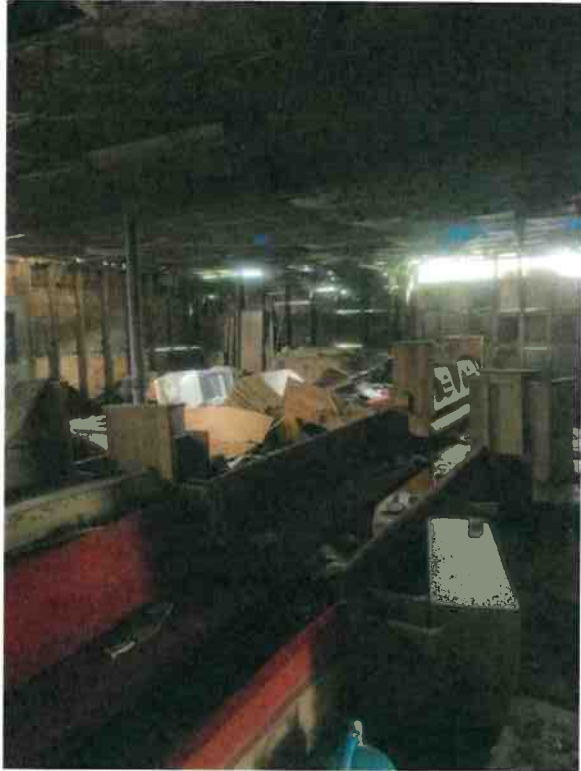
The gray plaster and tan stucco sample, which is located on the exterior and interior of the implement dealership, contain vermiculite in the matrix of the material. This material was in poor condition at the time of this assessment. Quantities for this material are unknown as half of the building is no longer standing. The structure is in extremely poor condition (See Attached Photos).

Photo 1- Implement Dealership- North and West facing walls

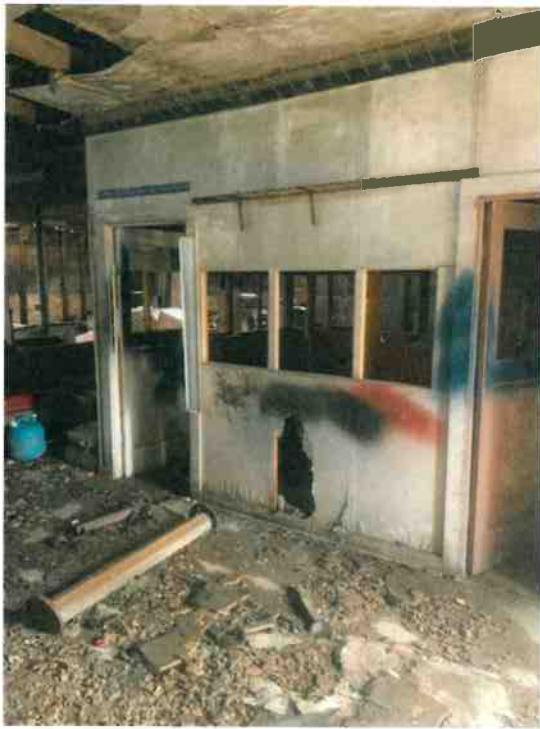
There was also some asbestos-containing sheetrock in the implement dealership located in the south office of the implement dealership. The sheetrock itself was in good condition at the time of this assessment, however the building itself is in extremely poor condition.

Photo 2- Implement Dealership- Office area- North office

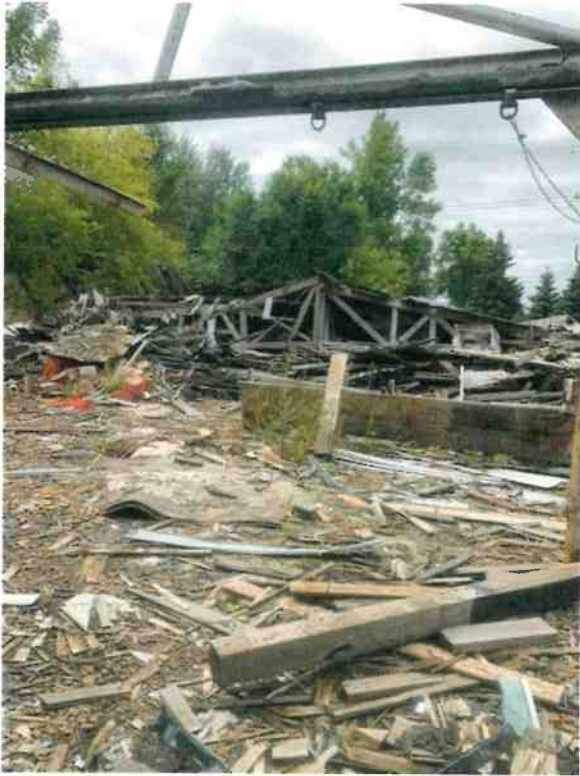
Photo 3- Implement Dealership- South end of the Property

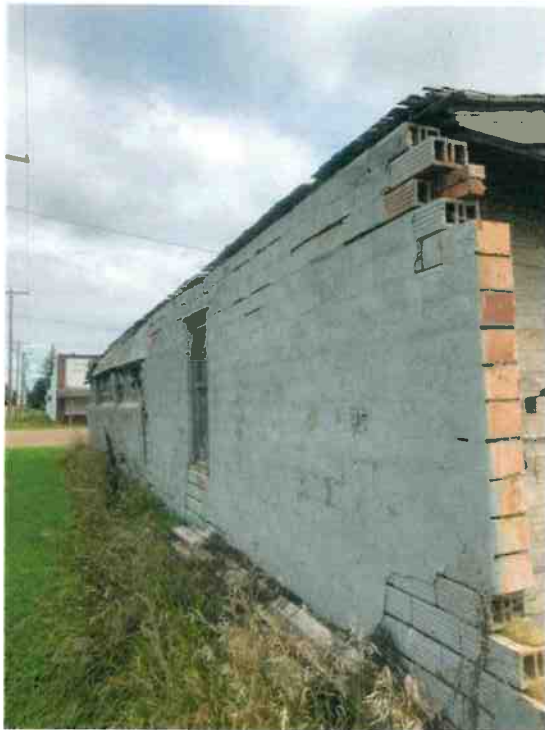
Photo 4- Implement Dealership- Exterior photo of the west side of the building

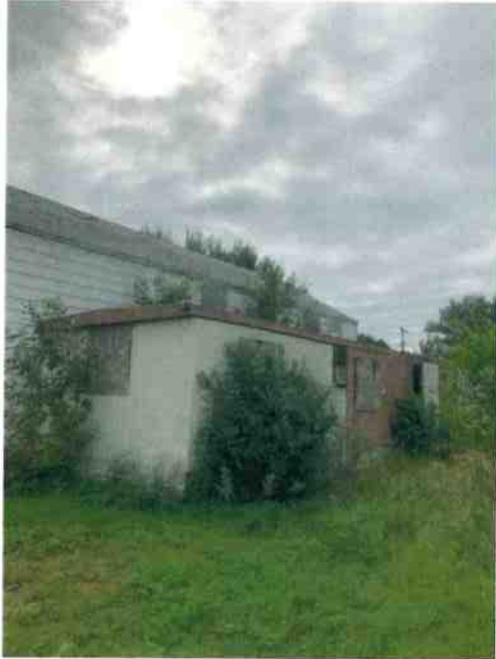
The asbestos-containing sink undercoating was located in a trailer house (north trailer), which was located to the west of the motel. The sink itself was in good condition during the time of this assessment.

The asbestos-containing green floor tile and brown linoleum were located in the bathroom of the north trailer. These materials were in poor condition at the time of this assessment.

Photo 5- North Trailer- Located to the west of the motel.

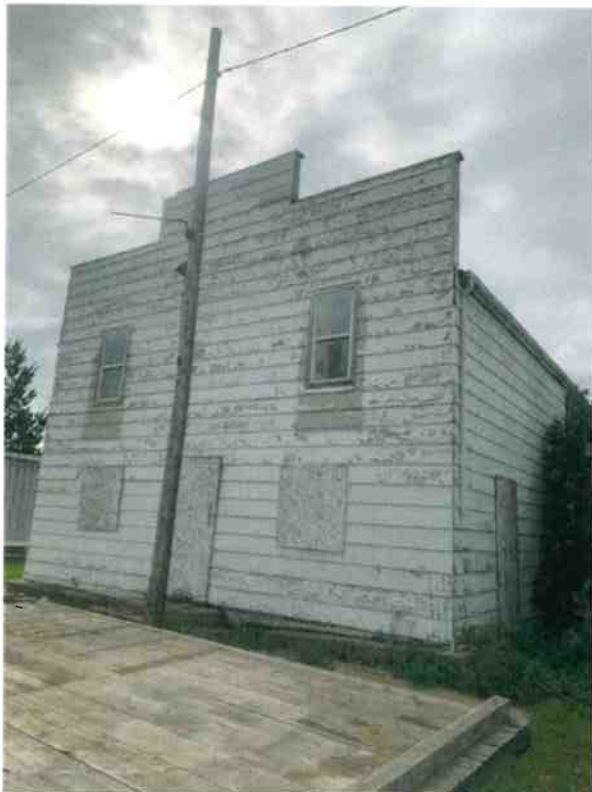
Photo 6- Exterior of the motel- North End

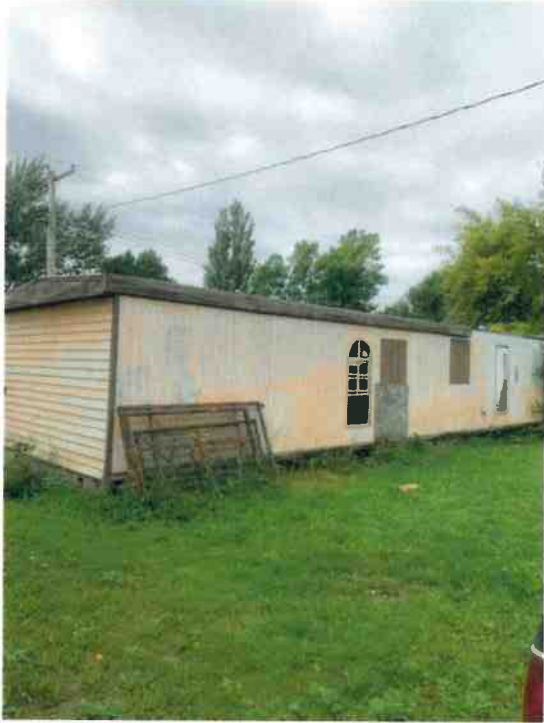
Most of the materials that were surveyed at the time of this assessment were in poor condition, delaminating and falling apart. The implement dealership and the south trailer were not structurally sound. There were two other buildings that the City of Selfridge wanted assessed, however we determined that these structures were unsafe to enter. The first location was located at 79 N. Main Street., this property was unsafe because most of The main level floor had collapsed . The other property was located at 69 N. Main. The supporting wall was almost completely caved in (See Attached Photos).

Photo 7- South Trailer- South of the Motel

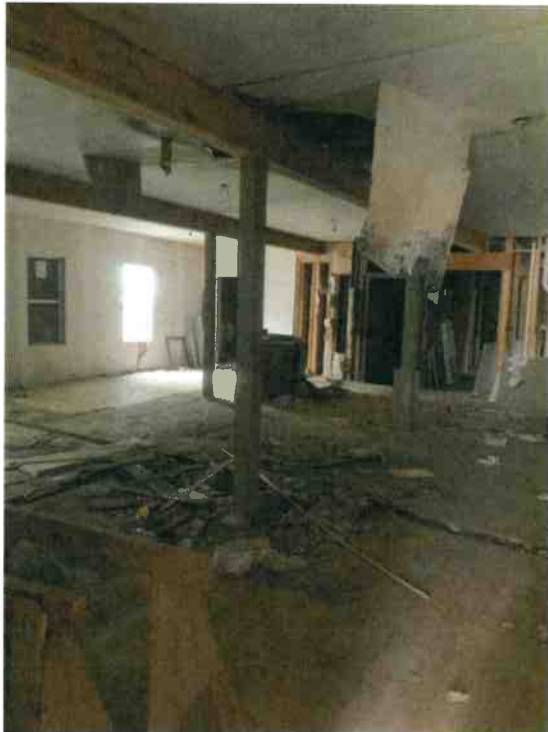
There was 12" x 12" asbestos-containing floor tile located throughout most of the main floor of the motel. This material was poor condition at the time of this assessment.

Photo 8 – 1st Floor of the Motel interior

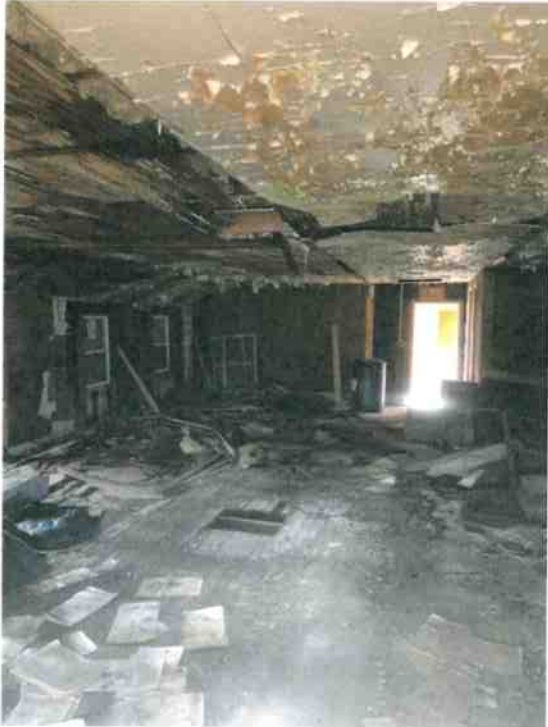
There were two types of asbestos-containing linoleum floor covering located on the second floor in the bathroom of the motel. These materials were in poor condition at the time of this assessment.

Photo 9- 2nd Floor of the Motel facing North

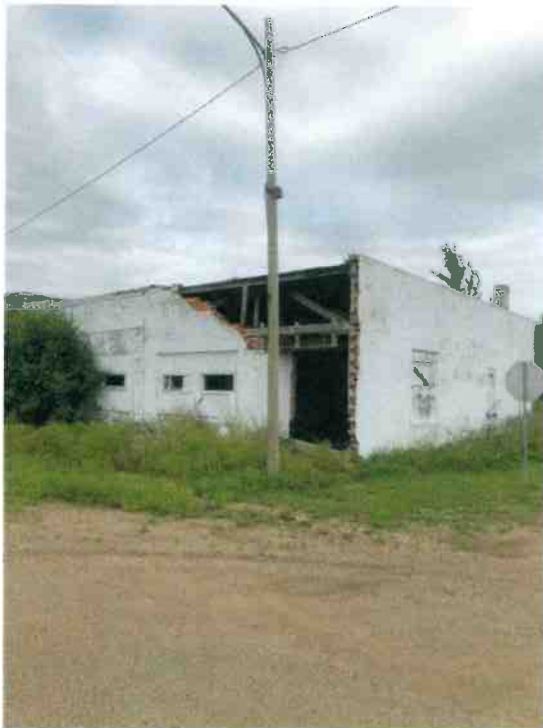
Photo 10- Building across the street from the implement dealership 67 North Main Street

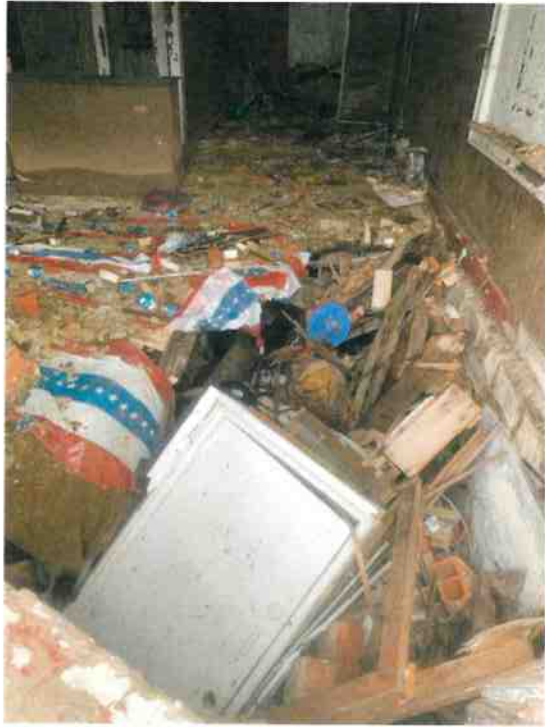
Photo 11- Floor of Building located at 67 North Main Street

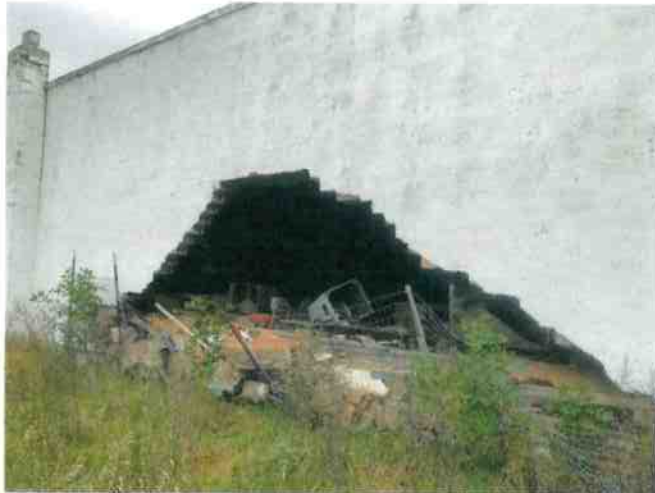
Photo 12- Picture of the west side of 72 N Main Street

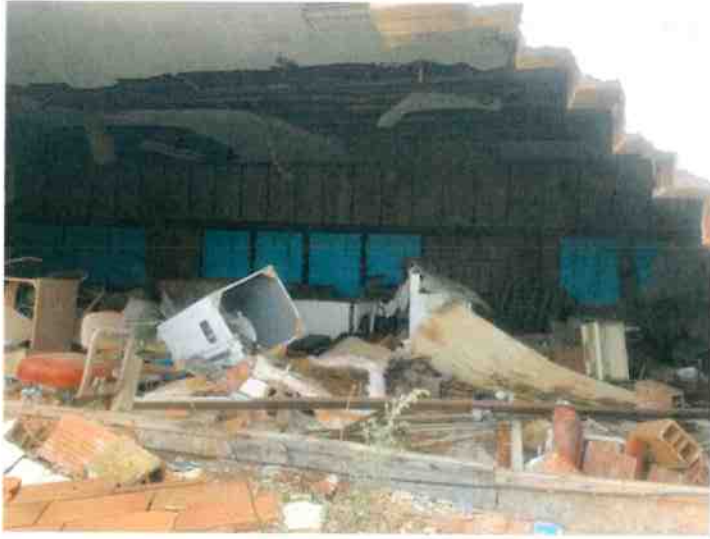
Photo 13- Inside 72 North Main Street for West wall.
