**Subject: Selfridge Abandoned Buildings  
Selfridge, Sioux County, North Dakota  
TD No: 207-2110-07**

Tetra Tech, Inc. (Tetra Tech) is pleased to submit the following trip report for the Selfridge Abandoned Buildings Project in Selfridge, Sioux County, North Dakota (Figure 1, Appendix A). On November 9, 2021, the Superfund Technical Assessment Response Team (START) conducted asbestos site sampling and evaluation at the following properties (Figures 2 through 5 Appendix A):

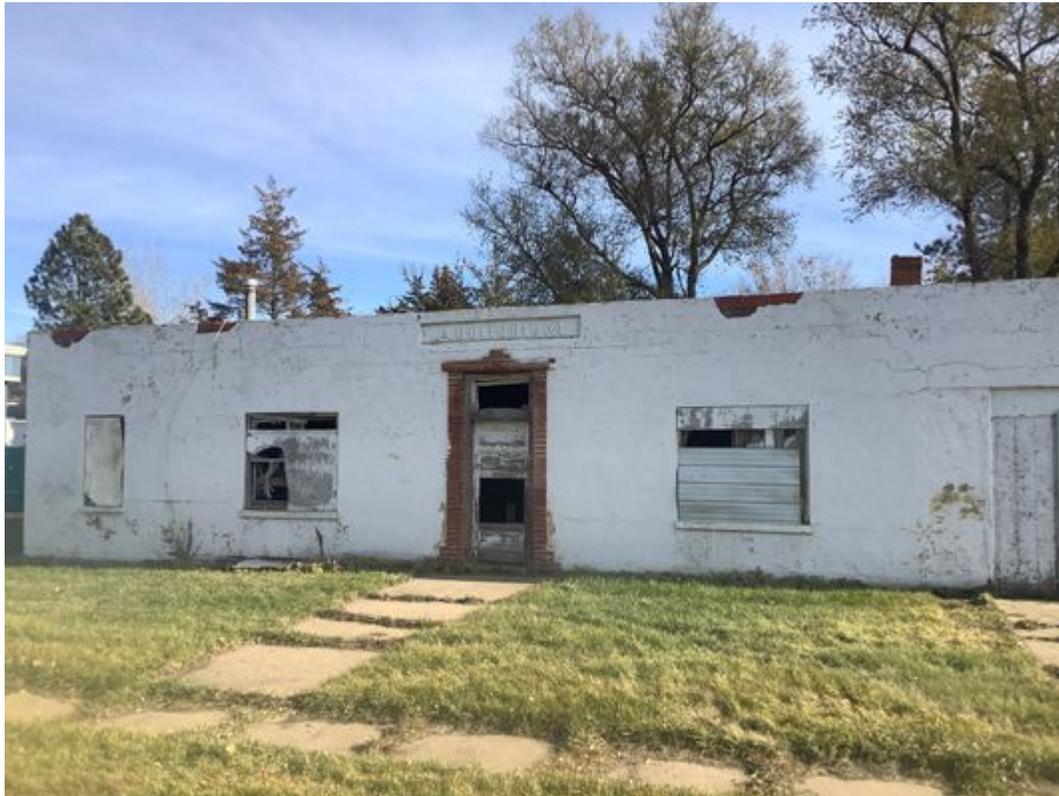
**Photo Description:** An exterior view of the former city auditorium in Selfridge, North Dakota.

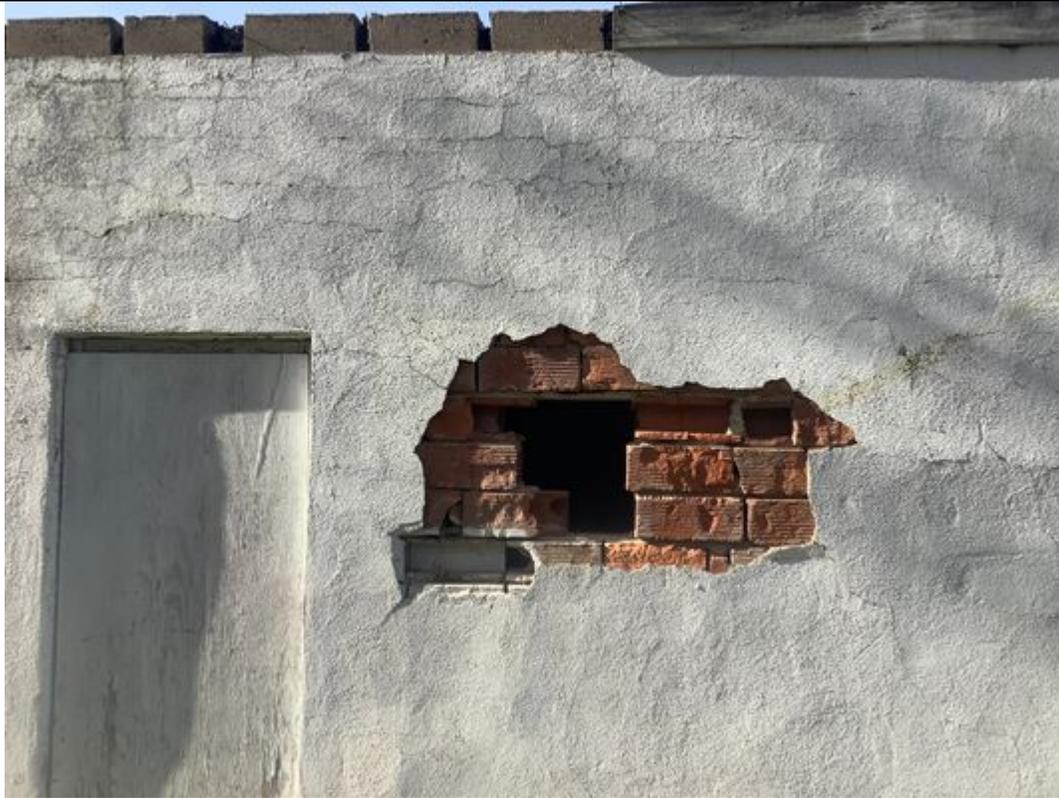
**Photo Description:** An exterior photo of a hole in the back wall of the city auditorium in Selfridge, North Dakota.

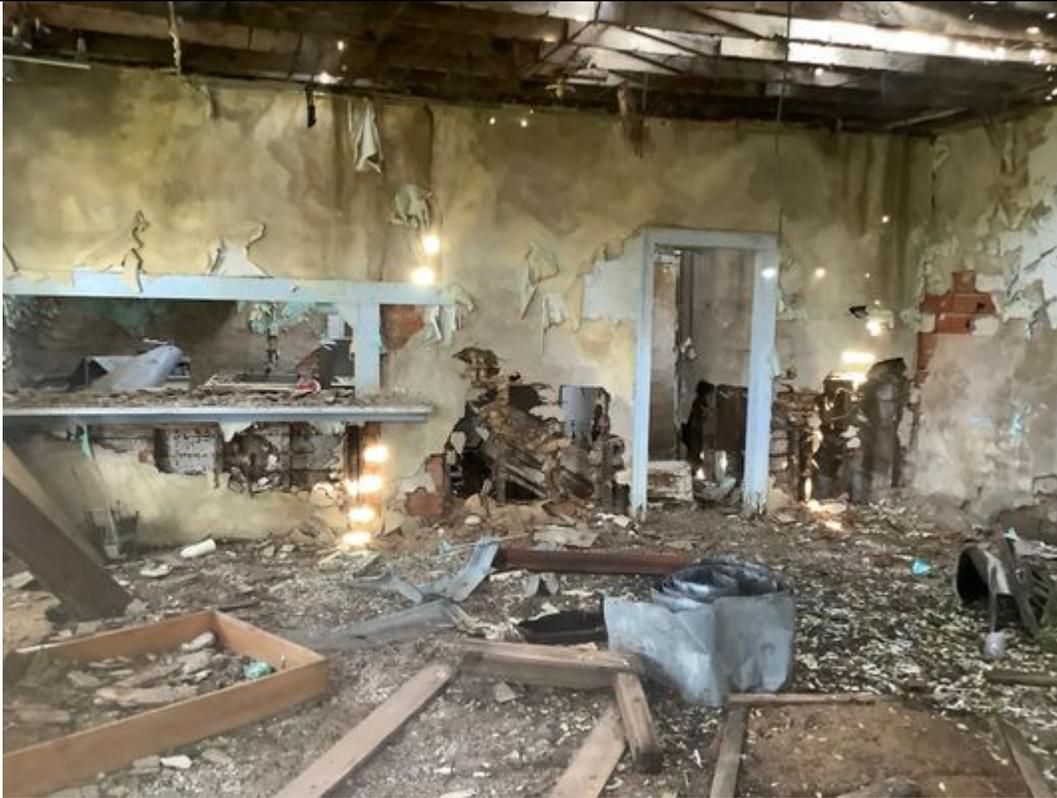
**Photo Description:** An interior view of the former city auditorium in Selfridge, North Dakota. The building has structural damage, and sections of the roof have partially collapsed.

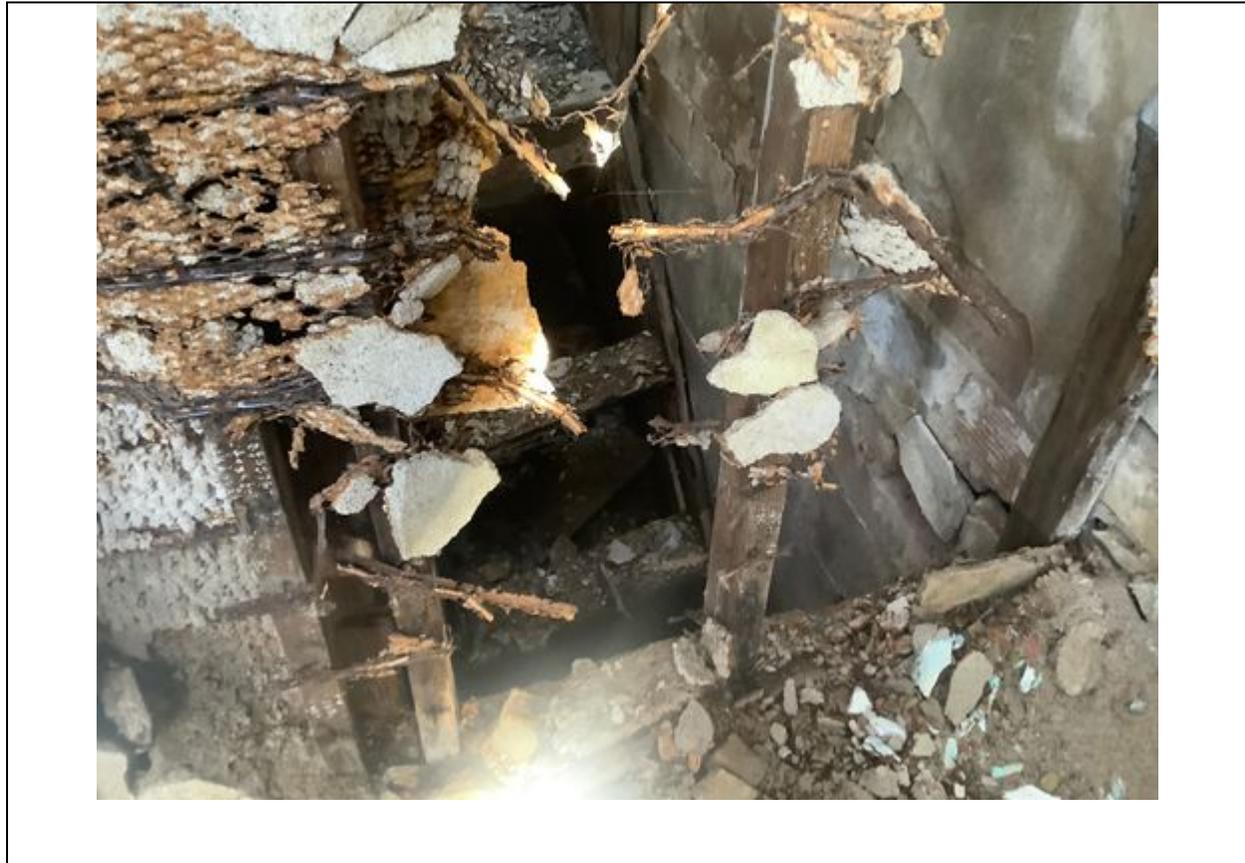
**Photo Description:** An interior view of the city auditorium in Selfridge, North Dakota. Standing water was observed in the basement.

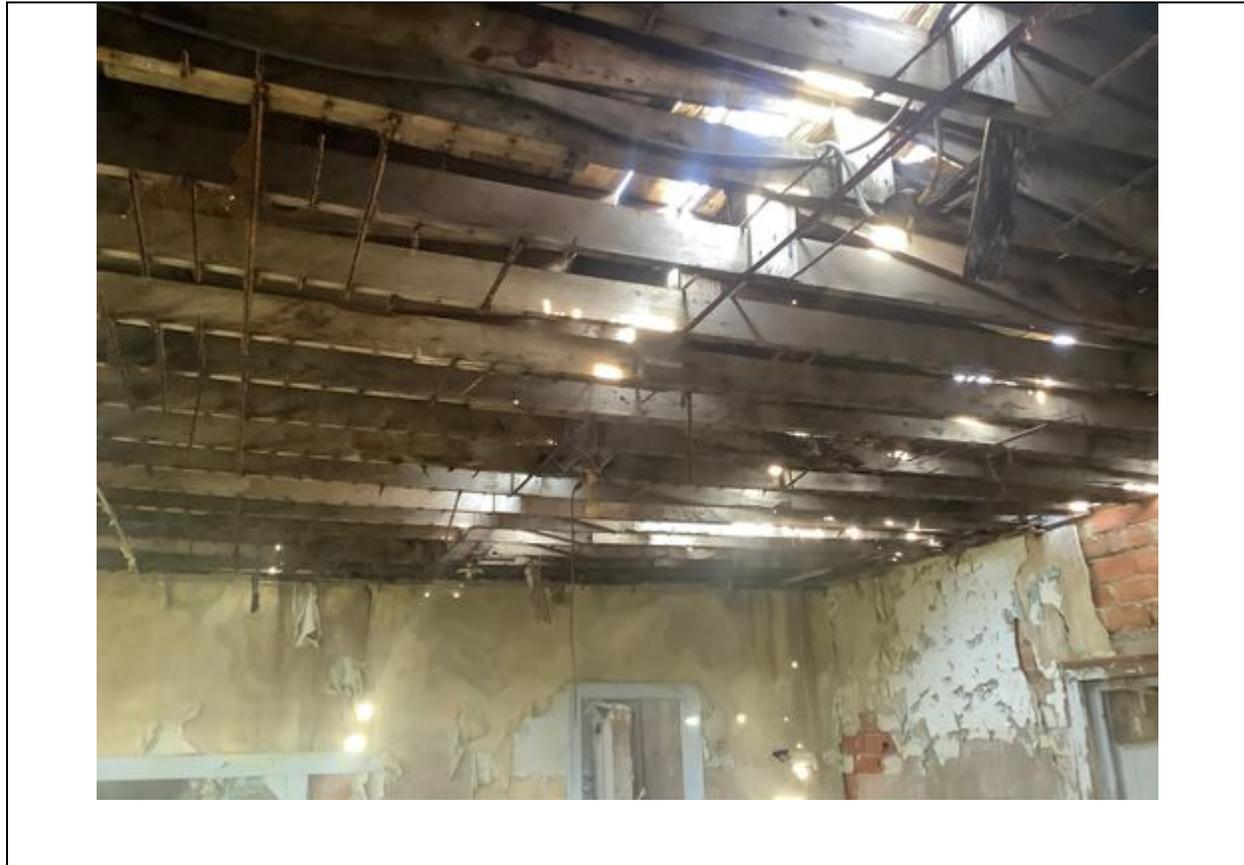
**Photo Description:** An interior view of the roof at the city auditorium in Selfridge, North Dakota. The roof is damaged and partially collapsed.

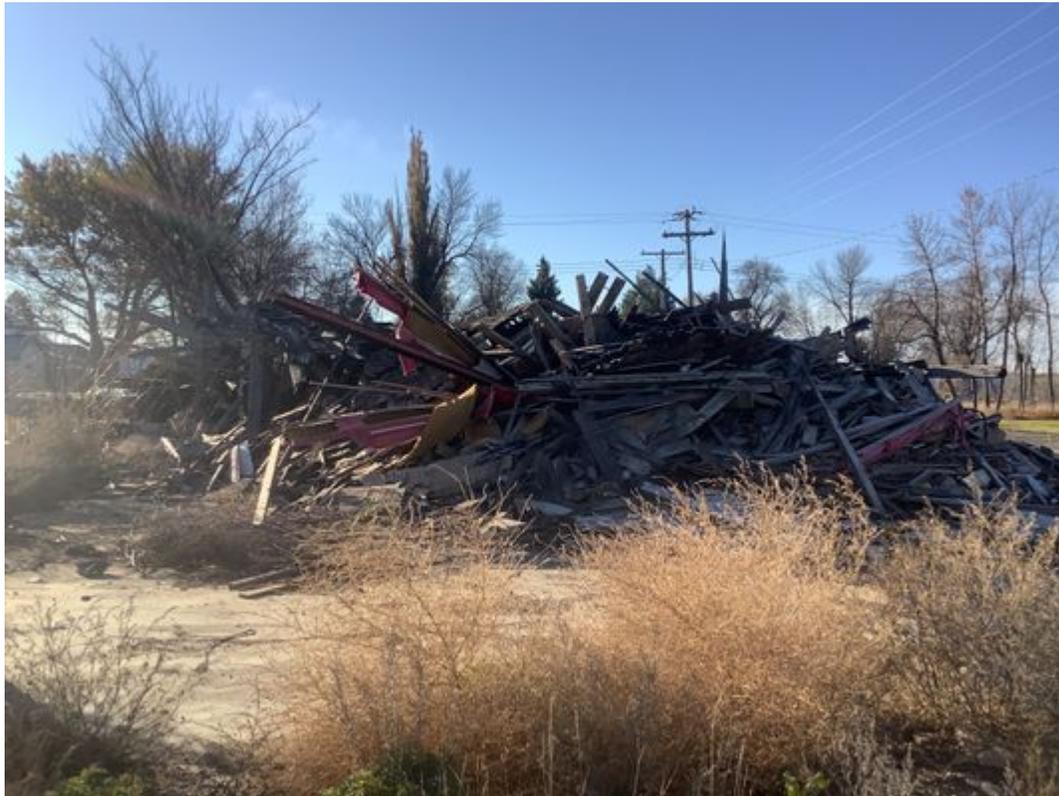
**Photo Description:** A southwest view of the former implement dealer in Selfridge, North Dakota. The building has been demolished.

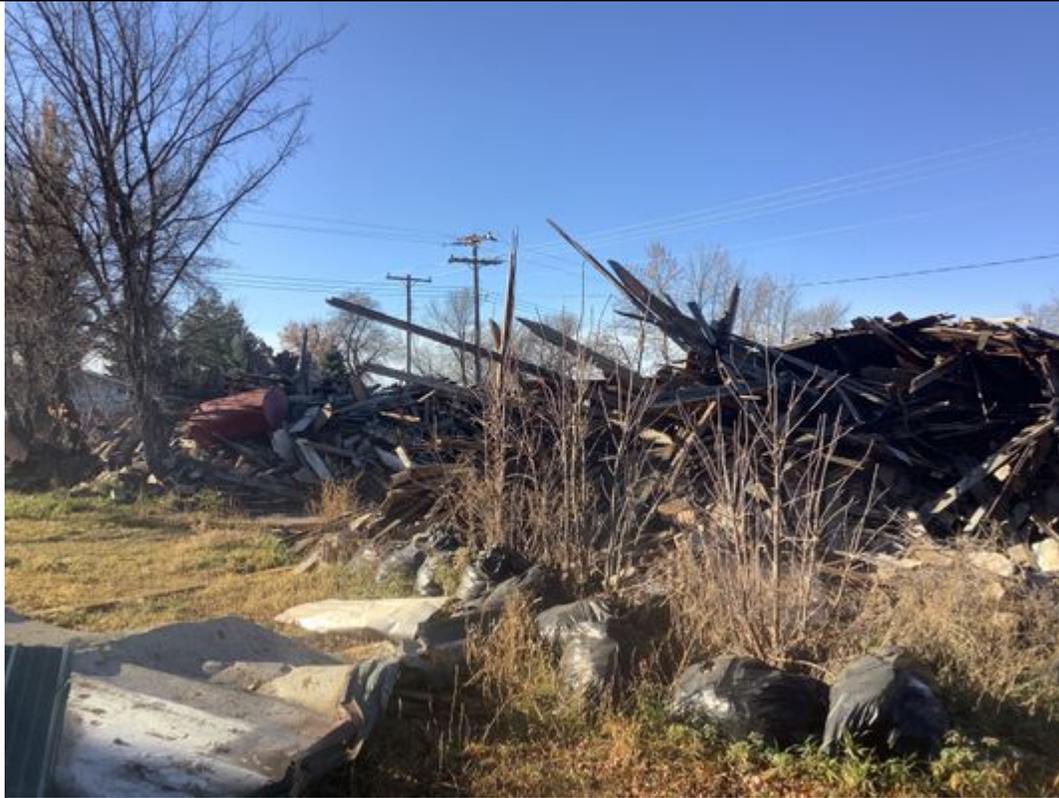
**Photo Description:** A western view of former implement dealer. The building has been demolished.

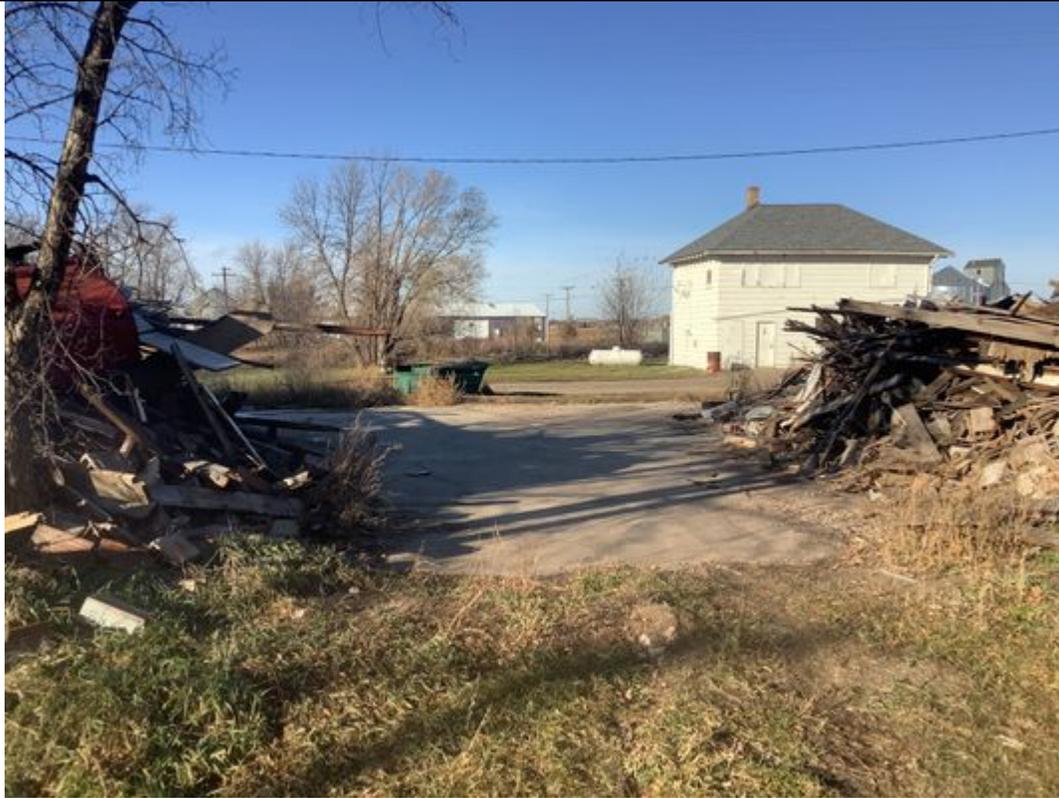
**Photo Description:** A northeastern view of the former implement dealer. The building has been demolished and debris has been placed into two piles.

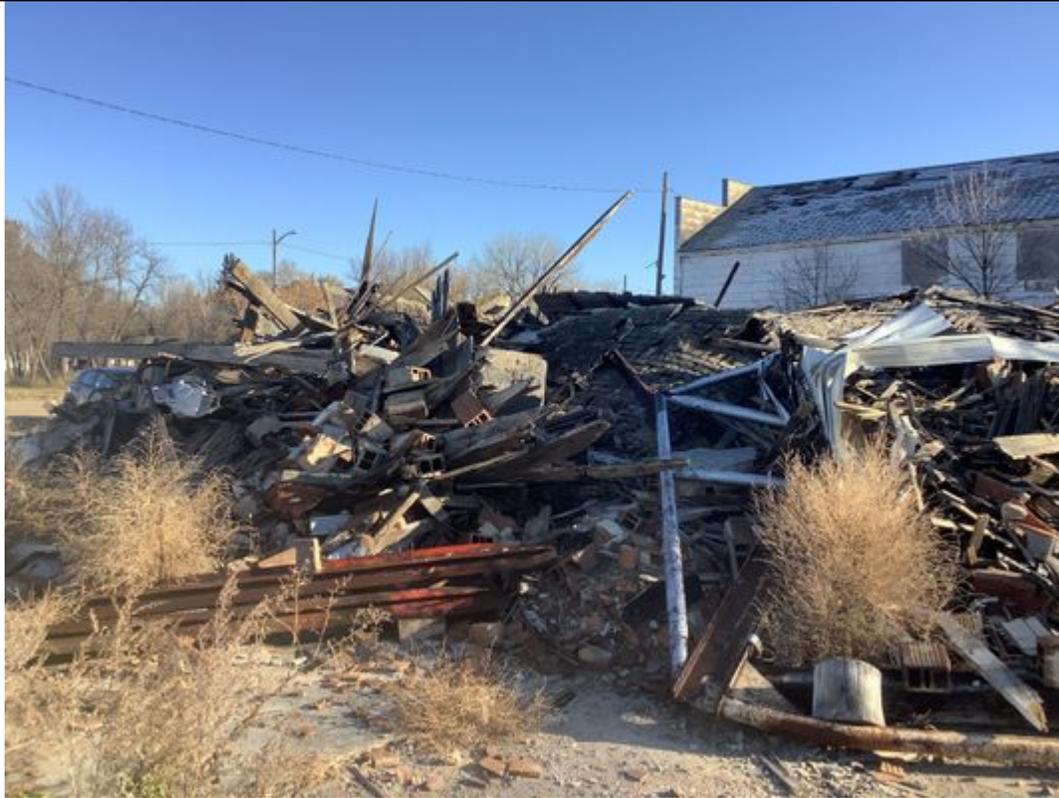
**Photo Description:** A northeastern view of the demolished implement dealer in Selfridge, North Dakota.

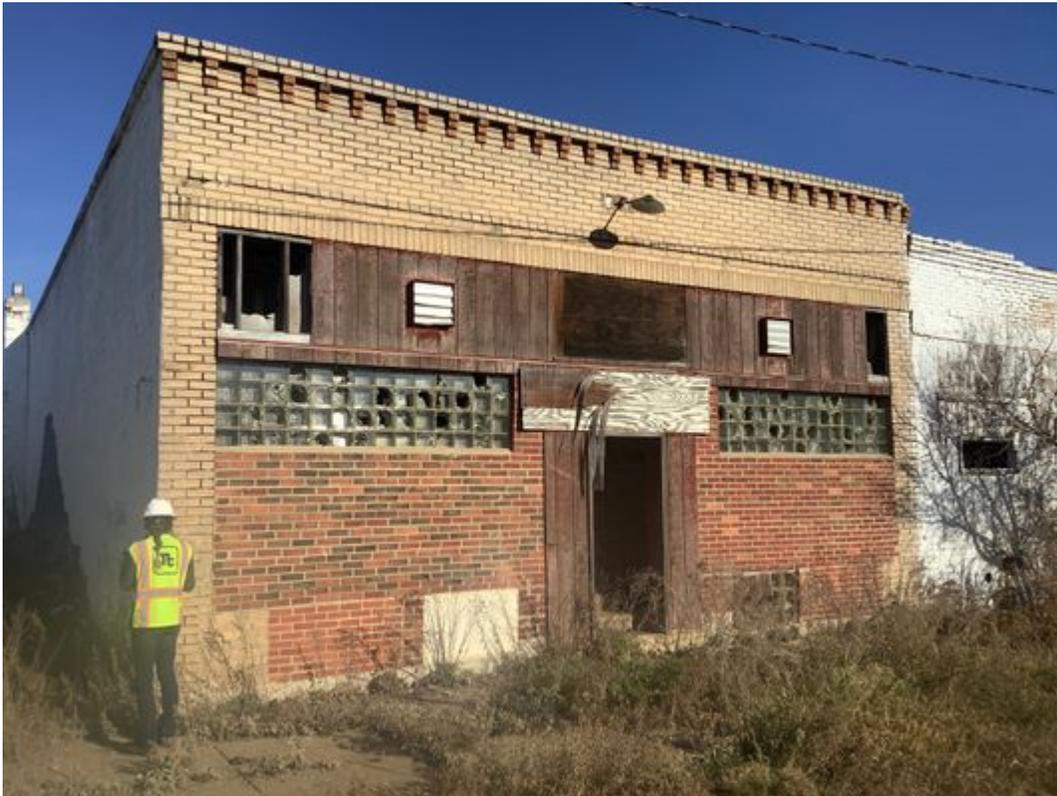
**Photo Description:** A view of the southern exterior of the legion hall in Selfridge, North Dakota. The building appears to have been subject to trespassing and vandalism.

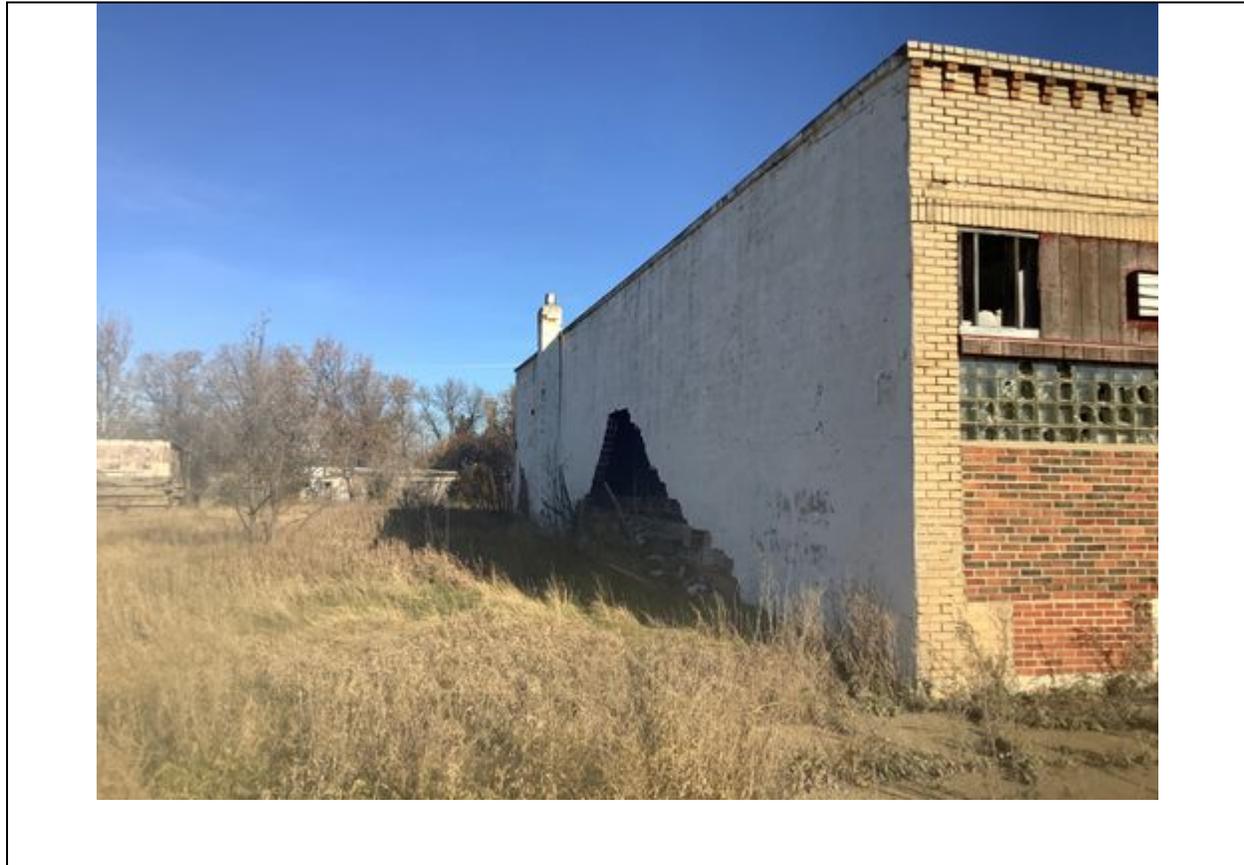
**Photo Description:** A view of the west side of the legion hall in Selfridge, North Dakota. A piece of the side wall has collapsed on itself and the building does not appear to be structurally sound.

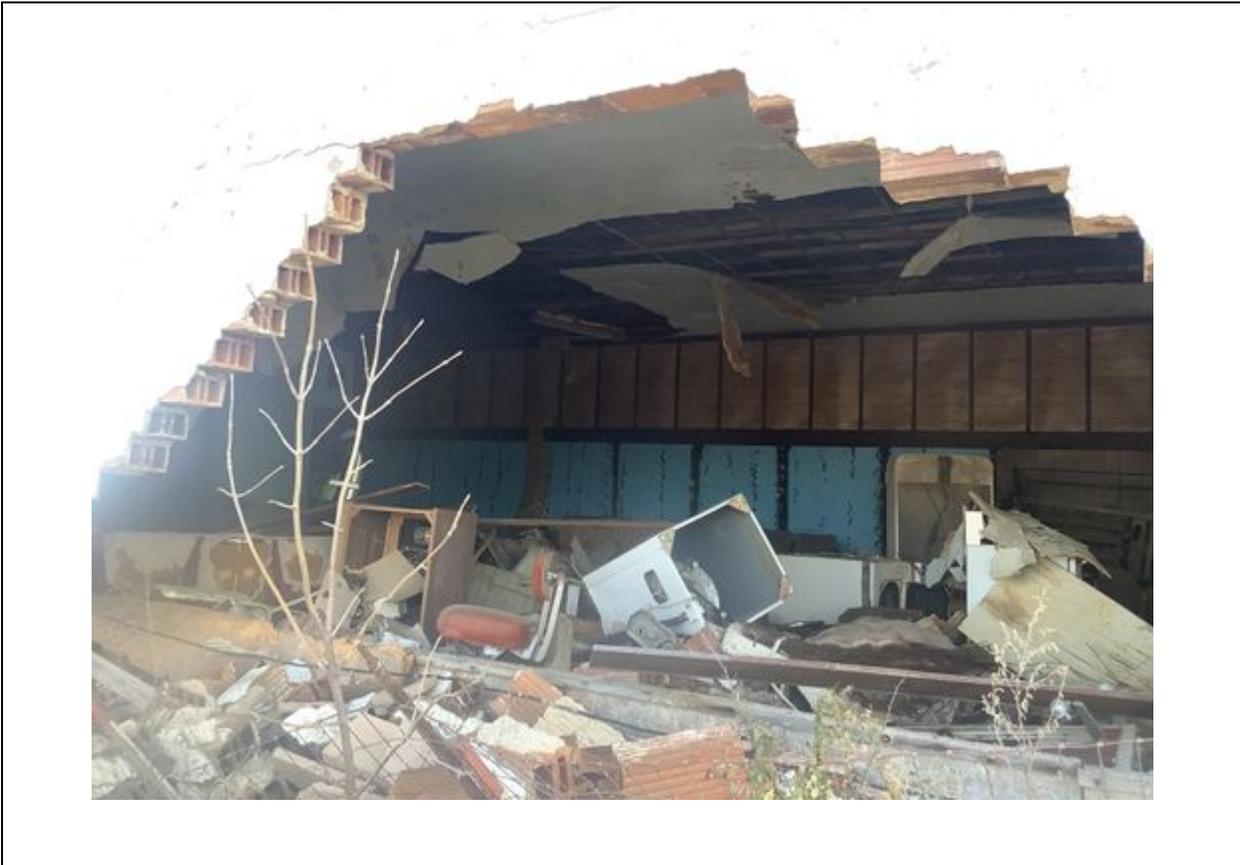
**Photo Description:** A view of the collapsed roofing and missing section of the side wall from the legion hall in Selfridge, North Dakota.

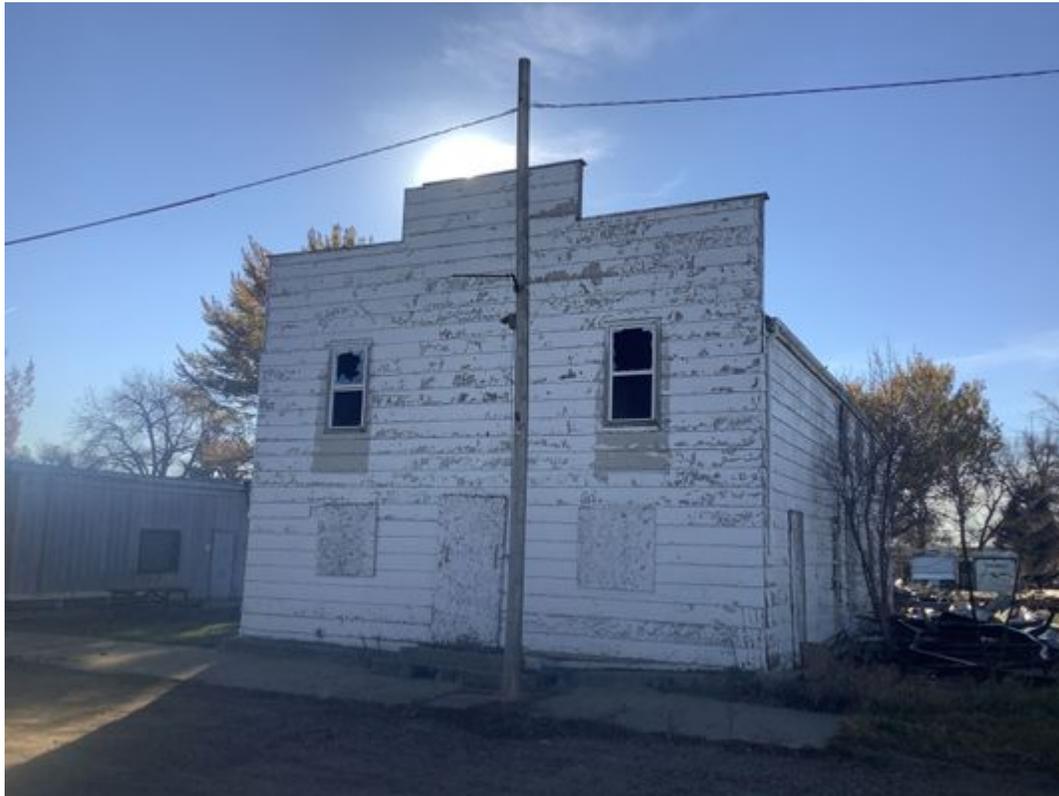
**Photo Description:** A southwestern view of the old motel in Selfridge, North Dakota.

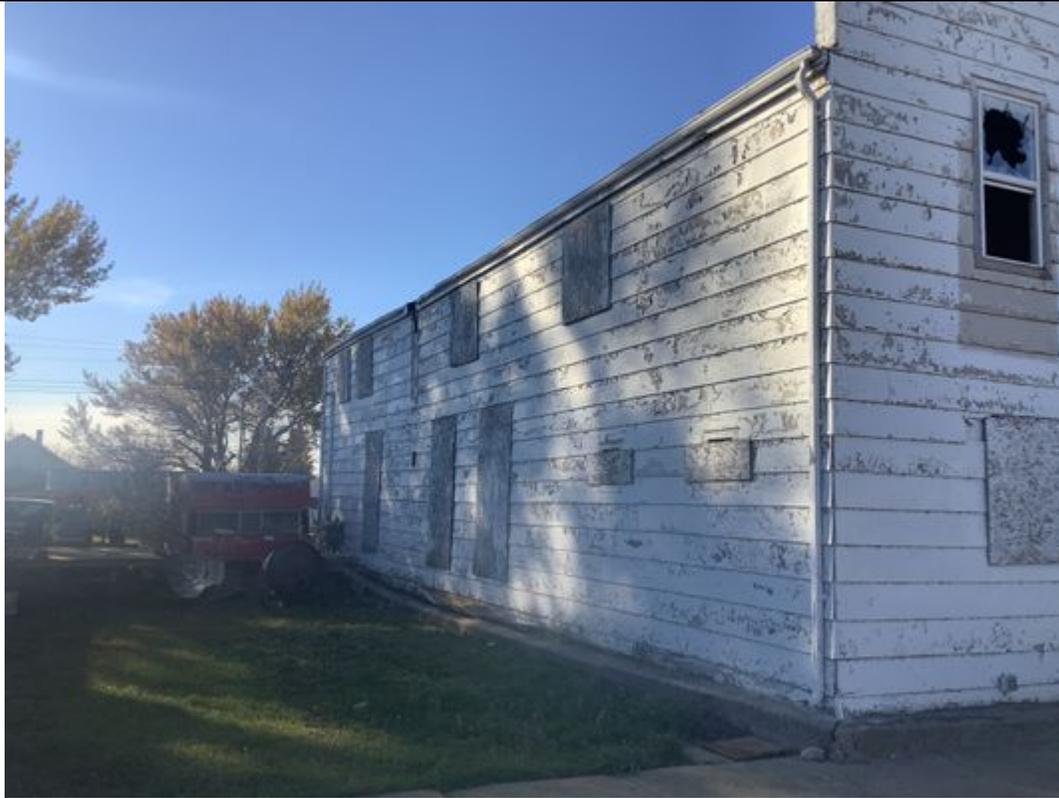
**Photo Description:** A view of the western side of the motel in Selfridge, North Dakota. Doors and windows have been boarded up to prevent trespassing and vandalism.

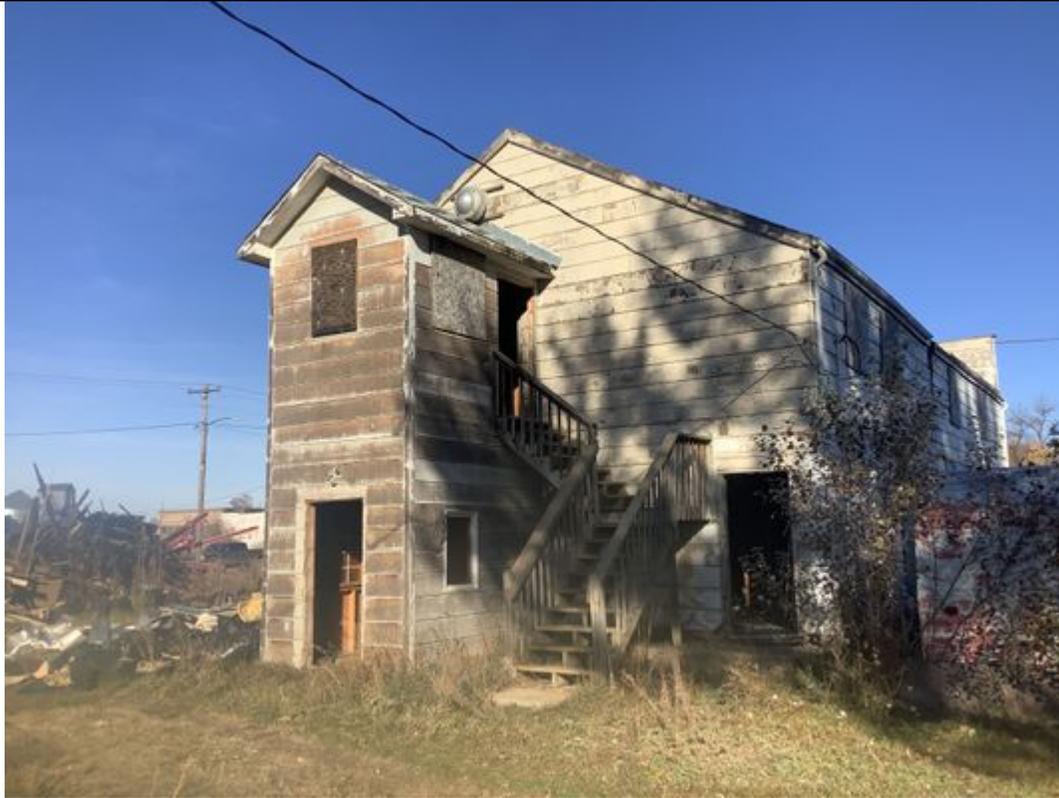
**Photo Description:** A northern view of the back exterior of the motel in Selfridge, North Dakota.

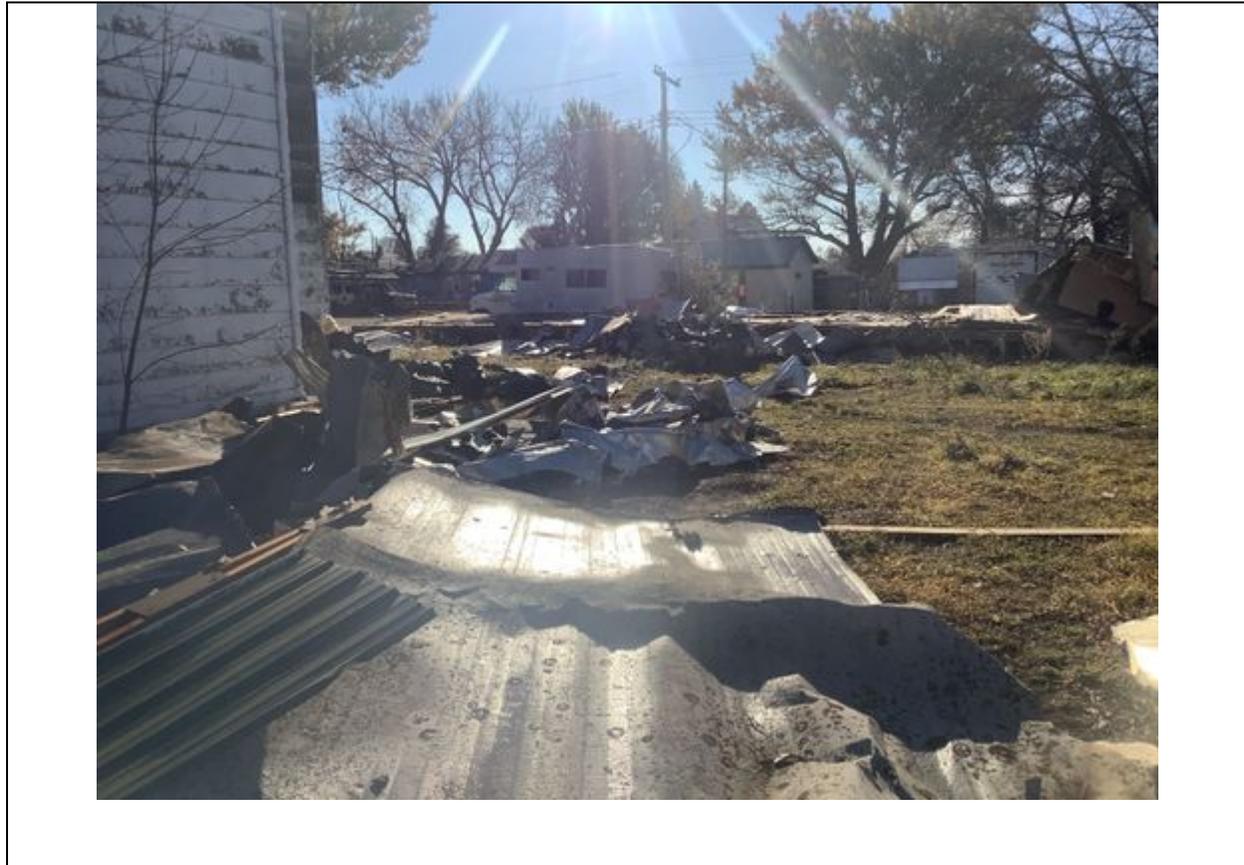
**Photo Description:** A southwestern view of debris from the old motel and adjacent trailers in yard in Selfridge, North Dakota.

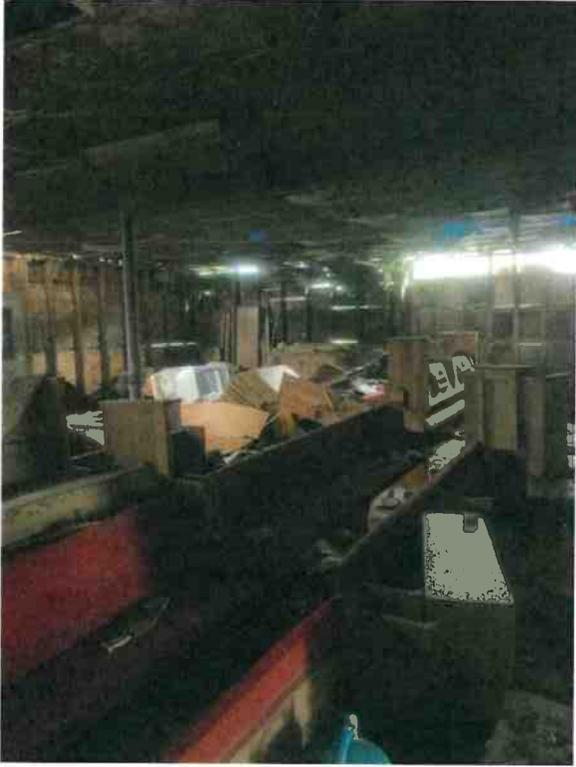
Photo 1- Implement Dealership- North and West facing walls

The gray plaster and tan stucco sample, which is located on the exterior and interior of the implement dealership, contain vermiculite in the matrix of the material. This material was in poor condition at the time of this assessment. Quantities for this material are unknown as half of the building is no longer standing. The structure is in extremely poor condition (See Attached Photos).
