TRIP REPORT

***Treoil Industries Biorefinery
Ferndale, Whatcom County, Washington
Contract No.: 68HE0720D0005
Task Order No.: 68HE0722F0042***

March 2022

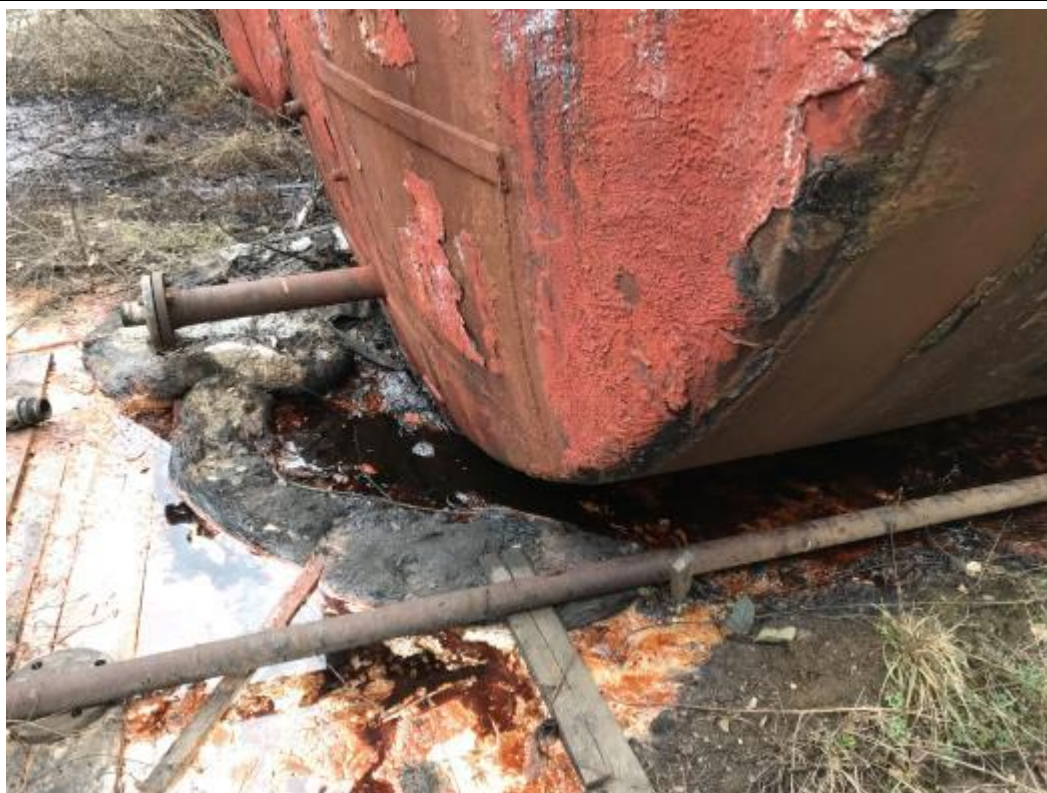
Photo No. 5	Date: 02/17/2022
Photo Coordinates	
Lat	48.879608
Long	-122.710608
Direction Photo Taken: S	
Description: Product floating on ground surface.

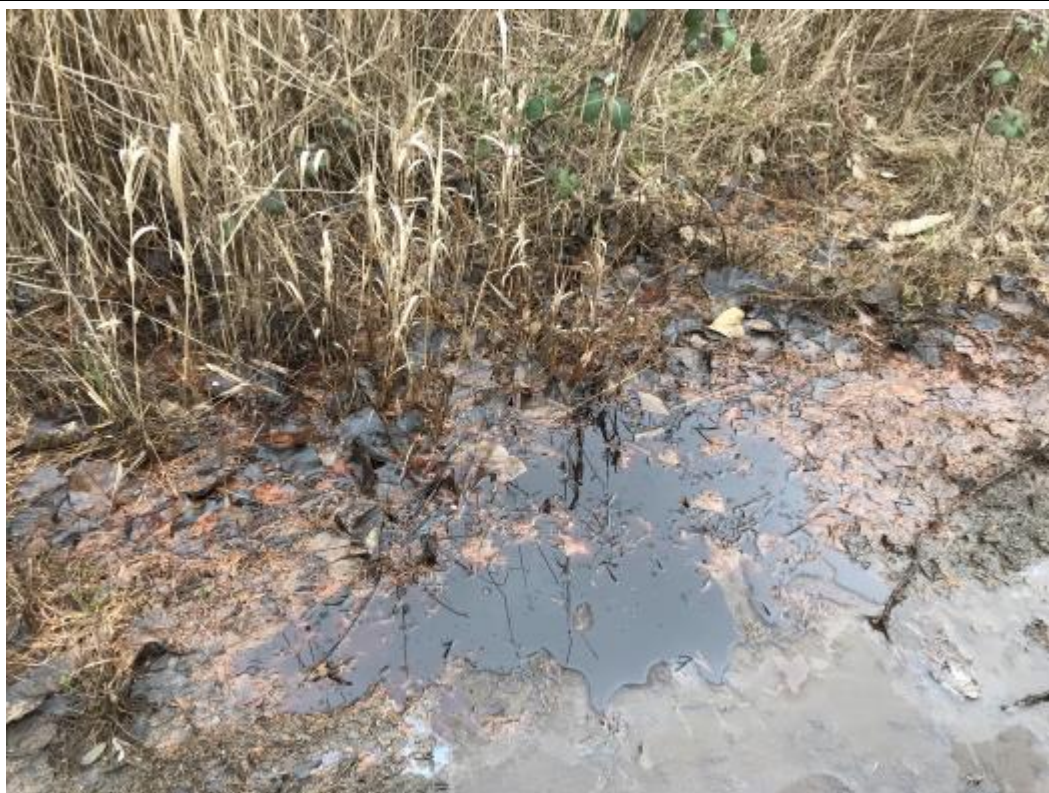
Photo No. 6	Date: 02/17/2022
Photo Coordinates	
Lat	48.879425
Long	-122.710817
Direction Photo Taken: SW	
Description: Product observed floating on surface water and stained soil.

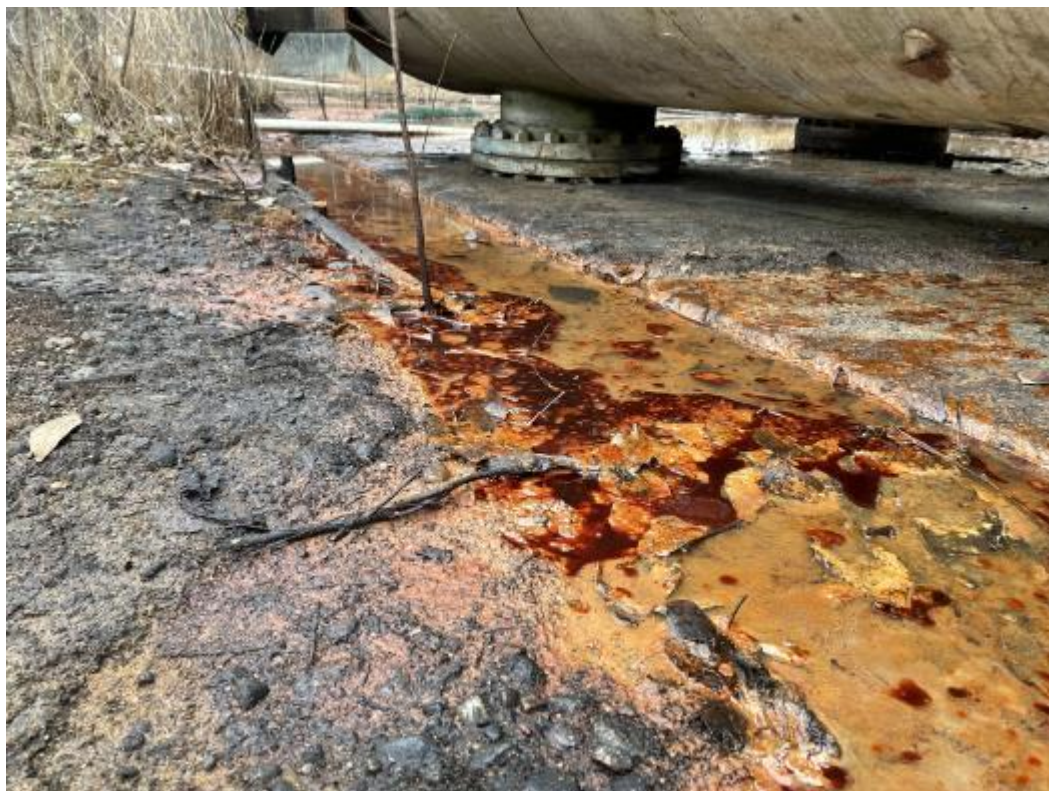
Secondary Containment C holds nine large ASTs previously used for tall oil production. During the 2017 response action, Secondary Containment C was observed partially filled with water. Analytical results from water samples collected within Secondary Containment C, indicated the presence of VOCs, and SVOCs and concentrations of metals likely associated with deterioration of the tanks themselves. Activities during the 2017 response did not include removing the water, as it was outside of the scope of the action, and, if pumped down, would quickly refill with precipitation. During the February 2022 Site walk, Secondary Containment C was observed in

much the same condition: filled with stagnant water greater and a significant portion what appeared to be tall oil sludge. In addition, the containment wall showed multiple large, leaking cracks throughout the perimeter.

Photo No. 7	Date: 02/17/2022
Photo Coordinates	
Lat	48.879269
Long	-122.710664
Direction Photo Taken: W	
Description: Flooded secondary containment for nine enclosed ASTs.

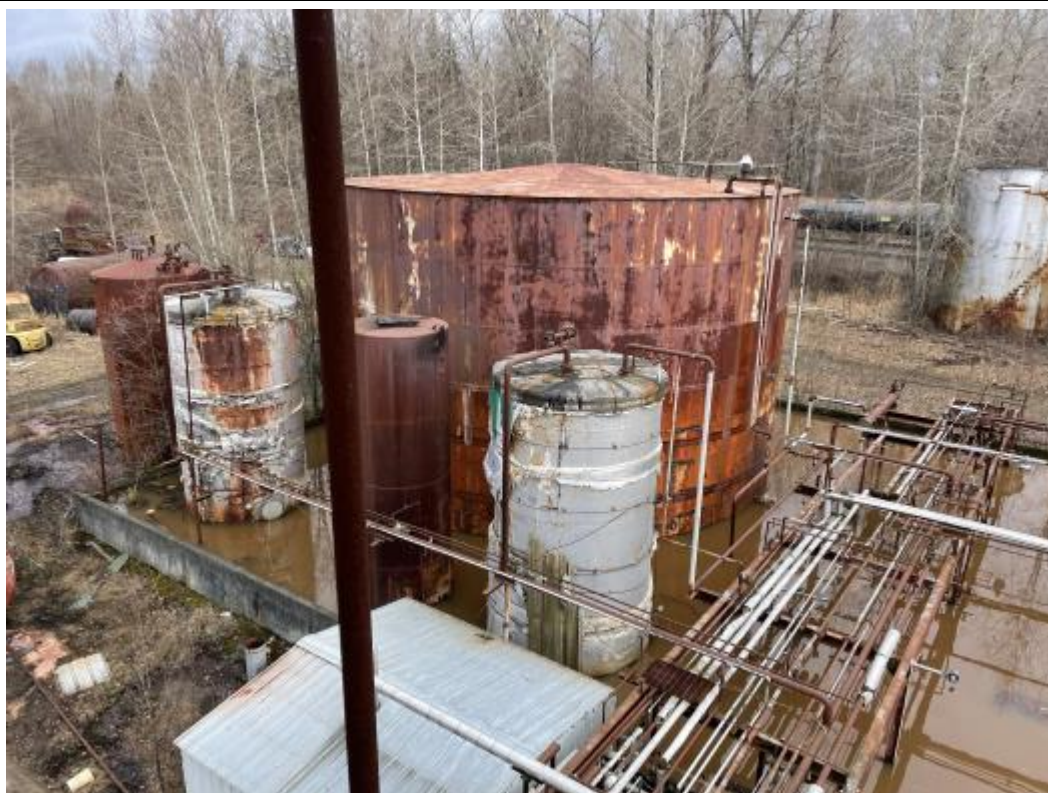
- A concrete, secondary containment ('Secondary Containment C' [E&E, 2017a]) full of water with large cracks at numerous locations around the perimeter allowing the release of liquids from the structure.

The continued presence of contents in AST T-20 along with new information provided to EPA following its 2017 action, increases the risk this material poses. The deterioration of Secondary Containment C, along with the presence of large volumes of what appears to be tall oil sludge, create the risk of a significant discharge of oil to nearby waterways.

Photo No. 8	Date: 02/17/2022
Photo Coordinates	
Lat	48.879508
Long	-122.710517
Direction Photo Taken: S	
Description: Fracture in failing secondary containment.

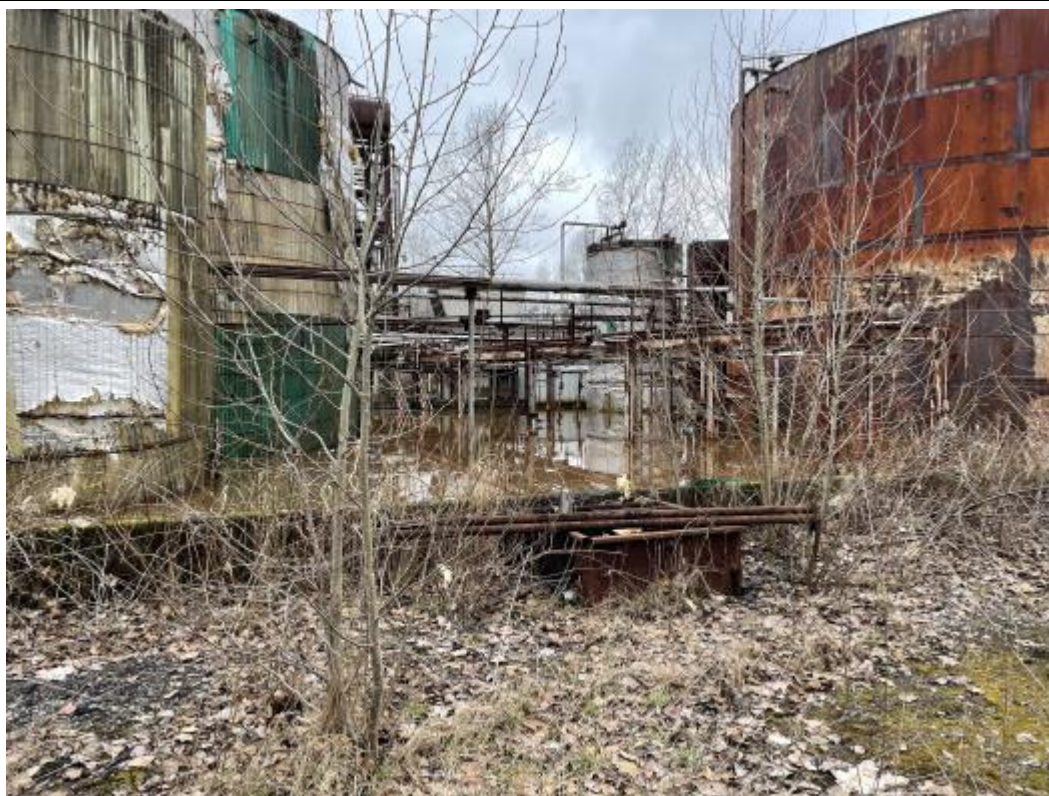
Several of the ASTs and ancillary equipment were observed to be wrapped with suspect ACM, which was no longer intact. Additionally, flaking from potential lead-based paint (LBP) was observed on the ground surface near AST T-3.

Photo No. 10	Date: 02/17/2022
Photo Coordinates	
Lat	48.879428
Long	-122.710717
Direction Photo Taken: N	
Description: Uncontrolled release of suspect lead-based paint from AST.

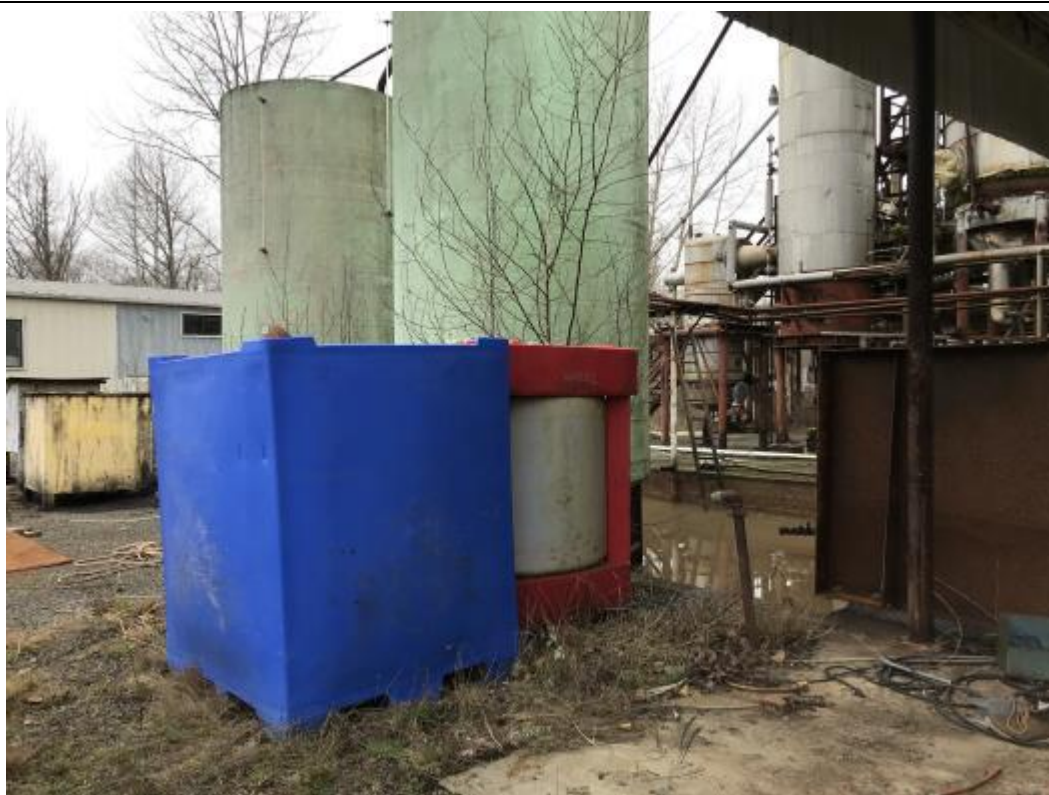
Photo No. 12	Date: 02/17/2022
Photo Coordinates	
Lat	48.879047
Long	-122.710769
Direction Photo Taken: NE	
Description: 400-gallon poly totes containing unknown products.

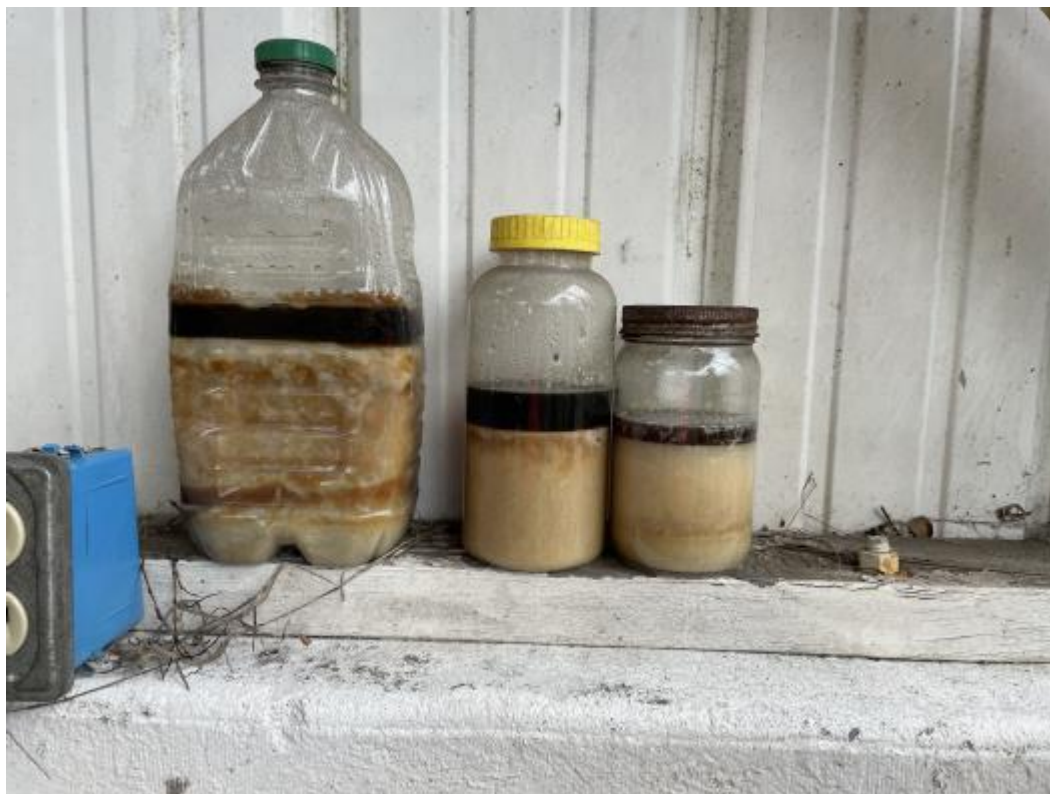
Photo No. 14	Date: 02/17/2022
Photo Coordinates	
Lat	48.879722
Long	-122.711075
Direction Photo Taken: NE	
Description: Chemicals stored post 2107 TRCA in former laboratory trailer.

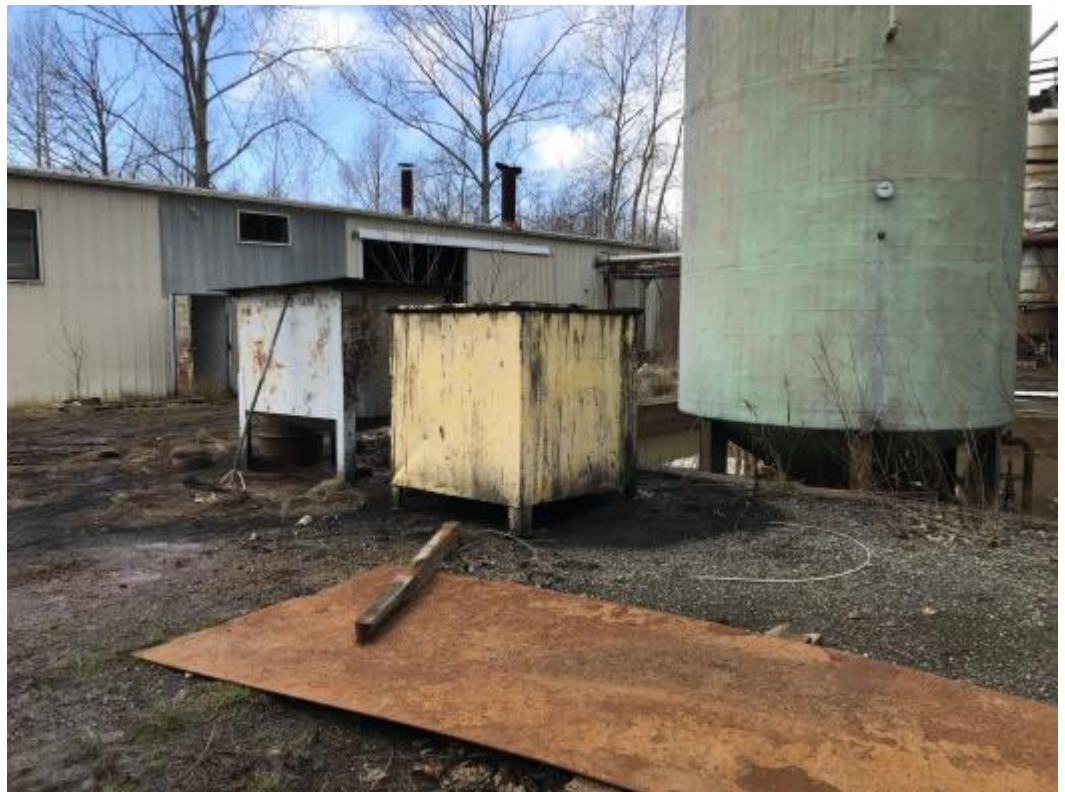
Photo No. 16	Date: 02/17/2022
Photo Coordinates	
Lat	48.879025
Long	-122.710892
Direction Photo Taken: NE	
Description: Burned and stained soil around footprints of metal vats. Evidence of leaking was observed.

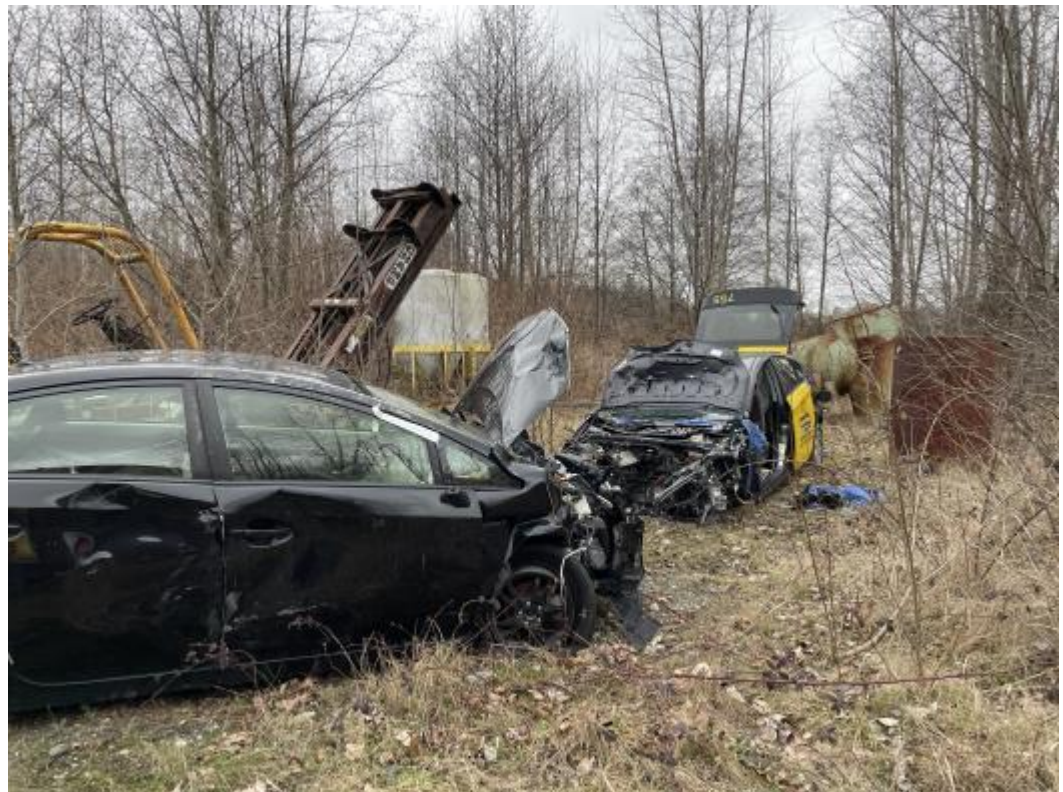
Photo No. 18	Date: 02/17/2022
Photo Coordinates	
Lat	48.8798
Long	-122.710092
Direction Photo Taken: N	
Description: Additional photos of wrecked vehicles.
