# Site Investigation Report of Findings

APN 525-171-009-000  
Loop Road, Hoopa, California

Hoopa Valley Tribe Department of  
Natural Resources

August 2021

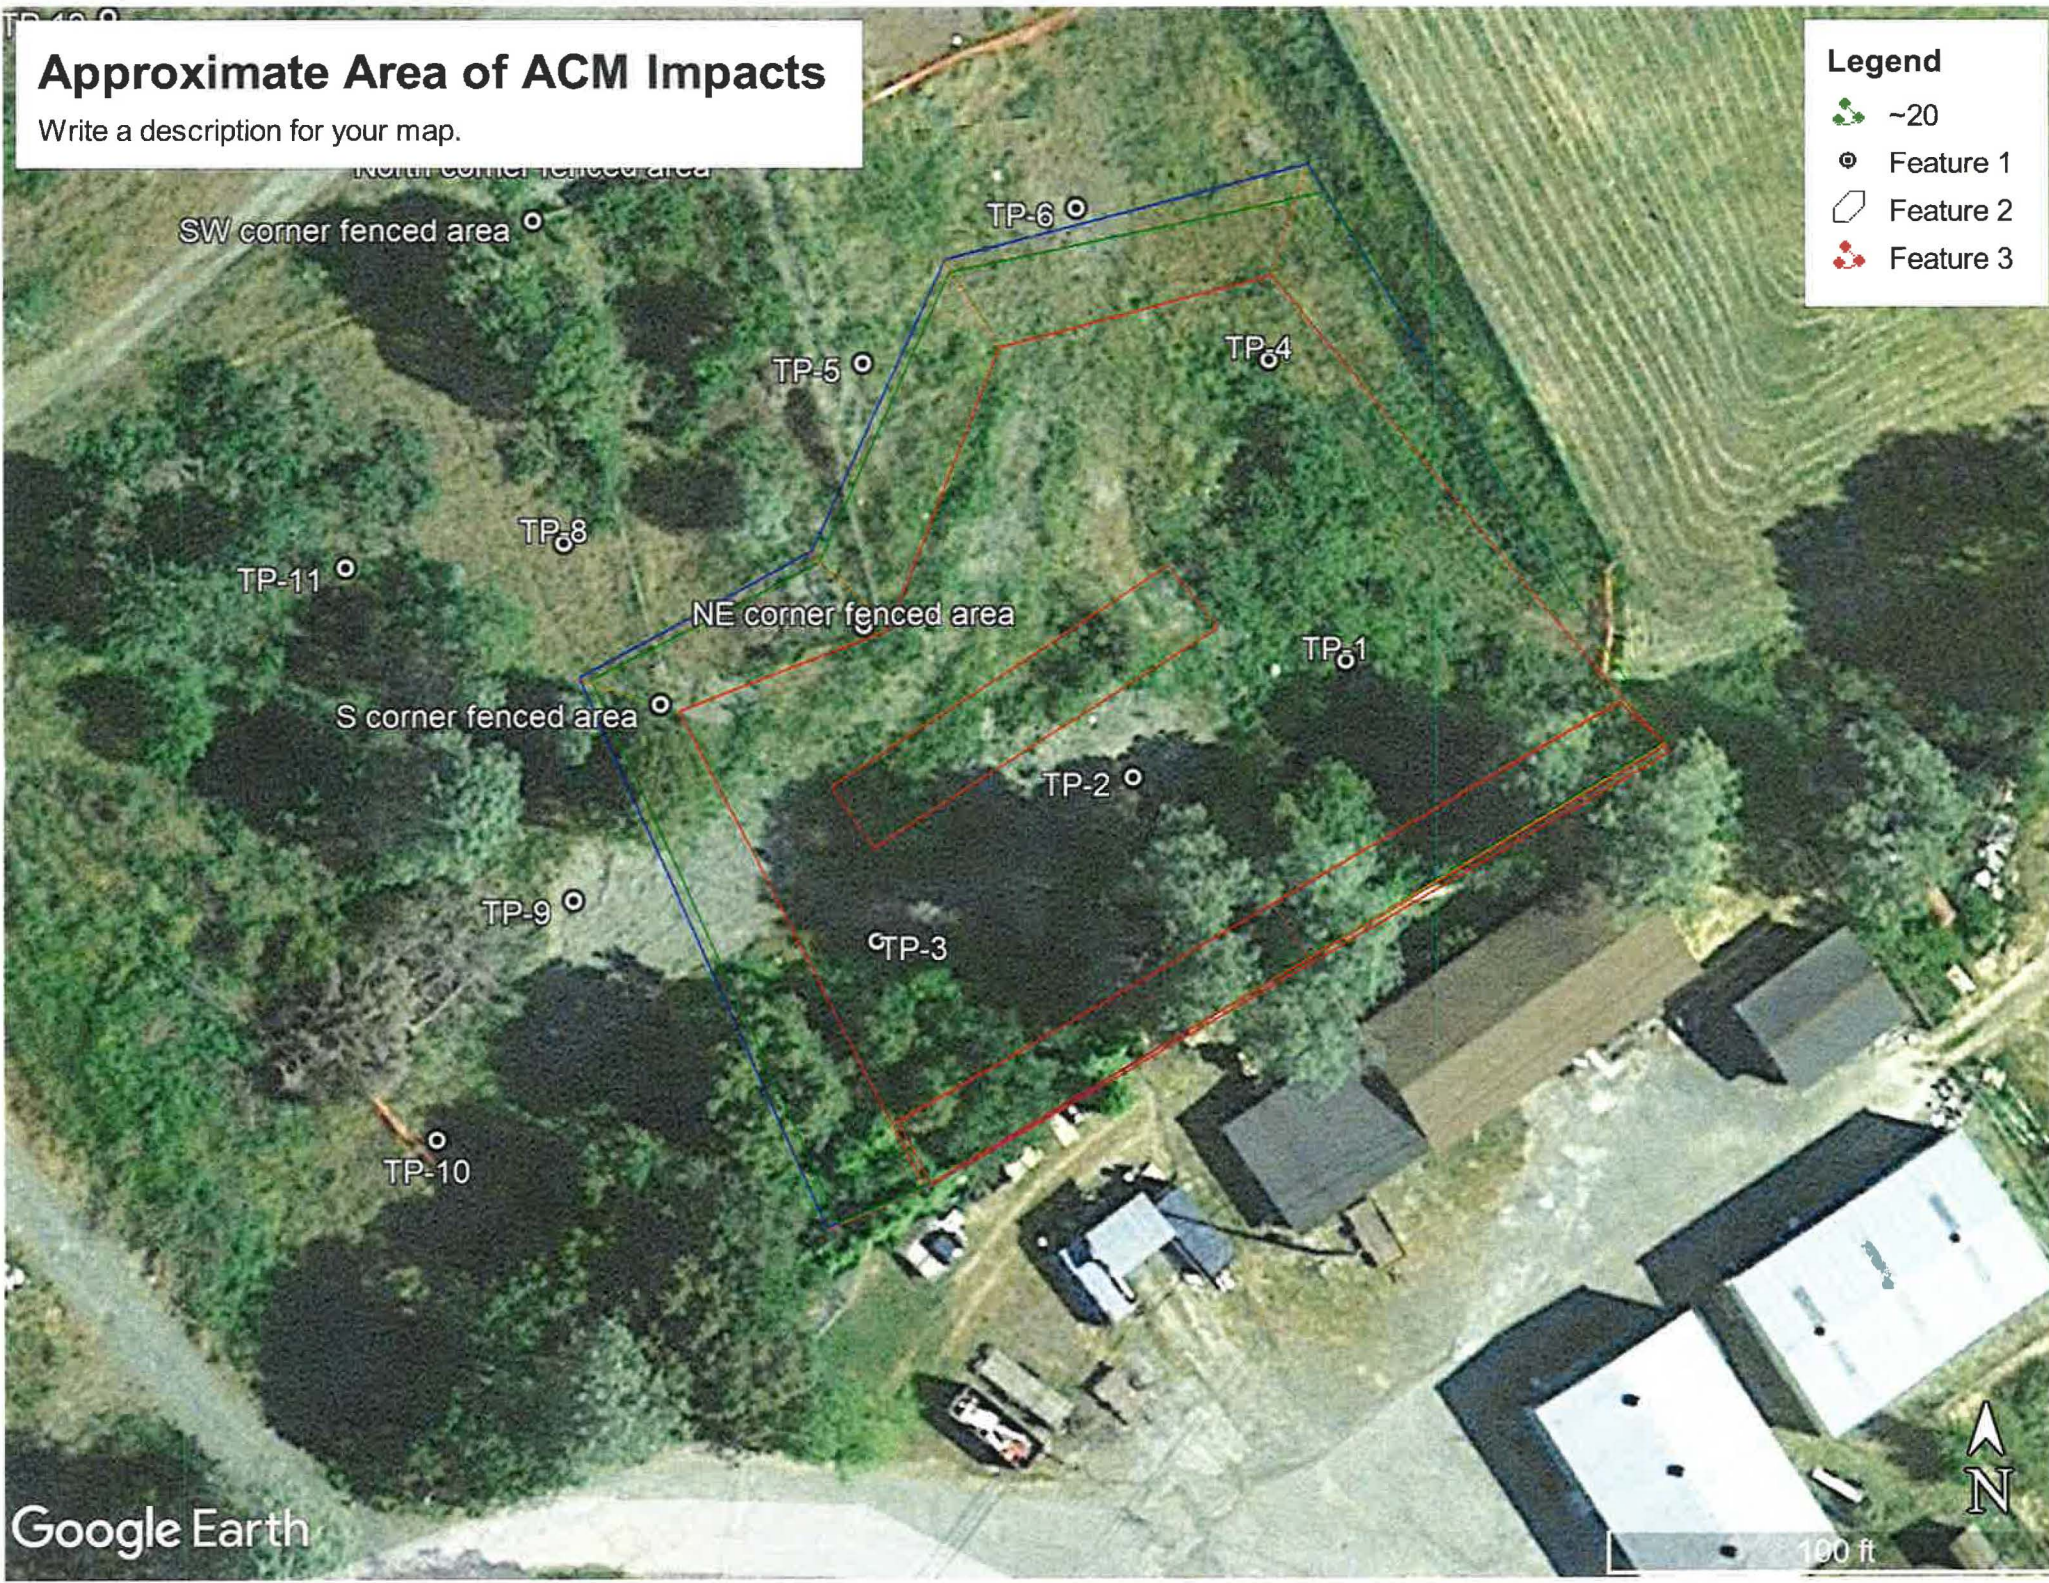
Areas, Lengths, and volumes used in final volume estimation					
		Units		Units	Assumptions
estimated ACM impacted area assumed for mitigation	3,395	sy	30,619	ft <sup>2</sup>	Area estimated on Google Earth using GHD Fig 1 sample locations and ACM detections. A conservative area was estimated by adding an additional <b>20 foot</b> area outside of the perimeter of observed ACM detections.
estimated area of large stock pile in center of ACM impacted area	175	sy	1,579	ft <sup>2</sup>	Area estimated on Google Earth
Estimated depth of stockpile	0.33	yd	1	ft	Based on onsite observations
estimated length of berm on south east edge of project site	63	yd	188	ft	Assumed based on field observation
estimated rise and run of berm on south east edge of project site	5	yd	15	ft	Assumed 45 degree slope and 15 foot rise based on field observation
Used <b>depth of 2 ft</b> (the depth to which ACM material was identified in construction material samples)	0.67	yd	2	ft	From GHD construction material sample results and SHN confirmation soil sample results

Scattered debris volume estimate to be equivalent to the stock pile in the south east quadrant of the project area					Assumed conservative estimate to be equivalent to stock pile volume

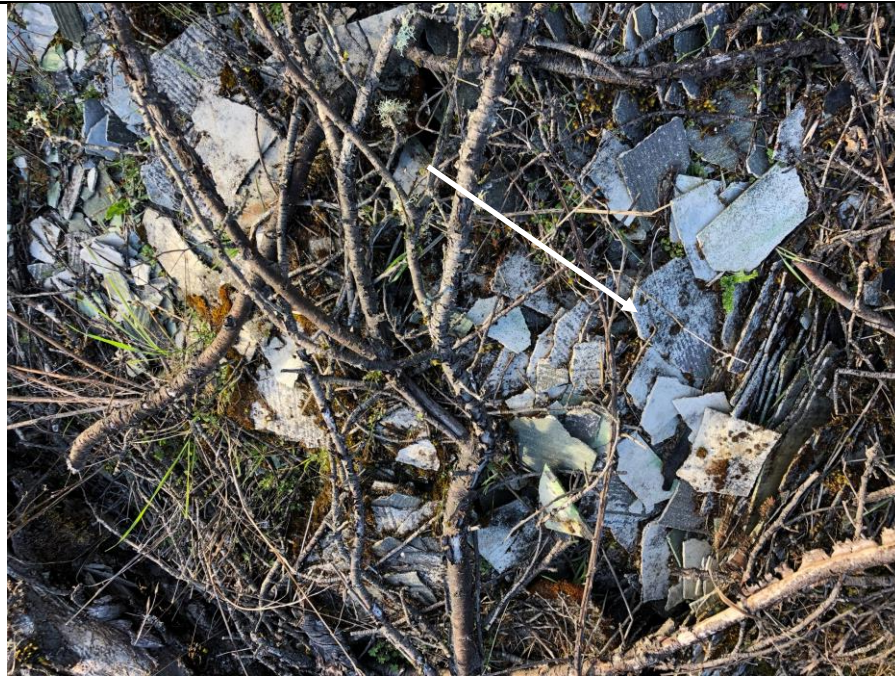
Photograph 1 – Northeast debris pile – Cementitious panel debris reported to contain asbestos.

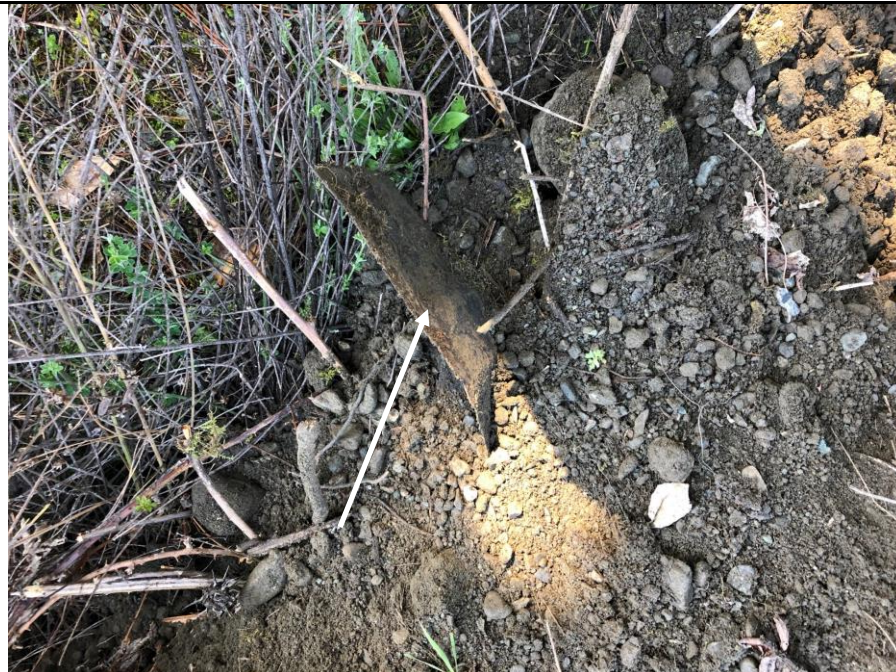
Photograph 2 – Northeast debris pile – Roofing debris (typical) (ACM).

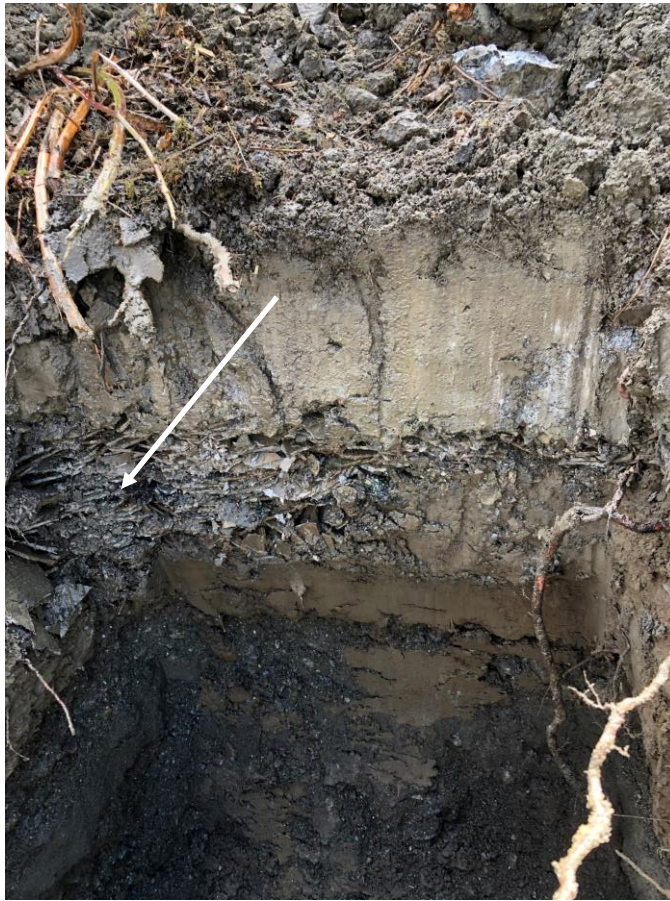
Photograph 3 – Test Pit 1 – Cementitious panel debris (typical) below grade (ACM).

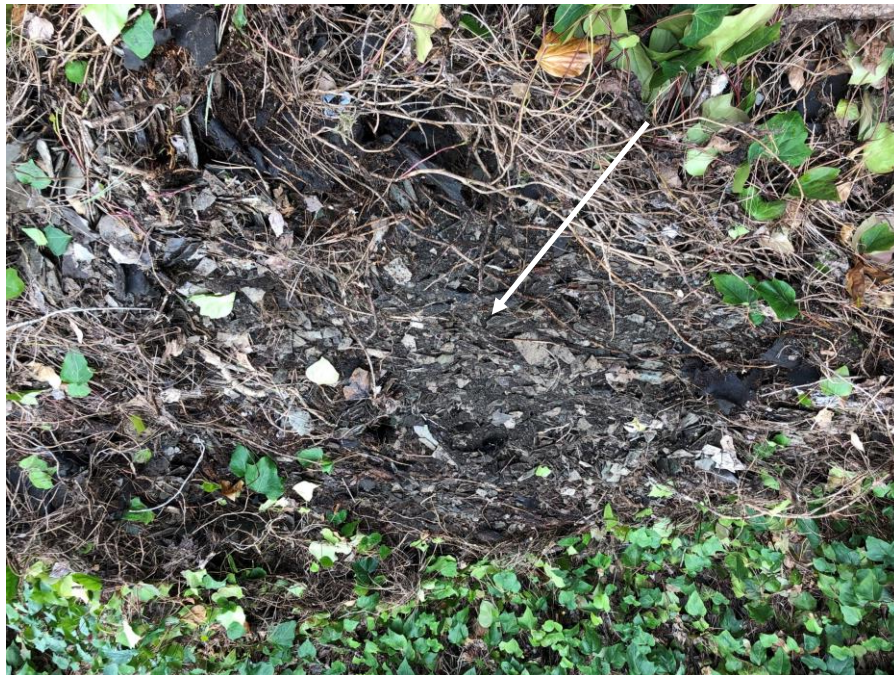
Photograph 4 – East slope – Cementitious panel and vinyl floor tile debris (typical) (ACM).

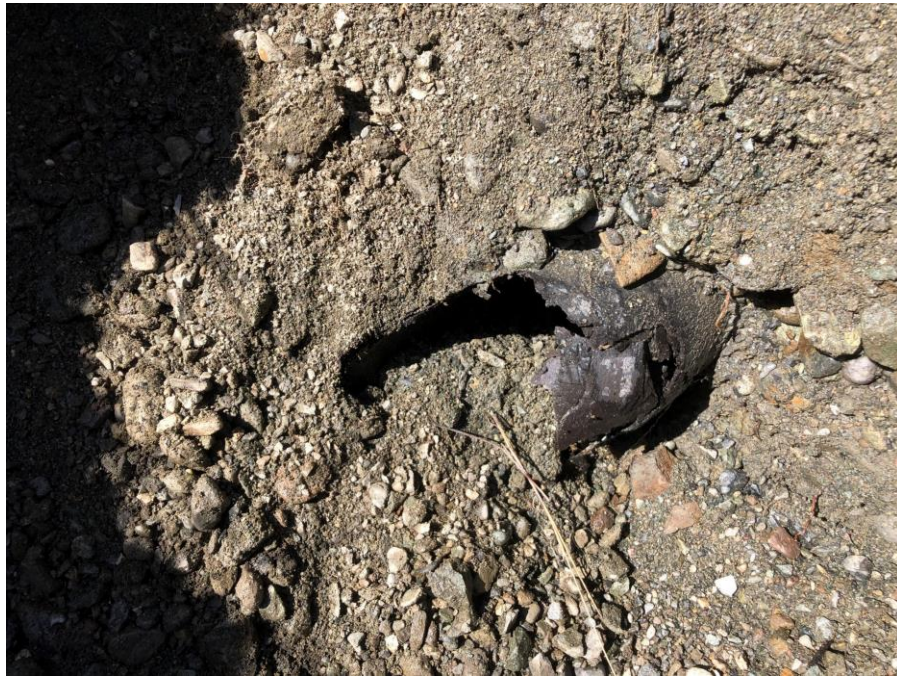
Photograph 5 – Test Pit 10 – Bituminous piping reported to be nondetect (not asbestos).

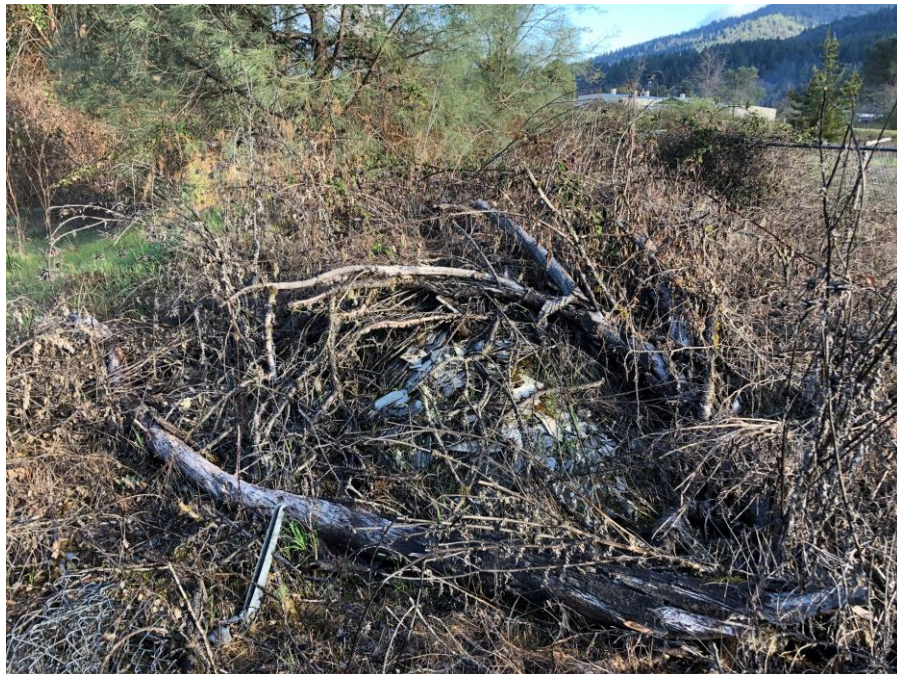
Photograph 6 – Debris pile at center fenced area containing ACM.

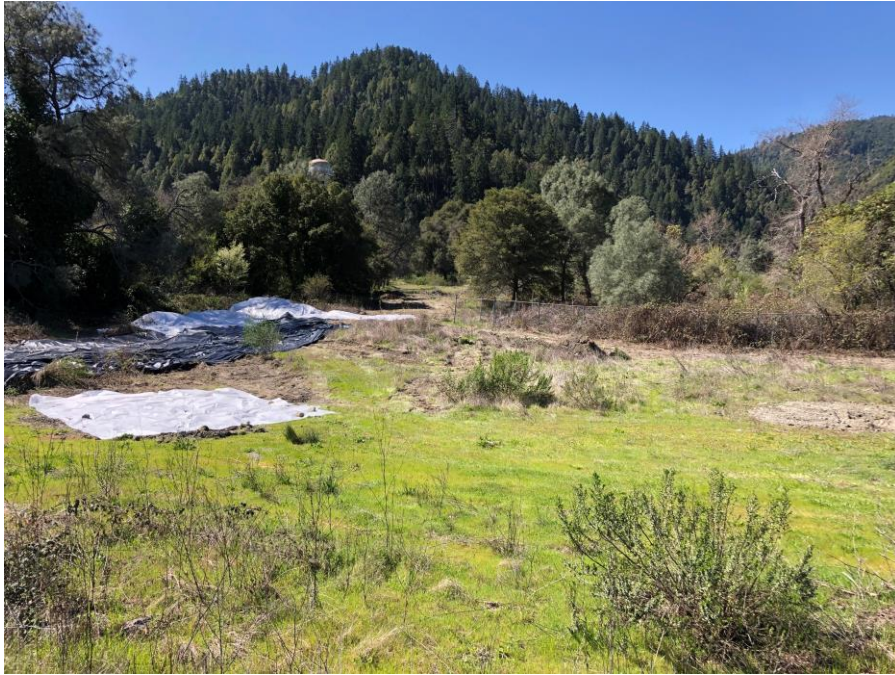
Photograph 7 – Northeast portion of Project Site with areas of covered ACM debris

It is recommended that any coverings overlaid on the ACM be regularly inspected to assess the integrity of the covering(s). Degradation of plastic sheeting may be expected due to weather exposure, thus subsequent applications of plastic sheeting (if used) should be directly overlaid on existing in situ plastic sheeting. Plastic sheeting should be weighted using sandbags, or other suitable materials, to prevent damage and/or fly-away due to wind.
