**Appendix B:
Site Reconnaissance Interview
and
Observation Report/
Photo Documentation**

Photodocumentation - Halaco Engineering Integrated Assessment

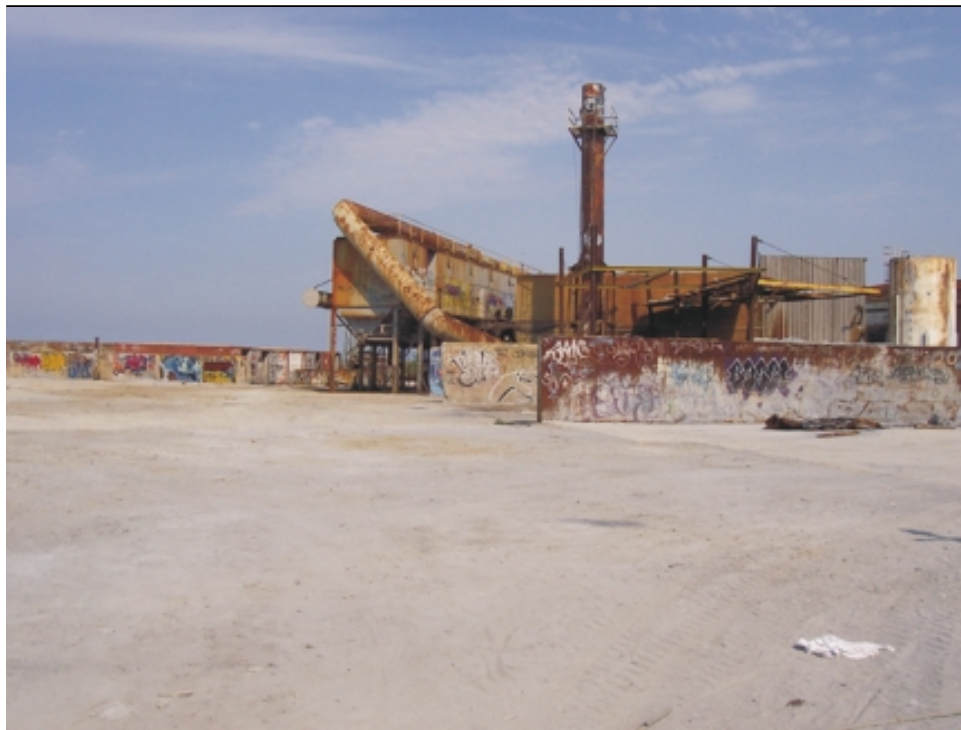
Several lean-to structures and Connex boxes lie in the receiving area; inspection of these reveal trash, drums of what appear to be oil-based chemicals, and SuperSacs filled with fine-grained, gray slag material. Most of the building also have large accumulations of slag waste either in SuperSacs or in a large pile in the Smelter building. Large areas of the paved surface in and around the old workings are coated with slag as well. Sumps associated with the machinery around the Smelter area contain highly turbid water, presumably due to the fine-grained, metal-rich wastes. Most of the structures around the site are covered with very complex graffiti, indicating that taggers are spending a significant amount of time on the property.

Photo 1: The Halaco Smelter Facility. Note the prolific graffiti at almost every accessible surface. Photo by B. Castellana.

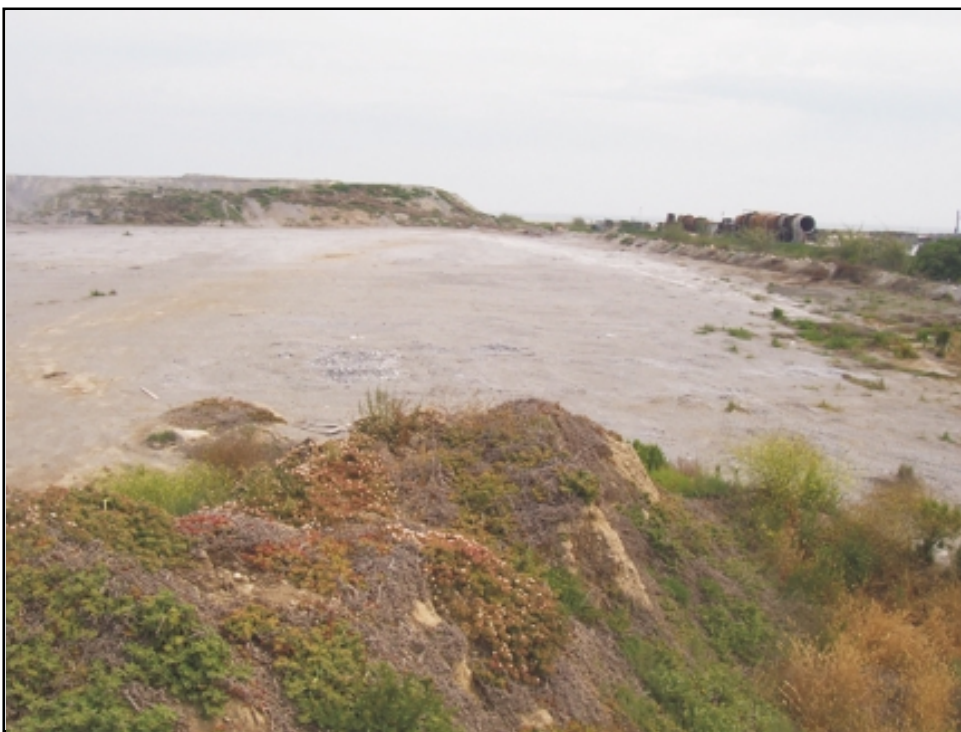
Photo 2: The Waste Disposal Area and Waste Management Unit taken from the berm along the northern part of the site. The Oxnard Industrial Drain is to the right in the photo. Photo by B. Castellana

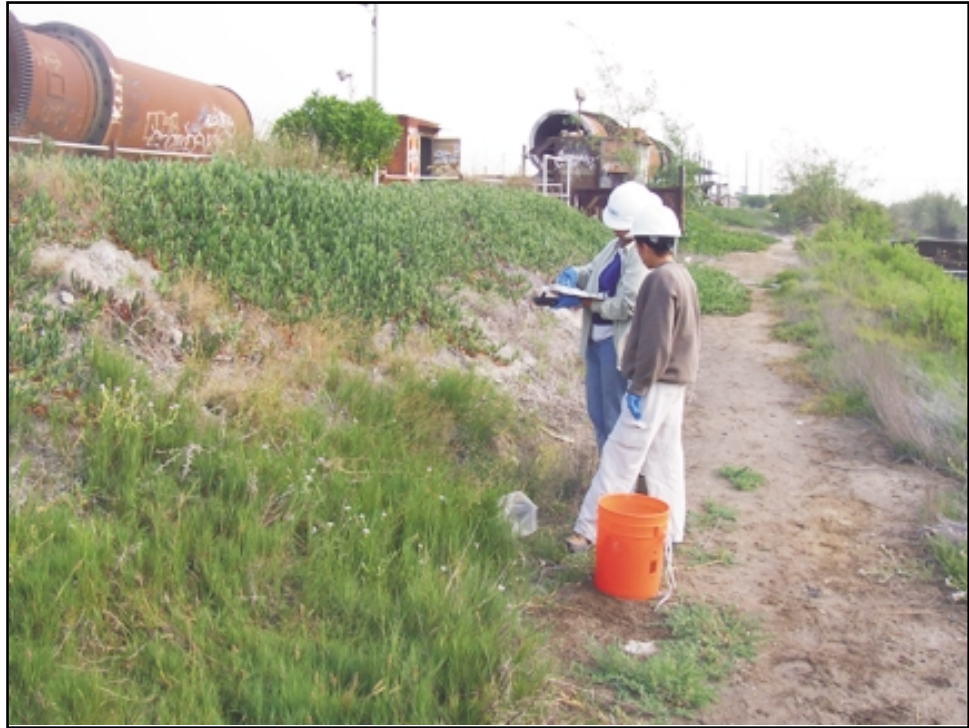
Photo 3: Collecting soil samples from the Smelter Area, along the OID.
Some of the highest Gamma readings were observed in this area.
Photo by B. Castellana.

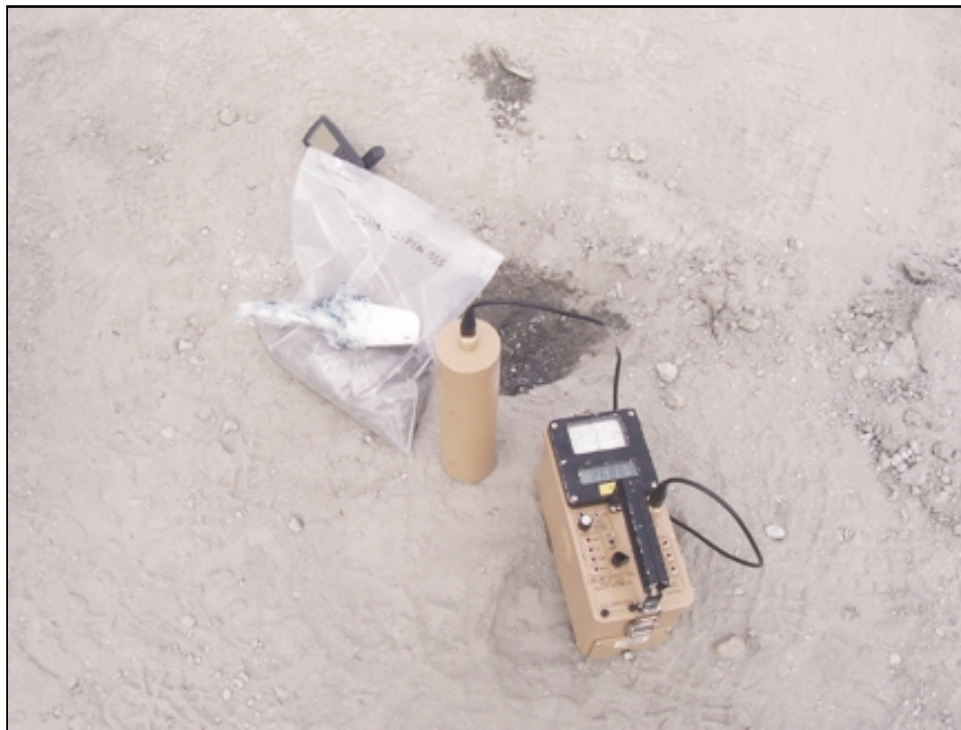
Photo 5: Collecting sample SSN51 from the Waste Disposal Area. The soil here is dominated by two to five feet of waste material used to fill in the surface. Photo by B. Castellana on 06-21-06.

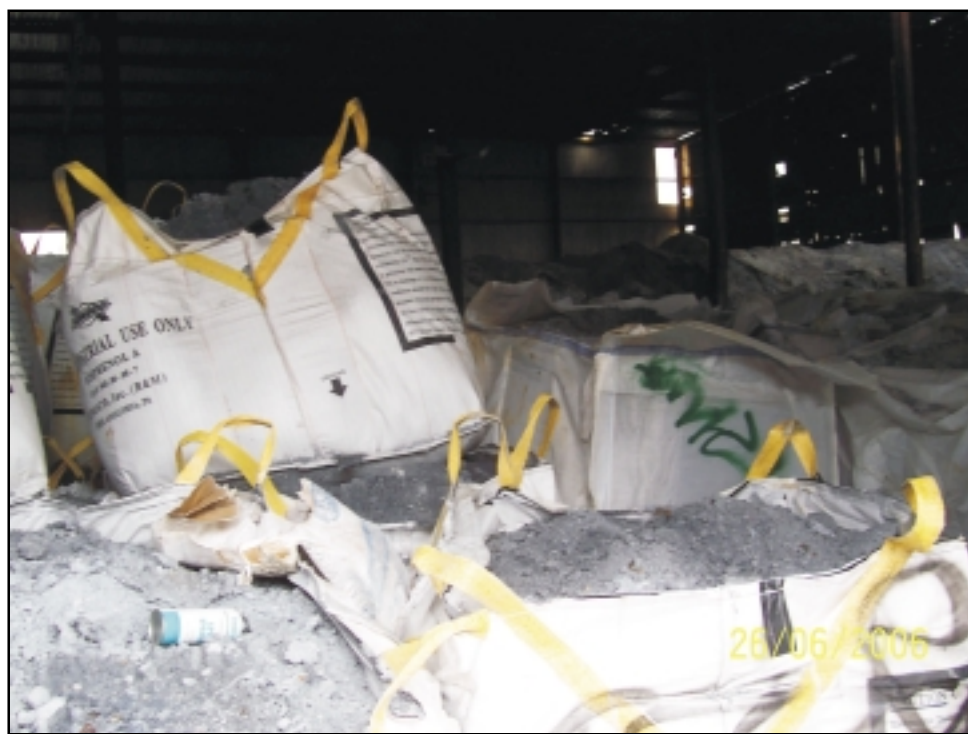
Photo 5: Smelter waste stored in SuperSacs in the warehouse, smelter, and multiple Connex boxes throughout the Smelter Area. Five composite samples were collected from these areas. Photo by A. Rice on 06-26-06

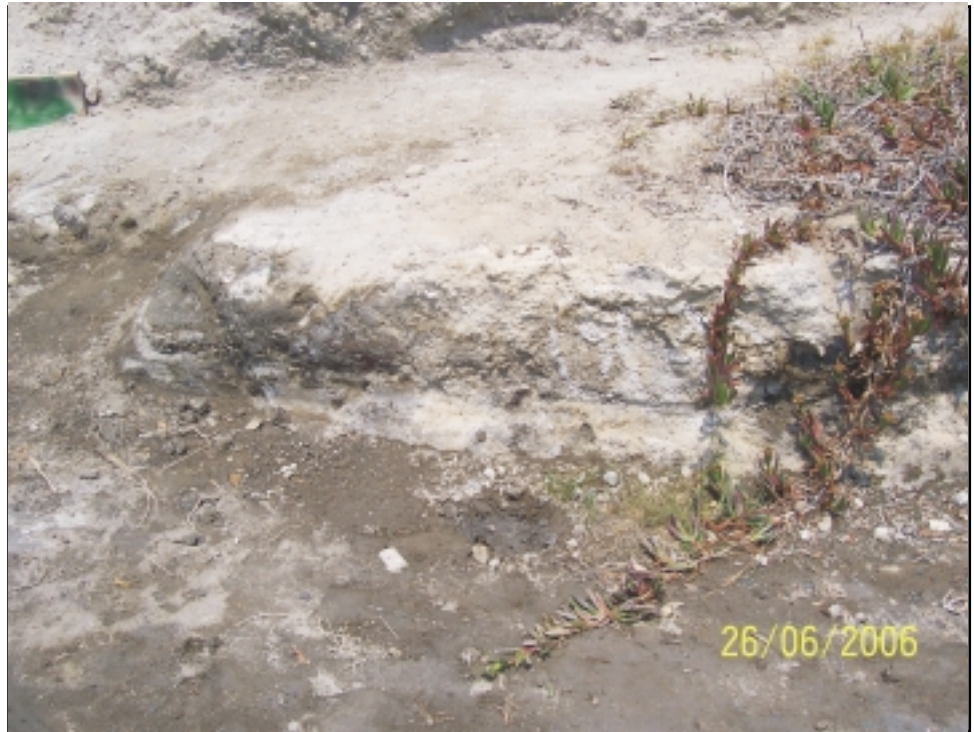
Photo 7: Soil sample location along the eastern boundary of the Smelter Area. High gamma readings were observed in this area. Photo by A. Rice.

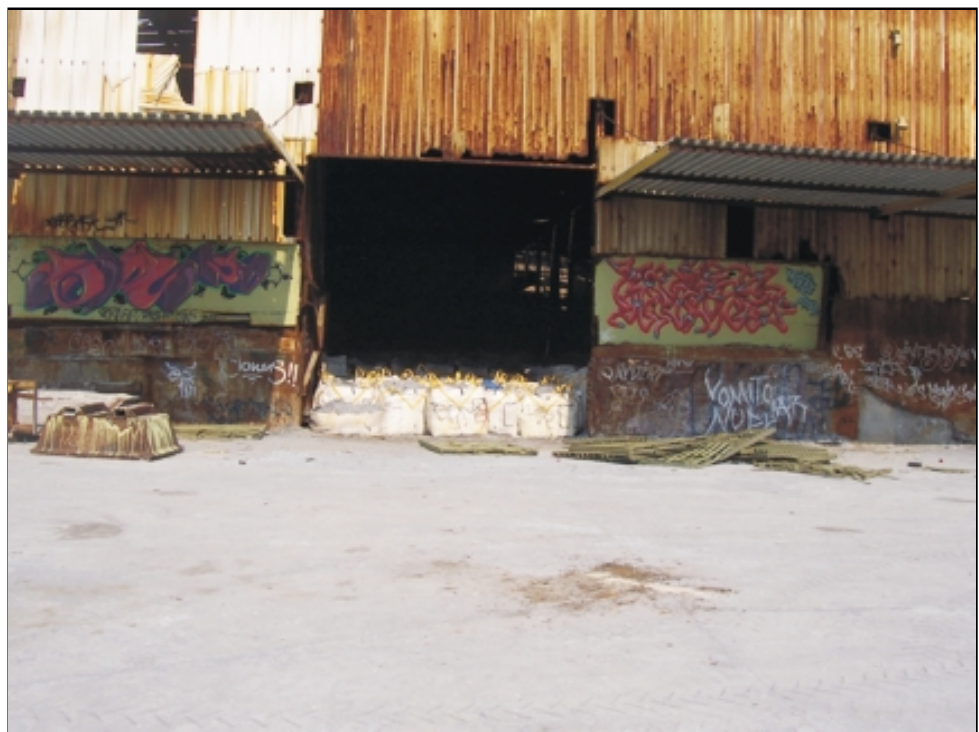
Photo 8: Supersacs stored in the smelter building. Note the graffiti. Photo by B. Castellana on 06-28-06.

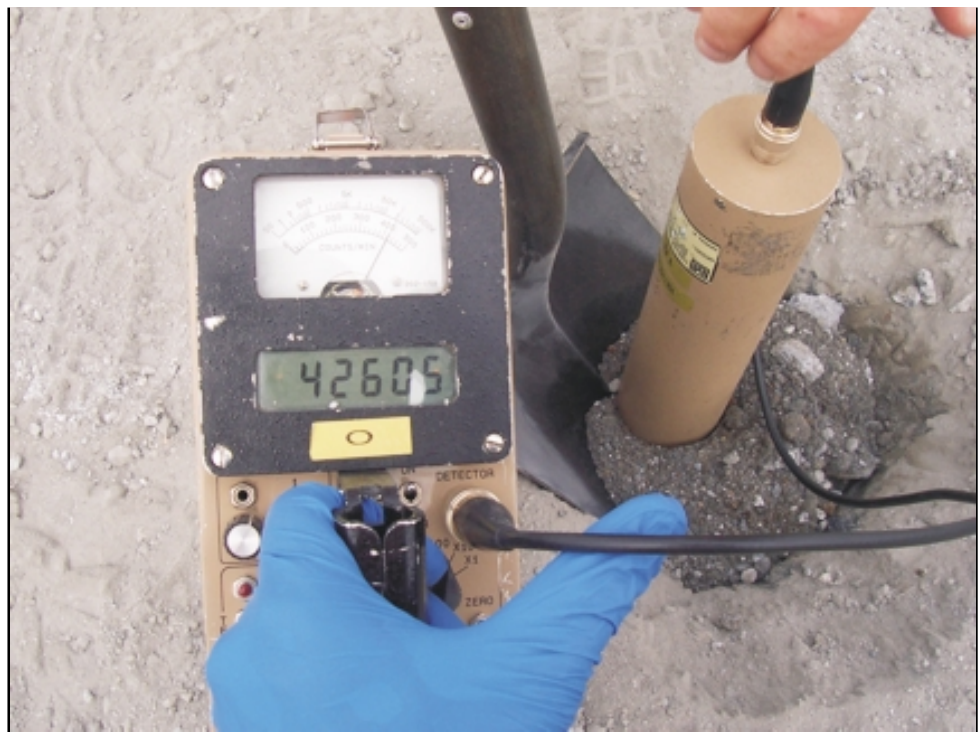
Photo 10: Gamma screening at sampling locations in the Waste Disposal Area. Background readings range from 7,000 to 14,000 counts per minute. Photo by B. Castellana taken on 06-21-06.

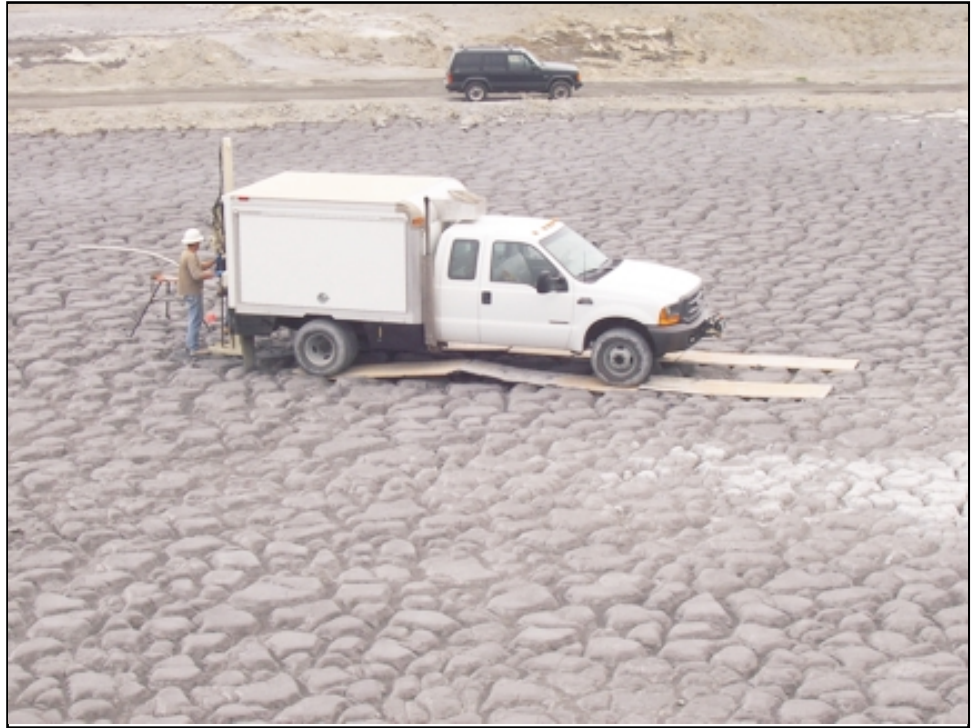
Photo 11: The EPA GeoProbe collecting waste samples in the WMU. The Geoprobe had to be driven on 1.25" plywood boards to keep it from sinking into the waste pile. Photo by B. Castellana taken on 06-27-06.

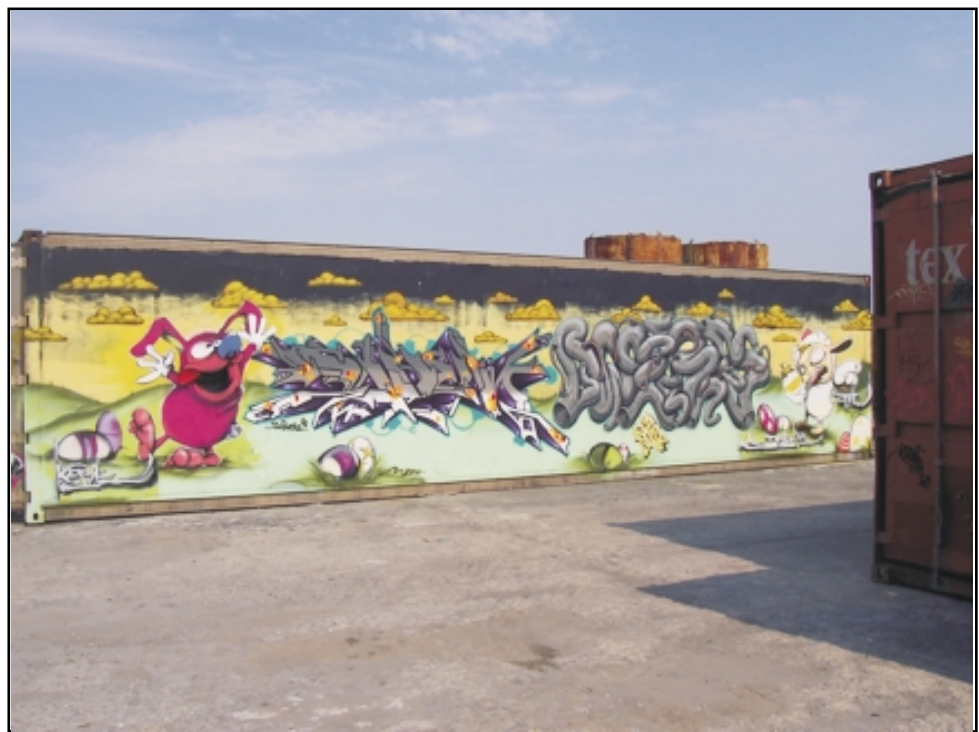
Photo 12: Complex graffiti at the site. Photo by B. Castellana taken on 06-27-06.

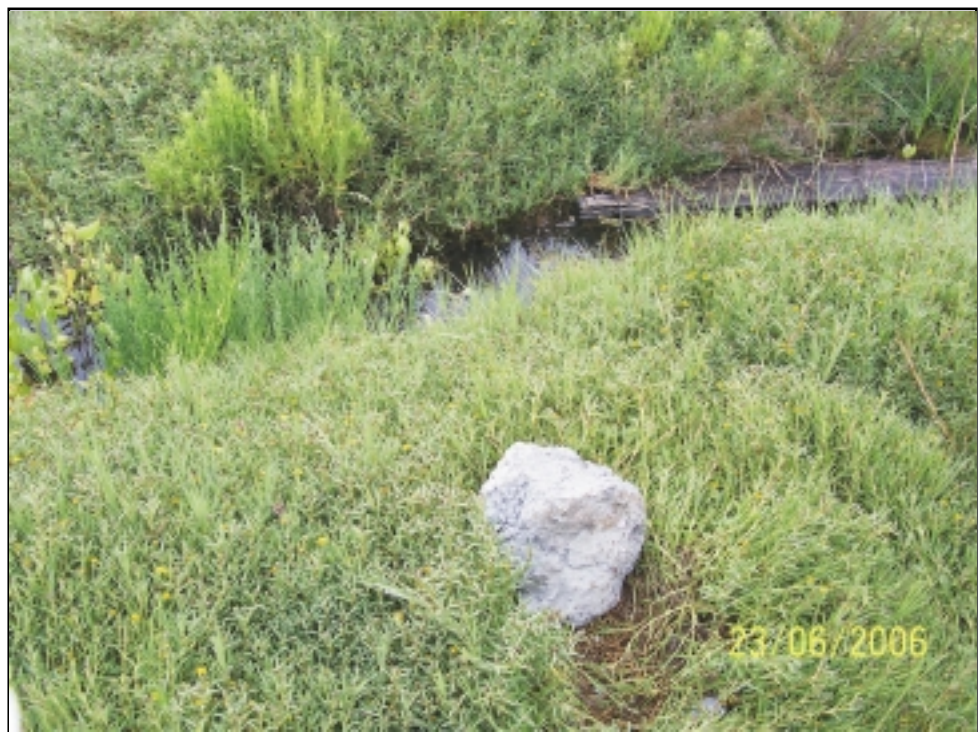
Photo 16: Large chunk of waste spalled off of the WMU into the wetlands to the south. Photo by A. Rice.

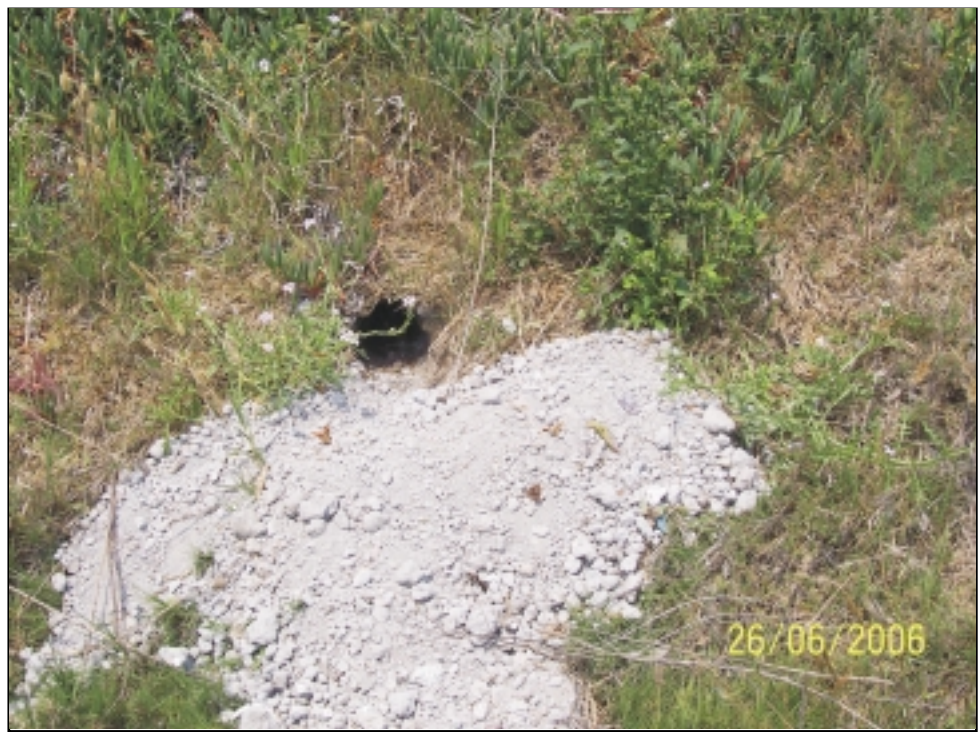
The WMU is approximately 20 to 25 feet above ground surface. There are three containment pond areas constructed in the top of the WMU. There appears to have been some cover and erosion control installed along the berm walls, as there is sporadic areas of vegetation, especially on the south and east sides of the WMU. These areas are broken up by what appears to be areas of slumping, where the internal depositional layering is evident. There is a silt fence and straw boom constructed around the south and east toes of the berm; in spite of this, large chunks of waste may be found in the adjacent wetlands. Weston noted burrows into the soil cover where ground squirrels and other burrowing animals have exposed waste materials at several places around the WMU.

Photo 18: Waste material extracted from under the soil cover by burrowing animals. Photo by A. Rice.

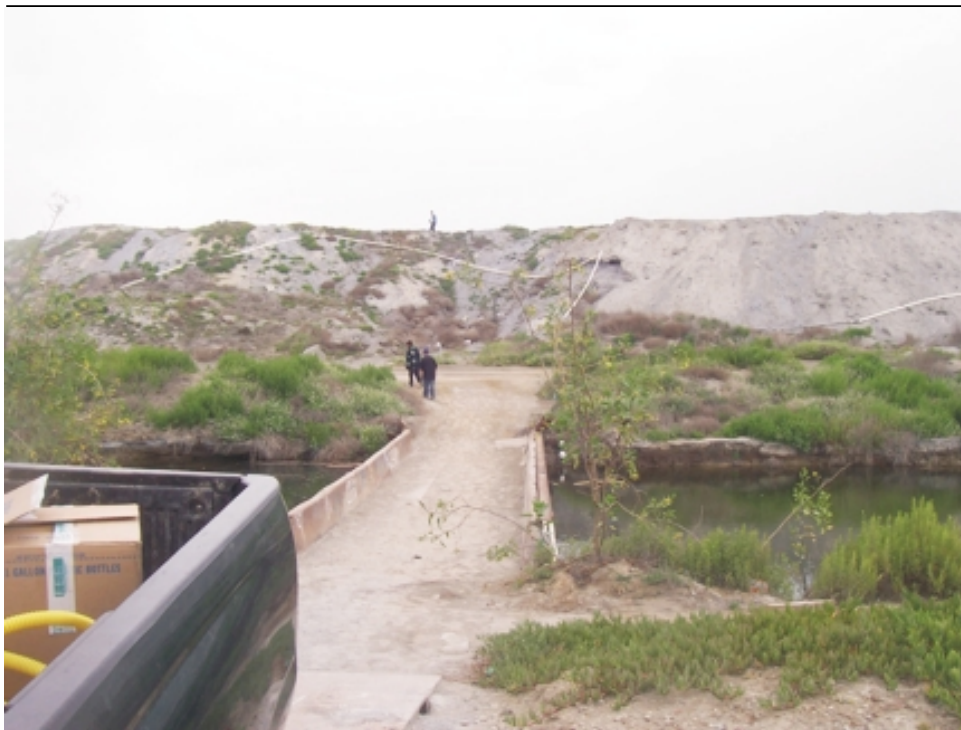
There is a bridge over the OID connecting the Smelter Area and the Waste Disposal Area. Inspection of the banks indicates the presence of slag in the wall of the OID. Concave cutbacks into the banks of the OID indicate mass wasting at periods of high flow.

Photo 19: View across the OID bridge on the Smelter side, looking east toward the WMU. The people on the WMU are trespassers. There is grey-colored waste material present in the wall of the OID, just above the water line. Photo by B. Castellana taken on 06-28-06.

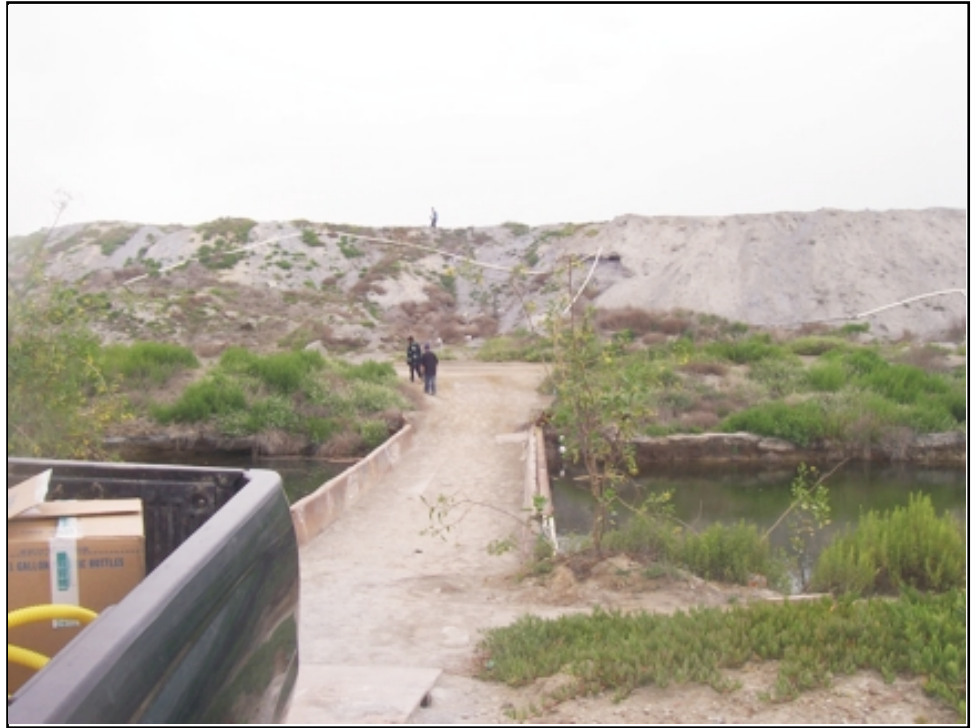
Photo 21: View of the WMU from the Smelter Area. Note the waste material in the wall of the banks of the OID. Photo by B. Castellana.
