April 27, 2021

SUBJECT: Action Memorandum for an Emergency Response Action at the Klamath Falls Motel Mercury Site, Klamath Falls, Klamath County, Oregon, Pursuant to the On-Scene Coordinator's Delegated Authority under Section 104 of the Comprehensive Environmental Response, Compensation, and Liability Act (CERCLA)

Site ID: 10TF

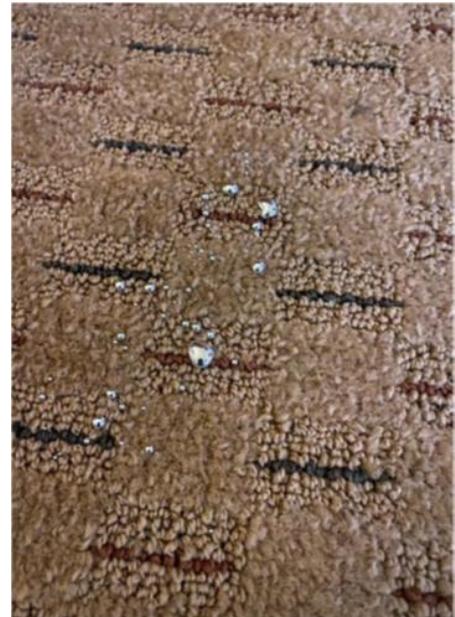
The motel owner contacted a local environmental clean-up company, who performed an assessment, found a vial with residual mercury on a dresser in the room, photographed mercury beads on the carpet, and provided a cost estimate to clean up the room.¹ The clean-up company estimated that, potentially, two ounces of elemental mercury may have been released to the carpet and other surfaces in the room. The motel owner did not contract with the clean-up company who performed the assessment; instead it hired a different company that removed a patch of carpet and bedding, overpacked the contaminated materials into a drum, and transported it for disposal under manifest on December 4, 2020.

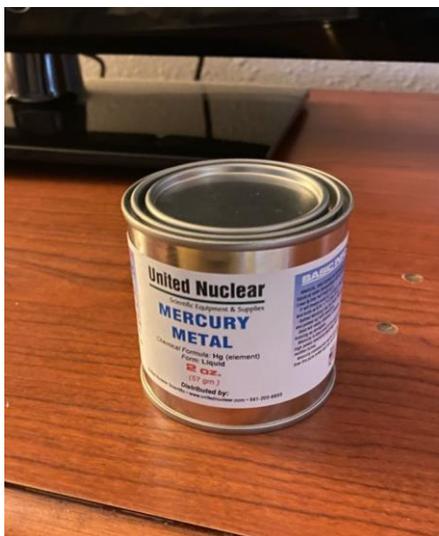
The attached photo of the mercury container shows an outer metal paint can labeled as containing two ounces of elemental mercury, and it is believed to have contained an inner vial of elemental mercury. A conservative estimate of up to two fluid ounces of elemental mercury could have been released into the environment with an unknown amount remaining as residue in the vial when the individual spilled the vial of mercury onto the motel room carpet and some bedding in the small 16-foot by 16-foot room.³
