**Subject: Contract 68HERH19D0018; Task Order (TO) 68E0719F0190
Joplin Union Depot, 205 North Main Street, Joplin, Jasper County, Missouri
Targeted Brownfields Assessment, Hazardous Materials Survey**

**TARGETED BROWNFIELDS ASSESSMENT
HAZARDOUS MATERIALS SURVEY**

**JOPLIN UNION DEPOT
205 NORTH MAIN STREET
JOPLIN, JASPER COUNTY, MISSOURI**

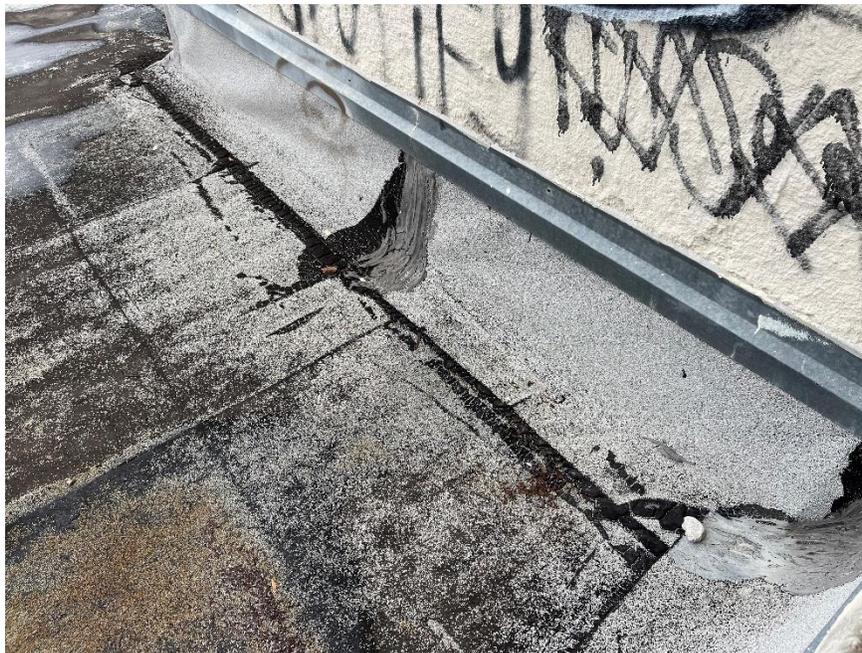
| SUBTASK NO. 19.05 | DESCRIPTION | This photograph shows confirmed asbestos-containing material (ACM) black roof flashing typical of material present across the roof. | 2 |

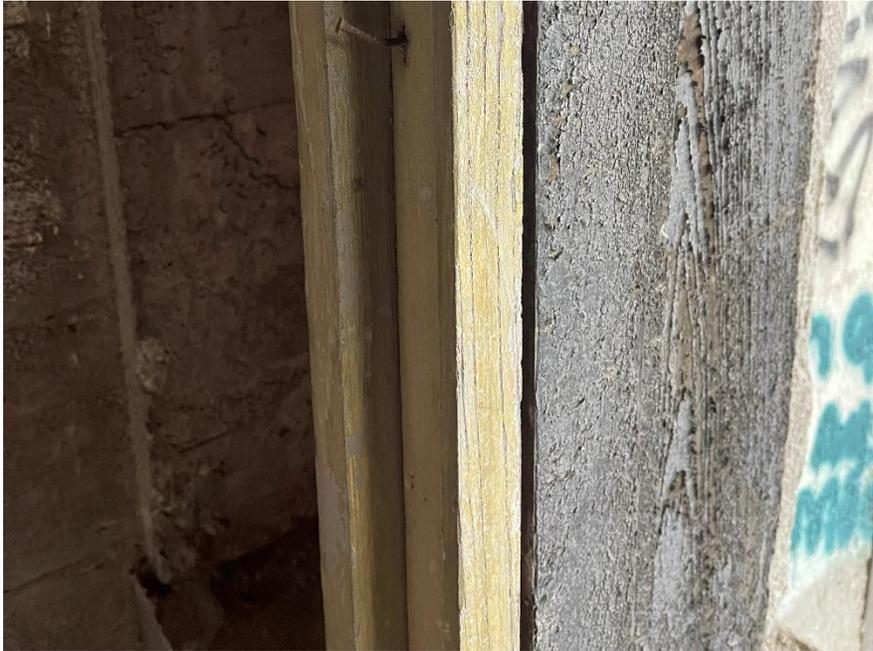
| SUBTASK NO. 19.05 | DESCRIPTION | This photograph shows olive lead-based paint (LBP) on a wood window frame in Room 3. | 3 |

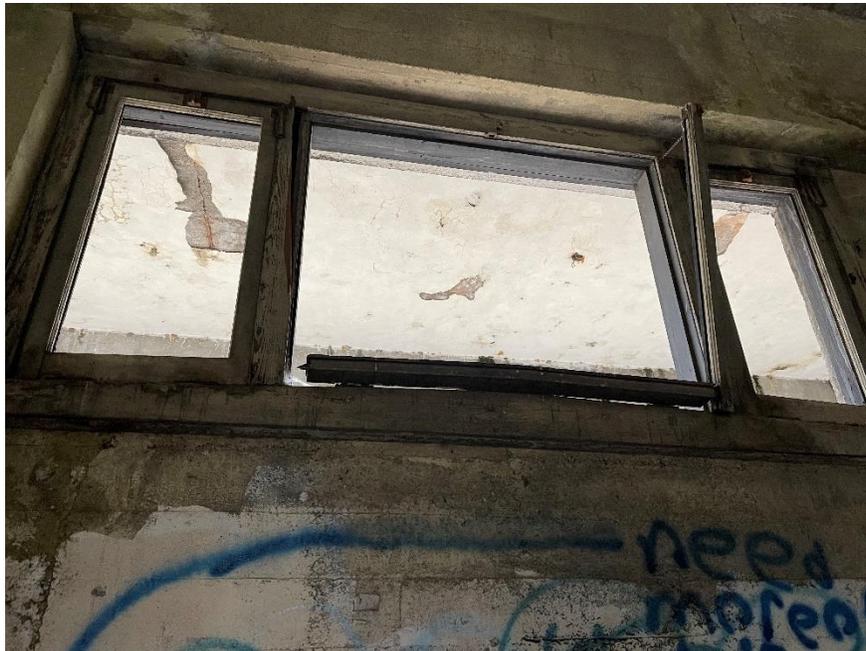
| SUBTASK NO. 19.05 | DESCRIPTION | This photograph shows yellow LBP present on wood windows and window frames in Room 4. | 4 |

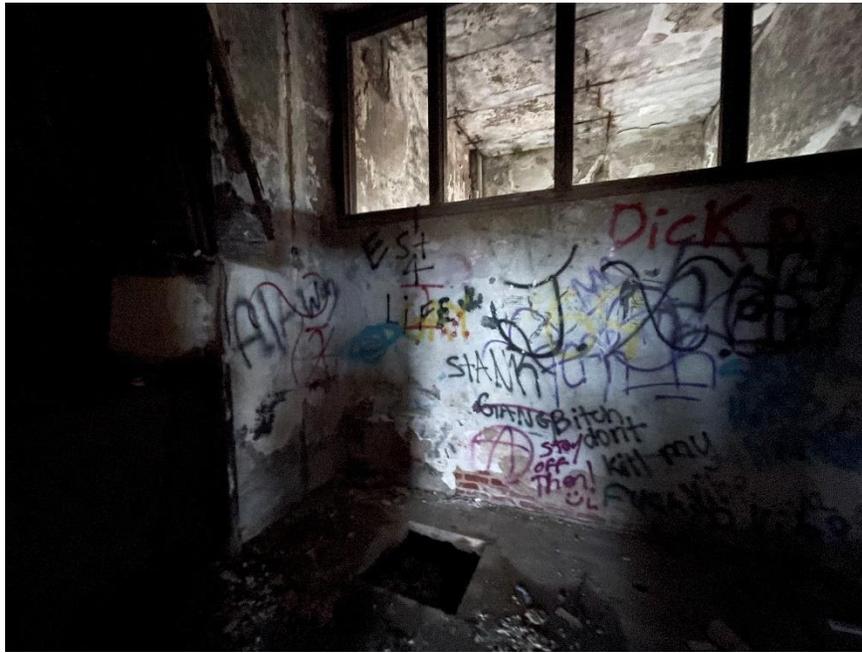
| SUBTASK NO. 19.05 | DESCRIPTION | This photograph shows gray LBP present on plaster walls in Room 5. | 5 |

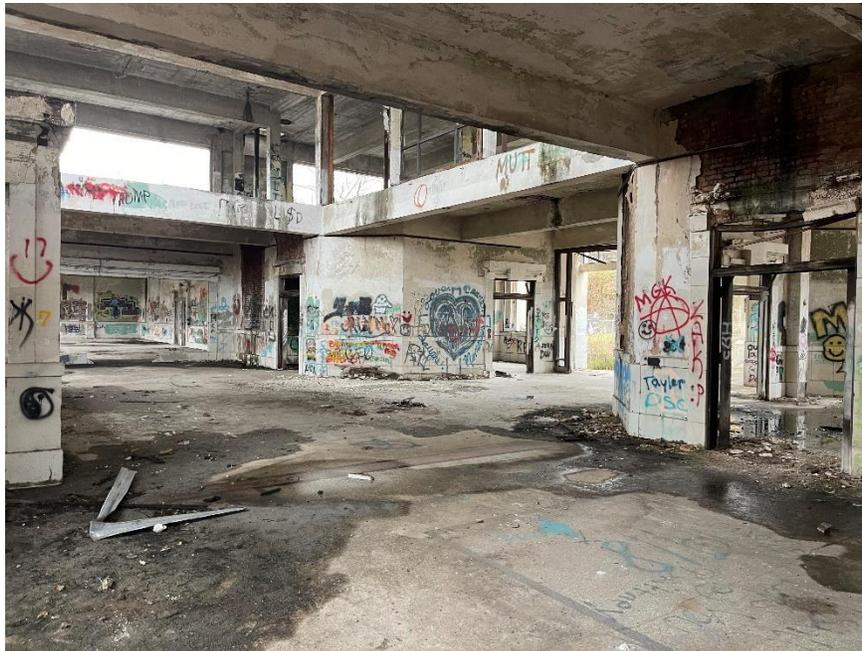
| SUBTASK NO. 19.05 | DESCRIPTION | This photograph shows tan LBP on plaster walls and ceiling in the Main Room (Room 7). | 6 |

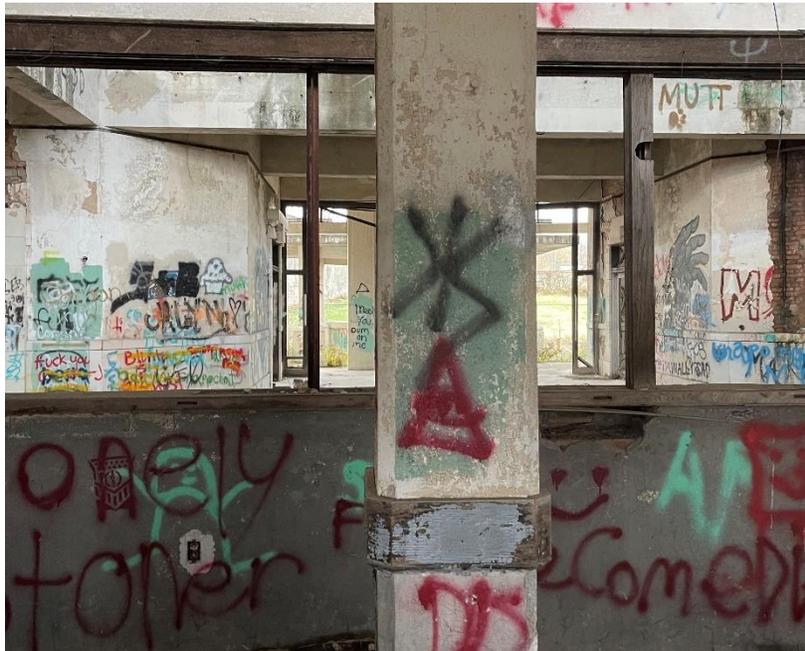
| SUBTASK NO. 19.05 | DESCRIPTION | This photograph shows tan LBP present on plaster columns in the Check-in Area. | 7 |

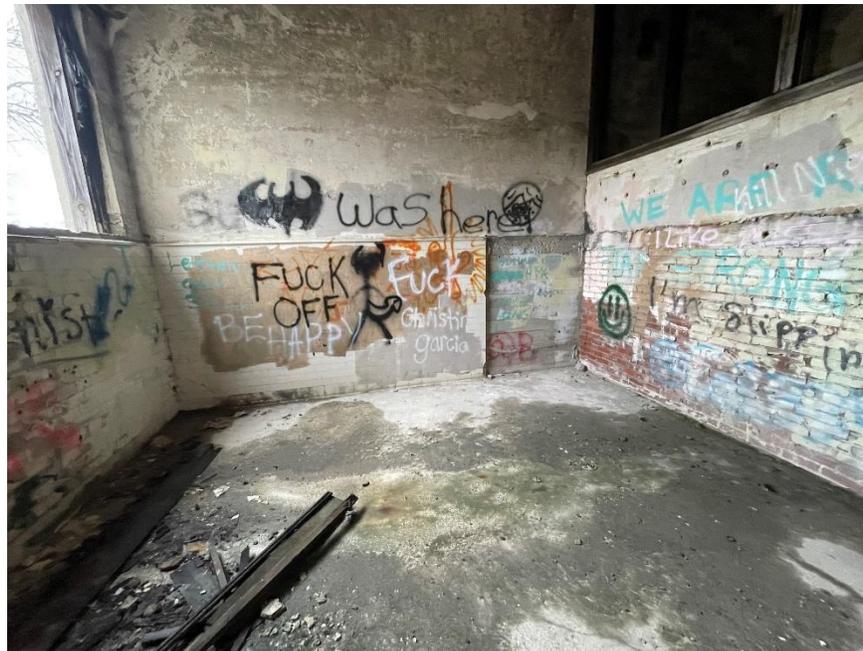
| SUBTASK NO. 19.05 | DESCRIPTION | This photograph shows white LBP on plaster walls in the Women's Restroom (Room 8). | 8 |

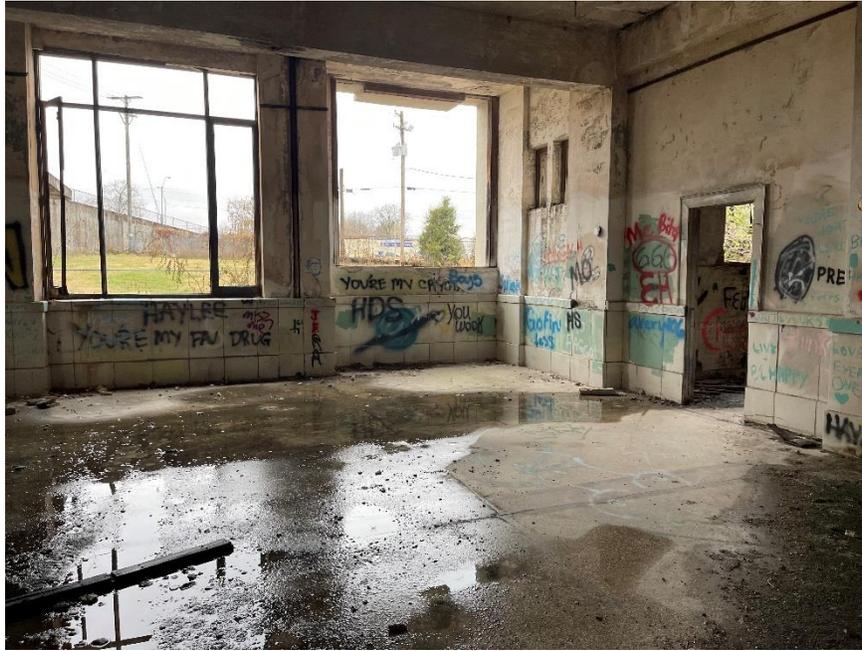
| SUBTASK NO. 19.05 | DESCRIPTION | This photograph shows tan and white LBP present on plaster walls and ceiling in Room 9. | 9 |

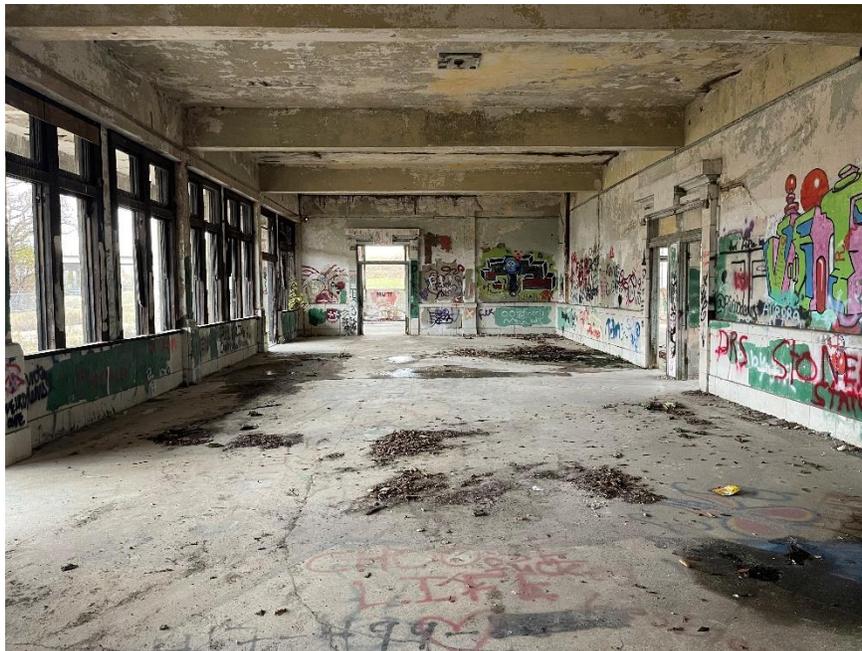
| SUBTASK NO. 19.05 | DESCRIPTION | This photograph shows white and green LBP on plaster walls and yellow LBP on the plaster ceiling in the Dining Room (Room 12). | 10 |

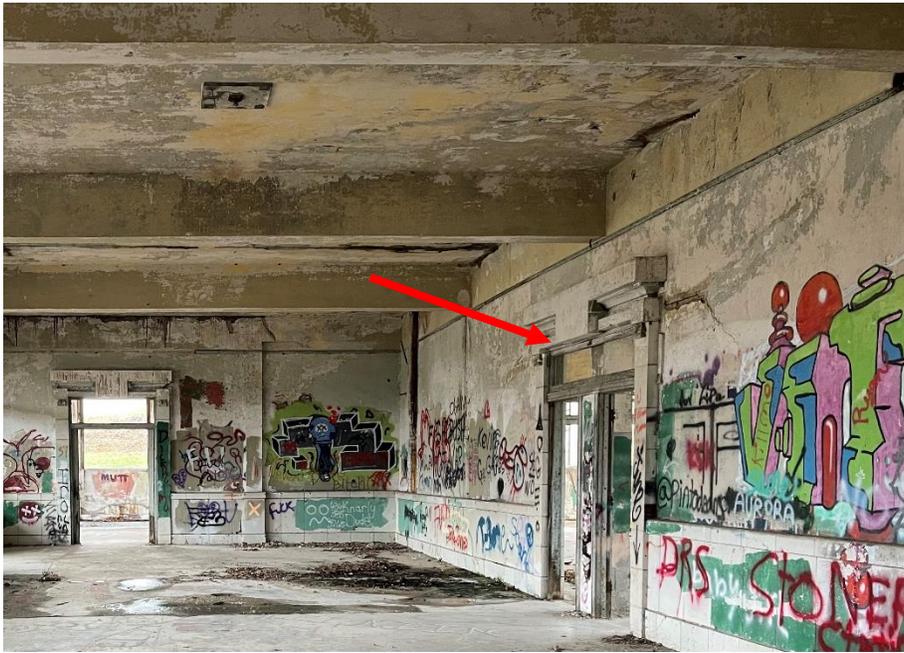
| SUBTASK NO. 19.05 | DESCRIPTION | This photograph shows green LBP on wood door casing trim in the Dining Room (Room 12). | 11 |

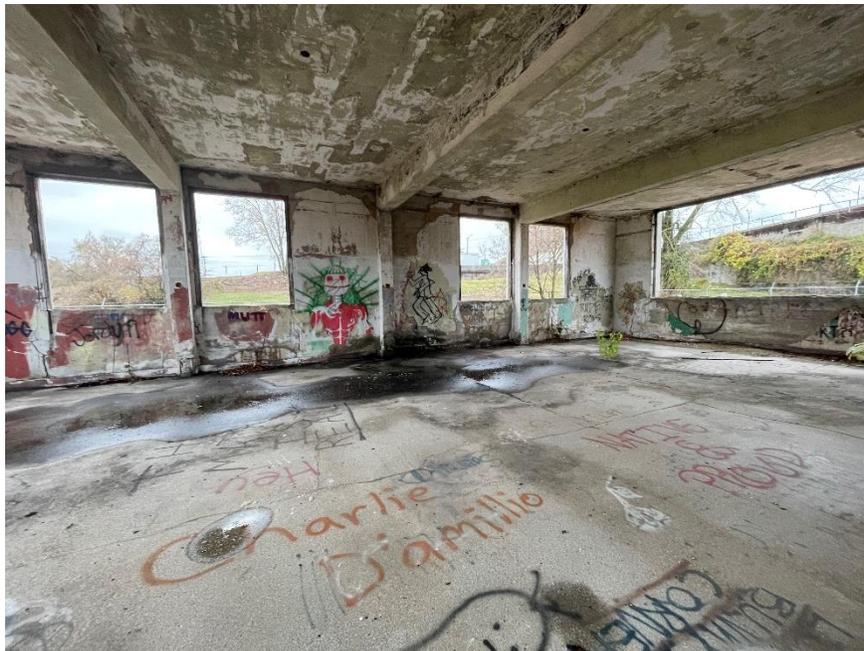
| SUBTASK NO. 19.05 | DESCRIPTION | This photograph shows beige and red LBP on plaster walls and ceiling in Room 13. | 12 |

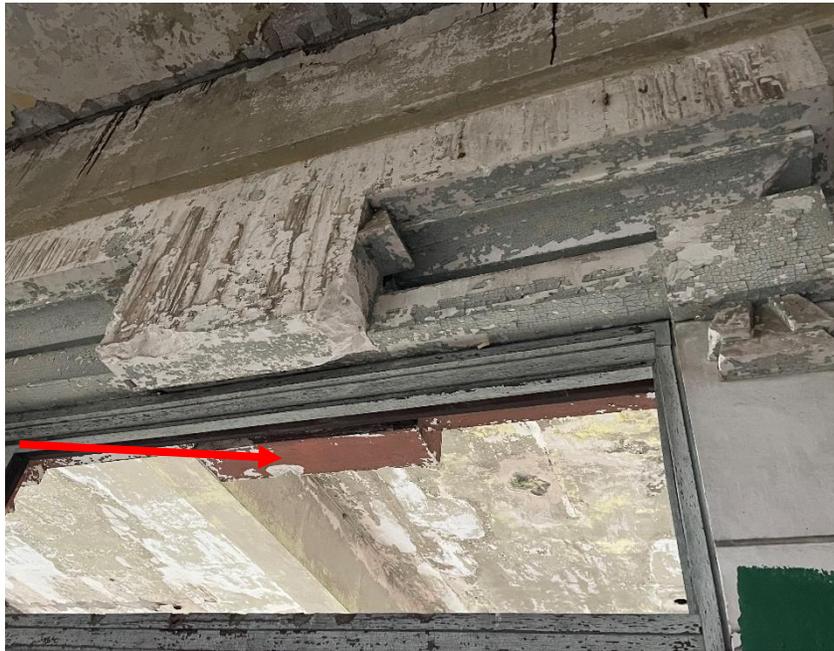
| SUBTASK NO. 19.05 | DESCRIPTION | This photograph shows red and white LBP on plaster decorative trim in Room 13. | 13 |

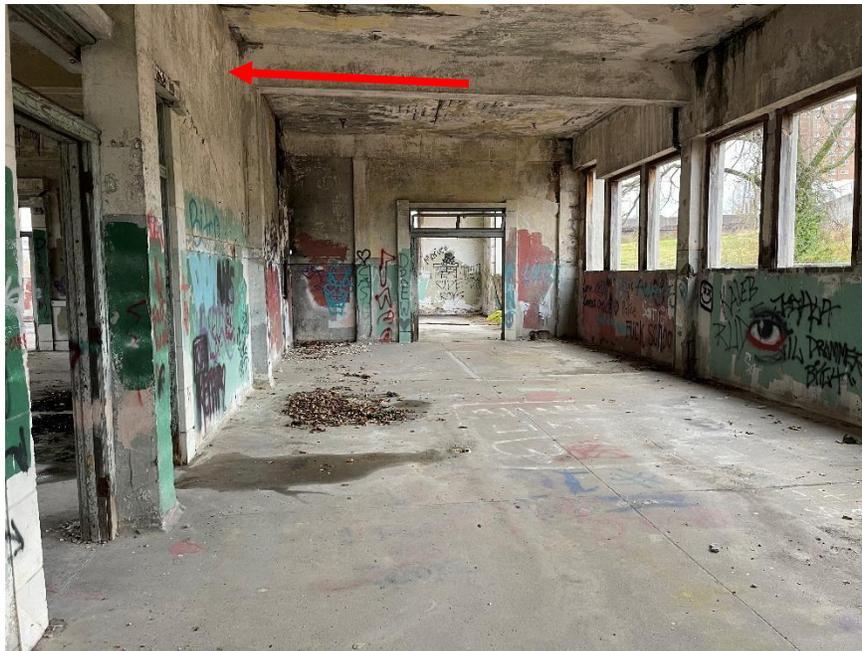
| SUBTASK NO. 19.05 | DESCRIPTION | This photograph shows beige LBP on the top half of plaster walls, as well as the plaster ceiling in the Kitchen (Room 14). | 14 |

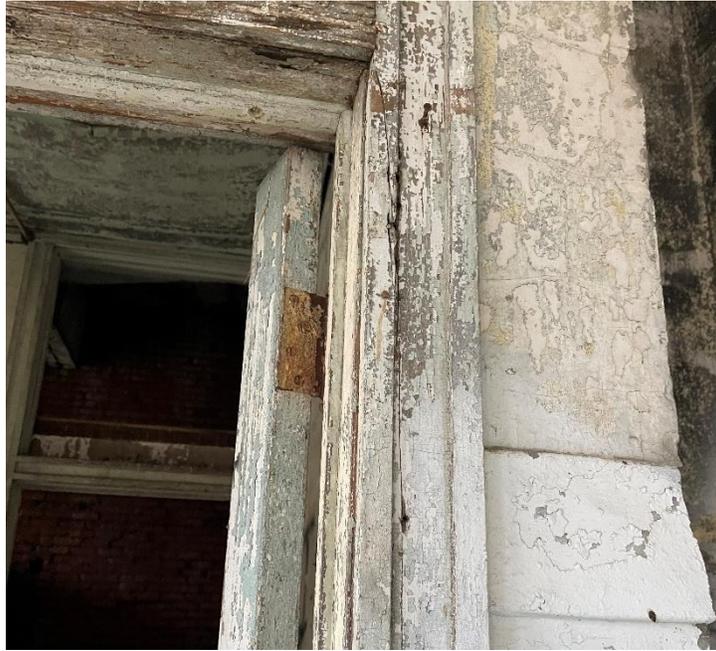
| SUBTASK NO. 19.05 | DESCRIPTION | This photograph shows green LBP on the wood door frame in the Kitchen (Room 14). | 15 |

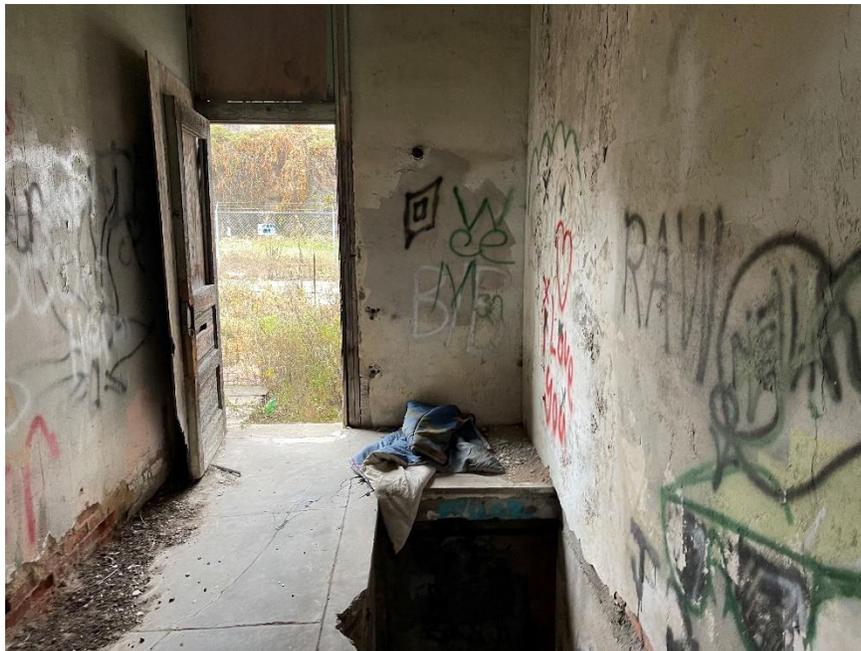
| SUBTASK NO. 19.05 | DESCRIPTION | This photograph shows white LBP on plaster walls in the Basement Access Room. | 16 |

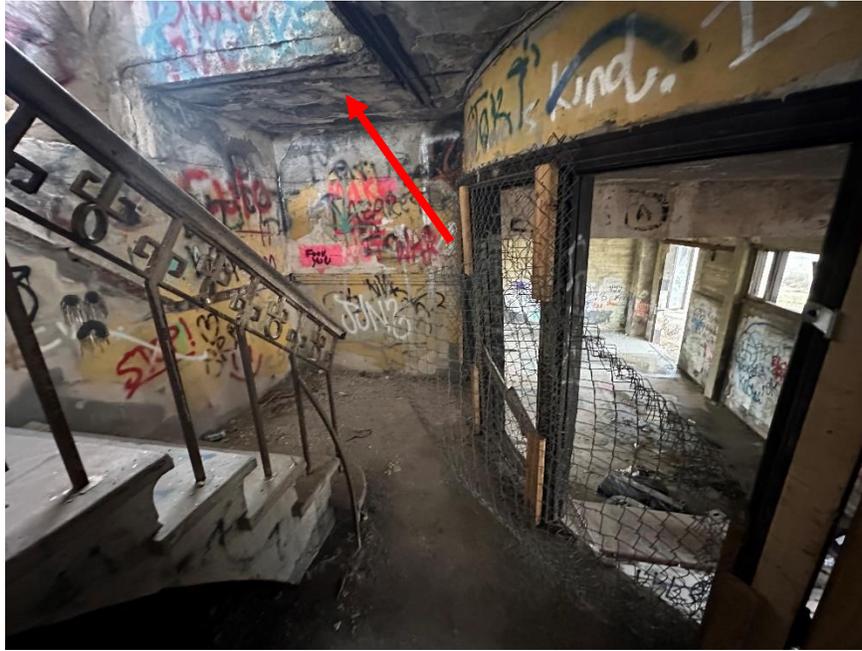
| SUBTASK NO. 19.05 | DESCRIPTION | This photograph shows gray LBP on the plaster ceiling in the 2 nd Floor Stairwell. | 17 |

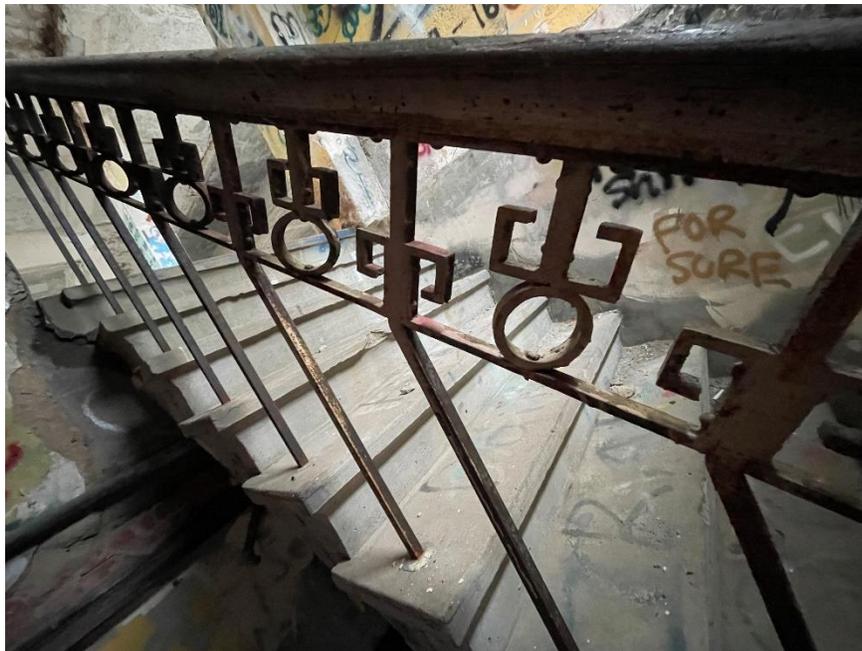
| SUBTASK NO. 19.05 | DESCRIPTION | This photograph shows white LBP on metal stair railings in the 2 nd Floor Stairwell. | 18 |

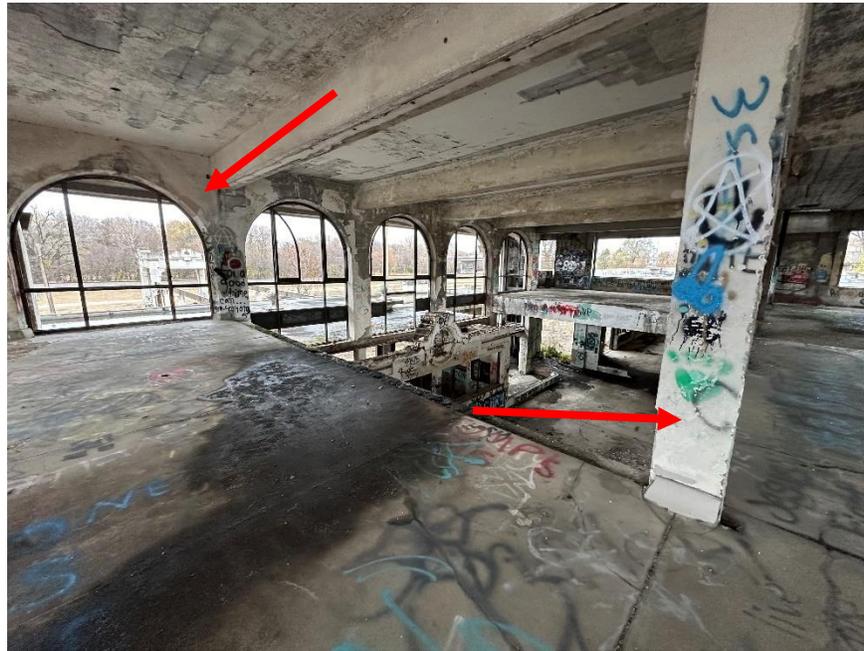
| SUBTASK NO. 19.05 | DESCRIPTION | This photograph shows white LBP on plaster walls, as well as on columns on the 2 nd Floor. | 19 |

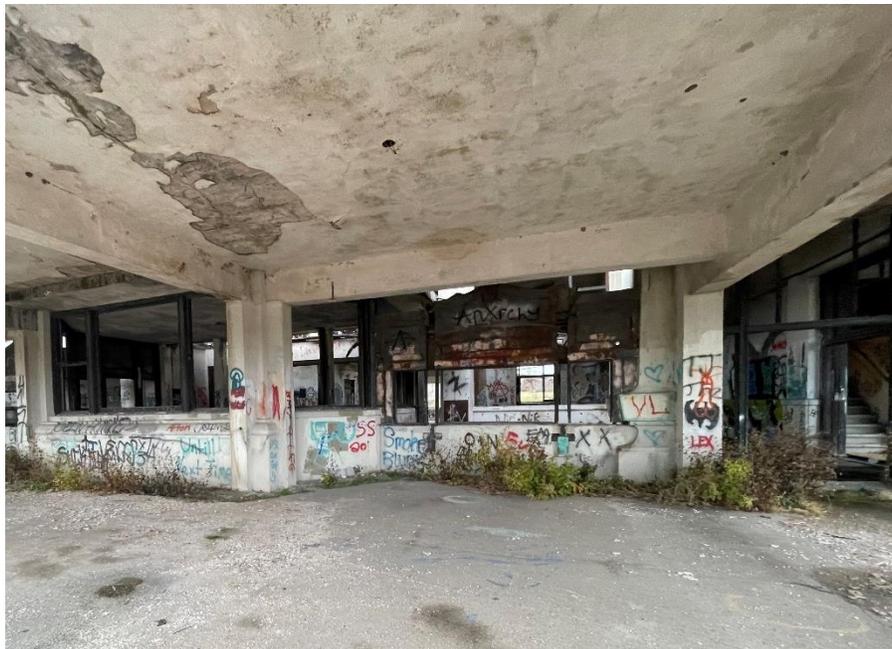
| SUBTASK NO. 19.05 | DESCRIPTION | This photograph shows black LBP on the exterior wood door and wood window frames. | 20 |
