February 2, 2024

**Subject: Letter Report**  
**Castle Pines Abandoned Drum**  
**560 Castle Pines Parkway, Castle Pines, Colorado, 80108**  
**U.S. EPA Region 8 START V, Contract No. 68HE0823F0059**  
**Technical Direction No: 2359-2312-08**

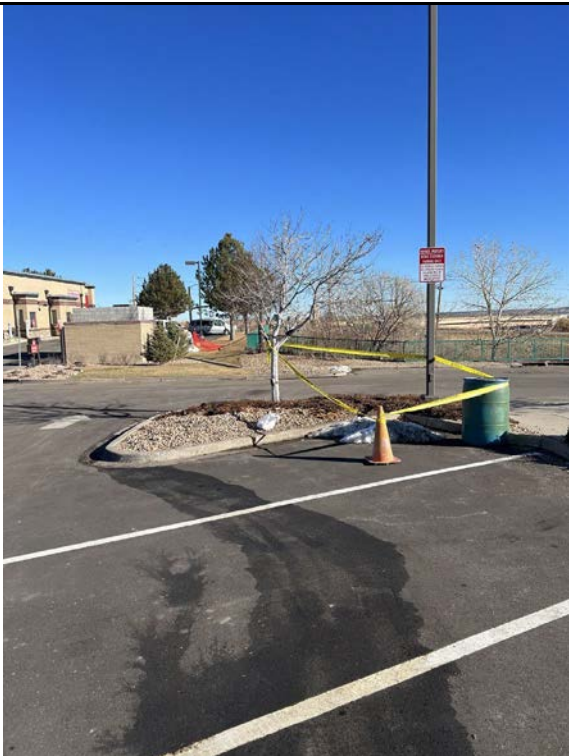
- Upon arrival at the Site, START assessed for immediate hazards, the drum condition, and perimeter of the exclusion zone. Noticeable staining marked the pavement, starting approximately 50 feet west of the area where the drum was abandoned and ended within approximately 5 feet of the abandoned drum location. A faint petroleum odor was detected near the staining. ERRS placed an absorbent material on the stained area and marked the exclusion zone.

<b>Photographer:</b>	leyoub_Patrick	
<b>Latitude:</b>	39.4712391	
<b>Longitude:</b>	-104.8745726	
<b>Photo Direction:</b>	NNE	
<b>Category:</b>	Emergency Response	
<b>Photo Description:</b> Initial exclusion zone set up by local agency around the unknown abandoned drum. Staining on asphalt is suspected petroleum contamination.		
<b>Photo Name:</b> Photos-20231218-173026.JPG

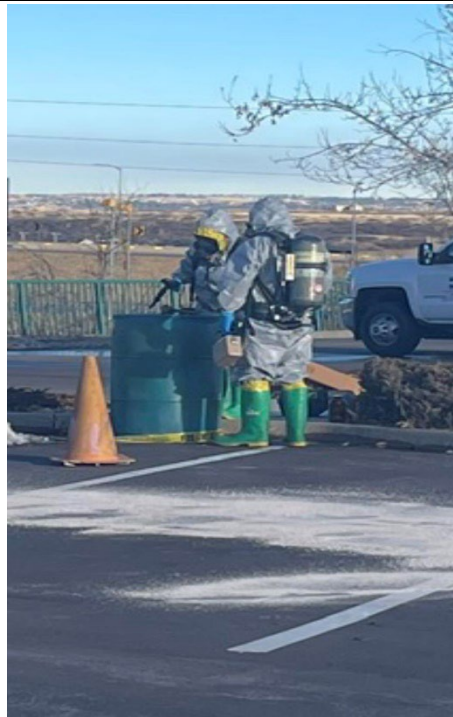
- START conducted an initial screening of the unopened drum around the drum sides and bung closures. The TVA and multi-gas meter had low-level detections on both the FID and PID for VOC and combustible vapors. No other detections on the multi-gas monitors were observed. Detections observed on the radiation meter were at background. Initial screenings between the FTIR and Raman analyzers were inconclusive, possibly due to the analysis being performed on the drum's uneven surface.

<b>Photographer:</b>	leyoub_Patrick		
<b>Latitude:</b>	39.4712391		
<b>Longitude:</b>	-104.8745726		
<b>Photo Direction:</b>	NNE		
<b>Category:</b>	Emergency Response		
<b>Photo Description:</b> START monitoring around closures on the top of the abandoned drum to assess for physical and chemical hazards prior to opening.			
<b>Photo Name:</b> Photos-20231218-172532.PNG

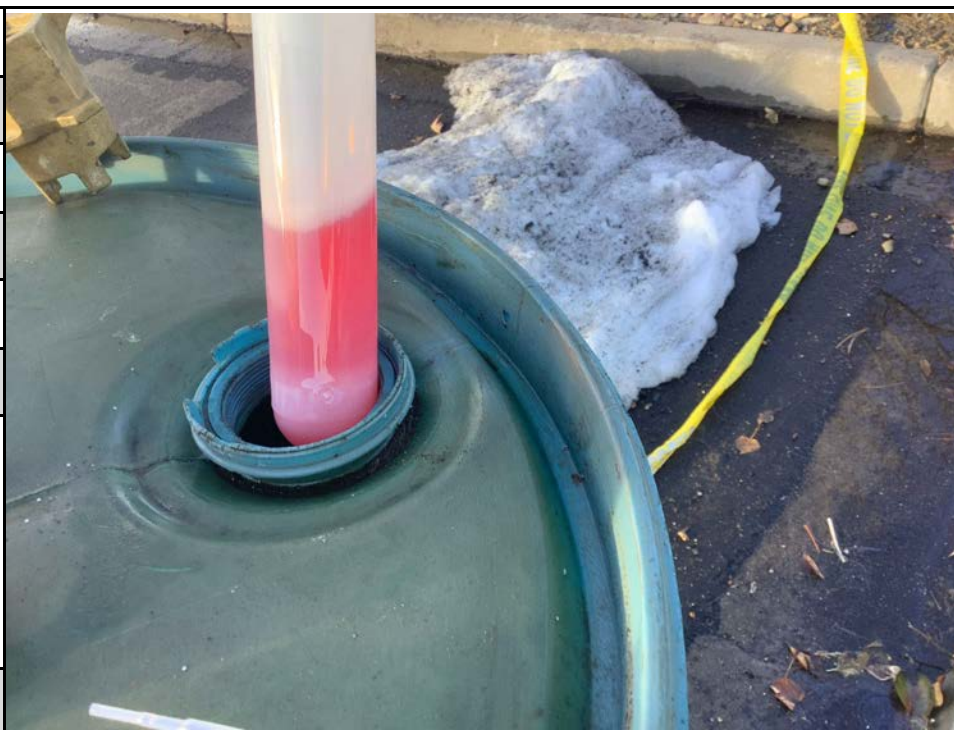
- An aliquot was collected from the drum for field screening on a Fourier transform infrared (FTIR) and Raman analyzer. Both detectors indicated the liquid was a petroleum product (specifically diesel). The sample was a neon pink, single phase, low-viscosity fluid.

<b>Date/Time Taken:</b>	12/16/2023 3:05:00 PM
<b>Photographer:</b>	leyoub_Patrick
<b>Latitude:</b>	39.4712391
<b>Longitude:</b>	-104.8745726
<b>Photo Direction:</b>	N
<b>Category:</b>	Emergency Response
<b>Photo Description:</b>	View of the contents from inside the abandoned drum from the bung closure.
<b>Photo Name:</b>	Photos-20231218-173142.JPG

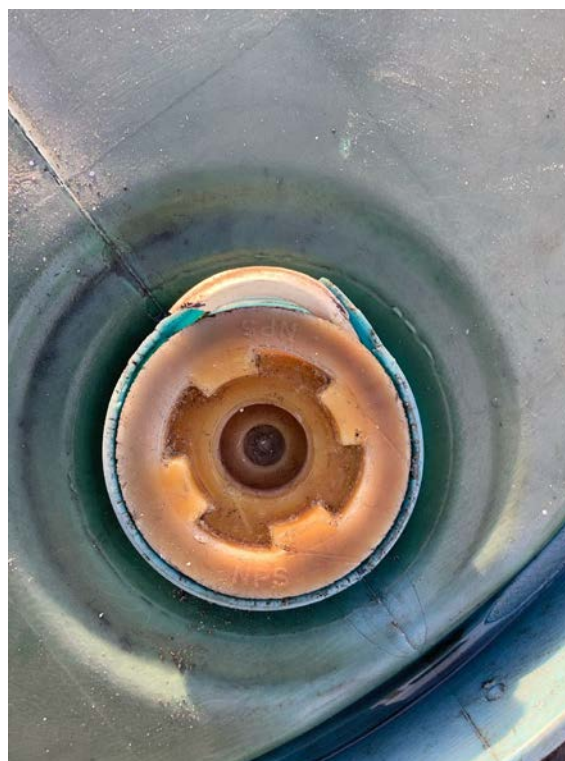
<b>Date/Time Taken:</b>	12/16/2023 3:07:00 PM
<b>Photographer:</b>	leyoub_Patrick
<b>Latitude:</b>	39.4712391
<b>Longitude:</b>	-104.8745726
<b>Photo Direction:</b>	N
<b>Category:</b>	Emergency Response
<b>Photo Description:</b>	Close-up view of the condition of the second bung closure located on the top of the abandoned drum. Bung closures are threaded plugs on drums to create liquid-tight seals that prevent dirt, dust, and contaminants from entering, as well as prevent material from leaking out of the drum during movement and handling. The bung and threads on the drum were damaged; therefore, the drum was not in condition to be shipped.
<b>Photo Name:</b>	Photos-20231218-175716.JPG

- START further tested the sample with hazard categorization field tests (Table 1 in Enclosure 4).
- The original drum was determined to be unshippable because the bung closure was visibly damaged. ERRS transferred the contents from the original drum into a new, shippable container.

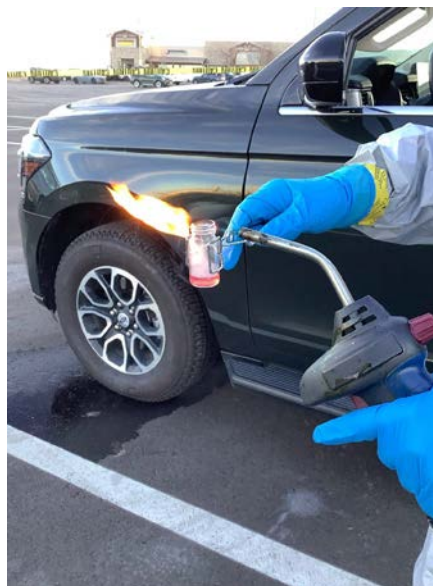
<b>Date/Time Taken:</b>	12/16/2023 3:39:00 PM
<b>Photographer:</b>	leyoub_Patrick
<b>Latitude:</b>	39.4712391
<b>Longitude:</b>	-104.8745726
<b>Photo Direction:</b>	ENE
<b>Category:</b>	Emergency Response
<b>Photo Description:</b>	Thermal field test performed on the sample from the abandoned drum showing ignitable vapors. The vehicle is several feet away from the test and is being used to shield the field testing from the wind as well as provide a dark backdrop to enable better flame color differentiation.
<b>Photo Name:</b>	Photos-20231220-143434.PNG

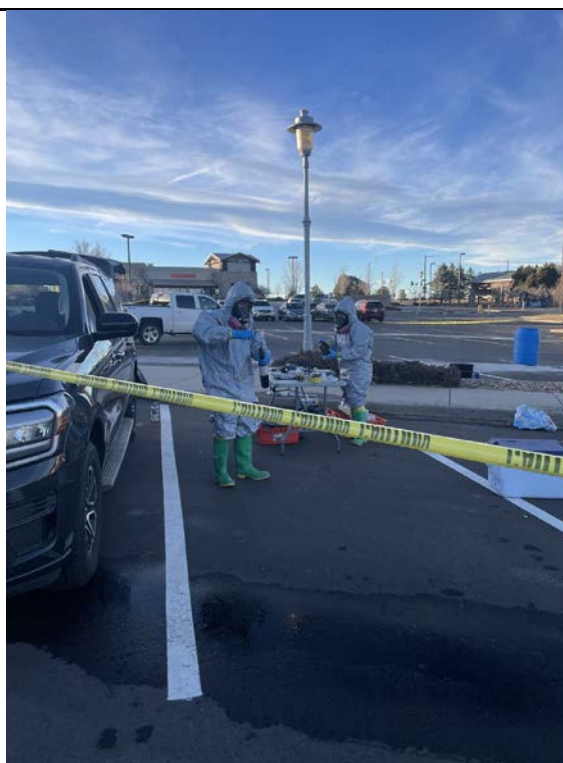
<b>Date/Time Taken:</b>	12/16/2023 3:56:00 PM
<b>Photographer:</b>	leyoub_Patrick
<b>Latitude:</b>	39.47113056
<b>Longitude:</b>	-104.87453611
<b>Photo Direction:</b>	WNW
<b>Category:</b>	Emergency Response
<b>Photo Description:</b>	START performing field tests to determine hazard categories of the contents from the abandoned drum. Personnel is wearing level C personal protective equipment (PPE).
<b>Photo Name:</b>	Photos-20231219-113232.JPG

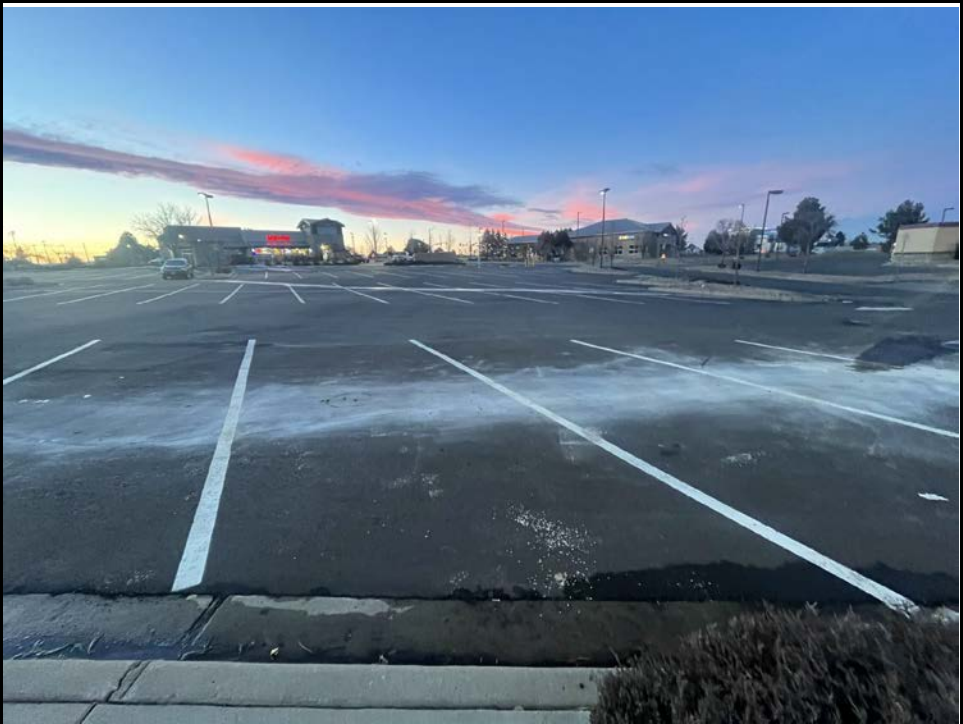
<b>Photographer:</b>	leyoub_Patrick	
<b>Latitude:</b>	39.47116944	
<b>Longitude:</b>	-104.87461944	
<b>Photo Direction:</b>	W	
<b>Category:</b>	Emergency Response	
<b>Photo Description:</b> Overview of the western side of the site after all site activities were completed.		
<b>Photo Name:</b> Photos-20231218-181831.JPG

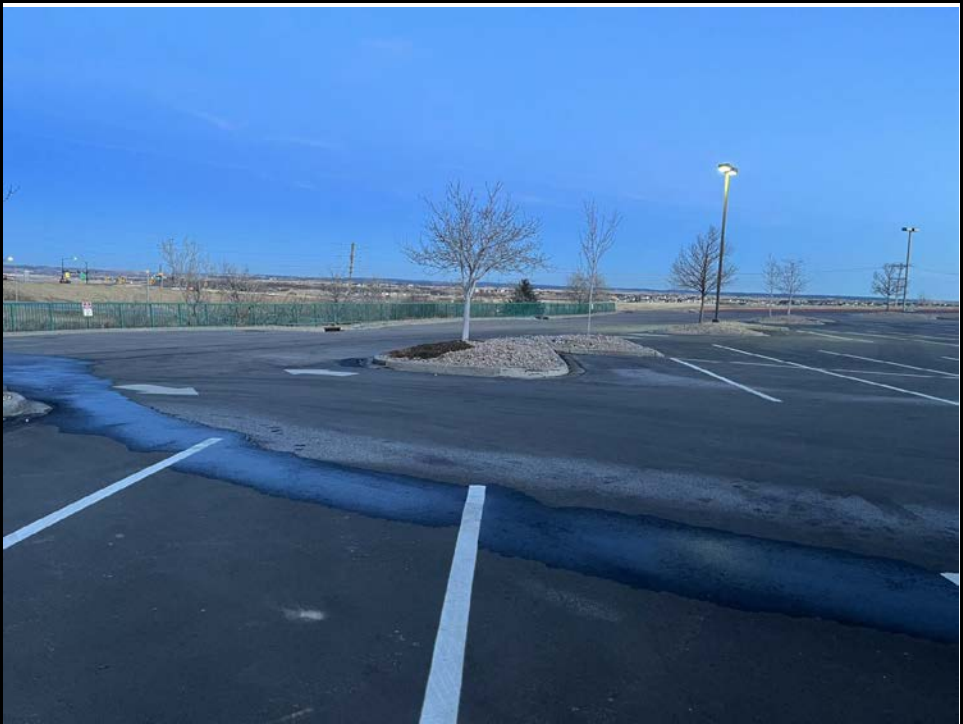
<b>Photographer:</b>	leyoub_Patrick	
<b>Latitude:</b>	39.47116944	
<b>Longitude:</b>	-104.87455833	
<b>Photo Direction:</b>	E	
<b>Category:</b>	Emergency Response	
<b>Photo Description:</b> Overview of the east side of site after site activities were completed.		
<b>Photo Name:</b> Photos-20231218-182550.JPG

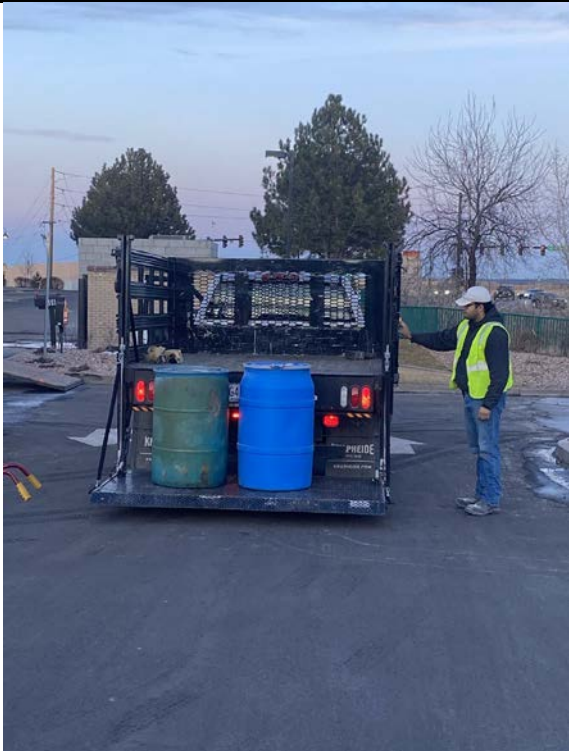
<b>Photographer:</b>	leyoub_Patrick	
<b>Latitude:</b>	39.4712391	
<b>Longitude:</b>	-104.8745726	
<b>Photo Direction:</b>	N	
<b>Category:</b>	Emergency Response	
<b>Photo Description:</b> The ERRS contractor loading the original damaged drum found on site and the new drum used to transport the contents of the damaged drum.		
<b>Photo Name:</b> Photos-20231218-181653.JPG

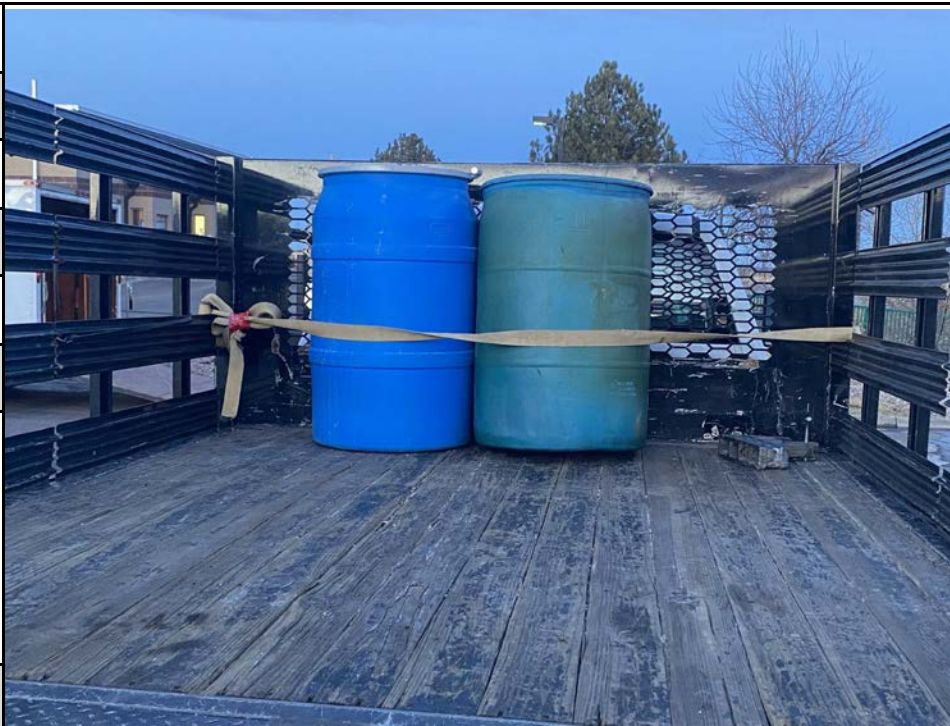
<b>Photographer:</b>	leyoub_Patrick	
<b>Latitude:</b>	39.4712391	
<b>Longitude:</b>	-104.8745726	
<b>Photo Direction:</b>	N	
<b>Category:</b>	Emergency Response	
<b>Photo Description:</b> Up-close view of the emptied drum found on site (right) and the new drum used to transport waste (left) secured on truck to be removed off site for disposal.		
<b>Photo Name:</b> Photos-20231218-181023.JPG
