Subject: Final Koehler Junction 2023 Construction Completion Report, Revision 0
Bonita Peak Mining District OU1 RS
San Juan County, Colorado
U.S. EPA Region 8 START V, Contract No. 68HE0820D0001 Task Order
No. 68HE021F0043
Technical Direction No. 2143-2307-01
Task Monitor: Craig Myers, EPA On-Scene Coordinator

BONITA PEAK MINING DISTRICT
KOEHLER JUNCTION 2023 CONSTRUCTION REPORT

SAN JUAN COUNTY, COLORADO

Revision 0

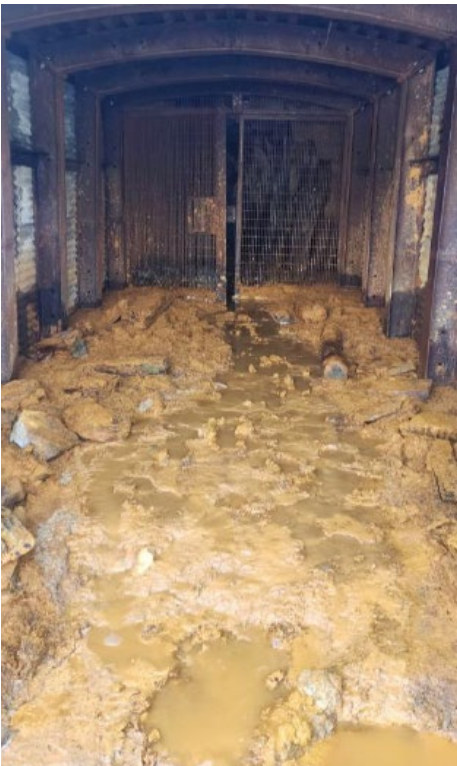
Photo: 4

Description: View inside of the Koehler Tunnel portal prior to maintenance activities.	
Date: 07/25/2023

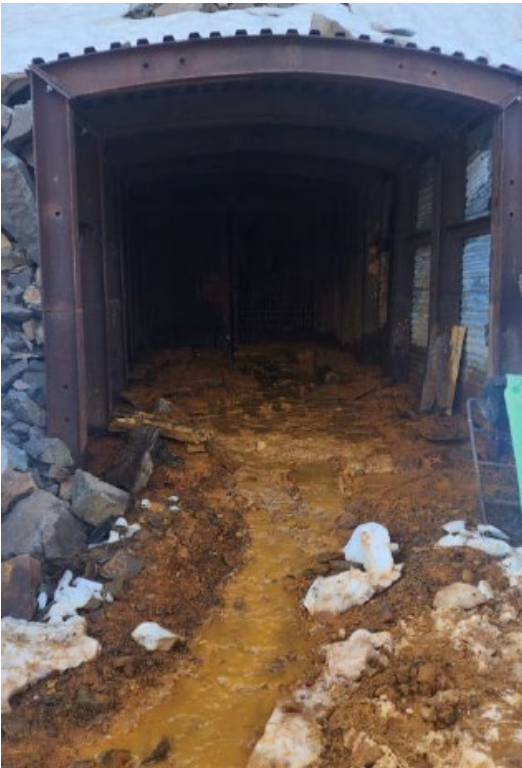
Photo: 5

Description: The Koehler Tunnel portal prior to maintenance activities.	
Date: 07/25/2023

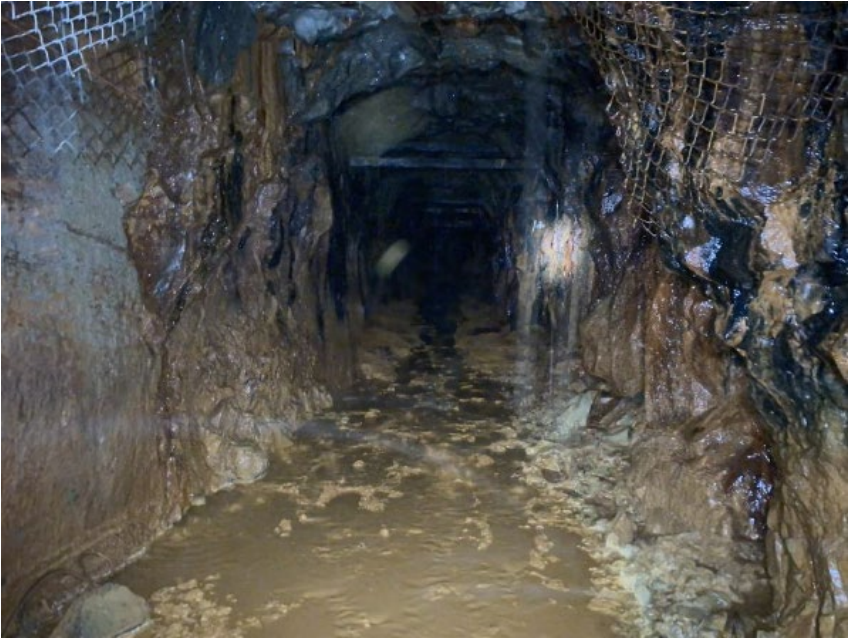
Photo: 6

Description: View inside of Koehler Tunnel looking toward the bulkhead, prior to maintenance activities.	
Date: 07/25/2023

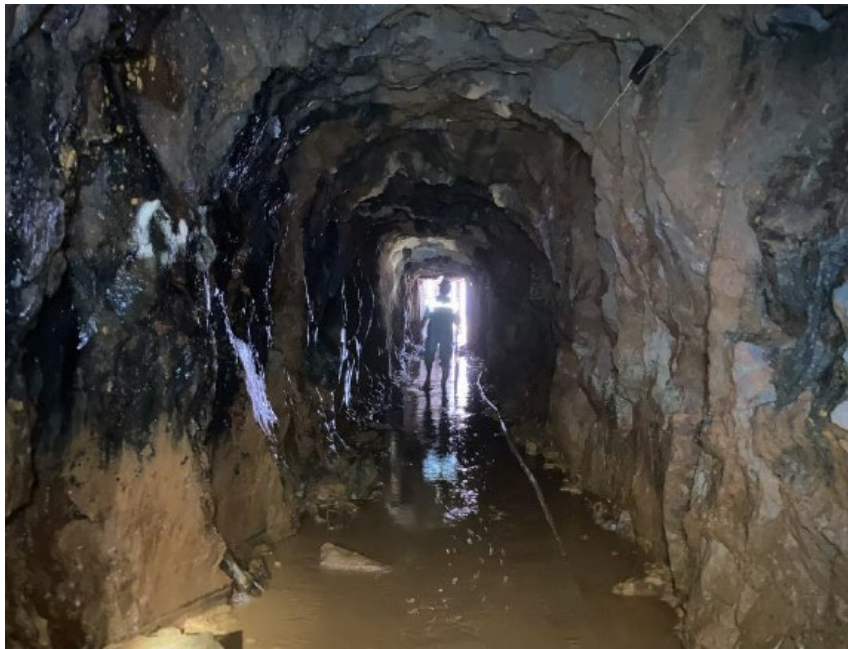
Photo: 7	
Description: View inside of Koehler Tunnel looking toward the tunnel's exit, prior to maintenance activities.

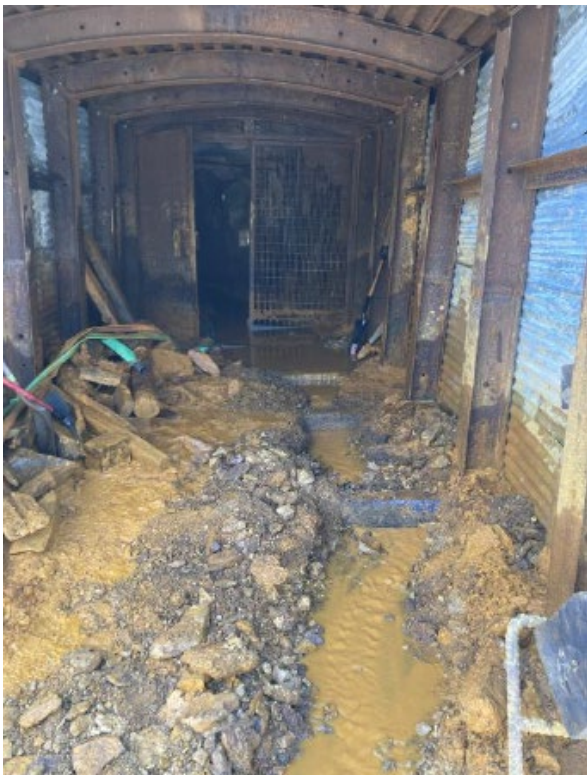
Photo: 8	
Description: The drainage ditch that was created just inside the Koehler Tunnel portal prior to sludge removal, intended to improve outward drainage of mine-influenced water (MIW) and sludge. Note timber sill beams inhibiting flow.

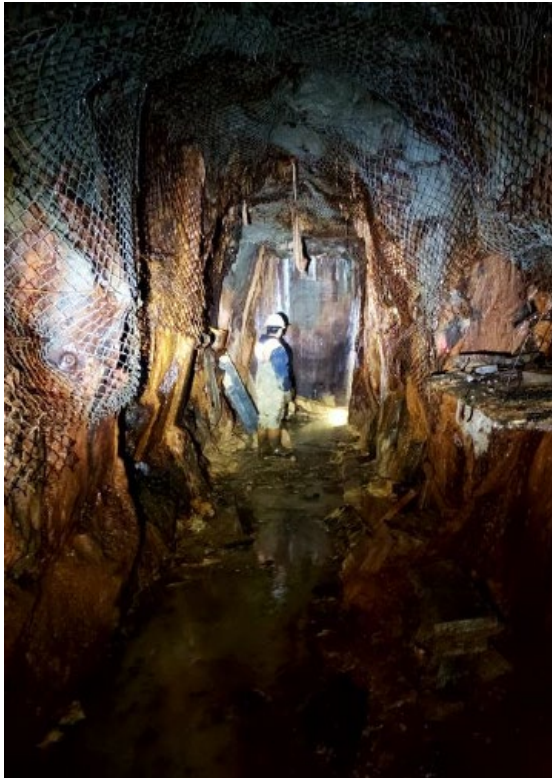
Photo: 9

Description: View inside of Koehler Tunnel after sludge removal, looking toward the bulkhead.	
Date: 07/26/2023

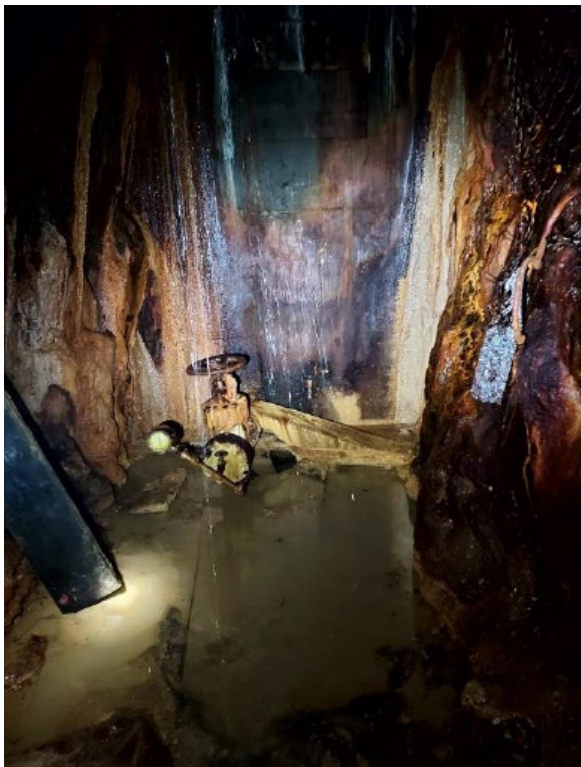
Photo: 10

Description: Closer view of the Koehler Tunnel bulkhead following sludge removal.	
Date: 07/26/2023

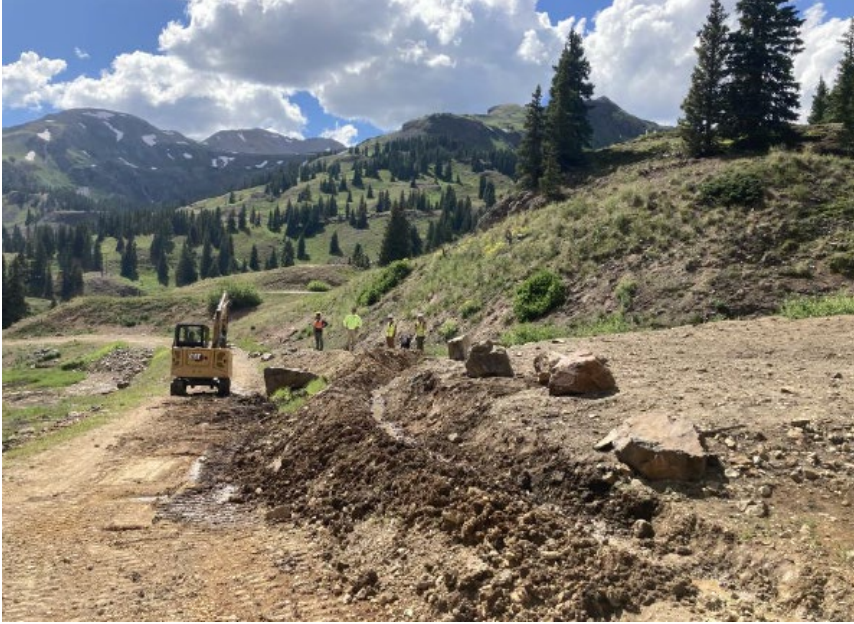
Photo: 11

Description: The run-off control channel downslope of the temporary repositories being re-established by deepening the channel and heightening its berm.	
Date: 07/26/2023

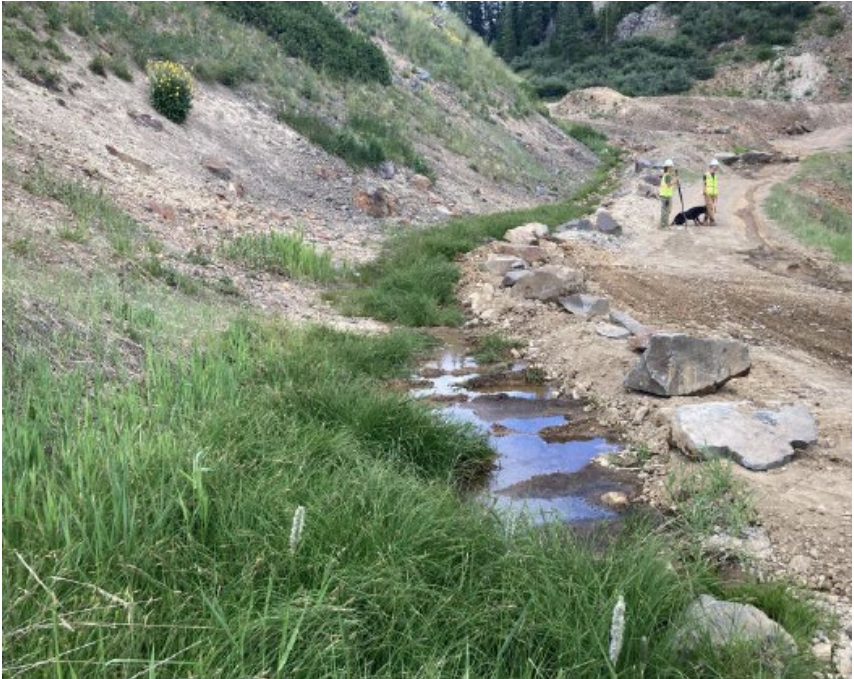
Photo: 12

Description: The re-established run-off control channel downslope of the temporary repositories, after deepening the channel and heightening its berm. The boulders were placed along the berm to add stability and improve erosion control.	
Date: 07/26/2023

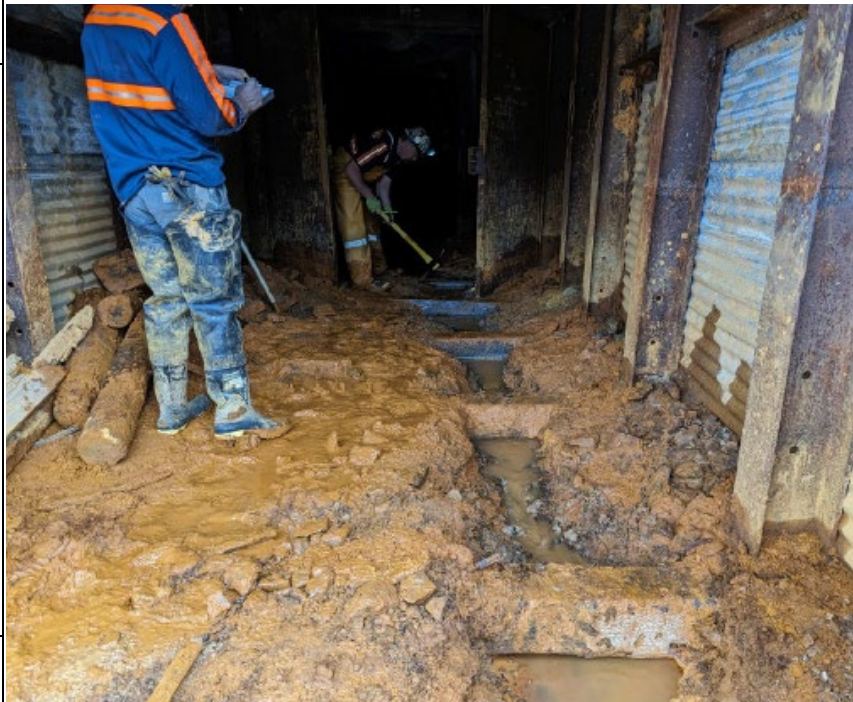
Photo: 13	
Description: Sediment being removed from beneath timber sill beams laying across the drainage ditch just inside the Koehler Tunnel portal. Water was previously forced to flow over the sills, inhibiting its flow, and this work was intended to further improve outward drainage of water flowing from the bulkhead.

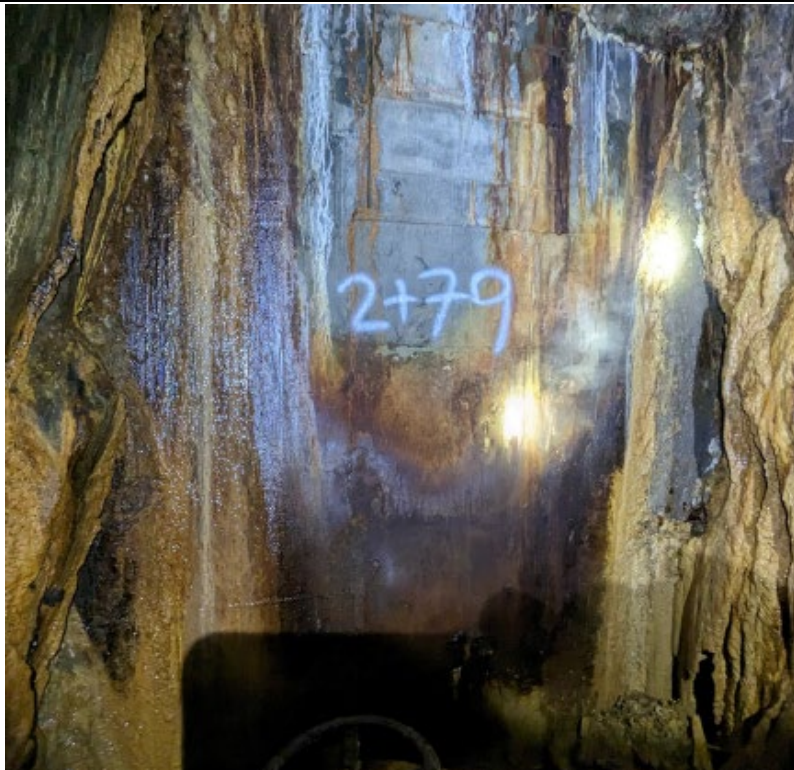
Photo: 15

Description: View of the Koehler Tunnel bulkhead upon completing measurements, showing its distance of 279 feet from the current portal. Note that the 2024 Koehler Tunnel portal rehabilitation design sheets show original stationing for historical consistency.	
Date: 09/20/2023

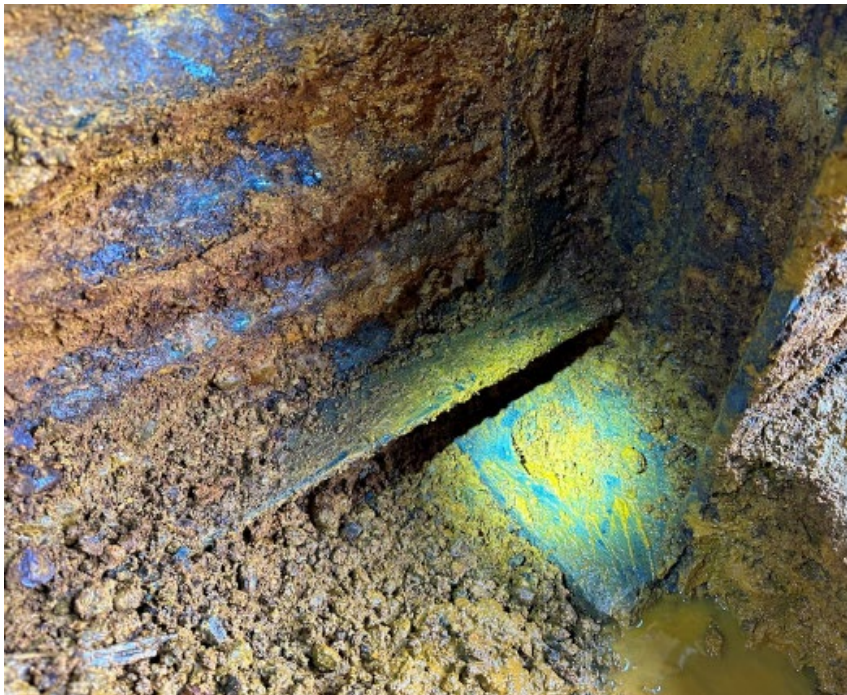
Photo: 16	
Description: Close up view of Koehler Tunnel portal, showing a timber sill beam, thin lagging, steel strut, steel post, and foot plate with predrilled holes.

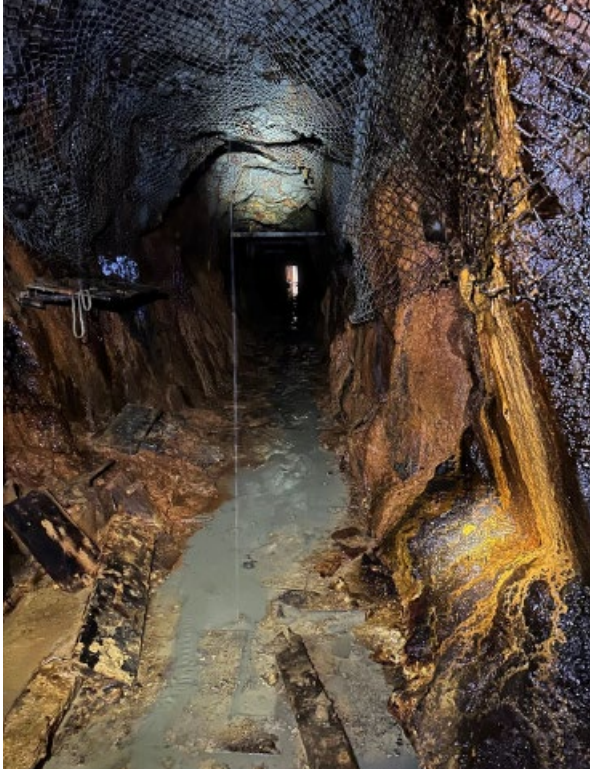
Photo: 17

Description: Overview of Koehler Tunnel looking toward its portal, showing sill, dripping water, chain link mesh, split set rock bolts, and debris.	
Date: 09/20/2023

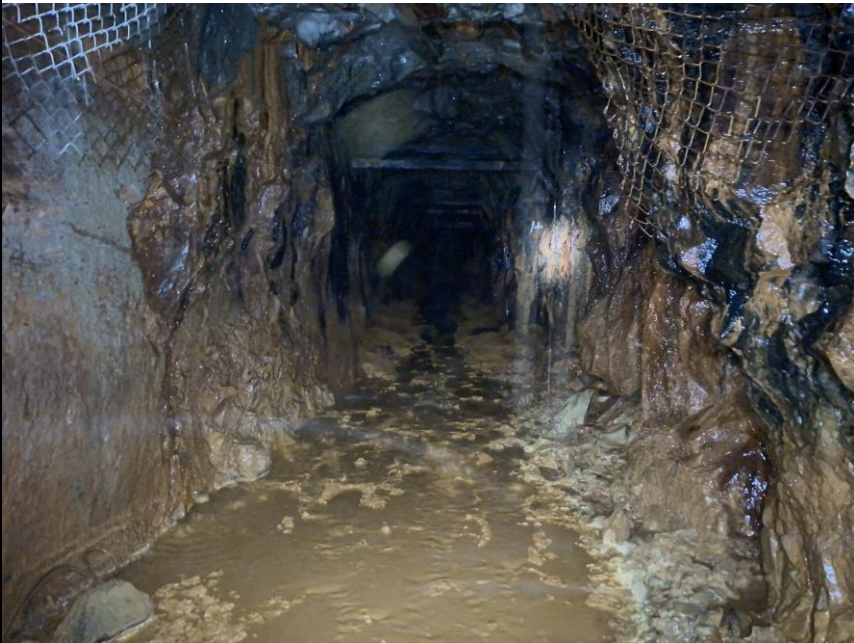
Photo: 2

Description: The Koehler Tunnel looking towards the bulkhead. The floor of the Tunnel before it had been mucked out.	
Date: 7/25/2023

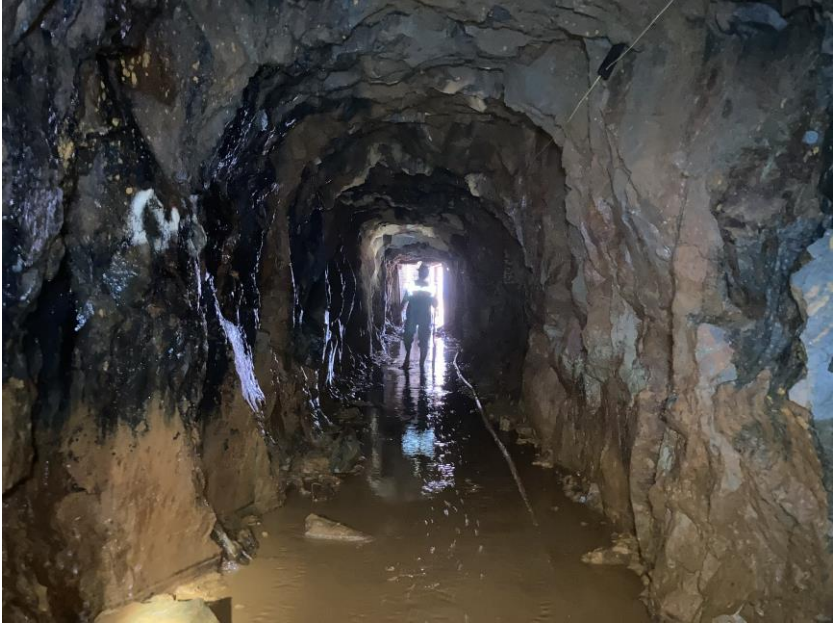
Photo: 3

Description: The Koehler Tunnel looking towards the Portal. The floor of the Tunnel after it had been mucked out.	
Date: 7/25/2023

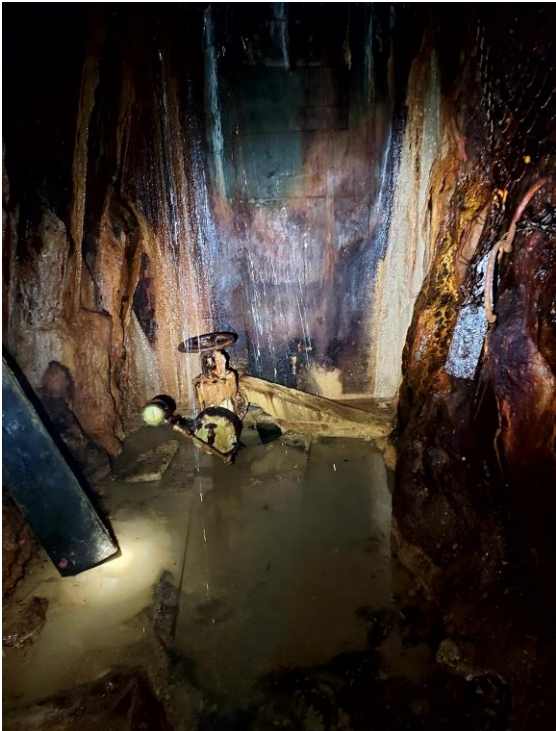
Photo: 5

Description: The Koehler Tunnel looking towards at the bulkhead. Note the value in front of the bulkhead.	
Date: 7/26/2023

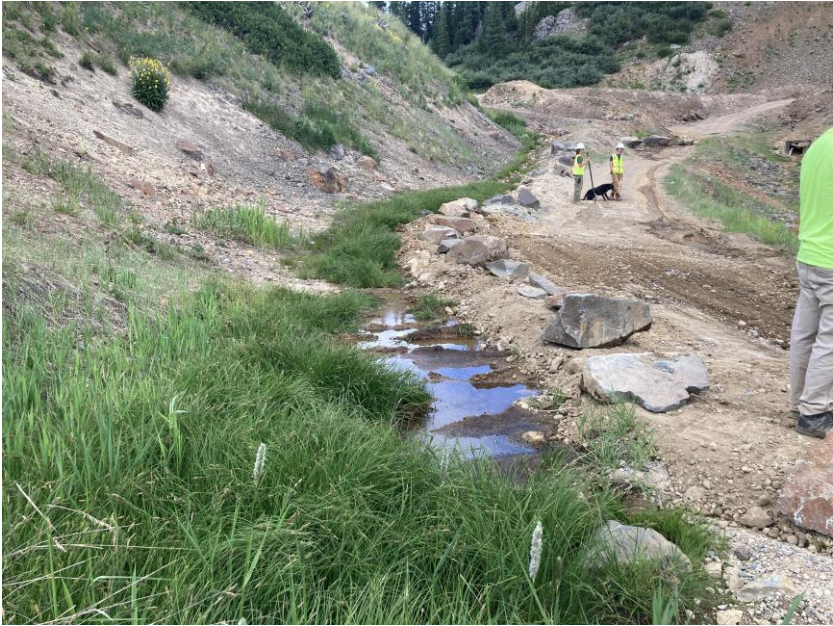
Photo: 7	
Description: Repairs made to run-on controls for the Longfellow Mine. ACT and ER made the berm next to the ditch taller and added rocks.

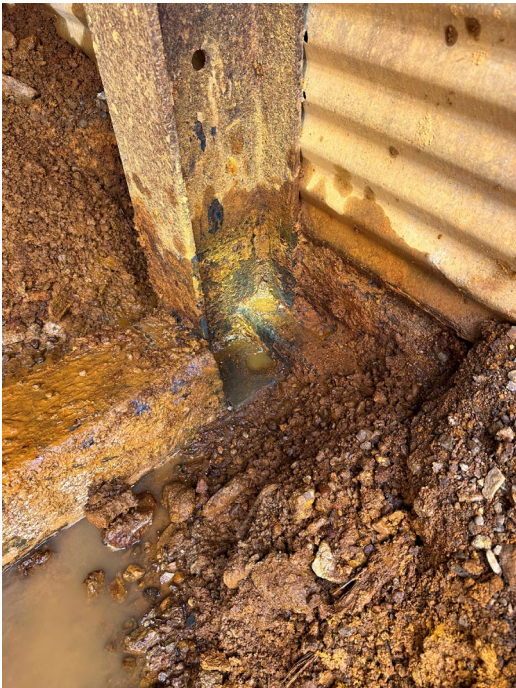
Photo: 5

Description: Timber sill beam, steel post, and foot plate with predrilled holes outby side	
Date: 9/20/2023

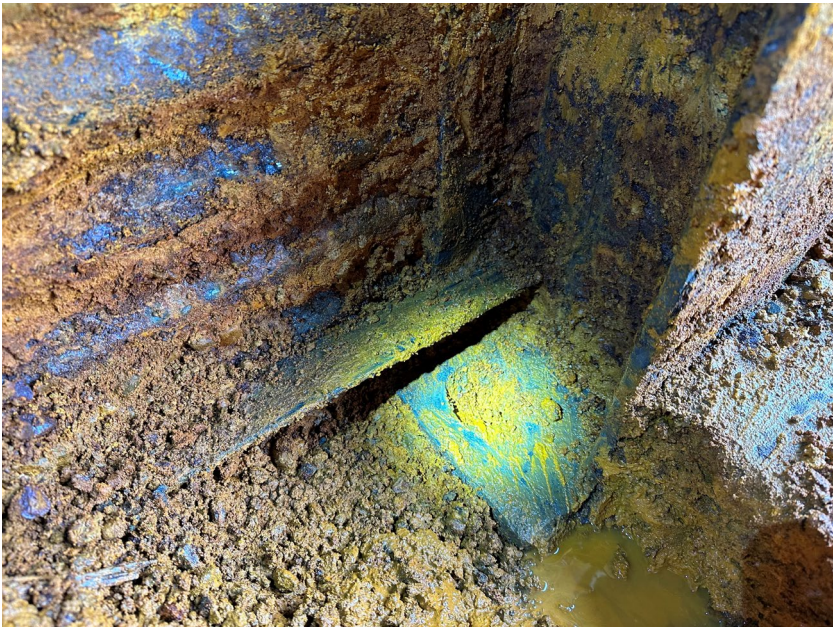
Photo: 6

Description: Timber sill beam, steel post, and foot plate with predrilled holes inby side	
Date: 9/20/2023

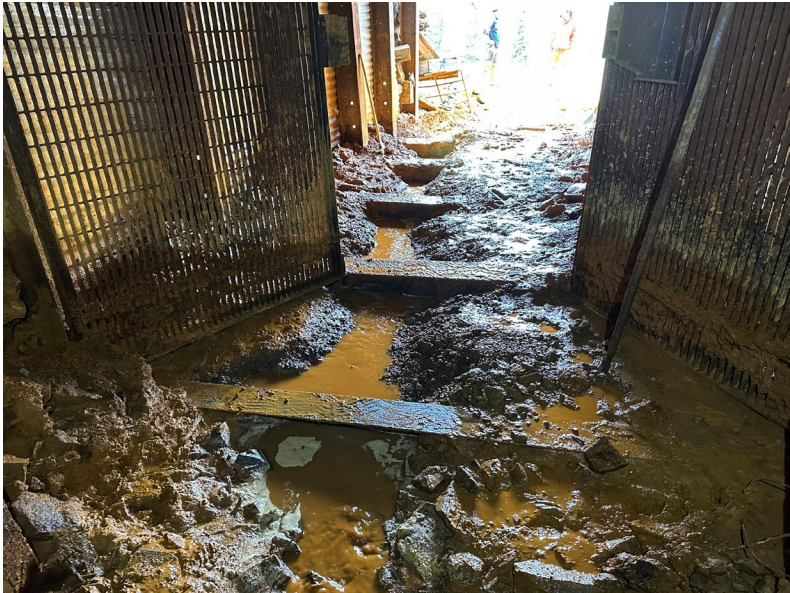
Photo: 7

Description: 6" steel sill beam at gate	
Date: 9/20/2023

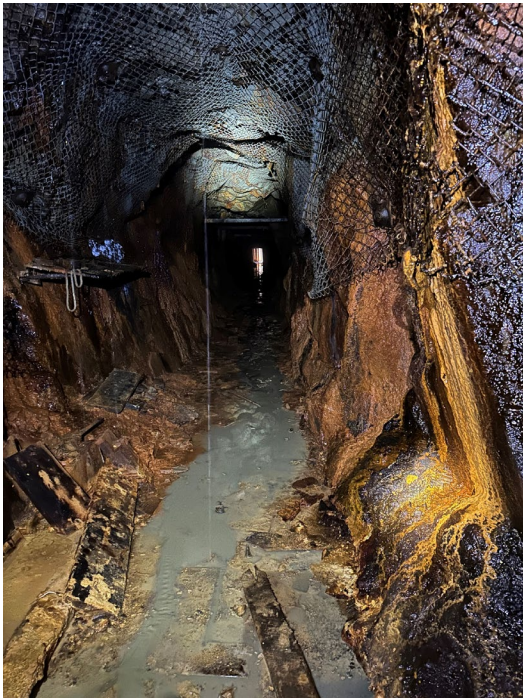
Photo: 8

Description: Tunnel overview showing sill, dripping water, chain link mesh, split set rock bolts and debris	
Date: 9/20/2023
