May 02, 2024

EPA and EGLE Update: Pilot Diesel Spill, Ottawa Lake, MI

This document provides on-site activities in response to the Pilot diesel spill in Ottawa Lake, Michigan.

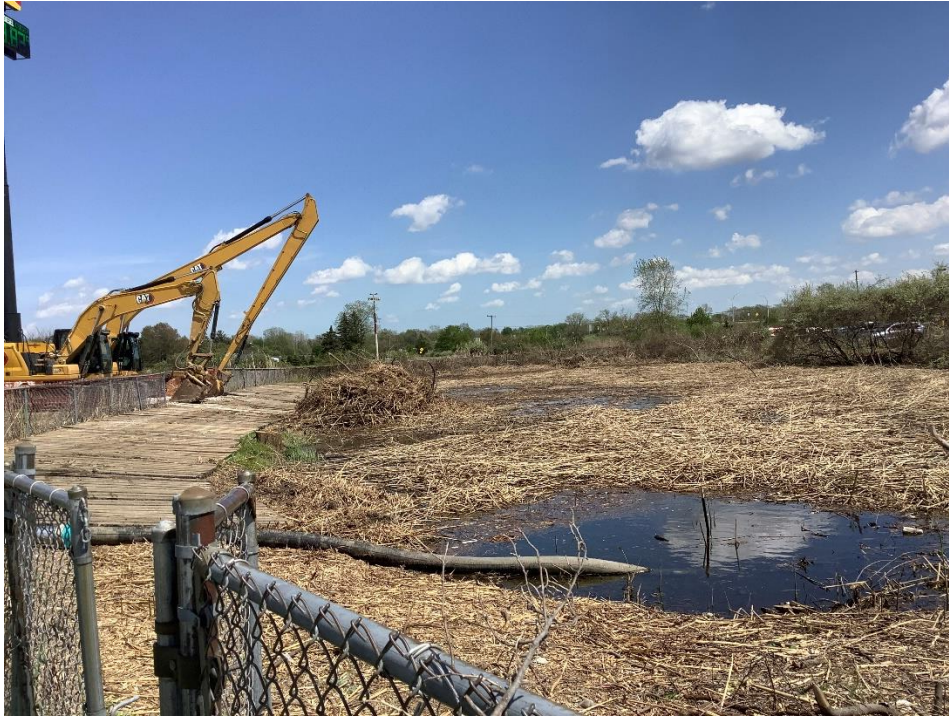
De-watering the on-site retention pond.

- On-site concrete removal and gravel/soil excavation continues in the rear parking lot. Pilot is actively recovering contaminated oil/water mixture from excavation due to recently exposed drains.
- De-watering of the on-site retention pond has started and is on-going until water levels are low enough for excavation to begin. Equipment is staged in preparation for the excavation and the dig is expected to begin next week.
- Temporary fencing is being expanded to include all excavation areas, including the area to remove the DEF tank over the weekend.
- The outfall behind Sunoco at North Tenmile Creek has been excavated and is awaiting restoration guidance from EGLE.

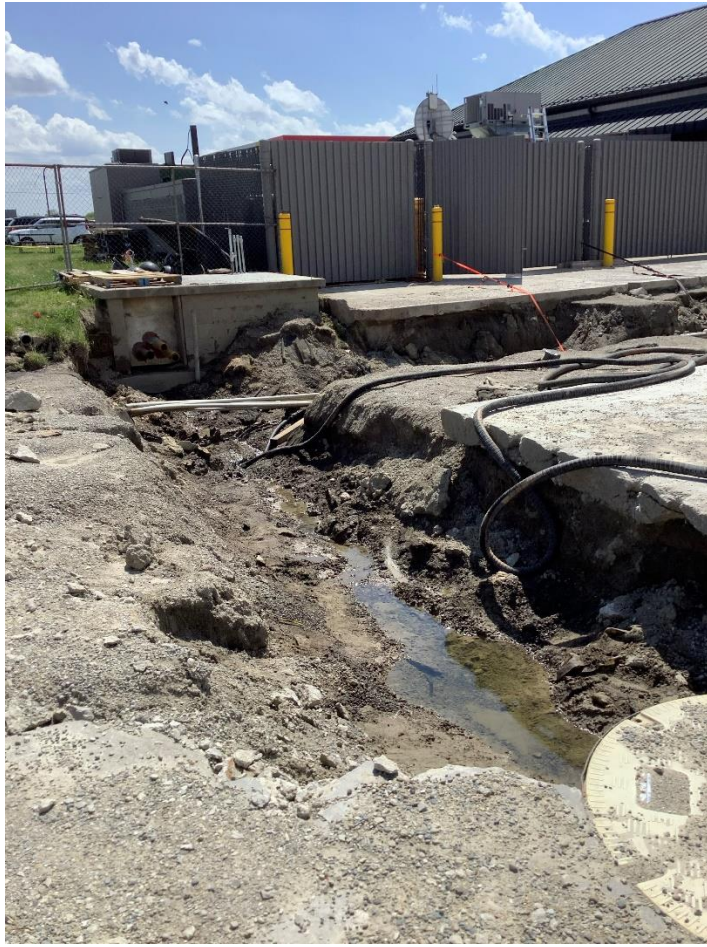
Active recovery of oil/water mixture from drain backflow in the excavation near the pumps.
