### **ACTION MEMORANDUM**

**SUBJECT:** Action Memorandum for a Removal Action at the Helena Mercury Release Site pursuant to the On-Scene Coordinator's delegated authority under CERCLA Section 104.

Site Name: Helena Mercury Release  
Site Spill ID (SSID): B8K9  
NRC Case Number: 1400383  
CERCLIS Number: MTN000826431  
Site Location: 2409 Bear Creek Road, Helena, MT 56901  
Lat/Long: 46.52679461217856, -112.1671382373062

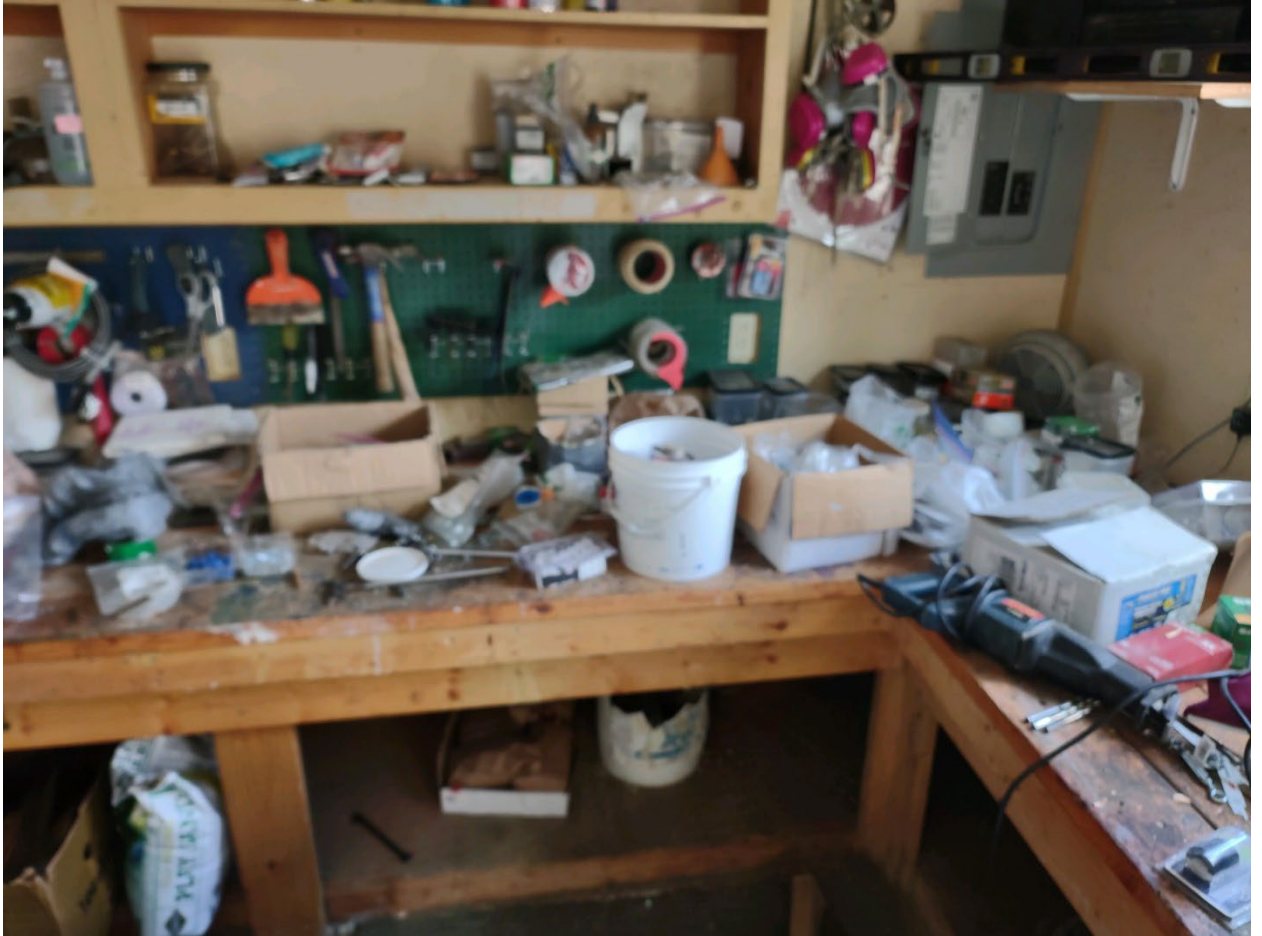
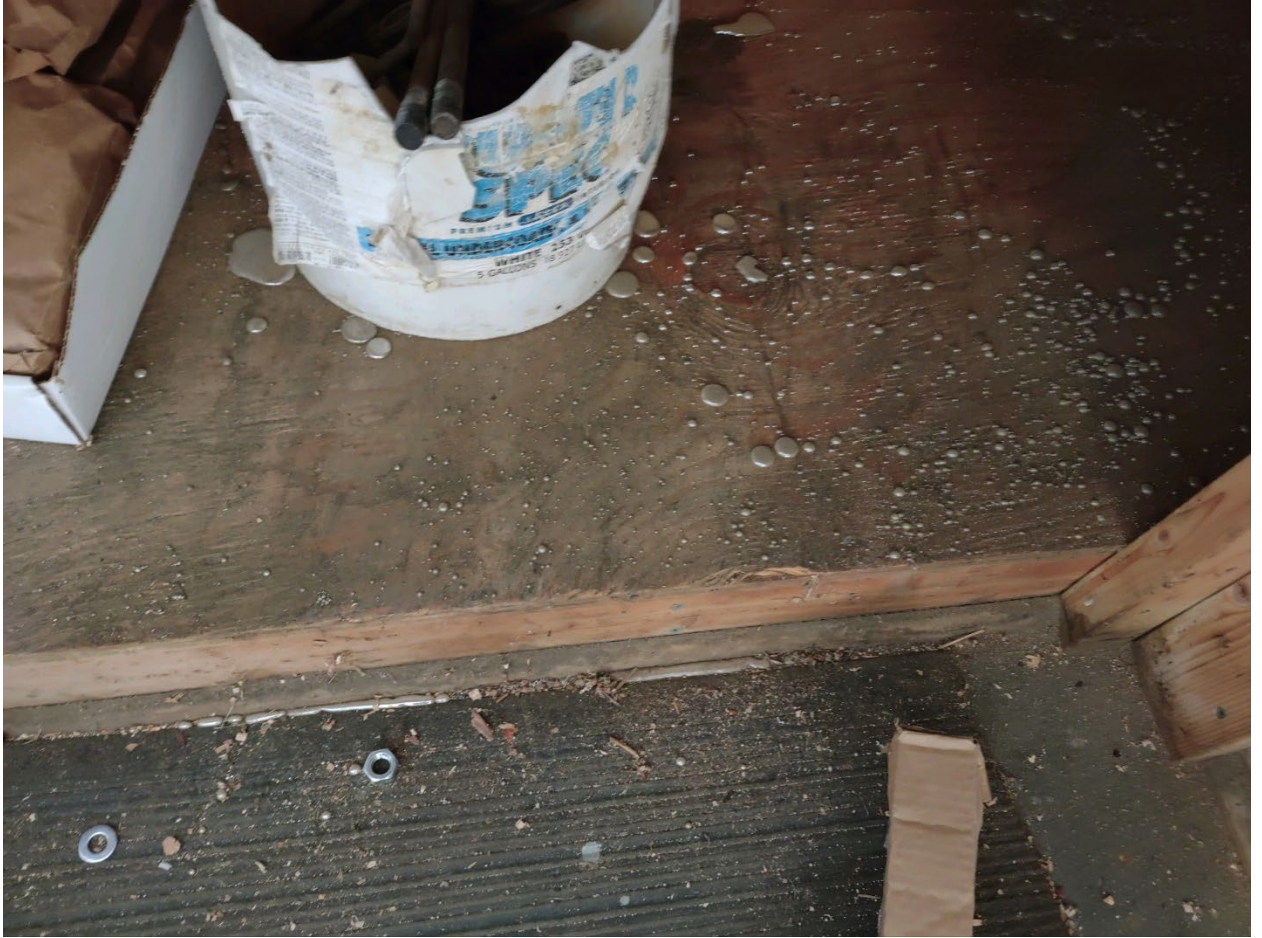
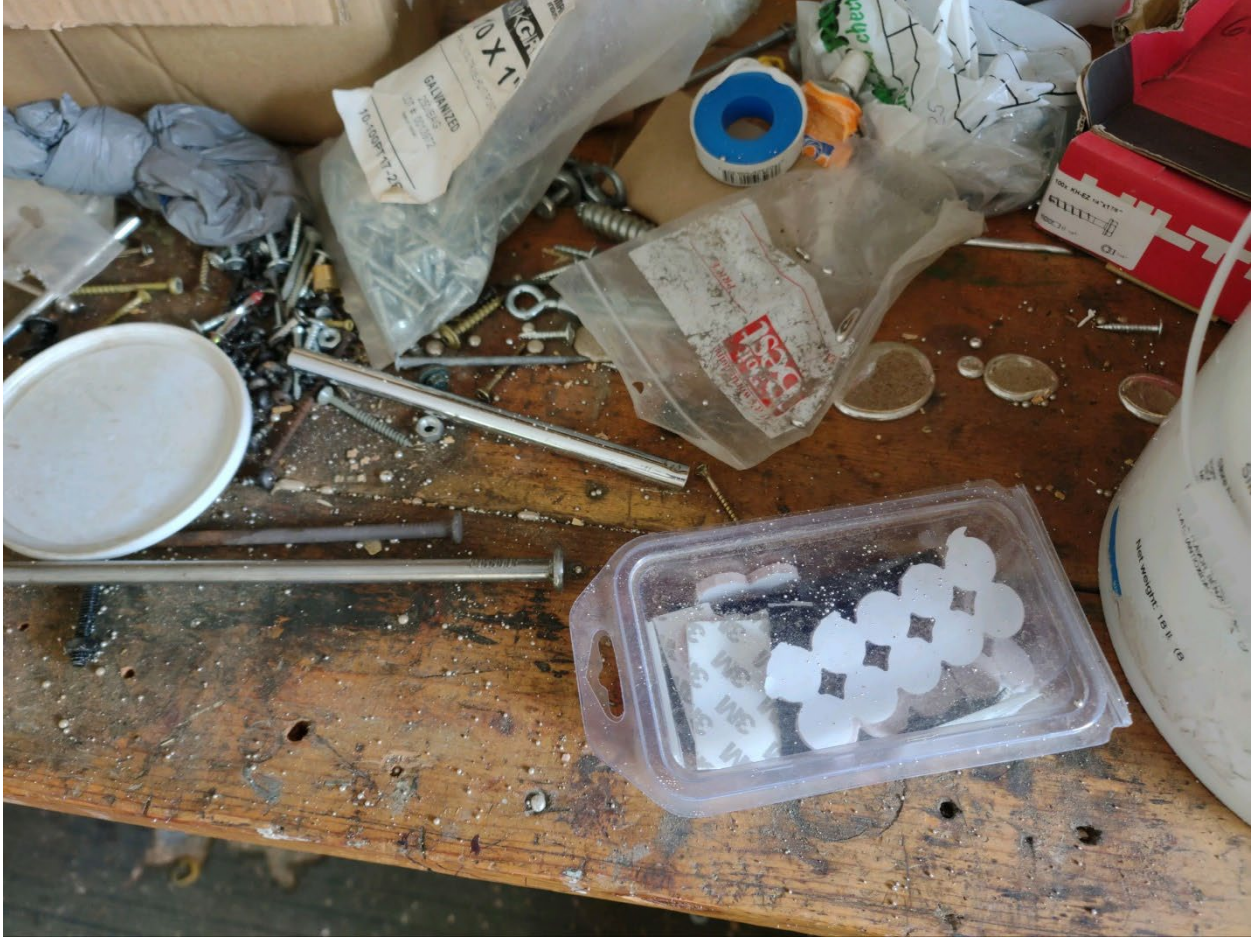
## Attachment 1: Initial Photos Provided by Reporting Party

On May 30, 2024, an employee of Feathered Pipe Ranch (a non-profit yoga retreat center) picked up an unlabeled bottle while cleaning out a detached garage which is used as a workshop and storage facility. The bottle was heavier than expected and slipped from his hand. The bottle hit a work bench and shattered, which resulted in a reported 500mL of mercury being released to the garage. The employee left the garage, bagged their contaminated clothing just outside the door, walked to a nearby bathhouse and rinsed themselves in a shower. Staff at the retreat center closed and isolated the garage before calling the National Response Center.
