## EPA Emergency Response Site Update

Helena Mercury Release

Operations Period 08

June 8-10, 2024

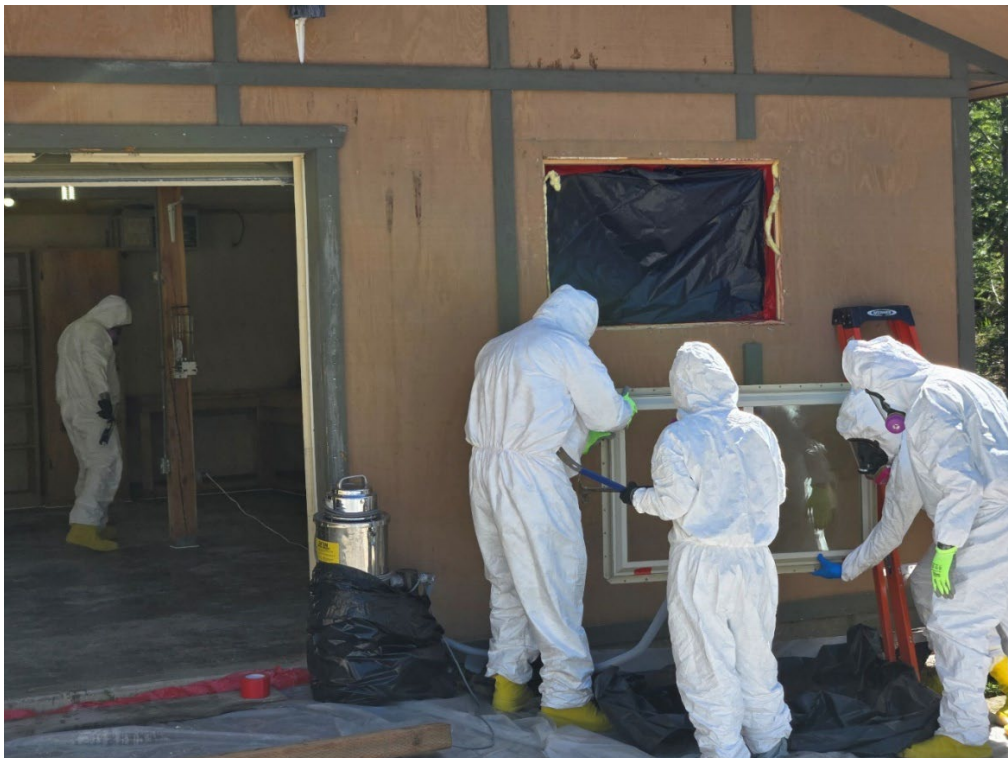
EPA's response team completed 5 cycles of heating/venting of the garage. During each cycle, the interior of the garage was heated to approximately 90 degrees fahrenheit. That temperature was held for roughly 1 hour before being vented using open doors, windows and fans for 15 minutes. Air monitoring readings taken after this process showed improvement but a hot spot was detected at the window near the location of the release. The entire window was removed, and the crew discovered approximately 15 milliliters of liquid mercury

trapped between the bottom window jam and the wood framing. This mercury was collected, and the window was added to the contaminated debris waste stream.

*Removing window with mercury trapped under bottom jam.*

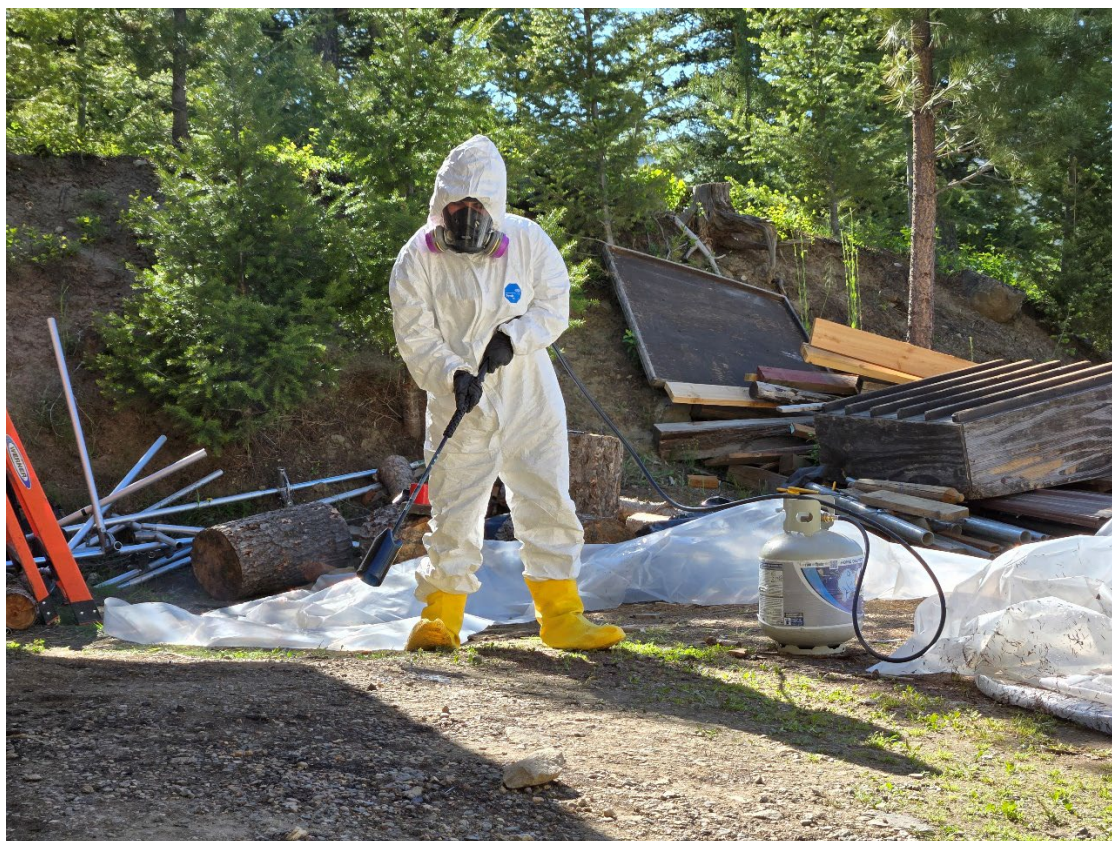
*Clearing residual mercury from soil outside garage door.*

No beads of mercury were discovered in the soil outside the overhead garage door. To prevent any undetected microbeads that may exist from being tracked elsewhere, the soil in this area was carefully heated with a propane weed burner and covered with 4 inches of fresh dirt.

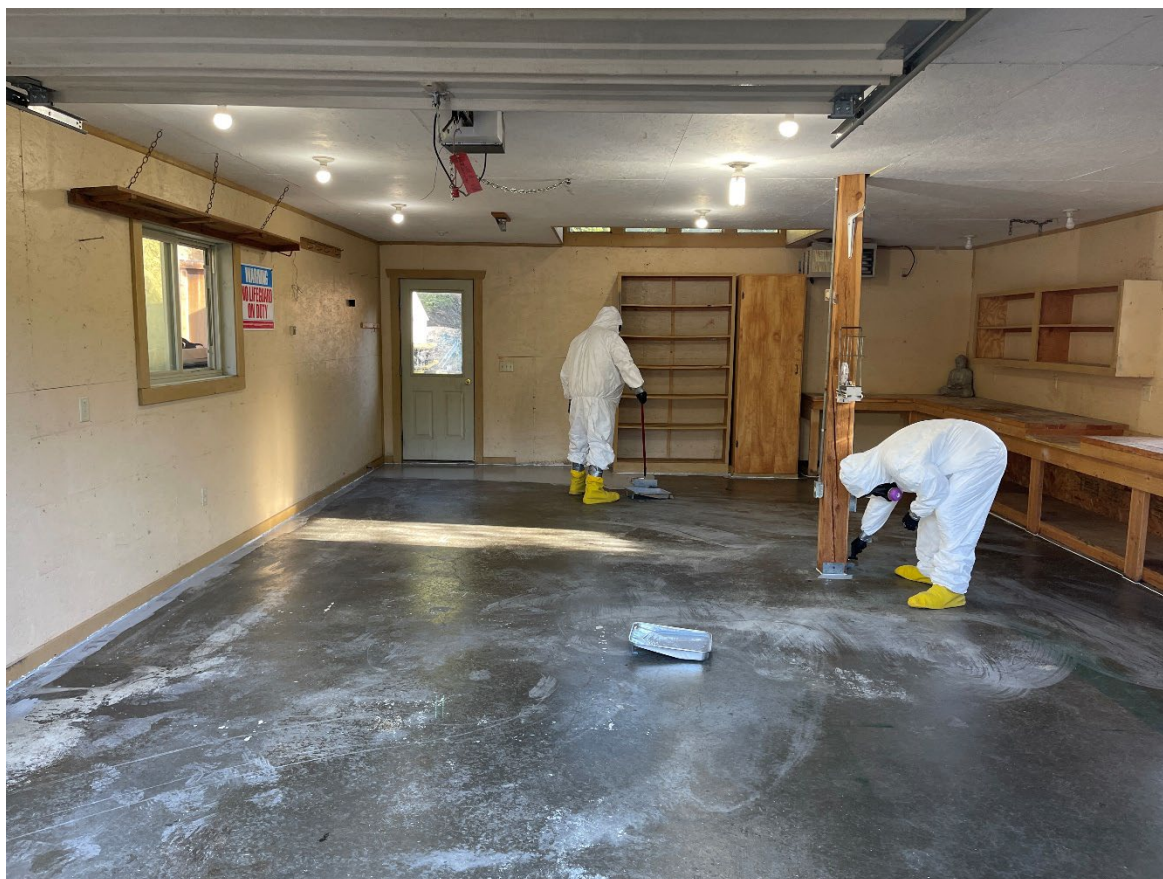
*Beginning to seal floor of garage.*

The cracks in the garage floor were sealed with caulk. The crew paid particular attention to the void beneath a section of the garage's base plate which was exposed when the plywood behind the work bench was removed. This section of the base plate remains a hot spot but cannot be removed because it is structural. The exposed base plate and the floor of the garage were painted with a concrete sealer.
