**REMOVAL PROGRAM  
PRELIMINARY ASSESSMENT/  
SITE INVESTIGATION REPORT  
FOR THE  
CARIBOU POWER PLANT SITE  
CARIBOU, AROOSTOOK COUNTY, MAINE  
15 NOVEMBER 2022**

Weston Solutions, Inc.  
Region I  
Superfund Technical Assessment and Response Team  
101 Billerica Avenue, Building 5, Suite 103  
North Billerica, Massachusetts 01862

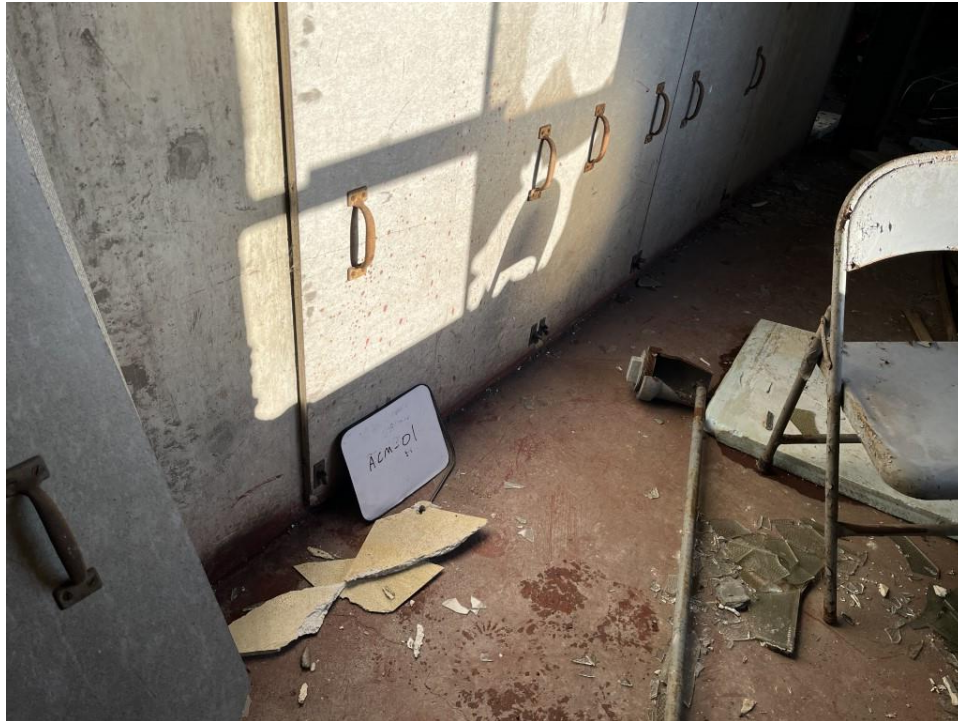
Asbestos was identified in 12 of 15 samples, with a maximum total concentration of 25% in ACM-01. Amosite was detected in six samples with a maximum concentration of 10% in ACM-01. Chrysotile was detected in 11 samples with a maximum concentration of 18% in ACM-04 and ACM-05. Crocidolite was detected in one sample at a concentration of 6% in ACM-06.

**SCENE:** View of sample location ACM-01, collected from transite on the first floor of the Steam Plant. Photograph taken facing northwest.

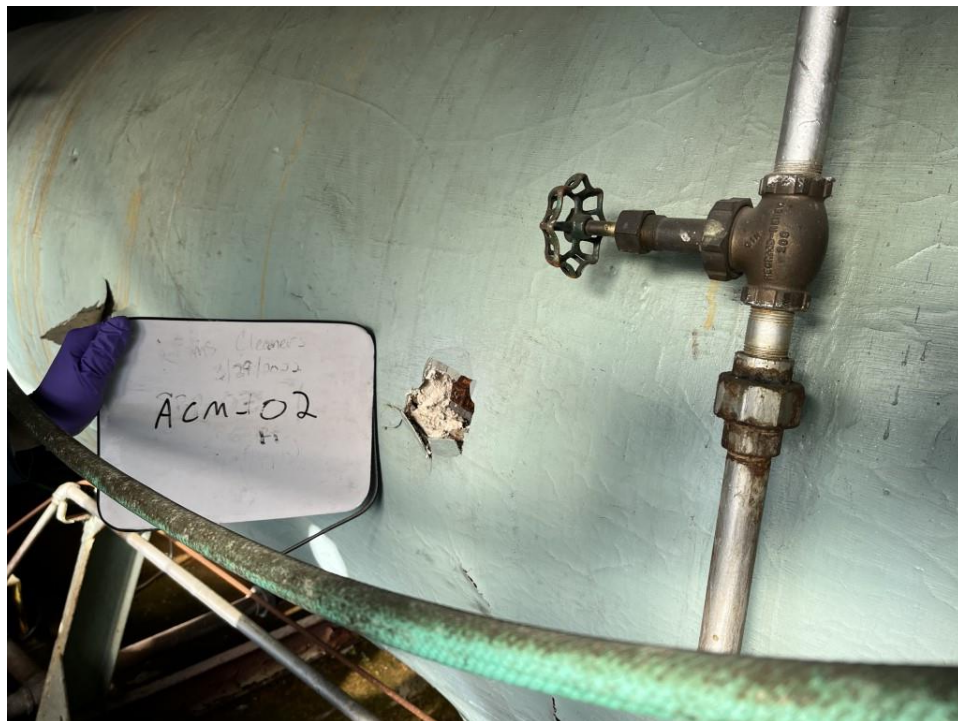
**SCENE:** View of sample location ACM-02, collected from white tank insulation on the first floor of the Steam Plant. Photograph taken facing west.

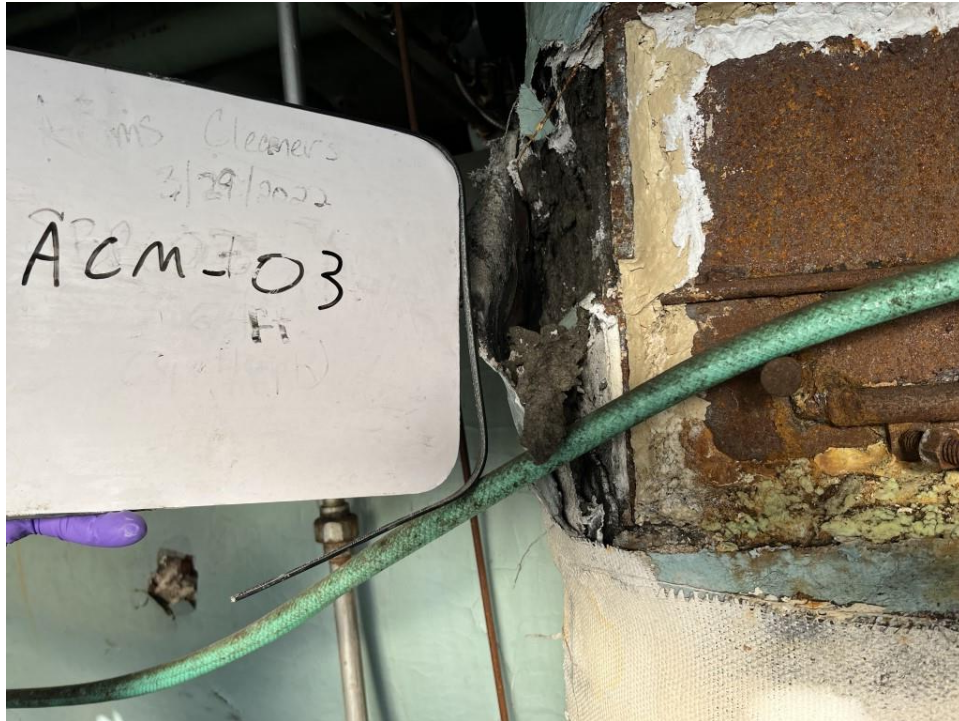
**SCENE:** View of sample location ACM-03, collected from white tank insulation on the first floor of the Steam Plant.

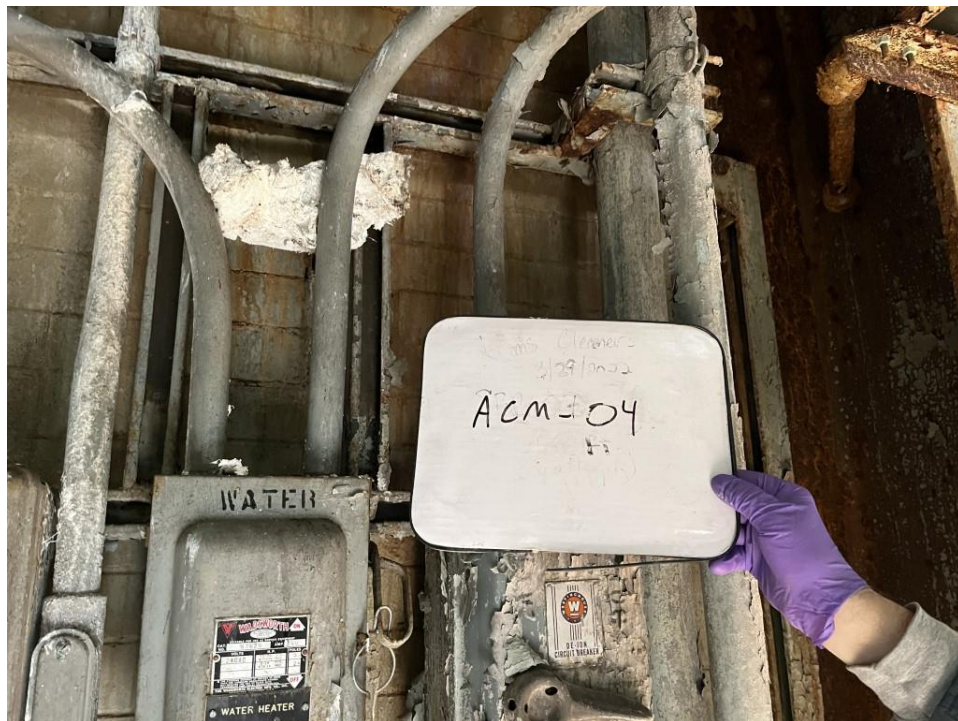
**SCENE:** View of sample location ACM-04, collected from white pipe insulation fallen from the ceiling on the first floor of the Steam Plant. Photograph taken facing northwest.

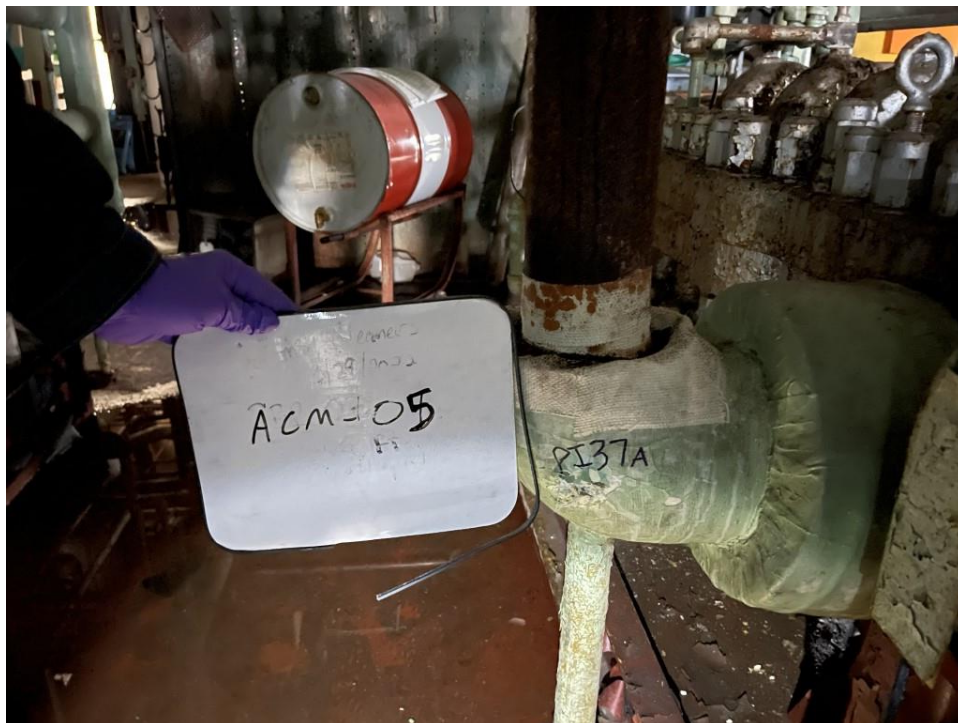
**SCENE:** View of sample location ACM-05, collected from white pipe insulation on the first floor of the Steam Plant.

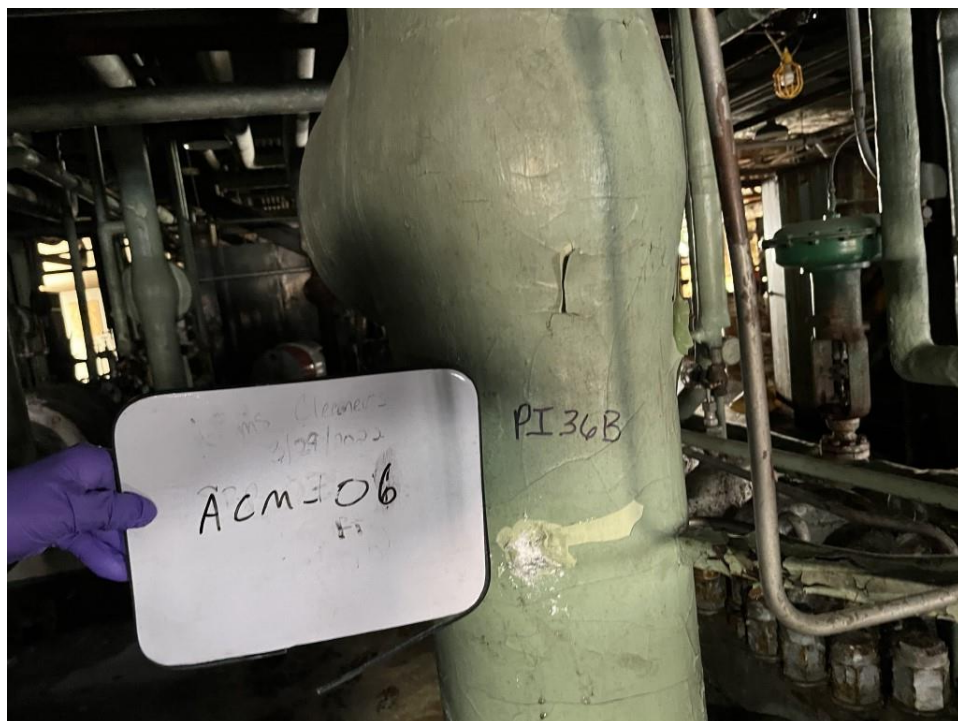
**SCENE:** View of sample location ACM-06, collected from white pipe insulation on the first floor of the Steam Plant.

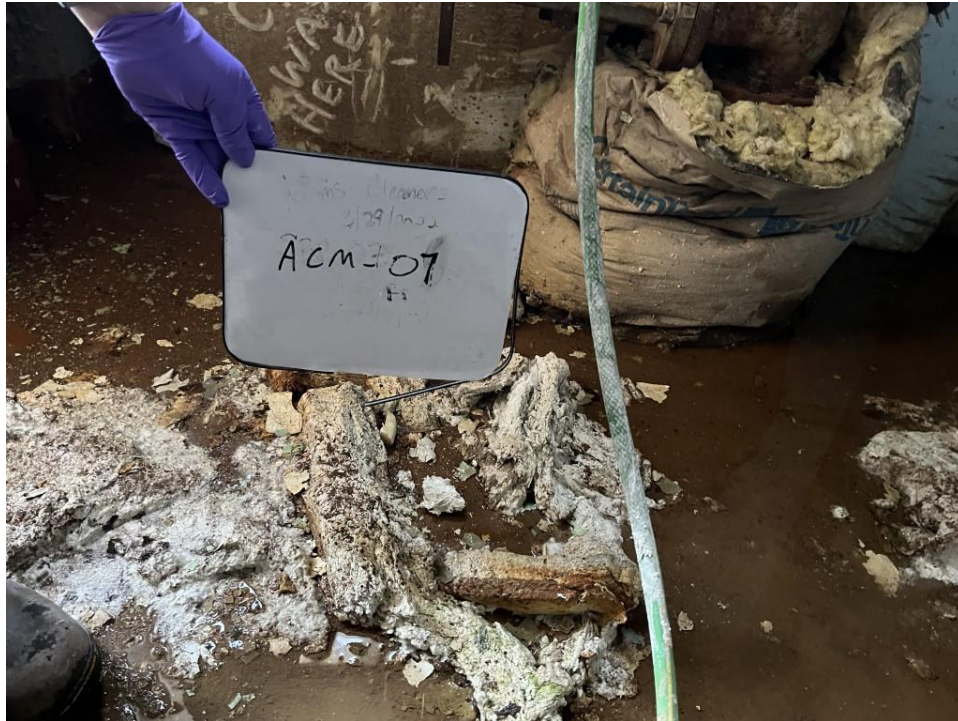
**SCENE:** View of sample location ACM-07, collected from white pipe insulation fallen from the ceiling on the first floor of the Steam Plant.

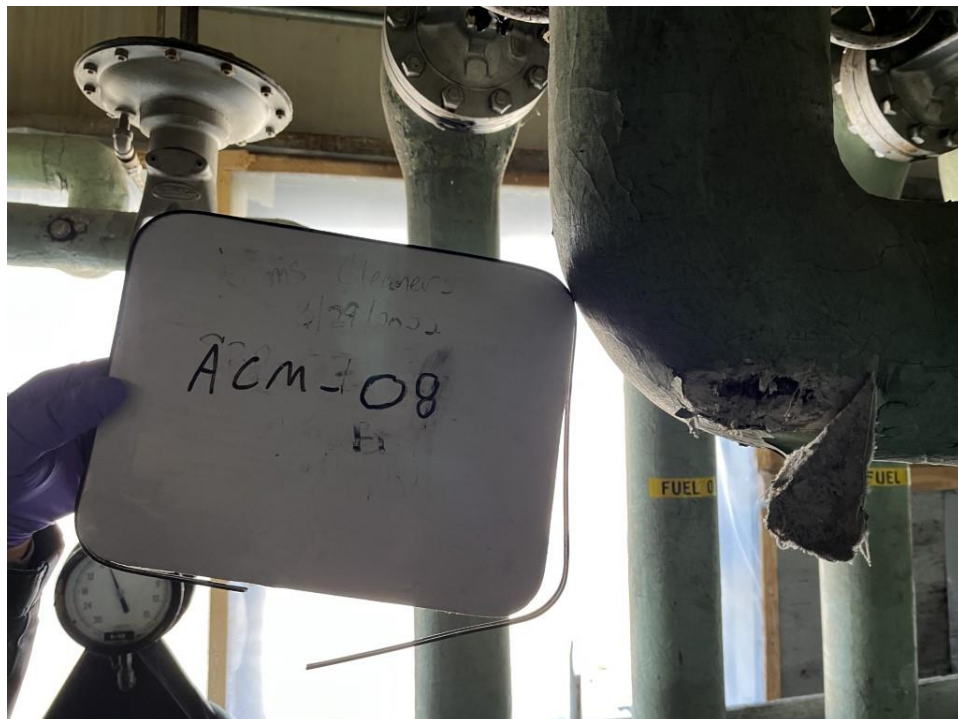
**SCENE:** View of sample location ACM-08, collected from white pipe insulation on the first floor of the Steam Plant. Photograph taken facing west.

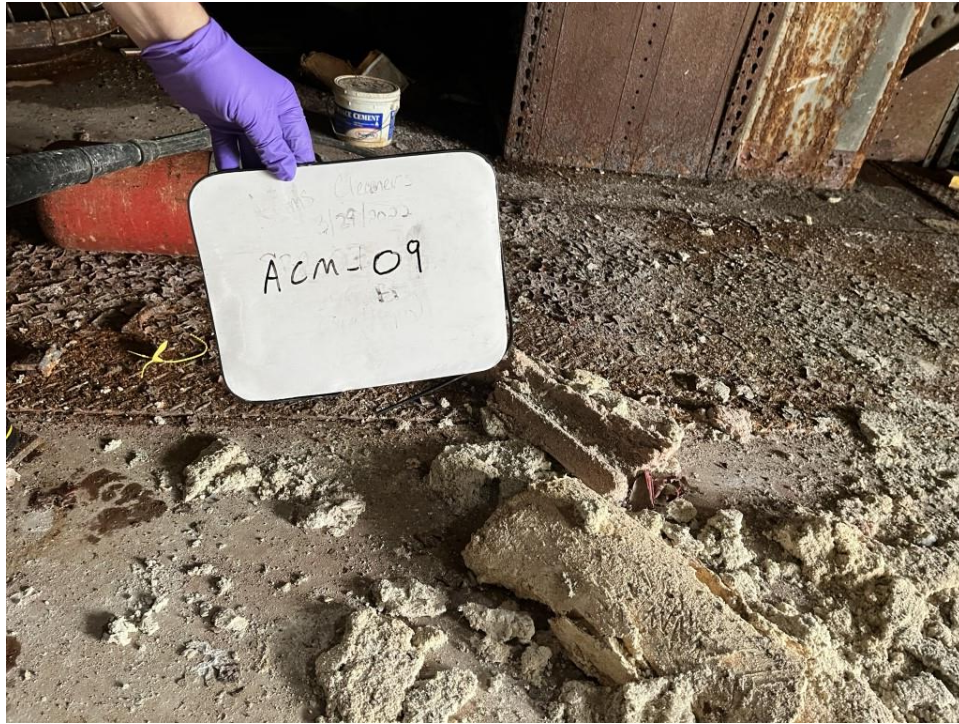
**SCENE:** View of sample location ACM-09, collected from pipe insulation fallen from the ceiling on the first floor of the Steam Plant.

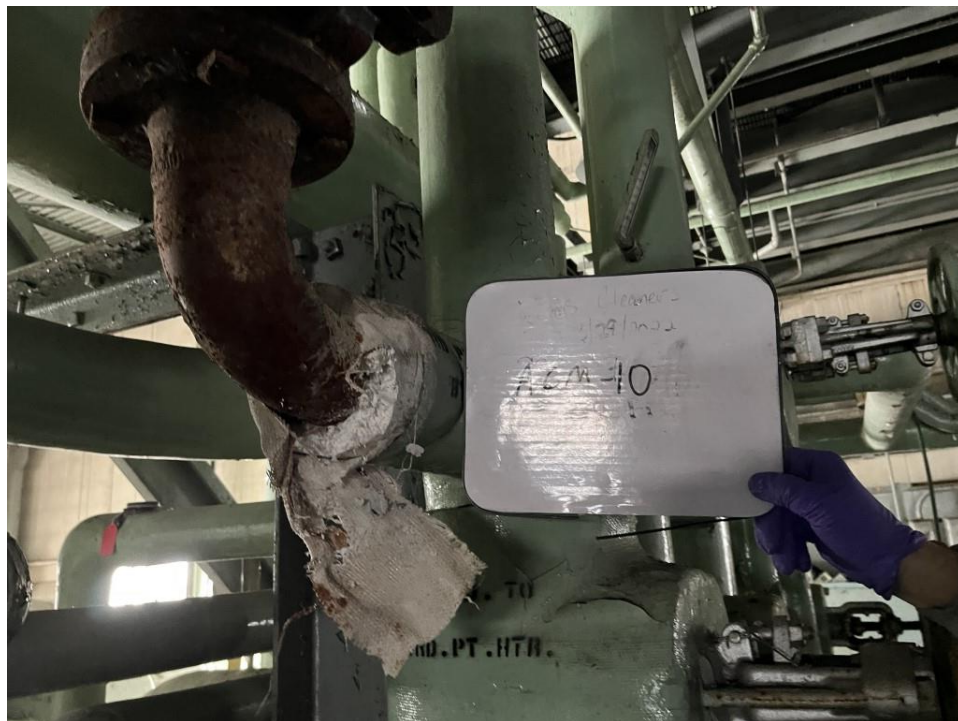
**SCENE:** View of sample location ACM-10, collected from white pipe insulation on the second floor of the Steam Plant.

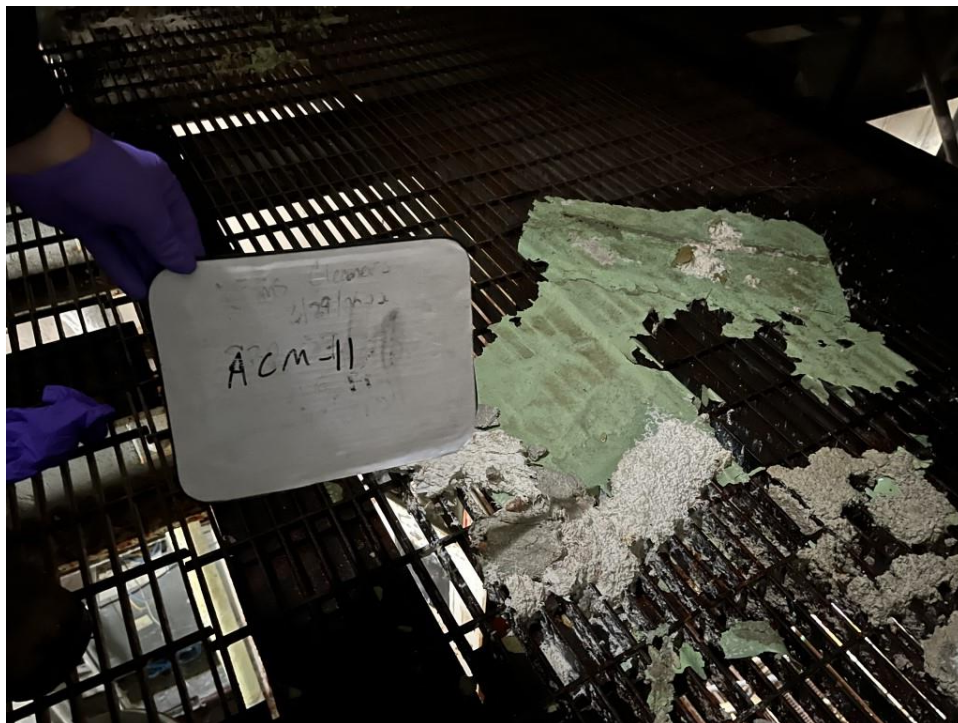
**SCENE:** View of sample location ACM-11, collected from white tank insulation on the third floor of the Steam Plant.

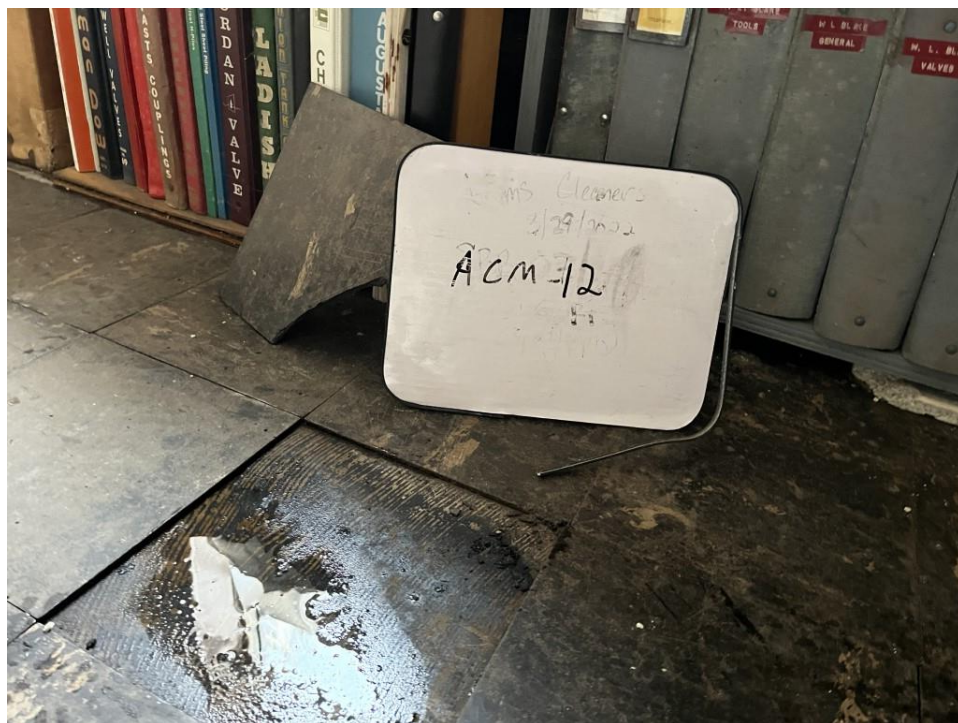
**SCENE:** View of sample location ACM-12, collected from black floor tiles on the second floor of the Diesel Plant.

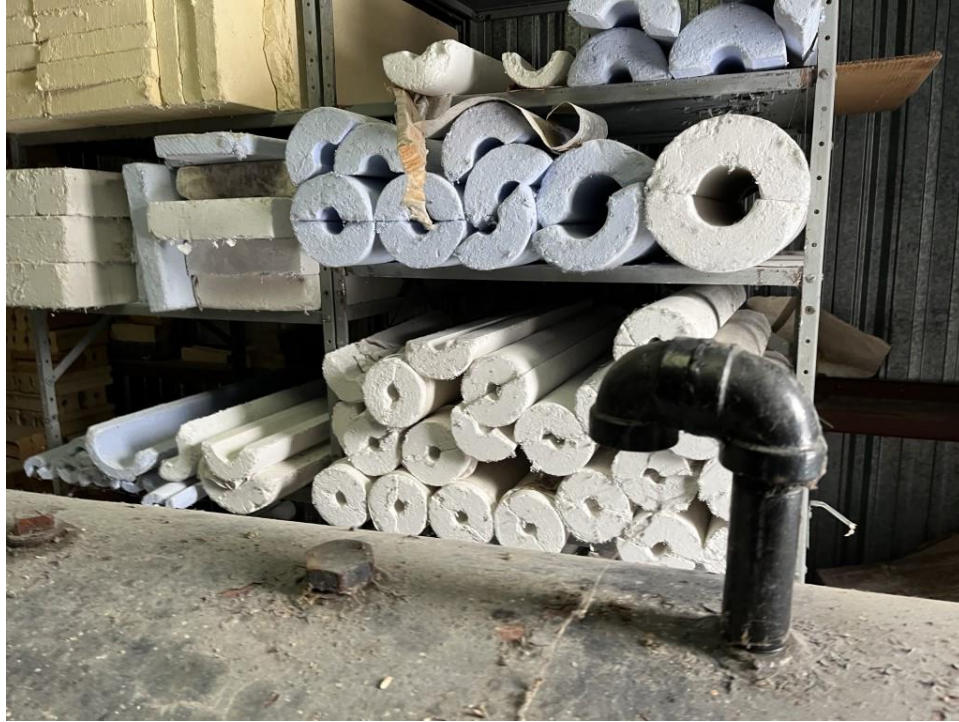
**SCENE:** View of unused pipe insulation and fire brick in the Southern Storage Building. Photograph taken facing south.

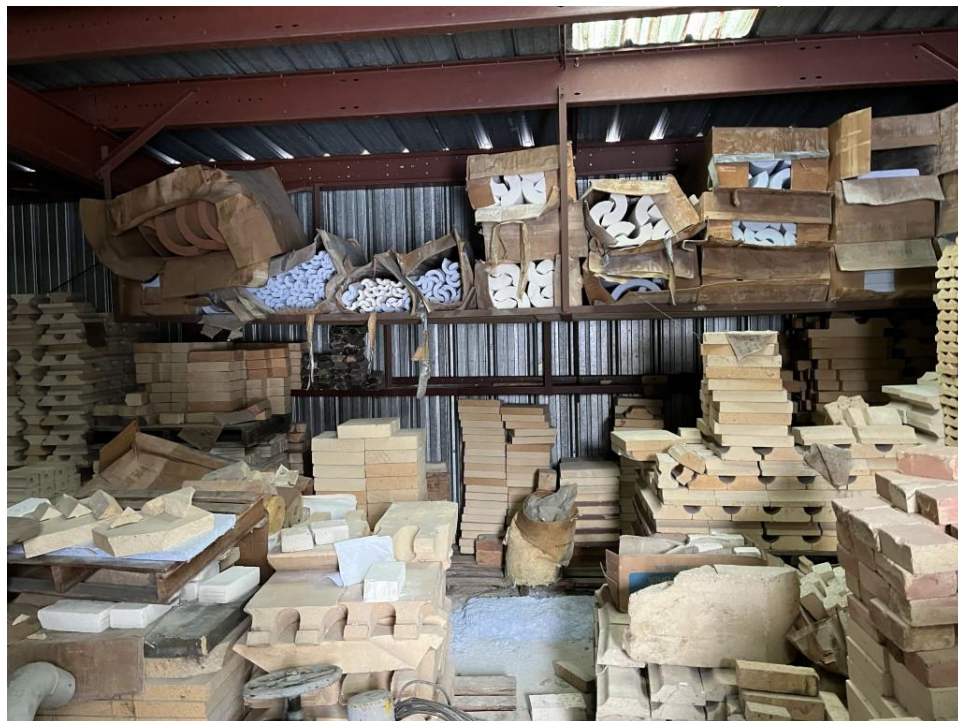
**SCENE:** View of unused pipe insulation and fire brick in the Southern Storage Building. Photograph taken facing east.

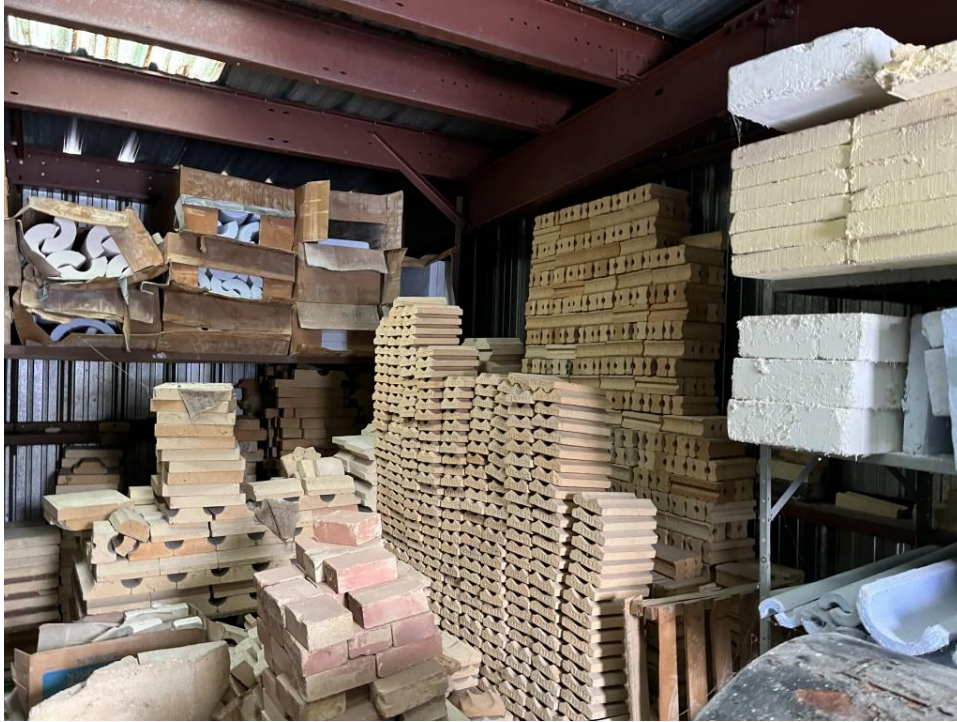
**SCENE:** View of unused pipe insulation and fire brick in the Southern Storage Building. Photograph taken facing northeast.

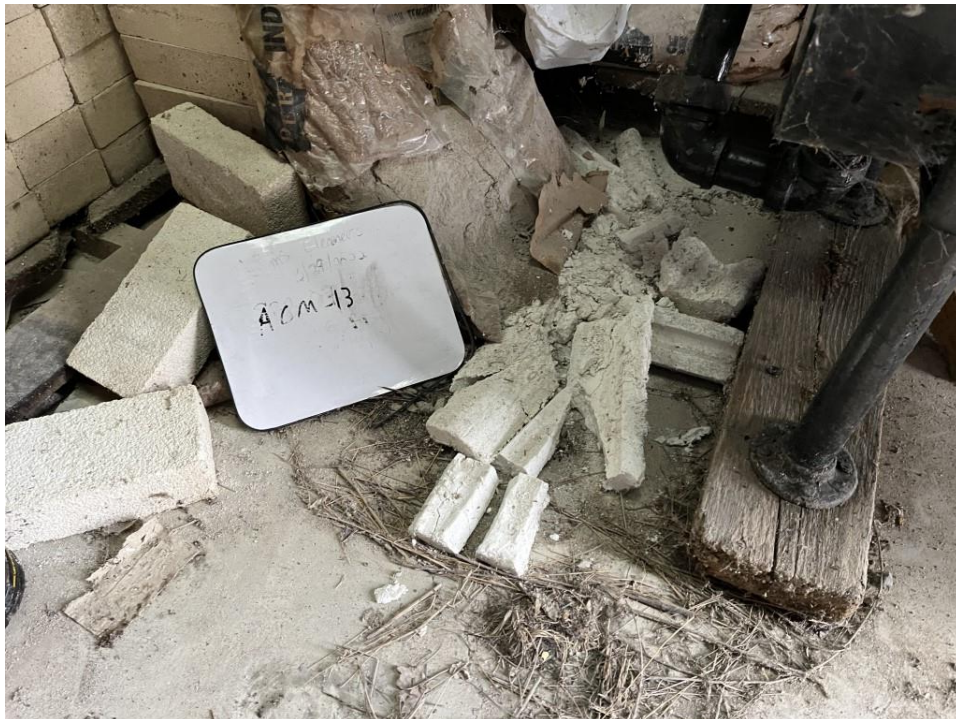
**SCENE:** View of sample location ACM-13, collected from unused white pipe insulation in the Southern Storage Building. Photograph taken facing southeast.

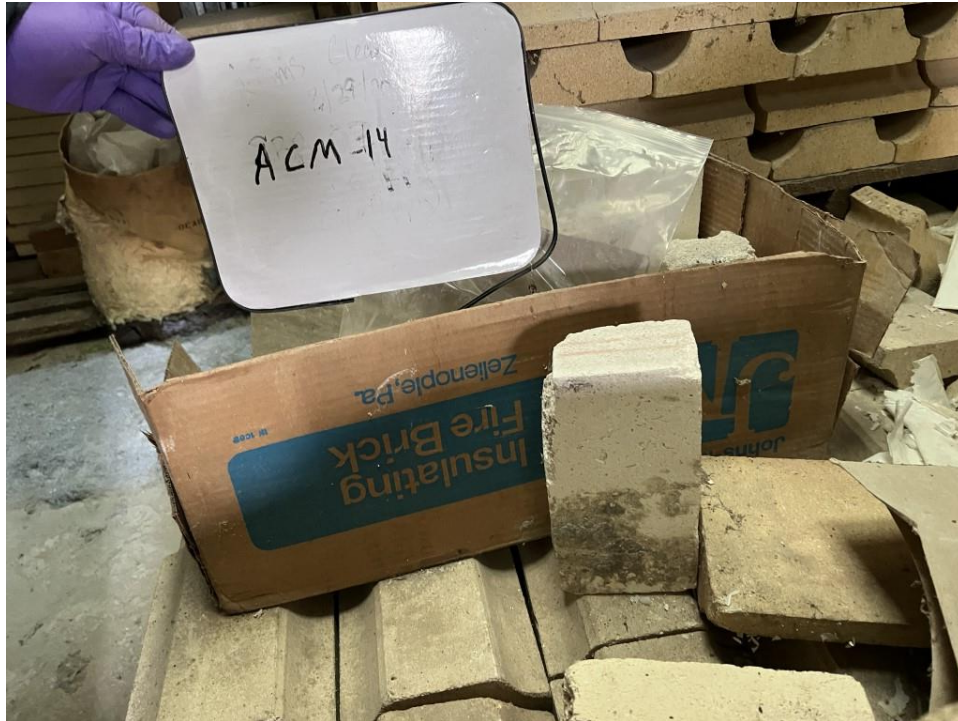
**SCENE:** View of sample location ACM-14, collected from unused Johns Manville fire brick in the Southern Storage Building. Photograph taken facing east.

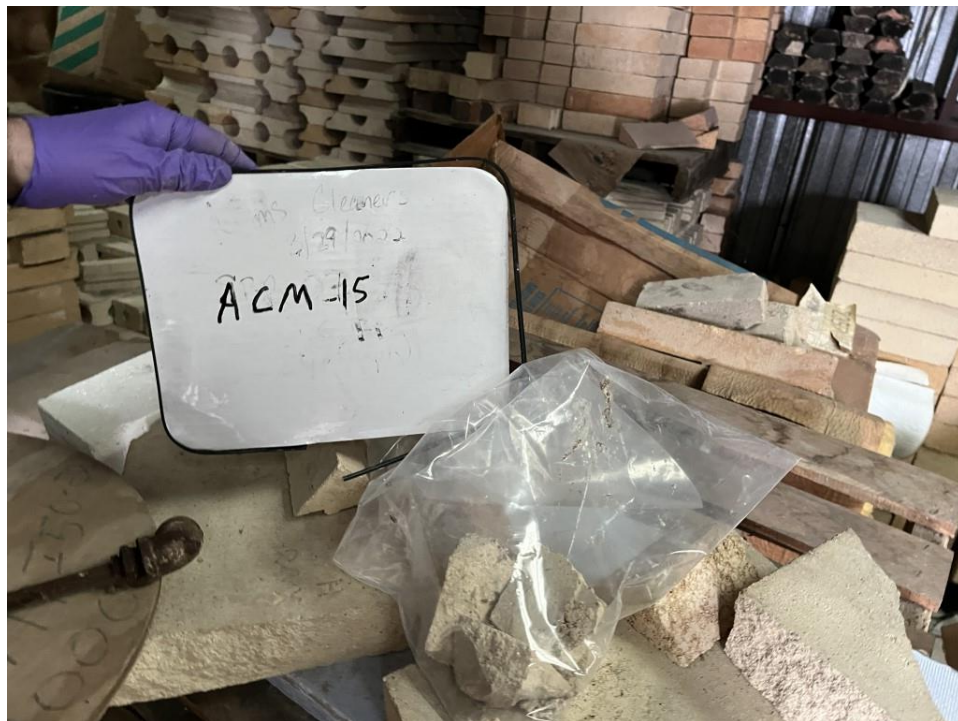
**SCENE:** View of sample location ACM-15, collected from yellowish fire brick in the Southern Storage Building. Photograph taken facing northeast.
