**Subject: Contract No. 68HERH19D0018; Task Order No. 68E0719F0190  
Pottawatomie Courthouse Structural Evaluation  
106 Main Street, Westmoreland, Pottawatomie County, Kansas  
Building Upgrade Cost Analysis**

**TARGETED BROWNFIELDS ASSESSMENT  
POTTAWATOMIE COURTHOUSE STRUCTURAL EVALUATION**

**POTTAWATOMIE COURTHOUSE  
106 MAIN STREET  
WESTMORELAND, POTTAWATOMIE COUNTY, KANSAS**

RE: Structural Investigation Report  
Pottawatomie County Courthouse Structural Assessment  
106 Main St  
Westmoreland, Kansas

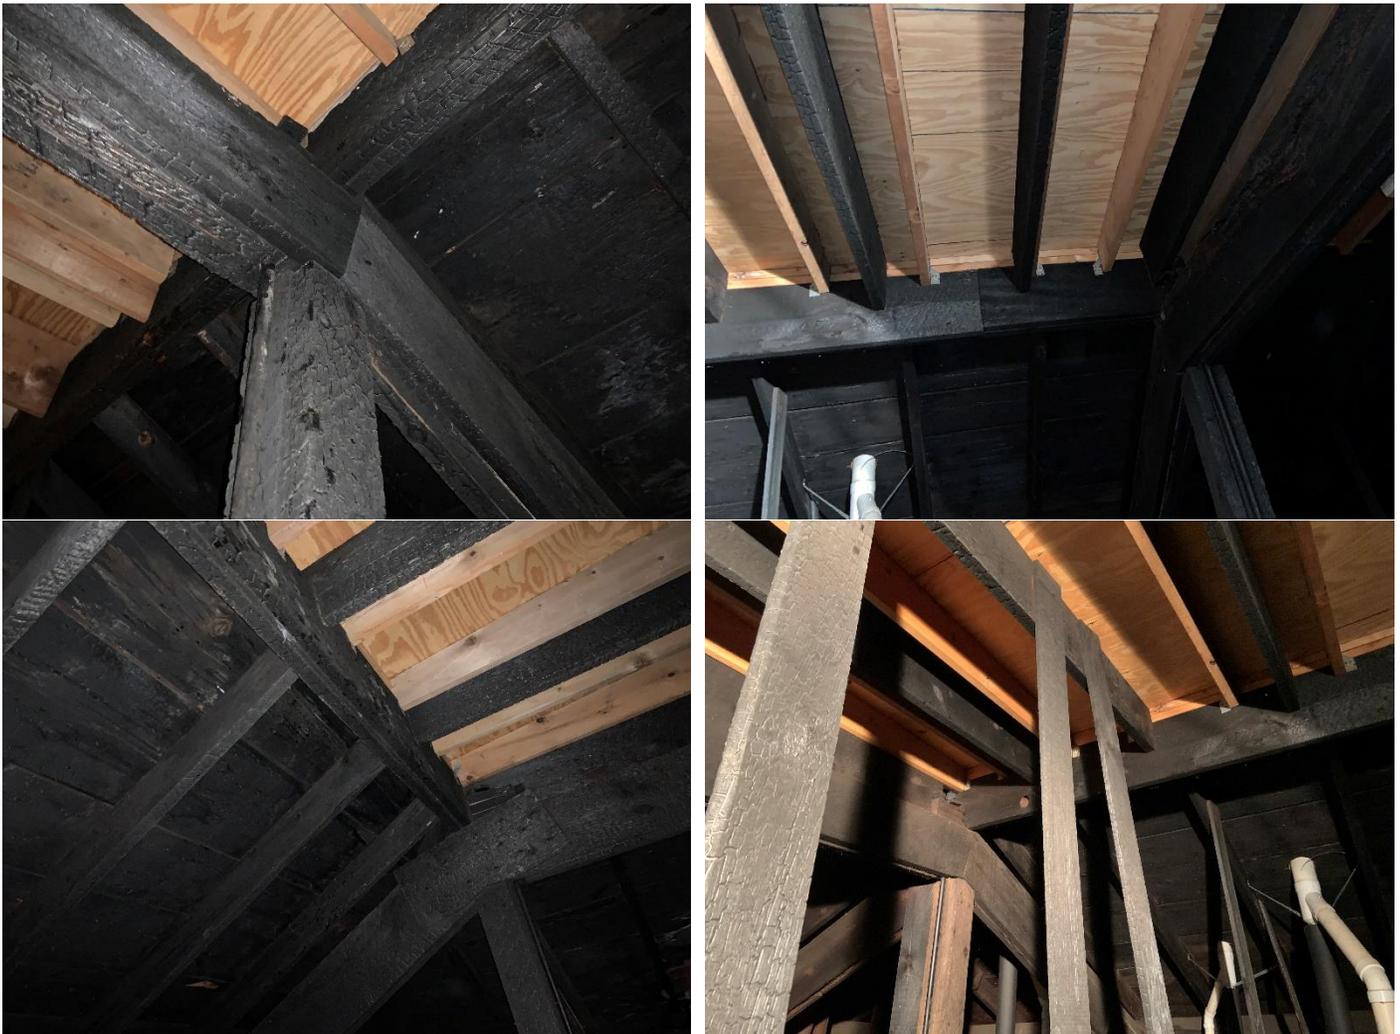
1. **Fire Damage** – Evaluation of the roof structure indicated a fairly well-designed roof, however, some areas of concern with various roof elements were observed. There is approximately 1,500 square feet (SF) of fire damage as outlined in the following pictures:

Based on the damaged observed, we recommend full replacement with equivalent sized members for all fire-damaged wood. We estimate the cost of this repair at \$90,000.00.

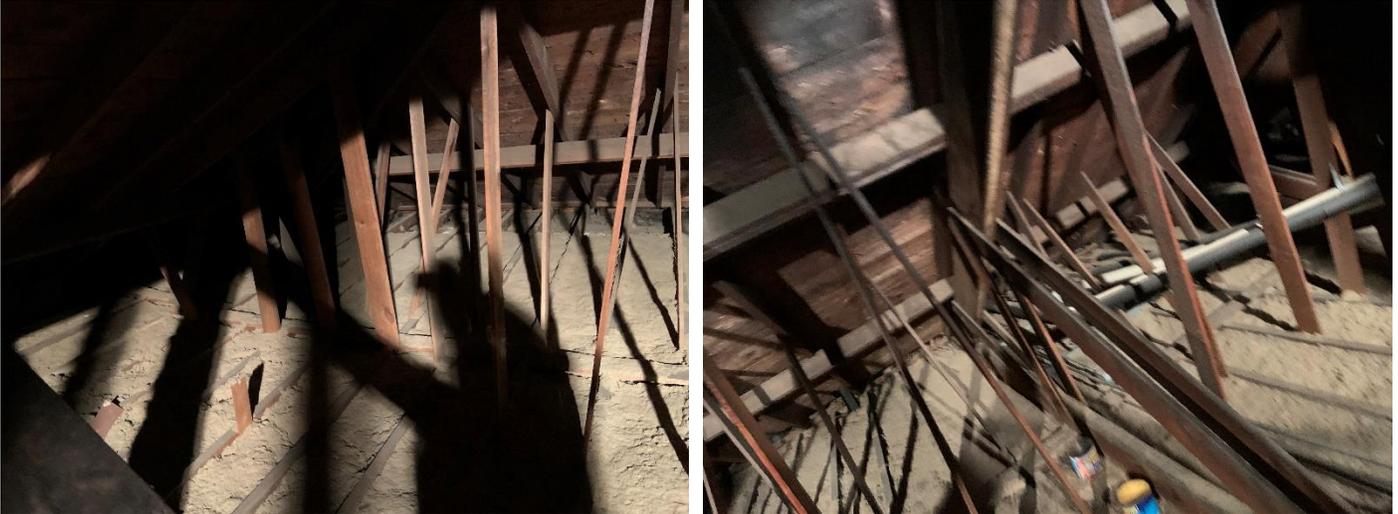
2. **Stiff-back Support** – The sloping rafters appear to need supplemental stiff-back support, which is presently constructed in rather unusual and variable patterns as shown in the following pictures:

We recommend reinforcement of all existing stiff-backs with a conventional reinforcing pattern. We estimate the cost of this repair at \$18,000.00.

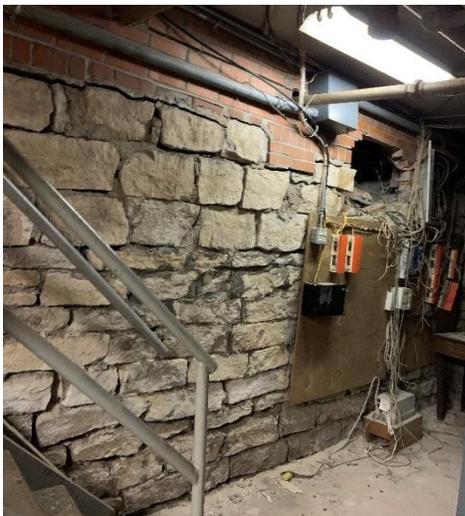
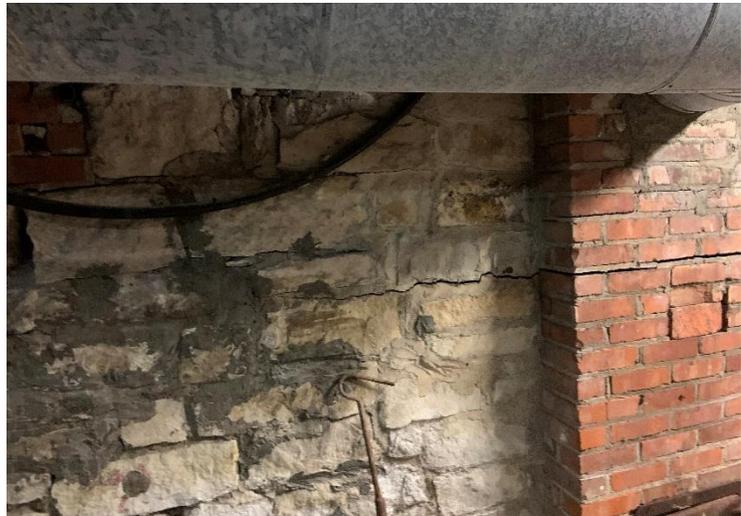
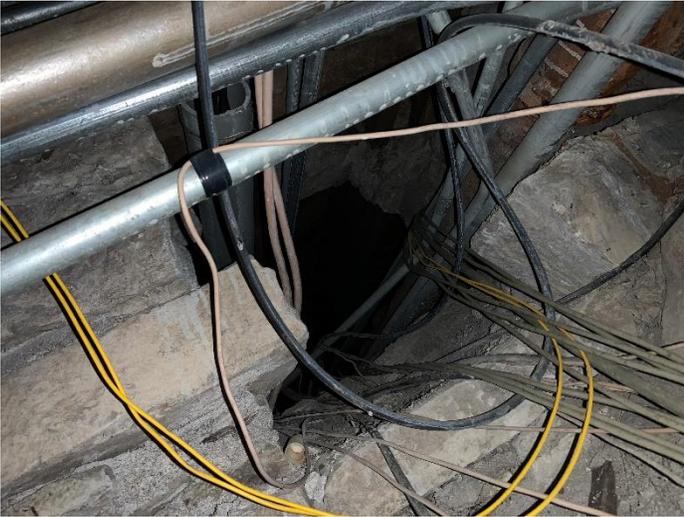
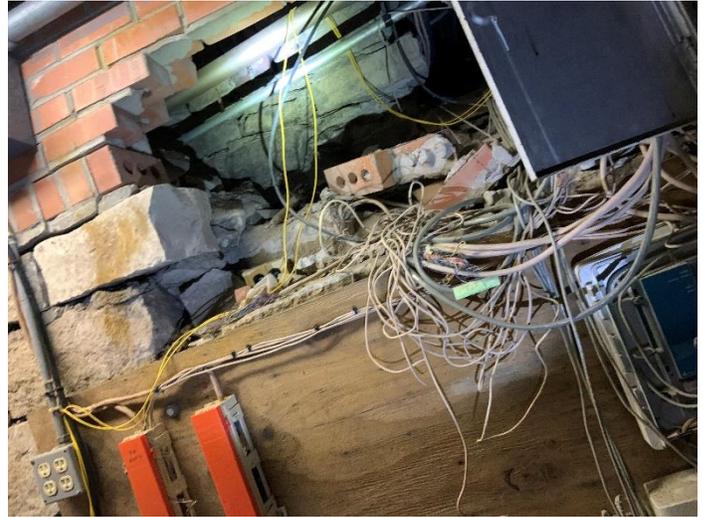
5. **Floor Framing** – Review of the first and second floor structures consisting of the rather simple framing of the 2x12s at 16" centers spanning east/west from bearing wall to bearing wall indicated a very well-designed floor more than capable of supporting present day live load of 100 lbs. per square foot (PSF) for a building of public use as required by today's building codes. Our only comment relative to the condition of these interior structures is that there is a need for some tuck-pointing/re-grouting/repair of stone masonry and shown in the following pictures:

We estimate the cost of this repair along with repair of item #6 below at \$125,000.00.

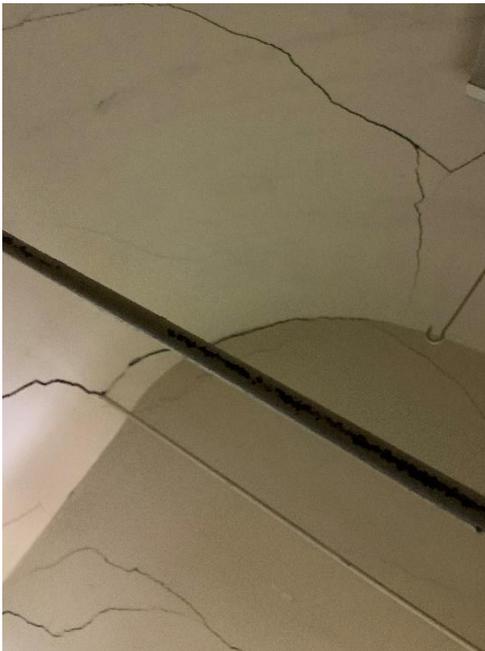
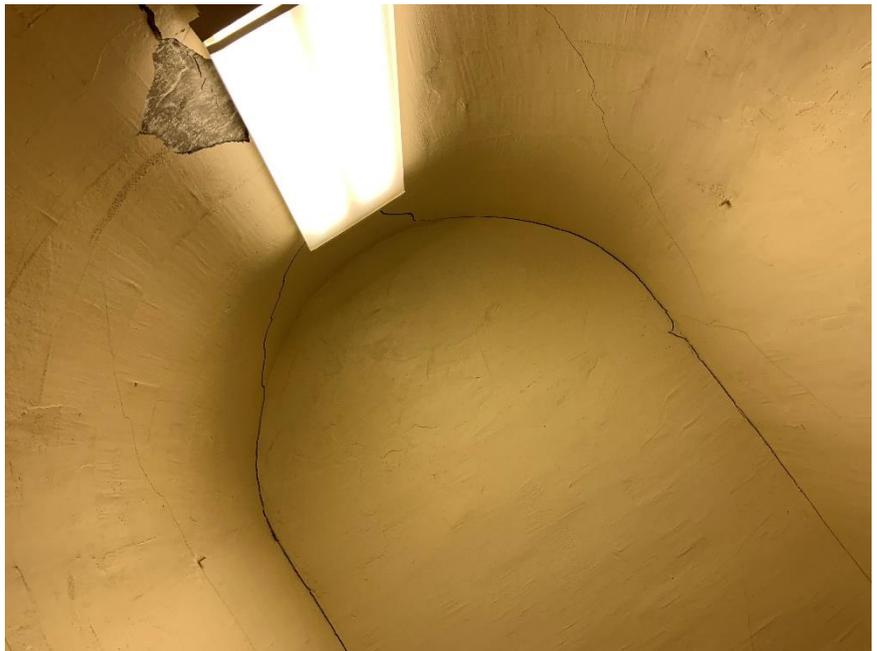
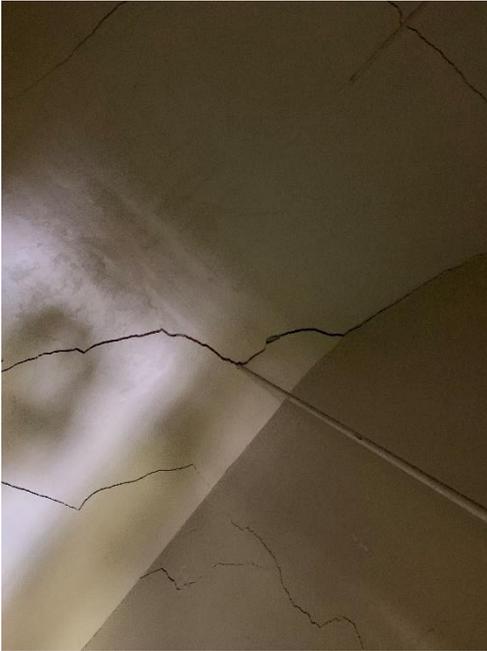
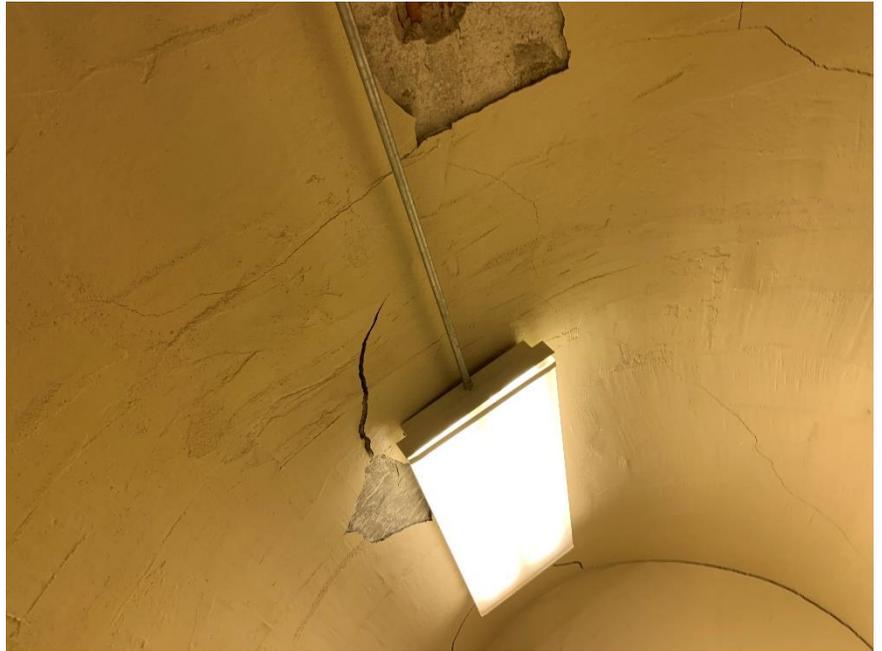
6. **Foundation Settlement** – Some foundation settlement has occurred over the past 138 years and some cracking has occurred, particularly in the vault areas, and is in need of repair as shown in the following pictures:

It may be prudent at the vault structure to remove the plaster and repair the stone to its original condition. These settlement cracks, which are quite old, are strictly cosmetic repairs to extend the serviceable life of this building.

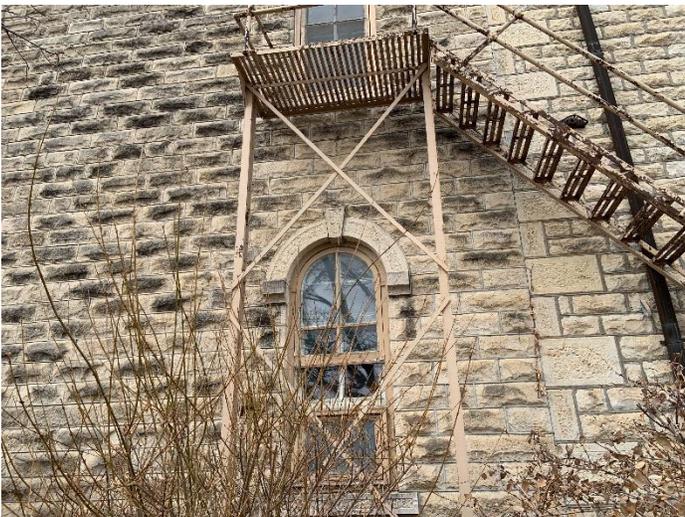
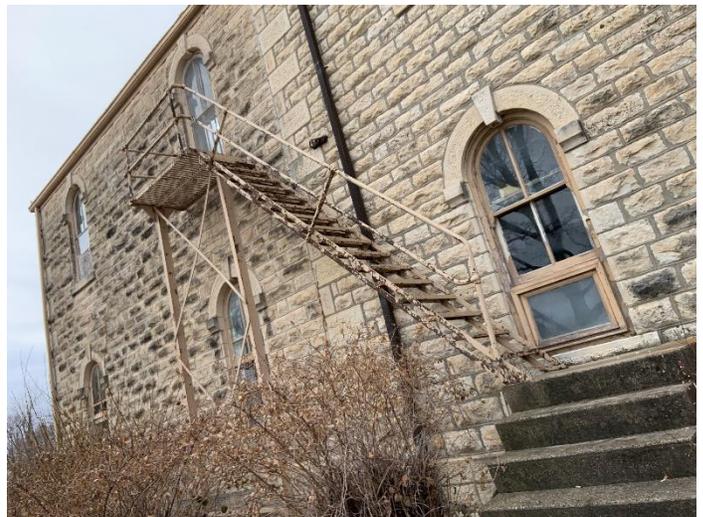
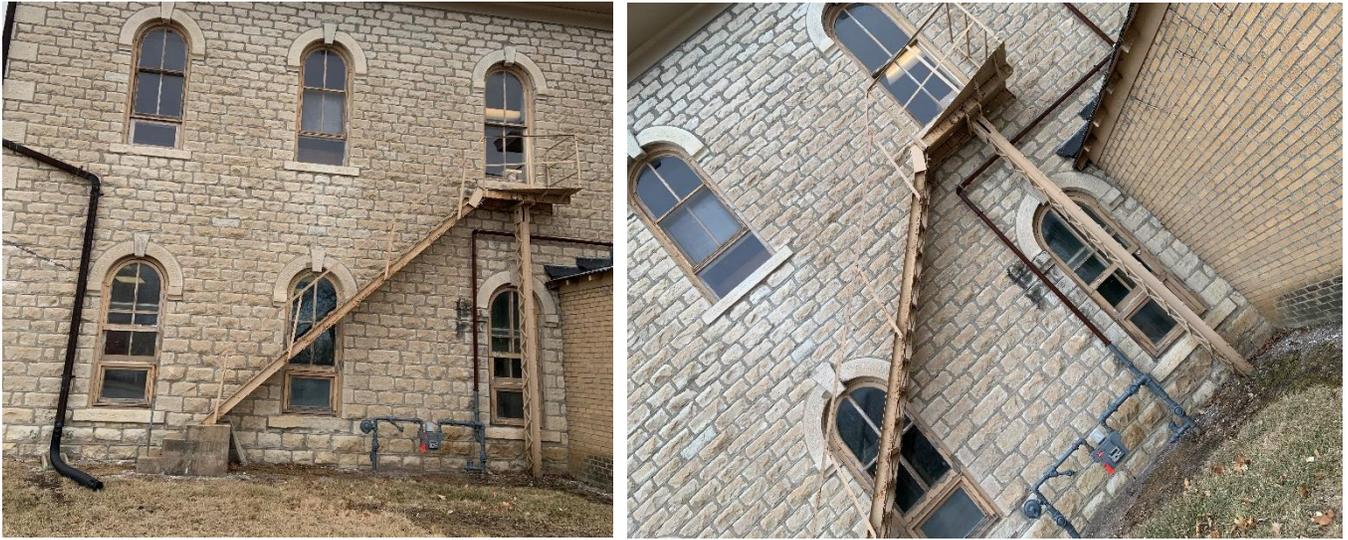
- Exterior Fire Escapes** – In review of the exterior of this building, structural steel fire escapes which were not part of the original construction but added at some time over the years (most probably in 1928/1929), are structurally inadequate by present day building code and would not satisfactorily serve as a means of egress for the building. Their demolition and reconstruction are recommended as part of any renovation of this building. The following pictures depict the condition of these fire escapes:

We estimate the cost of this repair at \$80,000.00

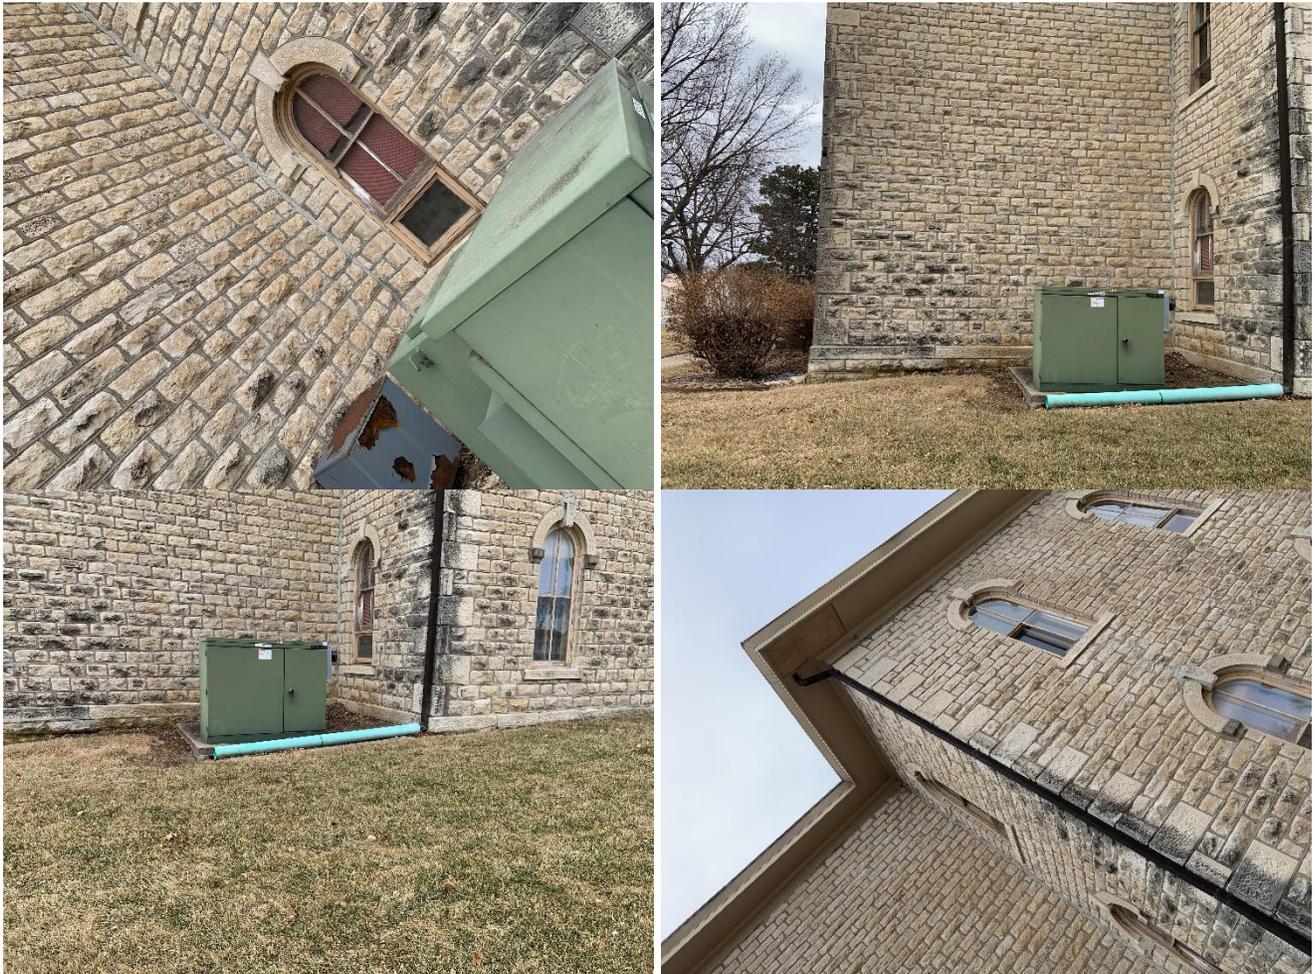
9. **Exterior Stone Masonry** – Around the exterior of this building, the stone masonry is in need of cleaning and limited tuck-pointing as shown in the following pictures:

We estimate the cost of the repair at \$75,000.00

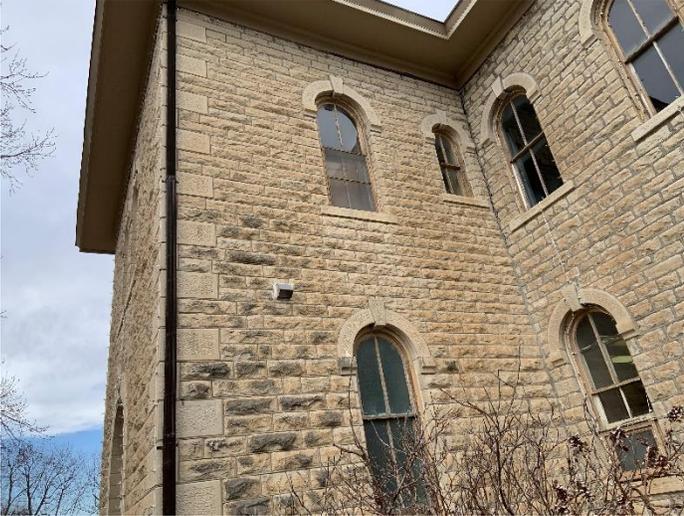
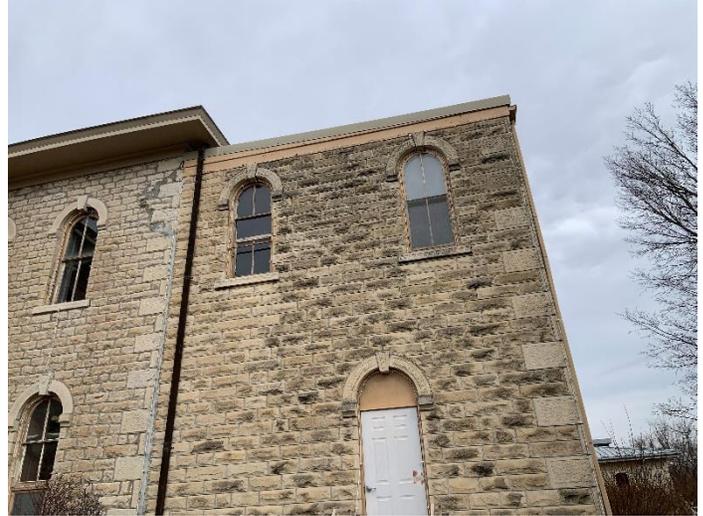
The masonry joints between the original 1884 structure and the additions constructed over the years are in need of special cleaning and tuck-pointing to restore them to their original conditions as shown in the following pictures:

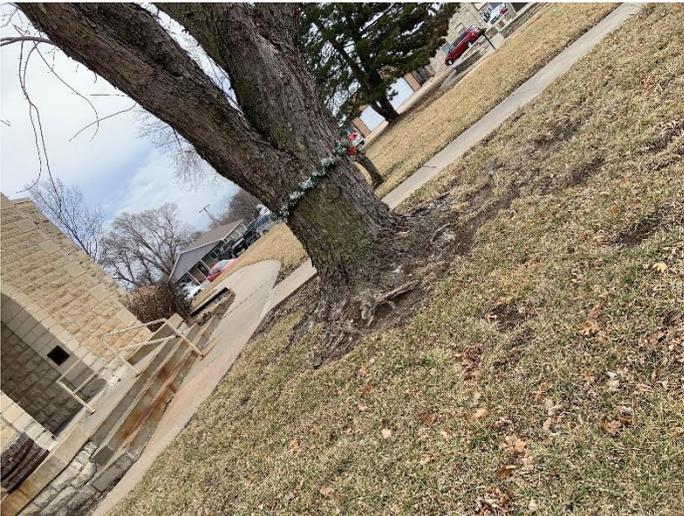
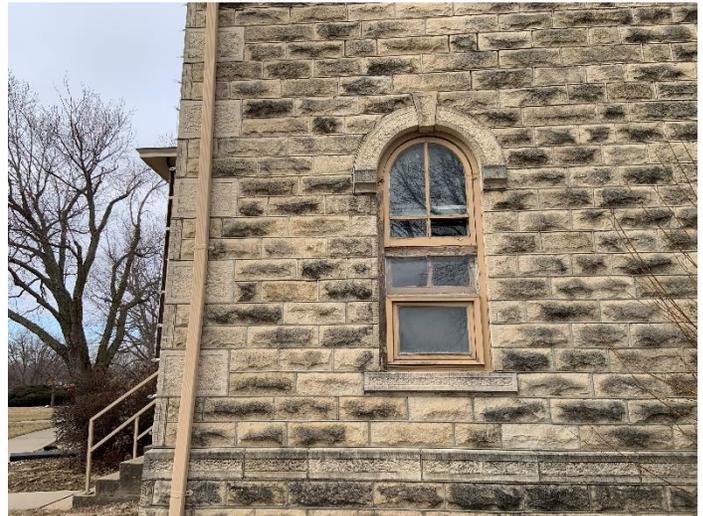
10. **Future Tree Removal** – Although not in the present scope, there are some rather large trees in close proximity to this building as shown in the following pictures:

Although we are not advocating for it at this time, there will be a day when these trees will threaten the integrity of this building and most probably will be in need of future removal.
